ACTEW Water  
Murrumbidgee Ecological Monitoring Program  
Burra Creek Geomorphology Update

June 2015

This report serves as an update to the previous report in April 2014. Updates to some site surveyed transects have been included along with visual inspections at key sites. Updated transects have been overlaid with previous transects for ease of comparison.

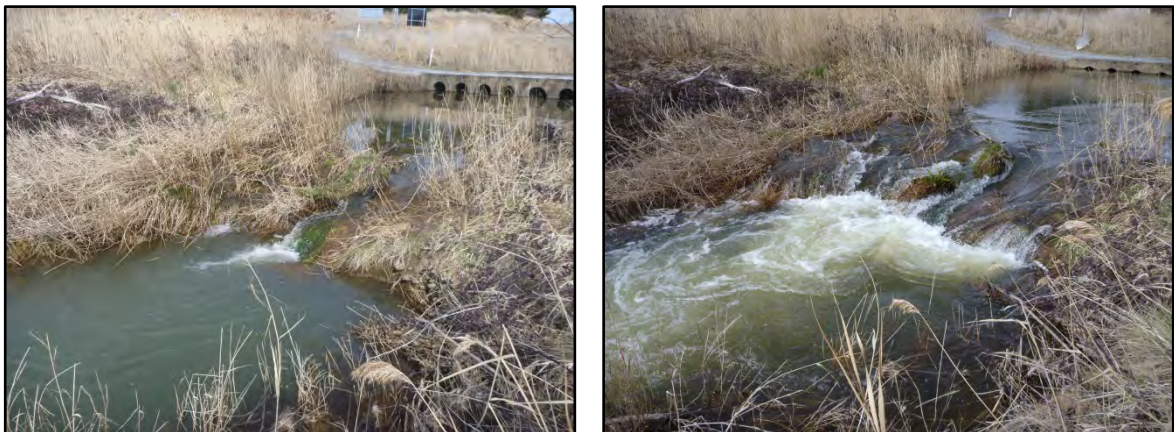
Plate 1. Step with moderate adjustment potential immediately downstream of Williamsdale Road, left at < 5 ML/d, right at 100 ML/d

There was potential for a small step (assessed as moderate) located immediately downstream of Williamsdale Road to be adjusted as a result of continuous increased flows from pumping. Plate 1 shows this section of creek at a flow of < 5 ML/d and at 109 ML/d. This step has recently heavily re-vegetated as flows have not been high enough to scour the channel.

In its current condition, flow from the M2G discharge is unlikely to create erosion of the central channel section. Sediment bars are unlikely to be eroded by normal pumping flows. This may change with further adjustments to the system from natural large events.

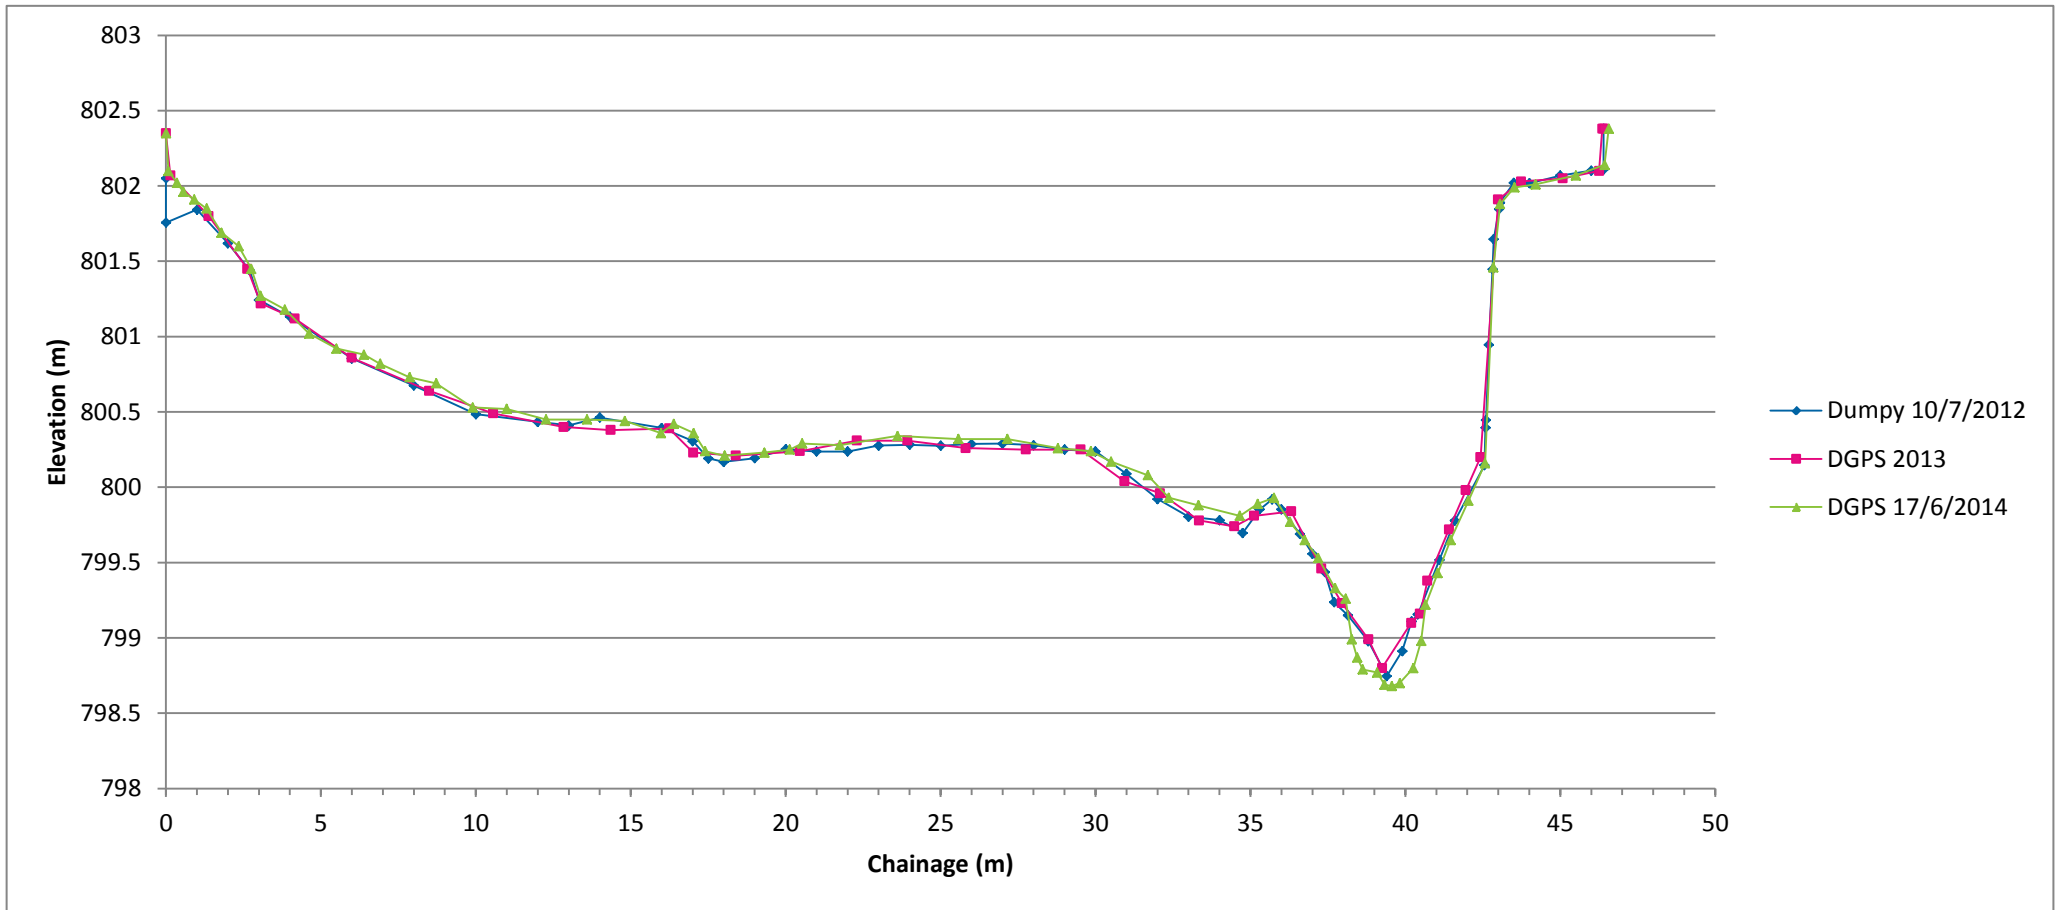
Figure 20 - BUR1 XS-1

- The 2013 cross section taken using a DGPS unit (Red) closely matches the cross section recorded by dumpy in 2012(Blue)
- The 2014 cross section closely matches previous sections except for in the bottom of the channel, which shows widening of the channel.

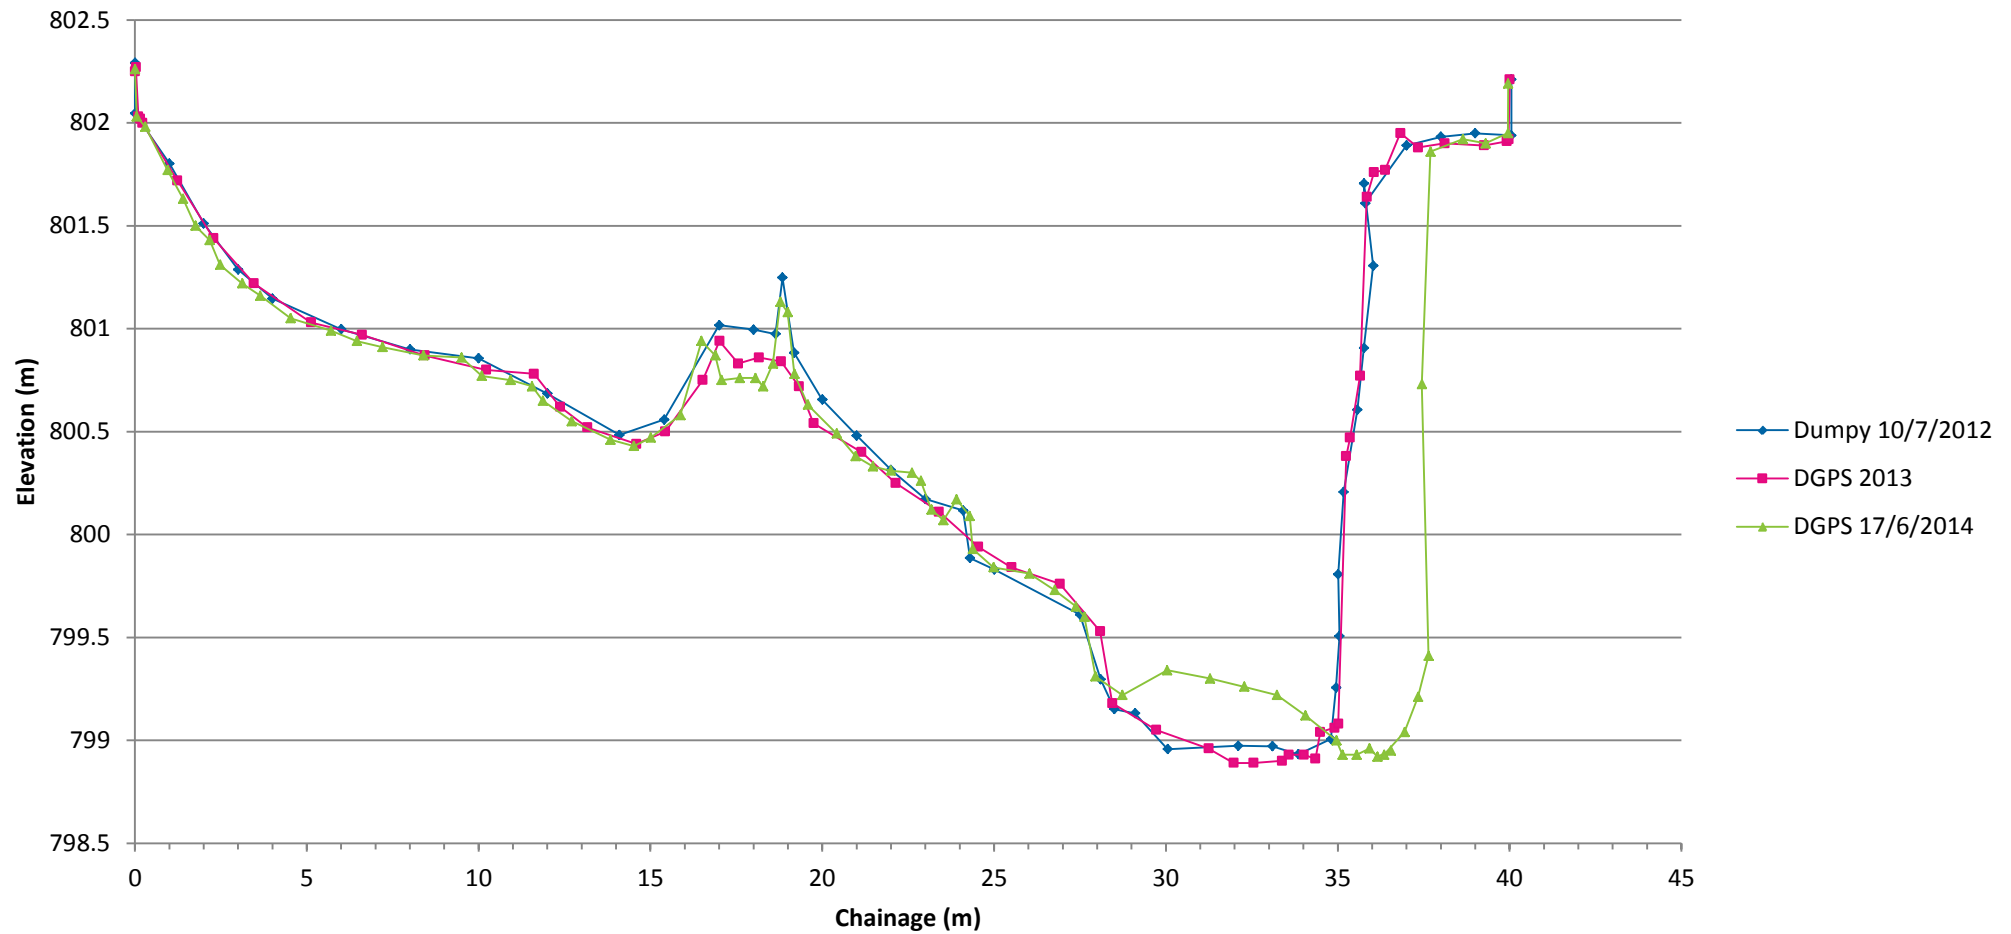
Figure 21 - BUR1 XS-2

- The 2013 cross section taken using the DGPS unit (Red) closely matches the cross section recorded by dumpy in 2012 (Blue)
- Difference at CH16-20m due to flood debris that has moved or eroded away. Peak point ~CH19m on top of log.
- The 2014 cross section closely matches on the left hand side, however the right hand side shows some erosion to the bank. Some of the difference is due to the sheer vertical bank making it difficult to take sections exactly up the same part of the bank as previously, actual material removal from the bank is ~1m.
- Left hand side of the channel at chainage 30m, which is on the inside of the bend, shows deposition of material from high flows.

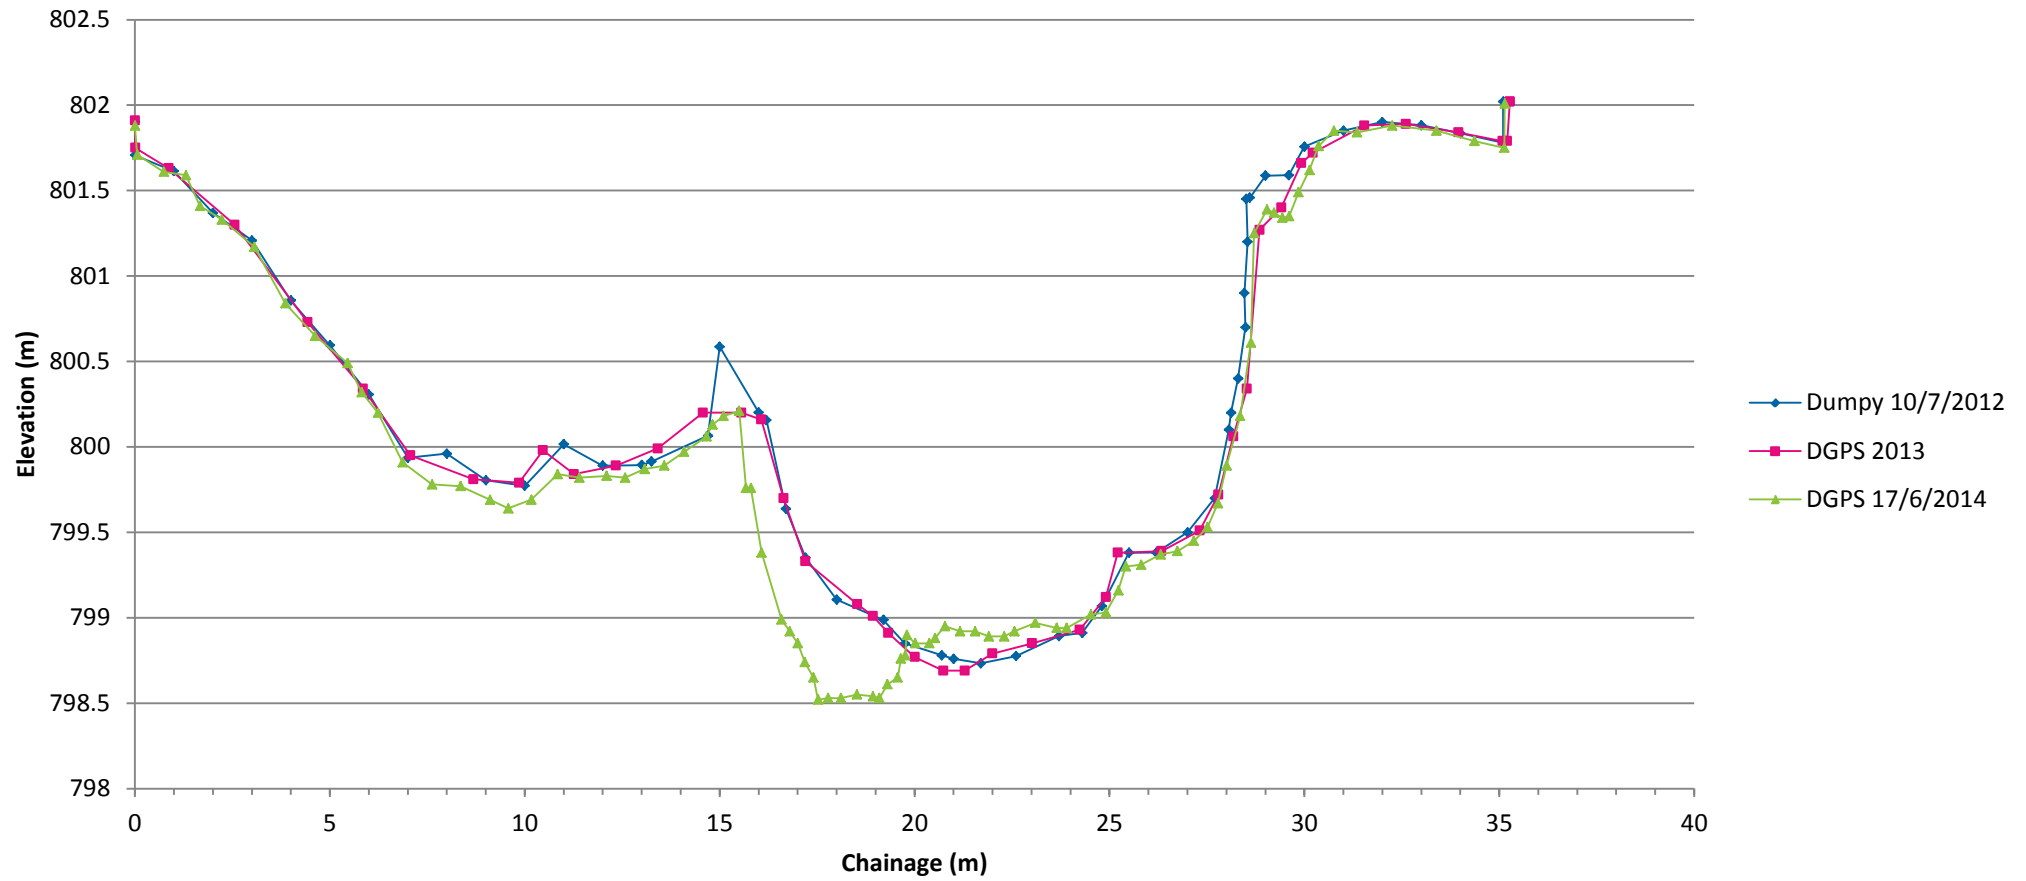
Figure 22 - BUR1 XS-3

- The 2013 cross section taken using the DGPS unit (Red) closely matches the 2012 cross section recorded by dumpy (Blue)
- Some erosion from top of bank at ~CH29m
- Spike at ~CH15m difference due to flood debris, top of branch.
- The 2014 cross section closely matches the 2013 section, however the central channel has shifted from chainage 22m to 18m, and become deeper and more defined.

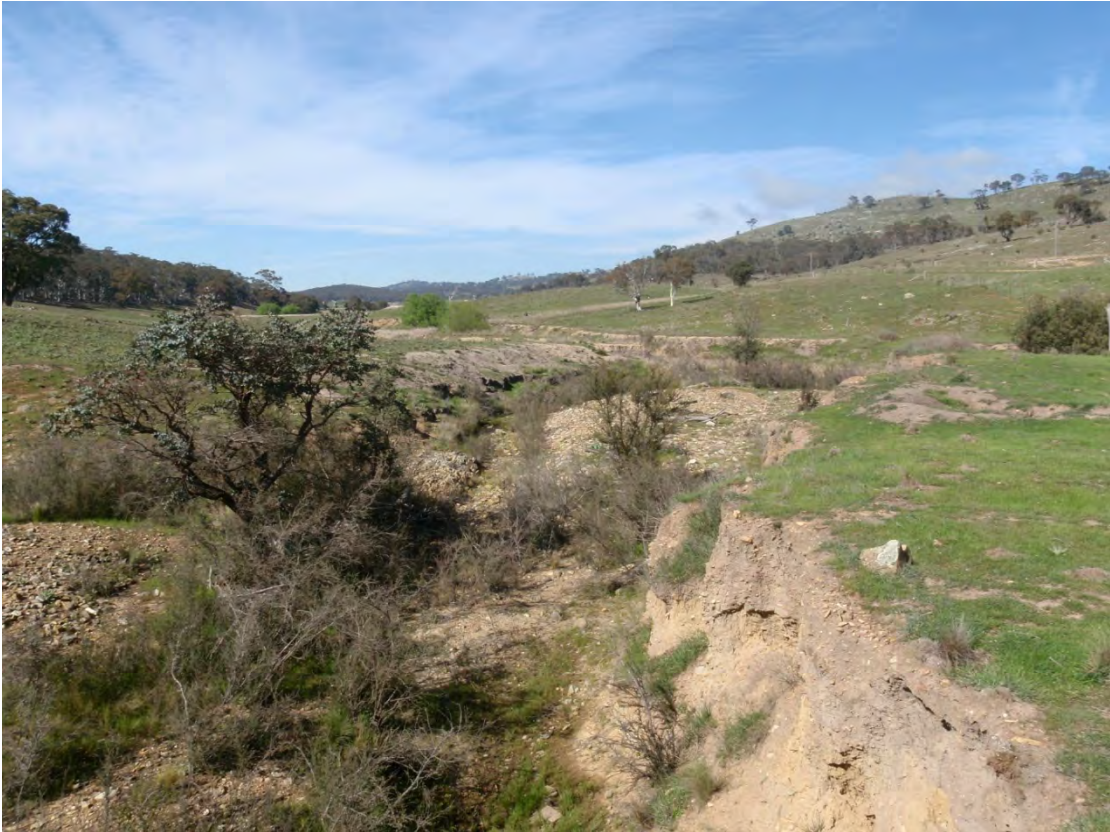
<p data-bbox="165 1055 552 1084">Photo 6 - BUR1 24/10/2009</p>	<ul style="list-style-type: none"> <li>- First photo on record for BUR1</li> <li>- Evidence of erosion outside of bend.</li> <li>- Stable vegetation on 60%-80% of visible stream banks.</li> <li>- Sediment deposits within channel.</li> <li>- Creek channel dry.</li> </ul>
  <p data-bbox="165 1957 536 1986">Photo 7 - BUR1 9/12/2010</p>	<ul style="list-style-type: none"> <li>- DS of BUR1 sample area at Cassidy's Crk confluence.</li> <li>- Turbid Burra Creek flowing left to right bottom of photo.</li> <li>- Less suspended material entering through Cassidy's Ck, due to less bank erosion and highly vegetated channel.</li> </ul>

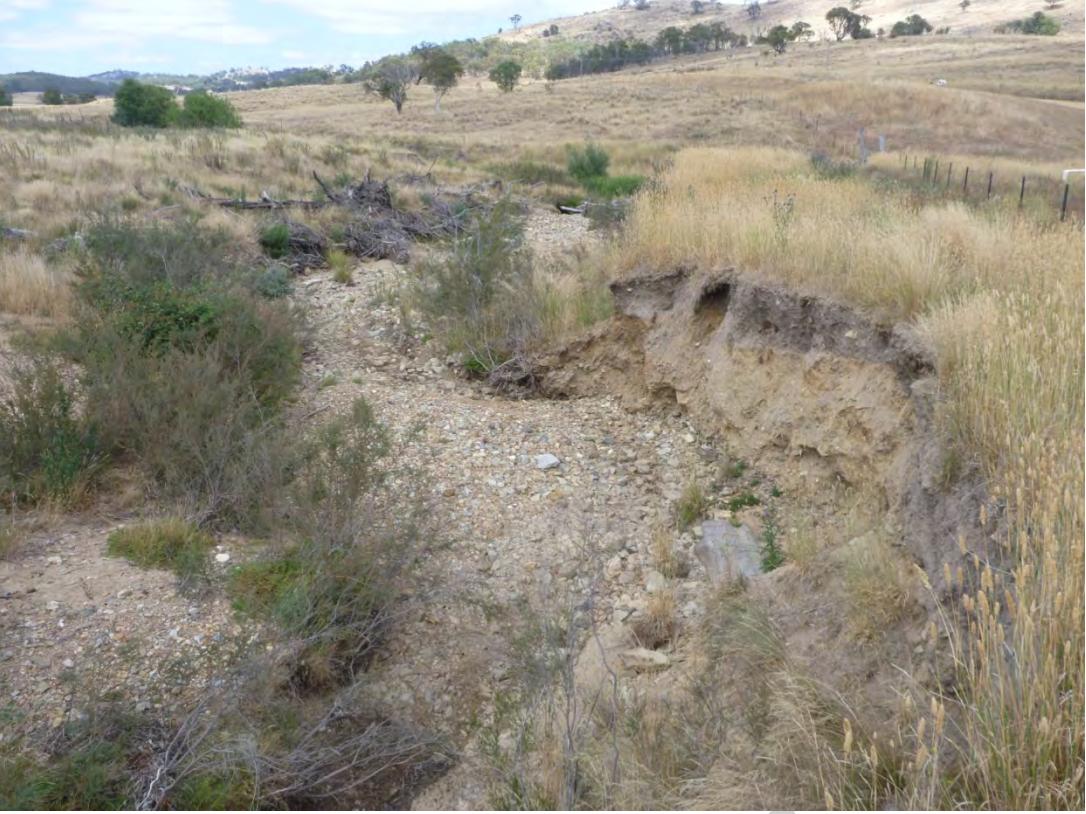
<p data-bbox="165 965 552 994">Photo 14 - BUR1 24/1/2013</p>	<ul data-bbox="1241 181 1509 479" style="list-style-type: none"> <li>• Summer die off of grasses</li> <li>• Increased vegetation recovery from previous year</li> <li>• Surface flow has ceased but sub surface remains moist</li> </ul>

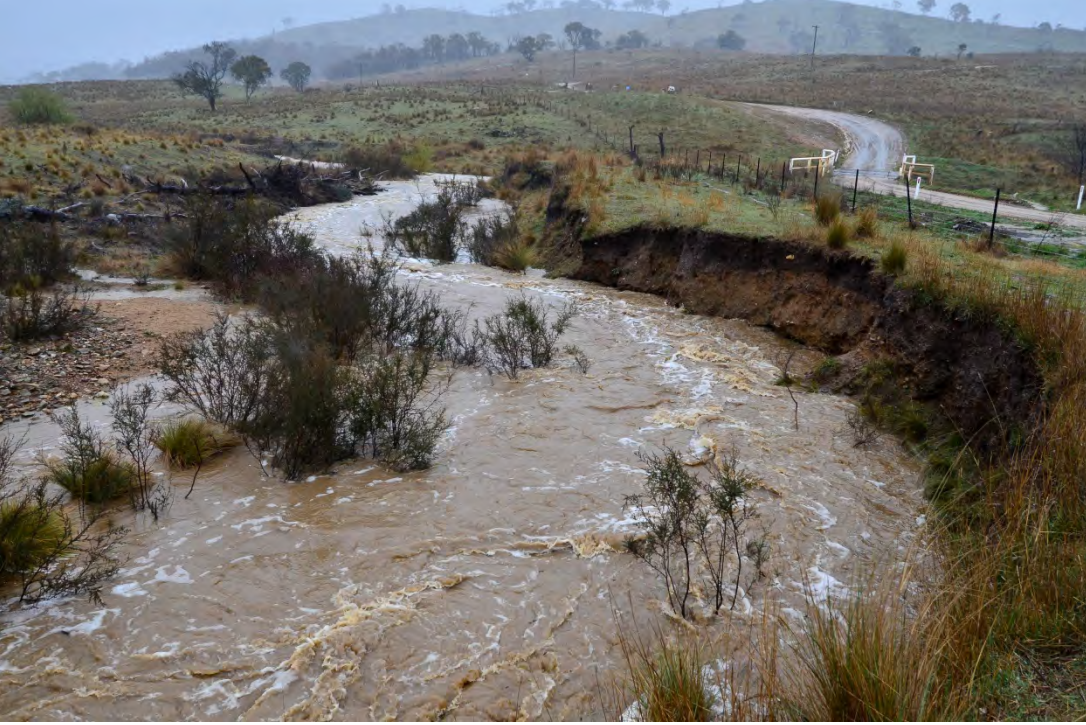
<p data-bbox="165 1749 552 1778">Photo 15 - BUR1 17/9/2013</p>	<ul data-bbox="1241 1025 1509 1106" style="list-style-type: none"> <li>- 3000 MI/d event (1 in 3yr ARI)</li> <li>-</li> </ul>

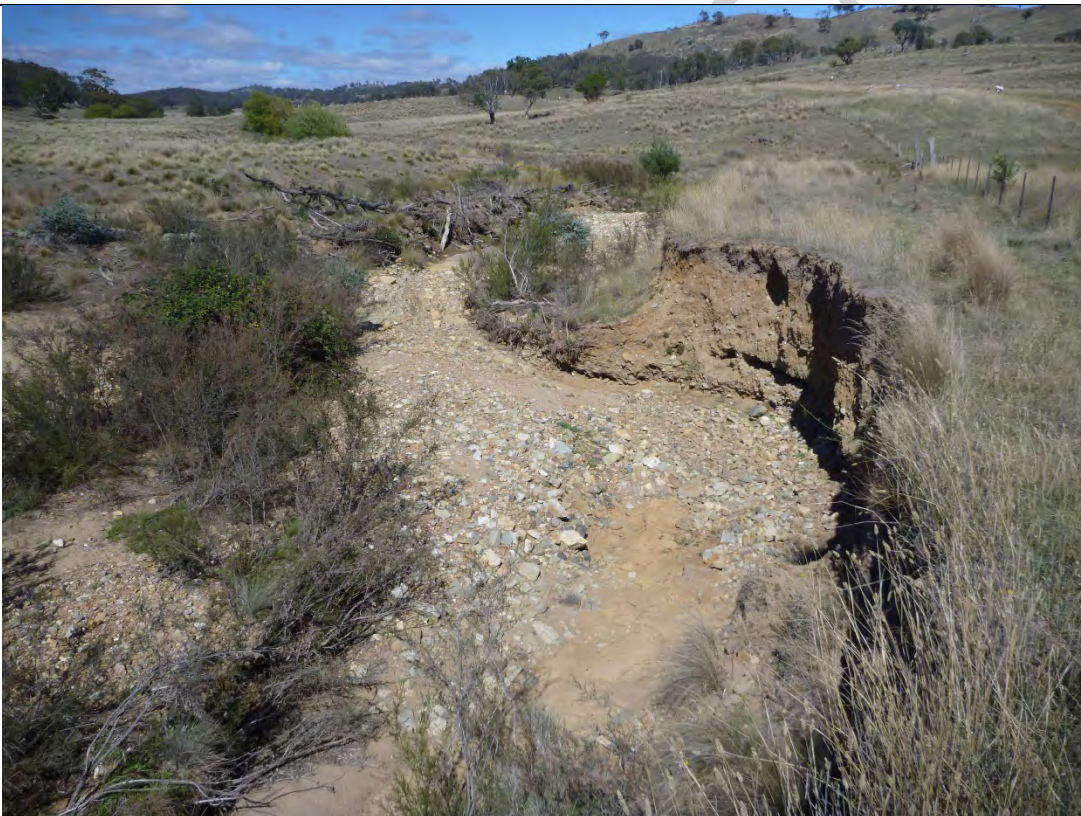
Photo 19 - BUR1 17/3/2014

- Dry conditions causing grass die off.

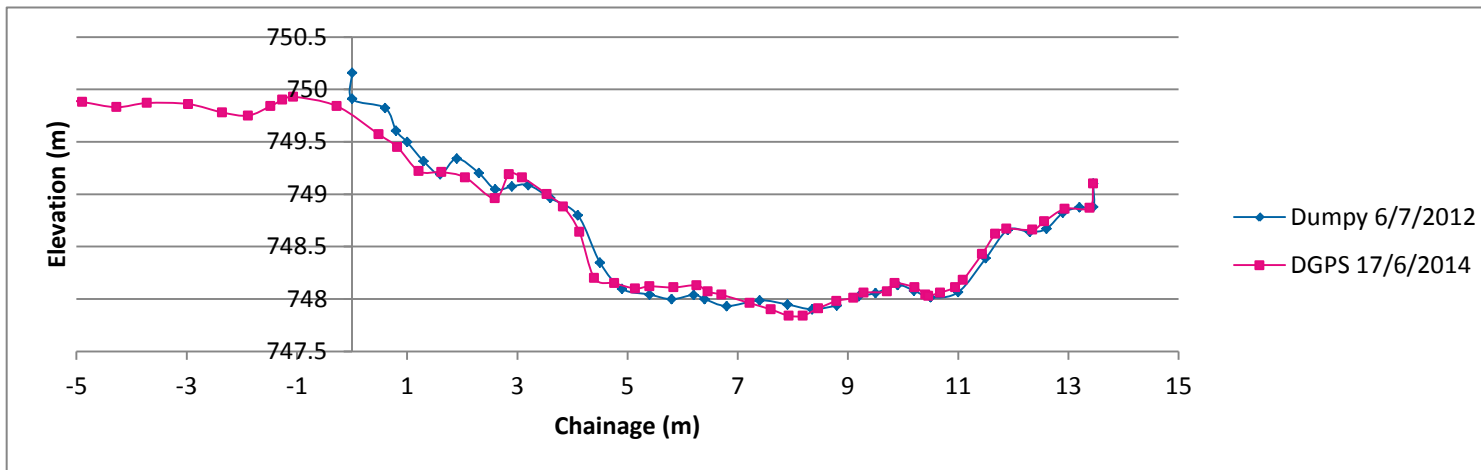
Figure 27 - BUR1C XS-3

- 2012 and 2014 cross sections closely match, marker pegs could not be found in 2012 for exact points, survey in 2014 was made using GPS coordinates. Minor differences due to vegetation.

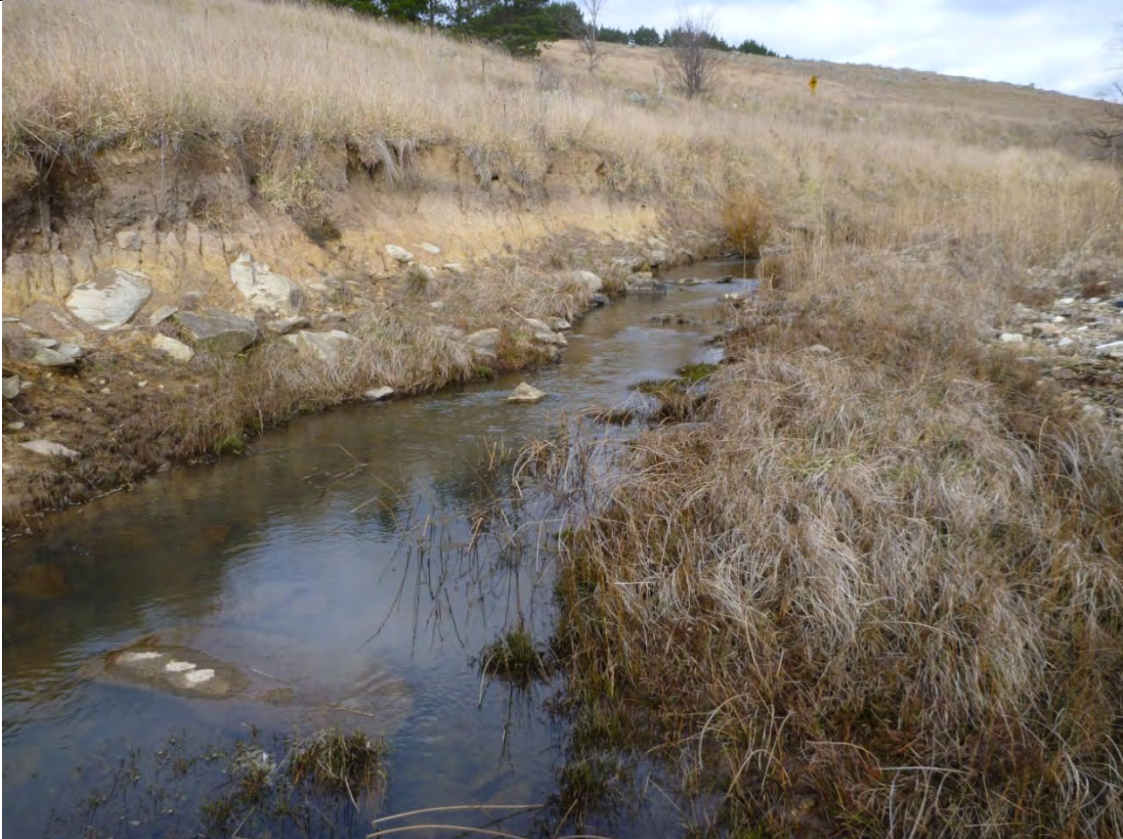
<p data-bbox="183 985 574 1019">Photo 29 - BUR2A 5/7/2012</p>	<ul style="list-style-type: none"> <li>- Normal water levels</li> <li>- Evidence of vegetation die off during winter months for emergent macrophytes</li> </ul>

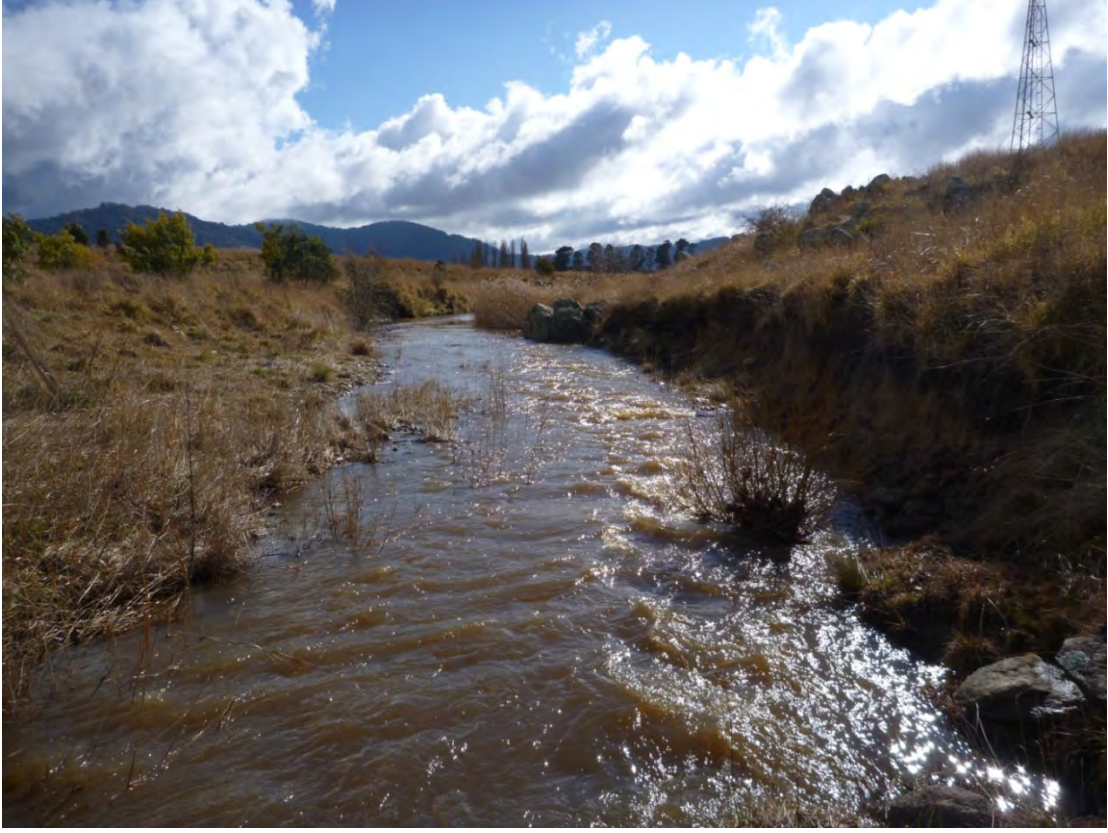
<p data-bbox="183 1877 590 1910">Photo 30 - BUR2A 13/7/2012</p>	<ul style="list-style-type: none"> <li>- Med flow event - ~110ML/d</li> </ul>

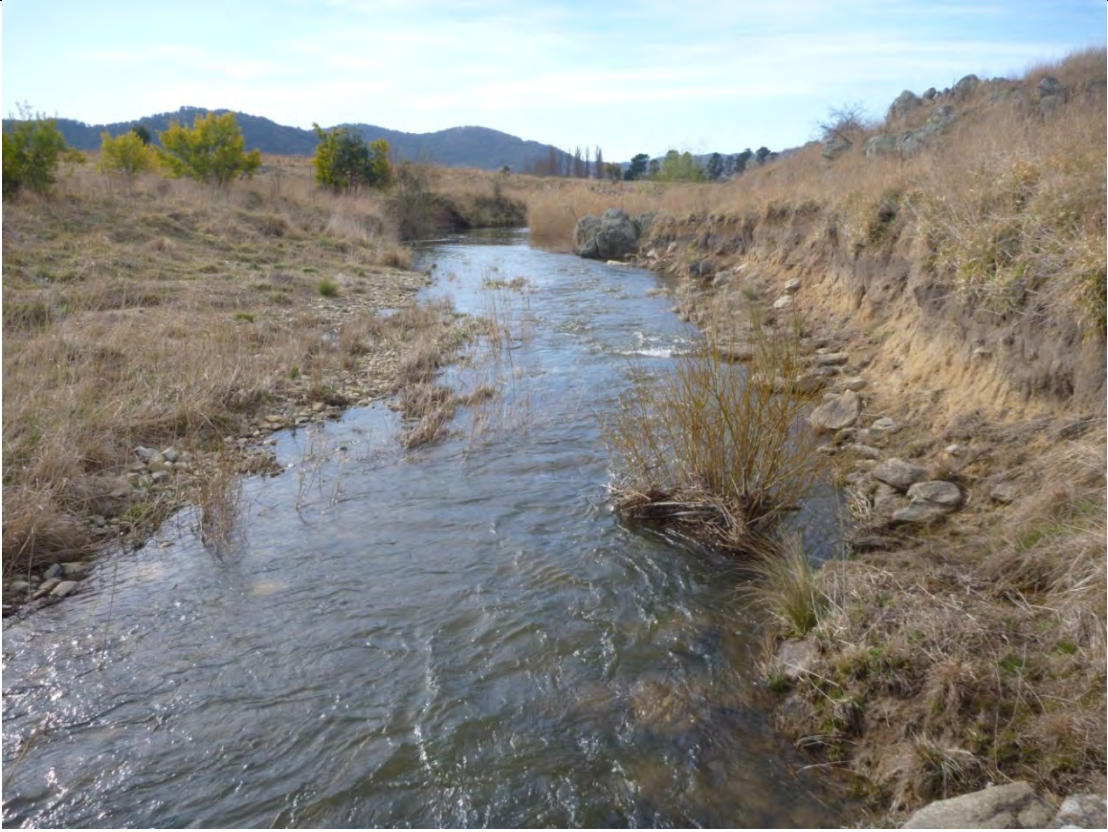
<p data-bbox="183 974 598 1008">Photo 31 - BUR2A 10/9/2012</p>	<ul style="list-style-type: none"> <li data-bbox="1260 145 1508 414">- Med flow event (This includes an M2G pump maintenance run ~20ML/d +~5ML/d baseflow)</li> <li data-bbox="1260 425 1508 571">- No evidence of new bank erosion from pumped flow</li> <li data-bbox="1260 582 1508 627">- Turbidity low</li> </ul>

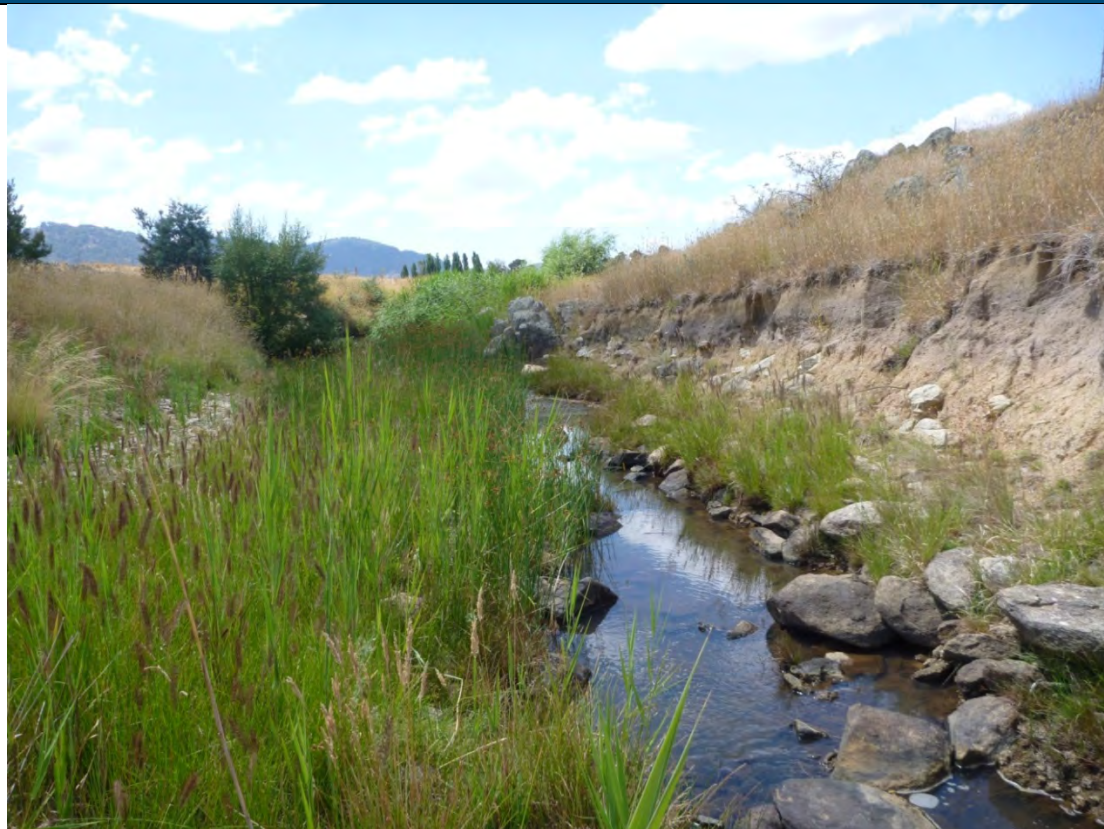
Photo 33 - BUR2A 24/1/2013

- Noticeable increase in reed growth along left side of stream

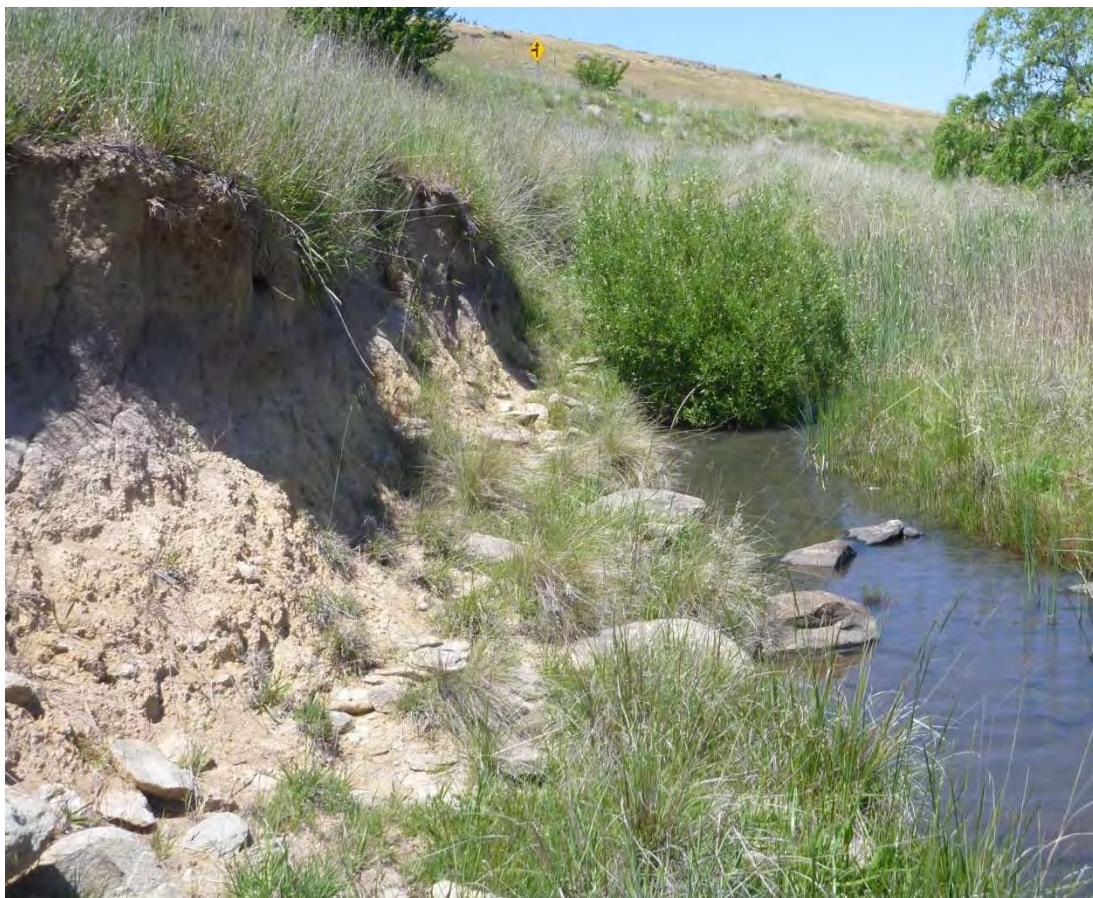
Photo 36 - BUR2A 4/11/2014

- Vegetation growth on banks has prevented any significant erosion.

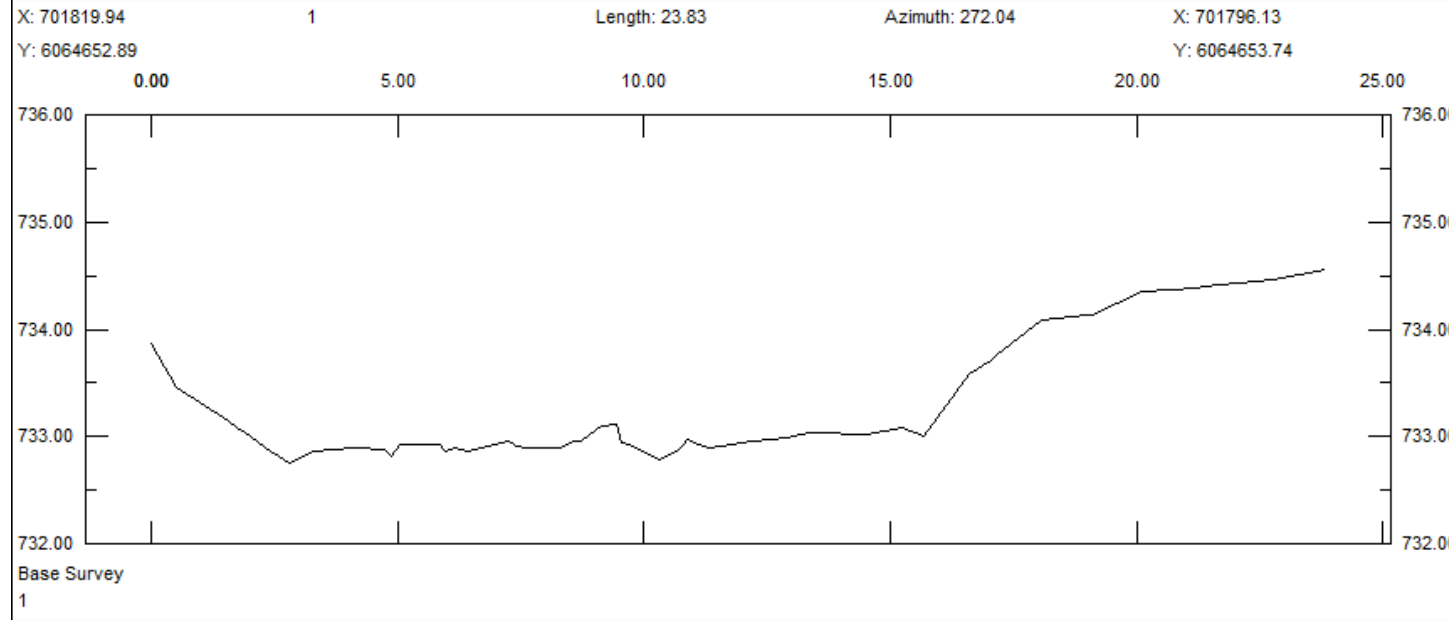
Figure 40 - BUR U/S Pool 50 3D GPS XS-1

- DGPS survey longer than Dumpy cross section to accommodate 3D profiling
- Original survey pegs could not be found at time of 3D survey.
- Channel sections indicate similar profile, accurate survey needed to re-establish section

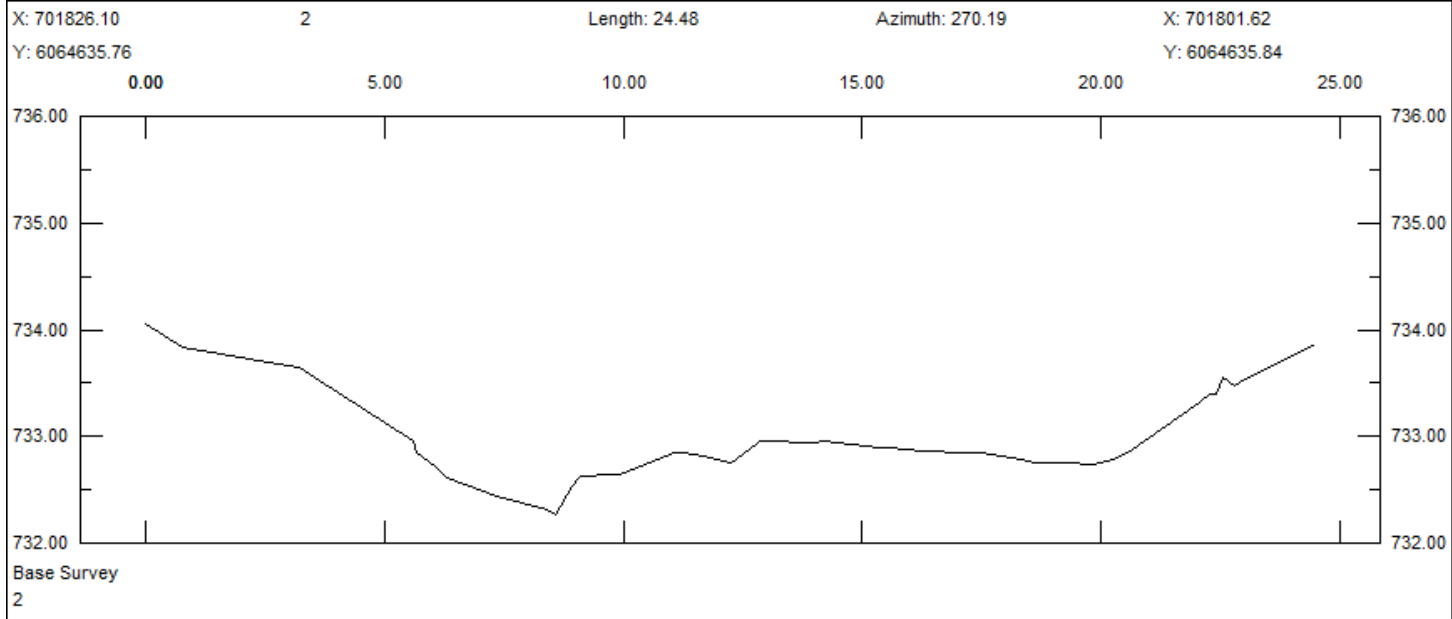
Figure 42 - BUR U/S Pool 50 3D GPS XS-2

- DGPS survey longer than Dumpy cross section to accommodate 3D profiling
- Original survey pegs could not be found at time of 3D survey.
- Channel sections indicate similar profile, accurate survey needed to re-establish section

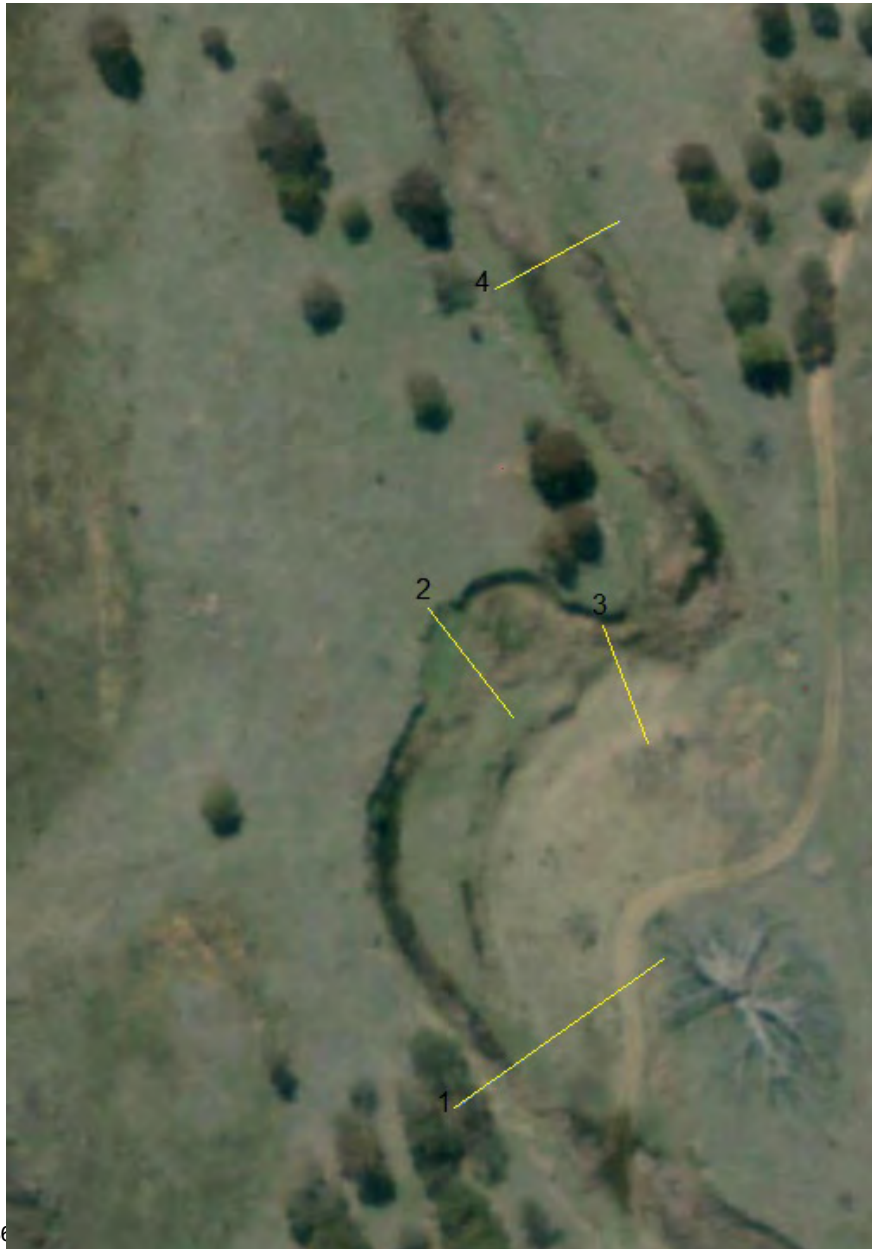
Yellow lines indicate location of cross-sections at BUR2C.

Some original cross-section pegs have moved due to erosion effects or earthwork impact from moving of the creek crossing.

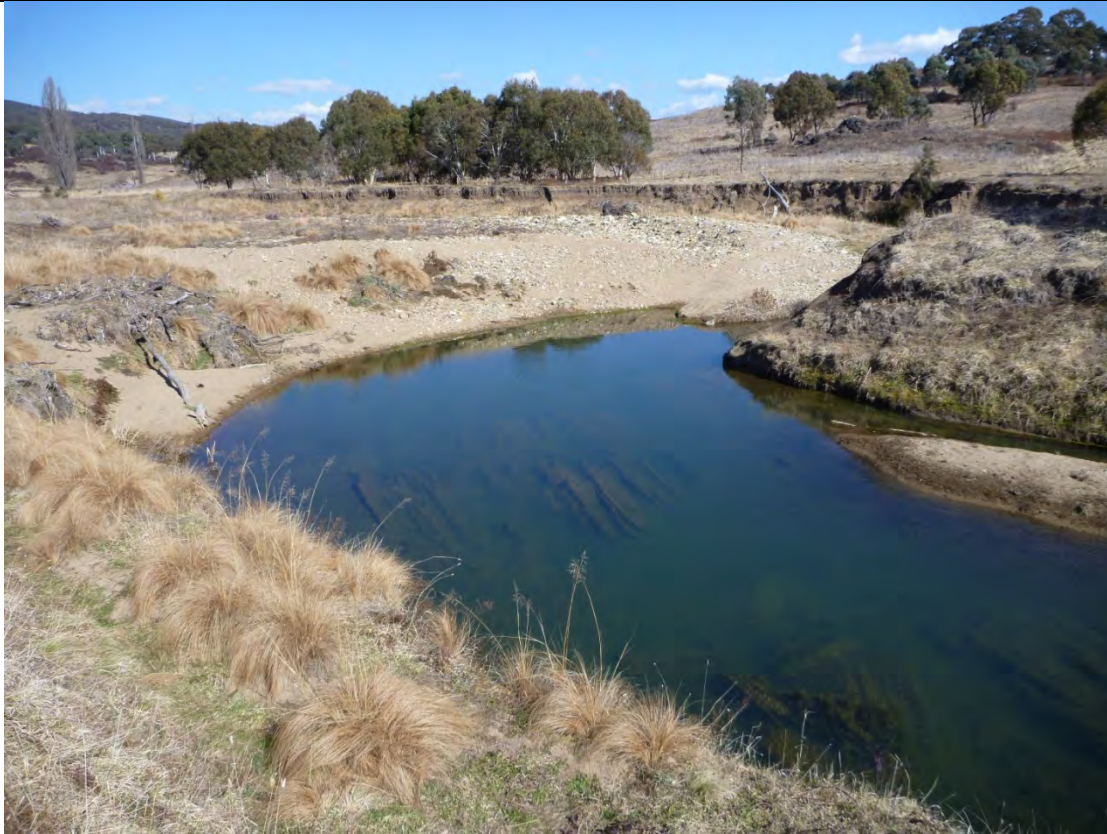
Photo 40 - BUR2C 3/8/2011

- looking upstream at dog-leg upstream of BUR 2C riffle site.
- Bedrock visible in pool with algal growth
- Significant sediment and cobble deposit on inside of bend as a result of December 2010 flood event

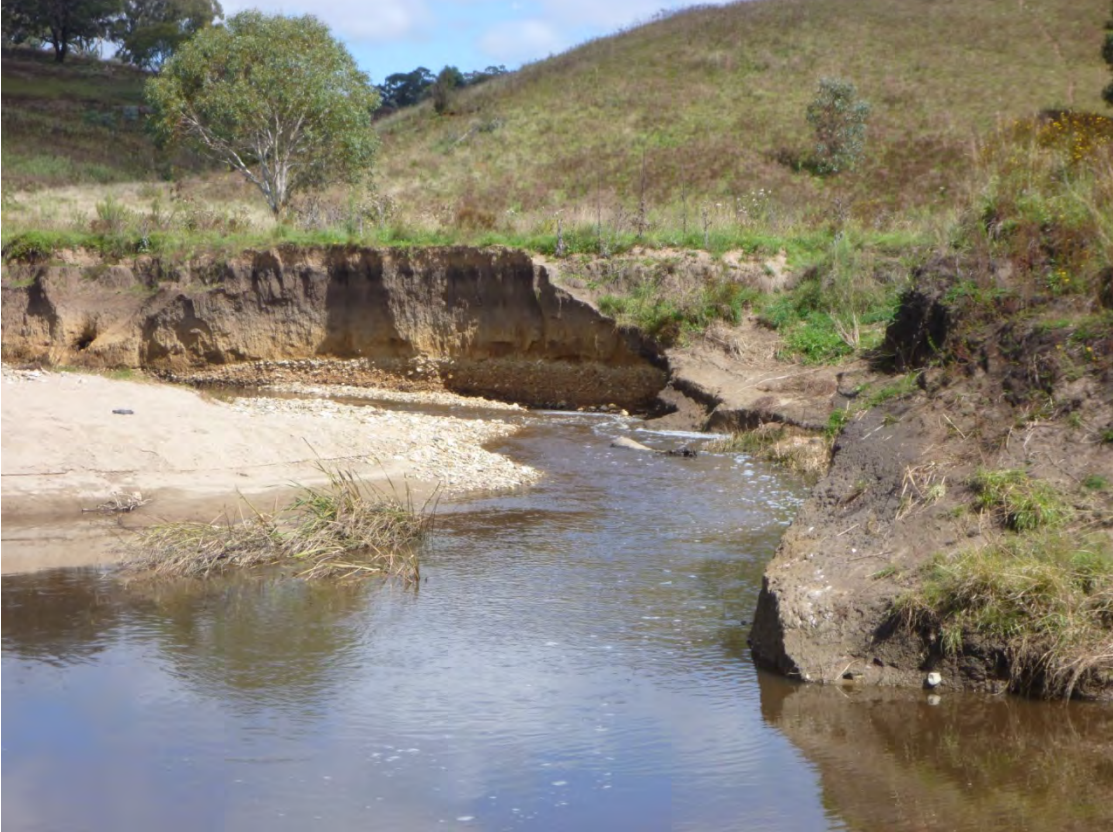
<p data-bbox="181 987 584 1016">Photo 42- BUR2C 20/3/2012</p>	<ul style="list-style-type: none"> <li data-bbox="1281 152 1506 264">- Evidence of bank erosion caused by flood</li> <li data-bbox="1281 275 1458 353">- Little bank vegetation remaining.</li> <li data-bbox="1281 365 1506 533">- XS-2 located at the downstream end of the eroded embankment</li> <li data-bbox="1281 544 1458 622">- XS-3 in foreground location</li> </ul>

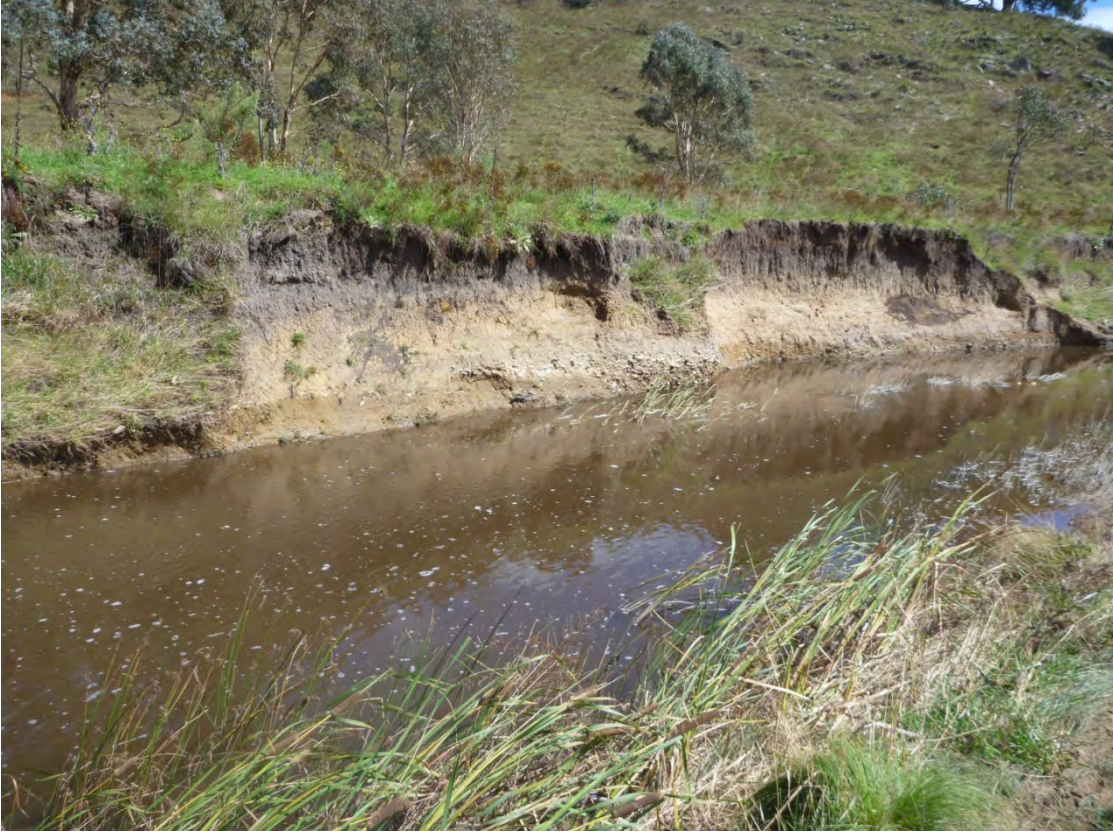
<p data-bbox="181 1883 584 1912">Photo 43 - BUR2C 20/3/2012</p>	<ul style="list-style-type: none"> <li data-bbox="1281 1048 1506 1160">- Further bank erosion downstream of bend.</li> </ul>
