ACTEW Water  
Murrumbidgee Ecological Monitoring Program  
Burra Creek Geomorphology Update

June 2015

This report serves as an update to the previous report in April 2014. Updates to some site surveyed transects have been included along with visual inspections at key sites. Updated transects have been overlaid with previous transects for ease of comparison.

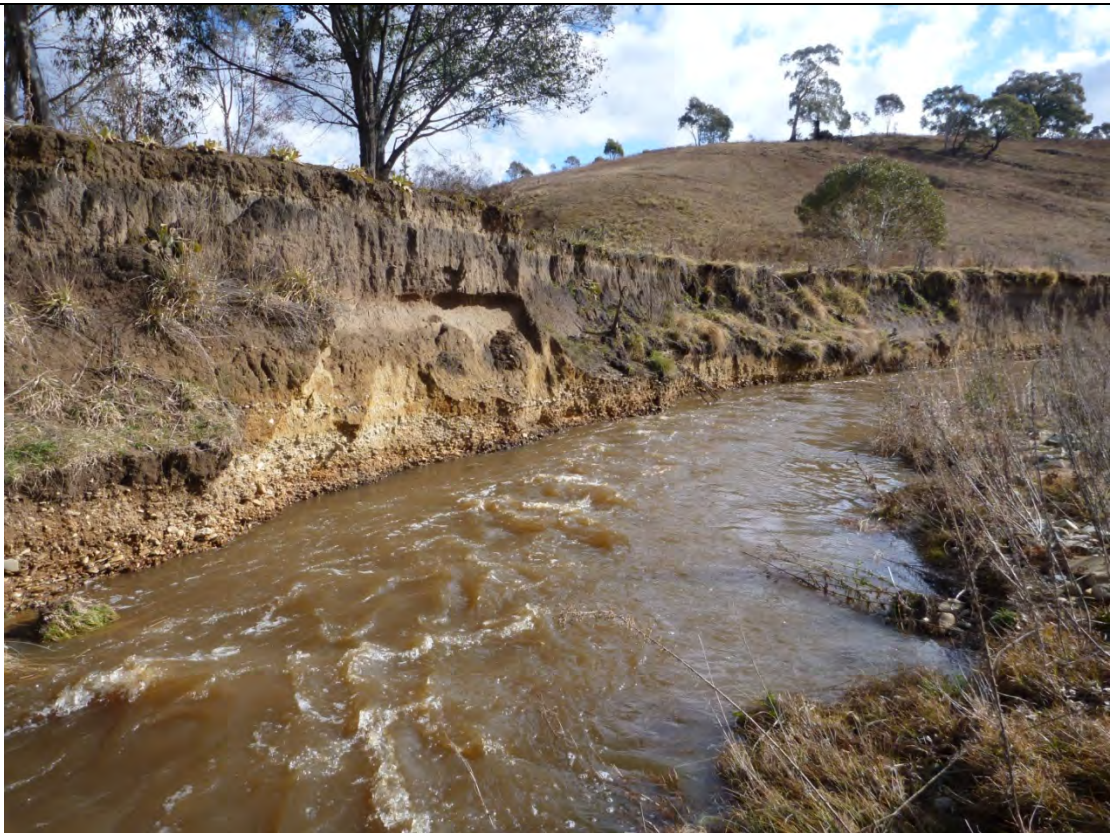
Photo 47 - BUR2C 13/7/2012

- Embankment erosion further upstream from BUR2C

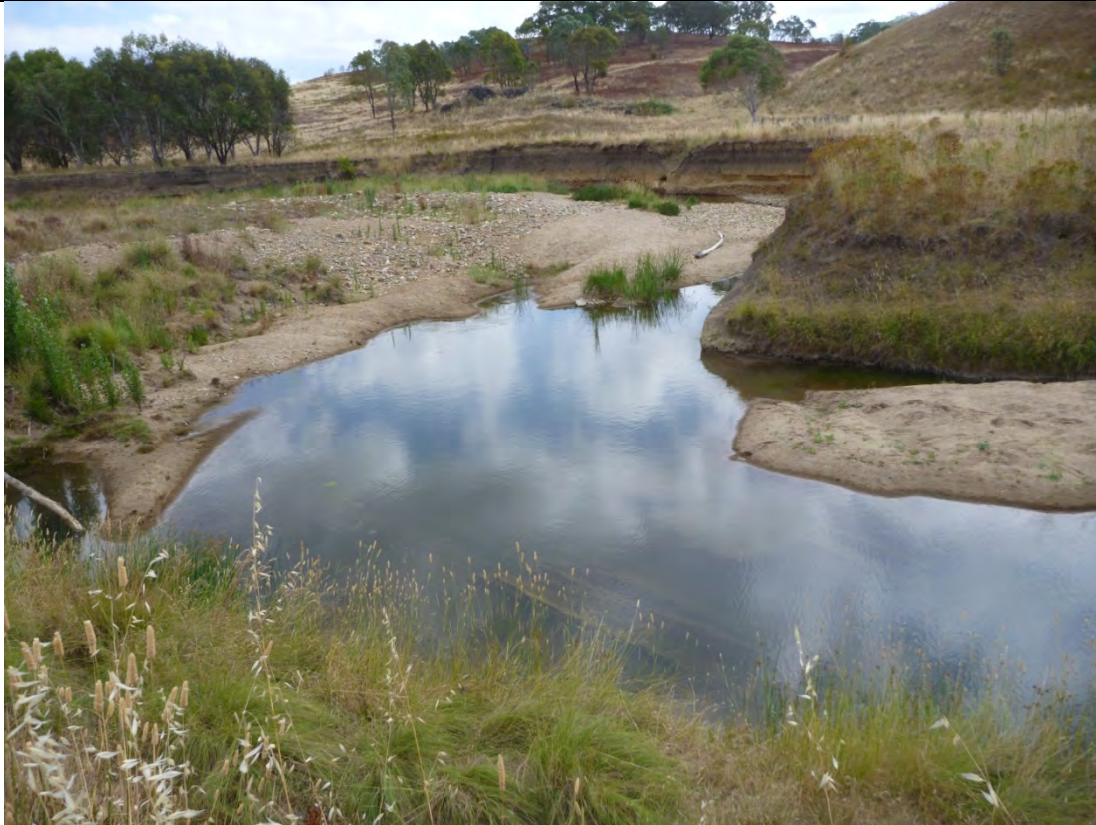
Photo 52 - BUR2C 23/1/2013

- Sloping banks show signs of vegetation recovery
- Vegetation growth commencing on sediment deposits

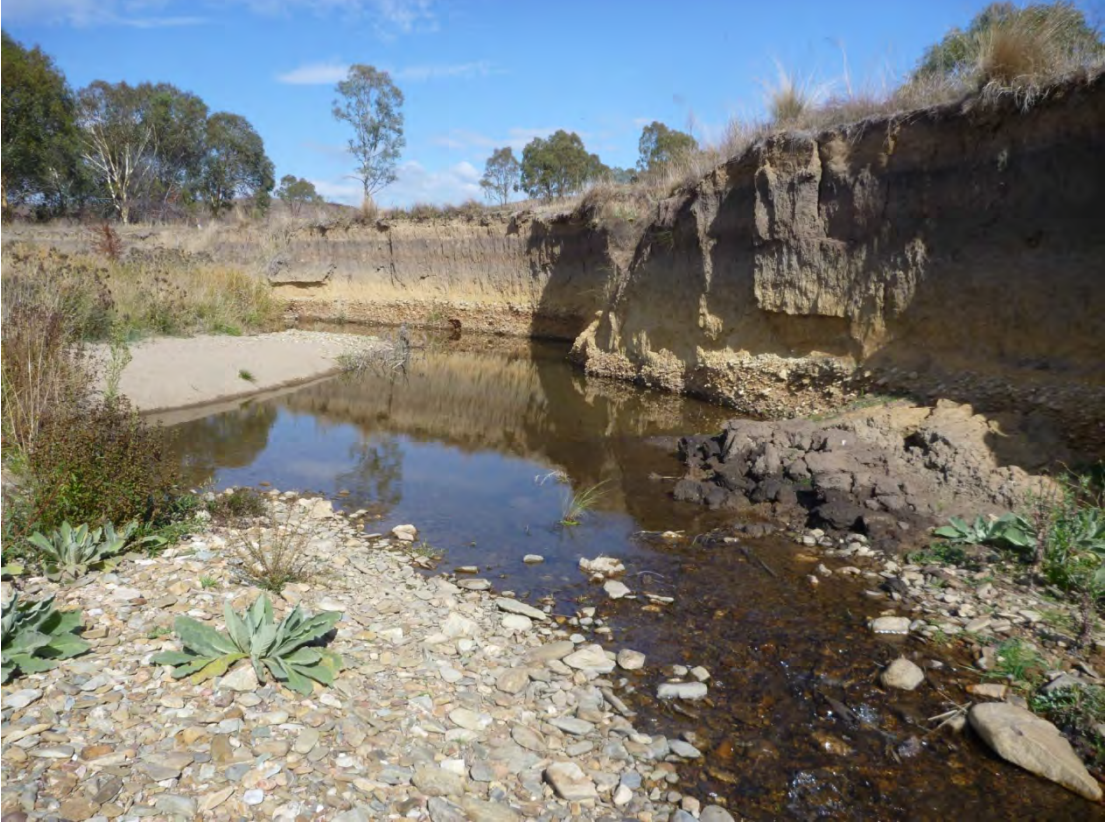
<p data-bbox="183 981 593 1012">Photo 54 - BUR2C 29/4/2013</p>	<ul style="list-style-type: none"> <li>- Section of bank has slumped into channel.</li> </ul>

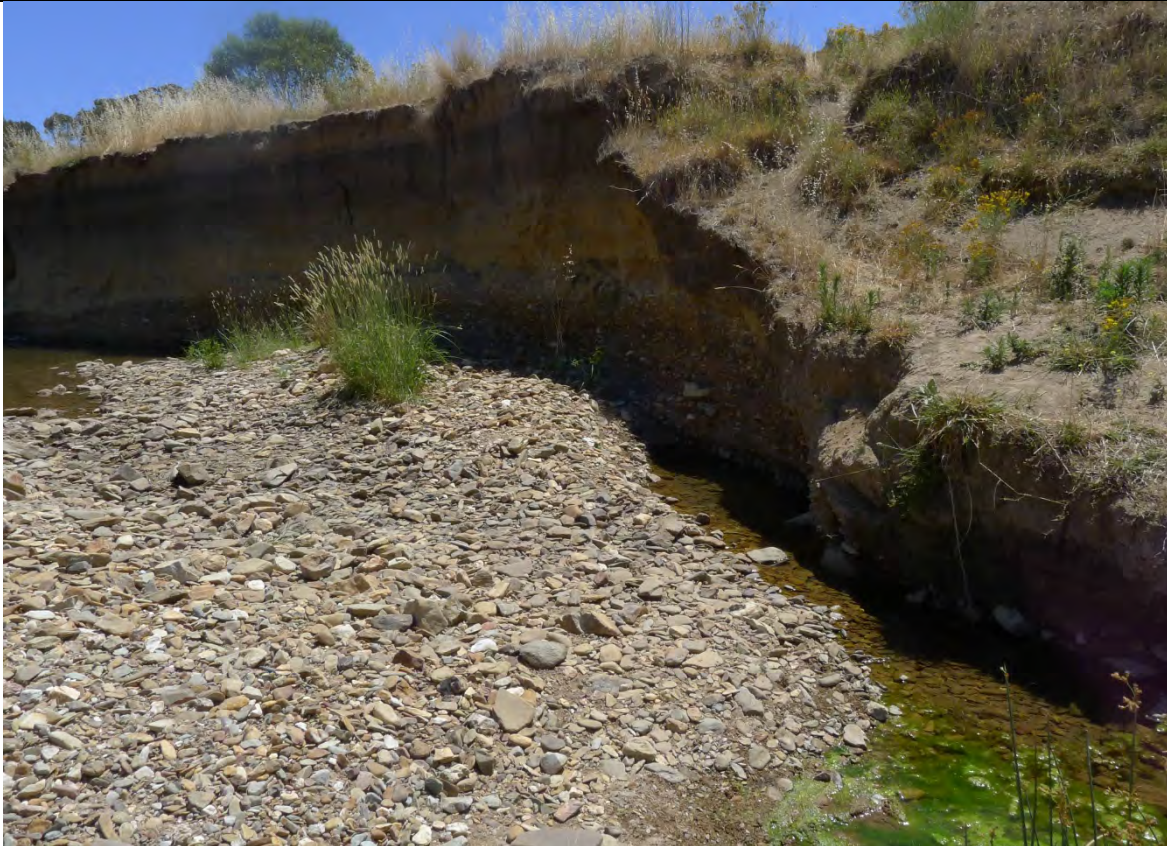
Photo 60 - BUR2C 13/1/2014

Flow beginning to cause significant undercutting of bank.

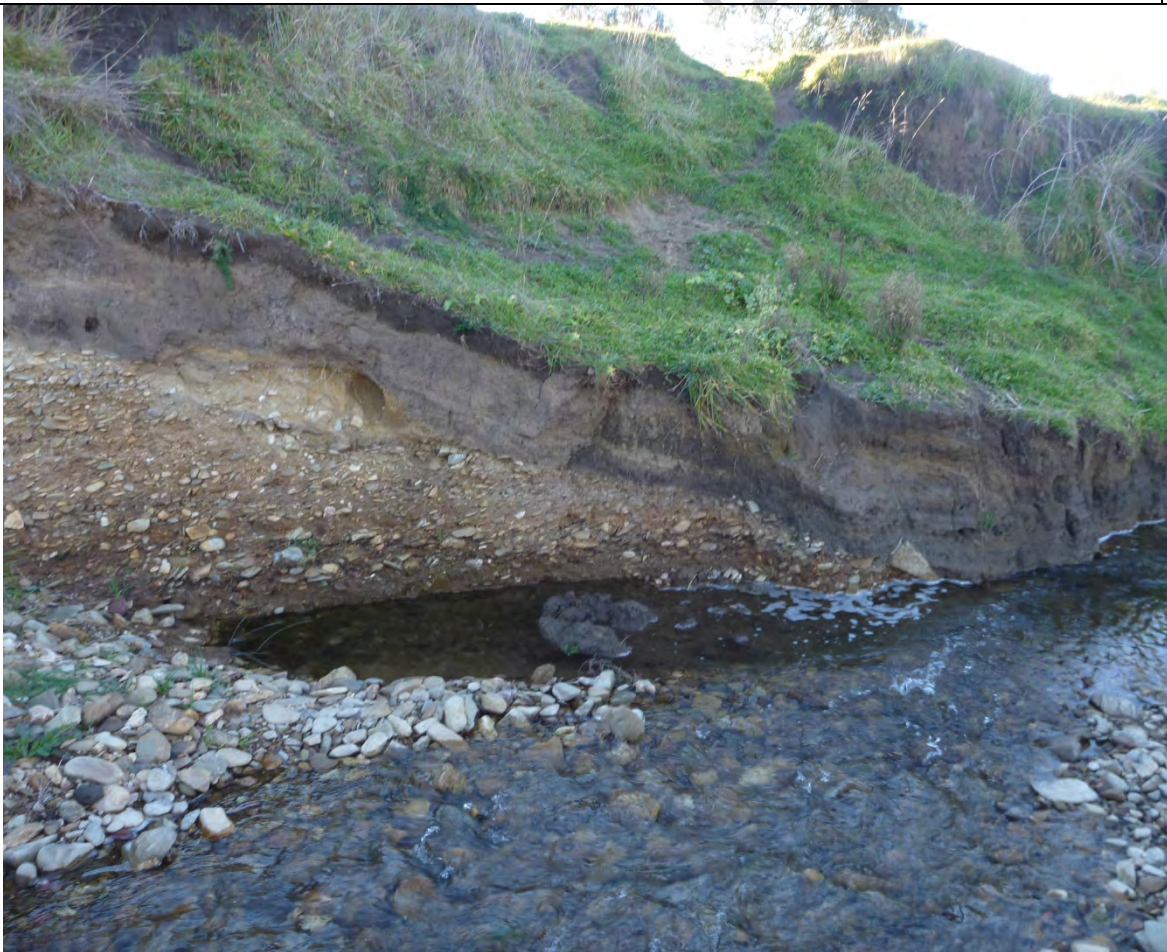
Photo 61 - BUR2C 6/6/2014

Bank has had minor collapsed from undercutting

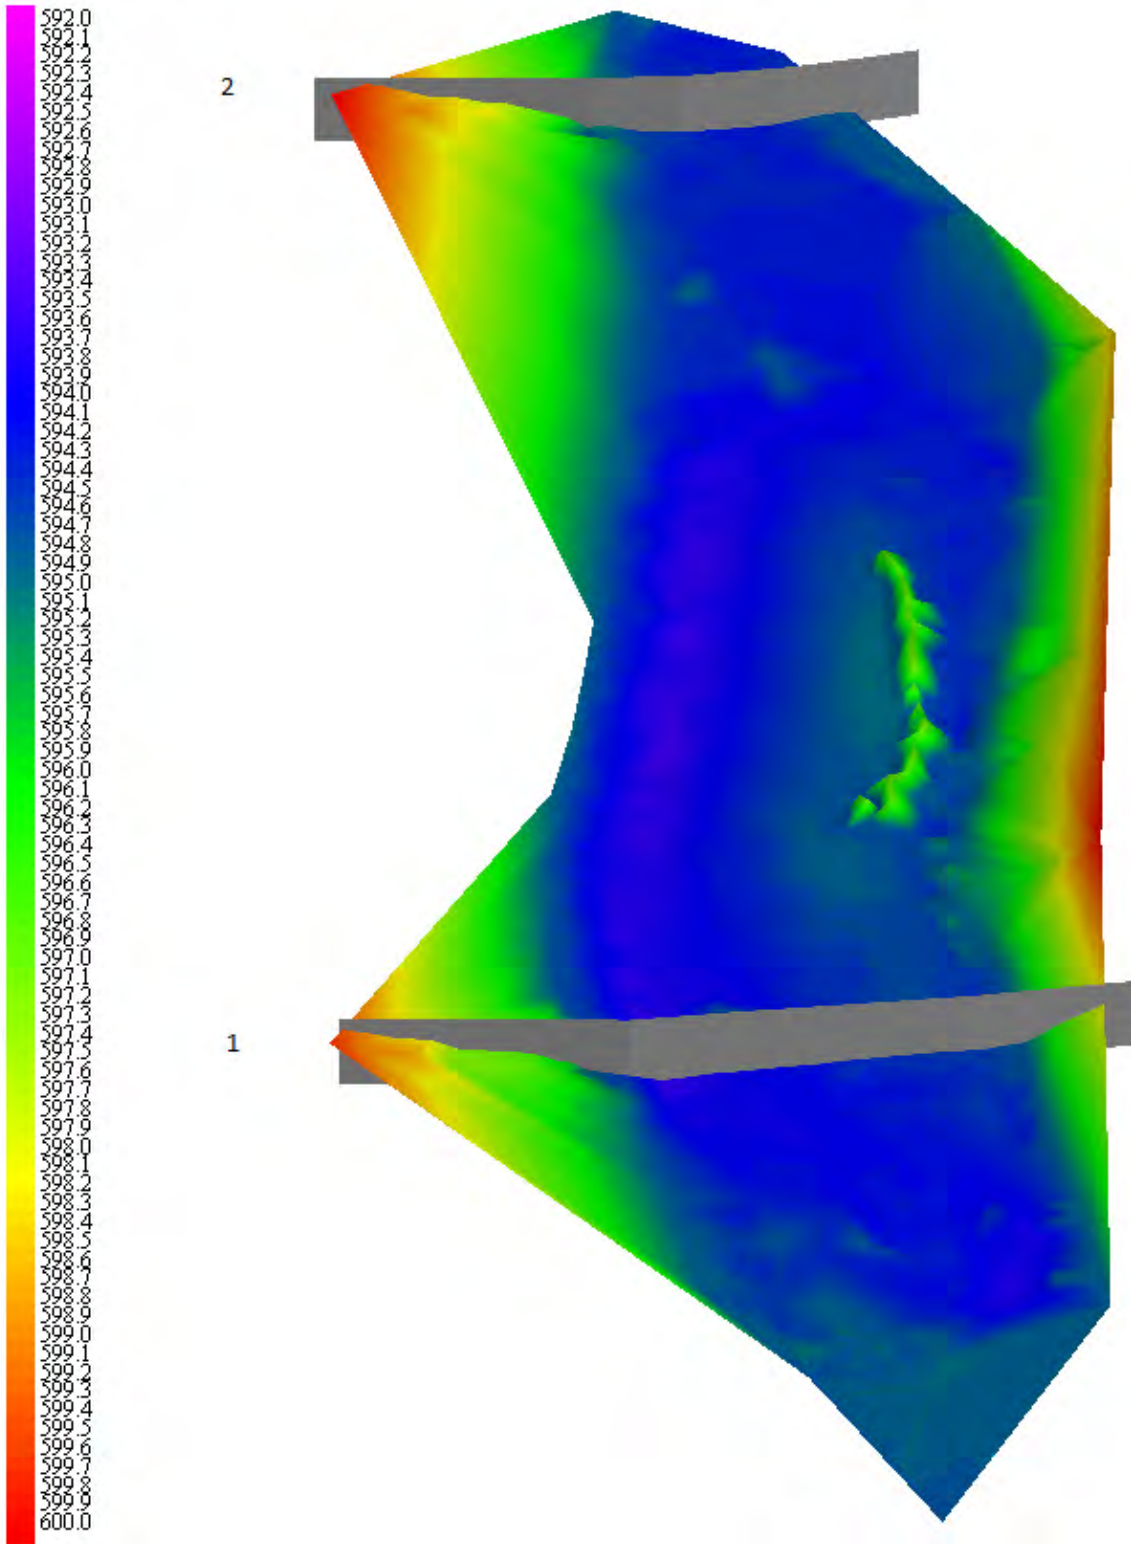
Figure 49 - Angle Crossing D/S DGPS Model (Jan 2013)

\*DGPS Model corresponds to area between the pink cross-sections in previous Figure 48. The change in the downstream sandbar due to the 2010 and 2012 flood events

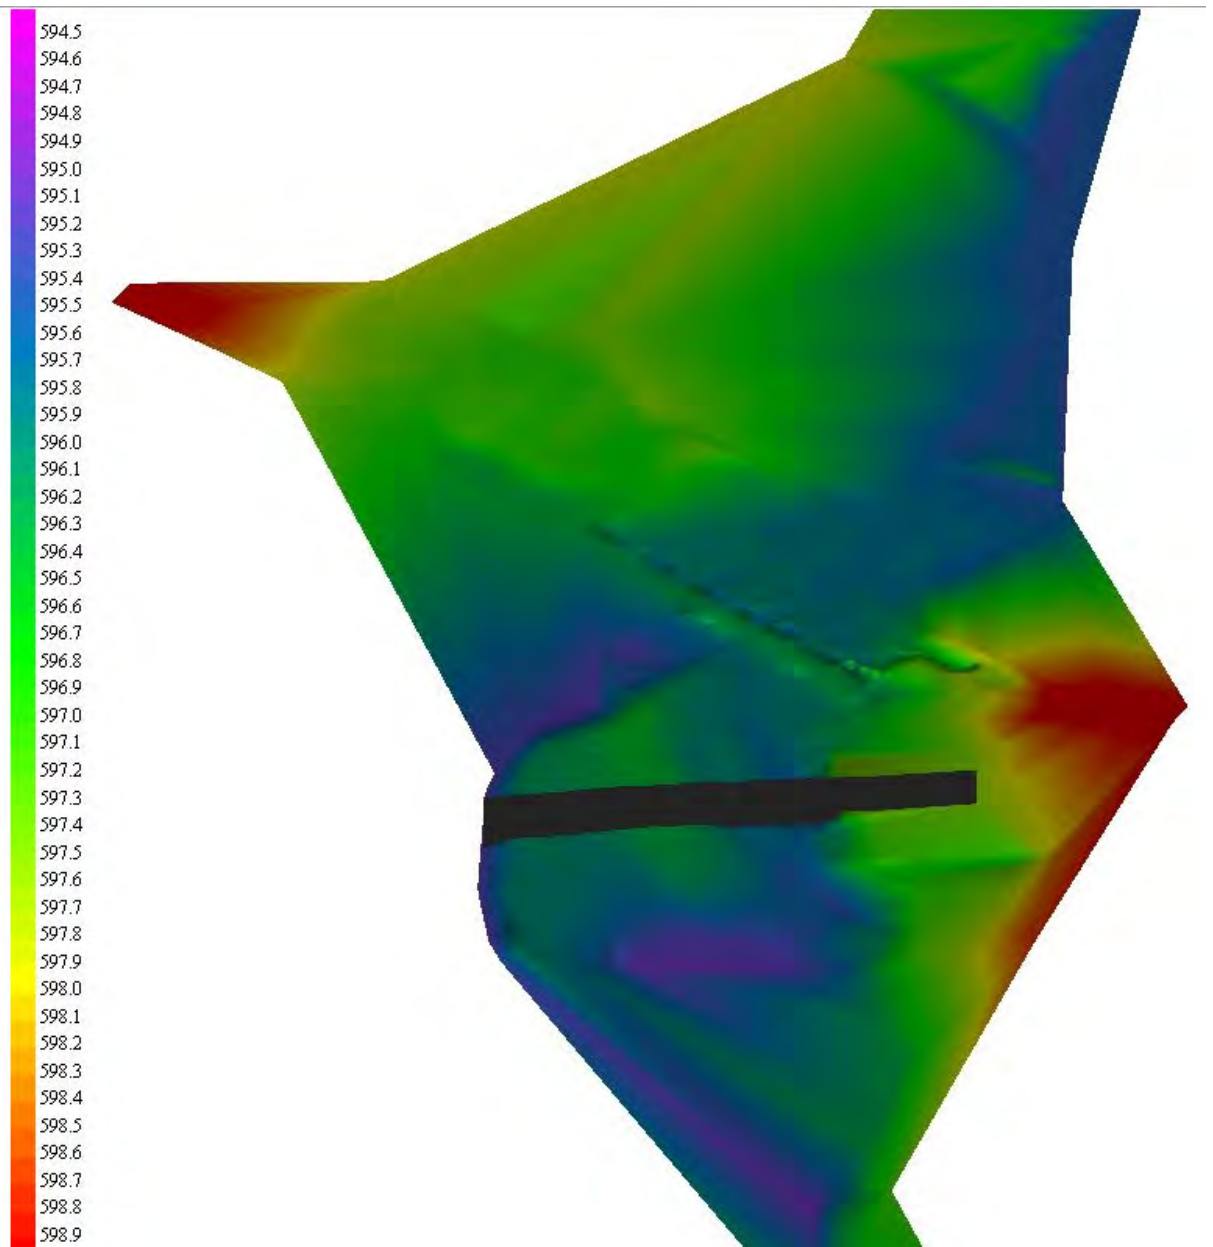
Figure 50 - Angle Crossing DGPS Model Jan 2014

Cross section shown in Figure 50 corresponds to the upstream corner of the inlet structure. The DGPS model does not cover the full extent of river due to the water level being outside of the range of the DGPS at some locations. This was outside of the designated survey area being near the inlet structure. The raised ridge in green through the centre of the river bathymetry is due to points collected along the concrete causeway.

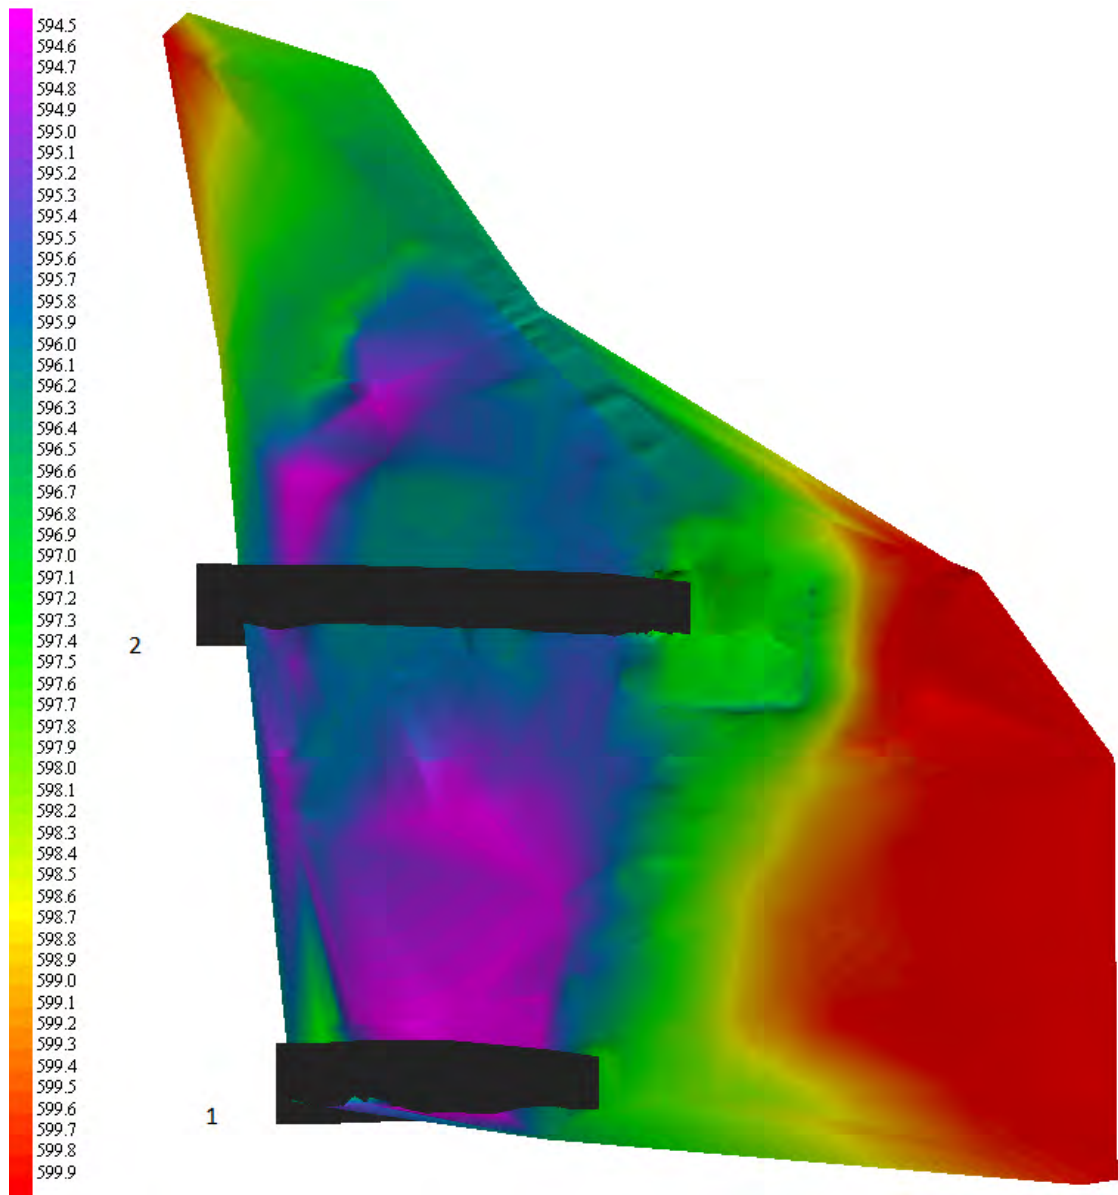
Figure 51 - Angle Crossing Intake Pool 2015

- Sand bar in the middle of the pool near the intake structure has had material removed, flattening the sand bar.
- Depth of water adjacent to the intake structure has remained largely unchanged at approximately 0.5m - 0.7m deep during baseflow conditions.

- 4) A re-survey of all transects should be undertaken before the commencement of continuous pumping operations.
- 5) The dynamics of the sandbar and macrophyte growth occurring at the pool adjacent to the intake structure at Angle Crossing should continue to be monitored.
