FINAL REPORT:

Cotter Catchment Actions for Clean Water Plan

March 2020

Ref: 0319009_R02_Cotter_ACWA_Plan_Final

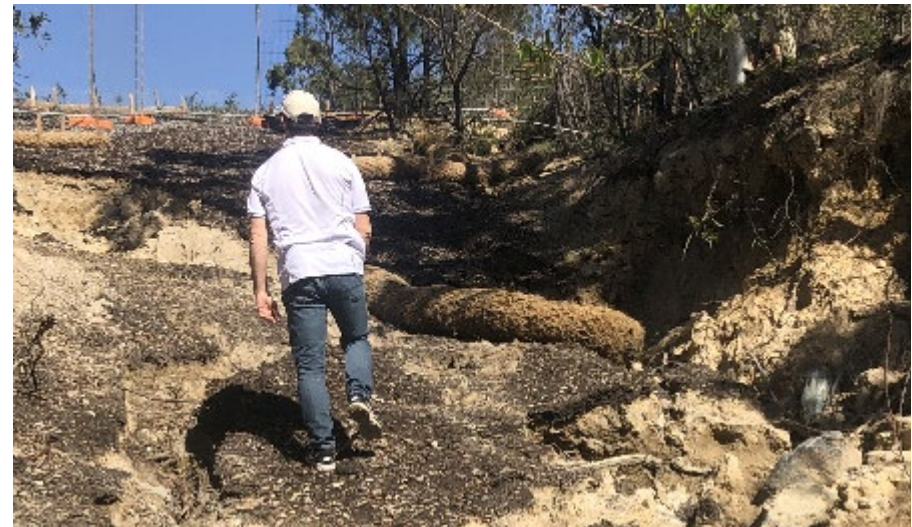
The site has already had significant stabilisation works; however recent rain has revealed the presence of channel instabilities in multiple locations. Furthermore, contour banks along tributary hillslopes have incised and failed, leading to further destabilisation. Outflanking of existing structures also appears to be occurring at the East-West Break Rd crossing, suggesting the need for road runoff management to protect existing works.

The site photo (right) shows how recent flows have scoured stabilisation works thus threatening their long-term stability. This is but one example of at least two head cuts between works along this gully line. While vegetative cover does provide some structural support, the steep grade of the channel, dispersive substrate and the lack of bedrock control mean that these instabilities are likely to worsen over time without intervention.

Site MZ1a looking upstream from 50 south of East West Break crossing

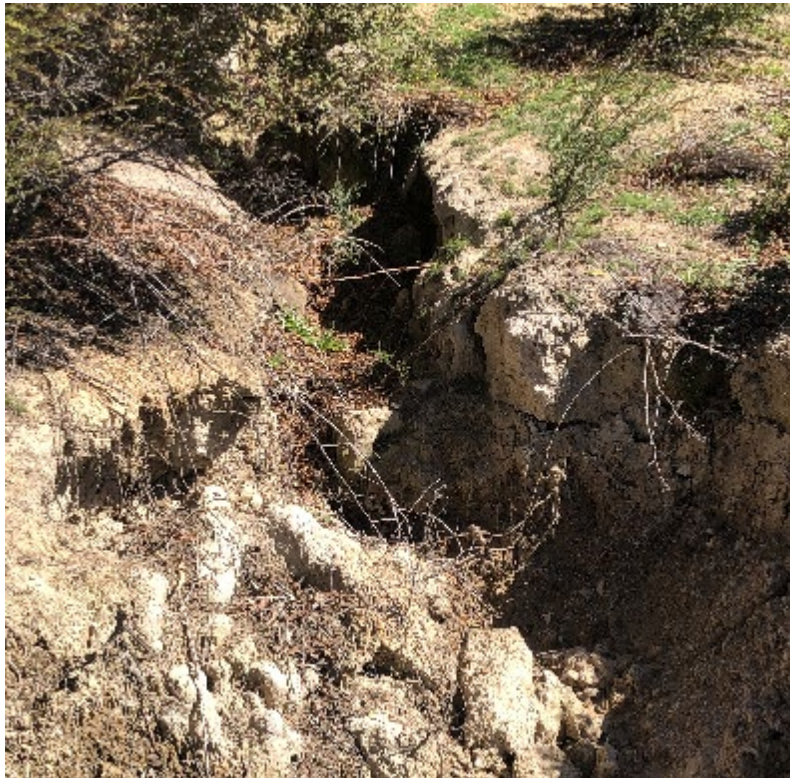
Site MZ1a: Another head cut progressing towards stabilisation works further upstream

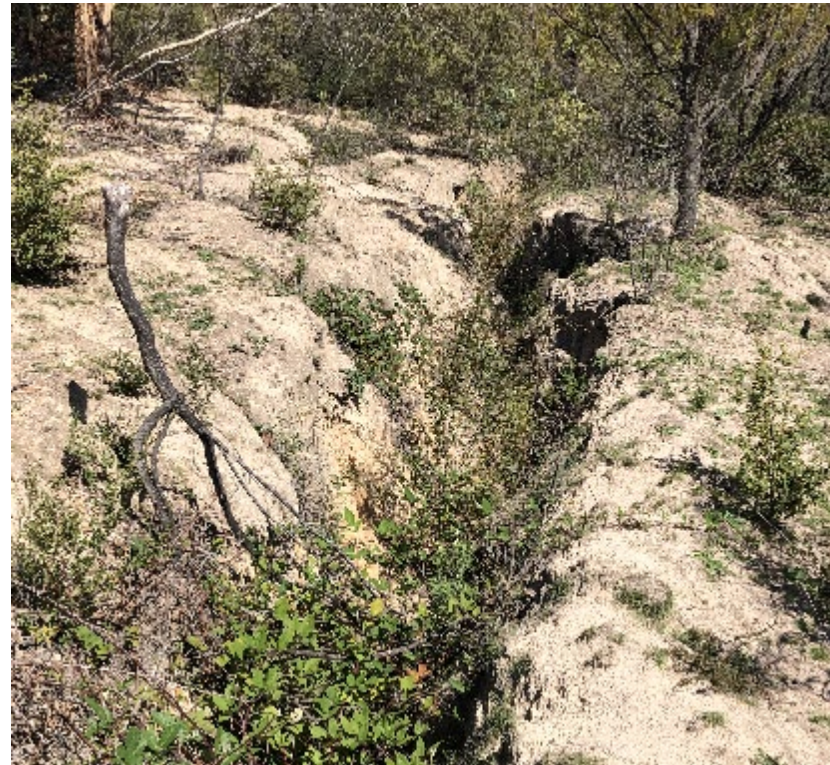
Site MZ1a: Approx. 2m deep incision along contour banks downstream of East West Break road crossing

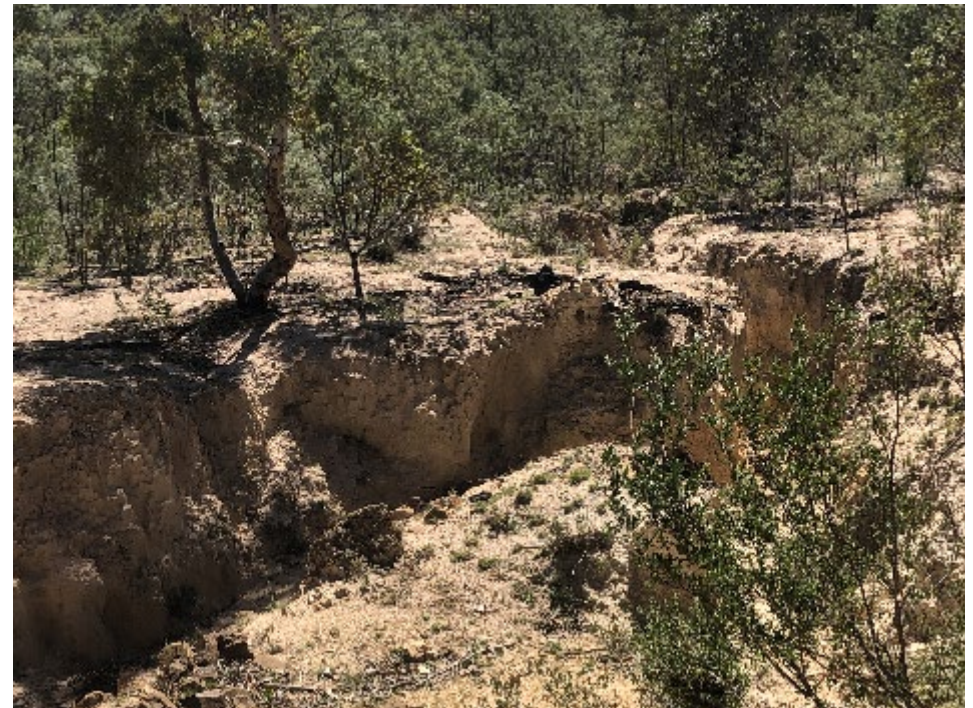
Site MZ2 looking downstream near Pierces Creek Rd

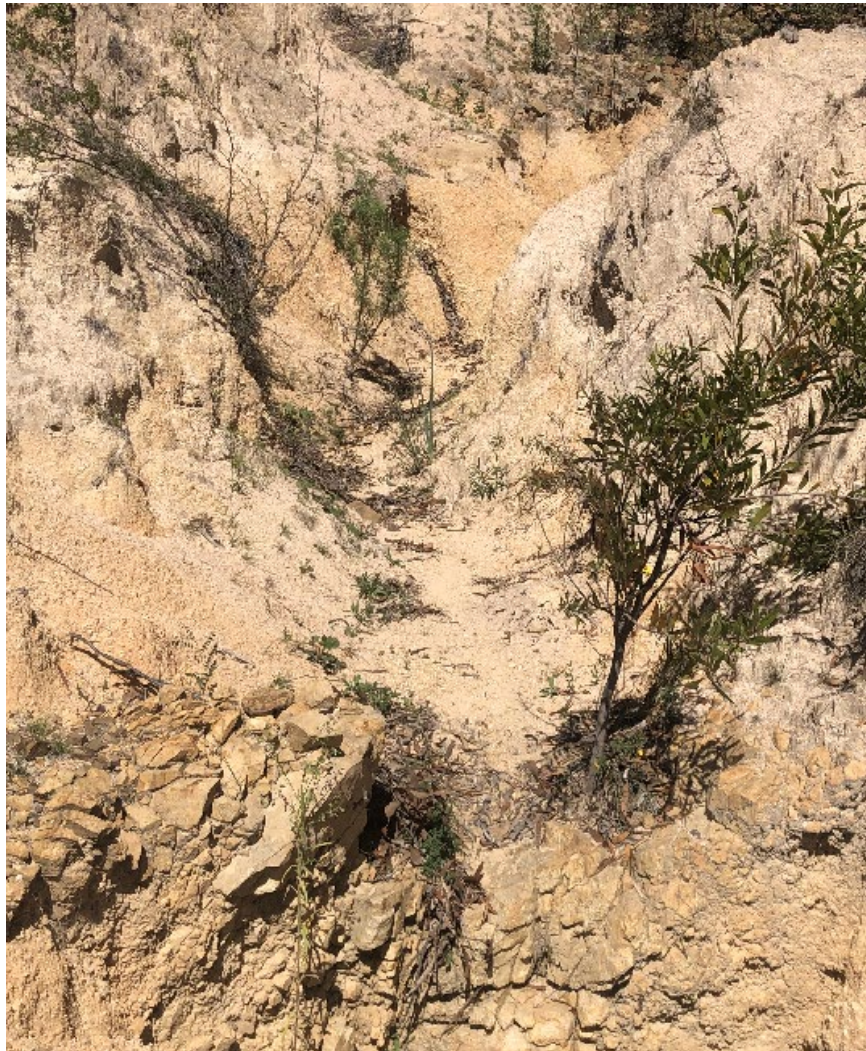
Site MZ2 looking upstream towards Pierces Creek Rd

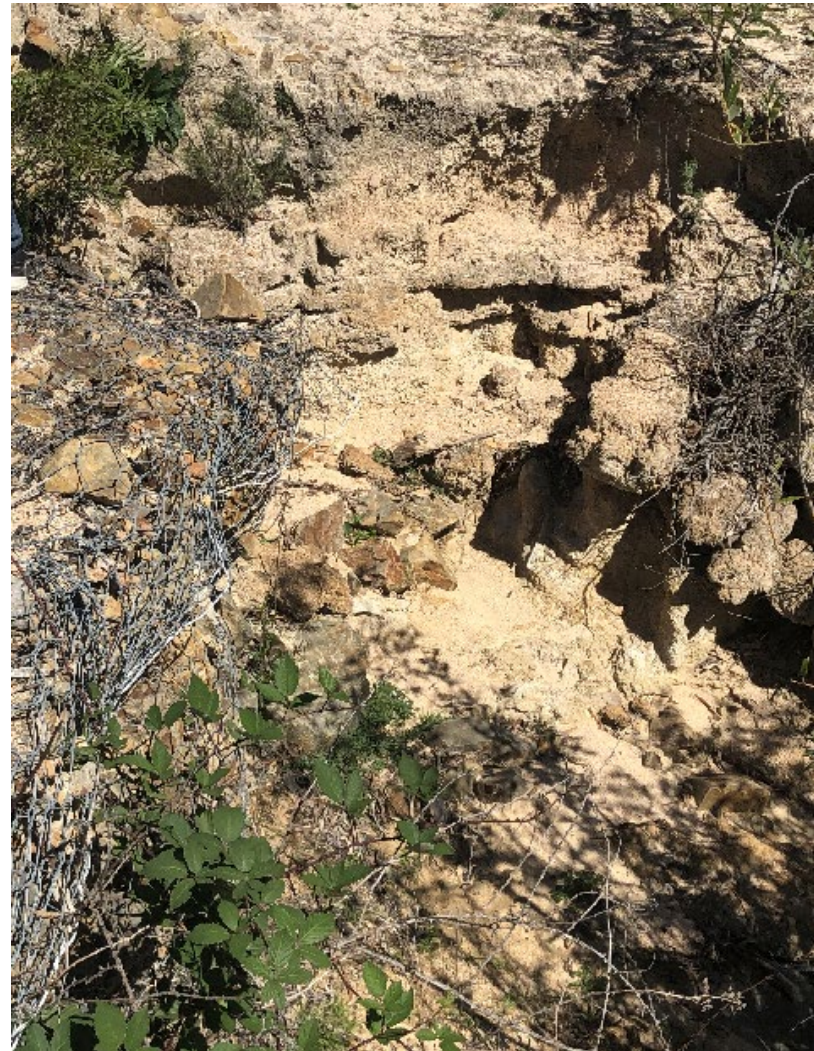
The figure in the bottom right is an example of outflanking which has occurred at least two gabions placed within the gully system, thus illustrating the need for well designed, keyed in stabilisation structures moving forward. While hydraulically designed and keyed in rock chutes are more expensive, their probability of long stabilisation is much higher.

Site MZ2 looking across stream near Quandry Rd

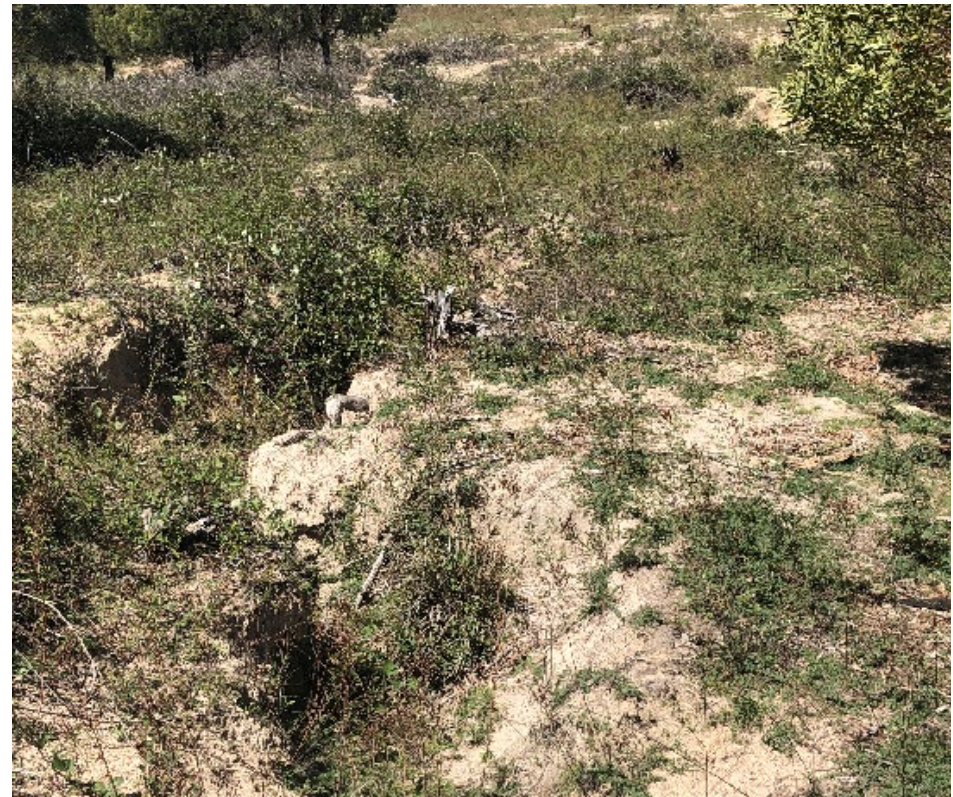
Without intervention (assisted revegetation and head cut stabilisation) the system is likely to continue to deliver fine sediment downstream, albeit a relatively smaller amount when compared the to the previous two sites

Site MZ3 looking upstream. Head-cut within finer substrate near Dry Creek Rd

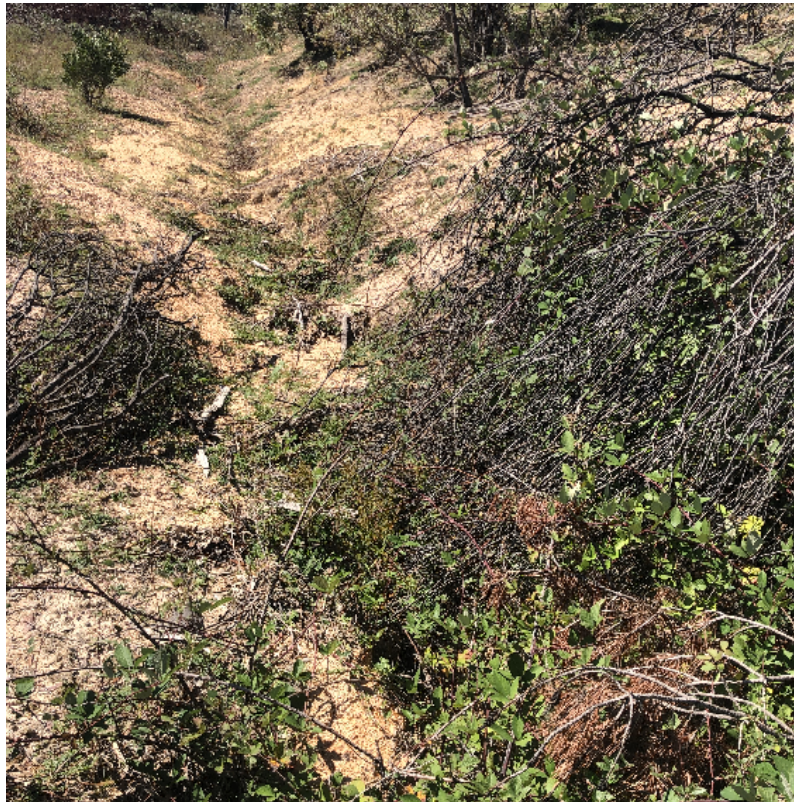
Site MZ3 looking upstream/east with head-cut in foreground.

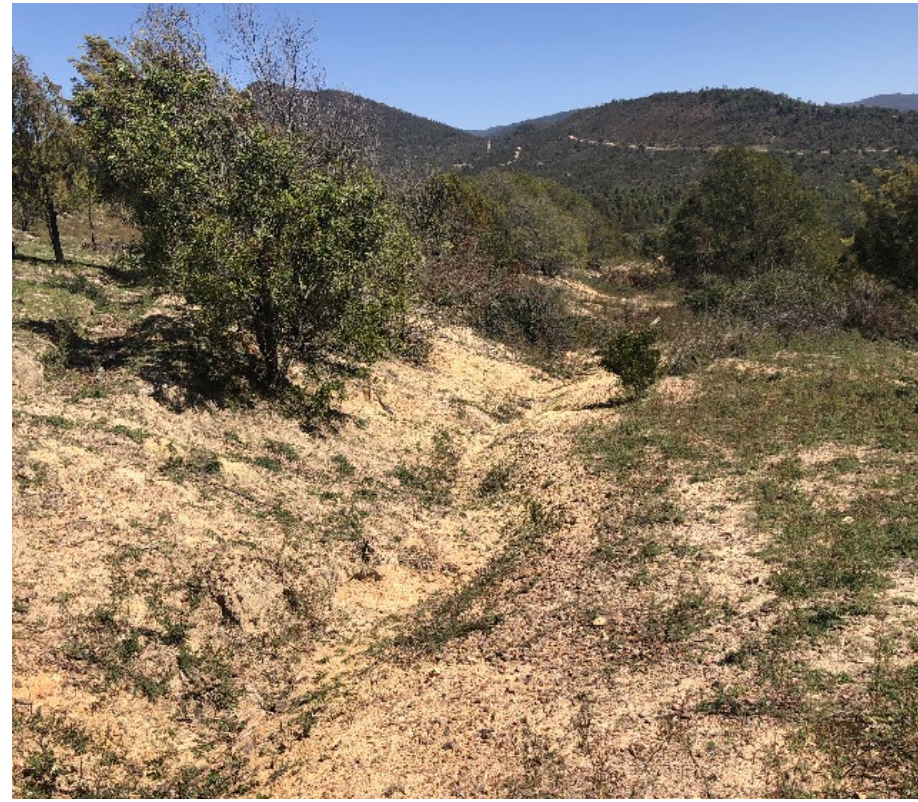
Site MZ3 looking west/ downslope along eroding trail with head-cut in background

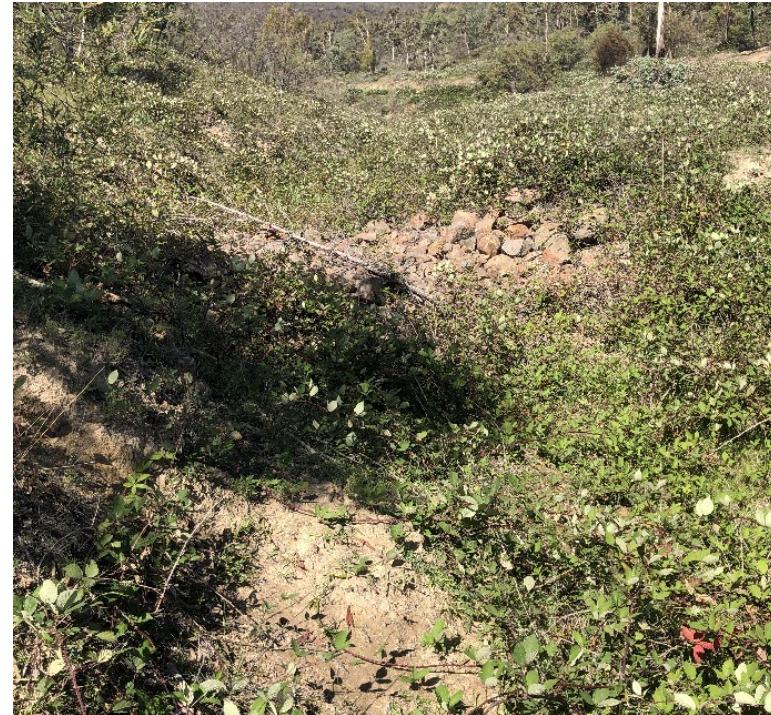
Extensive blackberry growth obscures much of the gully head cut and original rock stabilisation. Whether existing stabilisation works have failed or not remains unclear. The rock in places appears to have slumped, suggesting the head cut has outflanked and progressed further upstream. The bottom left figure shows a minor head-cut on the flank of the gully, revealing potential for further radial gully development upslope.

Site MZ4a looking downstream along gully obscured by blackberry

A review of previous management activities for this gully can provide an indication of gully activity to date and help inform if monitoring is necessary to determine the degree of gully activity. If gully is active, reshaping and erosional control structures will be beneficial given the proximity of this gully to the dam and the extent of available sediment upstream.

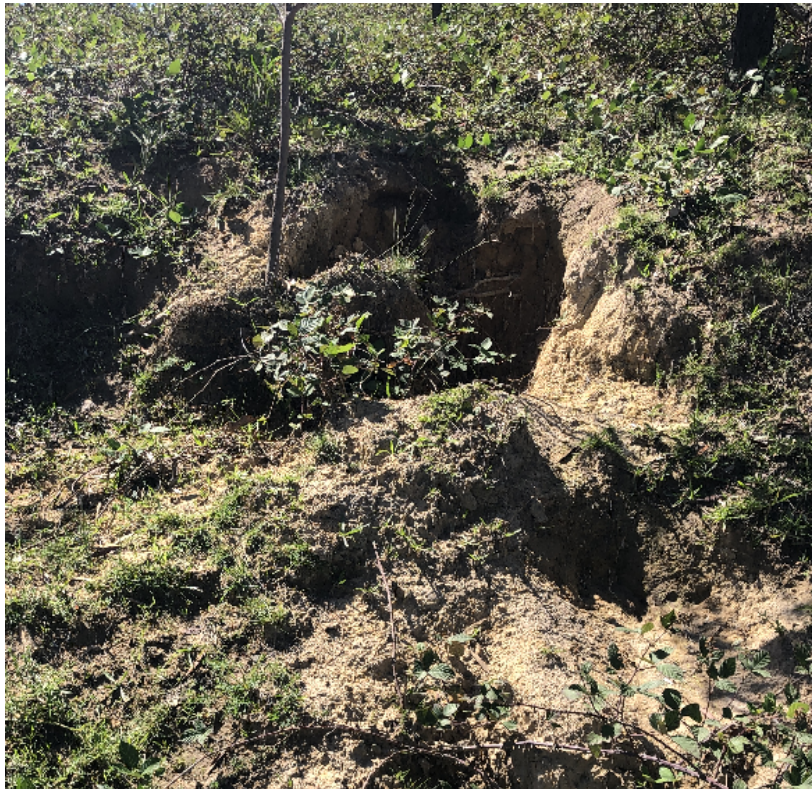
Site MZ4a slumping at radial head cut toward the upper end of the gully

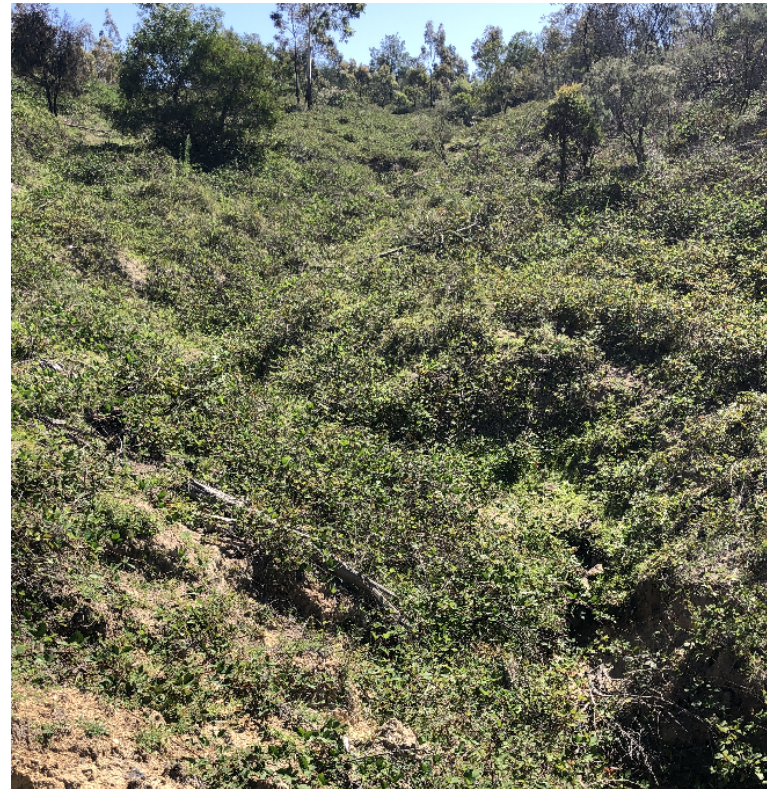
Site MZ4a looking upslope along gully trunk obscured by blackberry

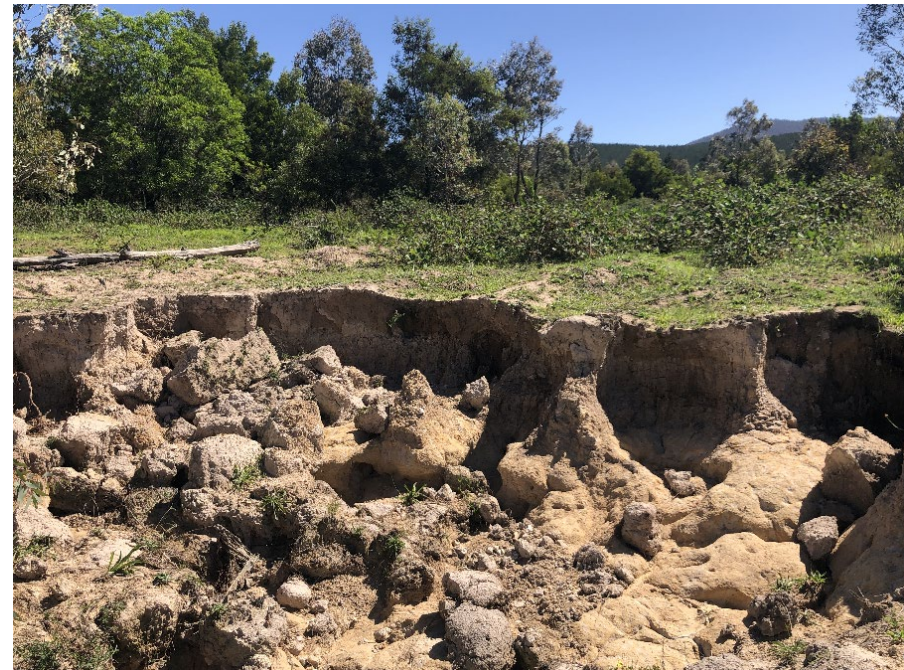
Site MZ4b: looking upstream at head cut within drainage depression

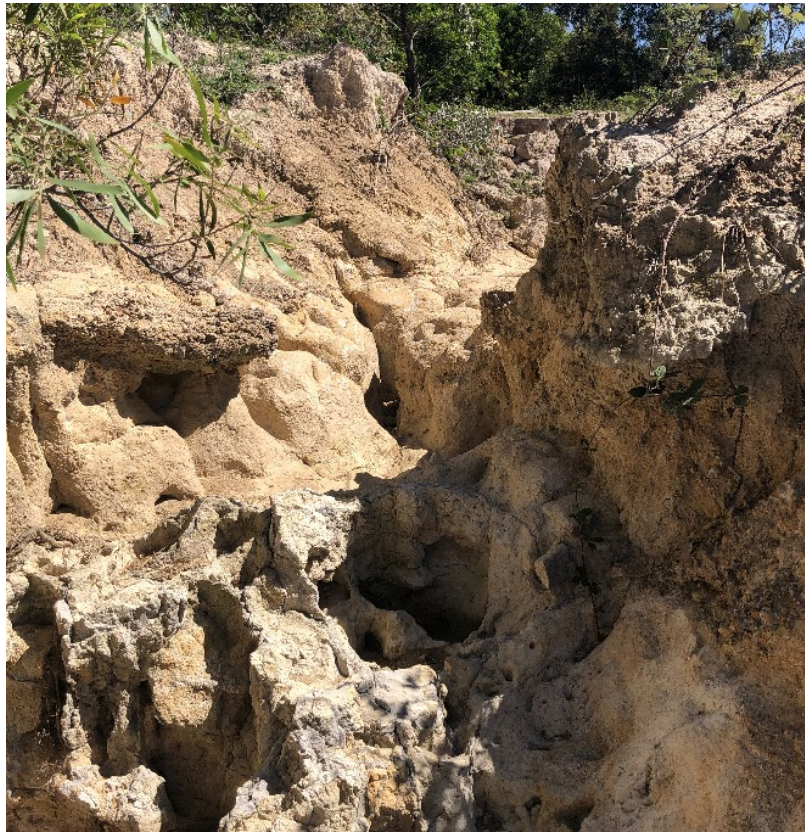
Site MZ4b secondary incision working through sub soil

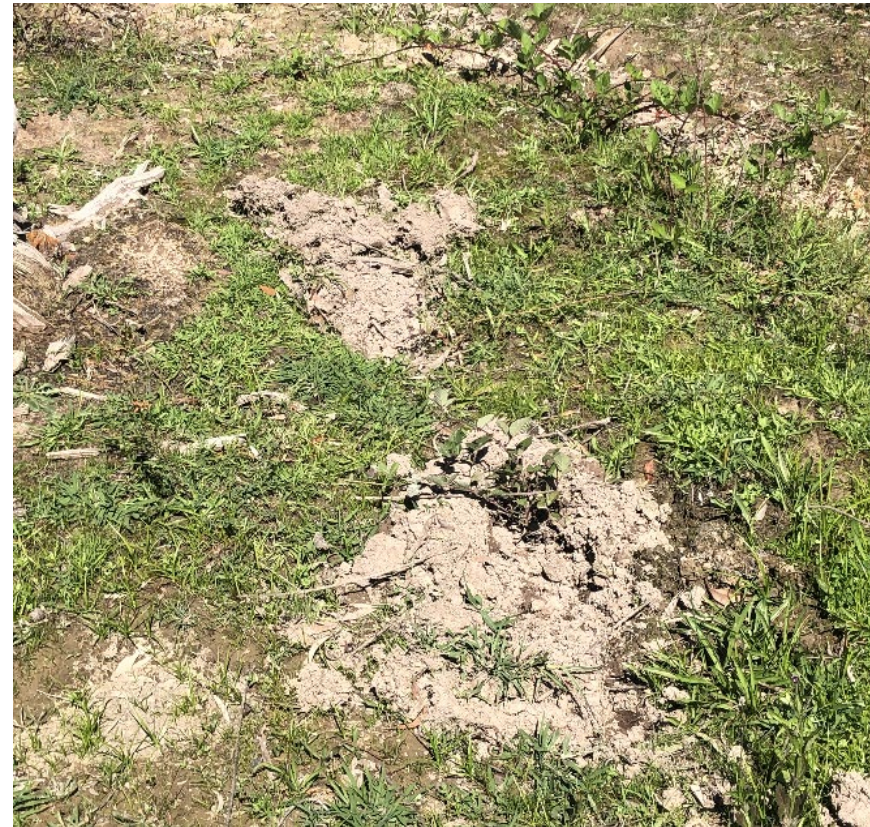
The figure in the bottom right displays evidence of feral animal browsing, possibly pigs. Any facilitated revegetation that accompanies gully stabilisation works at this site will need to take into consideration feral animal management.

Site MZ4b Evidence of feral animal disturbance – possibly feral pigs

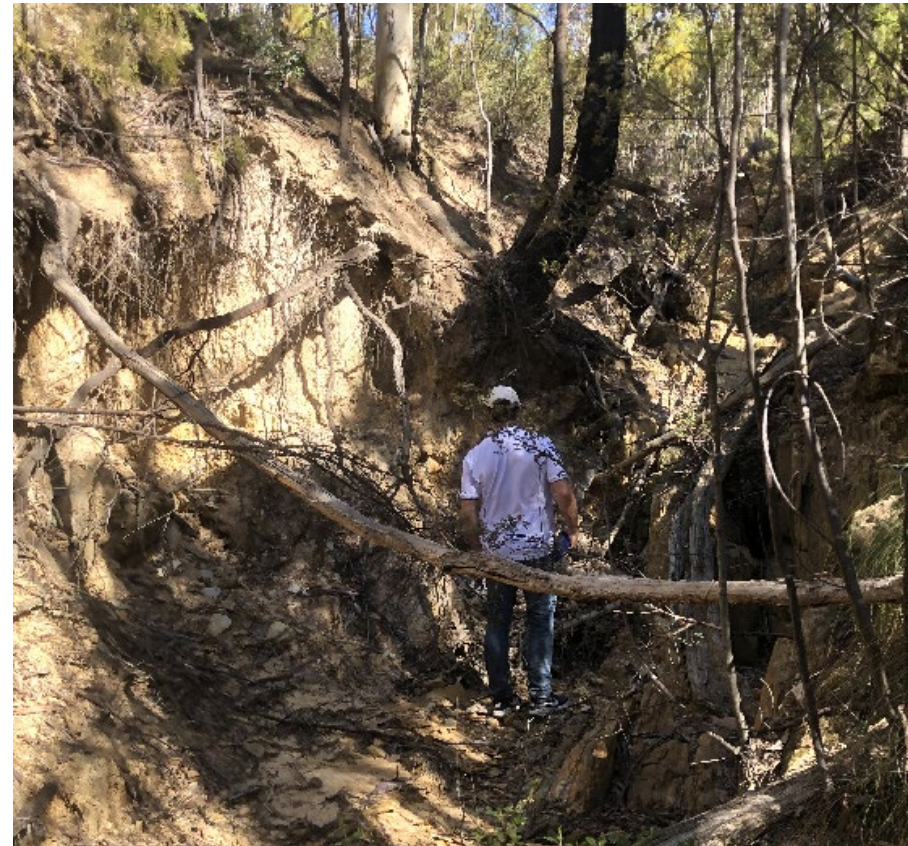
If all mapped active gullies in this management zone are similar in the sense that that bear a narrow gauge, are bedrock controlled and are well vegetated then any intervention is likely to lead to more sediment loss than what is already occurring. In terms of fine sediment control, the only other option then would be to treat the symptom rather than the cause, which would be the construction of wetlands further downstream, however given the confined nature of the channel downstream to the dam, there remains little opportunity for such an installation.

Site MZ5 looking upstream. Significant fluvial scour to bedrock

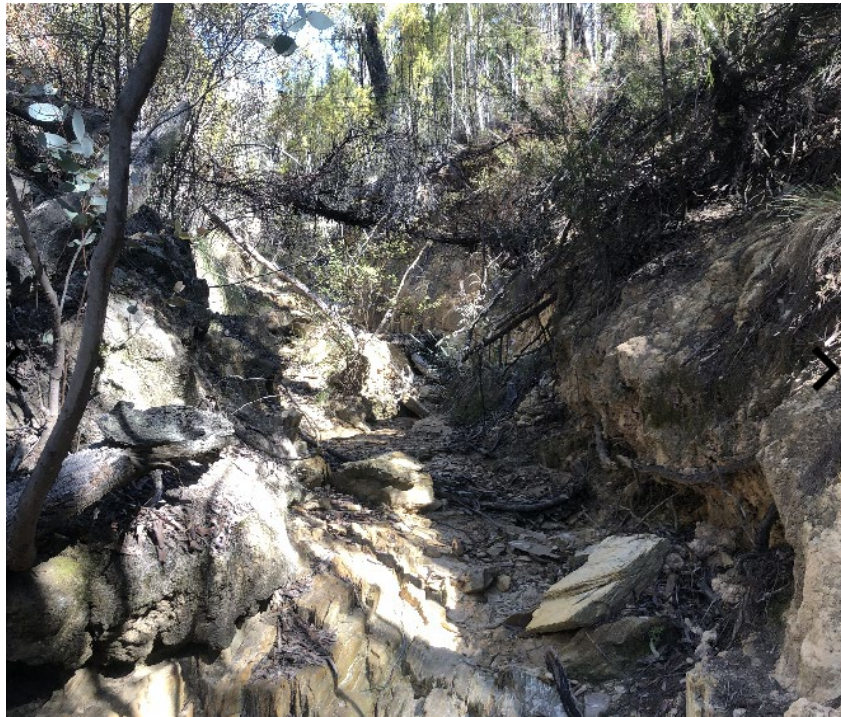
Site MZ5 looking upstream. Narrow gully with significant bedrock control

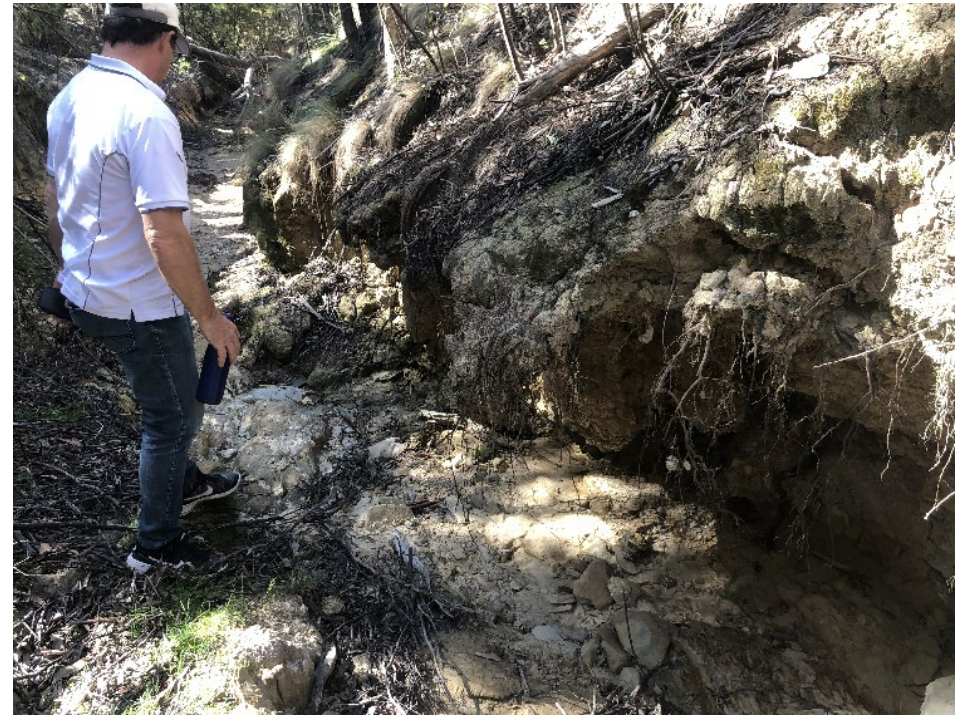
Site MZ5. Fluvial scour contributing to widening of the channel

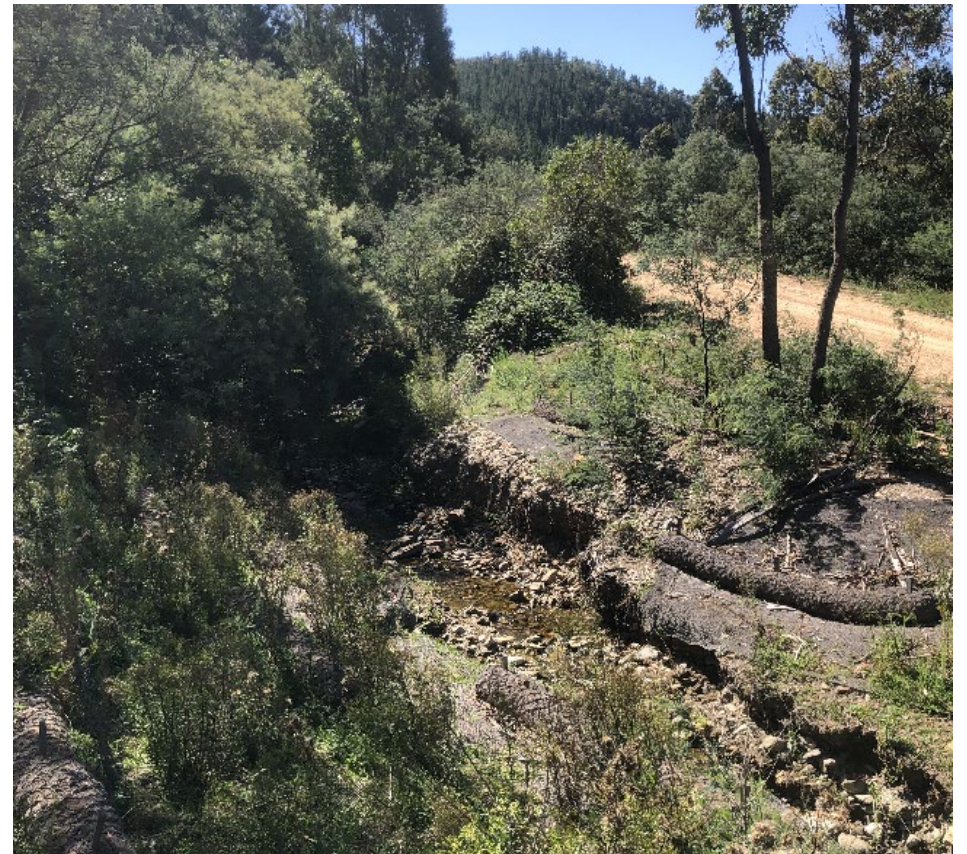
As shown the figure to the right, minor sections of the existing streambank stabilisation works have been washed out by recent high flows. Toe stabilisation and facilitated revegetation of damaged areas can assist in consolidating the riparian zone and minimising the possibility of flows outflanking of existing works.

Site MZ6: Looking upstream Lees Creek, with washed out rehabilitation works in foreground

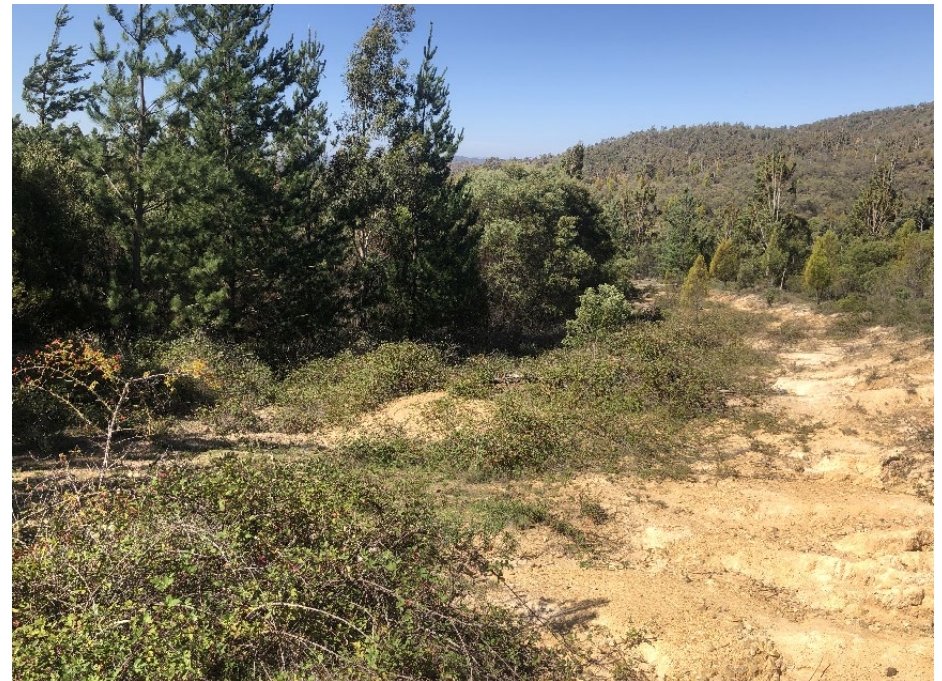
Site MZ7 consists of two mapped 'active gully' systems. Aerial imagery (as shown in the bottom right figure) and on ground observations (Figures to the right and bottom left were taken downstream) suggest that the most active gully in this subcatchment occurs along a disused trail adjacent to a tributary of Lees Creek. While some roll over banks have been put in place to direct flows into the original tributary channel, the dispersive nature of the exposed subsoil coupled with poor vegetation establishment appears to have led to bank failure and rill erosion

Site MZ4a looking downstream along gully obscured by blackberry

An inspection of all active gully systems (Cell IDs: 51136 and 47854) would be able to determine where the most cost-effective gully stabilisation measures may be installed.

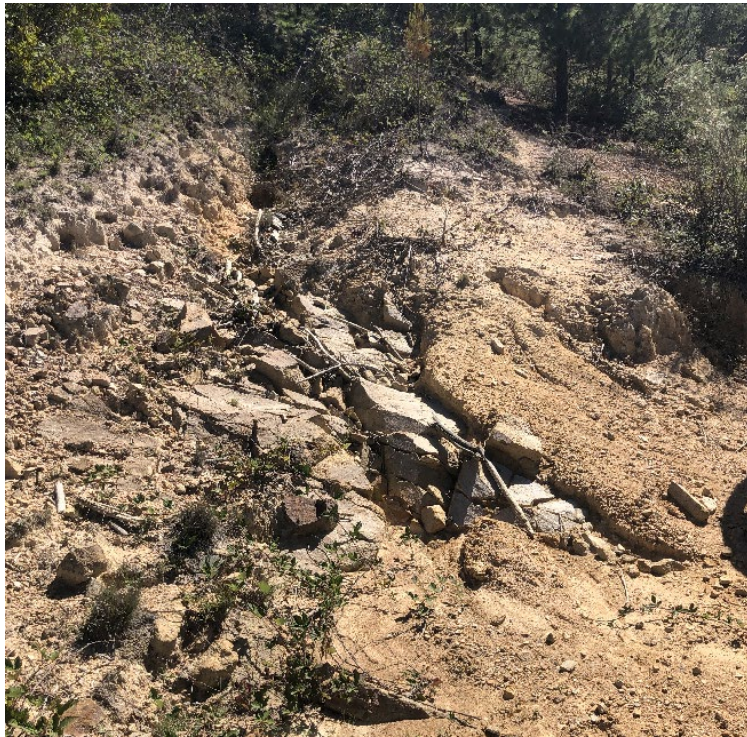
Site MZ7. Rill erosion along the disused track downstream of the shown in the image to the right.

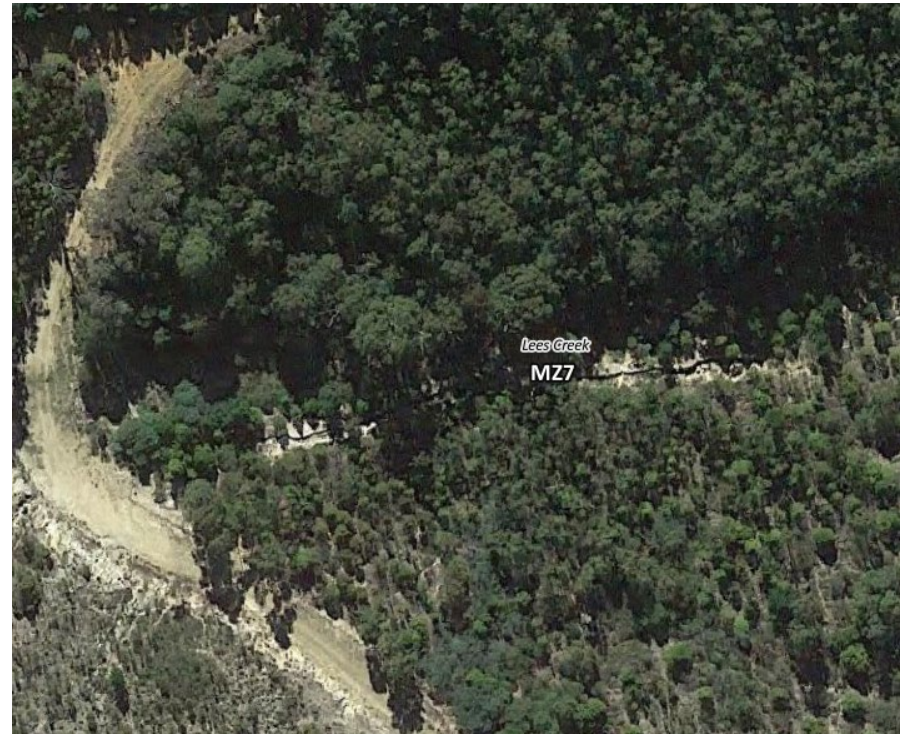
Site MZ7. Aerial imagery of gully development along disused trail
