Memo

Subject Upper Murrumbidgee ACWA Site Review
Date 14 March 2019
Distribution Brent Johnson (Icon Water)
Project Googong Dam catchment Actions for Clean Water Plan

1 Introduction

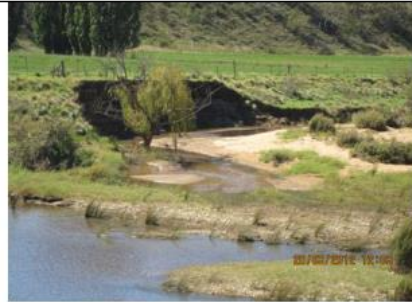
Bank erosion along Buchan Creek

This site is located at the confluence of Buchan Creek and the Bredbo River. It has been assessed as having a high connectivity for fine sediments. Fine sediments eroded from this creek are transferred to Bredbo River, which in turn has a high connectivity with the Murrumbidgee River.

Management Option: Stabilisation of eroding bank via construction of rock beaching. Fencing and revegetation of site in consultation with landholder.

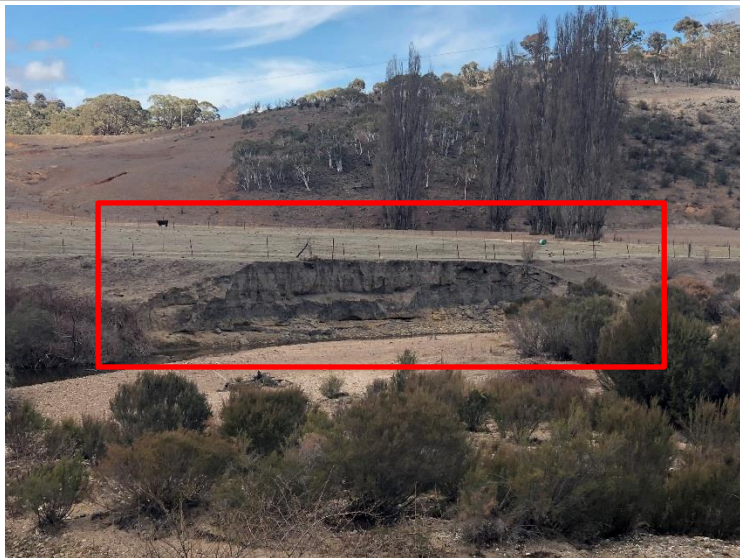
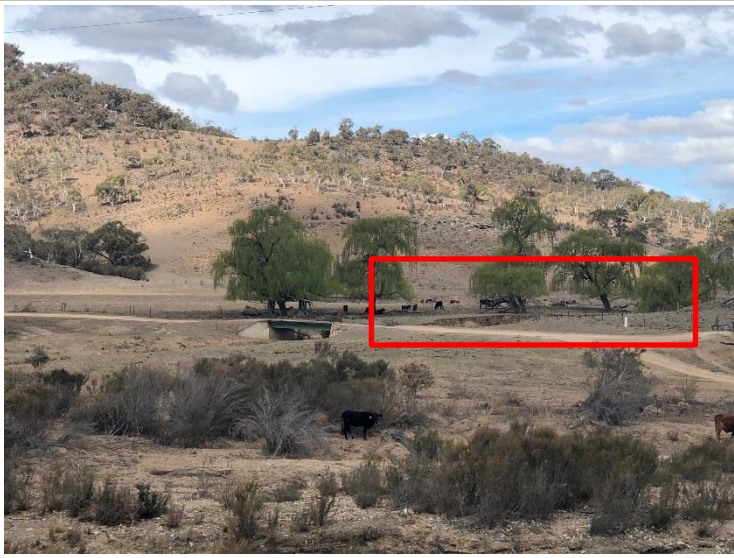
Site 2				
Condition assessment				
Vertical banks were observed along the right bank of the Buchan Creek for a section immediately upstream of its confluence with the Bredbo River and the road that crosses Buchan Creek. The Bredbo River has a high connectivity with the Murrumbidgee River, therefore fine sediments eroded from this site are highly connected with the Bredbo and Murrumbidgee Rivers.				
Site photos

Bank erosion along Buchan Creek upstream of its confluence with the Bredbo River		Bank erosion along Buchan Creek upstream of the road crossing		
Risk assessment				
<i>Likelihood</i>	<i>Consequence</i>	<i>Trajectory</i>	<i>Overall Score / risk</i>	
4	3	3	36 / High risk	
Management options				
Previous management option suggested works from the confluence between Buchan Creek and the Bredbo River to upstream of the road crossing of Buchan Creek. However, works are only required where vertical banks were present, as seen in the figure below. Recommended works are laying back and revegetating the banks, with rock placed at the toe of the banks as needed (more detailed hydraulic analysis is required to design these works).

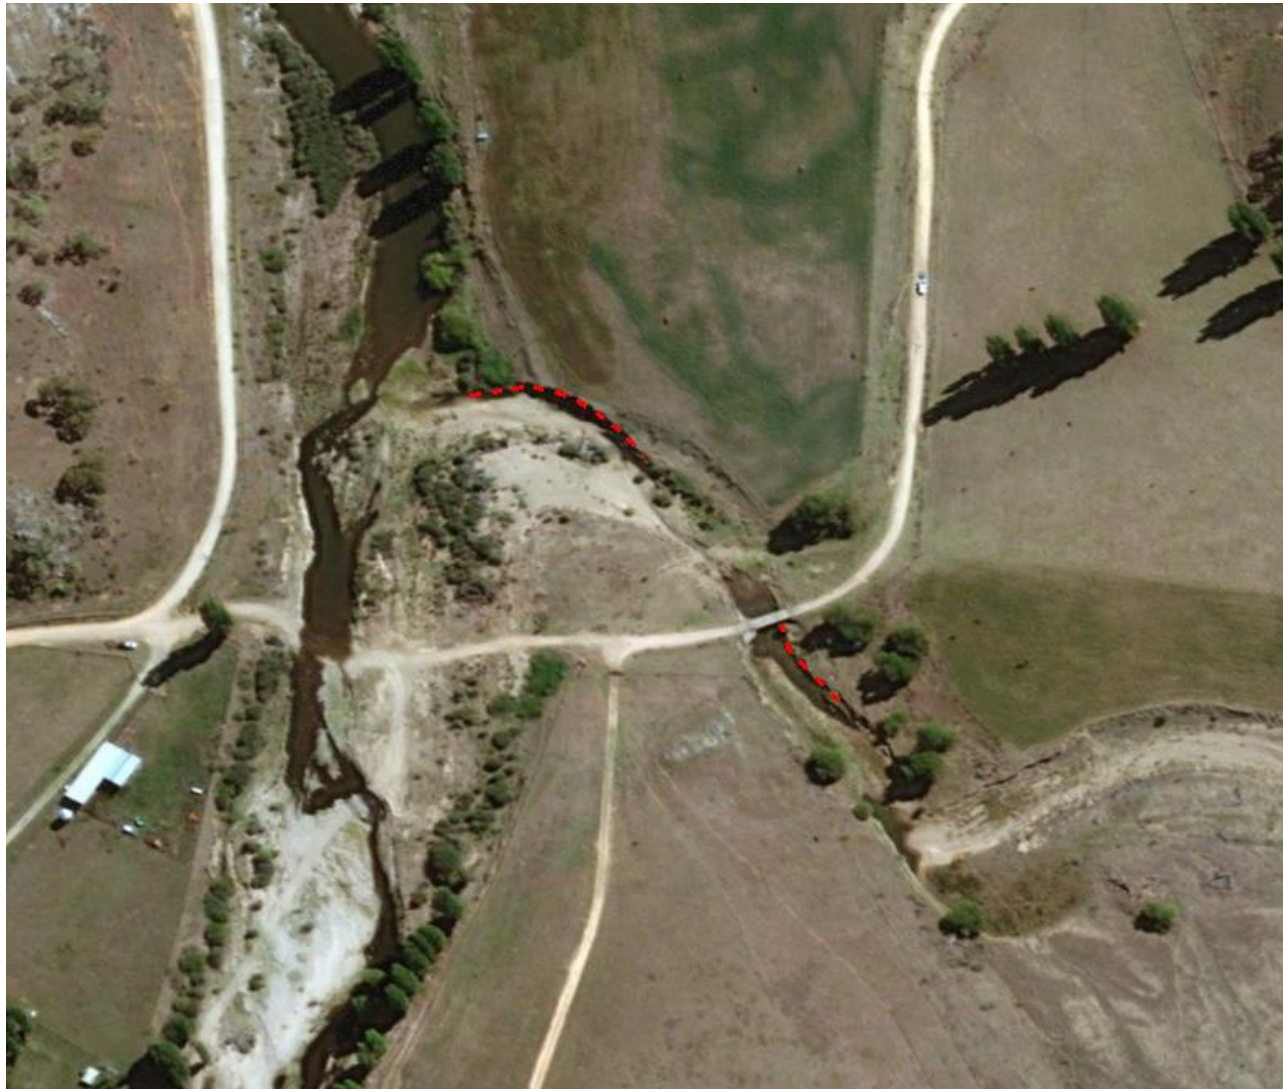
Composite aerial image of vertical banks present along Buchan Creek where bank stabilisation works are required

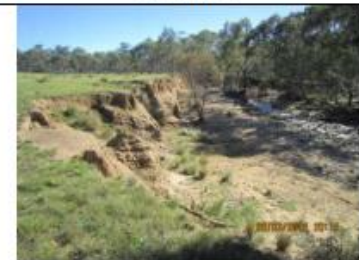
Bank erosion Buchan Creek

in further incision of the gully network. Downstream of the confluence of the gully with Buchan Creek, an 80m section of left bank, 4m in height, is evident. It is apparent that flows are actively undercutting banks.

Risk Rating: Extreme
Management Option: Undertake large woody debris stabilisation as alternative to rock beaching. Improve revegetation on site via mulching and revegetation.

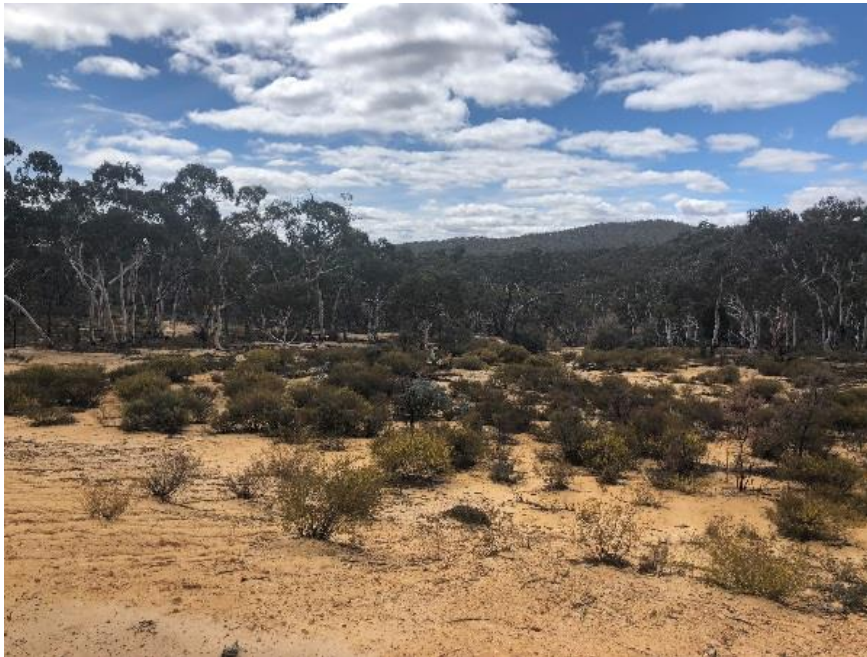
A steep slope which has historically been cleared of vegetation has been subjected to rill and gully erosion. In 2009 the gullies were filled in and the cleared area was revegetated. Small levees (referred to as 'push up banks') were constructed at the top of the cleared slope and half way down the slope. Coir logs were also placed just downstream of push up banks. The push up banks and revegetation in the cleared area at the top of the slope has been successful however further downstream the gully network has re-established, as unconsolidated fill material has been washed out. This is causing sediment to build up behind the second push up bank. While the second strip of coir logs have remained intact, they are being undercut by small rills, and the gully network has returned to its pre-works state. The gully network appears relatively stable, largely as result of flows being successfully diverted away down more resistant channels by the push up banks.

Revegetation of cleared land

Continue revegetation of cleared area with Eucalyptus spp. Monitor sediment load at the downstream 'push up bank'.
 Install large wood at the toe of sheer banks along Buchan Creek to reduce velocities at the toe of the bank to promote sediment deposition, reduce force on the bank toe and increase the rate of vegetation establishment.

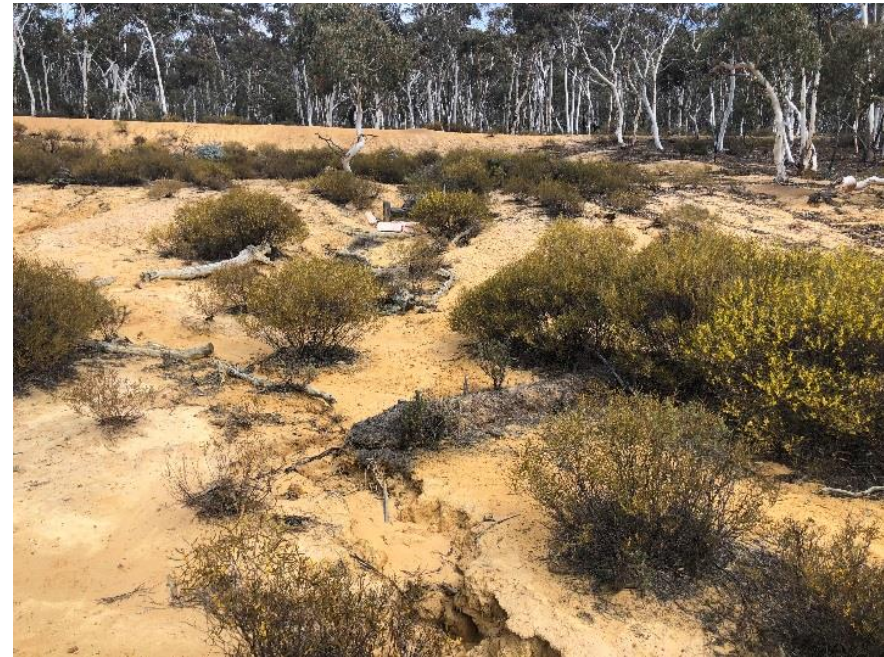
Coir logs on slope washed away with small gullies forming

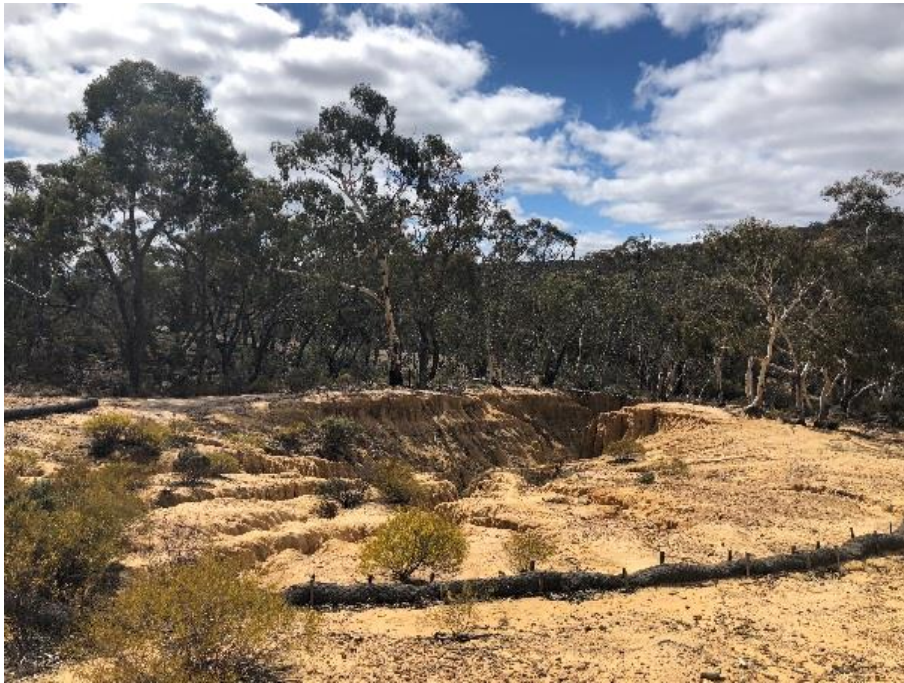
Relatively stable re-formed gullies

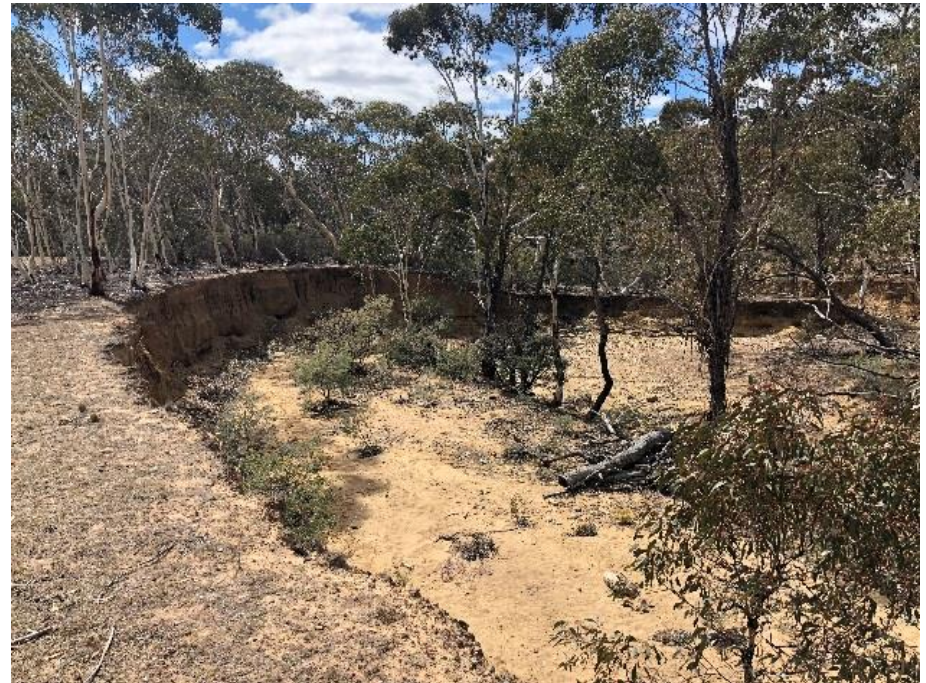
Downstream of the confluence of the gully and Buchan Creek, the banks of Buchan Creek are vertical and approximately five metres high for approximately 80 m of the left bank. There does not appear to have been significant erosion since the last assessment, and the banks are relatively stable due to the cohesive nature of the bank material, and the absence of ongoing bed incision in this reach of the Buchan Creek. A meander cut off is occurring at the end of this section. No works have been undertaken here.

Bank erosion Buchan Creek

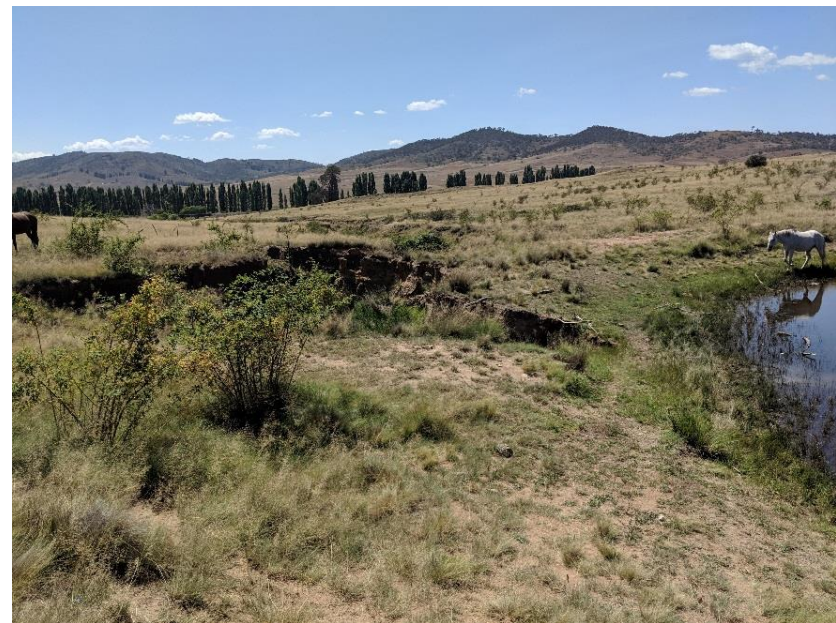
An existing farm dam located on a tributary of the Bredbo River is a risk of imminent failure due to recent overtopping of dam embankment. A lack of a dedicated spillway and overland flow path to control overtopping of the dam when full has led to a low point on the western side of the dam embankment directing overflow over the embankment and scouring away the embankment toe. This process has effectively set off a new head cut migrating back through the embankment. At the time of the site inspection the head cut was approximately 1 m away from initiating complete failure of the dam.

Without intervention imminent failure of the dam embankment is likely which would release both water and sediment stored within the base of the dam and set off a new phase of incision 1 to 2m deep in the tributary. This process would release a significant volume of sediment directly downstream to the nearby Bredbo River (500m downstream of the site).

Failing dam embankment looking east

Rebuild the failed dam embankment with clay core and incorporate dedicated spillway on eastern side set at least 500 mm below embankment crest. Rock armour spillway.

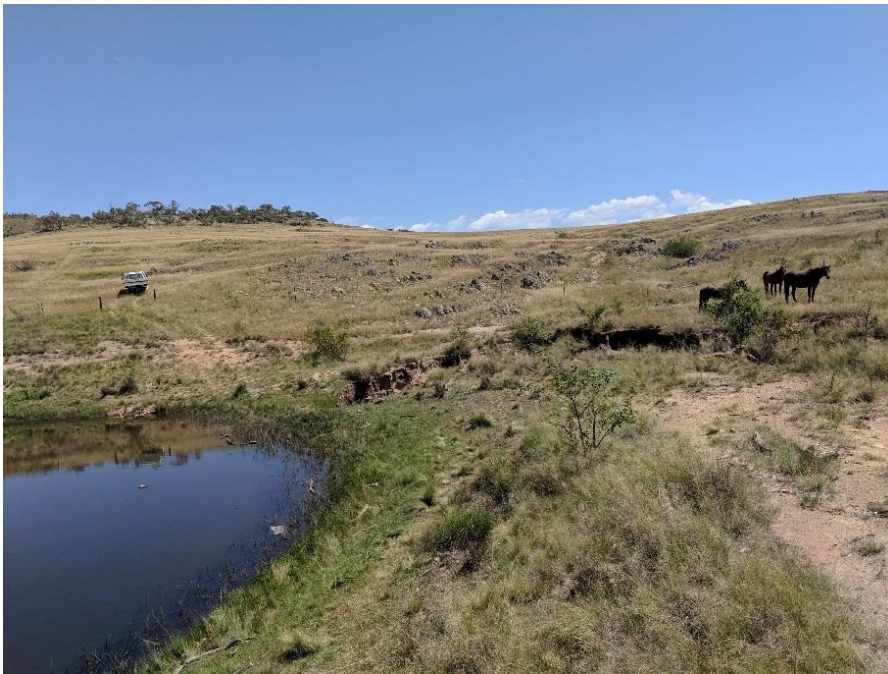
Failing dam embankment looking west

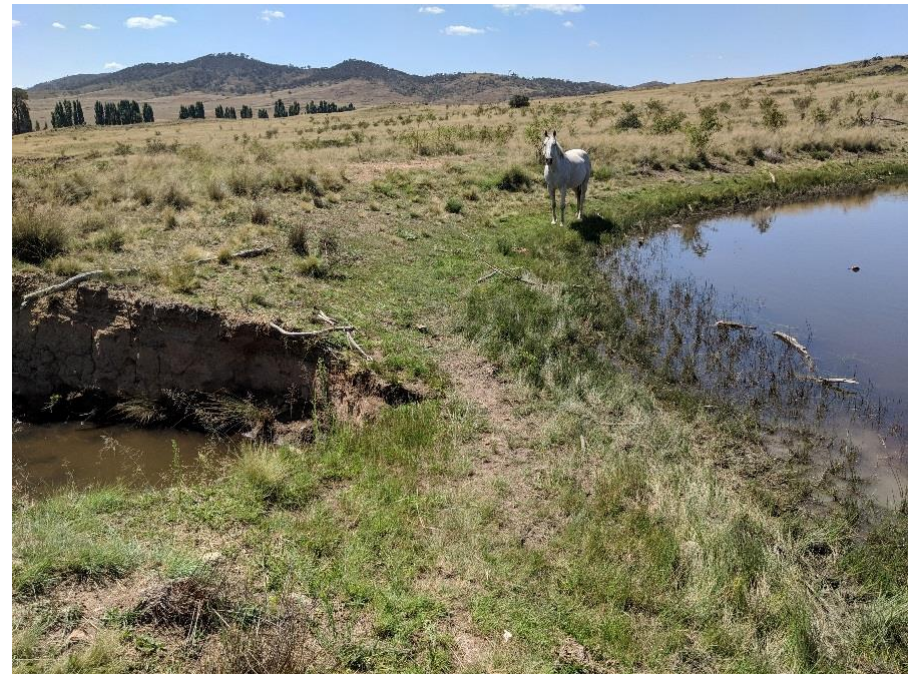
Head cut migrating through the embankment

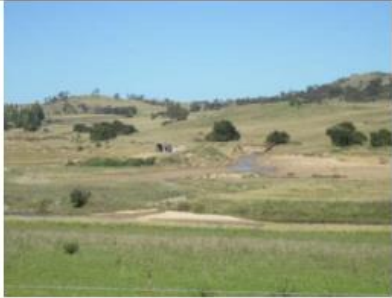
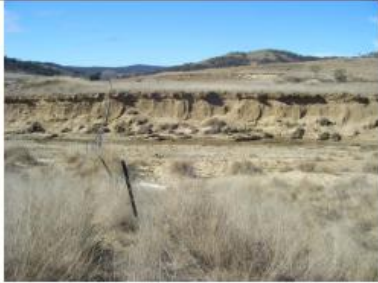
Alluvial fan where a tributary intersects with Bredbo River. Large amounts of sediment have been mined from this area.	Lowered bed level of a Bredbo River tributary showing deep sand layer.

This site concerns gravel/sand mining of the alluvial fans that intersect the Bredbo River and the channel and floodplain environment of the Bredbo River. It is possible that gravel/sand mining on Bredbo has lowered the bed level of the river and incoming tributaries, resulting in rejuvenation of the drainage network. Increased loadings of sediment can be expected from incoming tributaries which will impact on water quality in the Bredbo and Murrumbidgee Rivers.

Management Option: Review mining operations and investigate the impact that extraction is having on the stability of the Bredbo River and incoming tributaries. Construct rock chute upstream of existing extraction location to manage deepening of Bredbo River tributary. Fence and revegetate the site in consultation with landholder.

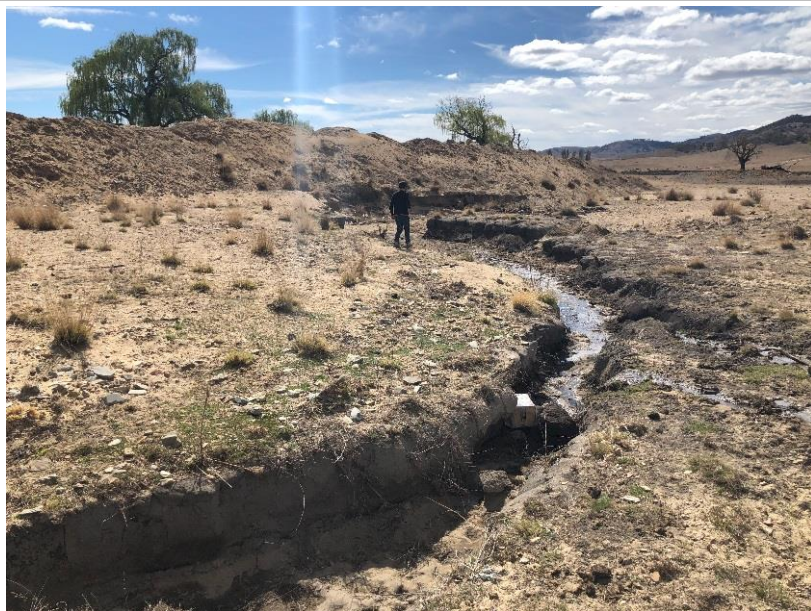
Large amounts of gravel/sand have been mined from the floodplain at this site. The site consists of an over-widened channel immediately upstream of its confluence with the Bredbo River. Banks of the over-widened channel are vertical, but relatively are stable, with isolated slumping. A new low-flow channel has formed through a new phase of incision that progressing upstream at a relatively slow rate. It is unlikely to impact on the banks of the over-widened channel as the low-flow channel is narrow and in the middle of the over-widened channel. No works have been undertaken.

New low flow channel slowly moving its way upstream

No major works recommended. New phase of incision should be monitored (once every two-three years). Possible to improve site with fencing and revegetation in consultation with the landholder.

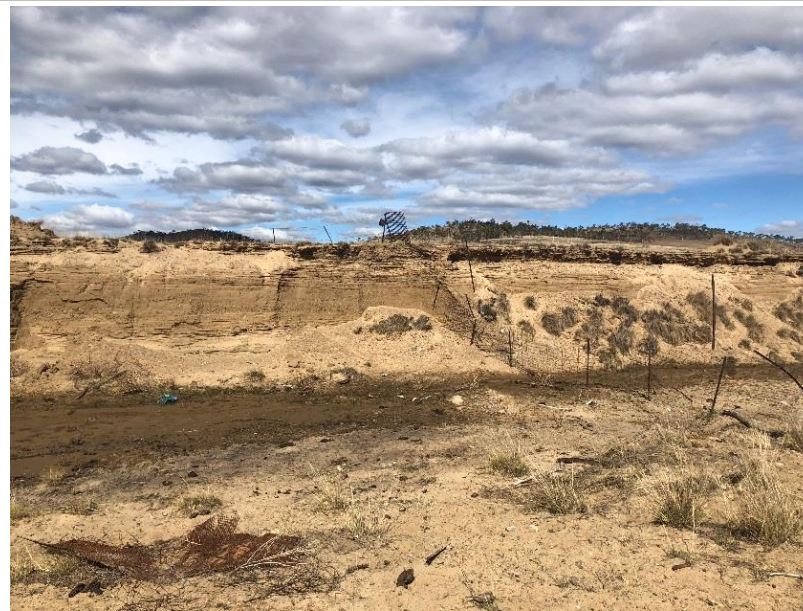
Banks with isolated slumping

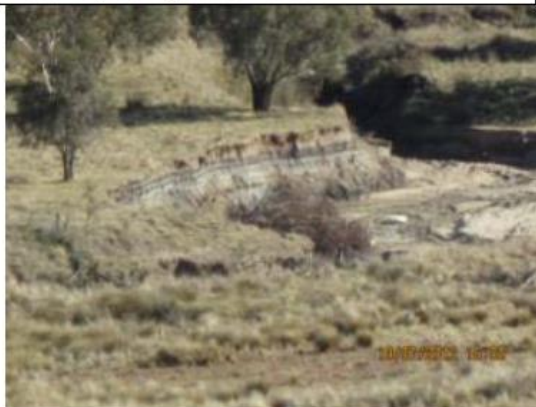
Bank erosion at the confluence

This site consists of active bank erosion on Spring Station Creek at a location where a secondary gully enters the creek. The creek was previously unchannelised, however following flooding in 2012, the gully has now channelized and is actively deepening and delivering sediment downstream. To stabilise the confluence of the gully and Spring Station Creek, bank stabilisation is required to prevent further erosion. To manage deepening in the gully survey should be undertaken, and then strategic grade control constructed to manage deepening.

Management Option: Construct rock beaching to stabilise bank at confluence of gully and Sheep Station Creek., Construct rock chutes in gully to control bed deepening. Fencing and revegetation of the site in consultation with the landholder.

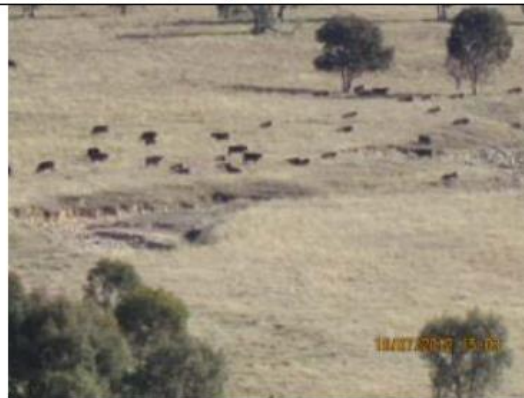
Overview of deepening up the gully line

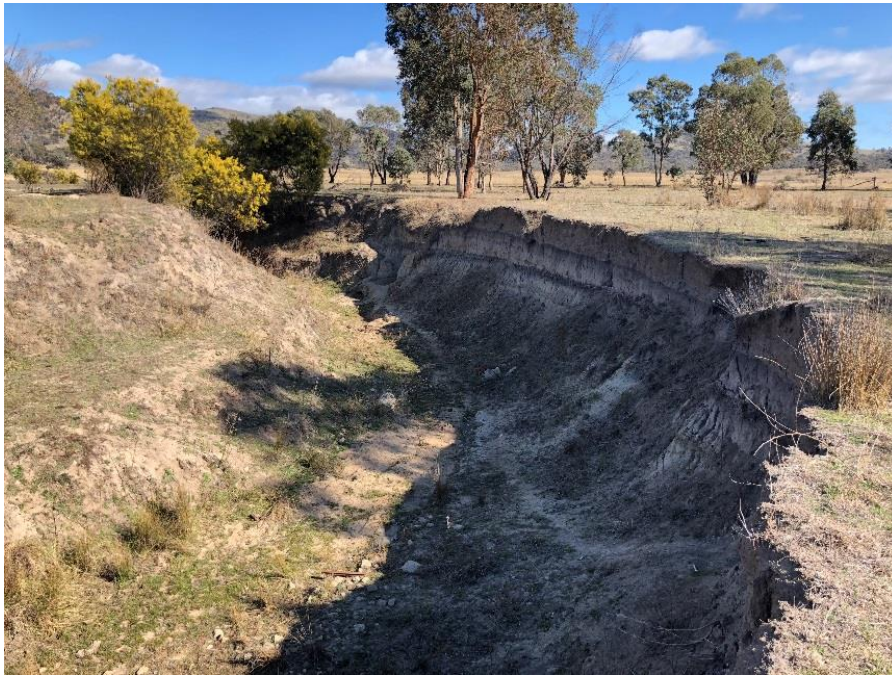
The site concerns active bank erosion where a secondary gully enters Spring Station Creek. The gully has reached bedrock therefore further incision is halted. The gully will continue to adjust via widening.

Bank erosion just upstream of the gully's confluence with Spring Station Creek

Management options include rock beaching and revegetation to control channel widening at the site. Revegetation of the riparian corridor should include a fully structured suite of native vegetation (groundcover, shrubs and trees) in consultation with the landholder.

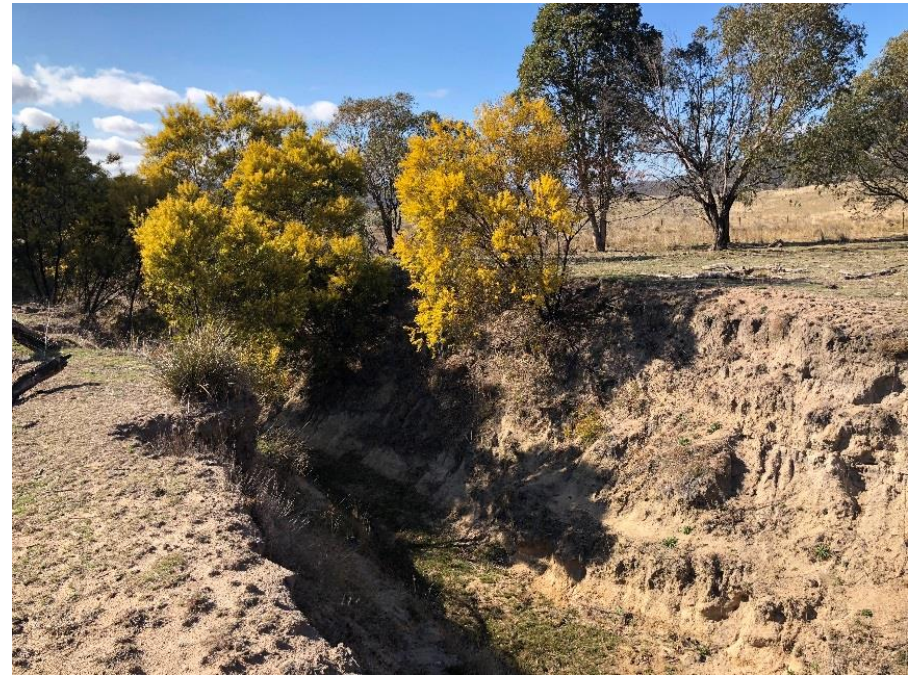
Bank erosion along Spring Station Creek

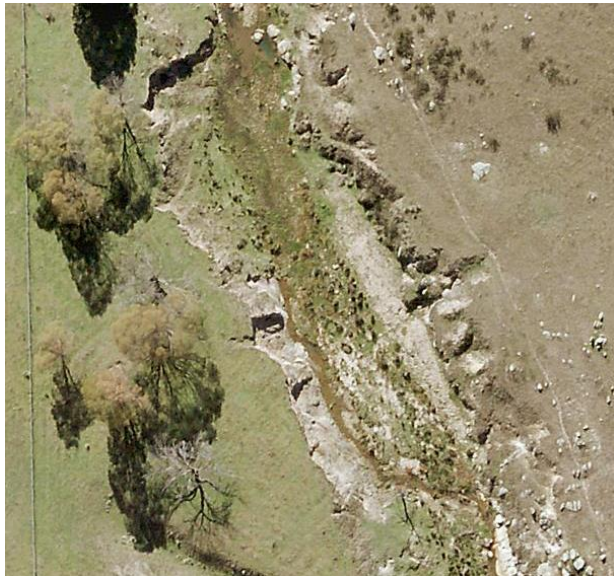
2017 aerial of bank erosion in Spring Station Creek upstream of the confluence with the gully

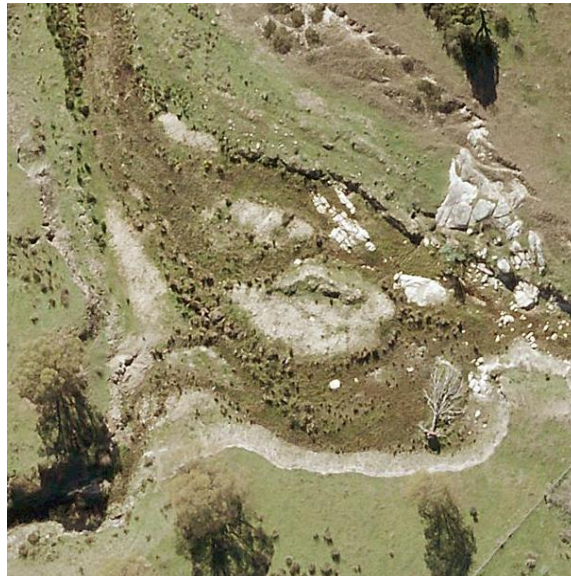
2017 aerial of bank erosion at confluence of Spring Station Creek and the gully

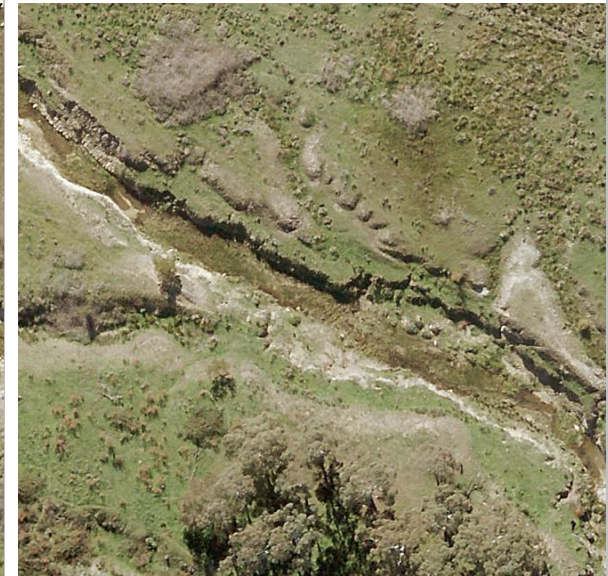
2017 aerial of bank erosion in Spring Station Creek downstream of the confluence with the gully

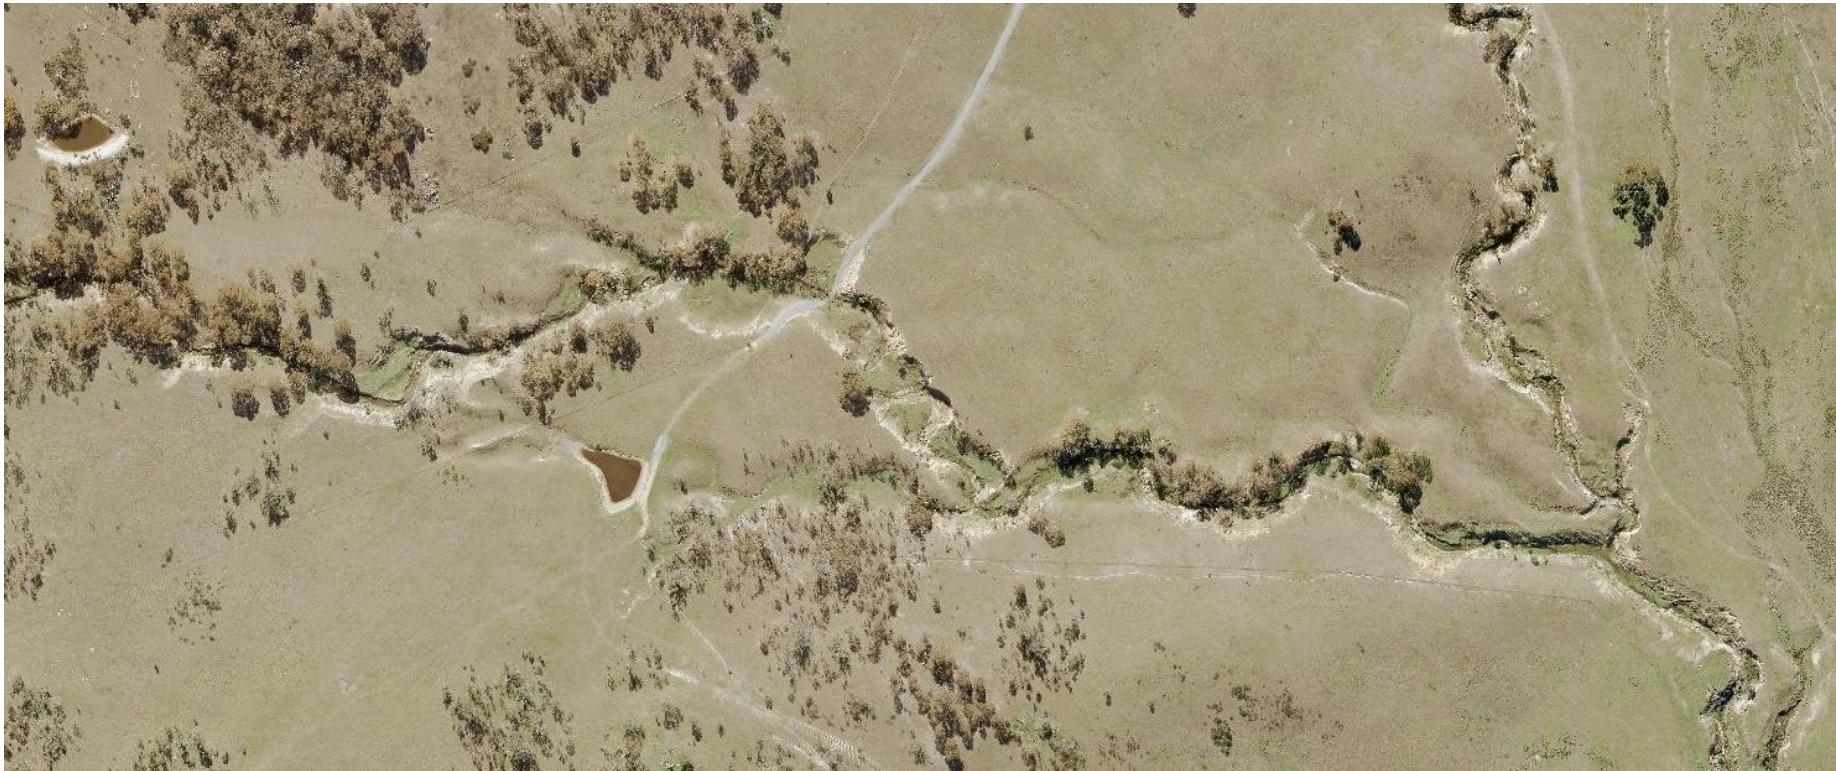
2017 aerial image of erosion of gully and Spring Station Creek upstream from the site

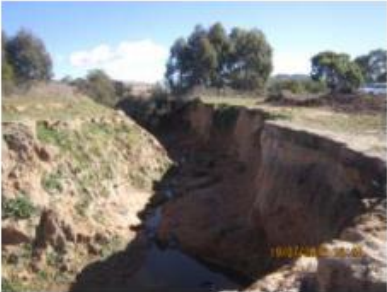
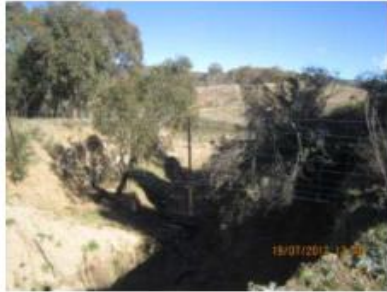
Looking downstream over erosion	Looking past fence to Murrumbidgee River

This site is known locally as the Lanyon Canyon. It consists of an erosion head approximately 5m high, which drops approximately 10m into the Murrumbidgee River. It would appear burrowing by Wombats has encouraged tunnel erosion which has set off a major gullying episode in close proximity to the Murrumbidgee River. To stabilise the site, check banks should be constructed to encourage flow to spill to the north into a more stable flowpath.

Management Option: Back fill existing scour hole with a clay bank. Face with rock beaching. Define northern spillway to improve overflow stability from the dam. Fencing and revegetation of site in consultation with landholder.

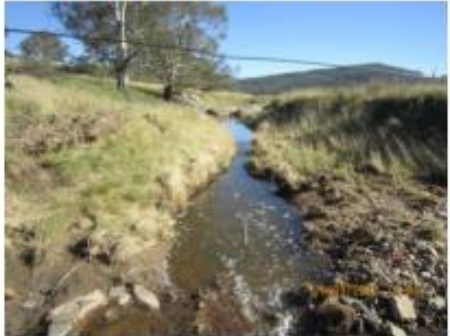
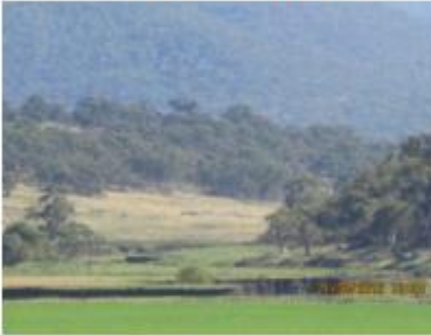
Murrumbucca Creek, facing downstream	Bank erosion present along lower reaches

Condition Assessment:			
Upstream of crossing, the silty/sand banks are eroding with minimal grassy vegetation present. Downstream of the crossing, bedrock control in channel is limiting further incision. This catchment appears to be a significant source of fine grained sediments to the Murrumbidgee. More significant incision, bank erosion and channel widening appears to be occurring in the lower reaches of this valley. This creek has been assessed as having high connectivity for fine sediments due to very fine grained sediments eroded from bed and banks of incising creek transferred efficiently to Murrumbidgee through gorge setting. This valley would once have been a swampy meadow, not an incised channel contributing large amount of sediments as it is today.			
Risk Assessment:			
Likelihood	Consequence	Trajectory	Risk
4	4	4-5	64-80
Risk Rating: Extreme			
Management Option: Install rock beaching to manage bank erosion. Fencing and vegetation of site to be undertaken in consultation with the landholder.

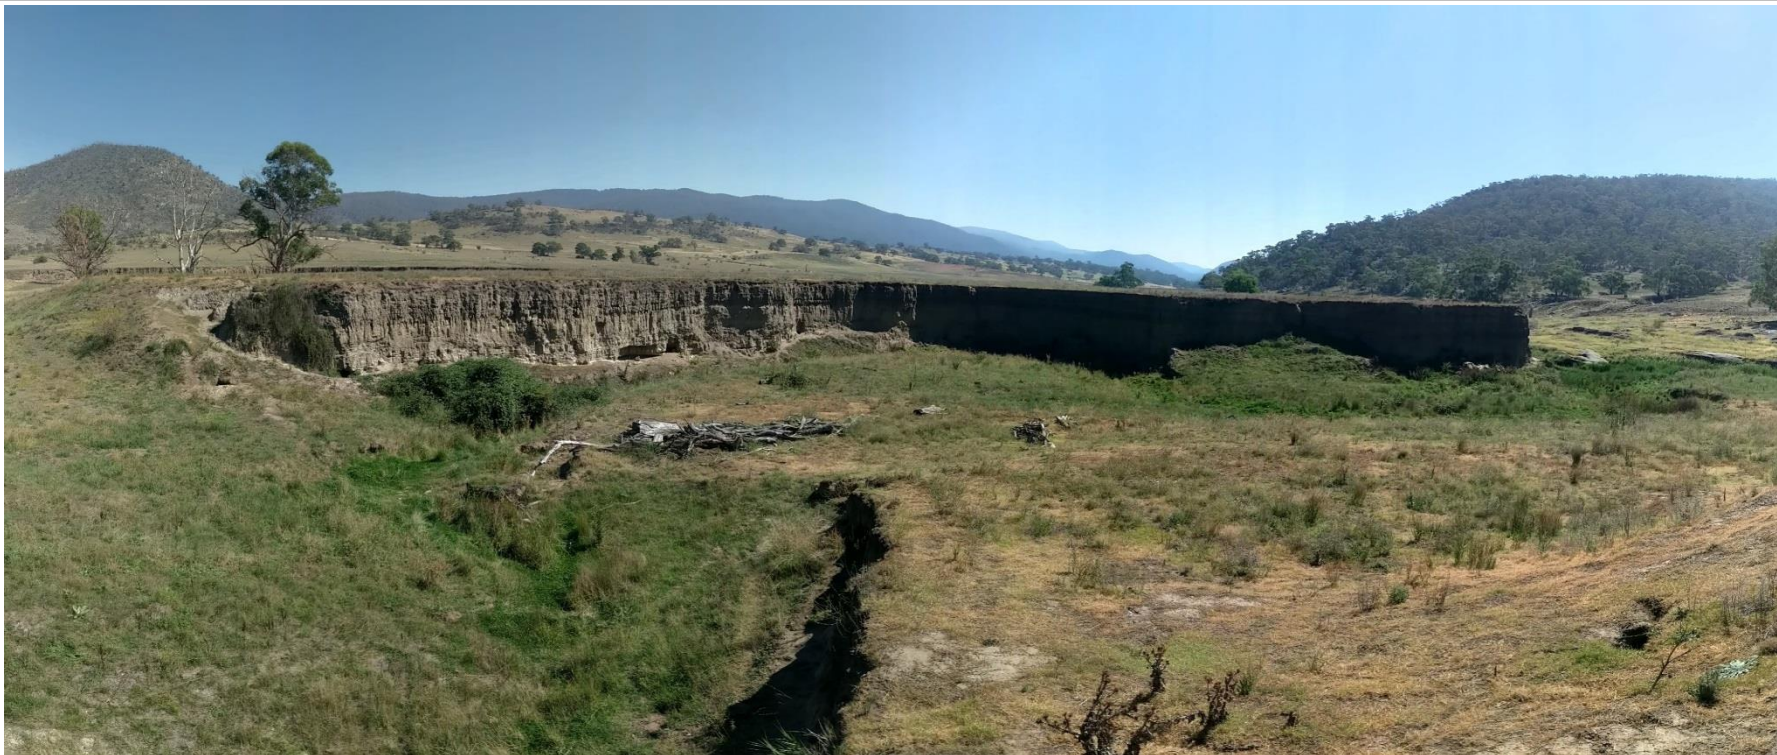
Without intervention ongoing bank adjustment has potential to liberate a significant amount of sediment into the receiving system.

Bank migration at Bakersdale Creek

Site 40			
Risk assessment			
<i>Likelihood</i>	<i>Consequence</i>	<i>Trajectory</i>	<i>Overall Score / risk</i>
4	4	3	48 / Very High
Management options			
Due to the number and length of bank migration occurring across the site a detailed reach bank management strategy should be developed to guide investment in the reach. Works are likely to include a mixture of alignment training measures (groynes and pile fields) and bank armouring (rock and logs)

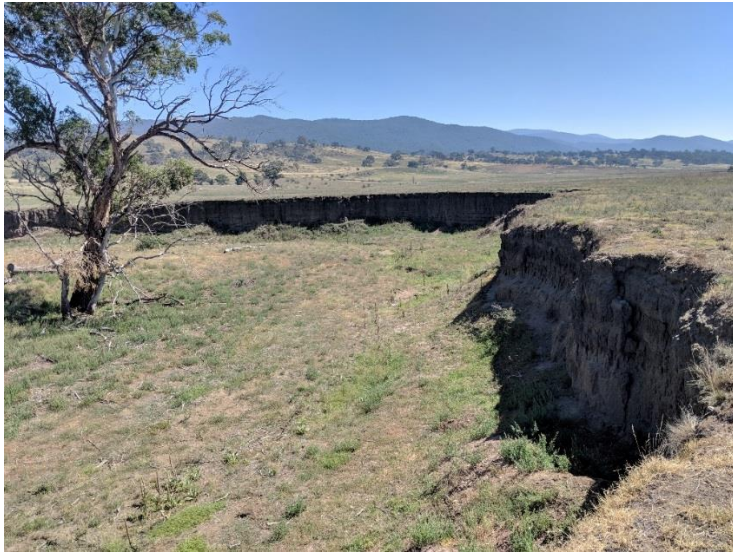
Bank migration at Bakersdale Creek

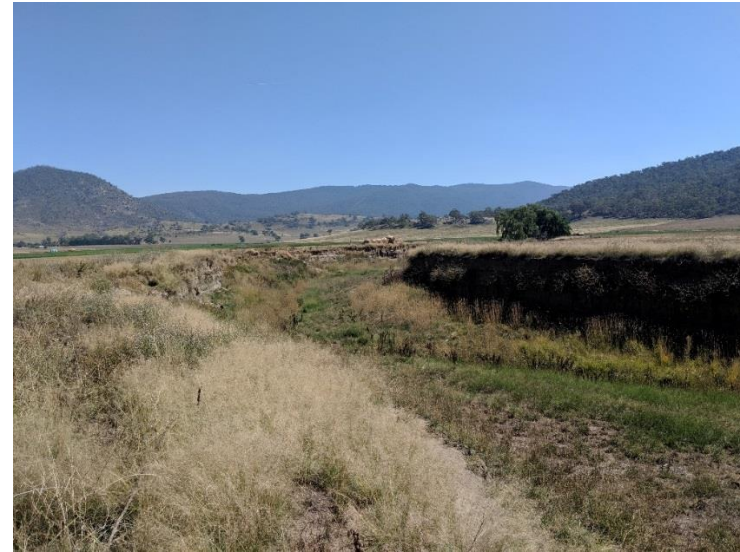
Ongoing back migration observed in Murrumbucca Creek

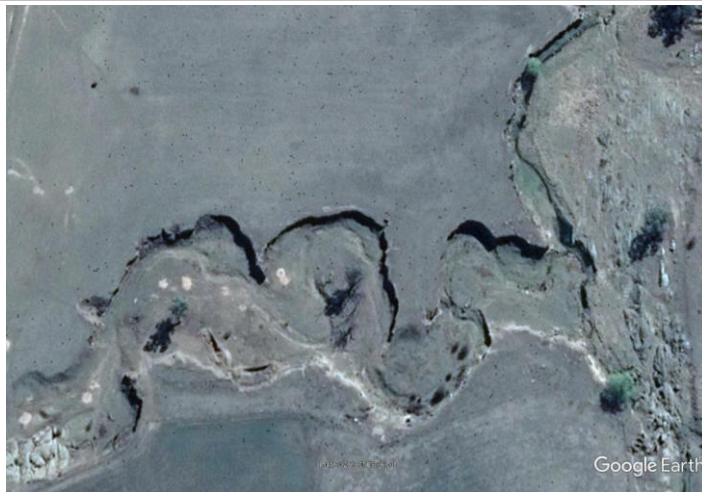
September 2018 aerial image of bank erosion in Bakersdale Creek and Murrumbucca Creek (down-stream of the confluence)

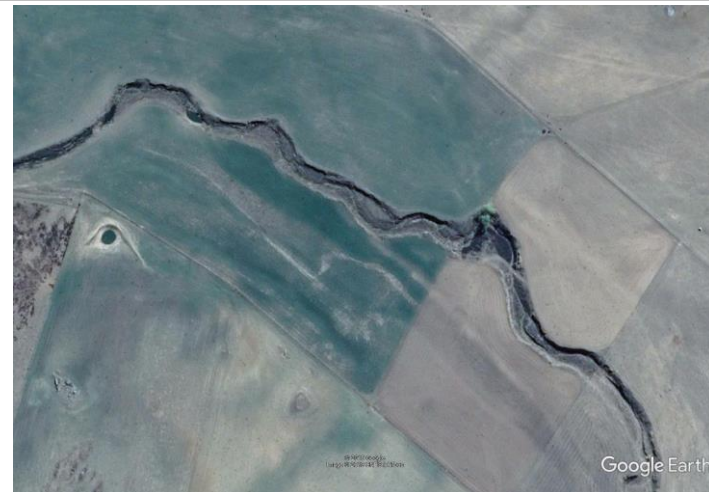
September 2018 aerial image of bank erosion in Murrumbucca Creek upstream from the confluence and site 40.

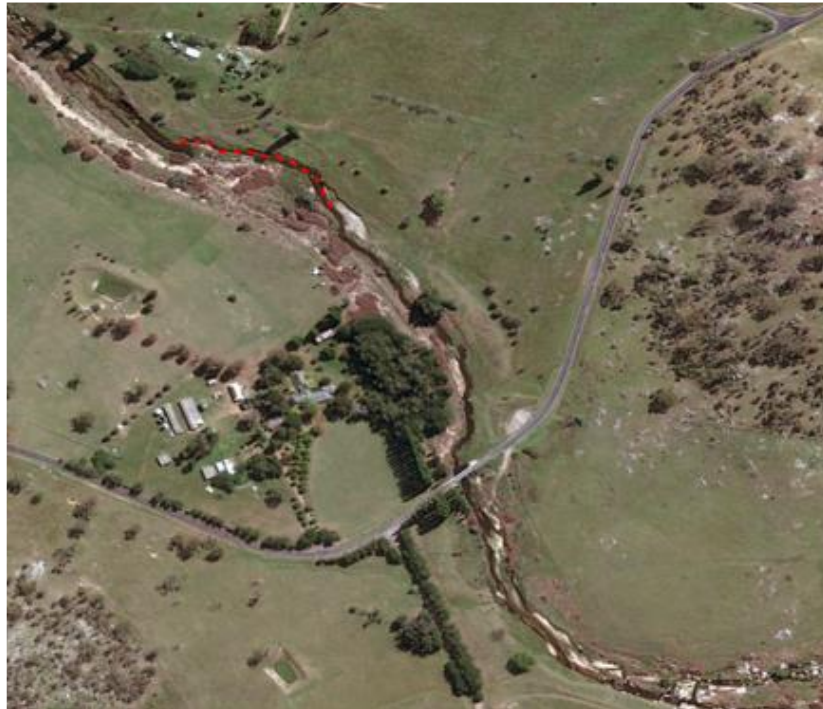
Area requiring further investigation identified upstream from site

No need for management aside from broken fencing being fixed. Investigate erosion identified on bend upstream in the Gudgenby River as shown in figure below.

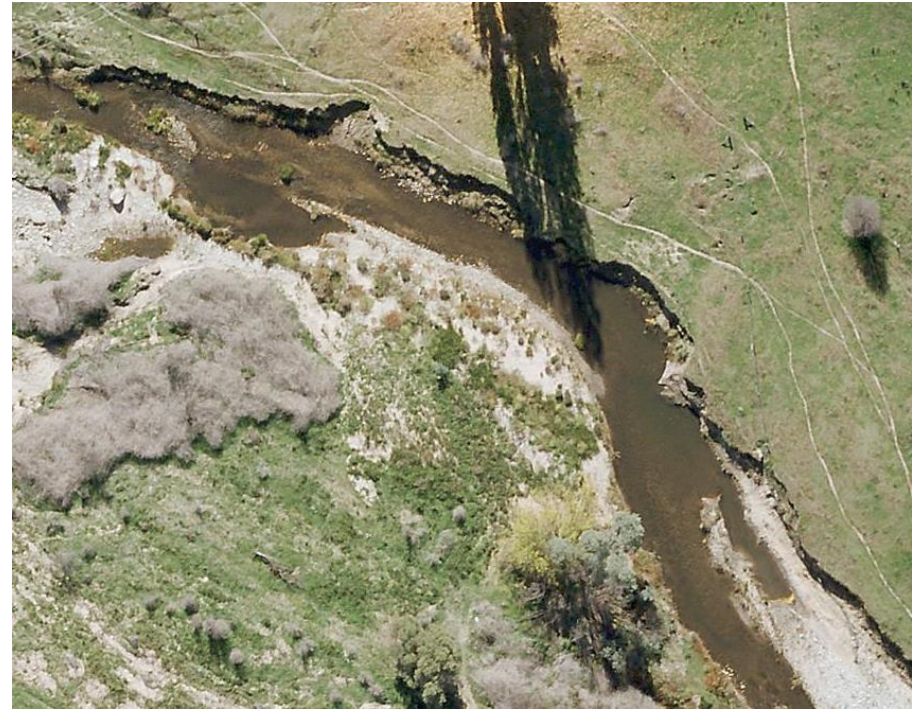
2017 aerial image of erosion requiring further investigation identified upstream from site

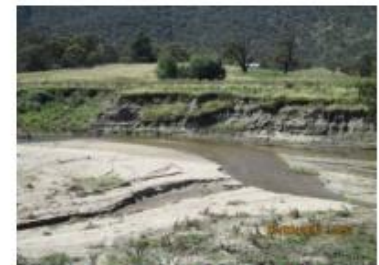
Bank erosion along the Naas River

Management Option: Undertake sediment extraction in gully to reduce sediment delivery. Construct pile fields to manage migration of main waterway. Fencing and revegetation of site in consultation with landholder.

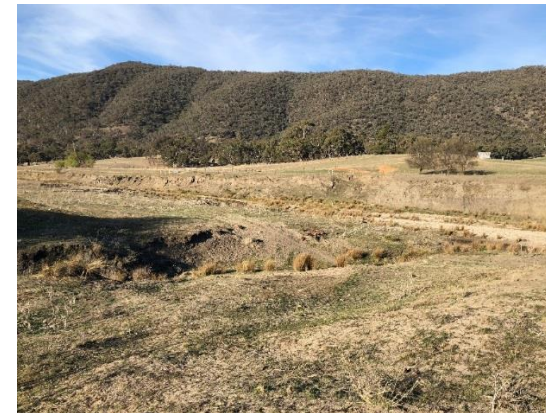
The site concerns the Naas River and a tributary gully. The tributary gully was previously assessed as containing a large amount of sediment, but at the time of inspection in this study very limited volumes of sediment were present. The culverts under Naas Road were observed to be clear of sediment. The culverts (including gabion walls) under Naas Road were very stable. Along the Naas River itself several kilometres of active bank erosion was observed, which is resulting in the mobilisation of a large amount of mixed grain size sediment. The risk assessment score below relates to the Naas River and not the tributary gully.

Bank erosion along the Naas River

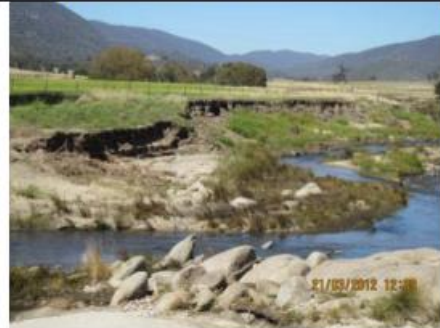
Further bank erosion downstream

Management Option: Construct rock beaching to manage bank erosion. Fencing and revegetation recommended in consultation with the landholder(s).

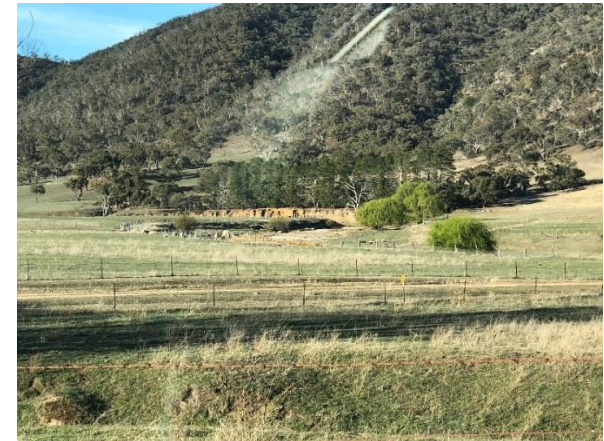
Bank erosion along the Naas River just downstream of the site

Reach-scale bed grade and stream power analyses are needed to determine whether the Naas River is still incising. If it is still incising treatment is needed along the whole reach which could include rock beaching, pile fields to manage migration of waterway and fencing and revegetation in consultation with the landholder(s).

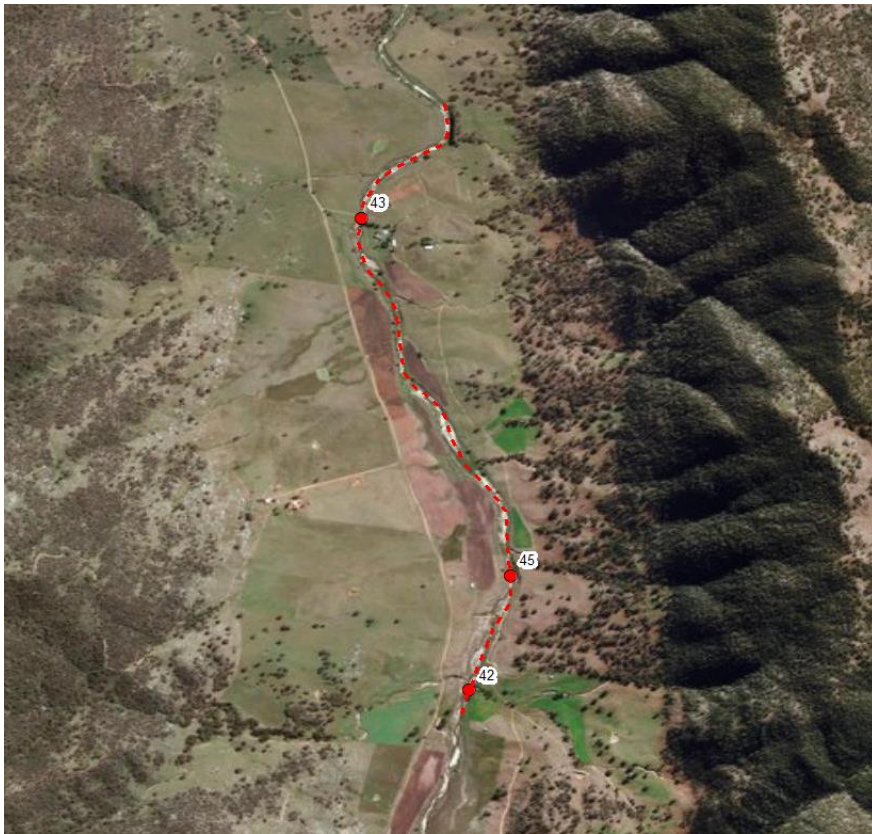
Aerial showing indicative location of several kilometres of active channel erosion

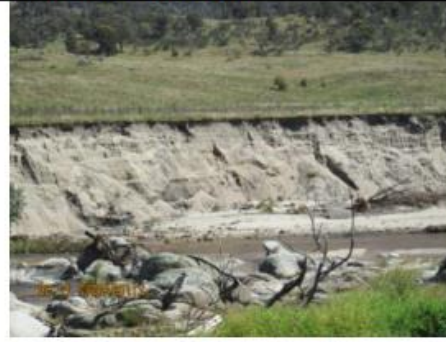
Widespread bank erosion along Naas River

Management Option: Install rock beaching to manage bank erosion and channel widening. Fencing and revegetation recommended in consultation with the landholder.
