Memo

Subject Upper Murrumbidgee ACWA Site Review
Date 14 March 2019
Distribution Brent Johnson (Icon Water)
Project Googong Dam catchment Actions for Clean Water Plan

1 Introduction

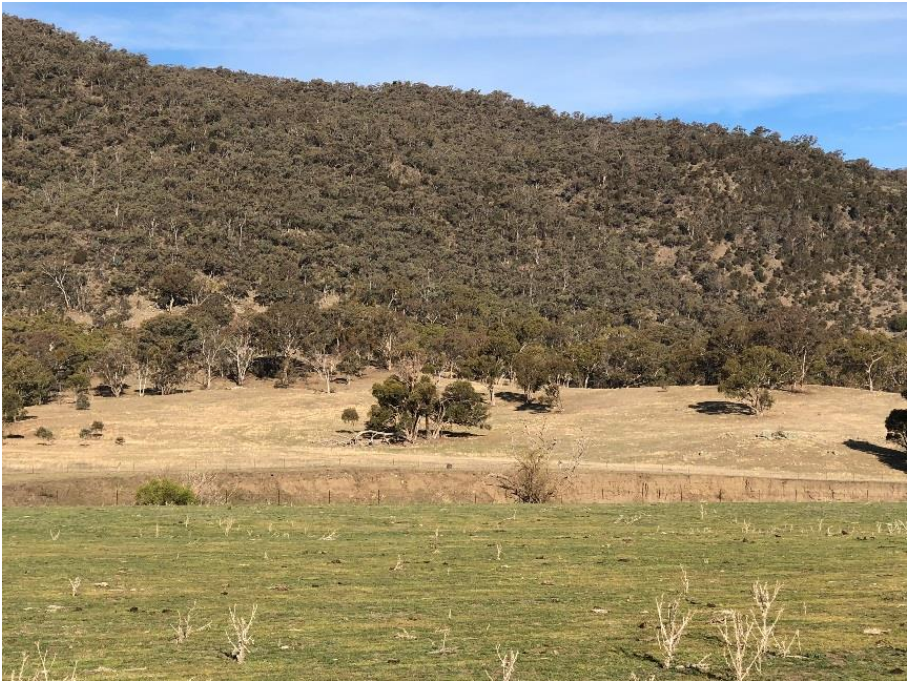
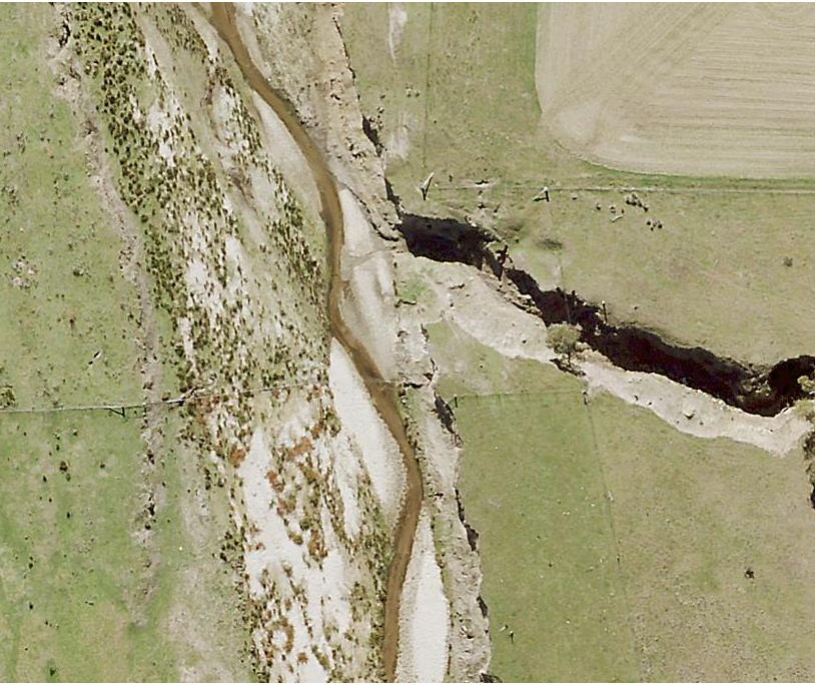
Site 45			
Condition assessment			
Along the Naas River there is several kilometres of active channel erosion which is resulting in the mobilisation of a large amount of fine sediment as can be seen at this site. Risk assessment remains the same as previous assessment (access was not available at this site).			
Site photos

Active channel erosion seen from road		2017 aerial of Naas River and tributary gully erosion.	
Risk assessment			
<i>Likelihood</i>	<i>Consequence</i>	<i>Trajectory</i>	<i>Overall Score / risk</i>
4	5	4	80 / Extreme
Management options			
Reach-scale bed grade and stream power analyses are needed to determine whether the Naas River is still incising. If it is still incising treatment is needed along the whole reach which could include rock beaching, pile fields to manage migration of waterway and fencing and revegetation in consultation with the landholder(s).

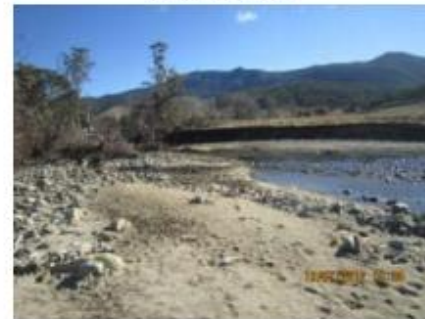
Major bank erosion
