M2G Planting (Tree & Shrub) Monitoring Report

Construction Corridor (Autumn 2016)

Prepared for
Icon Water

July 2016

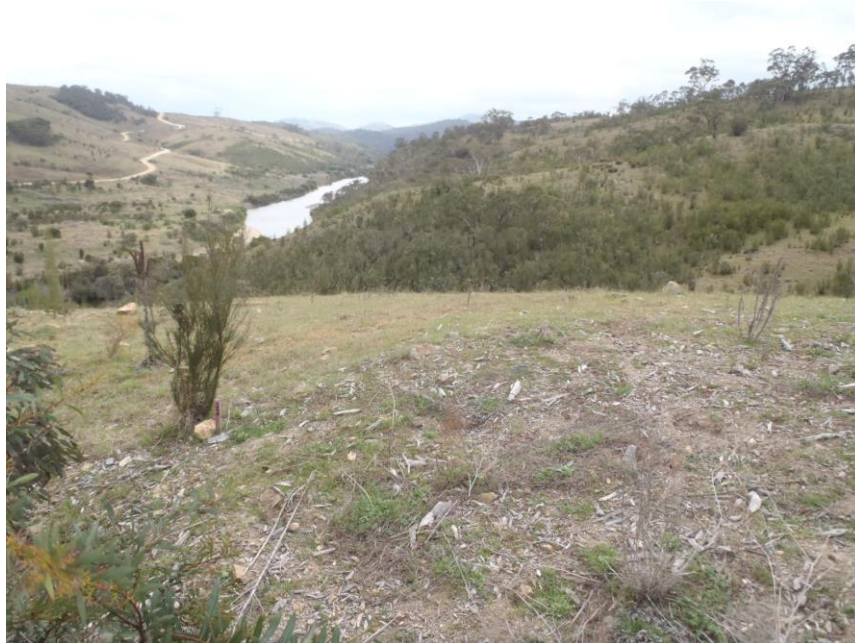
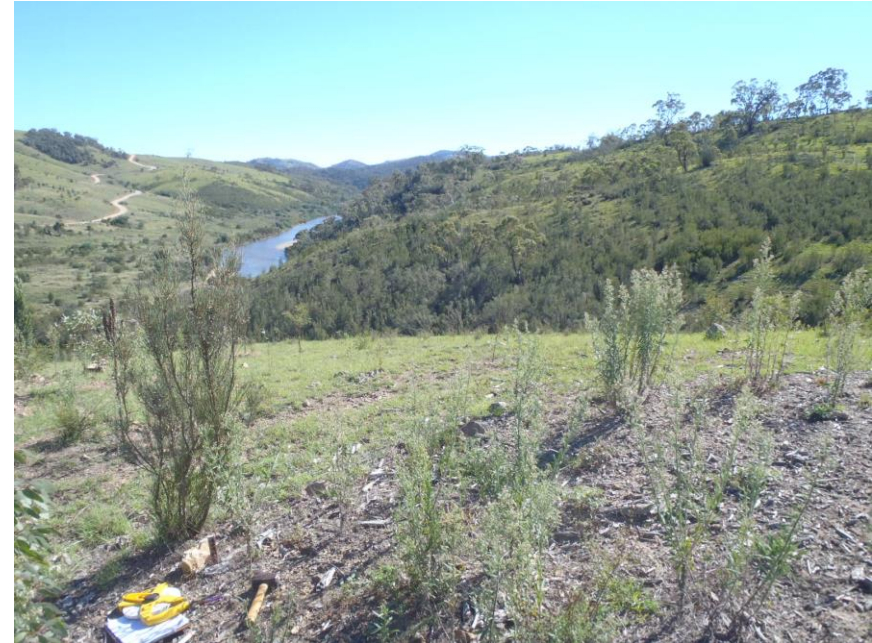
Jurisdiction	ACT	TSP1 Situated within the Murrumbidgee River Corridor immediately W and NW of the HLPS, about 250 m from the LLPS.
Co-ordinates	691345 – 6060236	
No. of tree & shrub species planted	8	Planting health improved by 16.3% with 32.6% of plantings currently in good condition. Contained an undetermined number of new plantings.
Specimen health		
Good	30 (15)	Recommendation: Provide sufficient maintenance for remaining specimens.
Poor	11 (25)	
Dead / Missing	50 (52)	
Total plantings	92

Plate 1: Monitoring Site TSP1. The image on the left is from spring 2015 and the right autumn 2016.

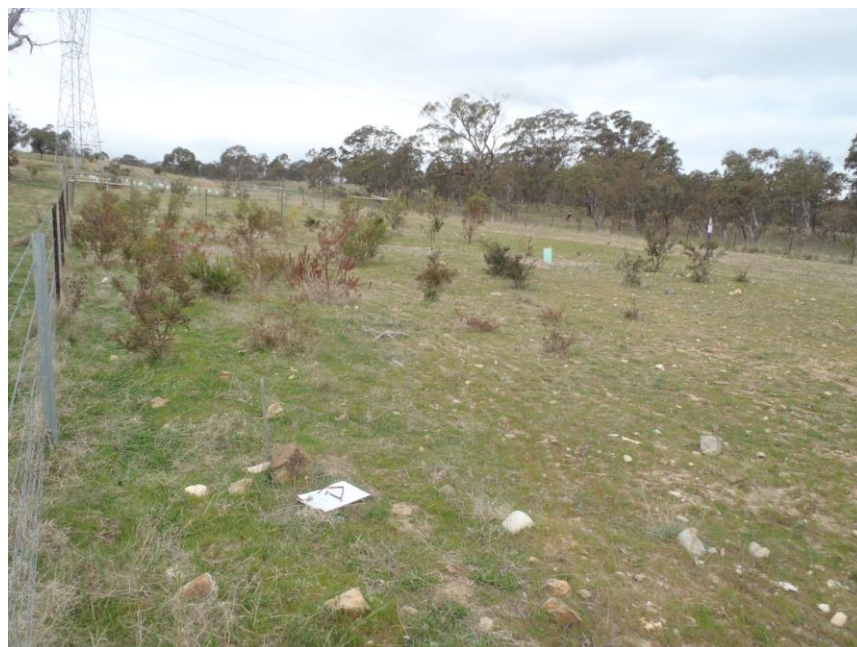
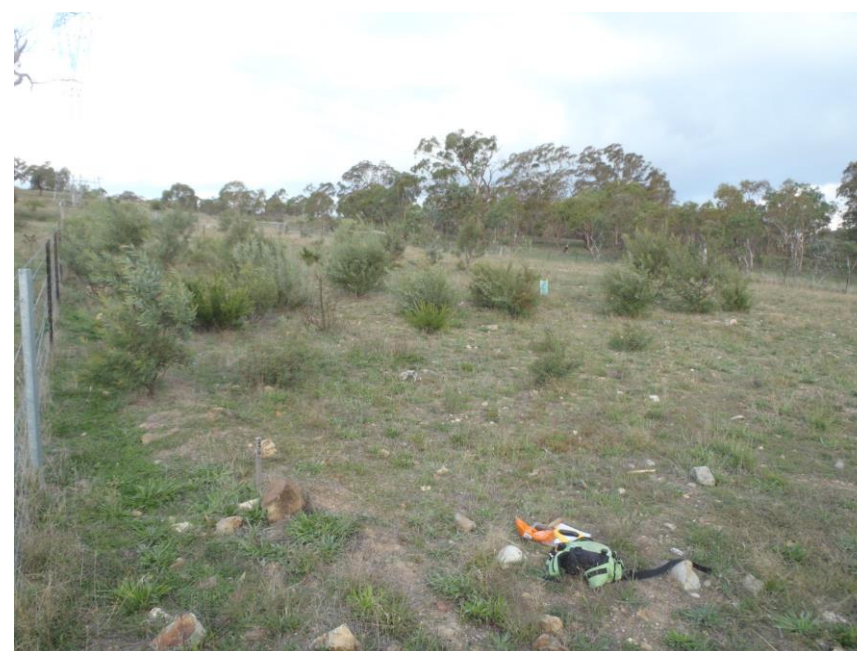
Jurisdiction	ACT	TSP2 is located within the Murrumbidgee River Corridor, about 1,025 m from the LLPS.
Co-ordinates	691964 – 6060519	
No. of tree & shrub species planted	5	Planting health improved by 9.4% with 52.7% of plantings currently in good condition. Replanting was not undertaken at this site. Recommendation: Provide sufficient maintenance for remaining specimens.
Specimen health		
Good	67 (55)	
Poor	2 (14)	
Dead / Missing	58 (58)	
Total plantings	127

Plate 2: Monitoring Site TSP2. The image on the left is from spring 2015 and the right autumn 2016.

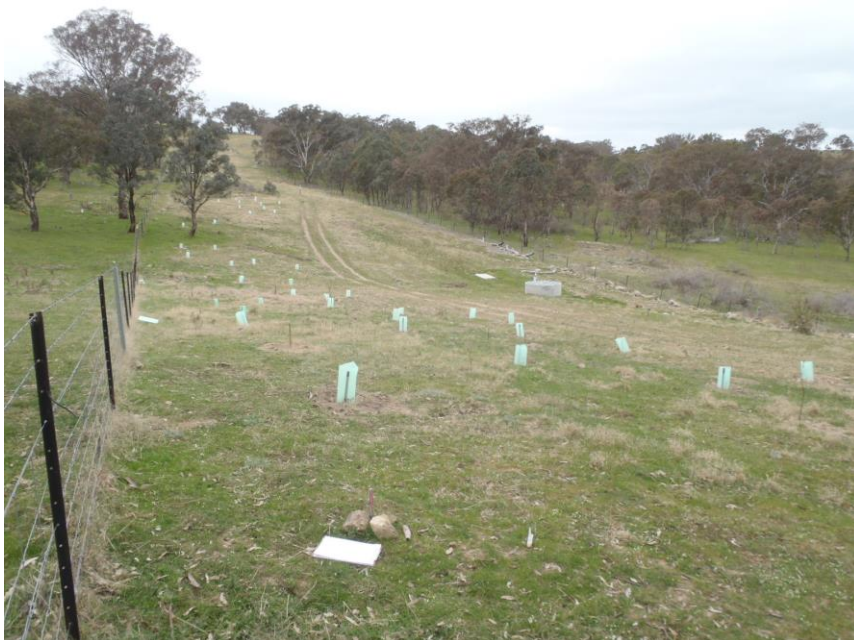
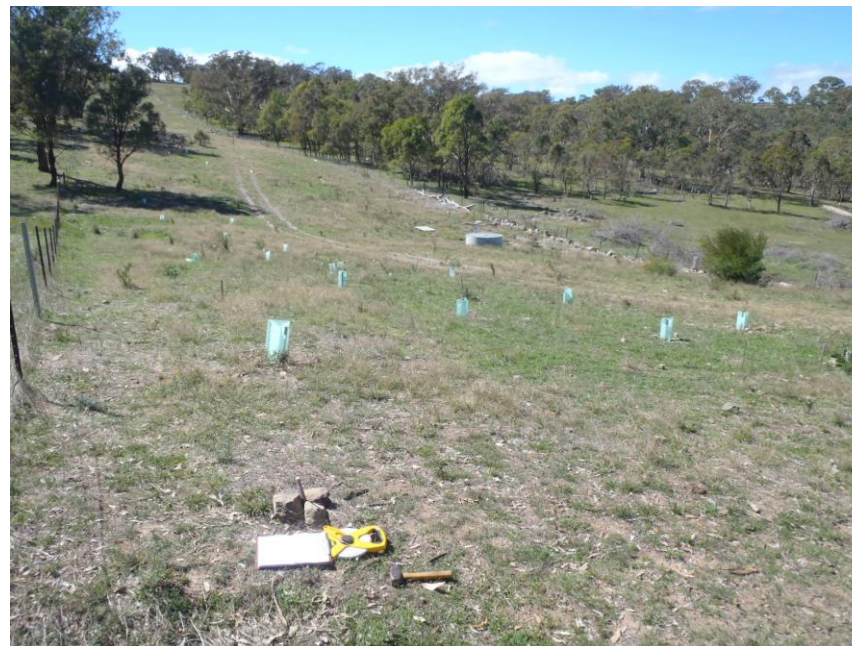
Jurisdiction	ACT	TSP3 is located within the Murrumbidgee River Corridor, about 1,350 m from the LLPS.
Co-ordinates	691964 – 6060519	
No. of tree & shrub species planted	6 (5)	Planting health improved by 8.4% with 32.6% of specimens currently in good condition. Recommendation: Provide sufficient maintenance for remaining specimens.
Seedling health		
Good	31 (23)	
Poor	8 (18)	
Dead / Missing	56 (54)	
Total plantings	95

Plate 3: Monitoring Site TSP3. The image on the left is from spring 2015 and the right autumn 2016.

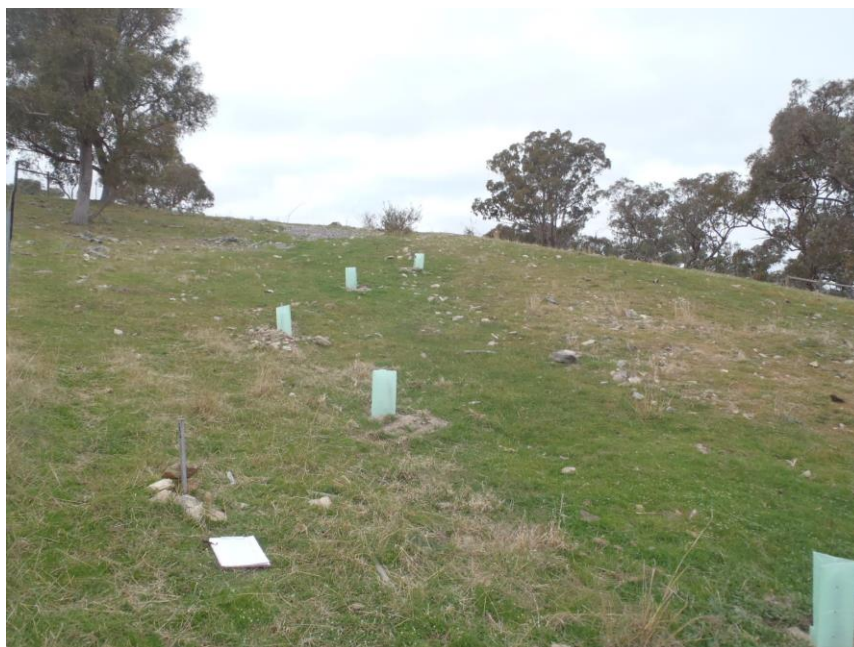
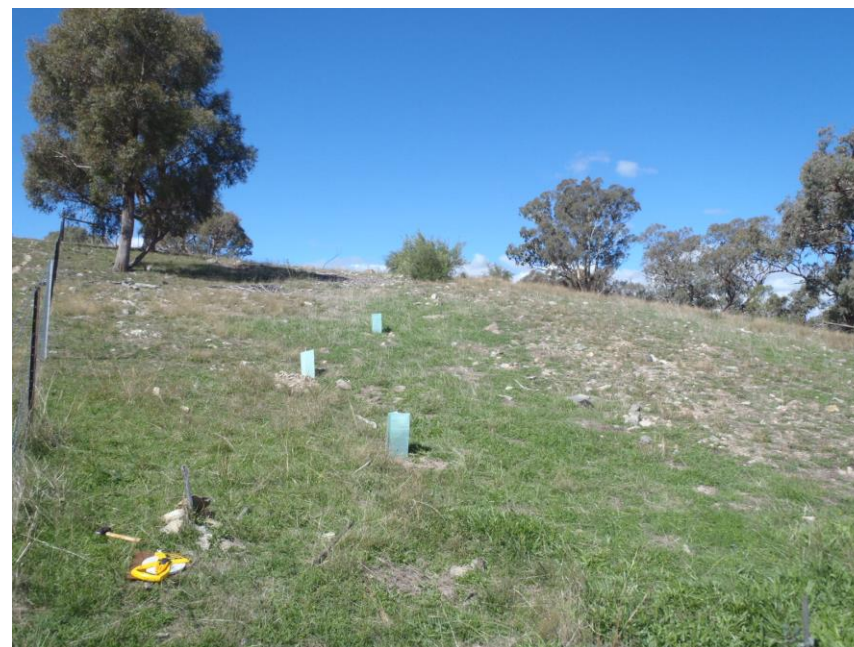
Jurisdiction	ACT	TSP4 is located about 1,900 m from the LLPS within the ACT.
Co-ordinates	692592 – 6060707	
No. of tree & shrub species planted	3	Planting health improved by 3.9% with 11.8% of specimens currently in good condition.
Seedling health		
Good	9 (6)	<i>Note: Most plantings either perished or were removed prior to autumn 2014.</i>
Poor	4 (6)	
Dead / Missing	63 (64)	
Total plantings	76	Recommendation: Additional planting is not recommended for this site.

Plate 4: Monitoring Site TSP4. The image on the left is from spring 2015 and the right autumn 2016.

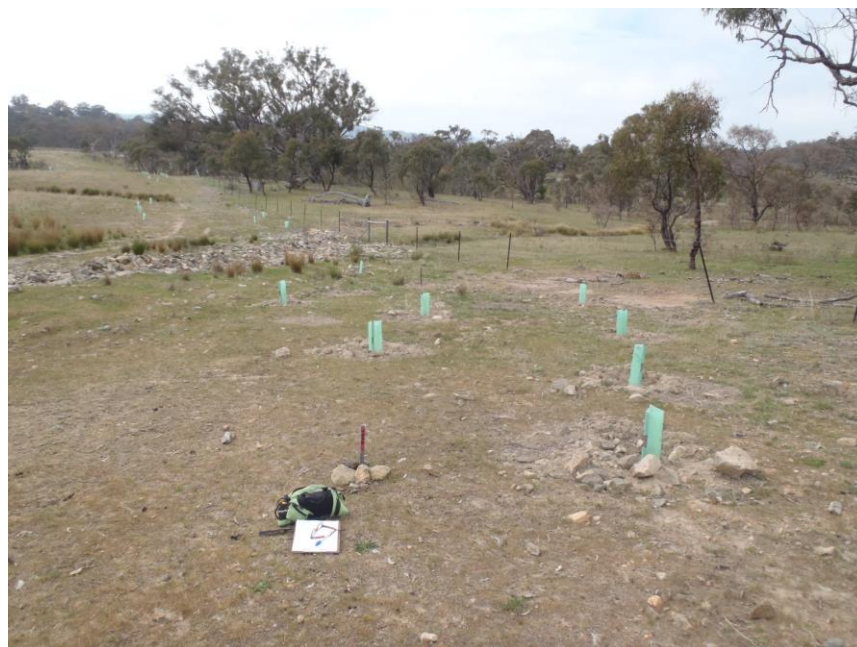
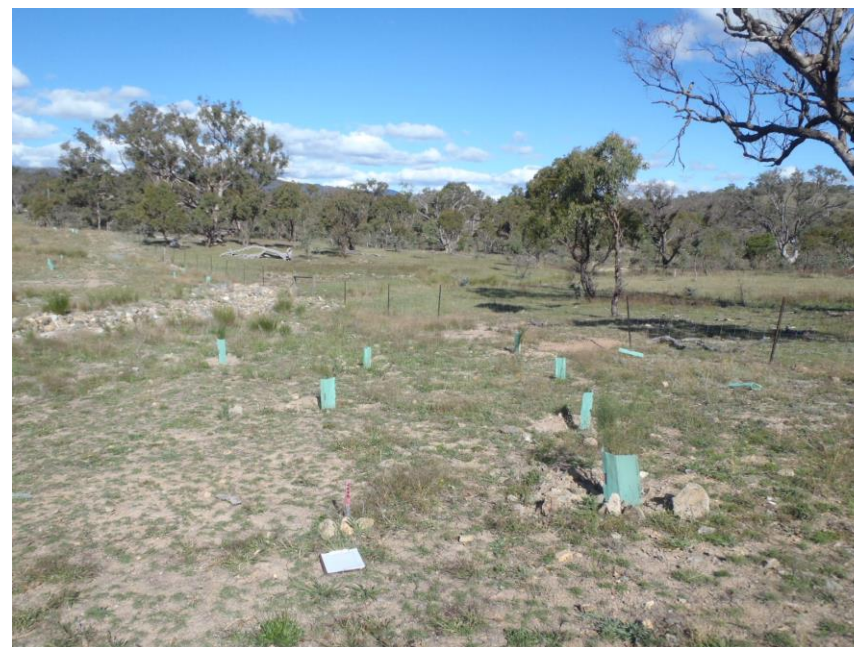
Jurisdiction	ACT	TSP5 is located about 2,325 m from the LLPS within the ACT.
Co-ordinates	693226 – 6060578	
No. of tree & shrub species planted	4 (3)	Planting health increased by 5.2% with 68.4% of specimens currently in good condition.
Seedling health		
Good	13 (12)	Recommendation: Provide sufficient maintenance for new plantings
Poor	1 (2)	
Dead / Missing	5 (5)	
Total plantings	19

Plate 5: Monitoring Site TSP5. The image on the left is from spring 2015 and the right autumn 2016.

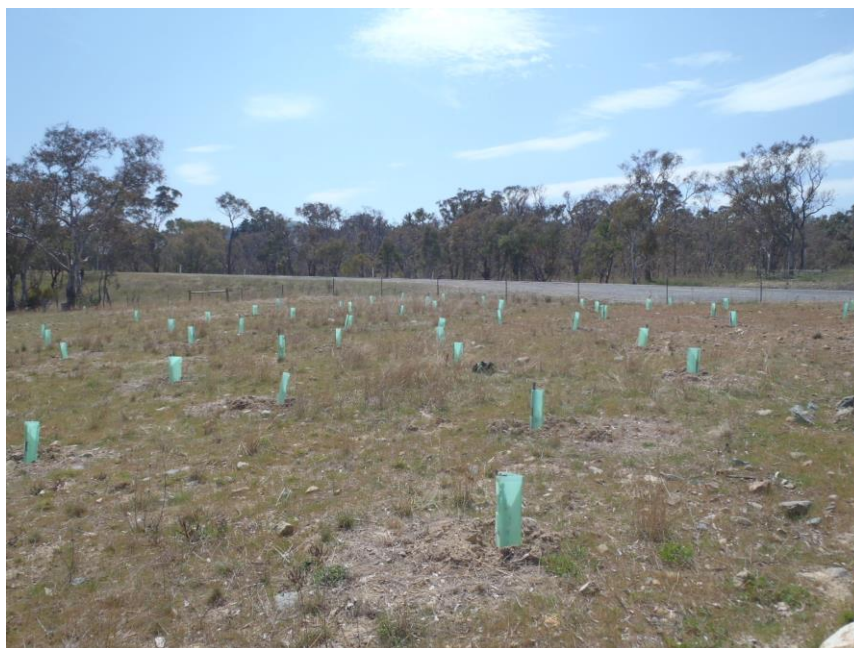
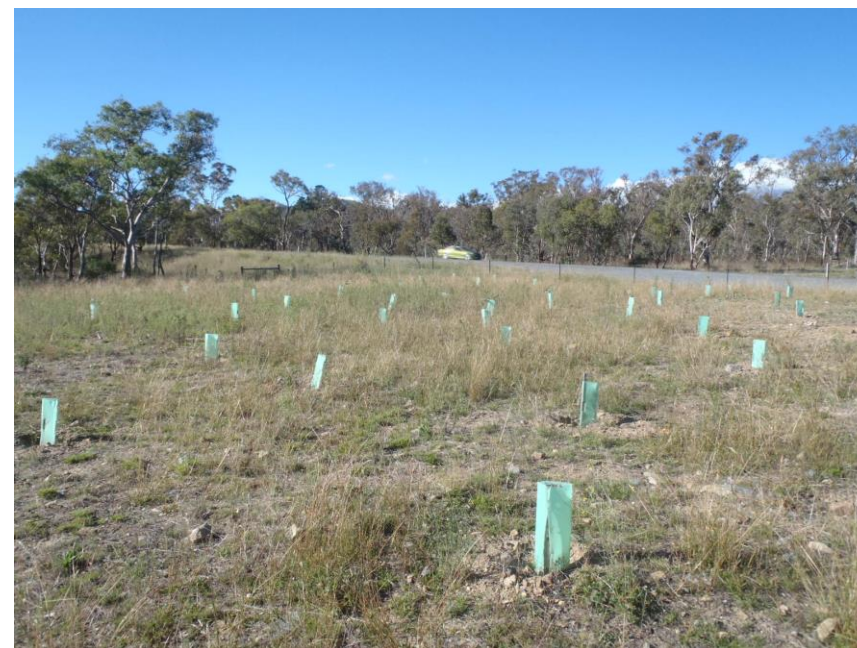
Jurisdiction	ACT	<p>TSP6 is located about 2,650 m from the LLPS - west of and adjacent to the Monaro Hwy within the ACT.</p> <p>Significant decline in planting health, falling from 80.7% in spring 2015 (following replanting) to 49.1% during the current survey.</p> <p>Recommendation: Provide sufficient maintenance for new plantings.</p>
Co-ordinates	693528 – 6060505	
No. of tree & shrub species planted	4 (3)	
Seedling health		
Good	28 (46)	
Poor	15 (5)	
Dead / Missing	14 (6)	
Total plantings	57

Plate 6: Monitoring Site TSP6. The image on the left is from spring 2015 and the right autumn 2016.

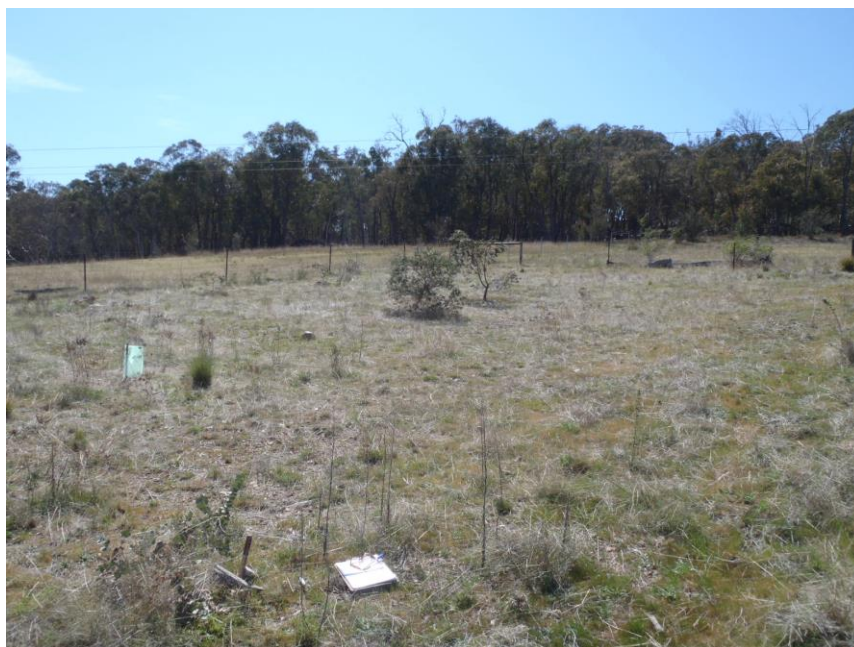
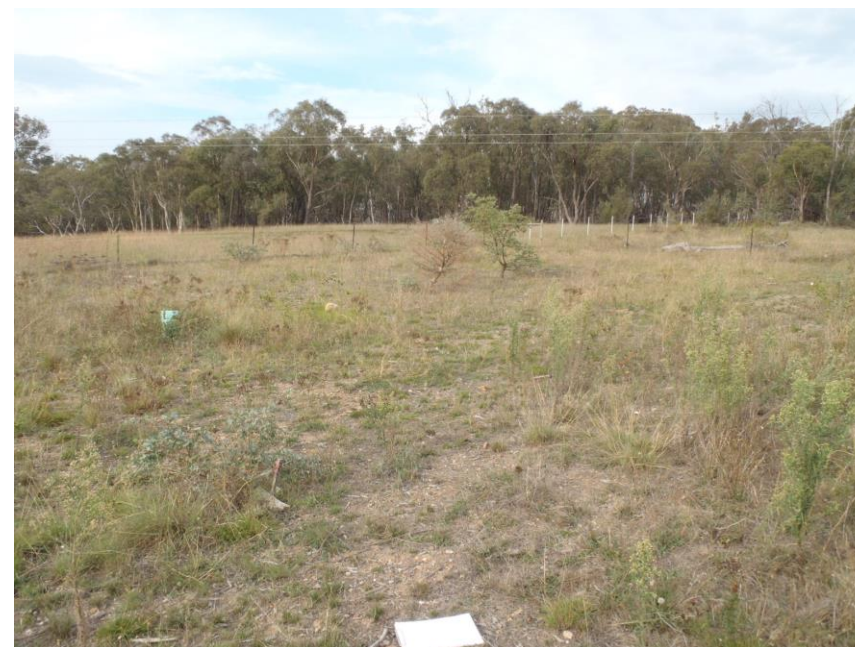
Jurisdiction	NSW	TSP7 is located about 3,040 m from the LLPS within the Smith property, NSW.
Co-ordinates	693927 – 6060542	
No. of tree & shrub species planted	4 (4)	There was a 12.4% decline in planting health, falling from 95.7% in spring 2015 (when replanted) to 83.3% during the current survey. Recommendation: Provide sufficient maintenance for new plantings.
Seedling health		
Good	20 (22)	
Poor	4 (0)	
Dead / Missing	0 (1)	
Total plantings	24 (23)

Plate 7: Monitoring Site TSP7. The image on the left is from spring 2015 and the right autumn 2016.

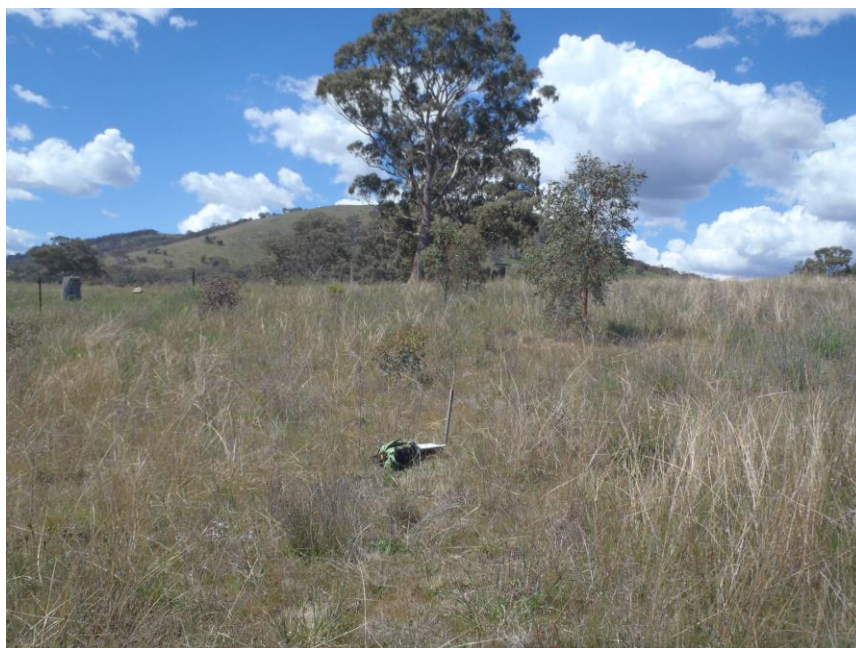
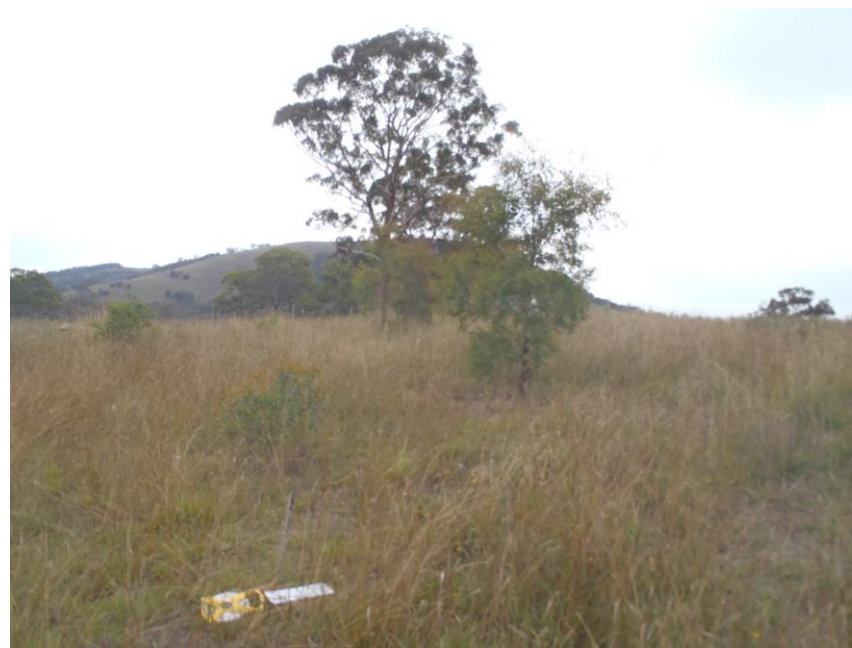
Jurisdiction	NSW	TSP8 is located about 4,975 m from the LLPS within the Lonergan property, NSW.
Co-ordinates	695663 – 6060392	
No. of tree & shrub species planted	2	The proportion of specimens in good health remained constant at 88.9% . Tree heights range from 1m – 4 m. Replanting was not undertaken at this site. Recommendation: Provide sufficient planting maintenance.
Seedling health		
Good	8 (8)	
Poor	0 (0)	
Dead / Missing	1 (1)	
Total plantings	9

Plate 8: Monitoring Site TSP8. The image on the left is from spring 2015 and the right autumn 2016.

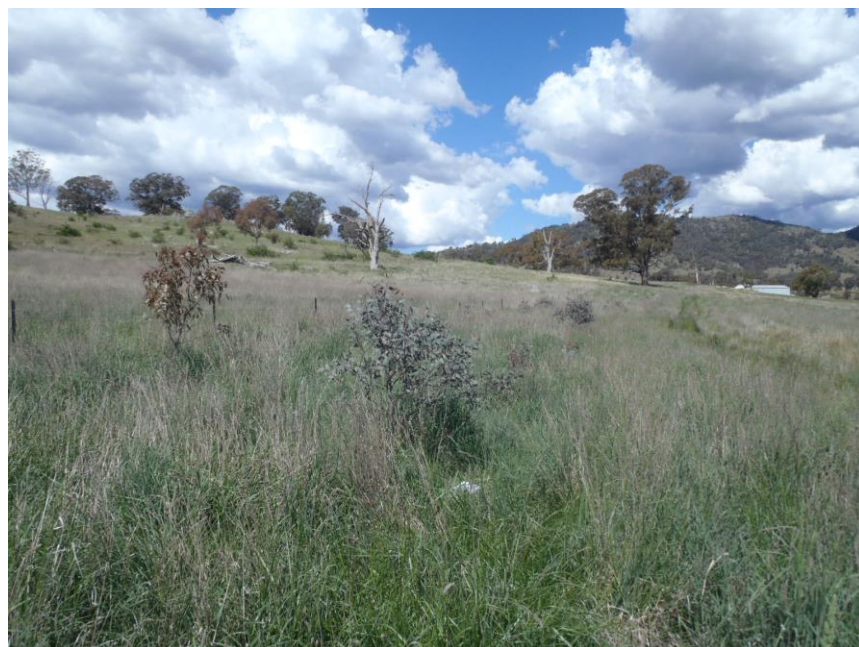
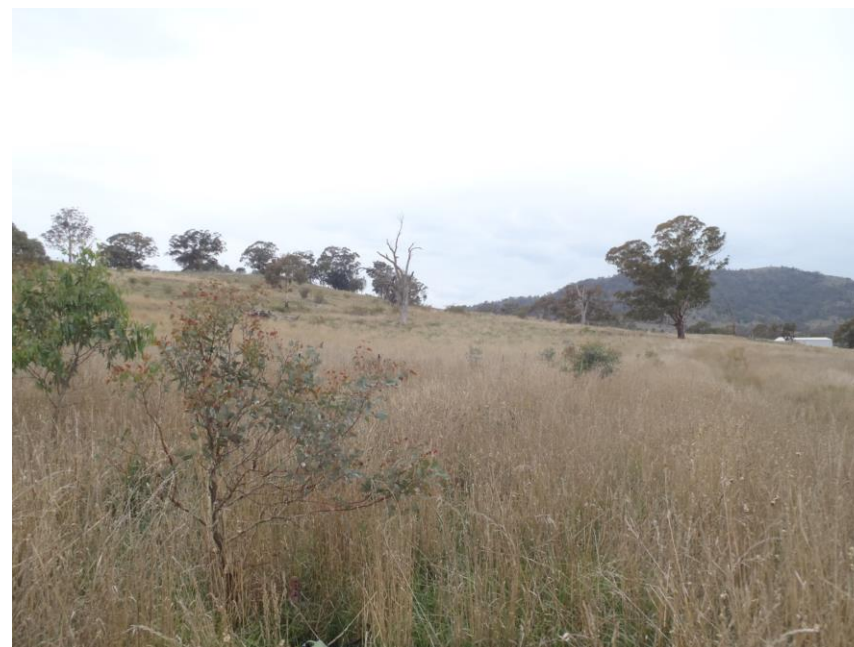
Jurisdiction	NSW	<p>TSP9 is located about 5,475 m from the LLPS within the Lonergan property, NSW.</p> <p>Planting health declined by 16.7% with 50.0% of specimens currently in good condition. At least two plantings had significant lerp infestation with other plantings engulfed by rank pasture grass, which may have a limiting effect on future planting success.</p> <p>Recommendation: Provide sufficient planting maintenance; i.e. reduce the density of groundcover herbage.</p>
Co-ordinates	696175 – 6060305	
No. of tree & shrub species planted	3	
Seedling health		
Good	12 (16)	
Poor	6 (6)	
Dead / Missing	6 (2)	
Total plantings	24

Plate 9: Monitoring Site TSP9. The image on the left is from spring 2015 and the right autumn 2016.

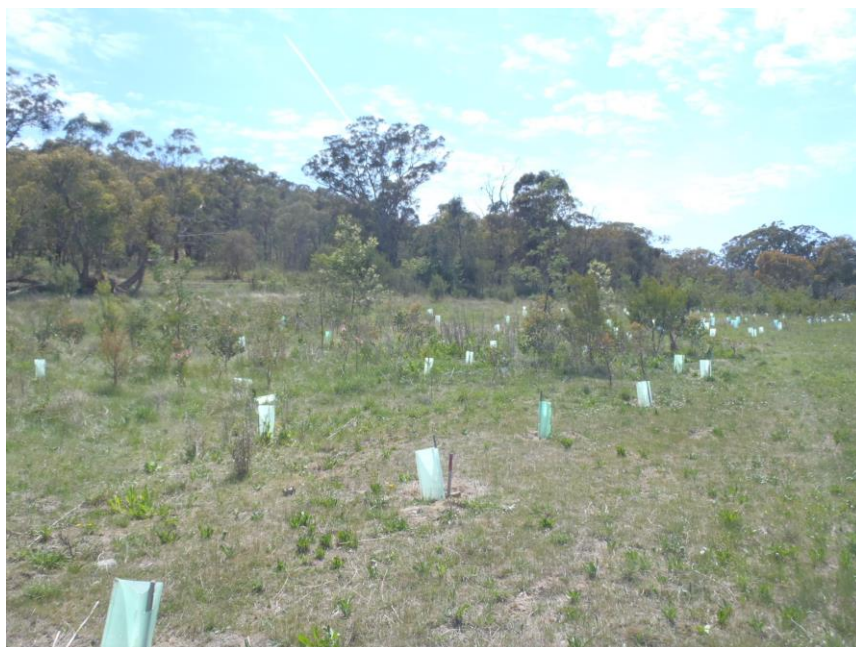
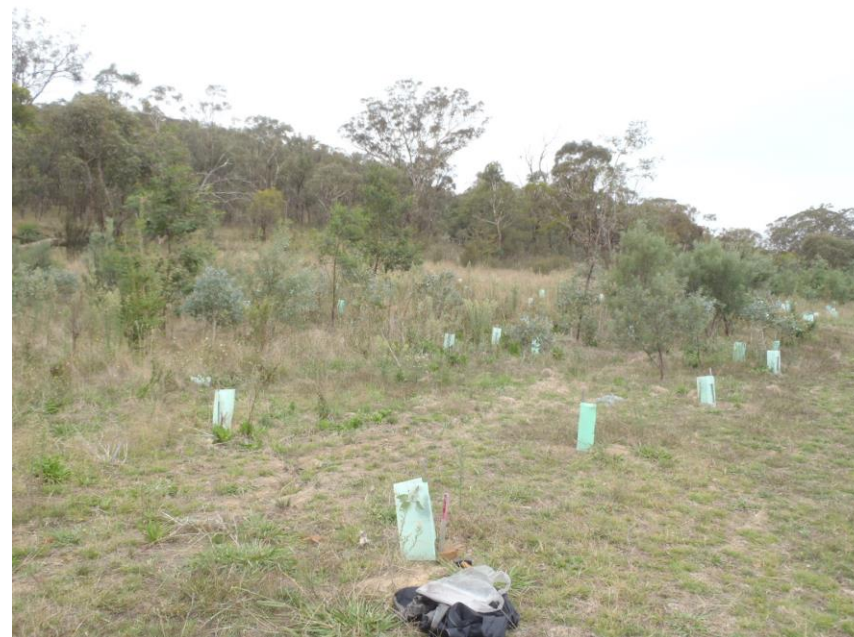
Jurisdiction	NSW	TSP10 is located about 6,425 m from the LLPS within the Johanson property, NSW.
Co-ordinates	697084 – 6060204	
No. of tree & shrub species planted	8	Planting health increased by 7.8% with 69.7% of specimens currently in good condition.
Seedling health		
Good	97 (86)	
Poor	10 (20)	Some tree guards remain choked with herbage, which may have a limiting effect on planting health.
Dead / Missing	32 (33)	
Total plantings	139	Recommendation: Provide sufficient planting maintenance.

Plate 10: Monitoring Site TSP10. The image on the left is from spring 2015 and the right autumn 2016.

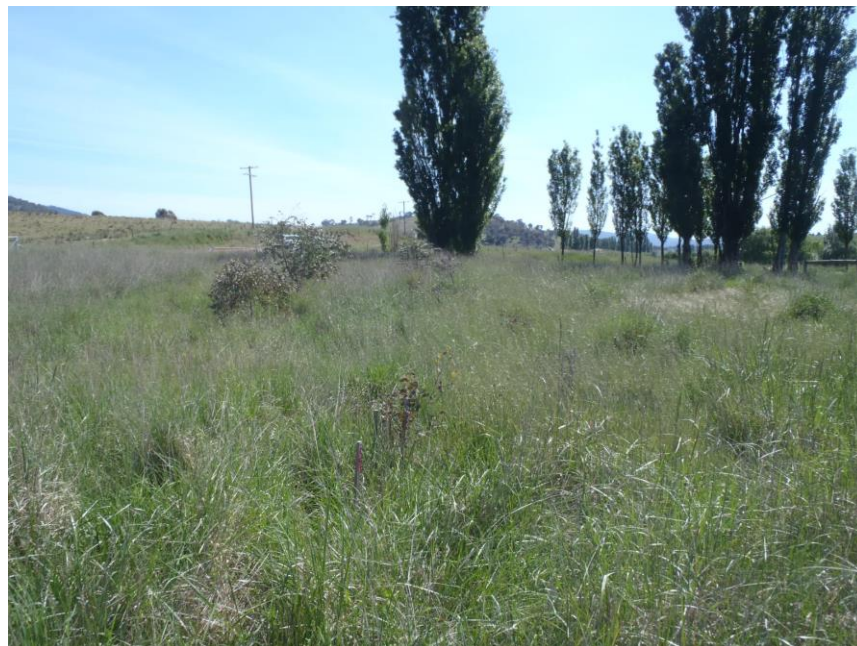
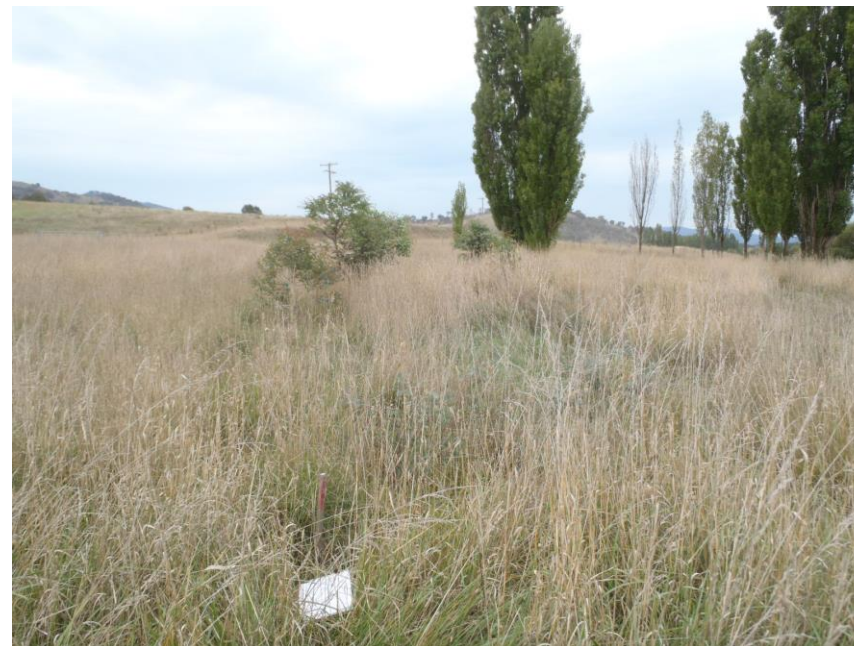
Jurisdiction	NSW	TSP11 is located about 9,300 m from the LLPS within the Latimer property, NSW.
Co-ordinates	699277 – 6061925	
No. of tree & shrub species planted	3	Planting health increased by 33.4% with 66.7% of plantings currently in good condition. It seems that some specimens previously identified as poor have exhibited some recovery with one specimen previously identified as dead exhibiting basal growth.
Seedling health		
Good	8 (4)	Most plantings were engulfed by pasture grass, which may have a limiting effect on planting health.
Poor	1 (4)	
Dead / Missing	3 (4)	
Total plantings	12	Recommendation: Provide additional planting maintenance, in particular, reduce the density of groundcover vegetation.

Plate 11: Monitoring Site TSP11. The image on the left is from spring 2015 and the right autumn 2016.

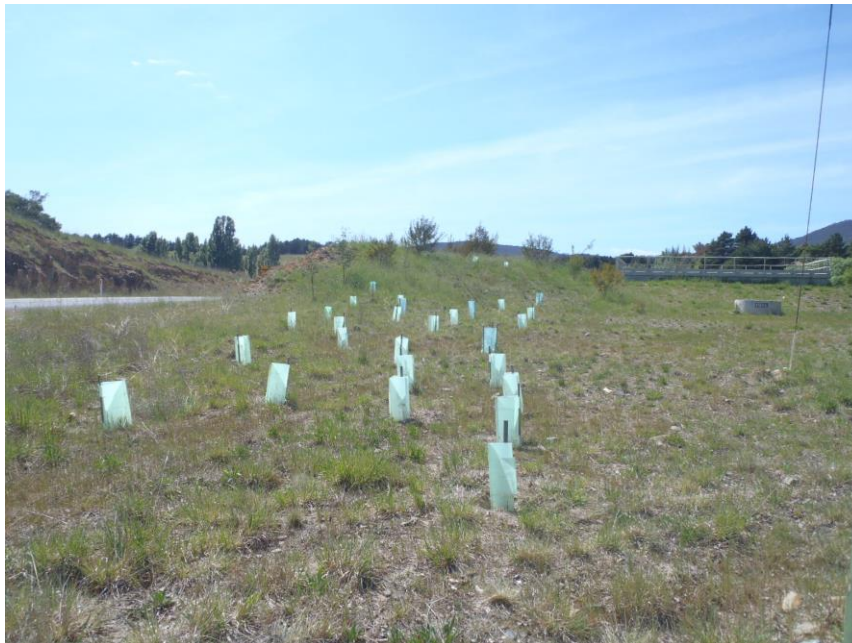
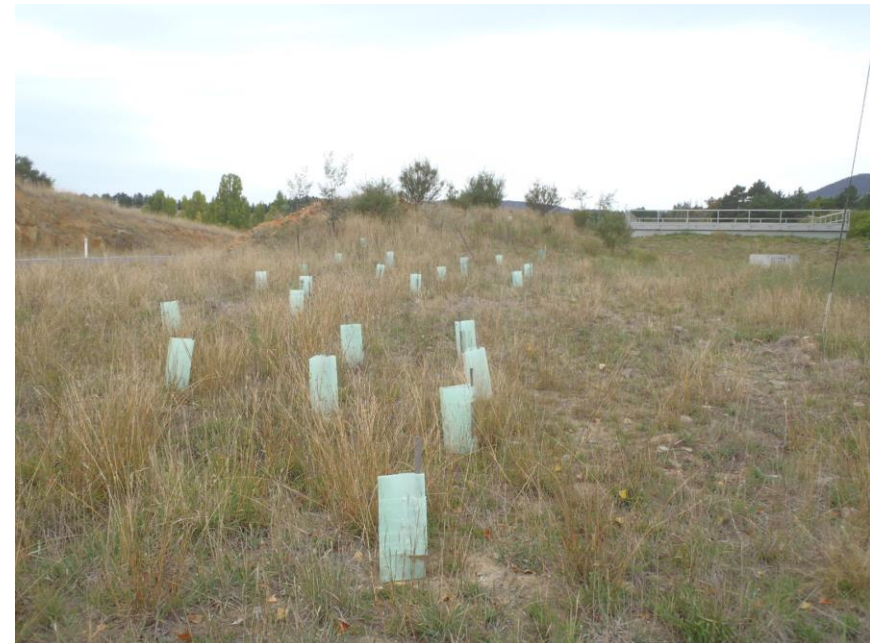
Jurisdiction	NSW	TSP12 is located about 11,900 m from the LLPS near the discharge facility, NSW.
Co-ordinates	701346 – 6063099	
No. of tree & shrub species planted	4	Planting health decreased by 13.9% with 64.6% of specimens currently in good condition. Recommendation: Provide sufficient planting maintenance.
Seedling health		
Good	42 (51)	
Poor	12 (5)	
Dead / Missing	11 (9)	
Total plantings	65

Plate 12: Monitoring Site TSP12. The image on the left is from spring 2015 and the right autumn 2016.
