DRAFT M2G Planting (Tree & Shrub) Monitoring Report

Construction Corridor (Spring 2015)

Prepared for
Icon Water

2 December 2015

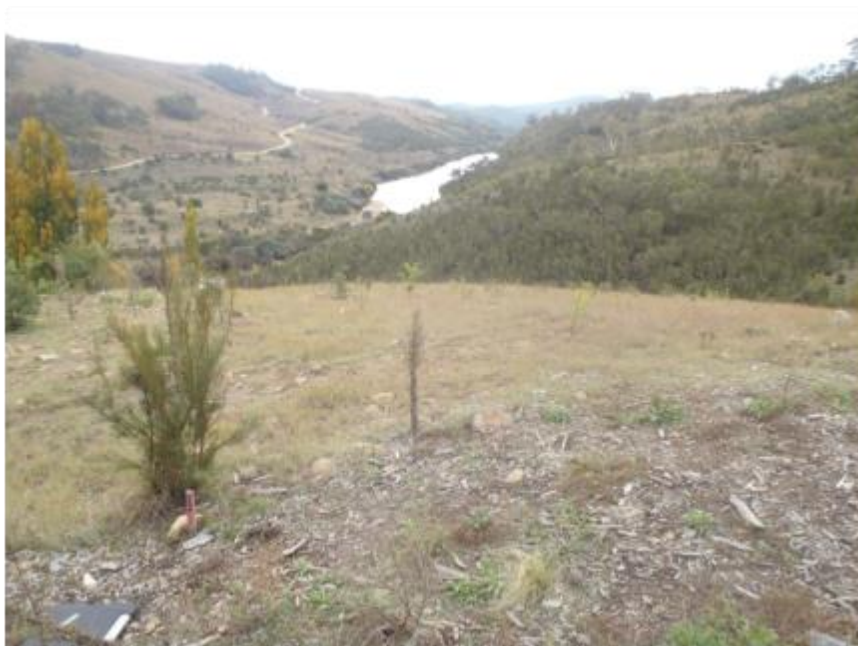
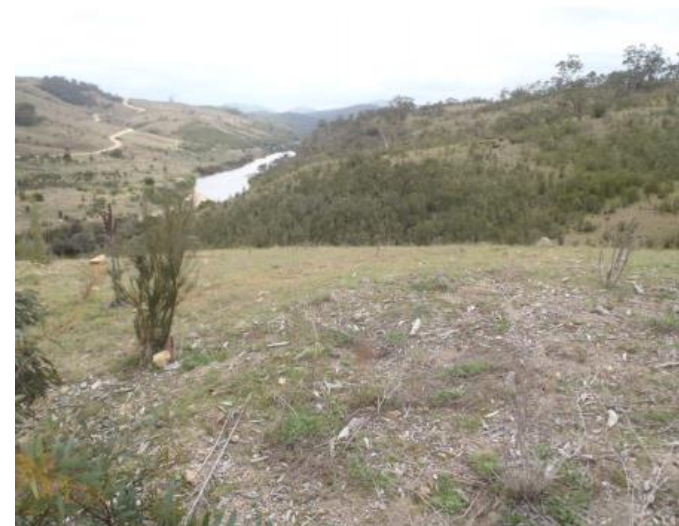
Plate 1: Monitoring Site TSP1. The image on the left is from autumn 2015 and the right spring 2015.

Jurisdiction	ACT	TSP1 Situated within the Murrumbidgee River Corridor immediately W and NW of the HLPS, about 250 m from the LLPS.
Co-ordinates	691345 – 6060236	
No. of tree & shrub species planted	8	Planting health declined by 24% with only 16.3% of plantings currently in good condition. Replanting was not undertaken at this site.
Seedling health		
Good	15 (37)	Recommendation: Provide sufficient maintenance for remaining specimens.
Poor	25 (3)	
Dead / Missing	52 (52)	
Total plantings	92

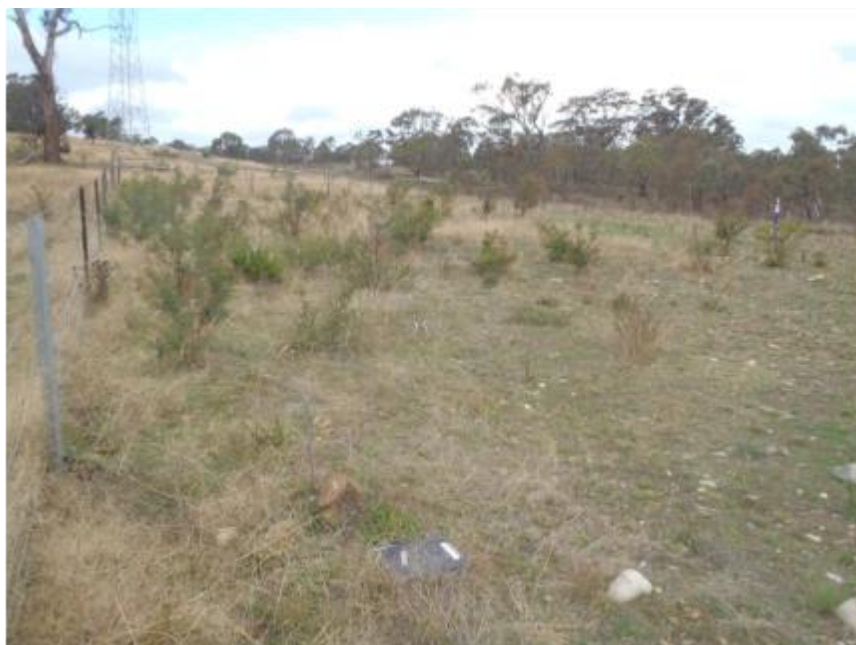
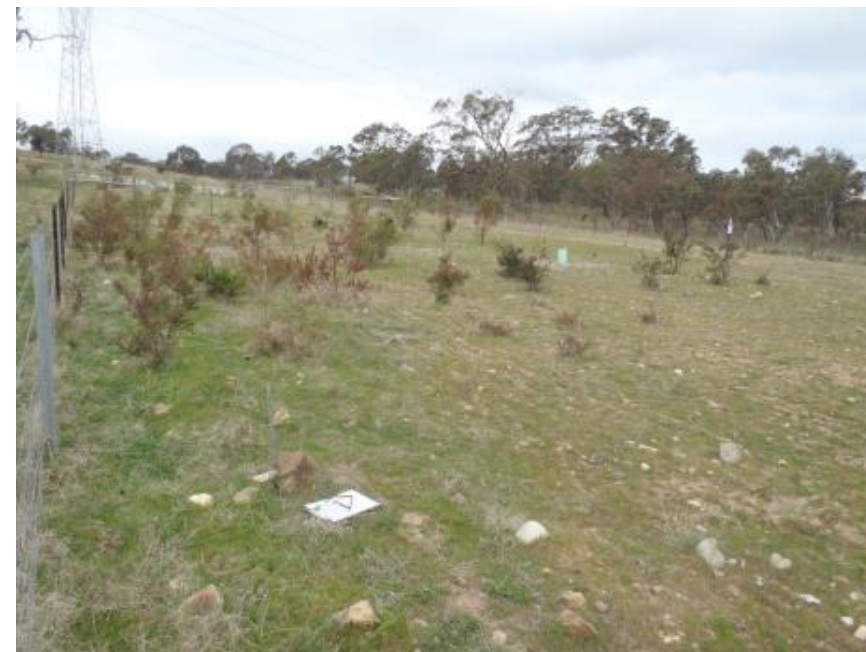
Plate 2: Monitoring Site TSP2. The image on the left is from autumn 2015 and the right spring 2015.

Jurisdiction	ACT	TSP2 is located within the Murrumbidgee River Corridor, about 1,025 m from the LLPS.
Co-ordinates	691964 – 6060519	
No. of tree & shrub species planted	5	Planting health declined by 5.5% with 43.3% of plantings currently in good condition. Replanting was not undertaken at this site. Recommendation: Provide sufficient maintenance for remaining specimens.
Seedling health		
Good	55 (62)	
Poor	14 (6)	
Dead / Missing	58 (59)	
Total plantings	127

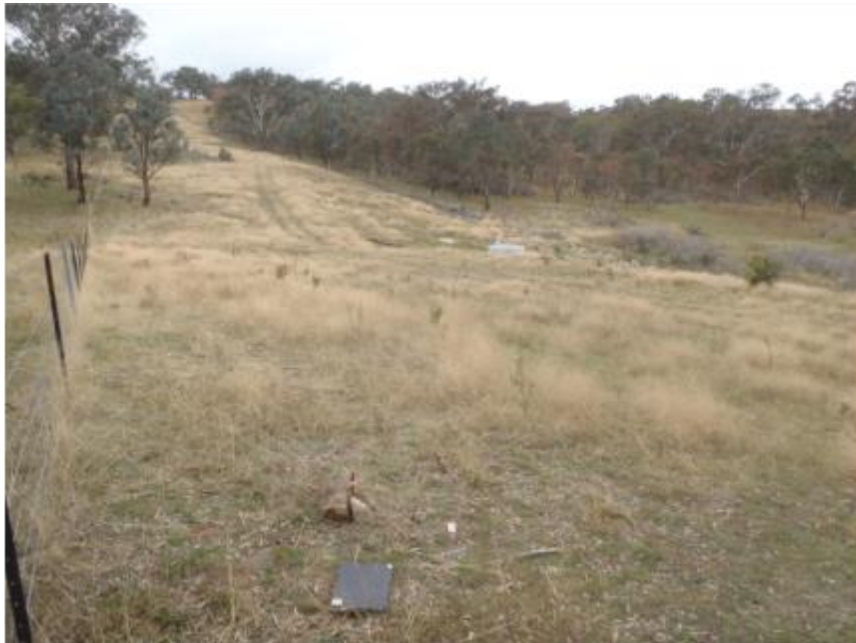
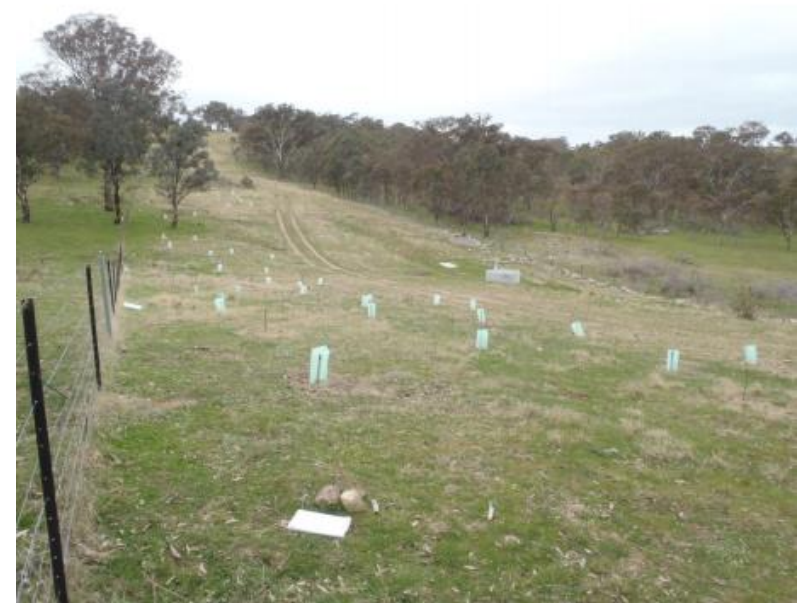
Plate 3: Monitoring Site TSP3. The image on the left is from autumn 2015 and the right spring 2015. *Insert: TSP3 in spring 2012 – within 12 months of planting.*

Jurisdiction	ACT	TSP3 is located within the Murrumbidgee River Corridor, about 1,350 m from the LLPS. Planting health increased by 8.4% with 24.2% of specimens currently in good condition. The increase is attributed to 33 new plantings, but many of these (mostly <i>Acacia</i> sp.) were in poor condition. Recommendation: Provide sufficient maintenance for remaining specimens.
Co-ordinates	691964 – 6060519	
No. of tree & shrub species planted	4	
Seedling health		
Good	23 (15)	
Poor	18 (4)	
Dead / Missing	54 (76)	
Total plantings	95

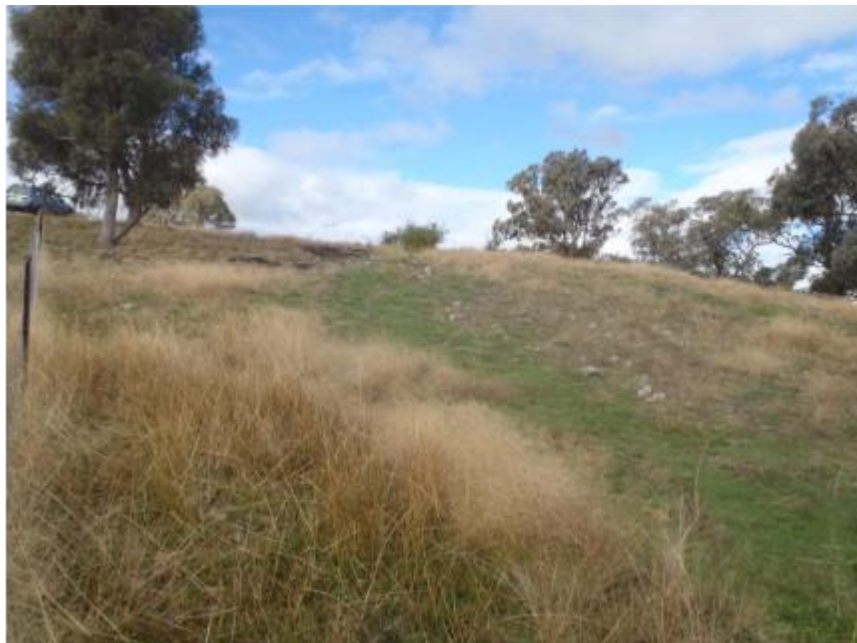
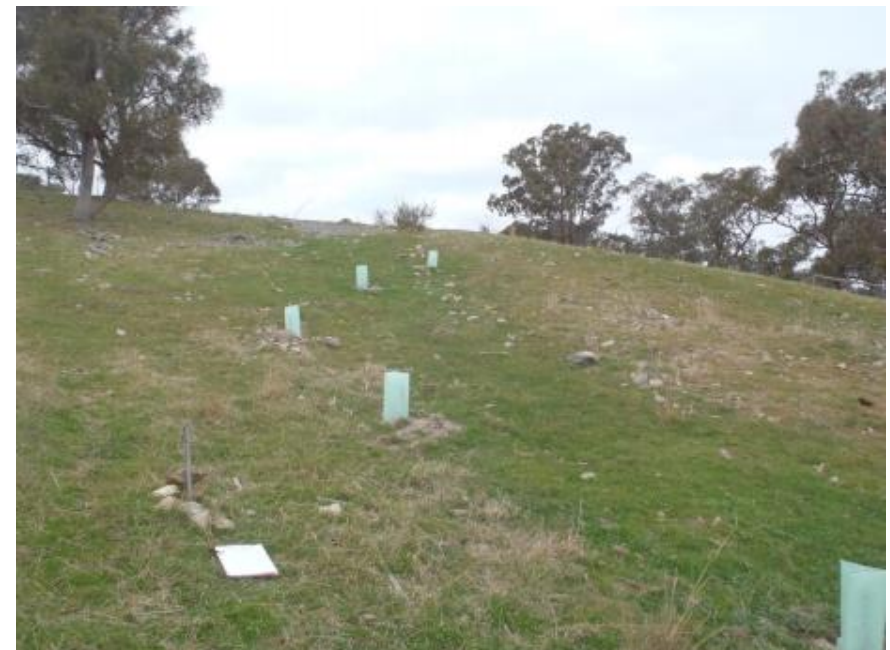
Plate 4: Monitoring Site TSP4. The image on the left is from autumn 2015 and the right spring 2015. Inset: *TSP4 in spring 2012, within 12 months of planting.*

Jurisdiction	ACT	TSP4 is located about 1,900 m from the LLPS within the ACT.
Co-ordinates	692592 – 6060707	
No. of tree & shrub species planted	3	Most plantings either perished or were removed prior to autumn 2014 with the remaining specimens steadily declining in condition. In autumn 2015 only 5.3% specimens remained in good health. A small number of additional plantings (4) advanced this to a modest 7.9% during the current surveys.
Seedling health		
Good	6 (4)	Recommendation: Unless a regular maintenance can be provided planting at this site should be discontinued.
Poor	6 (7)	
Dead / Missing	64 (65)	
Total plantings	76

Furthermore, sample sites shown to have significant planting failure (i.e. TSP 4) should not be re-planted.

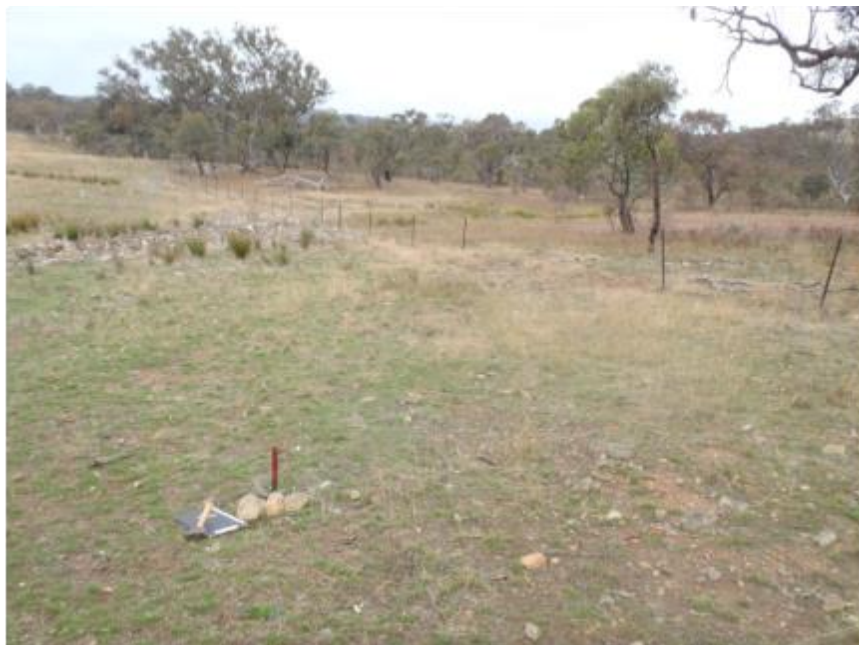
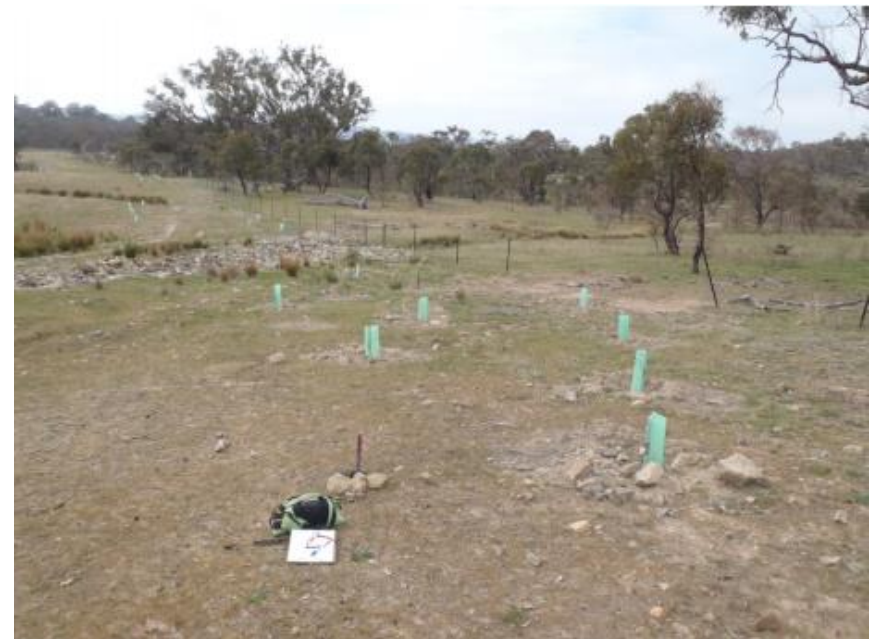
Plate 5: Monitoring Site TSP5. The image on the left is from autumn 2015 and the right spring 2015.

Jurisdiction	ACT	TSP5 is located about 2,325 m from the LLPS within the ACT.
Co-ordinates	693226 – 6060578	
No. of tree & shrub species planted	4 (3)	Planting health increased by 47.4% with 63.2% of specimens currently in good condition. The increase is attributed to 16 new plantings.
Seedling health		
Good	12 (3)	Recommendation: Provide sufficient maintenance for new plantings
Poor	2 (0)	
Dead / Missing	5 (16)	
Total plantings	19

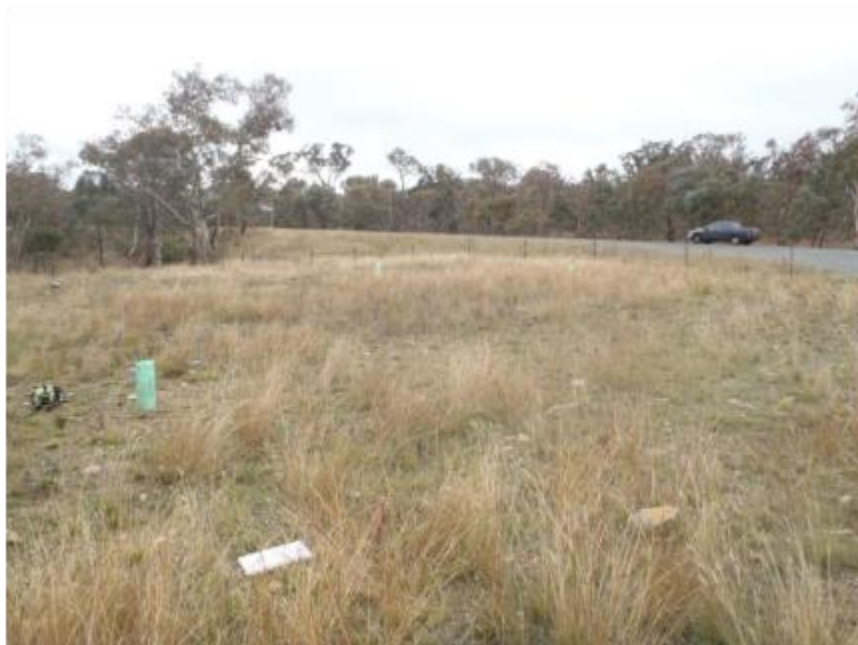
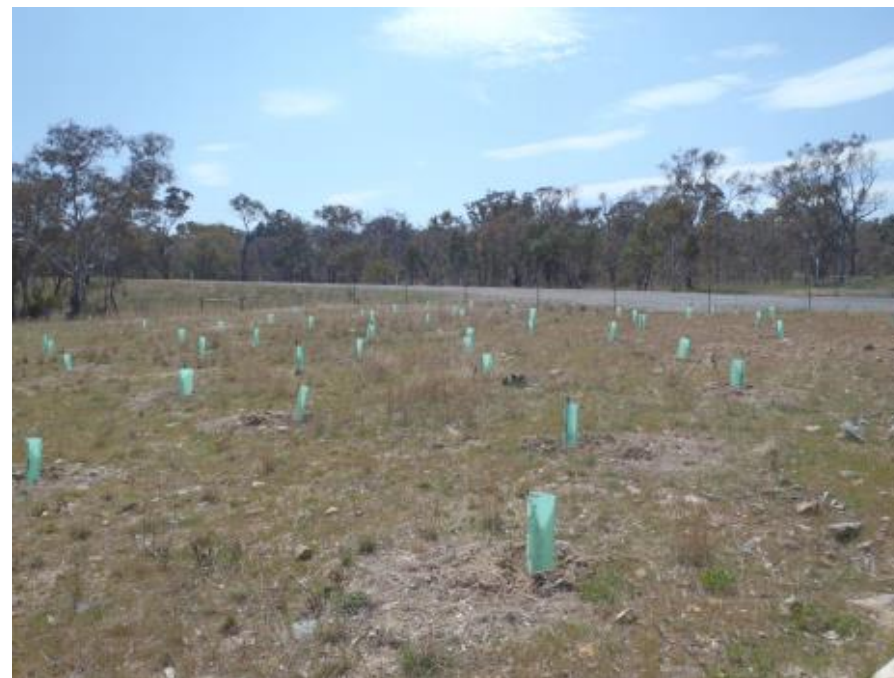
Plate 6: Monitoring Site TSP6. The image on the left is from autumn 2015 and the right spring 2015.

Jurisdiction	ACT	<p>TSP6 is located about 2,650 m from the LLPS - west of and adjacent to the Monaro Hwy within the ACT.</p> <p>Planting health increased by 75.9% with 80.7% of specimens currently in good condition. The increase is attributed to 55 new plantings.</p> <p>Natural recruitment of Yellow Box <i>Eucalyptus melliodora</i> and Blakely's Red Gum <i>E. blakelyi</i> in adjacent sections of the corridor.</p> <p>Recommendation: Provide sufficient maintenance for new plantings.</p>
Co-ordinates	693528 – 6060505	
No. of tree & shrub species planted	4 (3)	
Seedling health		
Good	46 (1)	
Poor	5 (2)	
Dead / Missing	6 (18)	
Total plantings	57 (21)

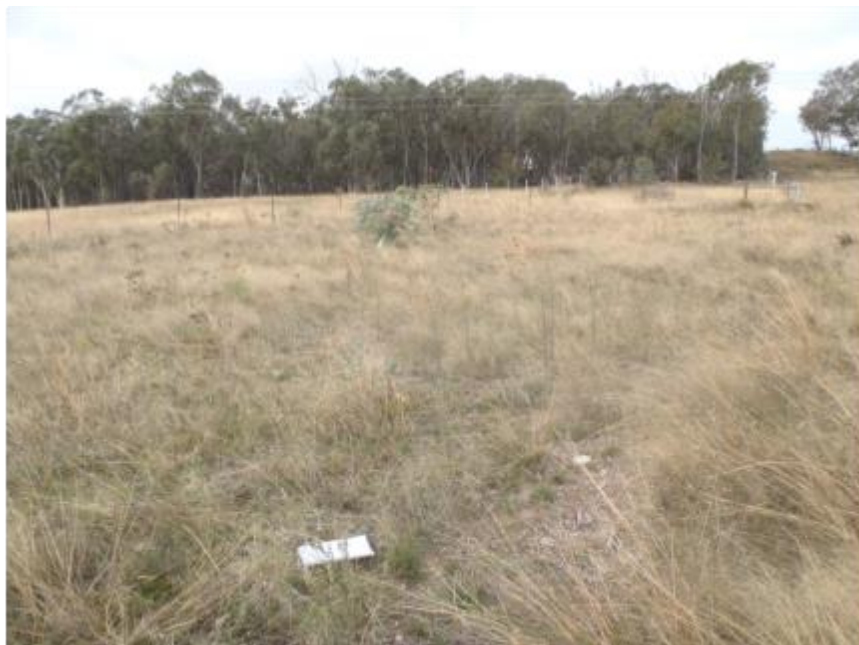
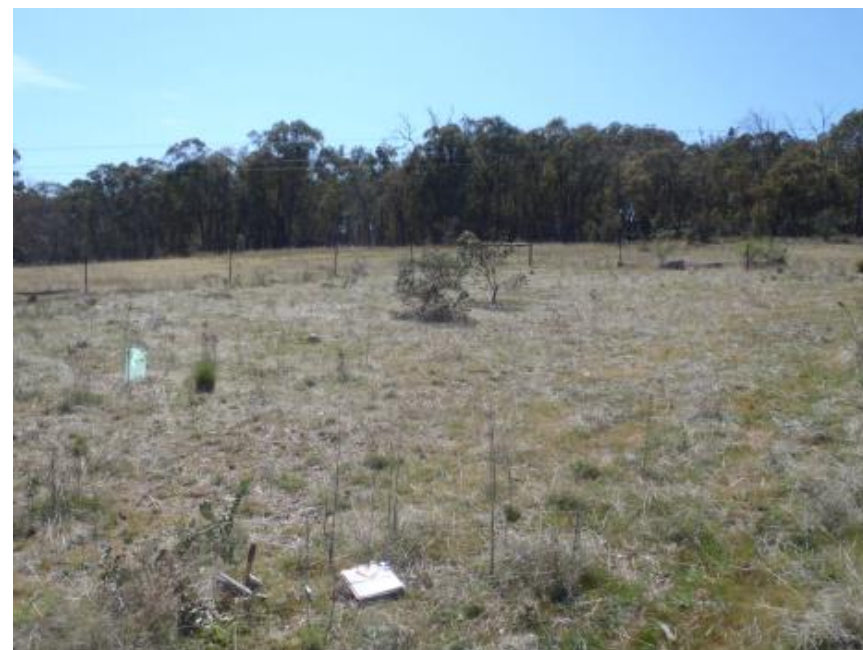
Plate 7: Monitoring Site TSP7. The image on the left is from autumn 2015 and the right spring 2015.

Jurisdiction	NSW	<p>TSP7 is located about 3,040 m from the LLPS within the Smith property, NSW.</p> <p>Planting health increased by 27.5% with 95.7% of specimens currently in good condition. The increase is attributed to 7 new plantings.</p> <p><i>Note:</i> Sample site is separated in to two planting areas - northern and southern sides of the construction corridor. Natural recruitment of Yellow Box <i>Eucalyptus melliodora</i>, Apple Box <i>E. bridgesiana</i> and Broad-leaved Peppermint <i>E. dives</i> was observed east and west of this site.</p> <p>Recommendation: Provide sufficient maintenance for new plantings.</p>
Co-ordinates	693927 – 6060542	
No. of tree & shrub species planted	4 (3)	
Seedling health		
Good	22 (15)	
Poor	0 (0)	
Dead / Missing	1 (7)	
Total plantings	23 (22)

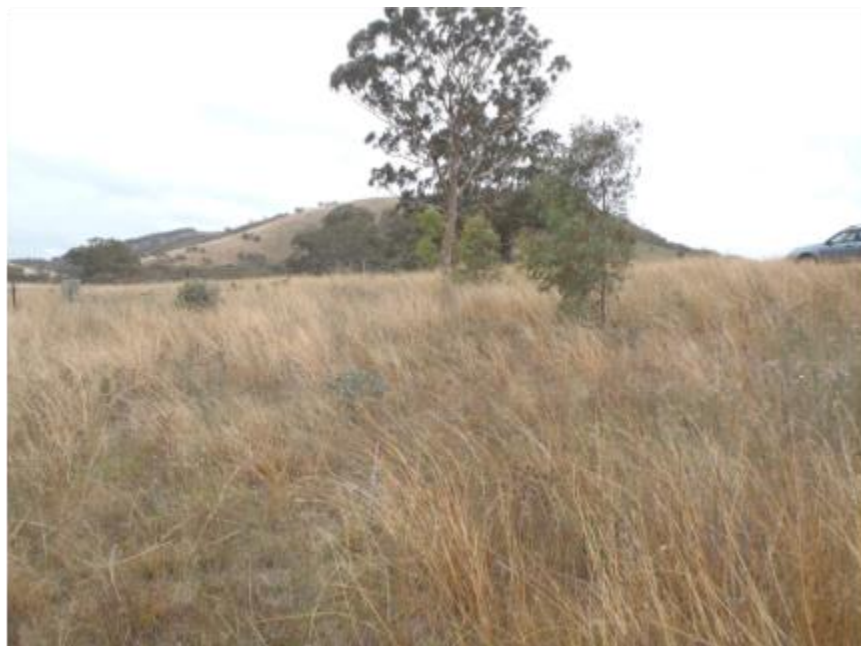
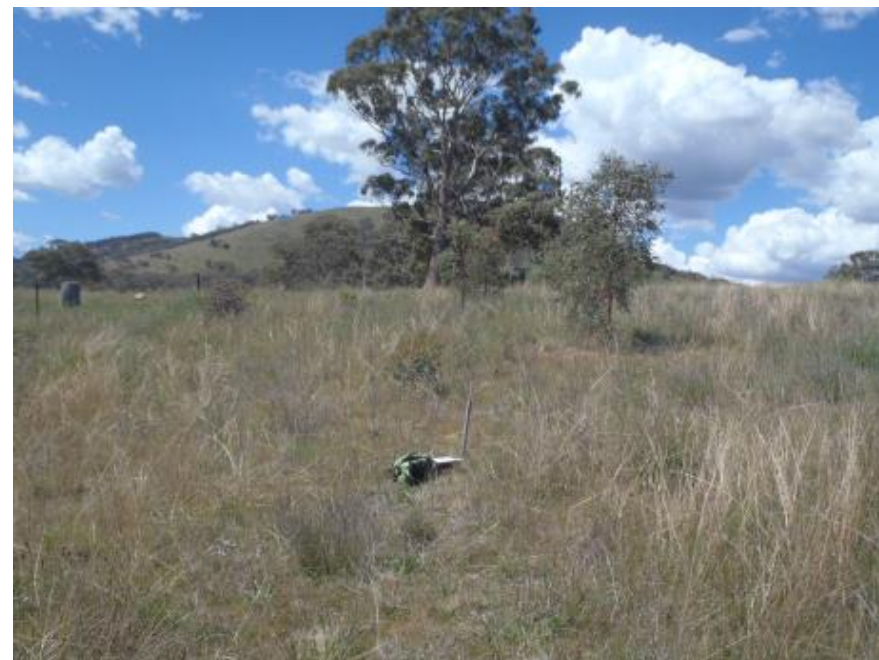
Plate 8: Monitoring Site TSP8. The image on the left is from autumn 2015 and the right spring 2015.

Jurisdiction	NSW	TSP8 is located about 4,975 m from the LLPS within the Lonergan property, NSW.
Co-ordinates	695663 – 6060392	
No. of tree & shrub species planted	2	This site contains just 9 plantings. The proportion of specimens in good health remained constant at 88.9% . Replanting was not undertaken at this site. Recommendation: Provide sufficient planting maintenance.
Seedling health		
Good	8 (8)	
Poor	0 (0)	
Dead / Missing	1 (1)	
Total plantings	9

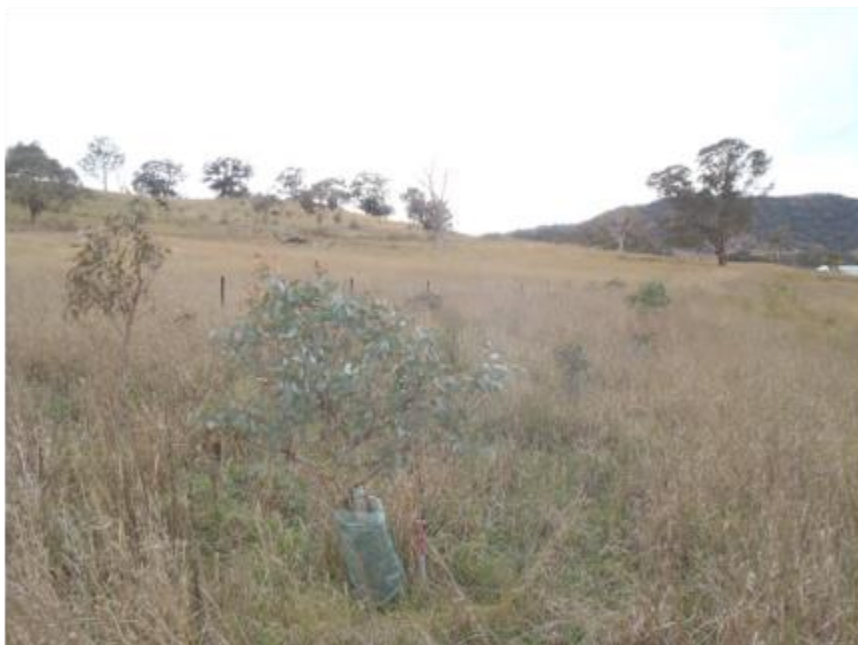
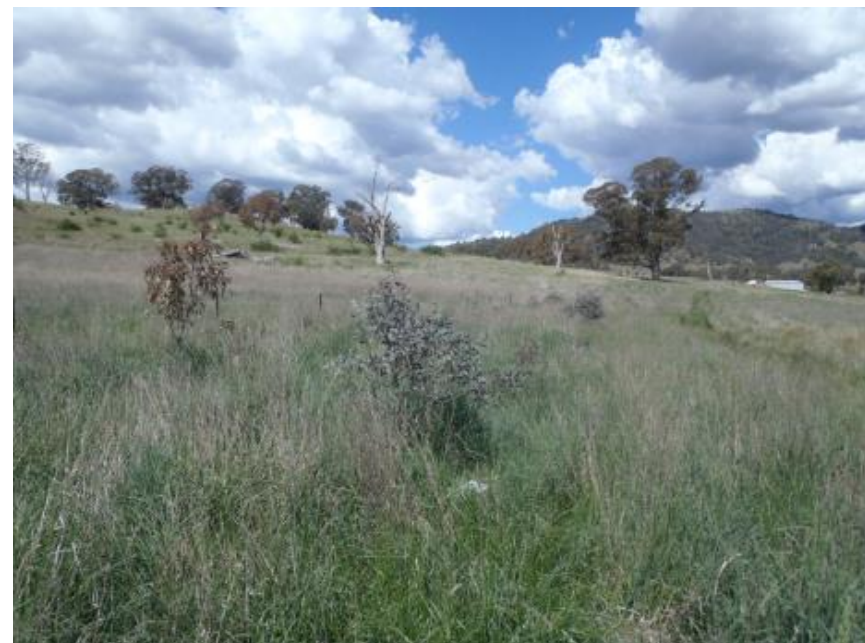
Plate 9: Monitoring Site TSP9. The image on the left is from autumn 2015 and the right spring 2015.

Jurisdiction	NSW	TSP9 is located about 5,475 m from the LLPS within the Lonergan property, NSW.
Co-ordinates	696175 – 6060305	
No. of tree & shrub species planted	3	The proportion of specimens in good health remained constant at 66.7% . Replanting was not undertaken at this site. <i>Note: Plantings are consistently engulfed by pasture grasses, which may affect future planting success.</i>
Seedling health		
Good	16 (16)	
Poor	6 (3)	
Dead / Missing	2 (5)	
Total plantings	24	Recommendation: Provide sufficient planting maintenance.

Persistent smothering of plantings was observed in the eastern and central sections of the corridor, particularly at Sites, TSP9, 10 and 11.

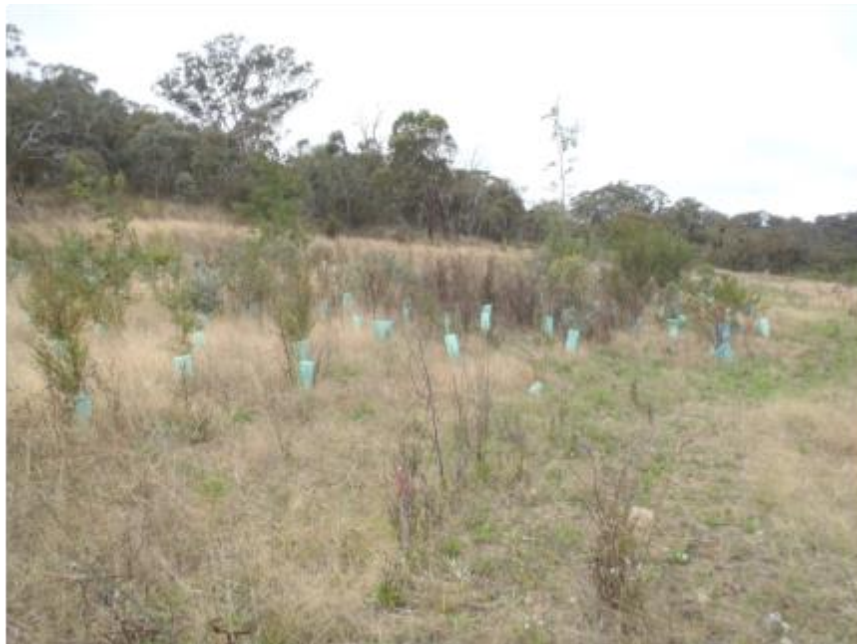
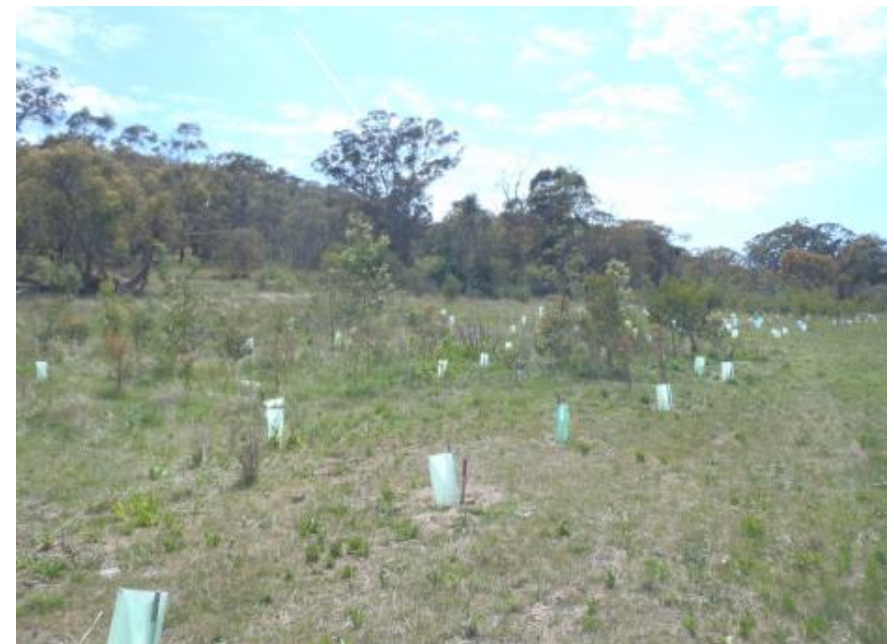
Plate 10: Monitoring Site TSP10. The image on the left is from autumn 2015 and the right spring 2015.

Jurisdiction	NSW	TSP10 is located about 6,425 m from the LLPS within the Johanson property, NSW.
Co-ordinates	697084 – 6060204	
No. of tree & shrub species planted	8	Planting health increased by 5.1% with 61.9% of specimens currently in good condition. The increase is attributed to 20 new plantings. <i>Note: Some tree guards remain choked with herbage that has resulted in the death and poor health of some plantings.</i>
Seedling health		
Good	86 (79)	
Poor	20 (18)	
Dead / Missing	33 (42)	
Total plantings	139	Recommendation: Provide sufficient planting maintenance.

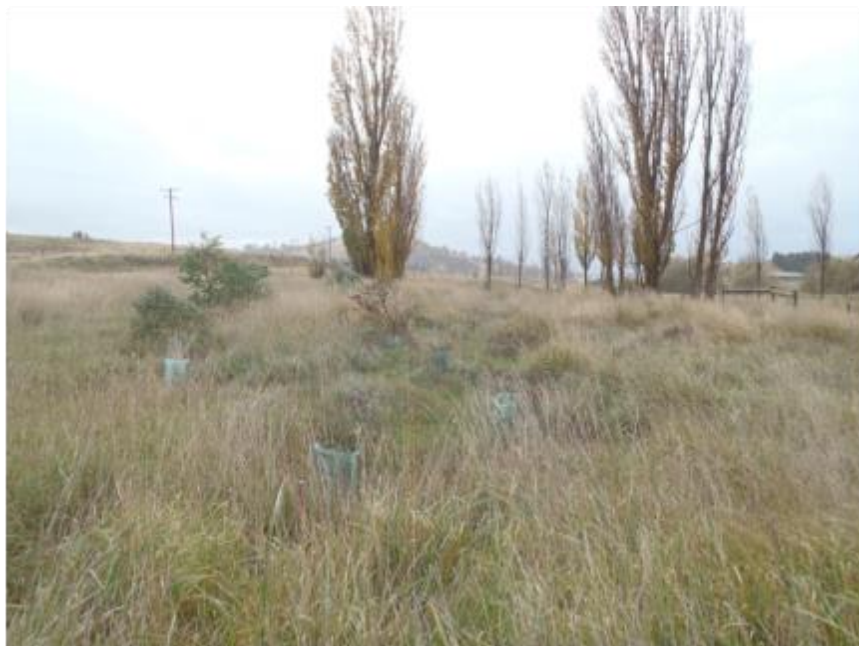
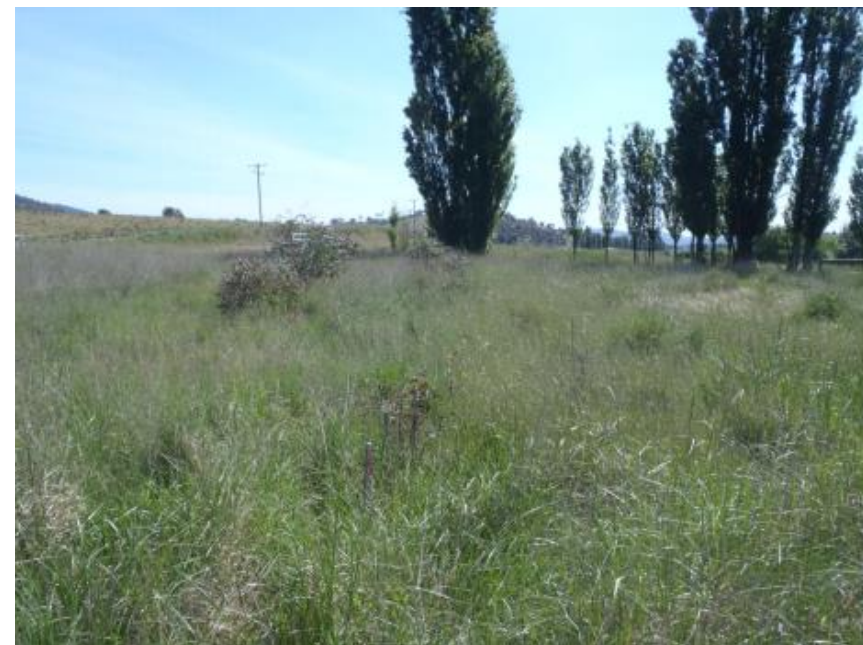
Plate 11: Monitoring Site TSP11. The image on the left is from autumn 2015 and the right spring 2015.

Jurisdiction	NSW	TSP11 is located about 9,300 m from the LLPS within the Latimer property, NSW.
Co-ordinates	699277 – 6061925	
No. of tree & shrub species planted	3	Planting health declined by 25% with 33.3% of plantings currently in good condition. Replanting was not undertaken at this site.
Seedling health		
Good	4 (7)	Plantings exhibited vigorous growth up to autumn 2014, after which there was a steady decline in health. Most plantings have become engulfed by pasture grasses, which may have affected the vigour of some specimens.
Poor	4 (3)	
Dead / Missing	4 (2)	
Total plantings	12	Recommendation: Provide sufficient planting maintenance.

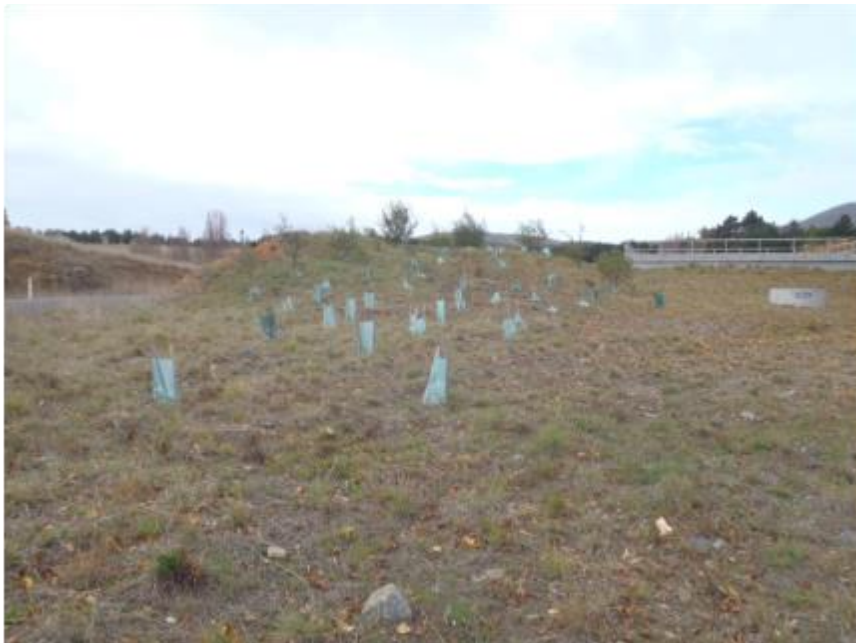
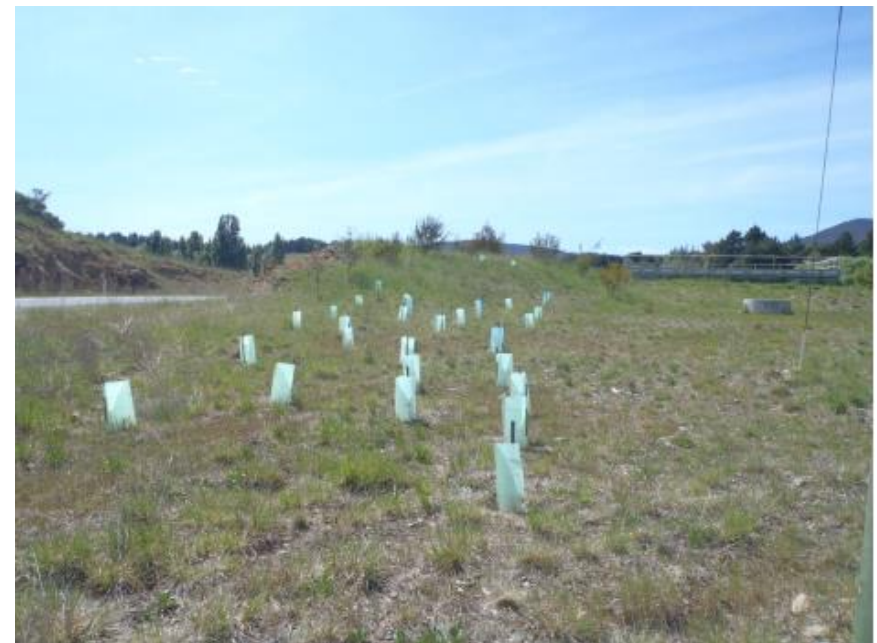
Plate 12: Monitoring Site TSP12. The image on the left is from autumn 2015 and the right spring 2015.

Jurisdiction	NSW	TSP12 is located about 11,900 m from the LLPS near the discharge facility, NSW.
Co-ordinates	701346 – 6063099	
No. of tree & shrub species planted	4	Planting health increased by 20% with 78.5% of specimens currently in good condition. The increase is attributed to 23 new plantings. Recommendation: Provide sufficient planting maintenance
Seedling health		
Good	51 (38)	
Poor	5 (6)	
Dead / Missing	9 (21)	
Total plantings	65
