**ACTEWAGL DISTRIBUTION**  
**MURRUMBIDGEE ECOLOGICAL MONITORING**  
**PROGRAM**  
**FIELD OBSERVATION REPORT: AUTUMN 2012**

**Client:** ActewAGL Distribution  
**Project Title:** Murrumbidgee Ecological Monitoring Program  
**Report Title:** **Field observation report: autumn 2012**  
**Document No:** 211063-12-R9  
**Document Status:** **Draft for client review**  
**Date of Issue:** **17/05/2012**

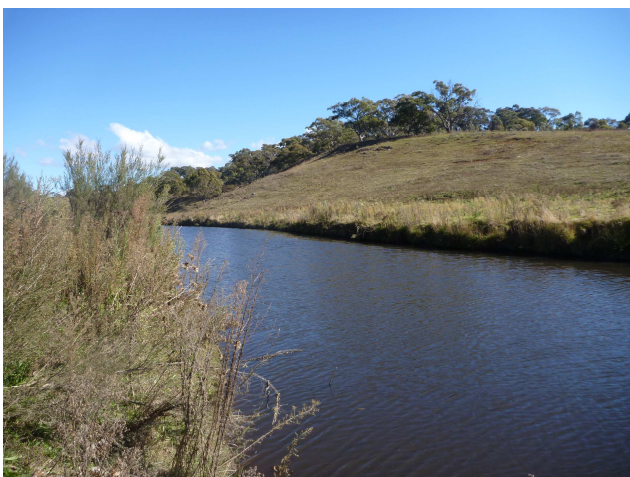
Sites BUR 3 and QBYN 2 remain inundated by water backing up from Googong reservoir (Plate 1) and consequently BUR 2c was sampled as a replacement for BUR 3; however, there are no appropriate alternatives for QBYN 2. Flows in the Queanbeyan River were still dropping after a small event in mid-April and flows in Burra Creek were stable (Figure 1).

**Plate 1.** Bur 3 inundated by Googong Reservoir water level

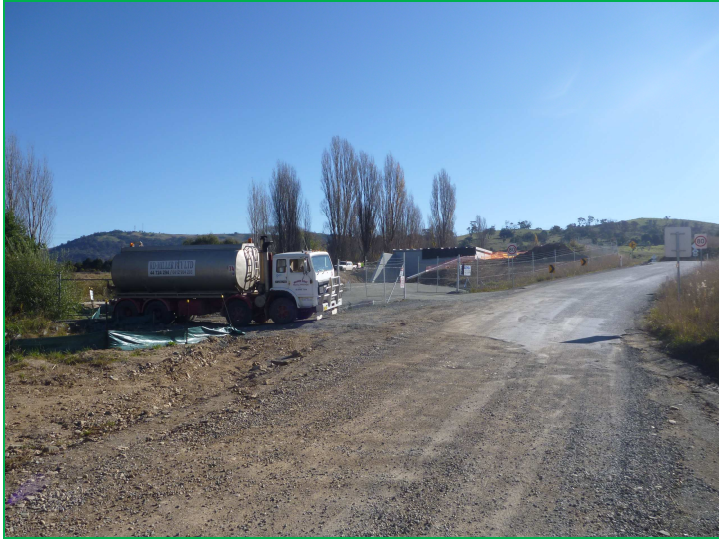
Since spring 2011 some of the restricted, fenced off areas upstream of Williamsdale Bridge has been removed (Plate 2); the silt boom downstream of the bridge has been removed as have the pipes diverting Burra Creek water from the upstream section to downstream of the bridge.

**Plate 2.** M2G construction site on the western side of Williamsdale Road Bridge

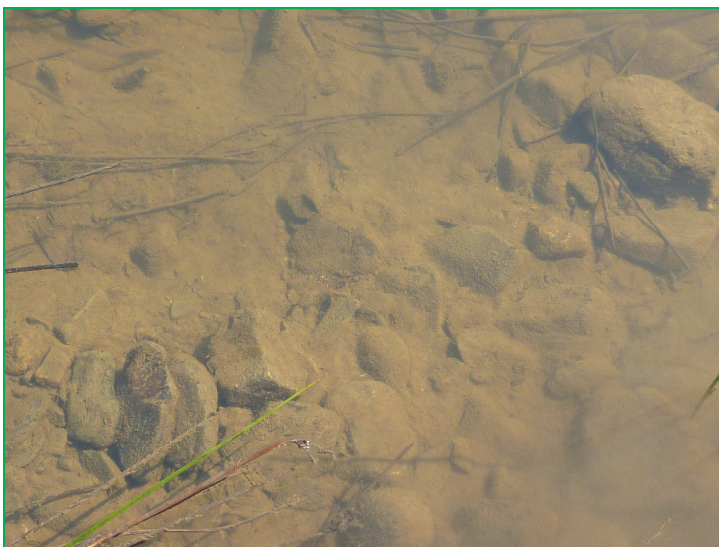
Stream side scans of the macroinvertebrate samples indicated reasonably “healthy” assemblages of invertebrates with a wide range of SIGNAL scores from each site. There was a noticeable decline in the abundance of Stoneflies (Plecoptera) compared to spring, which could be a seasonal factor. BUR 1c showed the lowest macroinvertebrate diversity and this is probably related to the high level of blanketing silt observed in the riffle habitat (Plate 3), which likely accounts for the few EPT taxa and the lower diversity at this site.

**Plate 3.** Silted substrate at BUR 1

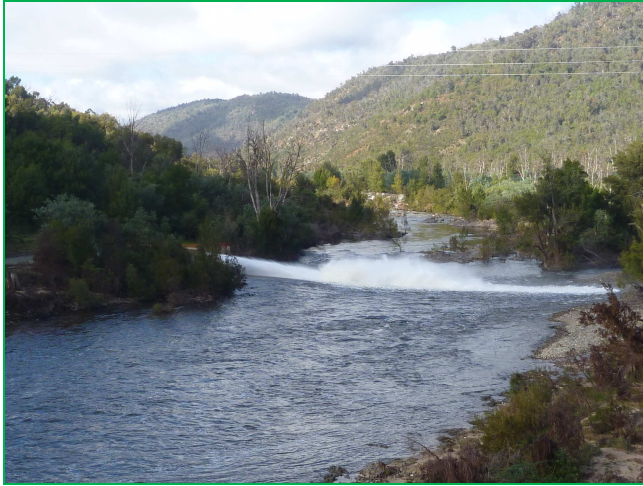
Autumn sampling was carried out between May 1<sup>st</sup> and May 11<sup>th</sup>. Weather conditions were fine during the sampling period although there was some rain on the 2<sup>nd</sup> of May which did not affect the sampling schedule. The sampling continuity of the Angle Crossing sites was interrupted slightly by the operation of the Bendora main scour valve which meant that MUR 28 was sampled some days after the remaining sites had been completed - once we were able to organise the valve to be temporarily turned off.

**Plate 4.** Bendora scour valve operational near MUR 28
