ACTEW Water
Murrumbidgee Ecological Monitoring Programme
Field observation report: autumn 2013

June 2013

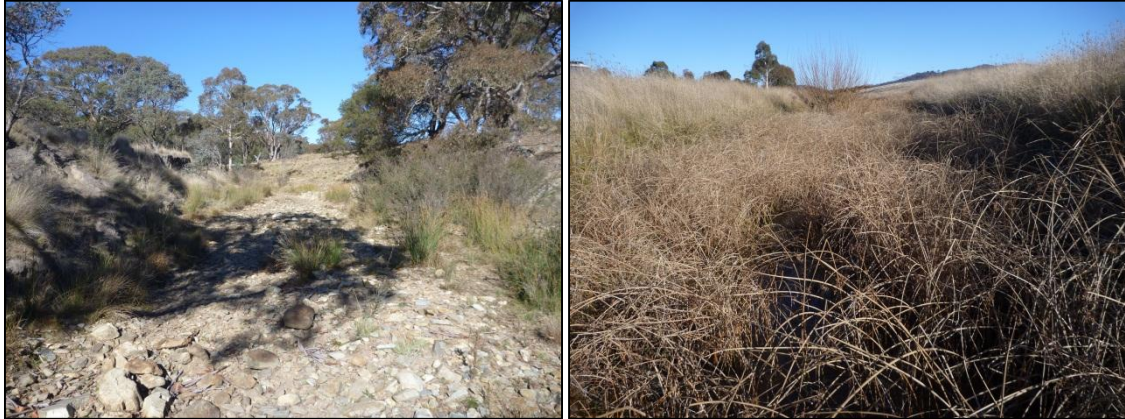
All sites in the Burra Creek component of the MEMP were sampled on the 20th and 21st of May 2013, with the exception of BUR 1a which was dry (Plate 1). The completion of sampling was delayed to accommodate the possibility that surface flow may have re-commenced following rainfall which was forecasted in late May. After returning to BUR 1a on the 31st May 2013 the site remained dry; and this included all of the pools in the sampling reach which usually hold at least small amounts of surface water. The low surface flow was evident through Burra Creek where some large stands of in stream macrophytes were noted. This was especially obvious upstream of the M2G outlet at BUR 1c, where the main channel was heavily encroached by spike rush (*Eleocharis sp.*) (Plate 1).

Stream-side scans of the macroinvertebrate samples indicated that most sites were healthy and contained a range of tolerant and sensitive taxonomic families. The exception to this rule was BUR 1c, where the macroinvertebrate communities were dominated by midge larvae, tolerant beetles and other taxa with SIGNAL scores of less than 4. This reflects the high silt and organic loads documented at this site and the low water levels and low current velocities.

Plate 1. Dry creek bed at BUR 1a (left) and channel encroachment at BUR 1c (right) and

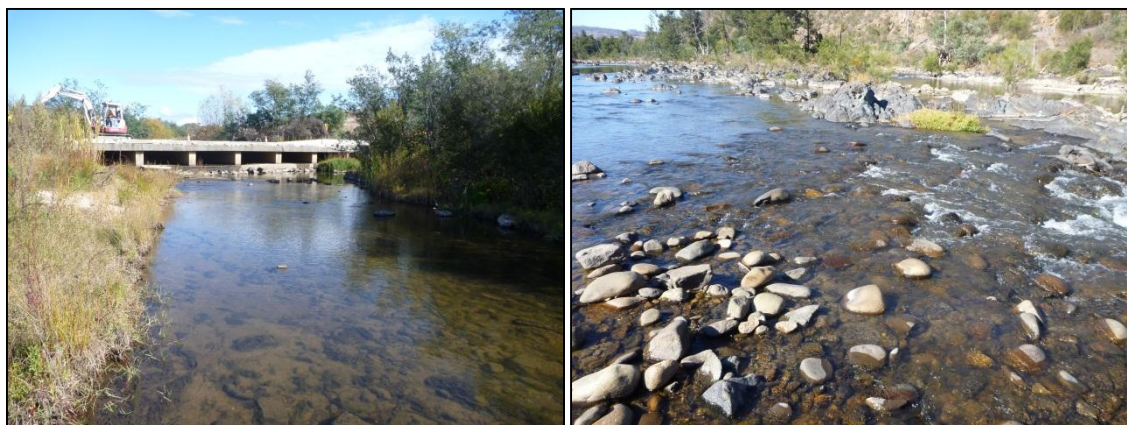
There was maintenance work was being carried out on Point Hut Crossing Bridge during sampling of MUR 23 (Plate 2); however it is unlikely that this would have any impact on the results because most of the work was being carried out on top of the bridge itself and did not involve in-stream work.

Plate 2. MUR 23 with maintenance work on the bridge (left), riffle at MUR 937 showing exposed bedrock

The lower river level during sampling exposed significant sections of bedrock and boulder across all sites which are usually inundated by flow (Plate 2), while also exposing larger areas of riffle habitat. Other indicators of the current low flow conditions, were the noticeably more

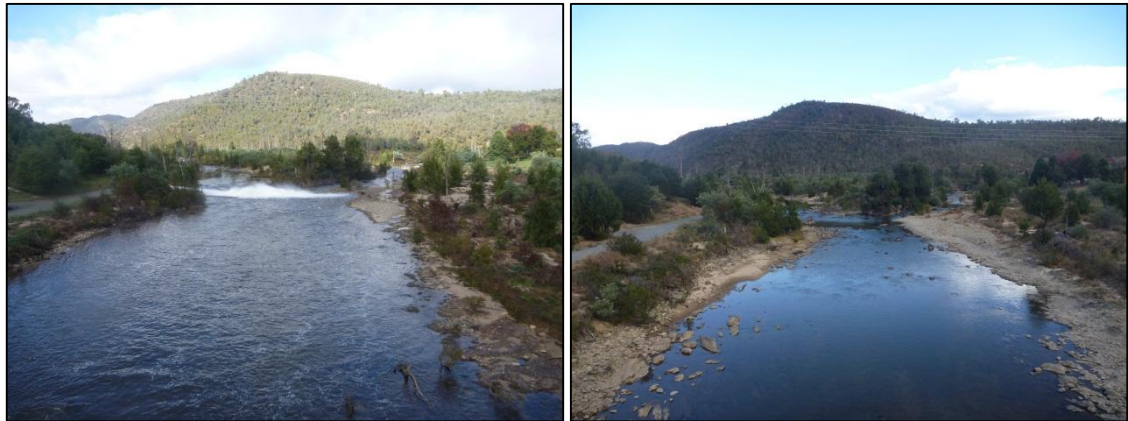
Sampling was conducted from the 8th to the 13th of May 2013. Plate 3 compares the flows during autumn 2013 to those during autumn 2012 and highlights the reduction in wetted width of the Murrumbidgee River downstream of MUR 28.

Plate 3. Downstream MUR 28 during autumn 2012 (left), downstream MUR 28 during autumn 2013 (right)

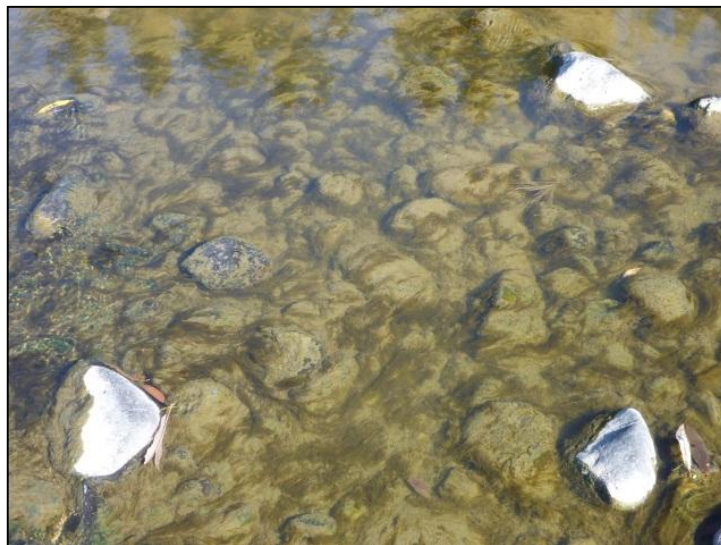
Throughout the catchment the low flows had implications for both edge and riffle habitats. The retreating wetted widths meant that some sites had reduced edge habitat available for sampling, while the habitat still present was shallower than during previous runs. This habitat loss is also thought to be the reason for large numbers of edge taxa being collected in riffle samples, with the potential for these taxa to be using the riffle as a refuge under current low flow conditions. In the riffle habitat large sections of bedrock and boulders were exposed which would normally be inundated. Low velocities along the margins of the channel resulted in patchy areas of filamentous algae growth (Plate 4).

Plate 4. Filamentous algae growth in the shallow margin at MUR 31
