ACTEW Water
Murrumbidgee Ecological Monitoring Program
Burra Creek geomorphology and vegetation assessment

March 2014

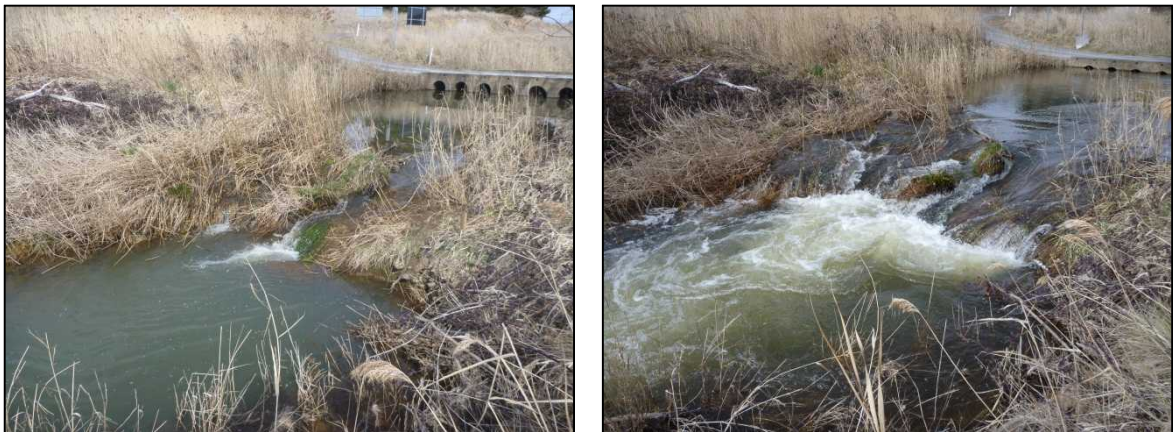
Plate 1. Step with moderate adjustment potential immediately downstream of Williamsdale Road, left at <5 ML/d, right at 100 ML/d

There is the potential for one channel area (a small step, assessed as moderate) located immediately downstream of Williamsdale Road to be adjusted as a result of continuous increased flows from pumping. Plate 1 shows this section of creek at a flow of < 5 ML/d and at 109 ML/d.

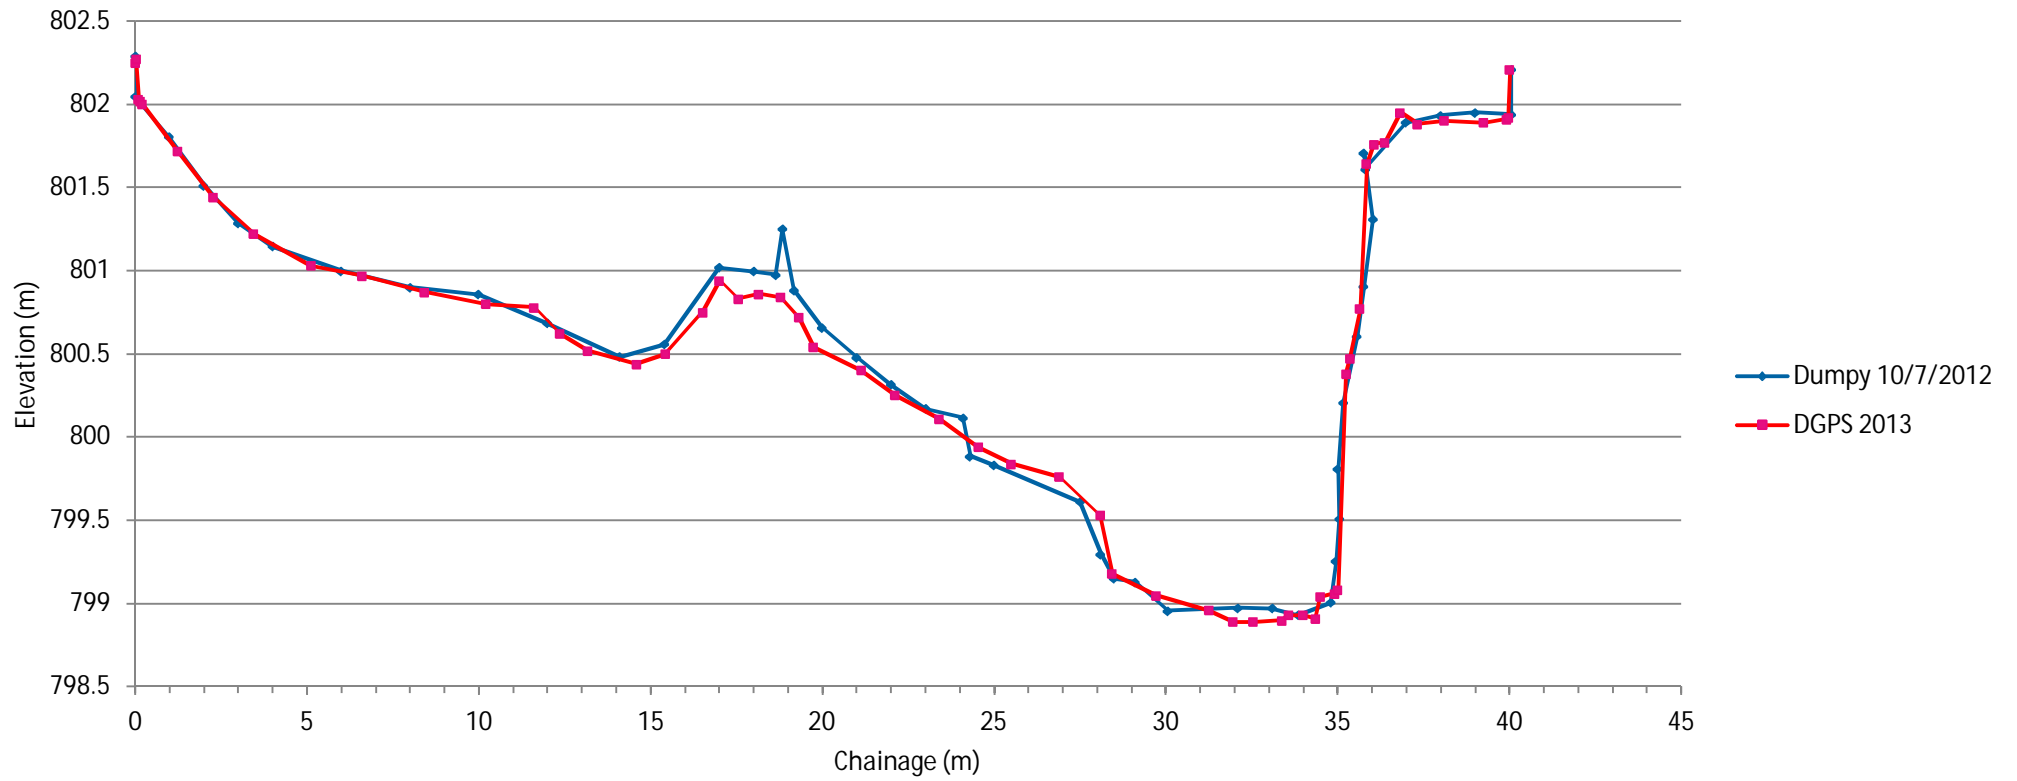
Figure 13 - BUR1 XS-2

- The cross section taken using the DGPS unit (Red) closely matches the cross section recorded by dumpy (Blue)
- Difference at CH16-20m due to flood debris that has moved or eroded away. Peak point ~CH19m on top of log.
-

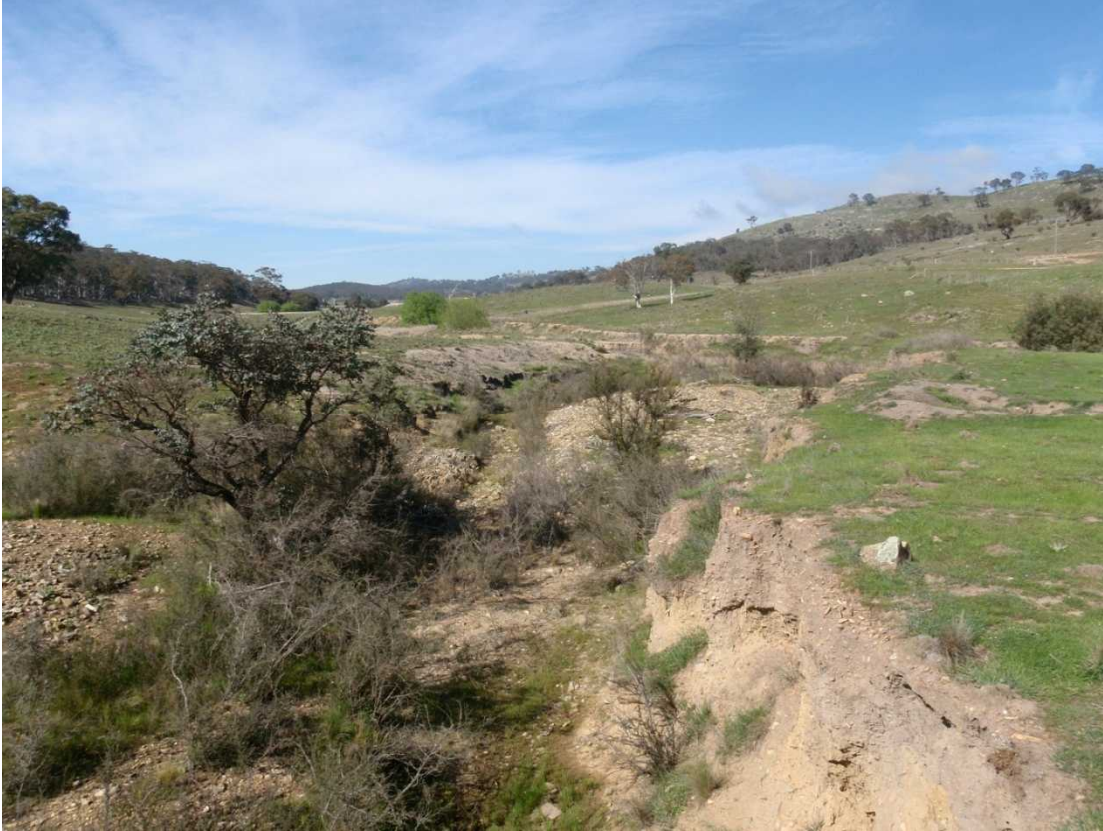
Photo 3 - BUR1 24/10/2009

- First photo on record for BUR1
- Evidence of erosion outside of bend.
- Stable vegetation on 60%-80% of visible stream banks.
- Sediment deposits within channel.
- Creek channel dry.

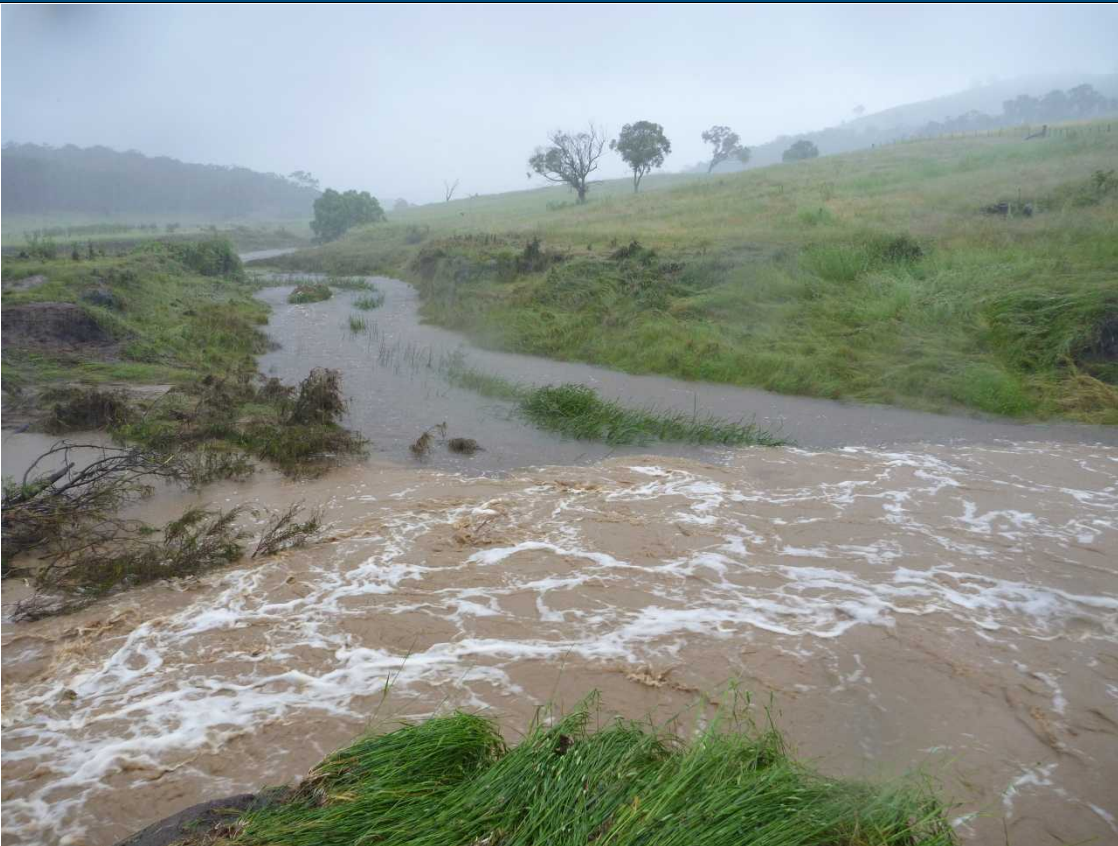
Photo 7 - BUR1 9/12/2010

- DS of BUR1 sample area at Cassidy's Crk confluence.
- Turbid Burra Creek flowing left to right bottom of photo.
- Less suspended material entering through Cassidy's Ck, due to less bank erosion and highly vegetated channel.

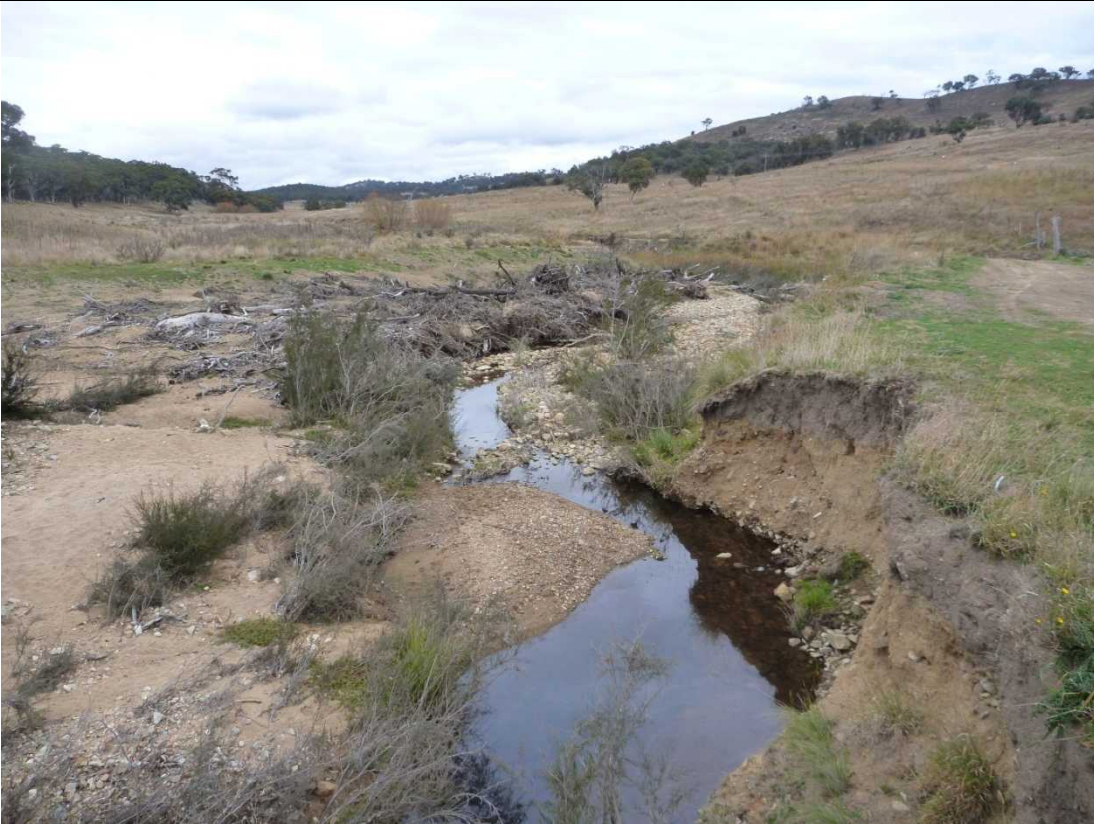
<p data-bbox="124 1682 496 1715">Photo 10 - BUR1 3/5/2011</p>	<ul style="list-style-type: none"> - Shrub vegetation showing evidence of dying, possibly as a result of previous flood damage. - Undercut banks slumped.

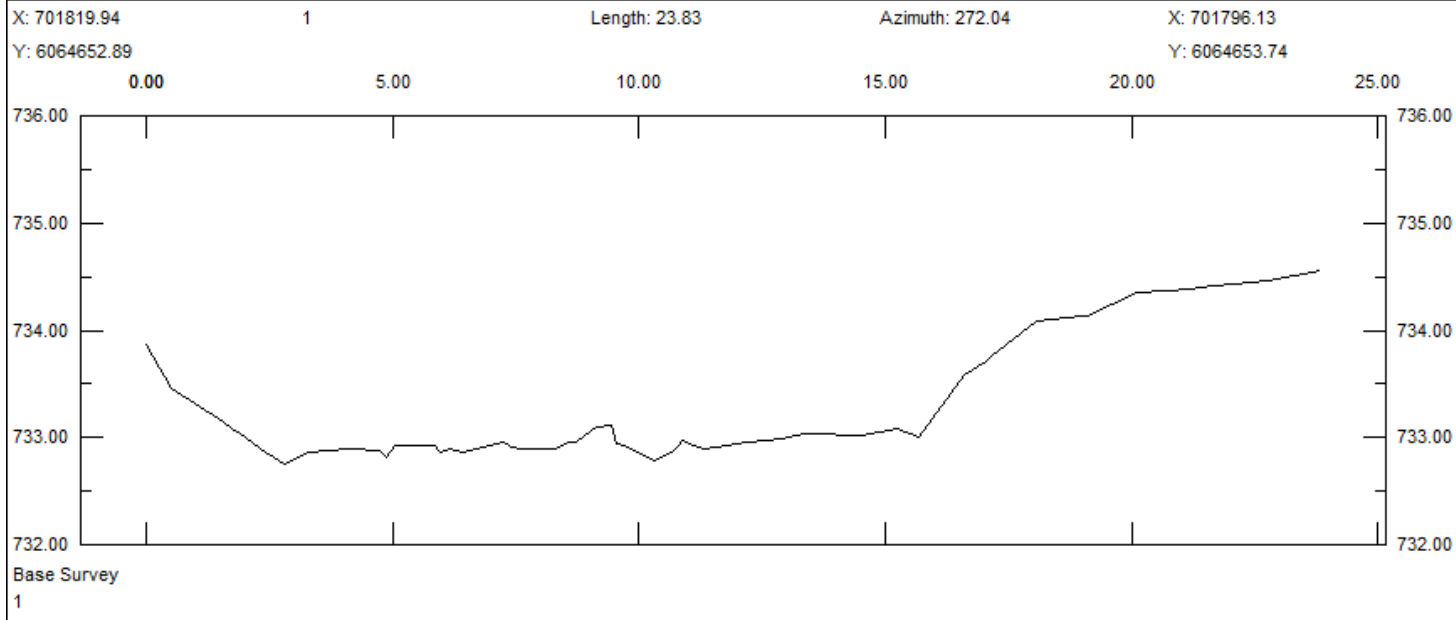
Figure 36 - BUR U/S Pool 50 3D GPS XS-1

- DGPS survey longer than Dumpy cross section to accommodate 3D profiling
- Original survey pegs could not be found at time of 3D survey.
- Channel sections indicate similar profile, accurate survey needed to re-establish section

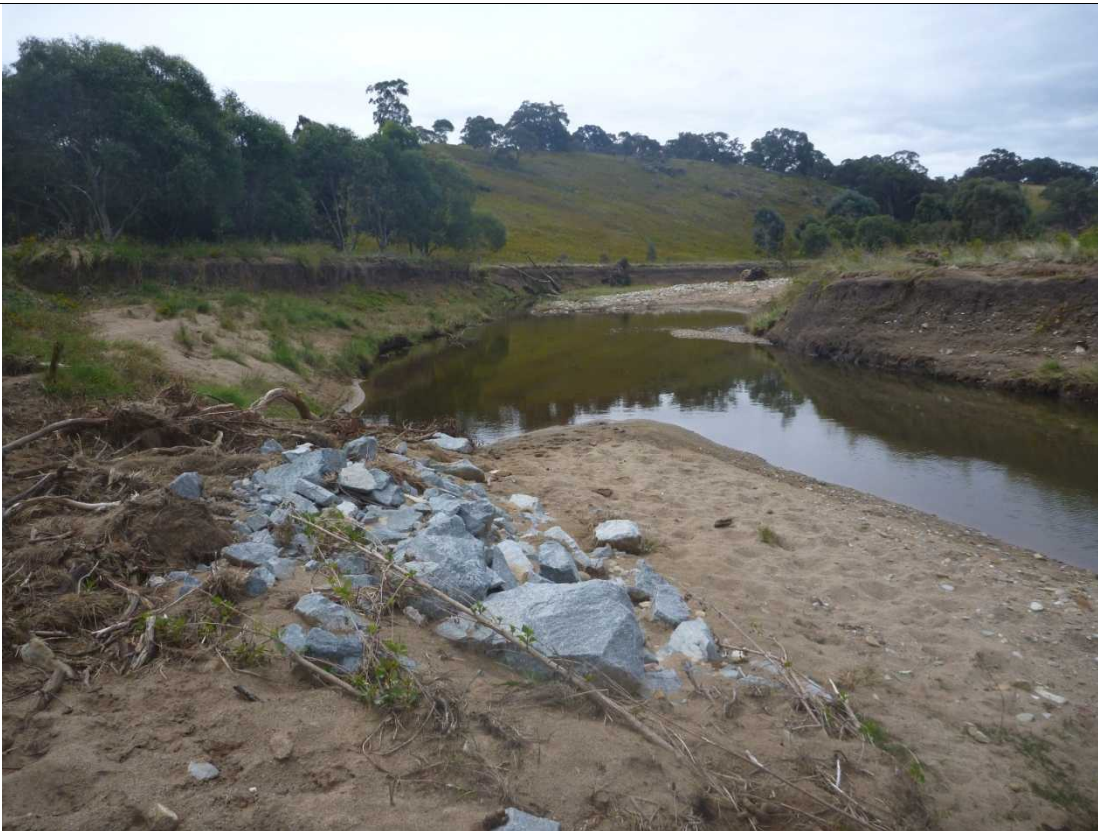
Photo 49 - BUR2C 7/1/2011

- Creek crossing no longer serviceable from Dec 2010 event. Some rock placed for stabilisation but crossing moved upstream

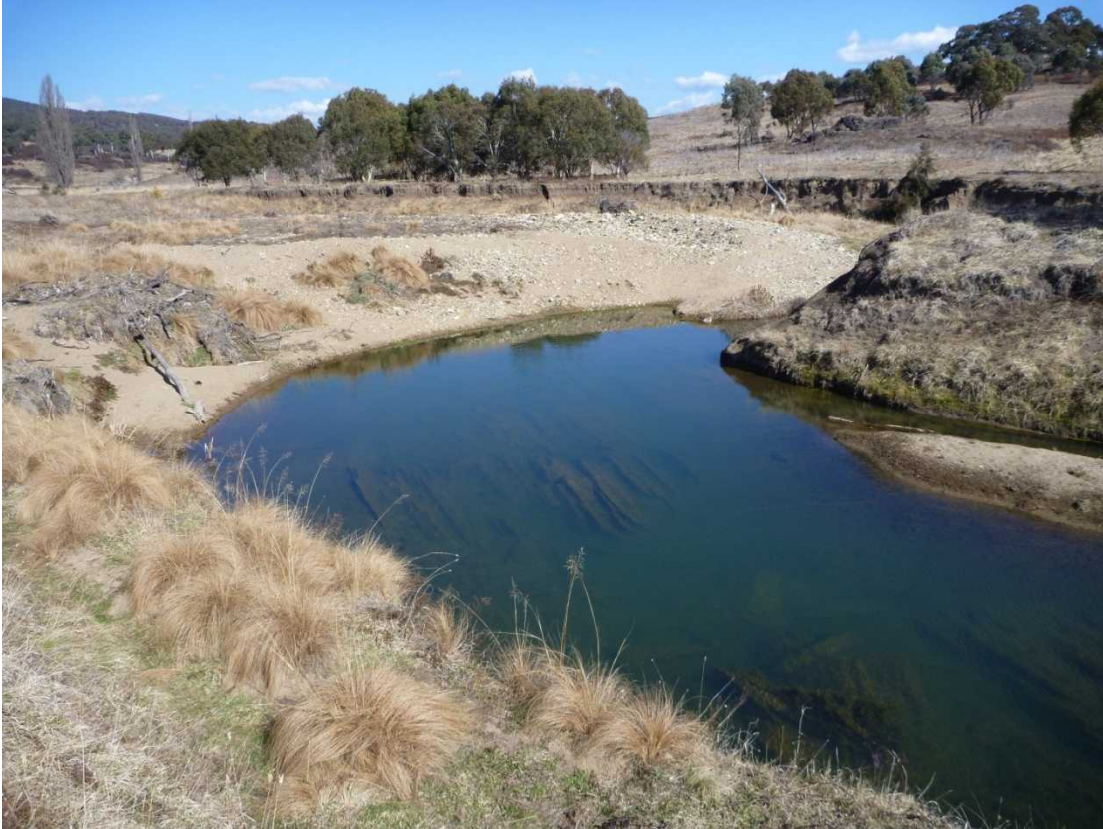
Photo 50 - BUR2C 3/8/2011

- looking upstream at dog-leg upstream of BUR 2C riffle site.
- Bedrock visible in pool with algal growth
- Significant sediment and cobble deposit on inside of bend as a result of December 2010 flood event

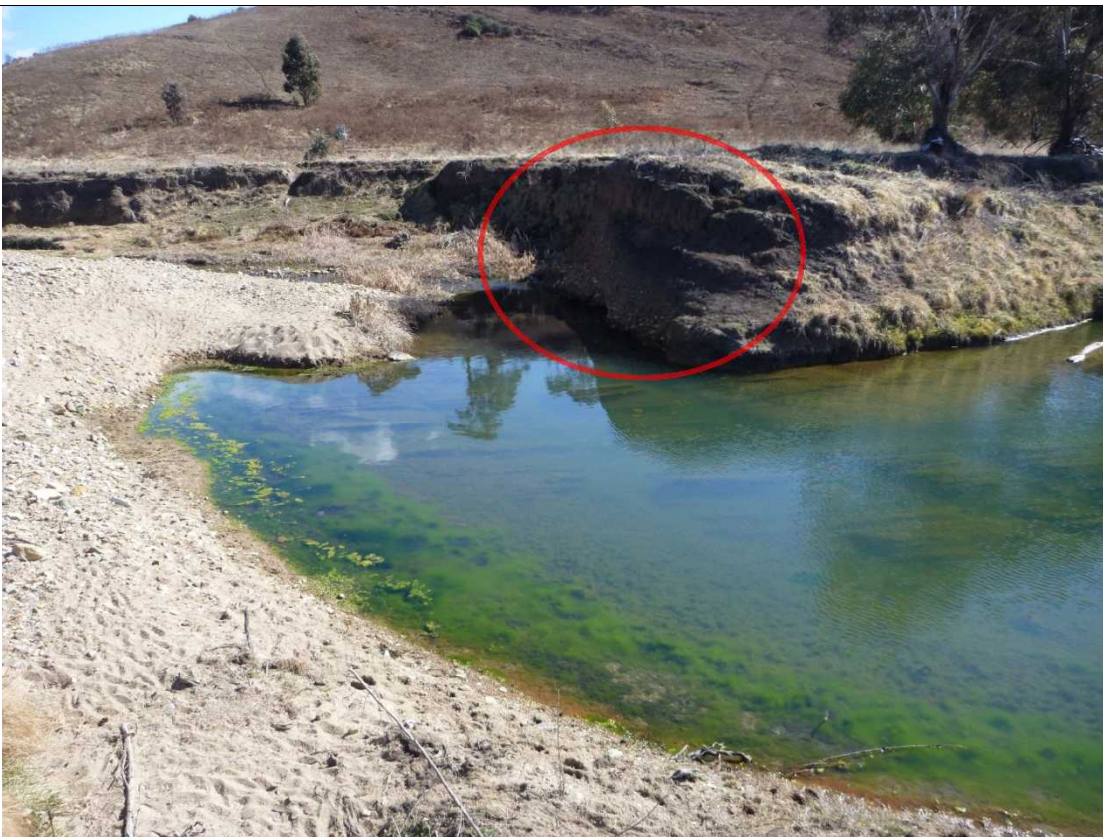
Photo 51 - BUR2C 3/8/2011

- Evidence of bank erosion
- Site of XS-3
- High algal growth due to elevated nutrient levels and warmer water temperature as vegetation previously shading the creek was washed out during flood

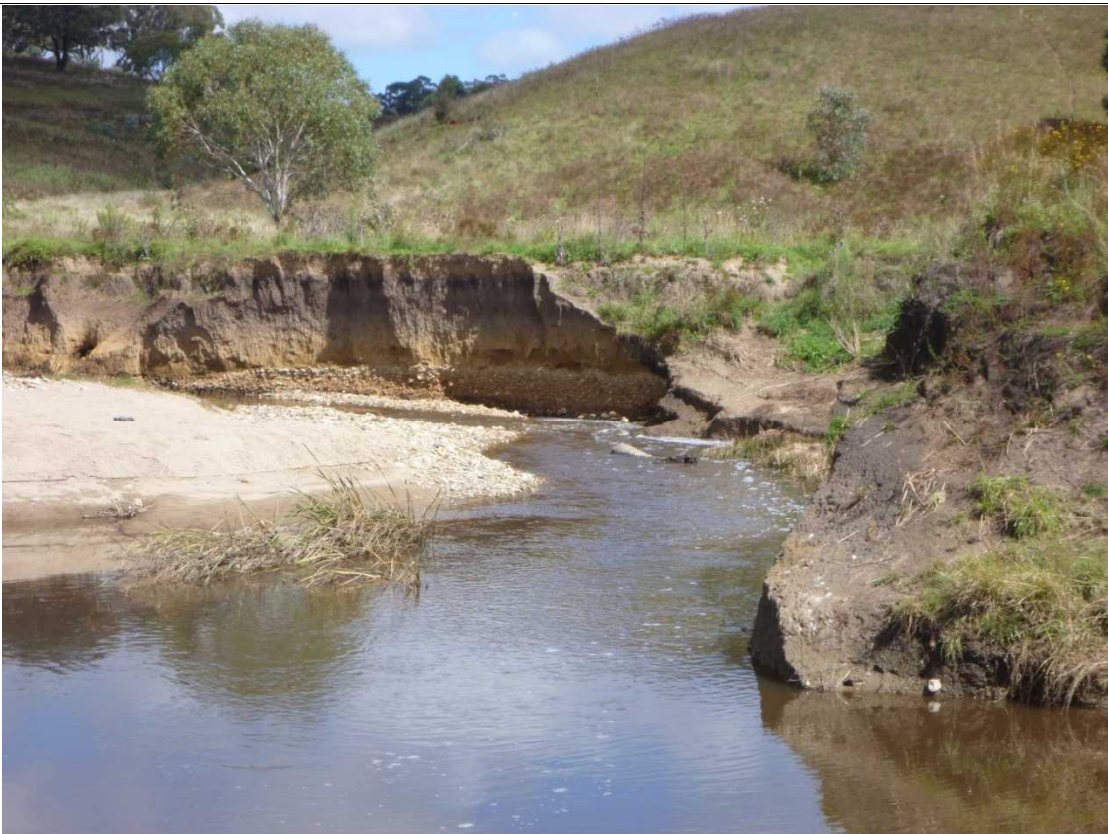
Photo 55- BUR2C 20/3/2012

- Evidence of bank erosion caused by recent flood
- Little bank vegetation remaining.
- XS-2 located at the downstream end of the eroded embankment
- XS-3 in foreground location

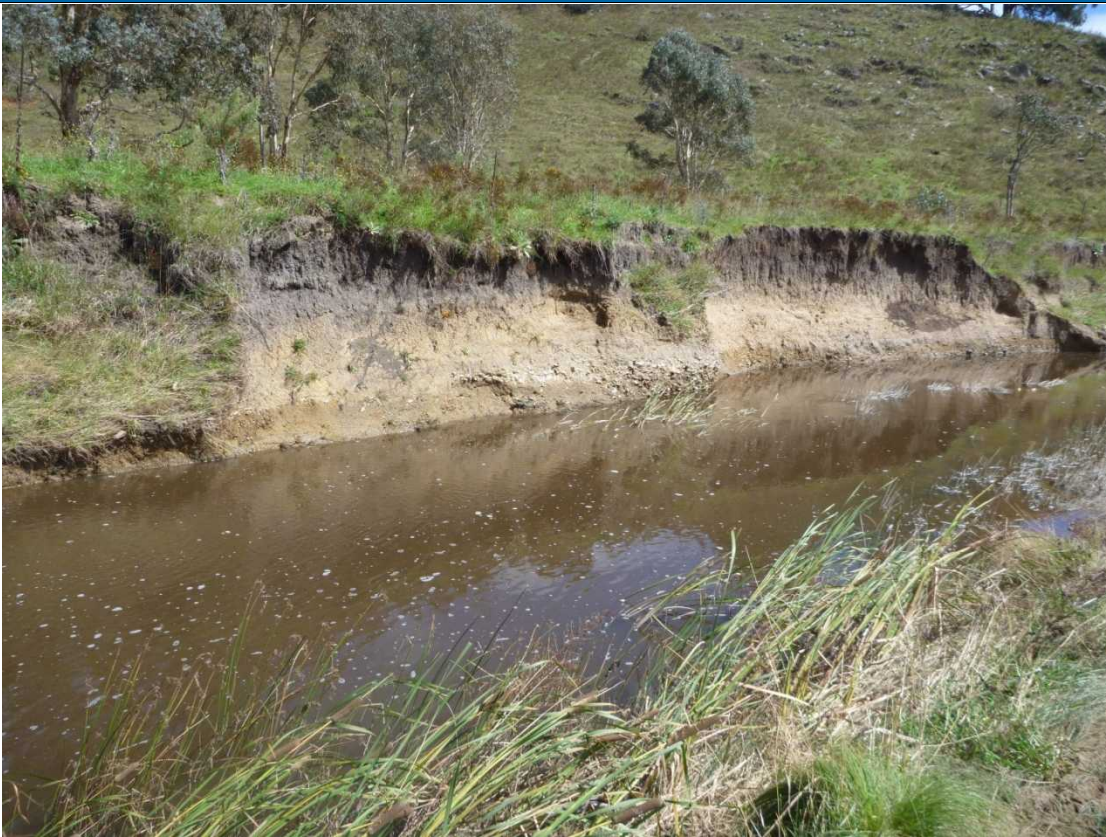
Photo 56 - BUR2C 20/3/2012

- Further bank erosion downstream of bend.

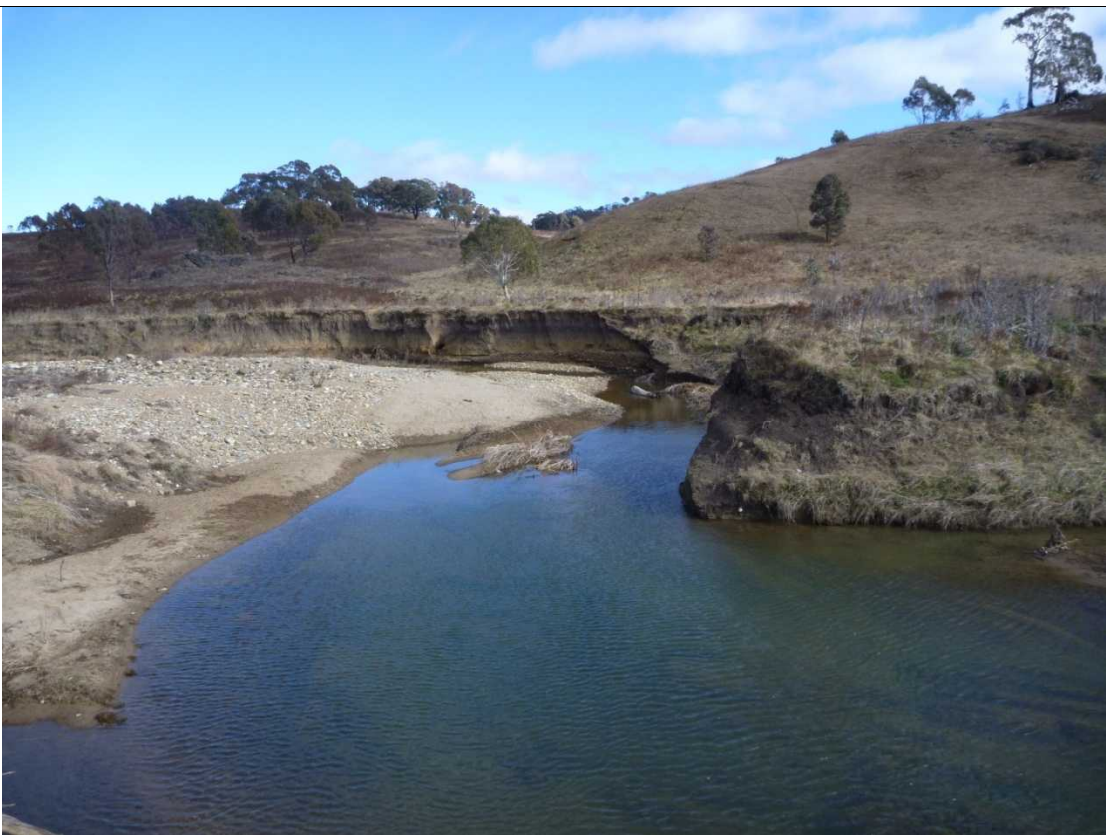
Photo 57 - BUR2C 5/7/2012

- Entire bank on outside of bend eroding
- No vegetation recovery during winter evident

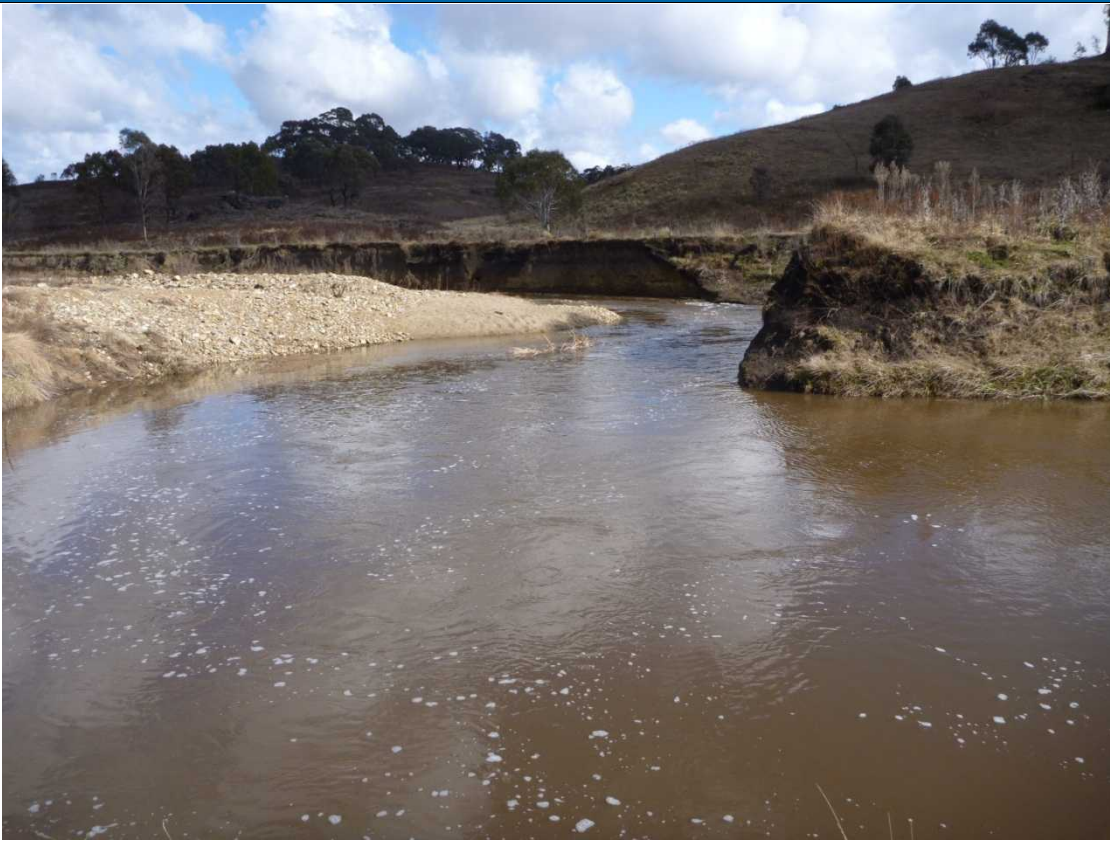
Photo 58 - BUR2C 13/7/2012

- Elevated flows
- Turbid flows indicate suspended sediment transport

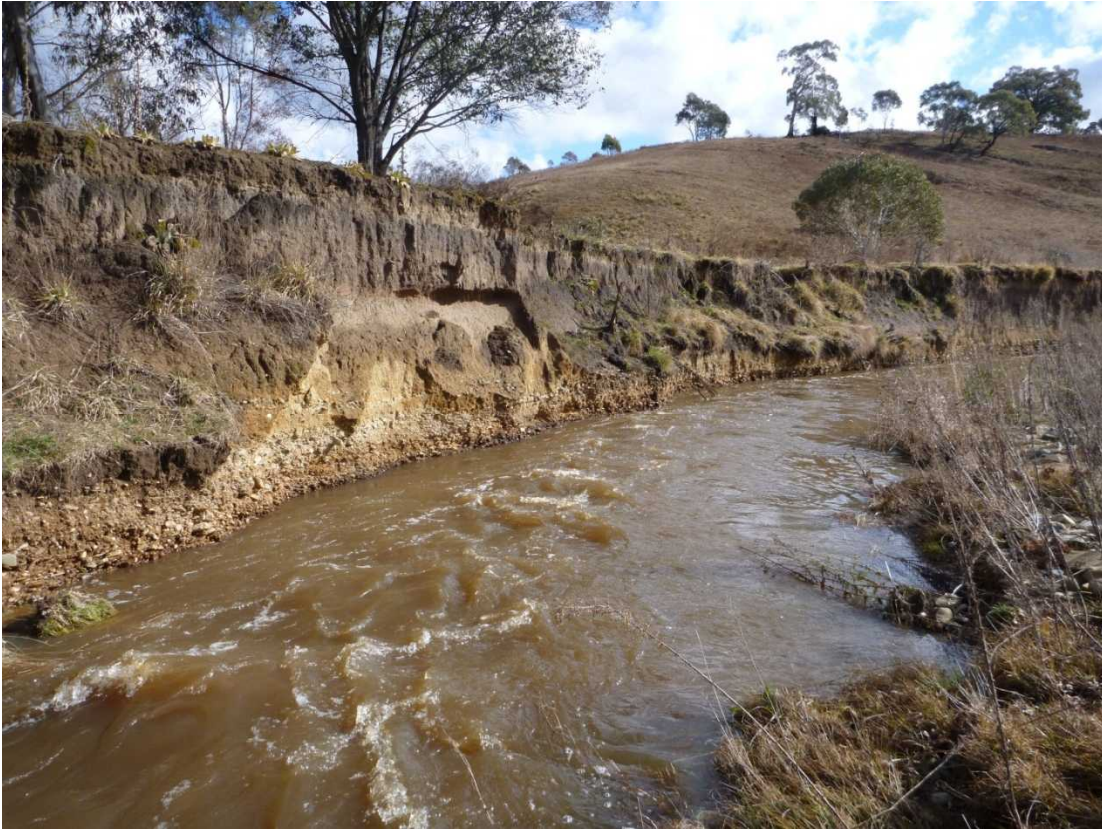
Photo 60 - BUR2C 13/7/2012

- Embankment erosion further upstream from BUR2C

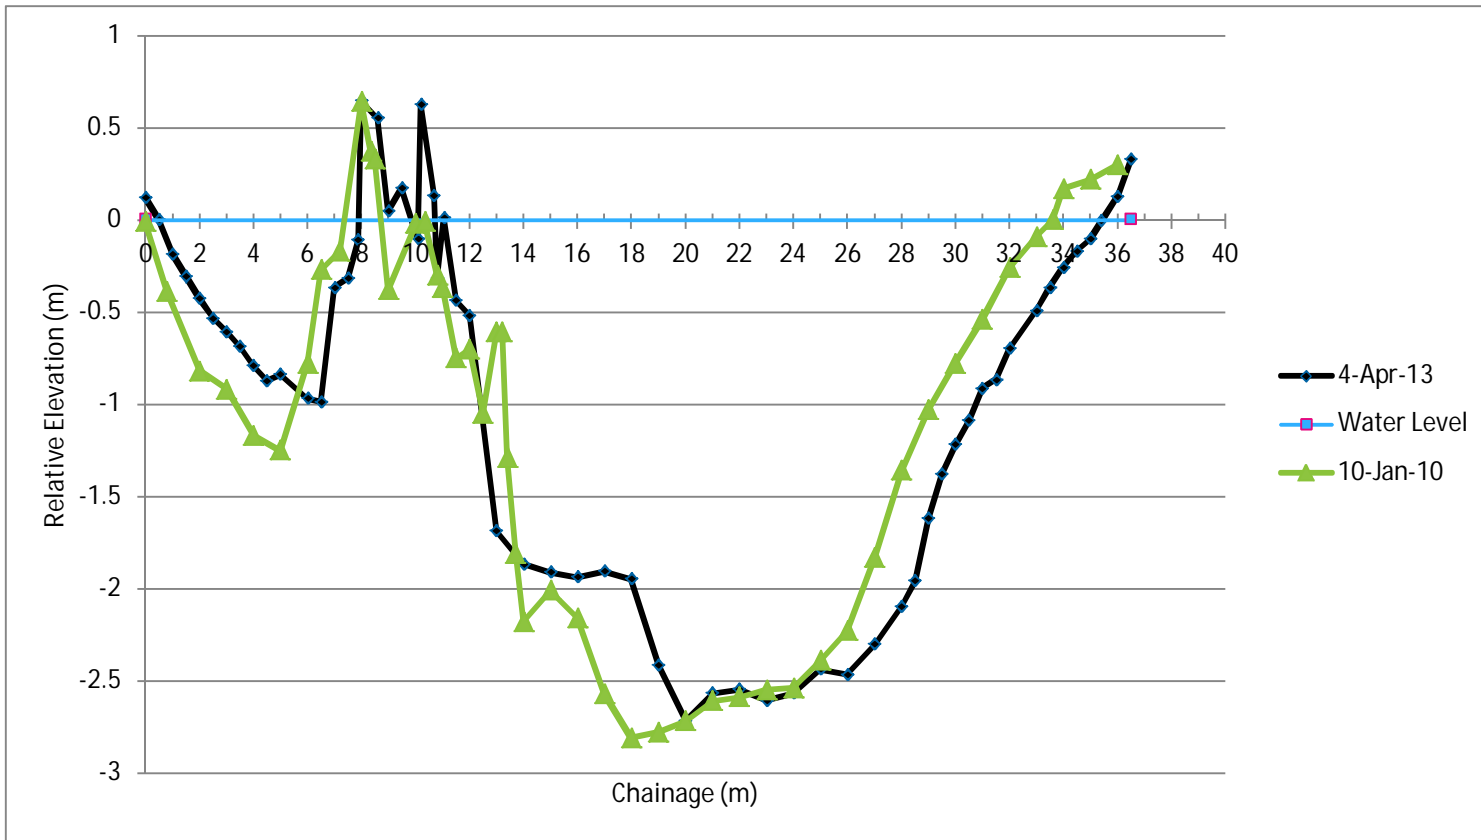
- Differences due to taking a slightly different line through the rock outcrop
- Minor sand deposition near rocky outcrop (13-18m)
- Minor erosion on right hand bank
- Movement of sand bed consistent with storm events during interim period
- Cross sections adjusted to 0m height at water level
