M2G Planting (Tree & Shrub) Monitoring Report

Construction Corridor (Spring 2014)

Prepared for ACTEW Water

February 2015

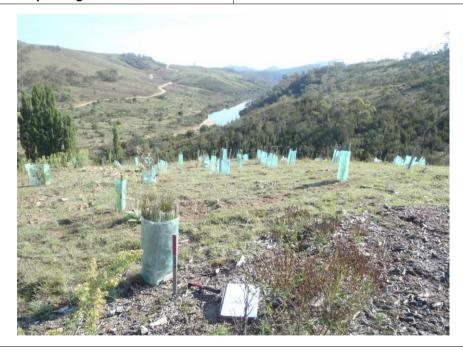
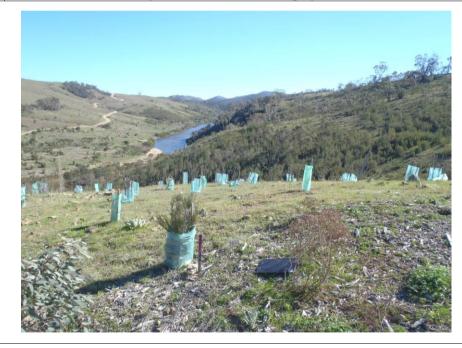
Plate 1: Monitoring Site TSP1. The image on the left is from autumn 2014 and the right spring 2014.

There has been a gradual decline in specimen health, which is now at 41.3%. Approximately one-third of plantings are either dead or missing. The original groundcover was retained at this site and comprised *Themeda* dominated grassland in moderate to good condition.

Recommendation: Replace dead and missing specimens

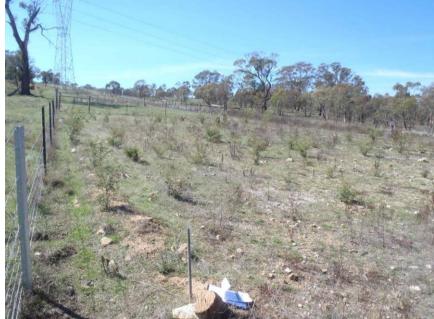
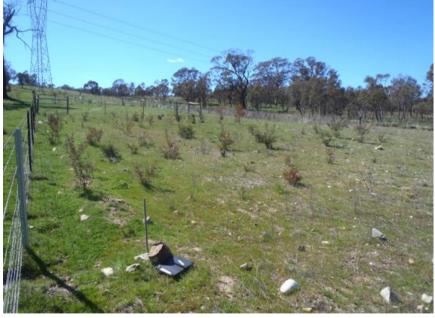
Plate 2: Monitoring Site TSP2. The image on the left is from autumn 2014 and the right spring 2014.

Although 68 plantings were in good health there has been a consistent

decline in the success rate with almost one-third

of specimens either dead or missing.

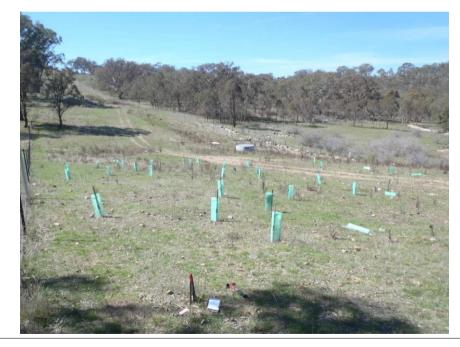
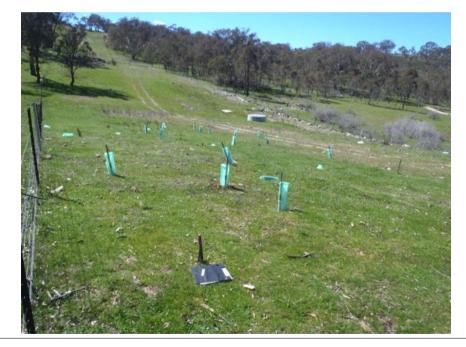
Plate 3: Monitoring Site TSP3. The image on the left is from autumn 2014 and the right spring 2014.

Planting success at this site peaked at 48 in autumn 2013 but has steadily

declined since that time. The majority of specimens are now either dead or missing *Inset: TSP3 in spring 2012,* within 12 months of planting.

Recommendation: Replace dead and missing specimens

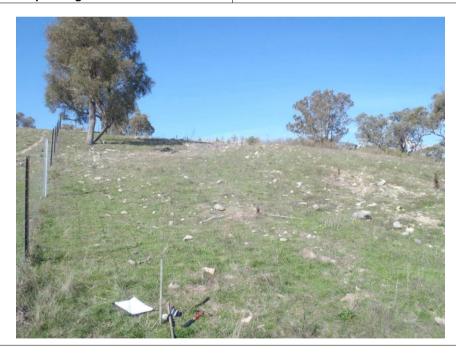
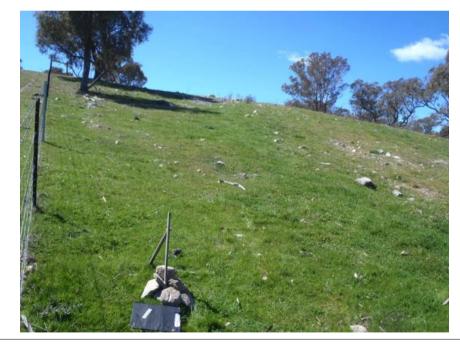
Plate 4: Monitoring Site TSP4. The image on the left is from autumn 2014 and the right spring 2014.

TSP4 is located about 1,900 m from the LLPS within the ACT. Plantings success at this site has never been high, but the last two results have seen a significant decline with the majority of specimens either dead or missing. *Inset: TSP4 in*

Recommendation: Replace dead and

missing specimens

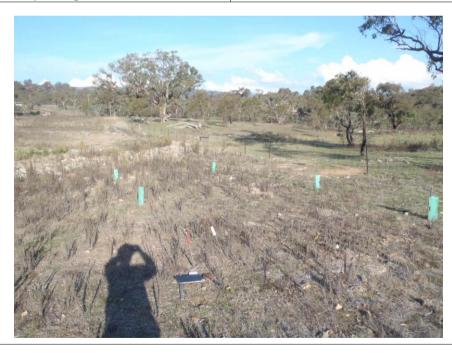
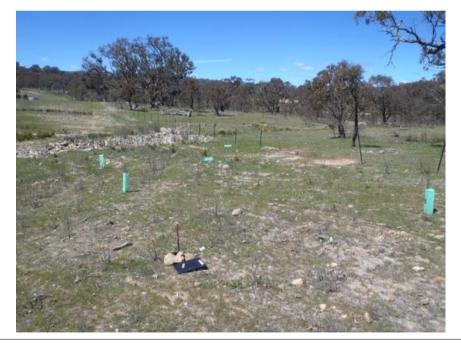
Plate 5: Monitoring Site TSP5. The image on the left is from autumn 2014 and the right spring 2014.

Only 2 of 19 plantings remain in good health with most either dead or missing.

Recommendation: Replace dead and missing specimens

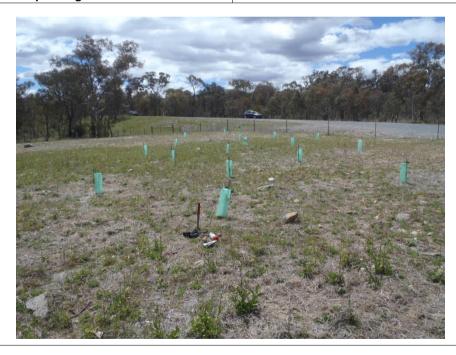
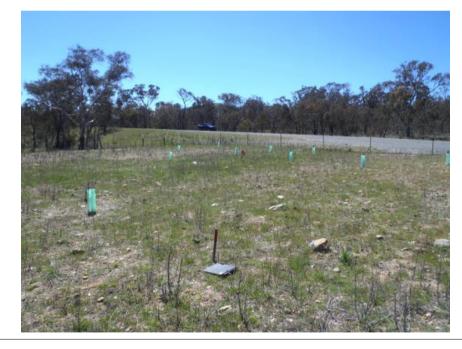
Plate 6: Monitoring Site TSP6. The image on the left is from autumn 2014 and the right spring 2014.

Only 2 of 21 plantings remain in good health with most either dead or missing.

Natural recruitment of Yellow Box *Eucalyptus melliodora* and Blakely's Red Gum *E. blakelyi* was recorded nearby, and these have not been included in the sample count.

Recommendation: Replace dead and missing specimens and improved maintenance (see Section 3.5 of the LRTEMP).

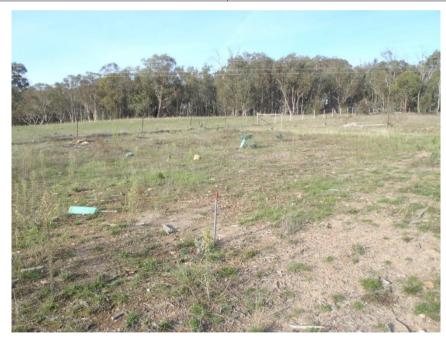
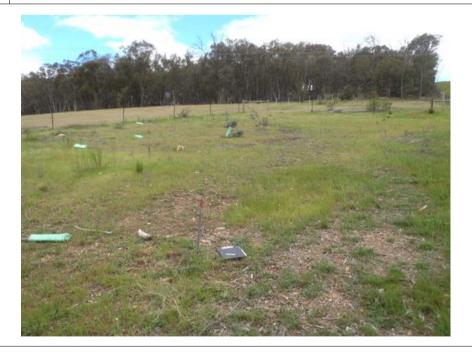
Plate 7: Monitoring Site TSP7. The image on the left is from autumn 2014 and the right spring 2014.

TSP7 is located about 3,040 m from the LLPS within the Smith property, NSW.Additional plantings have maintained the number of specimens in good health. *Note*: Sample site is separated in to two planting areas - northern and southern sides of the construction corridor. Natural recruitment of Yellow Box *Eucalyptus melliodora*, Apple Box *E. bridgesiana* and Broadleaved Peppermint *E. dives* was observed either side of this site within the construction corridor.

Recommendation: Replace dead and missing specimens (see Section 3.5 of the LRTEMP).

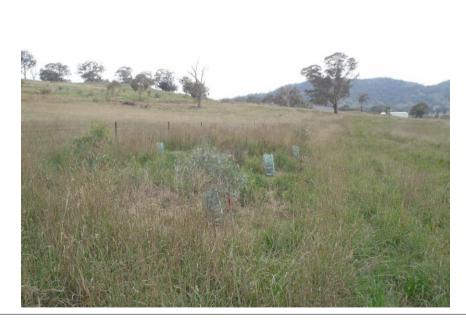
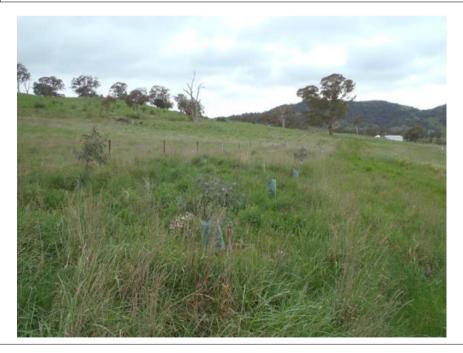
Plate 9: Monitoring Site TSP9. The image on the left is from autumn 2014 and the right spring 2014.

Planting success exceeded 80% during the first three monitoring sessions, but has since declined to 54%. A high proportion of specimens are in poor health mainly due to competition from pasture grasses.

Recommendation: Improve planting maintenance (see Section 3.5 of the LRTEMP).

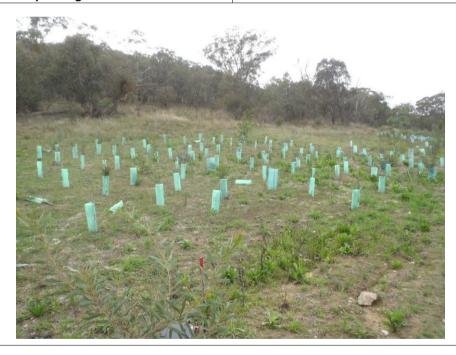
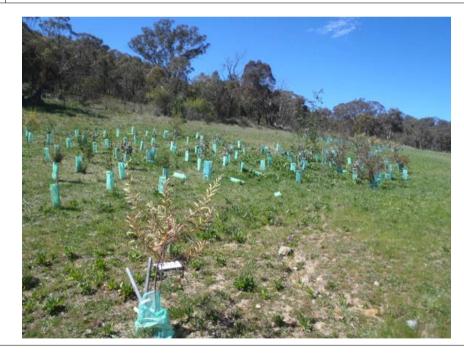
Plate 10: Monitoring Site TSP10. The image on the left is from autumn 2014 and the right spring 2014.

About 61% of plantings were in good health and suggests a reasonable result, however, there has been a declining trend in success since spring 2013.

At least 15 tree guards were choked with chicory or grass resulting in either death or poor health of plantings.

Recommendation: Replace dead and missing specimens and improve planting maintenance (see Section 3.5 of the LRTEMP).

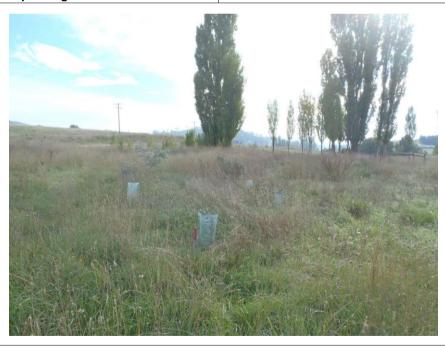
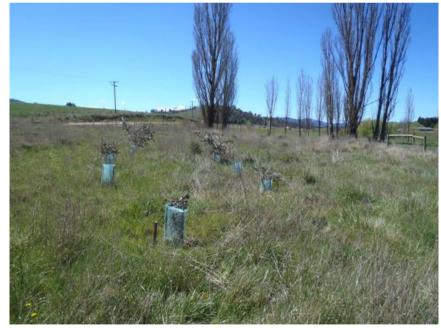
Plate 11: Monitoring Site TSP11. The image on the left is from autumn 2014 and the right spring 2014.

Specimen growth was vigorous with above 80% success rate.

Recommendation: Continue planting maintenance (see Section 3.5 of the LRTEMP).

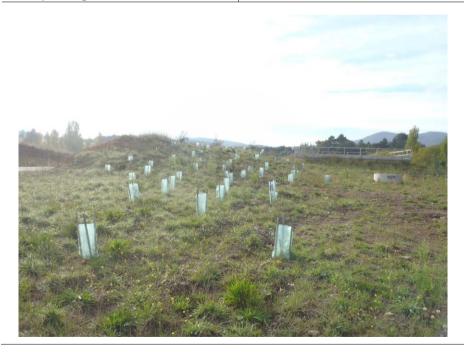
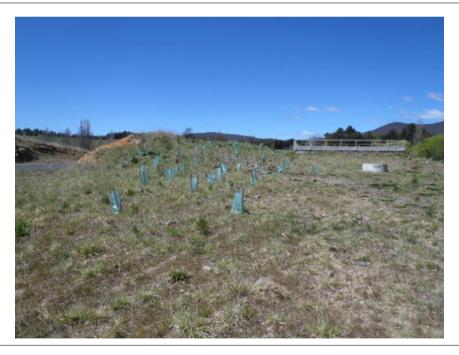
Plate 12: Monitoring Site TSP12. The image on the left is from autumn 2014 and the right spring 2014.

Just over half of the sample remains in good health with about a third either dead or missing. Planting success was about 80% in the period between spring 2012 and spring 2013, but has since declined to 55%.

Recommendation: Replace dead and missing specimens and improved planting maintenance (see Section 3.5 of the LRTEMP).
