Icon Water Limited

Murrumbidgee Ecological Monitoring Program Observation Report – Autumn 2020 Impact Monitoring Round 3

May 2020

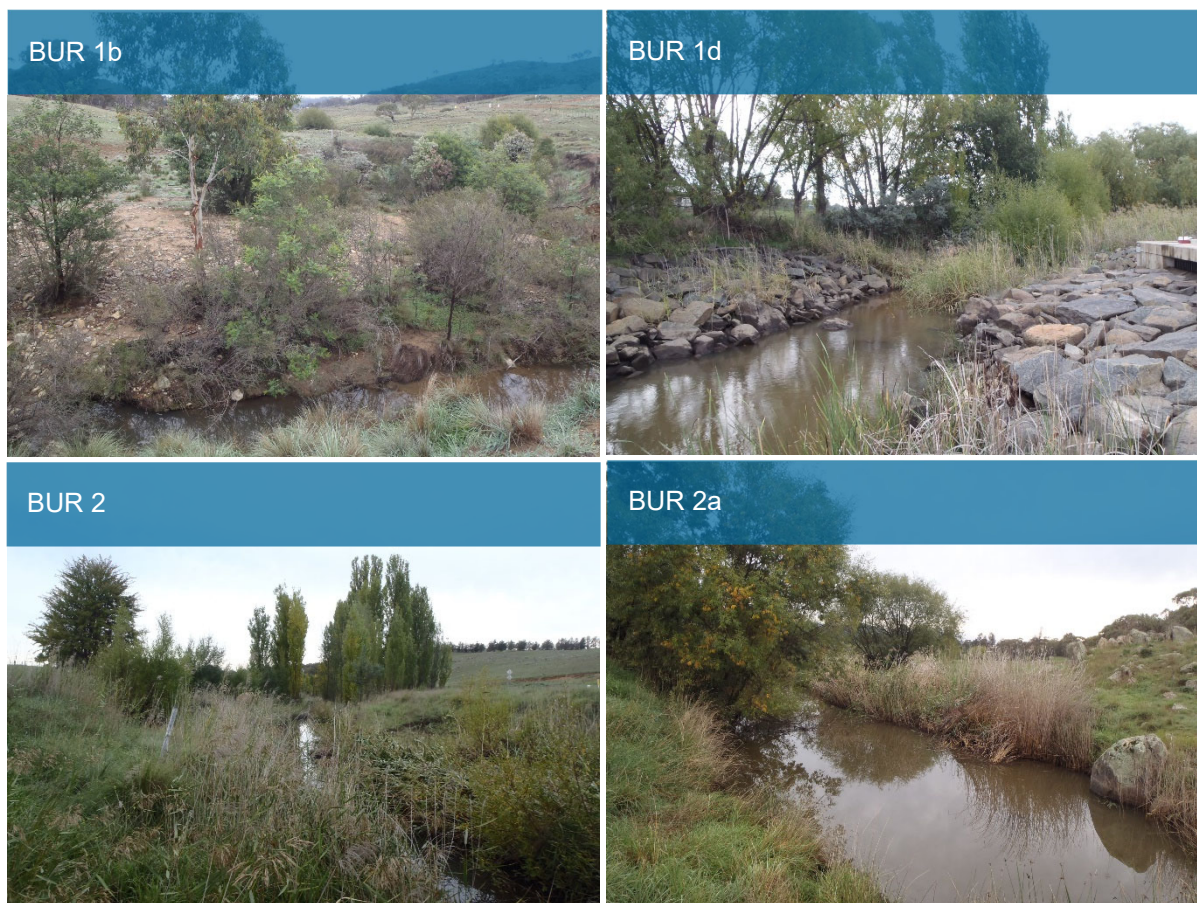
Plate 2-1 Photos of the Burra Creek macroinvertebrate sampling sites

The channel contained beds of dense macrophyte growth (*Typha* spp., *Phragmites australis*, and Great Bulrush (*Schoenoplectus validus*)) and there was no riffle habitat at any of the monitoring sites, meaning that riffle samples were not collected.

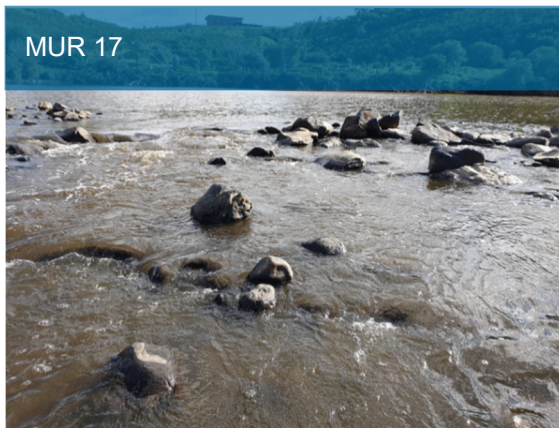
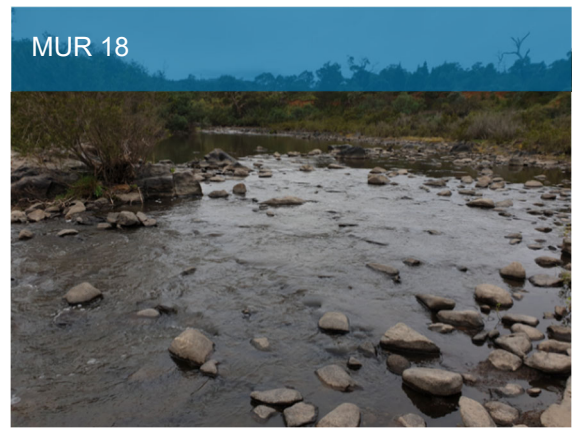
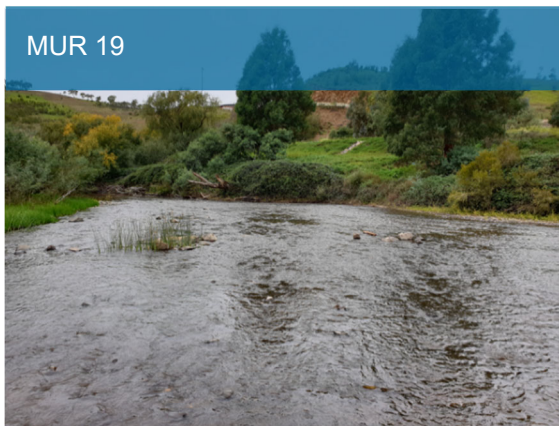
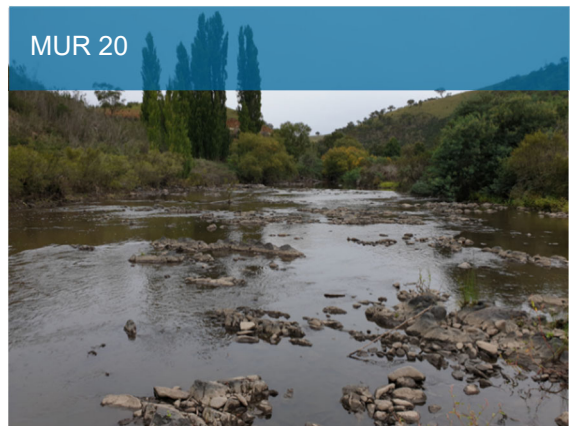
Plate 2-3 Photos of the Murrumbidgee River (M2G) sampling sites

Algae growth and periphyton cover were classified as 35 - 65% cover at all sites, which is an increase from 10% cover assessed in spring 2019. This is likely due to an increase in growth over the summer period. It is worth noting that the poor water clarity, silt deposition made the autumn 2020 assessment of periphyton cover difficult.

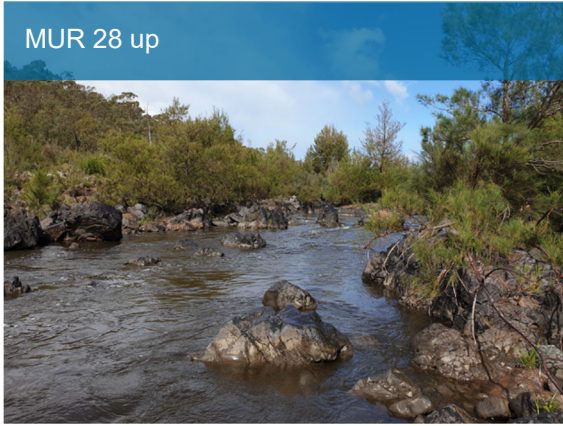
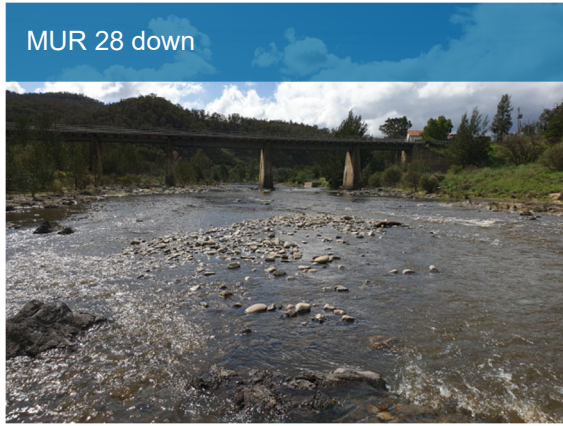
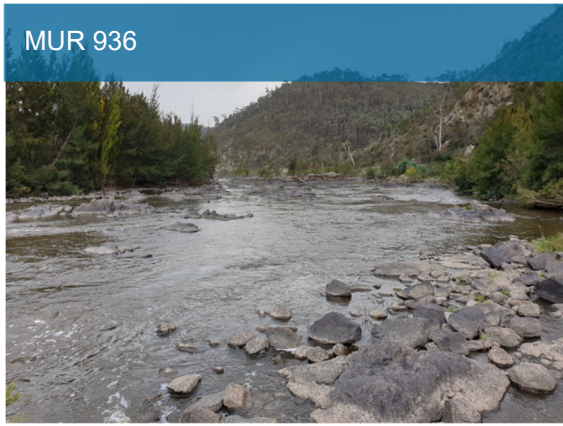
Plate 2-5 Photos of the Murrumbidgee River (MPS) sampling sites

Algae growth and periphyton cover were classified as 35 - 65% cover at all sites, which is an increase from 10% cover assessed in spring 2019. It is worth noting that the poor water clarity and silt deposition across all substrates made the autumn 2020 assessment of periphyton cover difficult. The only submerged macrophyte species was *Myriophyllum* spp.
