BIOLOGICAL RESPONSE TO FLOWS DOWNSTREAM OF CORIN, BENDORA, COTTER AND GOOGONG DAMS

Annual report July 2019

Report to Icon Water

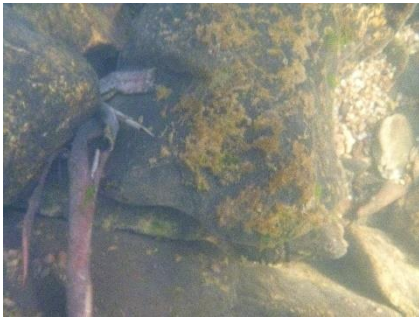
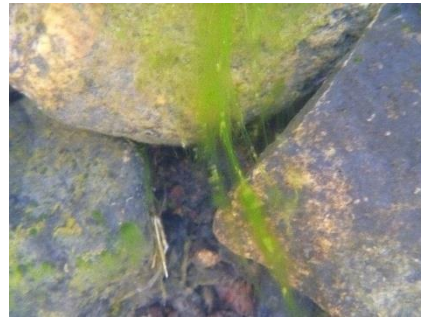
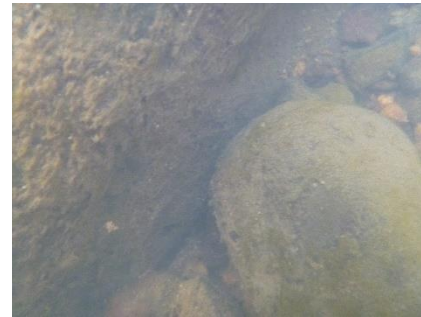
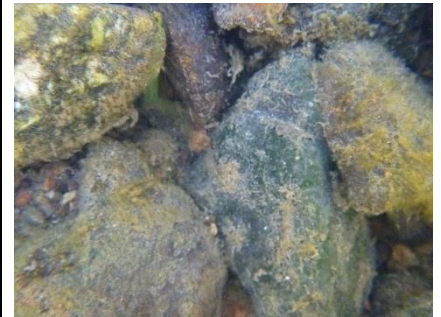
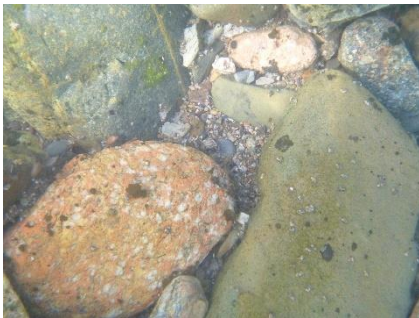
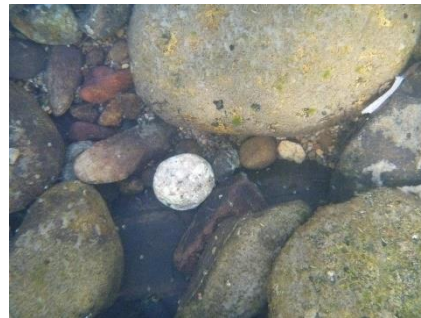
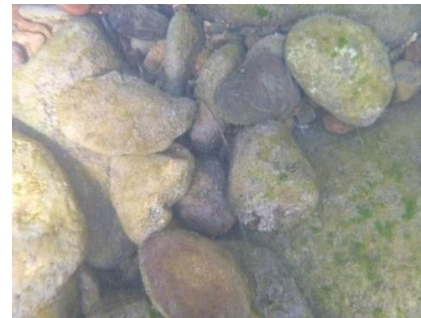
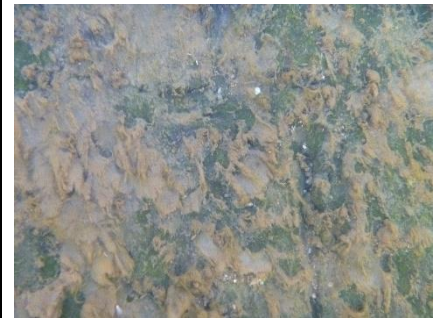
Figure 3. Filamentous algae and periphyton cover of riffle bed sediments at below dam test sites and corresponding reference sites on the Goodradigbee and Queanbeyan Rivers in **spring 2018**.

The environmental flow ecological objective of <20% cover of filamentous algae in riffle habitats was achieved at all below dams test sites in both assessments except for QM2 in spring 2018. Field observations of periphyton cover of riffle habitats were <20% in most of the sites, except for sites QM2, GM3, QM1 and QM3 in spring 2018 and all sites observed <20% periphyton cover in autumn 2019 (Table ; Figure 3 and Figure 4).

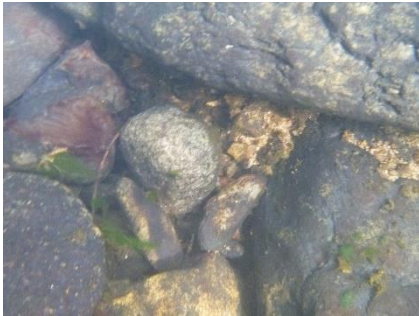
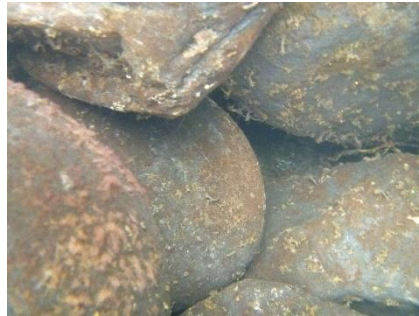
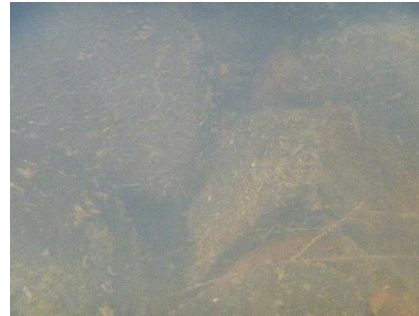
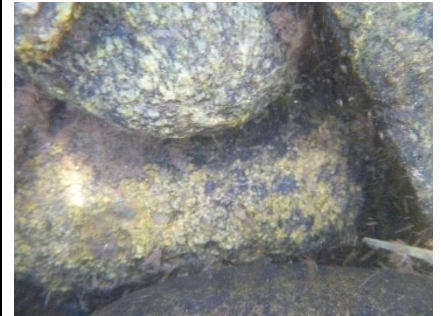
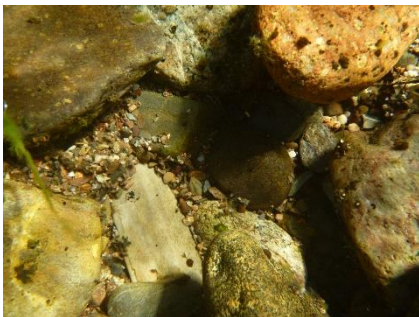
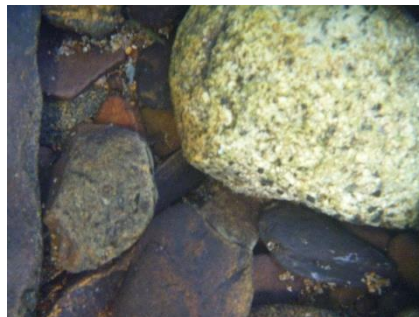
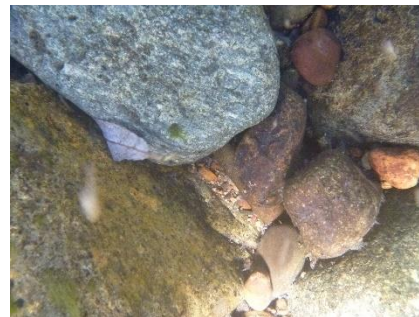
Figure 4: Filamentous algae and periphyton cover of riffle bed sediments at below dam test sites and corresponding reference sites on the Goodradigbee and Queanbeyan Rivers in **autumn 2019**.

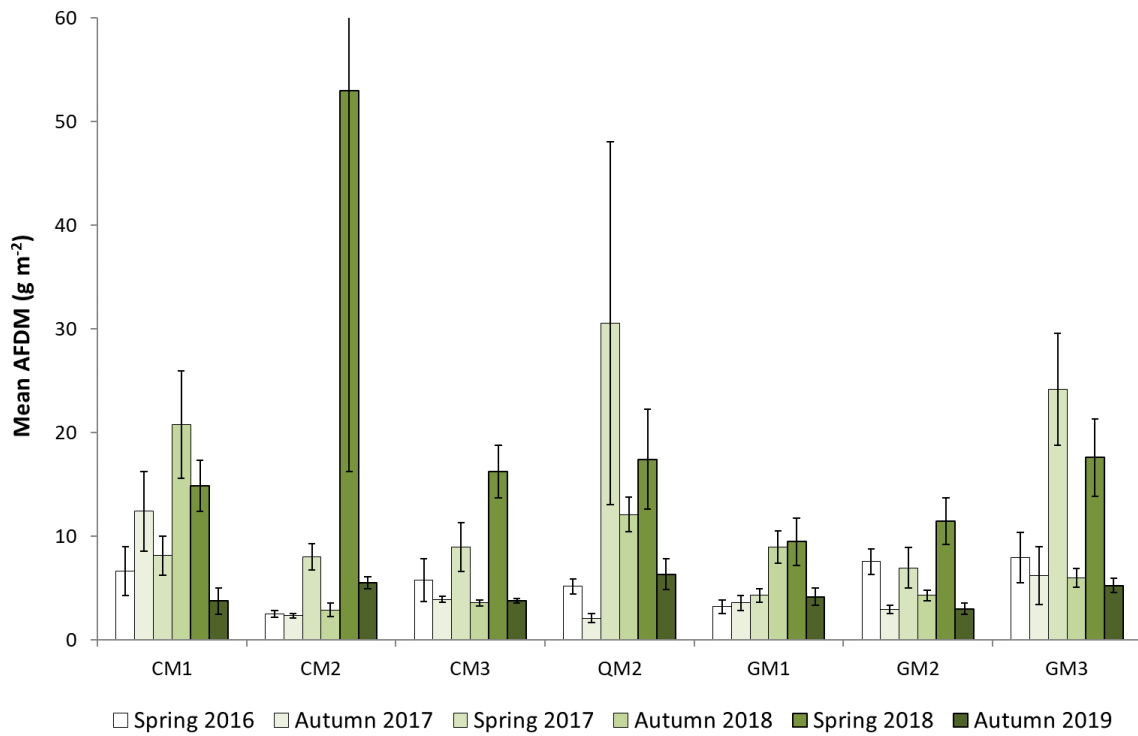
Figure 5: Mean AFDM (g m^{-2}) at below dam test sites and reference sites on the Goodradigbee River from spring 2016 to autumn 2019. Error bars represent +/- 1 standard error.

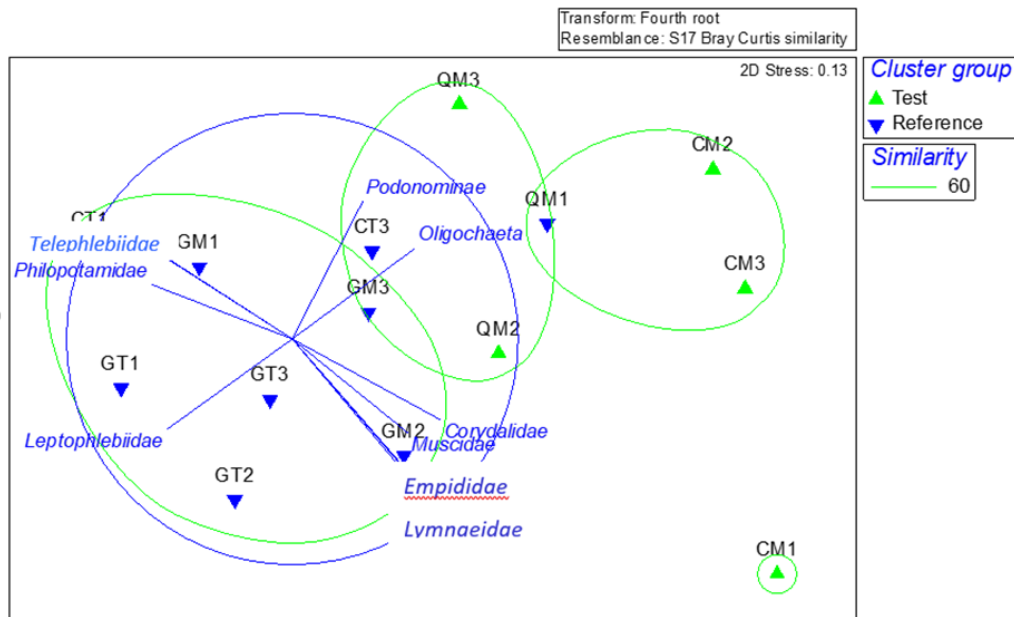
Figure 11. MDS ordination of 60% similarity between macroinvertebrate samples collected in **spring 2018** for the below dams assessment program (green oval lines). Similarity is based on macroinvertebrate relative abundance. Macroinvertebrate taxa with Pearson correlations greater than 0.60 (i.e. taxa that discriminate between the groups of sites) are overlaid on the MDS ordination. The closer the blue line for each taxa is to the edge of the blue circle the greater the correlation.

Cotter River test sites CM2 and CM3 had macroinvertebrate assemblages dissimilar to all other sites, (Figure 11) driven by [Podonomidae](#), [Corydalidae](#), [Empididae](#), [Lymnaeidae](#) and [Muscidae](#) in spring 2018 and [Simulidae](#) and [Caenidae](#) in autumn 2019. Cotter River test sites CM2 and CM3 and Queanbeyan River reference site QM1 had similar

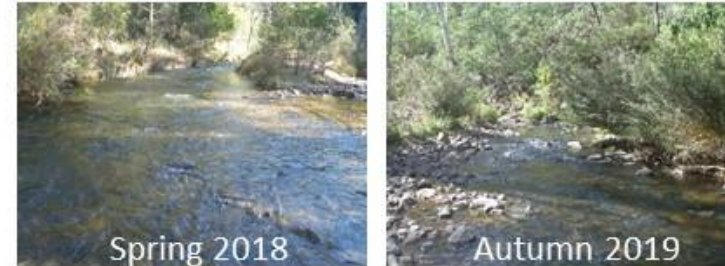
CM1 - Spring 2018 - Autumn 2019

Downstream of Corin Dam

Environmental flow ecological objective	Spring 2018	Autumn 2019	Objective met?
AUSRIVAS band A	Band B	Band B	No in both seasons
<20% filamentous algae cover in riffle habitat	<20%	<10%	Yes in both seasons

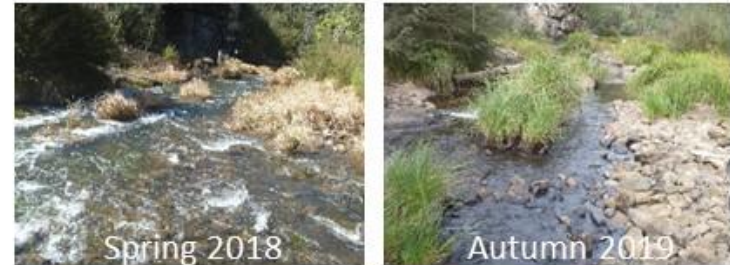
- Spring 2018
- Autumn 2019

Downstream of Bendora Dam

Environmental flow ecological objective	Spring 2018	Autumn 2019	Objective met?
AUSRIVAS band A	Band B	Band B	No in both seasons
<20% filamentous algae cover in riffle habitat	<10%	<10%	Yes in both seasons

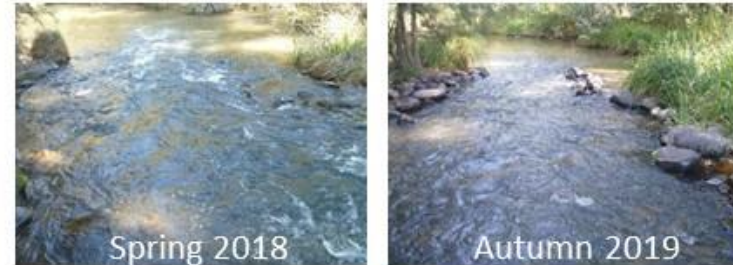
- Spring 2018
- Autumn 2019

Downstream of Cotter Dam

Environmental flow ecological objective	Spring 2018	Autumn 2019	Objective met?
AUSRIVAS band A	Band B	Band C	No in both seasons
<20% filamentous algae cover in riffle habitat	<20%	<10%	Yes in both seasons

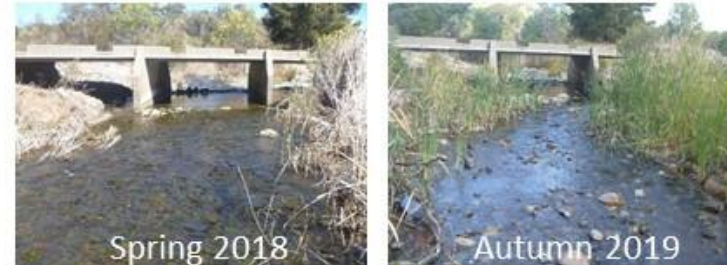
QM2 - Spring 2018 - Autumn 2019

Downstream of Googong Dam

Environmental flow ecological objective	Spring 2018	Autumn 2019	Objective met?
AUSRIVAS band A	Band A	Band C	Yes in spring 2018 but no in Autumn 2019
<20% filamentous algae cover in riffle habitat	>20%	<10%	No in spring 2018 but yes in Autumn 2019

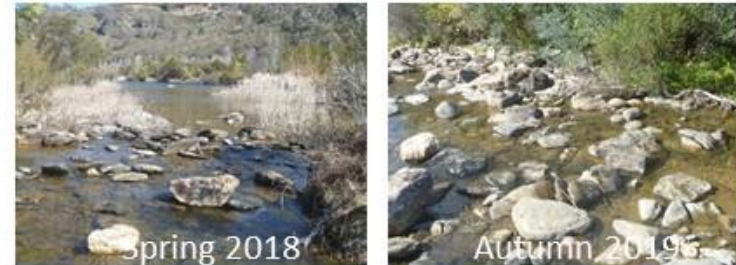
QM3 - Spring 2018 - Autumn 2019

2km Downstream of Googong Dam

Environmental flow ecological objective	Spring 2018	Autumn 2019	Objective met?
AUSRIVAS band A	Band A	Band B	Yes in spring 2018 but no in Autumn 2019
<20% filamentous algae cover in riffle habitat	<10%	<10%	Yes in both seasons

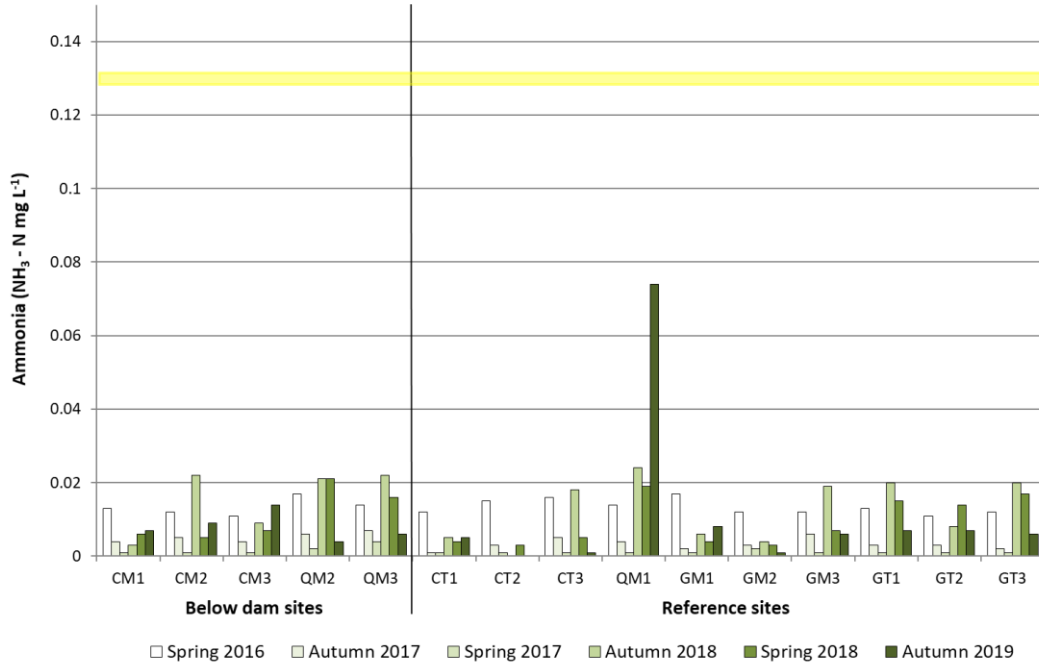
Ammonium (NH_4^+) concentration at all sites from **spring 2015 to autumn 2019**. Values below the minimum detectable limit of 0.002 mg L^{-1} are shown at 0.001 mg L^{-1} . The ANZECC/ARMCANZ (2000) guideline maximum concentration for ammonium (NH_4^+) is shaded yellow.

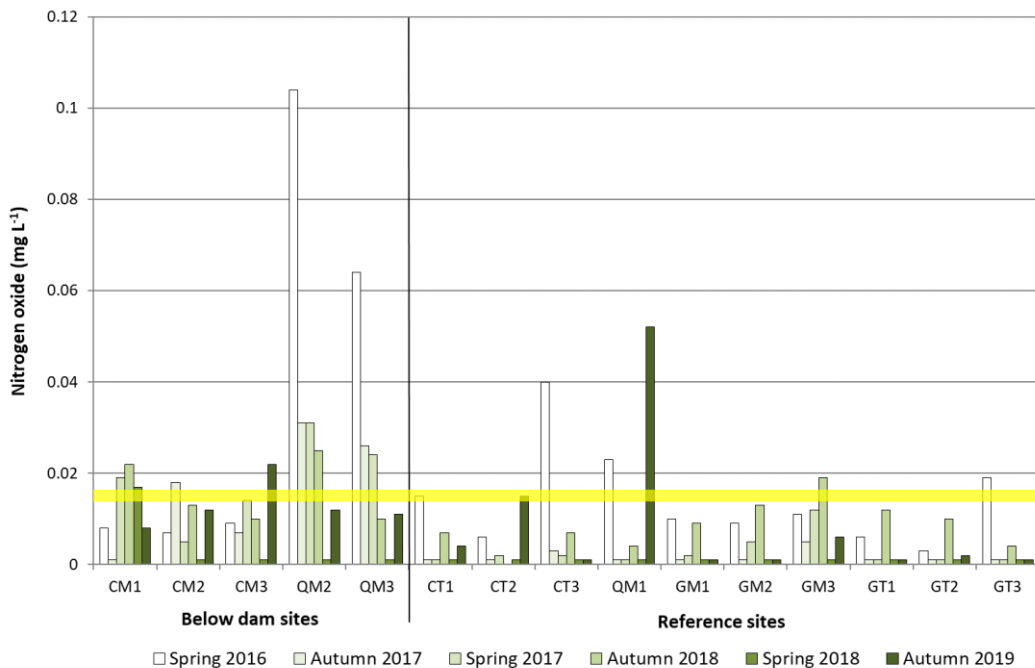
Nitrogen oxide concentrations at all sites from **spring 2016 to autumn 2019**. Values below the minimum detectable limit of 0.002 mg L^{-1} are shown at 0.001 mg L^{-1} . The ANZECC/ARMCANZ (2000) guideline maximum concentration for nitrogen oxide is shaded yellow.

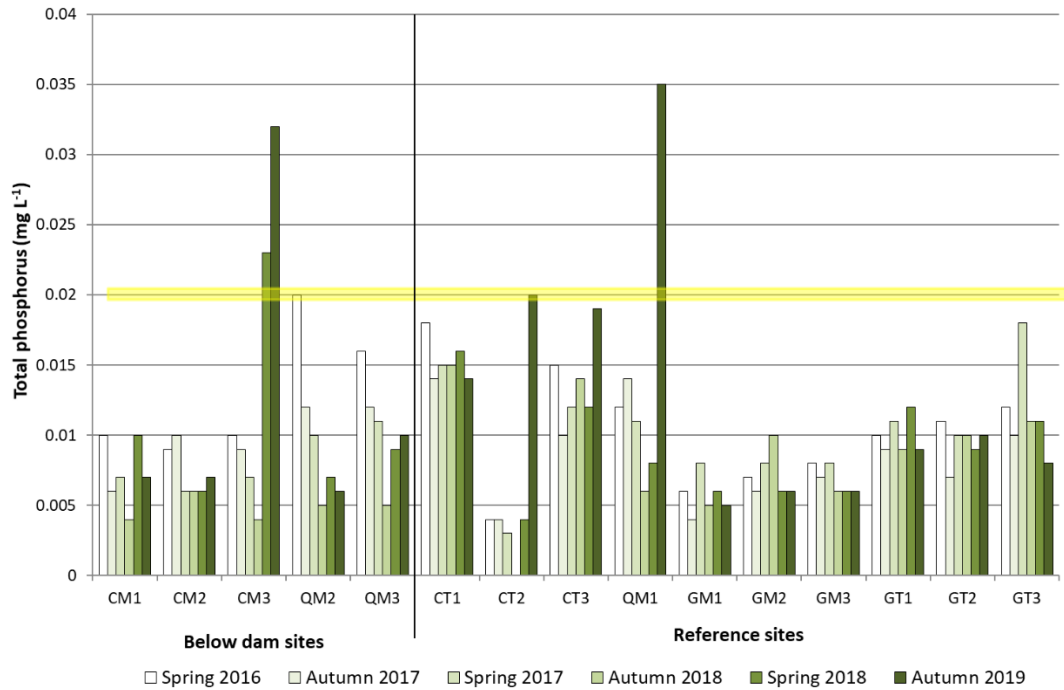
Total phosphorus concentrations at all sites from **spring 2016 to autumn 2019**. Values below the minimum detectable limit of 0.01 mg L⁻¹ are shown at 0.005 mg L⁻¹. The ANZECC/ARMCANZ (2000) guideline maximum concentration for total phosphorus is shaded yellow.

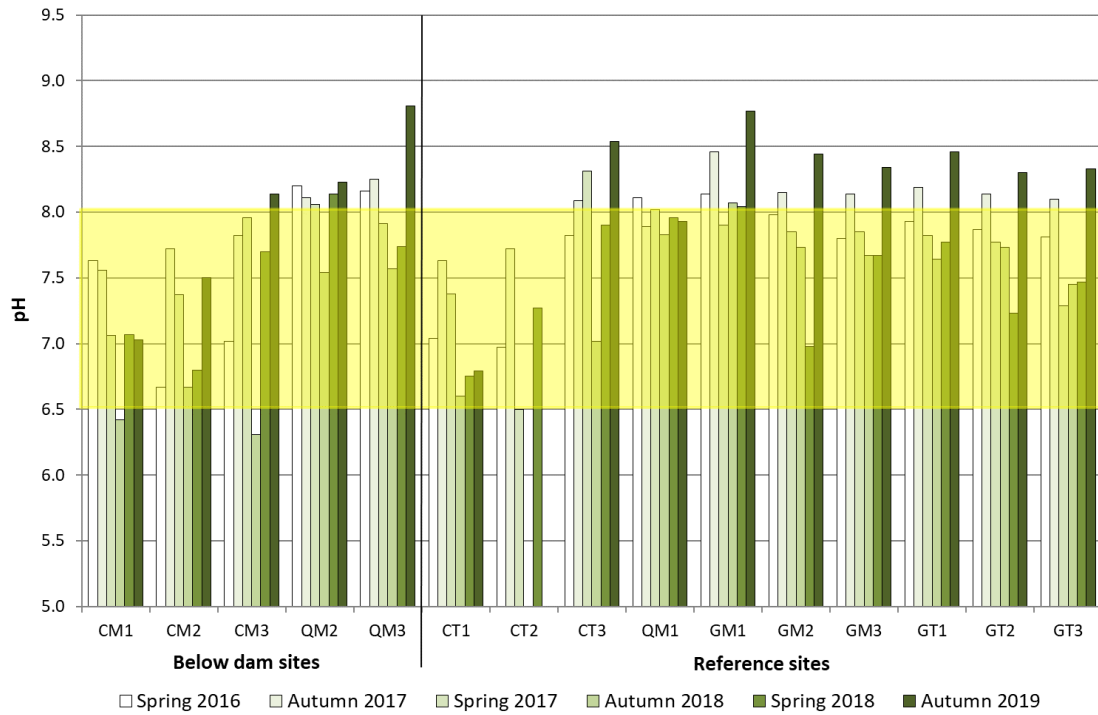
pH at all sites from **spring 2016 to autumn 2019**. The ANZECC/ARMCANZ (2000) guideline range for pH is shaded yellow.
