BIOLOGICAL RESPONSE TO FLOWS DOWNSTREAM OF CORIN, BENDORA, COTTER AND GOOGONG DAMS

Annual report July 2020
Report to Icon Water

Prepared for: Icon Water

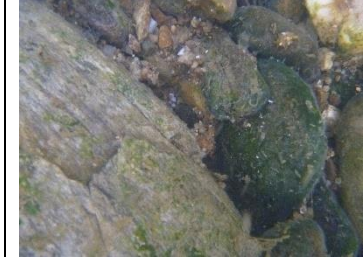
Site QM2

The below Googong Dam test site (QM2) was assessed as similar to reference (band A) in spring 2019 and severely impaired (band C) in autumn 2020 (Table 8). This continues a seasonal fluctuation that has occurred since spring 2018 (Table 8). The shift in condition between spring 2019 and autumn 2020 was largely driven by reduction in diversity and an increase in dominance of two taxa [Baetidae](#) and [Orthoclaadiinae](#), which accounted for approximately 65% of the total number of individuals identified (Appendix 2). The below Googong Dam test site (QM3) was assessed as band B (significantly impaired) in both spring 2019 and autumn 2020 (and the previous assessment autumn 2019) (Table 8). The O/E score at this site has remained very stable since autumn 2019 (0.76 – 0.77), which followed a period of drastic seasonal fluctuations of between 0.56 – 1.00 between assessments from spring 2016 – spring 2018 (Table 8). Taxa composition was relatively similar between spring 2019 and autumn 2020, though [Orthoclaadiinae](#) were much more dominant in spring 2019 (Appendix 2). The somewhat fluctuating biological condition of the test sites in the Queanbeyan River below Googong Dam contrast with the largely stable biological condition of the reference site (QM1) above Googong Dam, which has largely been assessed as similar to reference since spring 2016 (Table 8).

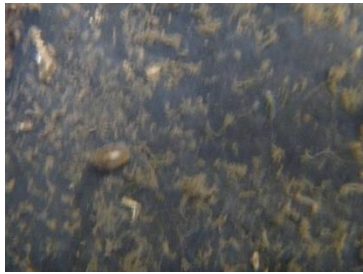
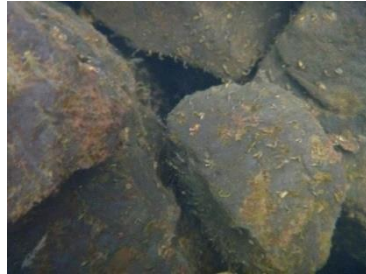
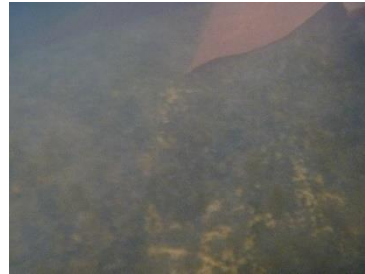
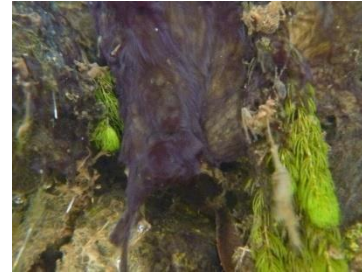
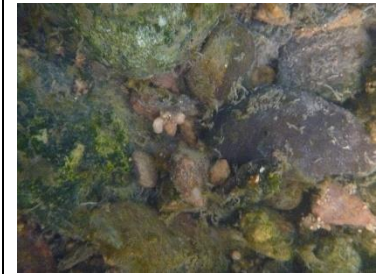
Figure 3. Filamentous algae and periphyton cover of riffle bed sediments at below dam test sites and corresponding reference sites on the Goodradigbee and Queanbeyan Rivers in **spring 2019**.

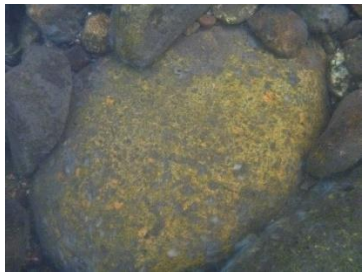
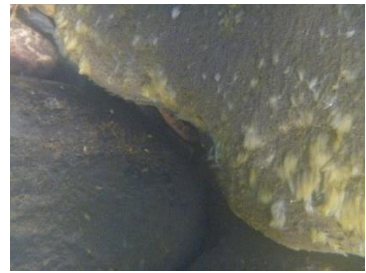
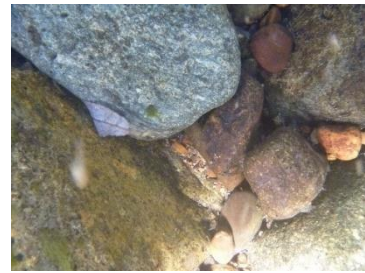
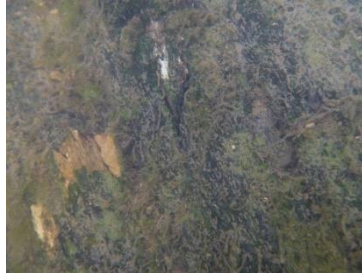
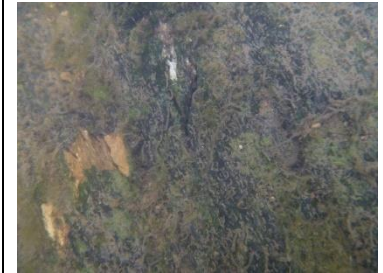
Figure 4: Filamentous algae and periphyton cover of riffle bed sediments at below dam test sites and corresponding reference sites on the Goodradigbee and Queanbeyan Rivers in autumn 2020.

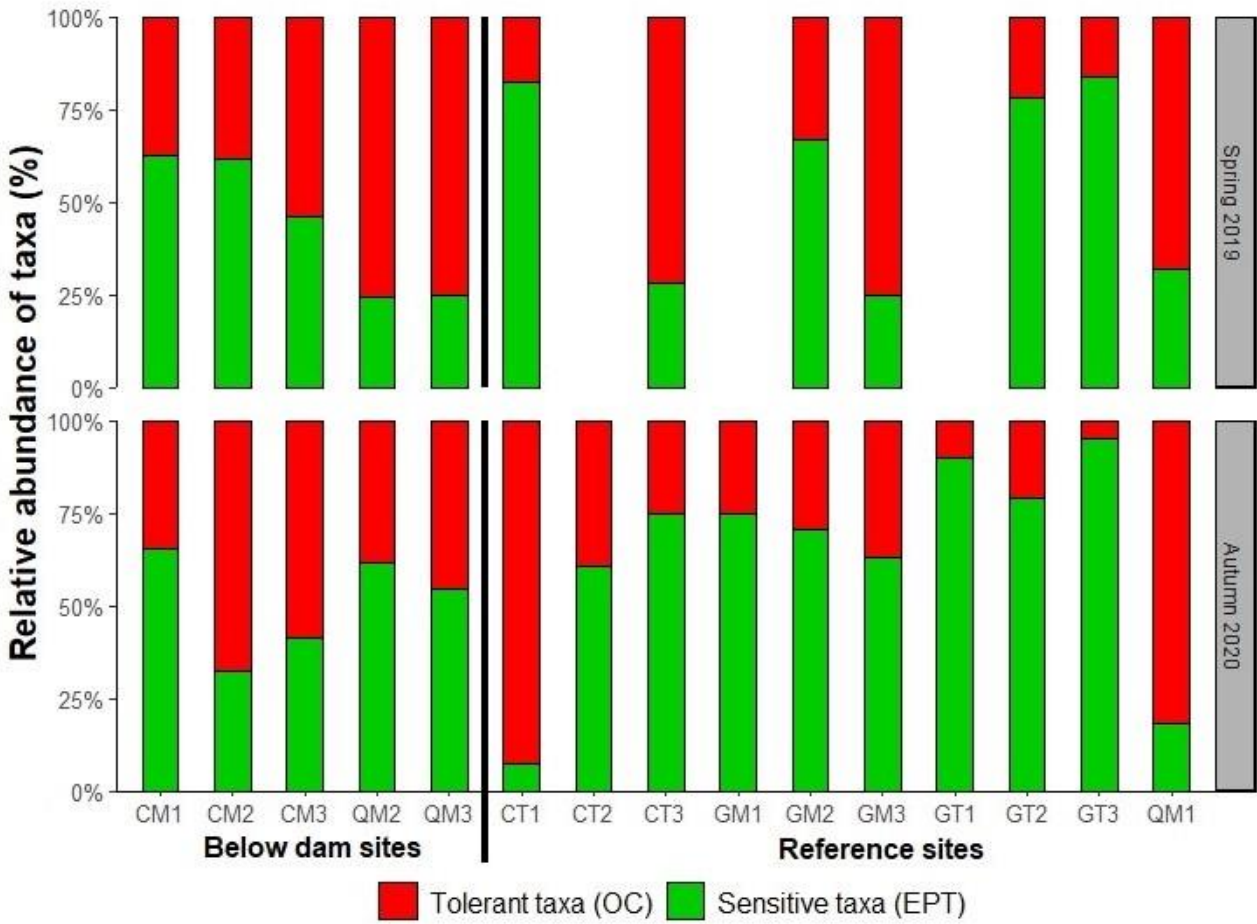
Figure 7. Relative abundance of environmentally tolerant (OC) taxa compared with environmentally sensitive (EPT) taxa from samples collected in **spring 2019 and Autumn 2020**. Note: Reference site CT2 (Burkes Creek) was not able to be sampled for macroinvertebrates in spring 2019 as the creek was too dry for standardised sampling methods. Reference sites GM1 and GT1 were not able to be sampled in spring 2019 due to road closure from a fallen tree.

The ratio of environmentally tolerant [Oligochaeta](#) and [Chironomidae](#) (OC) taxa to more sensitive [Ephemeroptera](#), [Plecoptera](#), and [Trichoptera](#) (EPT) taxa was variable across all sites (Figure 7, Figure 8, Figure 9) for both spring 2019 and autumn 2020 assessments. In spring 2019, tolerant OC taxa were dominant (> 50%) at below dam test sites below Cotter Dam (CM3) and below Googong Dam (QM2 and QM3) (Figure 7). In contrast, environmentally sensitive taxa (EPT) were dominant (>60%) in below dams test sites below Corin Dam (CM1) and below Bendora Dam (CM2) in spring 2019 (Figure 7). In autumn 2020, the site below Corin Dam (CM1) was again dominated by environmentally sensitive taxa, along with the two Queanbeyan River sites below Googong Dam (QM2 and QM3), whilst the other two sites on the Cotter River (CM2 and CM3) comprised macroinvertebrate communities dominated by tolerant taxa (primarily [Diptera](#) and [Chironomidae](#)) (Figure 7).

Generally, reference sites had a higher composition of environmentally sensitive taxa in autumn 2020 compared to spring 2019, with the exception of sites CT1 and QM1. The largest change in community was at the reference site on Kangaroo Creek (CT1), which went from being dominated by environmentally sensitive taxa in spring 2019 (~80%) to less than 10% environmentally tolerant taxa in autumn 2020, mainly driven by an increase in [Oligochaeta](#) and [Chironomidae](#) (Figure 7).

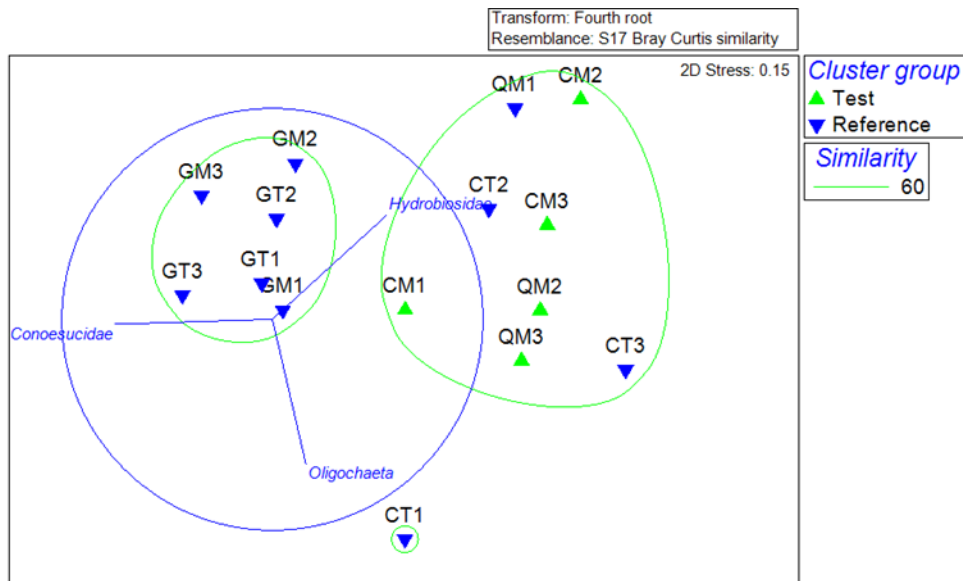
Figure 11. MDS ordination of 60% similarity between macroinvertebrate samples collected in **autumn 2020** for the below dams assessment program (green oval lines). Similarity is based on macroinvertebrate relative abundance. Macroinvertebrate taxa with Pearson correlations greater than 0.60 (i.e. taxa that discriminate between the groups of sites) are overlaid on the MDS ordination. The closer the blue line for each taxa is to the edge of the blue circle the greater the correlation.

In general macroinvertebrate assemblages at reference sites were similar to other reference sites both spring 2019 and autumn 2020 assessments (Figure 10 and Figure 11). Macroinvertebrate assemblages of test sites were varied for the spring 2019 assessment, however, test site assemblages were more similar to each other in the autumn 2020 assessment (Figure 10 and Figure 11). Differences in macroinvertebrate assemblage between test and reference sites were driven by higher abundances of [Elmidae](#), [Tanypodinae](#), [Conoesucidae](#) at reference sites in spring 2019 and higher abundances of [Conoesucidae](#) at reference sites in autumn 2020 (Figure 10 and Figure 11).

The macroinvertebrate assemblages of test sites below Corin Dam (CM1), below Bendora Dam (CM2) and downstream of Googong Dam (QM3) were dissimilar to all other sites in spring 2019 (Figure 10), driven by high abundances of [Gripopterygidae](#), [Simulidae](#) and [Orthocladiinae](#), respectively (Appendix 2). Reference site CT1 had a macroinvertebrate assemblage dissimilar to all other sites in autumn 2020, largely driven by an extremely high abundance of [Oligochaeta](#) (Figure 11 and Appendix 2).

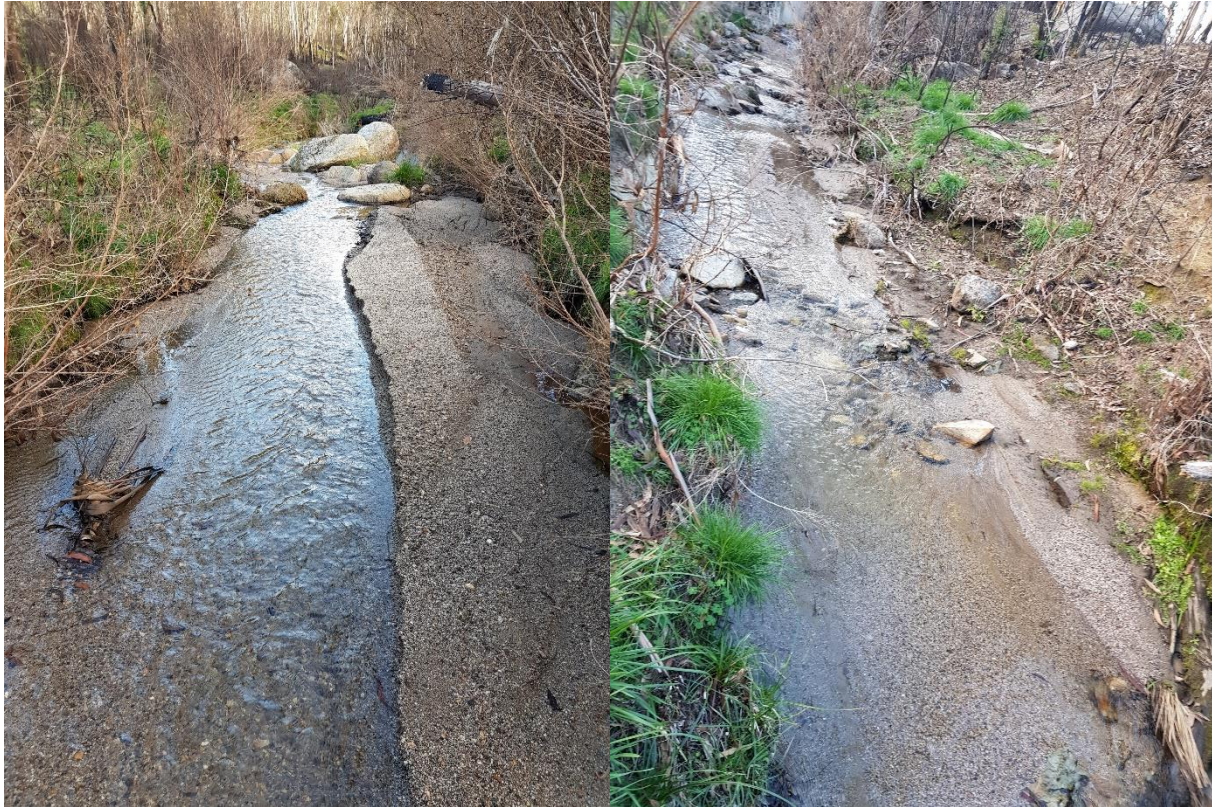
Figure 13. Sedimentation of Kangaroo Creek site (CT1) following January 2020 Bushfires (Photo: Ben Broadhurst).

The reference site at Kangaroo Creek undertook a significant change macroinvertebrate community assemblage between spring 2019 and autumn 2020. The macroinvertebrate assemblage at this site in spring 2019 was dominated by environmentally sensitive taxa (e.g. [Ephemeroptera](#), [Tricoptera](#) and [Plecoptera](#)) but changed to a community assemblage dominated by [Oligochaeta](#) and [Chironomidae](#). This was likely due to impacts of bushfire and resultant sedimentation from erosion from fires that burnt the catchment in early 2020 (Figure 13). Despite this significant disturbance event, the site remained in band A (similar to reference) in autumn 2020, which highlights the resilience of the macroinvertebrate community at this site.

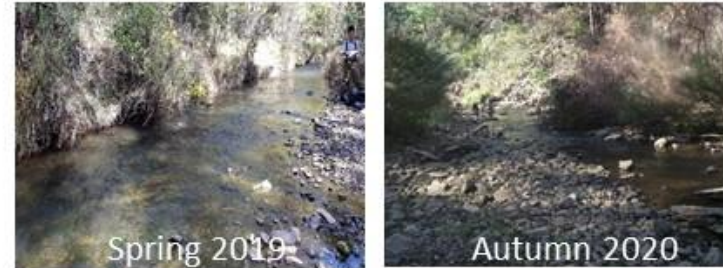
Downstream of Corin Dam

Environmental flow ecological objective	Spring 2019	Autumn 2020	Objective met?
AUSRIVAS band A	Band B	Band B	No in both seasons
<20% filamentous algae cover in riffle habitat	<30%	<10%	No - spring 2019 Yes - Autumn 2020

Cotter River test sites have varied in biological condition over the past eight assessments. Cotter River below Corin Dam (CM1) was assessed as significantly impaired (band B) in spring 2019 and autumn 2020 (Table 8). Test site CM1 remained in band B for the past eight assessments and has had a very stable O/E score of between 0.84 – 0.85 since spring 2018 (Table 8). The dominant taxa at this site for both spring 2019 and autumn 2020 was [Gripopterygidae](#) (Appendix 2). One taxa ([Hydrobiosidae](#)) which was predicted to have a ≥50% chance of occurrence by the AUSRIVAS model was detected in the whole sample scan (Table 9) but not in the subsample that was processed, suggesting that this taxon was present, but in low abundances at this site in autumn 2020.

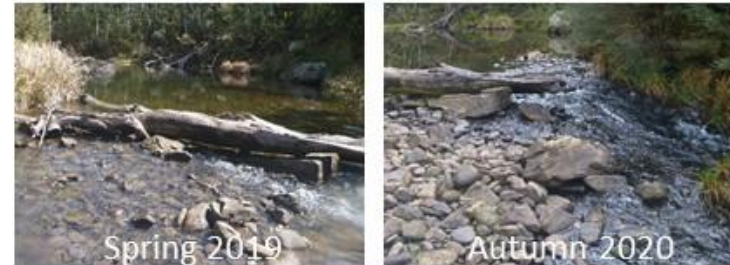
Downstream of Bendora Dam

Environmental flow ecological objective	Spring 2019	Autumn 2020	Objective met?
AUSRIVAS band A	Band B	Band B	No in both seasons
<20% filamentous algae cover in riffle habitat	<10%	<10%	Yes in both seasons

Condition of the Cotter River below Bendora Dam (CM2) was assessed as band B in both spring 2019 and autumn 2020 assessment. This site has remained in similar biological condition since autumn 2017, with some fluctuation in O/E score of between 0.67 – 0.86 (Table 8). The macroinvertebrate community at CM2 in spring 2019 was characterised by an extremely high abundance of [Simuliidae](#) and more so in autumn 2020 (Appendix 2).

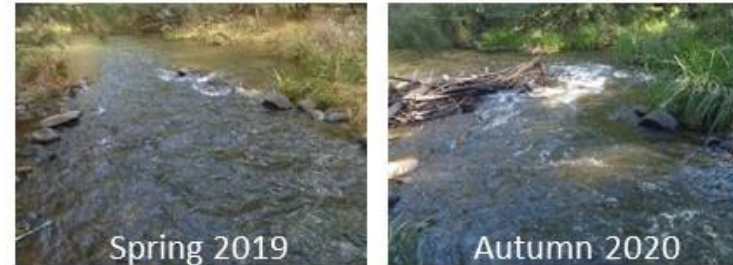
Downstream of Cotter Dam

Environmental flow ecological objective	Spring 2019	Autumn 2020	Objective met?
AUSRIVAS band A	Band A	Band A	Yes in both seasons
<20% filamentous algae cover in riffle habitat	<10%	<10%	Yes in both seasons

The condition of the Cotter River below Cotter Dam (CM3) was assessed as similar to reference (band A) in both spring 2019 and autumn 2020 assessments, an improvement from autumn 2019 (band C) and its previous assessments dating back to spring 2017 (band B) (Table 8). [Simuliidae](#) and [Orthoclaadiinae](#) were the dominant taxa in both the spring 2019 and autumn 2020, though other taxa such as [Gripopterygidae](#), [Oligochaeta](#) and [Caenidae](#) were also abundant (Appendix 2).

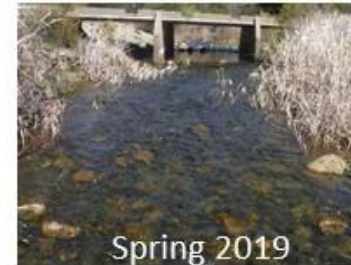
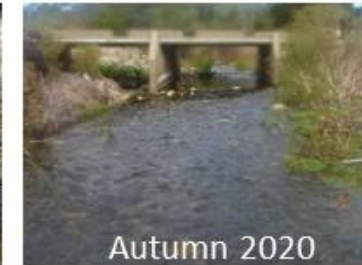
Downstream of Googong Dam

Environmental flow ecological objective	Spring 2019	Autumn 2020	Objective met?
AUSRIVAS band A	Band A	Band C	Yes - Spring 2018 No - Autumn 2019
<20% filamentous algae cover in riffle habitat	<10%	<10%	Yes in both the season

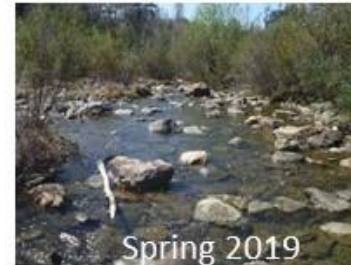
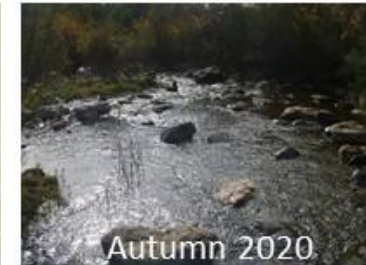
2km Downstream of Googong Dam

Environmental flow ecological objective	Spring 2019	Autumn 2020	Objective met?
AUSRIVAS band A	Band B	Band B	No in both the seasons
<20% filamentous algae cover in riffle habitat	<10%	<20%	Yes in both seasons

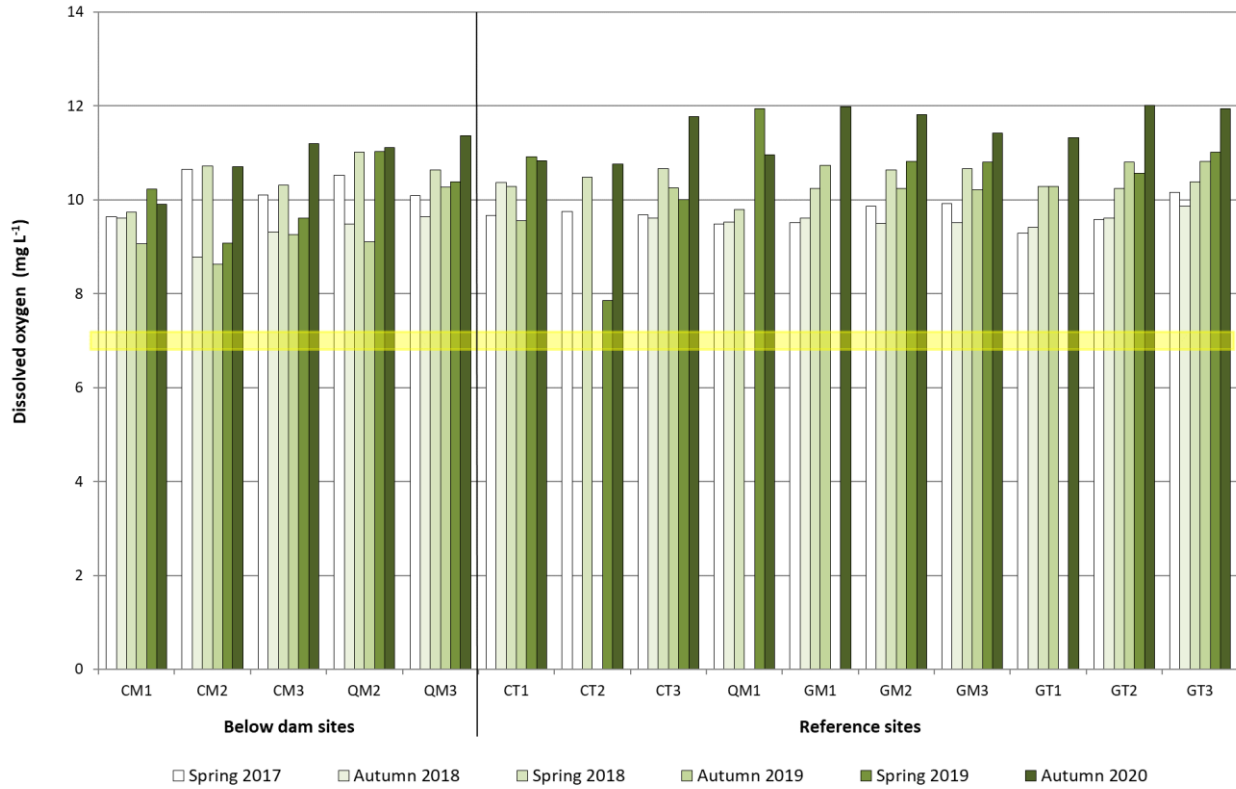
Dissolved oxygen concentration at all sites from **spring 2017 to autumn 2020**. The minimum guideline for dissolved oxygen is shaded yellow (Environment Protection Regulation SL2005-38).
