BIOLOGICAL RESPONSE TO FLOWS DOWNSTREAM OF CORIN, BENDORA, COTTER AND GOOGONG DAMS

Annual report July 2021
Report to Icon Water

Prepared for: Icon Water

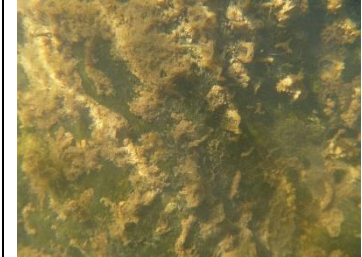
Site QM2

Figure 3. Filamentous algae and periphyton cover of riffle bed sediments at below dam test sites and corresponding reference sites on the Goodradigbee and Queanbeyan Rivers in spring 2020.

The environmental flow ecological objective of <20% cover of filamentous algae in riffle habitats was achieved at all below dams test sites in both assessments except for CM2 and in spring 2020 and QM2 in autumn 2021. Field observations of periphyton cover of riffle habitats were <20% in most of the sites, except for sites GM3, QM2 and CM2 in spring 2020 (Table 7; Figure 3 and Figure 4).

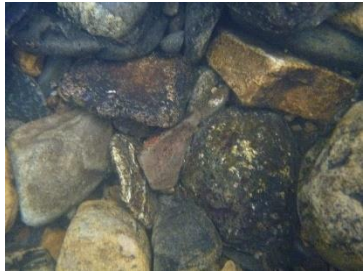
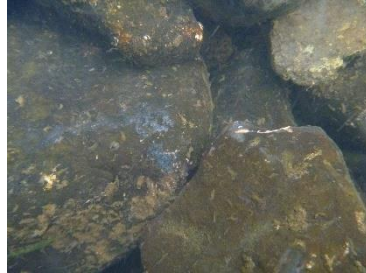
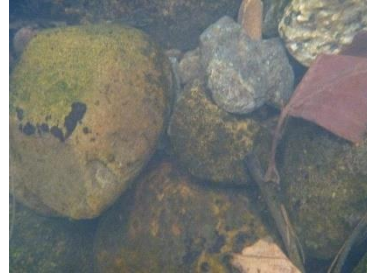
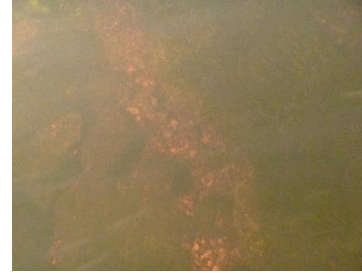
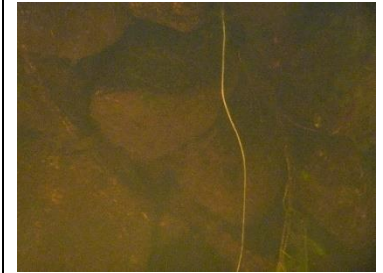
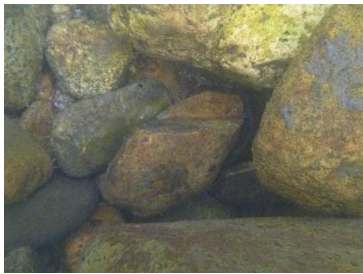
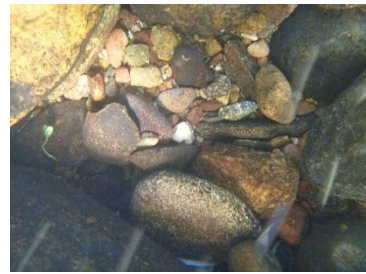
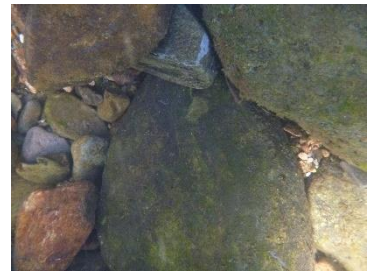
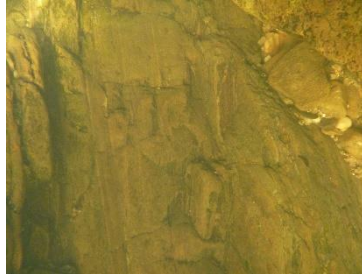
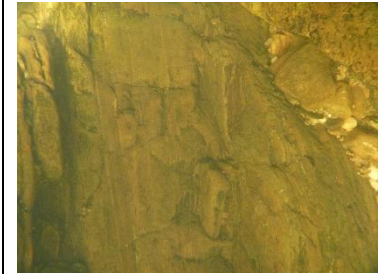
Figure 4: Filamentous algae and periphyton cover of riffle bed sediments at below dam test sites and corresponding reference sites on the Goodradigbee and Queanbeyan Rivers in autumn 2021.

- All test and reference sites met the environmental flow ecological objective of <20% cover of filamentous algae in riffle habitats, except for the test sites downstream of Bendora Dam (CM2) in spring 2020 and Googong Dam (GM2) in autumn 2021. [Click here for more information.](#)

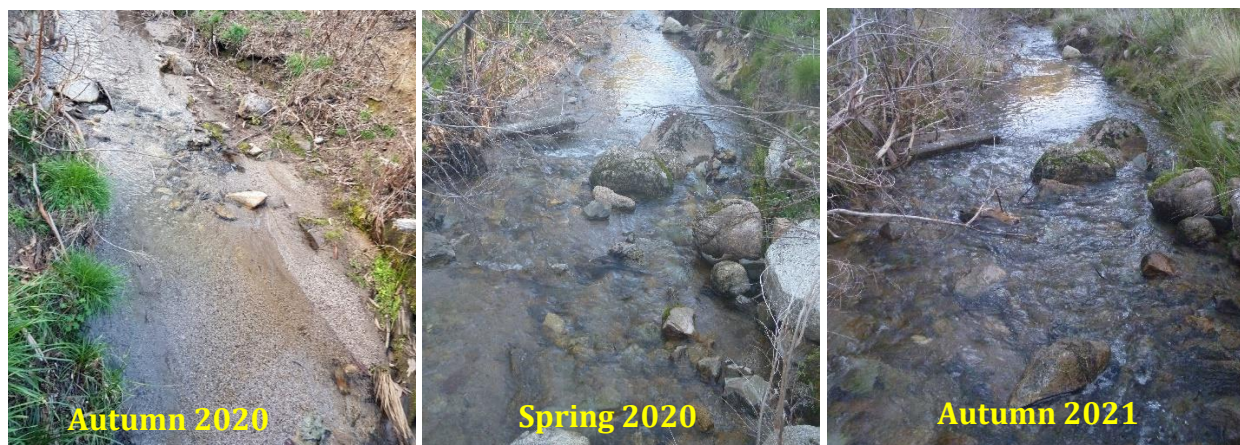
The reference site at Kangaroo Creek undertook a significant recovery of macroinvertebrate community assemblage between spring 2020 and autumn 2021. The macroinvertebrate assemblage at this site in spring 2020 was dominated by environmentally tolerant taxa ([Oligochaeta](#) and [Chironomidae](#)). However, the macroinvertebrate assemblage at this site in autumn 2021 was dominated by environmentally sensitive taxa (e.g. [Ephemeroptera](#), [Tricoptera](#) and [Plecoptera](#)). Despite the impacts of the bushfire and resultant sedimentation from erosion in early 2020, the site is gradually improving (Figure 12).

Figure 12. Condition of Kangaroo Creek site (CT1) following January 2020 Bushfires (Photo: Ben Broadhurst; Ugyen Lhendup).

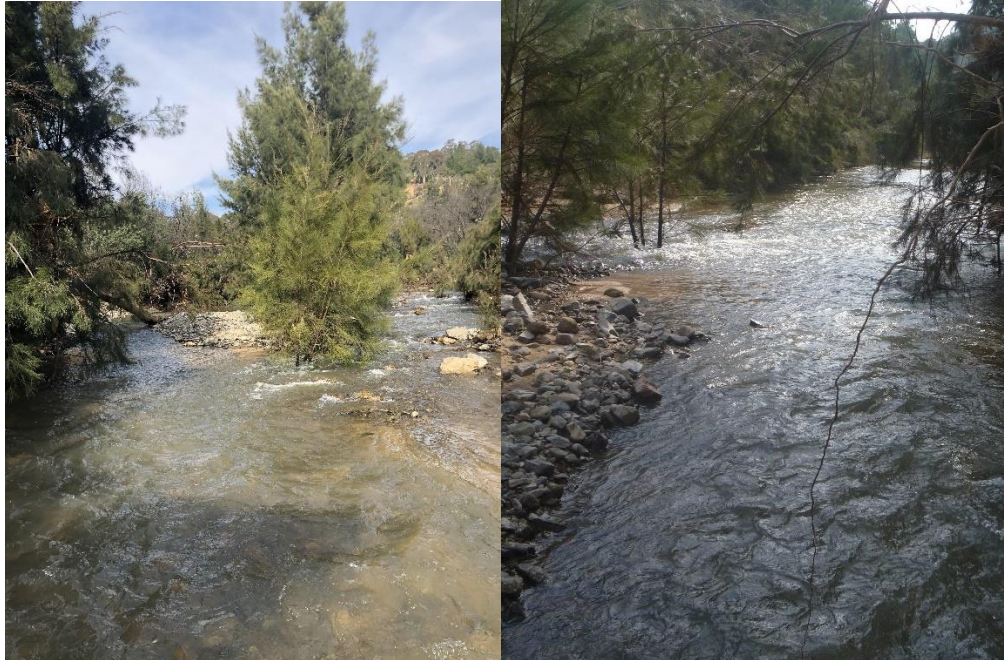
The reference site CT3 (Paddy's River) upstream of Cotter River Junction has significantly changed its condition in autumn 2021. The biological condition at this site was assessed as severely impaired (band C) from being assessed as significantly impaired (band B) in spring

2020. The site has been characterised by low abundance of macroinvertebrates and dominated by environmentally tolerant taxa ([Oligochaeta](#) and [Chironomidae](#)) (Table 8). It is likely the large flood event prior to sampling and higher turbidity (3-fold higher than guideline level) have driven the numerical dominance of tolerant taxa, and subsequently influenced the outcome of the AUSRIVAS assessment in autumn 2021 (Table 6; Figure 7; Figure 13).

Figure 13. Condition of Paddy's River site (CT3) following flood event prior the sampling in autumn 2021 (Photo: Ugyen Lhendup; Rhian Clear).

Turbidity at reference site CT3 (Paddy's River above Cotter River Junction) exceeded the guideline level of <10 NTU in autumn 2021 assessment. The higher level of turbidity is because of instream sedimentation caused by catchment land use (predominantly forestry, rural and large density of unsealed roads) and huge flood event which occurred prior to sampling in autumn 2021.

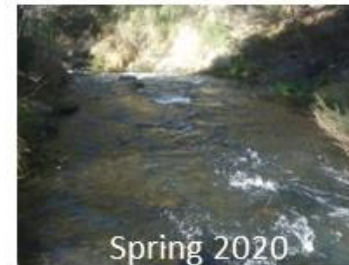
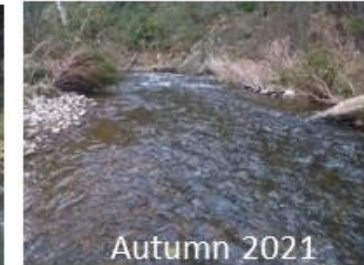
Downstream of Corin Dam

Environmental flow ecological objective	Spring 2020	Autumn 2021	Objective met?
AUSRIVAS band A	Band B	Band B	No in both seasons
<20% filamentous algae cover in riffle habitat	<30%	<10%	No - spring 2020 Yes - Autumn 2021

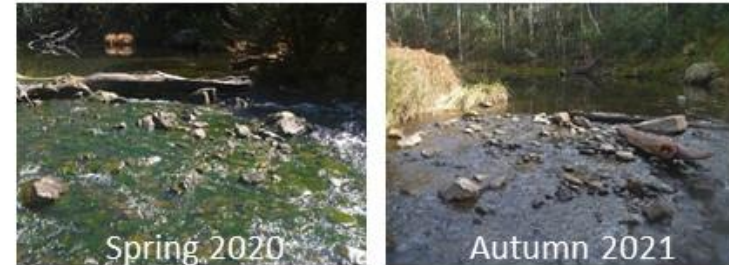
Downstream of Bendora Dam

Environmental flow ecological objective	Spring 2020	Autumn 2021	Objective met?
AUSRIVAS band A	Band B	Band A	No – Spr. 2020 Yes – Aut. 2021
<20% filamentous algae cover in riffle habitat	<10%	<10%	Yes in both seasons

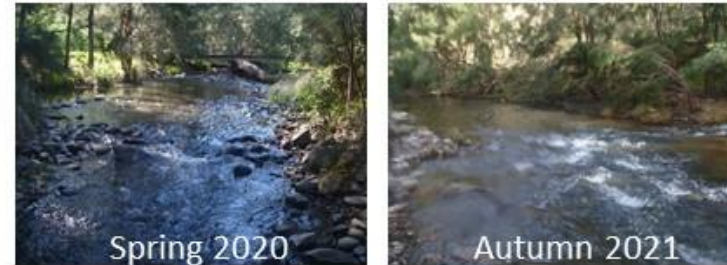
Downstream of Cotter Dam

Environmental flow ecological objective	Spring 2020	Autumn 2021	Objective met?
AUSRIVAS band A	Band B	Band B	No in both seasons
<20% filamentous algae cover in riffle habitat	<10%	<10%	Yes in both seasons

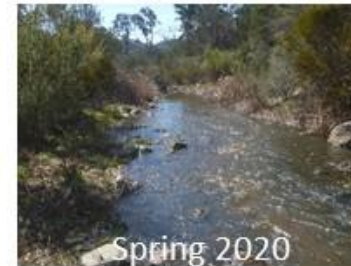
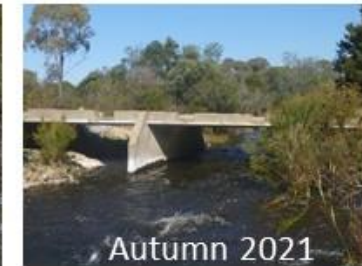
Downstream of Googong Dam

Environmental flow ecological objective	Spring 2020	Autumn 2021	Objective met?
AUSRIVAS band A	Band A	Band B	Yes - Spring 2020 No - Autumn 2021
<20% filamentous algae cover in riffle habitat	<10%	30%	Yes - Spr. 2020 No - Aut. 2021

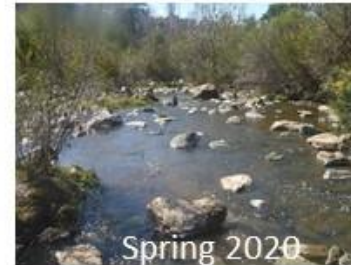
2km Downstream of Googong Dam

Environmental flow ecological objective	Spring 2020	Autumn 2021	Objective met?
AUSRIVAS band A	Band B	Band C	No in both seasons
<20% filamentous algae cover in riffle habitat	<10%	<10%	Yes in both seasons
