# BIOLOGICAL RESPONSE TO FLOWS DOWNSTREAM OF CORIN, BENDORA, COTTER AND GOOGONG DAMS

Annual report August 2022  
Report to Icon Water

**Prepared for:** Icon Water

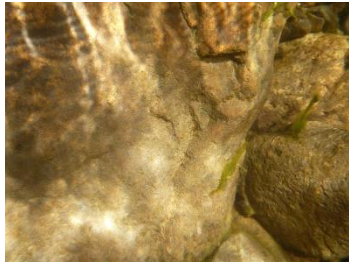
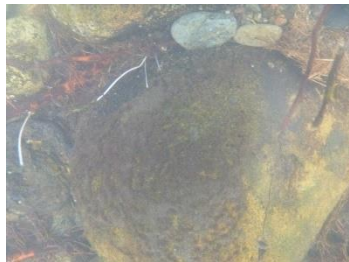
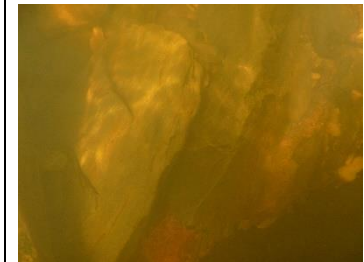
Figure 2. Filamentous algae and periphyton cover of riffle bed sediments at below dam test sites and corresponding reference sites on the Cotter, Goodradigbee and Queanbeyan Rivers in spring 2021.

- All test and reference sites met the environmental flow ecological objective of <20% cover of filamentous algae in riffle habitats, except for the test sites downstream of Bendora Dam (CM2) in spring 2021. [Click here for more information.](#)

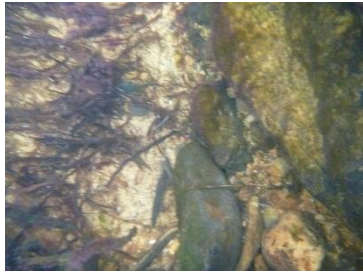
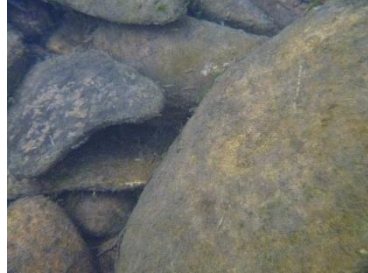
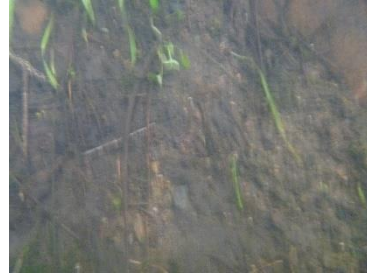
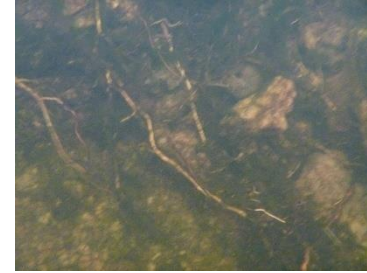
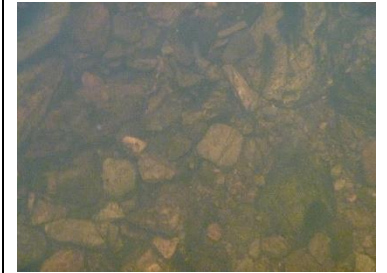
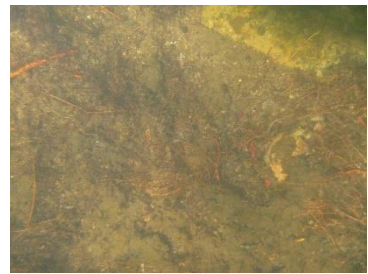
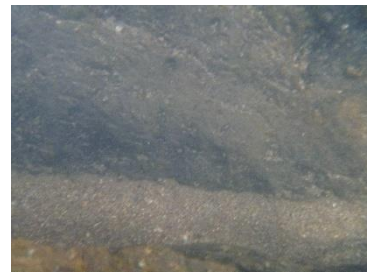
Figure 3: Filamentous algae and periphyton cover of riffle bed sediments at below dam test sites and corresponding reference sites on the Cotter, Goodradigbee and Queanbeyan Rivers in autumn 2022.

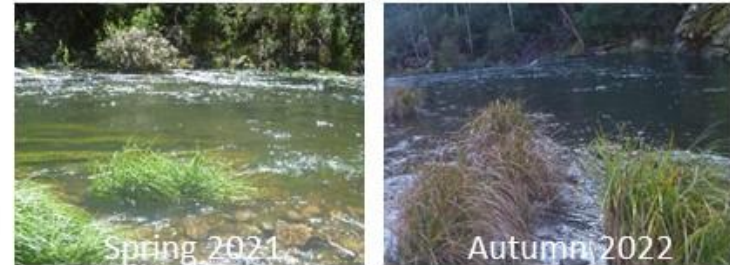
## Downstream of Bendora Dam

Environmental flow ecological objective	Spring 2021	Autumn 2022	Objective met?
AUSRIVAS band A	Not assessed	Not assessed	N/A
<20% filamentous algae cover in riffle habitat	30%	<10%	No in Spring 2021 and Yes in autumn 2022

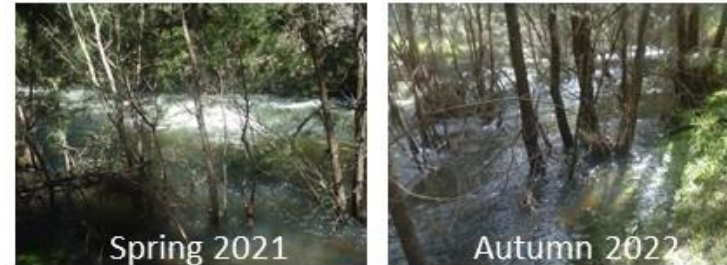
## Downstream of Cotter Dam

Environmental flow ecological objective	Spring 2021	Autumn 2022	Objective met?
AUSRIVAS band A	Not assessed	Not assessed	N/A
<20% filamentous algae cover in riffle habitat	<10%	<10%	Yes in both seasons

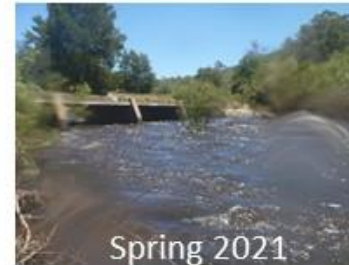
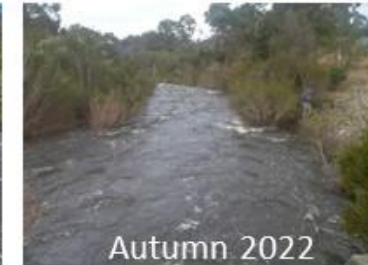
## Downstream of Googong Dam

Environmental flow ecological objective	Spring 2021	Autumn 2022	Objective met?
AUSRIVAS band A	Not assessed	Not assessed	N/A
<20% filamentous algae cover in riffle habitat	<10%	<10%	Yes in both seasons

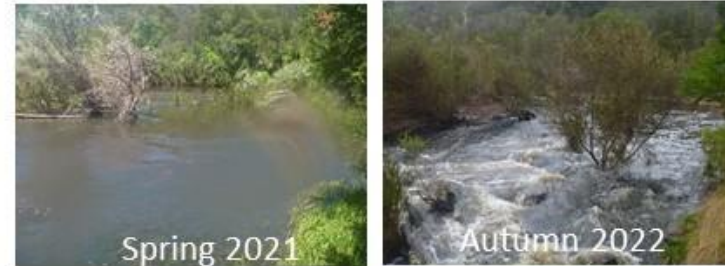
## 2km Downstream of Googong Dam

Environmental flow ecological objective	Spring 2021	Autumn 2022	Objective met?
AUSRIVAS band A	Not assessed	Not assessed	N/A
<20% filamentous algae cover in riffle habitat	<10%	<10%	Yes in both seasons

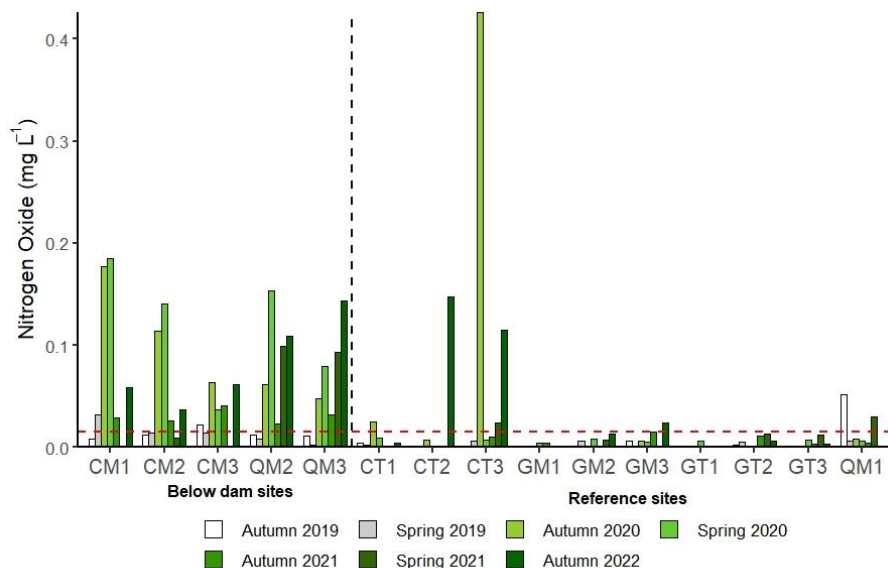
Nitrogen oxide concentrations at all sites from autumn 2019 to autumn 2022. Values below the minimum detectable limit of 0.002 mg L<sup>-1</sup> are shown at 0.001 mg L<sup>-1</sup>. The ANZECC/ARMCANZ (2000) guideline maximum concentration for nitrogen oxide is dashed line and shaded red.

Nitrogen oxides (NO<sub>x</sub>) had exceeded guideline level at the sites QM2 and QM3 and reference sites CT3 and QM1 in spring 2021 and all the test sites and reference sites CT2 and CT3 in autumn 2022. High Nitrogen levels and denitrification within the reservoir and flood events prior the sampling could be the cause of elevated NO<sub>x</sub> concentrations at sites directly below reservoirs and the high concentrations experienced in autumn 2022 are not likely related to the environmental flow regime (Saunders and Kalff 2001).

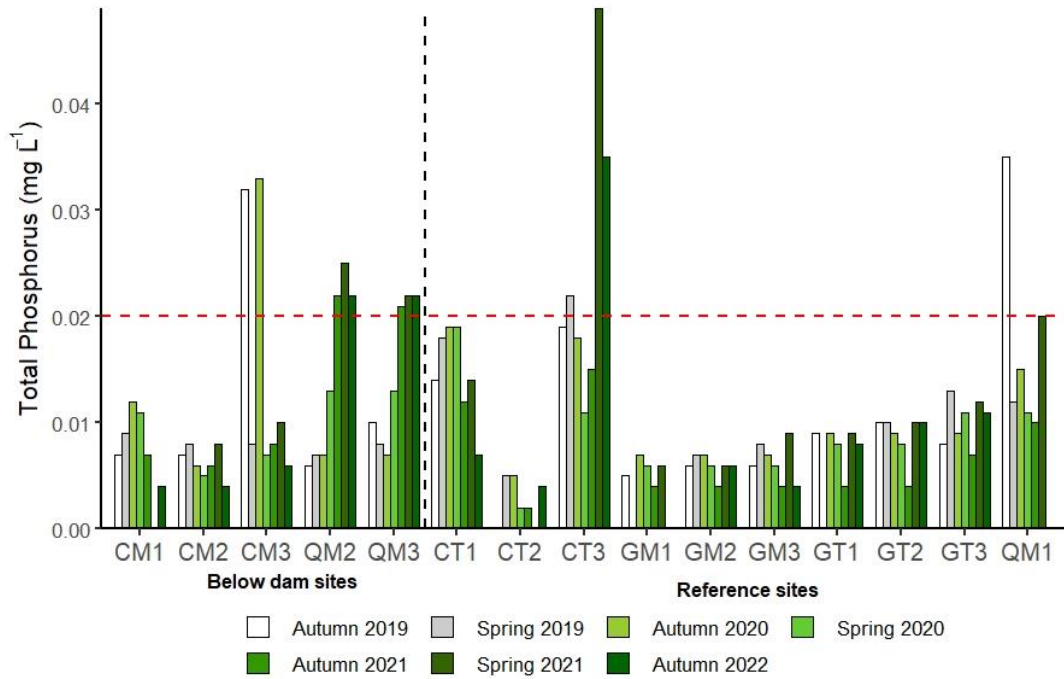
Total phosphorus concentrations at all sites from autumn 2019 to autumn 2022. Values below the minimum detectable limit of 0.01 mg L<sup>-1</sup> are shown at 0.005 mg L<sup>-1</sup>. The ANZECC/ARMCANZ (2000) guideline maximum concentration for total phosphorus is dashed line and shaded red.

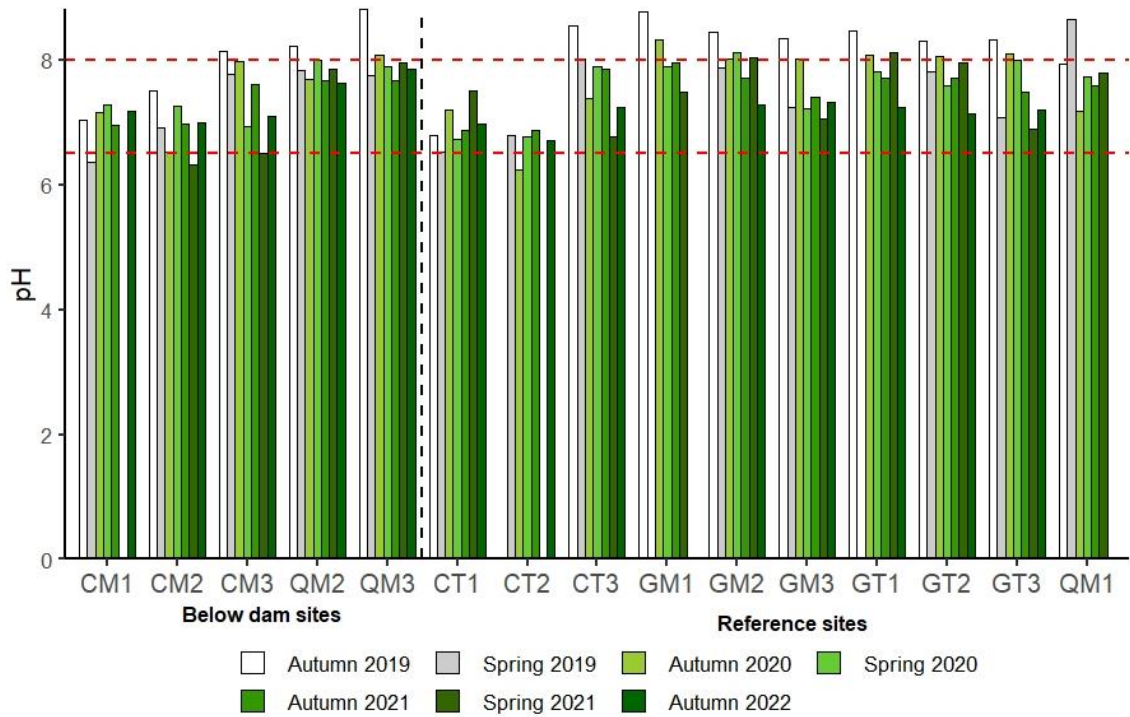
pH at all sites from autumn 2019 to autumn 2022. The ANZECC/ARMCANZ (2000) guideline range for pH are dashed lines and shaded red.

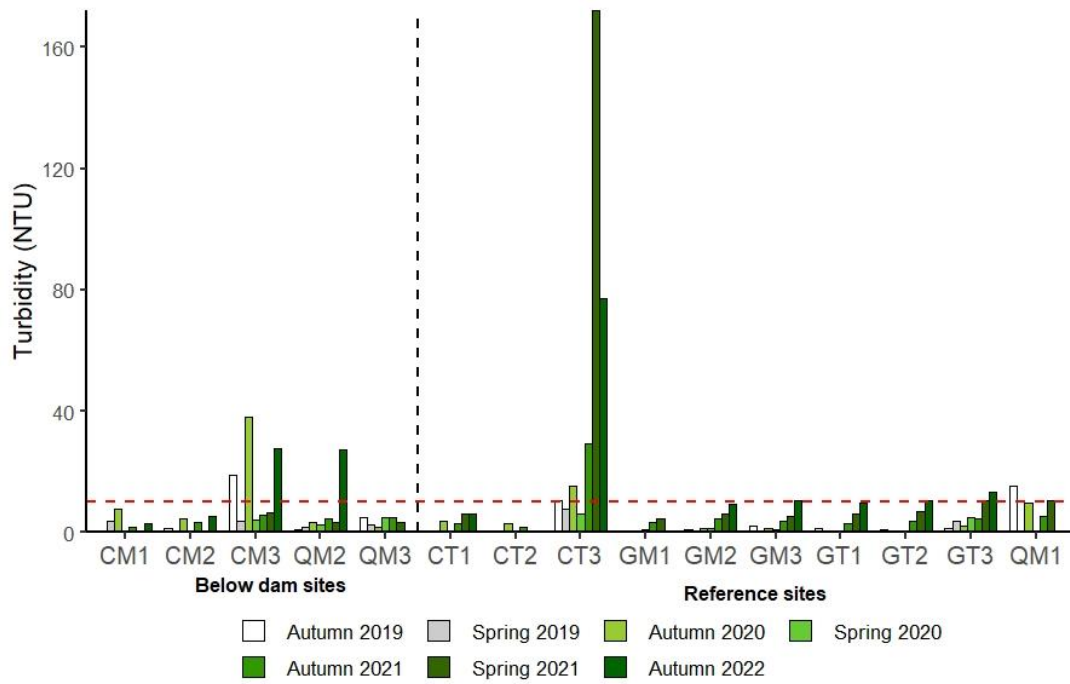
Turbidity at all sites from autumn 2019 to autumn 2022. The guideline for maximum turbidity is dashed line and shaded red (Environment Protection Regulation SL2005-38).

Turbidity at reference site CT3 (Paddy's River above Cotter River Junction) exceeded the guideline level of <10 NTU in both spring 2021 and autumn 2022 assessment. The higher level of turbidity is because of instream sedimentation caused by catchment land use (predominantly forestry, rural and large density of unsealed roads) and a large flood event which occurred prior to sampling.

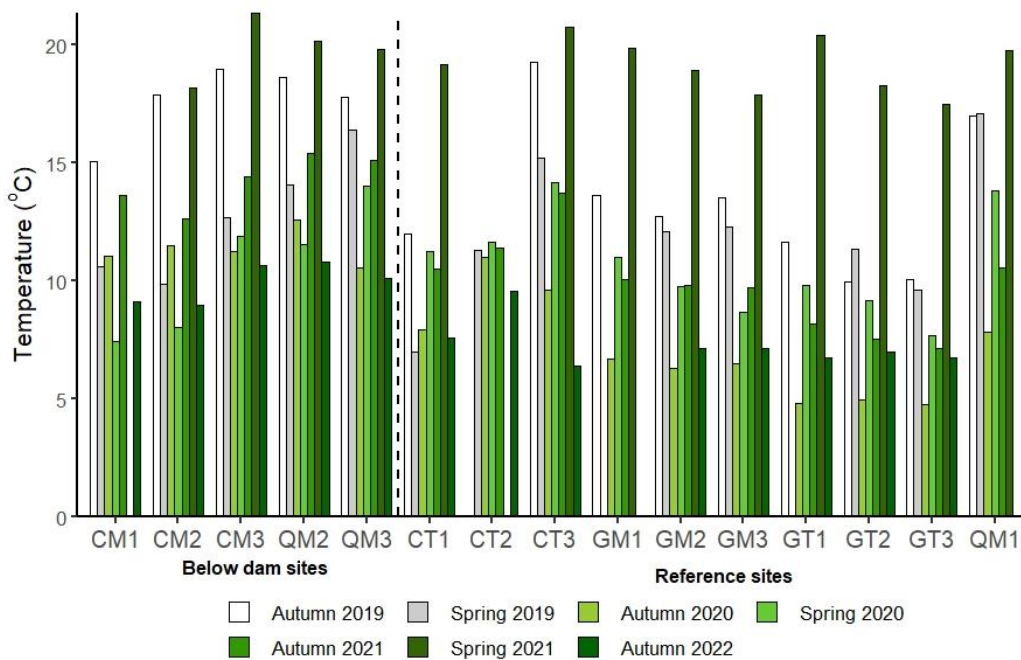
Water temperature at all sites from autumn 2019 to autumn 2022.
