# BIOLOGICAL RESPONSE TO FLOWS DOWNSTREAM OF CORIN, BENDORA, COTTER AND GOOGONG DAMS

Annual report August 2023  
Report to Icon Water

**Prepared for:** Icon Water

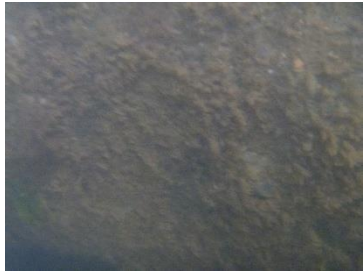
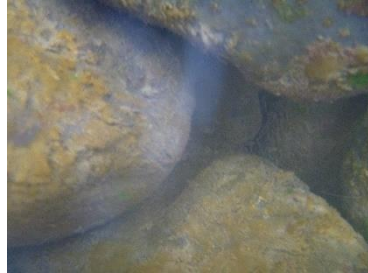
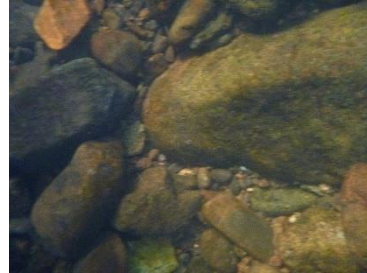
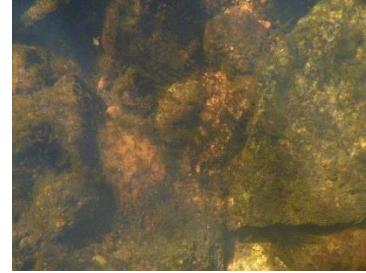
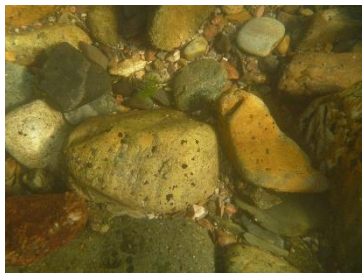
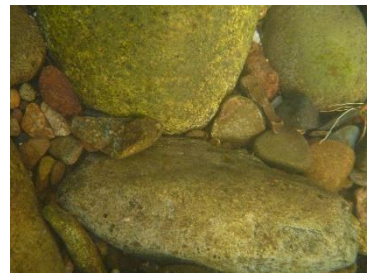
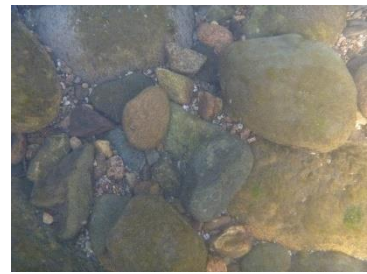
Figure 4: Filamentous algae and periphyton cover of riffle bed sediments at below dam test sites and corresponding reference sites on the Cotter, Goodradigbee and Queanbeyan Rivers in autumn 2023.

- In both sampling seasons, the ecological objective of maintaining a filamentous algae cover of less than 20% in riffle habitats was achieved at all test and reference sites. However, in spring 2022, the test sites downstream of Googong Dam (QM3) and in autumn 2023, test sites downstream of Corin Dam (CM1), downstream of Bendora Dam (CM2), and downstream of Googong Dam (QM2, and QM3) failed to meet the ecological objective of maintaining the periphyton cover below 20% in riffle habitats. [Click here for more information.](#)

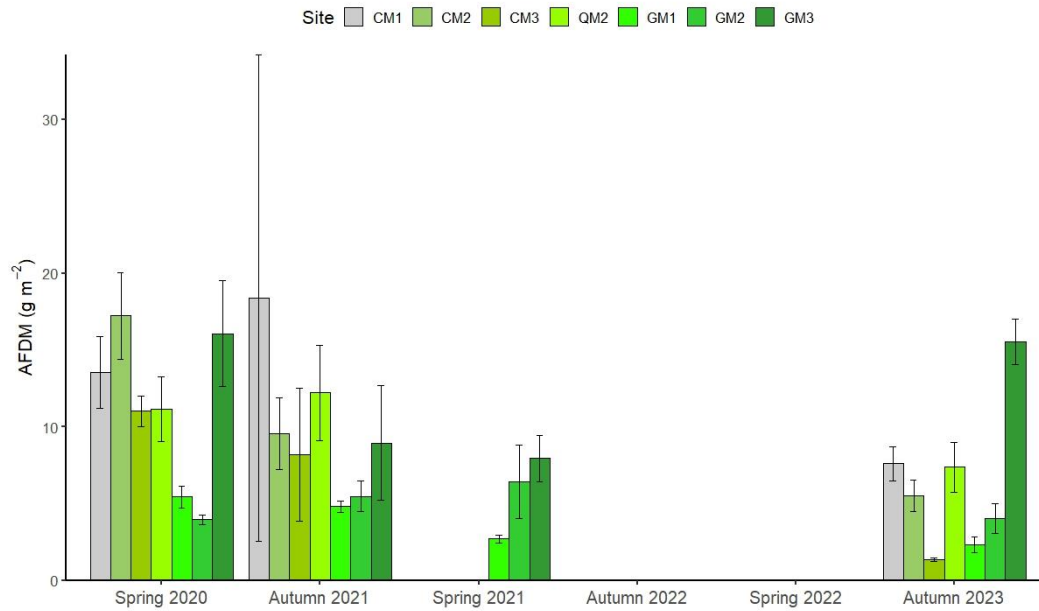
Figure 5: Mean AFDM (g m<sup>-2</sup>) at below dam test sites and reference sites on the Goodradigbee River from spring 2020 to autumn 2023. Error bars represent +/- 1 standard error. **NOTE:** AFDM samples were not collected in autumn 2022 and spring 2022 due to high flow during sampling period.

In the autumn 2023 assessment, there were differences in the mean ash-free dry mass (AFDM) concentrations observed among the sites ( $F_{6,35} = 18.77$ ,  $p = 0.001$ ). The mean AFDM concentration varied across the sites, with the reference site GM3 exhibiting significantly higher levels compared to the other sites. Specifically, the mean AFDM concentration at GM3 was 7.94  $\text{gm/m}^2$  higher than CM1 ( $p < 0.001$ ), 10.02  $\text{gm/m}^2$  higher than CM2 ( $p = 0.0000035$ ), 14.19  $\text{gm/m}^2$  higher than CM3 ( $p < 0.001$ ), 13.22  $\text{gm/m}^2$  higher than GM1 ( $p < 0.001$ ), 11.50  $\text{gm/m}^2$  higher than GM2 ( $p < 0.001$ ), and 8.18  $\text{gm/m}^2$  higher than QM ( $p < 0.001$ ), (Figure 5).

Concentration of AFDM at reference site (GM3 at Brindabella Valley above Brindabella Road Crossing) was significantly higher. The high concentration of AFDM suggests the potential for nutrient-rich sediments or biomass accumulation in the area due to natural factors such as decaying of plant materials (leaves and algae) and agricultural practices (grazing) in the Brindabella Valley.

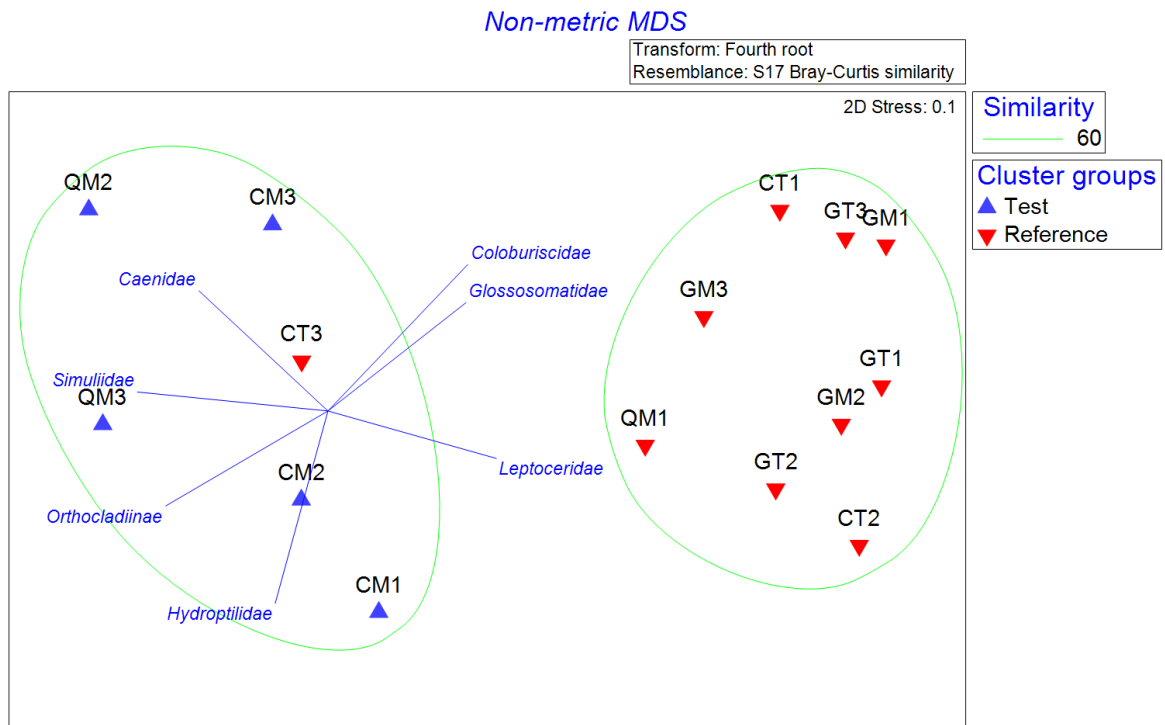
Figure 9. MDS ordination of 60% similarity between macroinvertebrate samples collected in autumn 2023 for the below dams assessment program (green oval lines). Similarity is based on macroinvertebrate relative abundance. Macroinvertebrate taxa with Pearson correlations greater than 0.60 (i.e. taxa that discriminate between the groups of sites) are overlaid on the MDS ordination. The closer the blue line for each taxa is to the edge of the blue circle the greater the correlation.

Macroinvertebrate communities of test sites were largely dissimilar to that of reference sites in autumn 2023 (Figure 9). Differences in macroinvertebrate assemblage between test and reference sites were driven by higher abundances of environmentally sensitive [Coloburiscidae](#), [Glossosomatidae](#) and [Leptoceridae](#) at reference sites and environmentally tolerant [Caenidae](#), [Simuliidae](#), [Orthocladiinae](#) and [Hydroptilidae](#) in test sites (Figure 9).

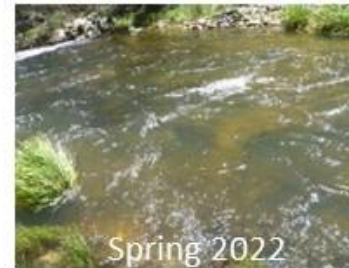
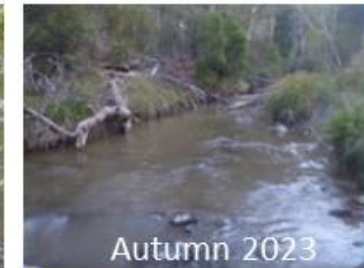
## Downstream of Corin Dam

Environmental flow ecological objective	Spring 2022	Autumn 2023	Objective met?
AUSRIVAS band A	Not assessed	Band B	Not in autumn 2023
<20% filamentous algae cover in riffle habitat	<10%	<10%	Yes in both seasons

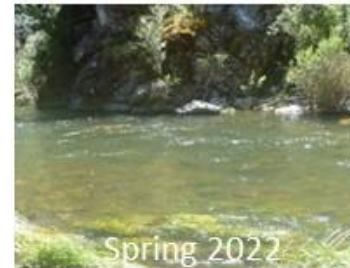
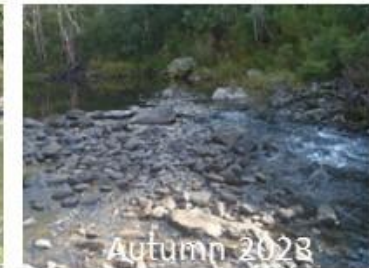
## Downstream of Bendora Dam

Environmental flow ecological objective	Spring 2022	Autumn 2023	Objective met?
AUSRIVAS band A	Not assessed	Band A	Yes in autumn 2023
<20% filamentous algae cover in riffle habitat	<10%	<10%	Yes in both seasons

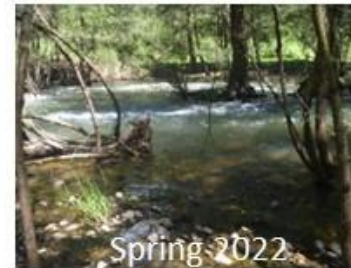
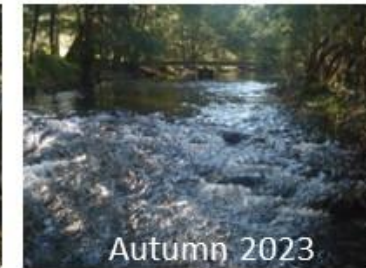
## Downstream of Cotter Dam

Environmental flow ecological objective	Spring 2022	Autumn 2023	Objective met?
AUSRIVAS band A	Not assessed	Band B	Not in autumn 2023
<20% filamentous algae cover in riffle habitat	<10%	<10%	Yes in both seasons

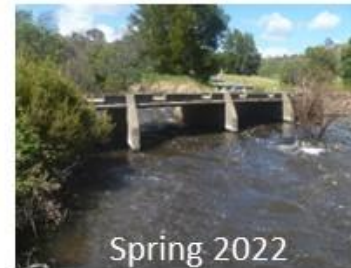
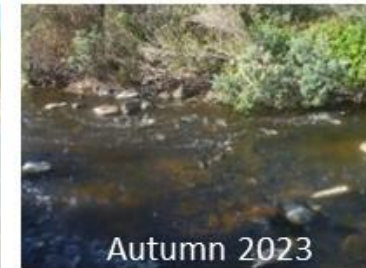
# QM2 - Spring 2022 - Autumn 2023

Environmental flow ecological objective	Spring 2022	Autumn 2023	Objective met?
AUSRIVAS band A	Not assessed	Band C	Not in autumn 2023
<20% filamentous algae cover in riffle habitat	<10%	<10%	Yes in both seasons

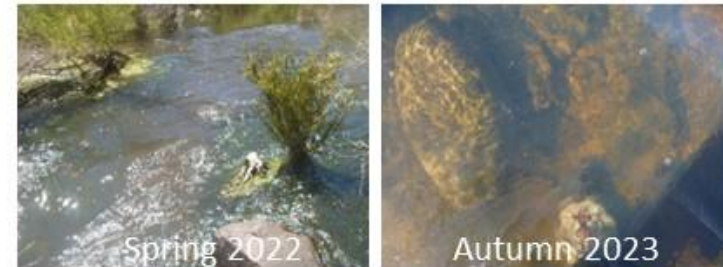
## 2km Downstream of Googong Dam

Environmental flow ecological objective	Spring 2022	Autumn 2023	Objective met?
AUSRIVAS band A	Not assessed	Band B	Not in autumn 2023
<20% filamentous algae cover in riffle habitat	<10%	<10%	Yes in both seasons

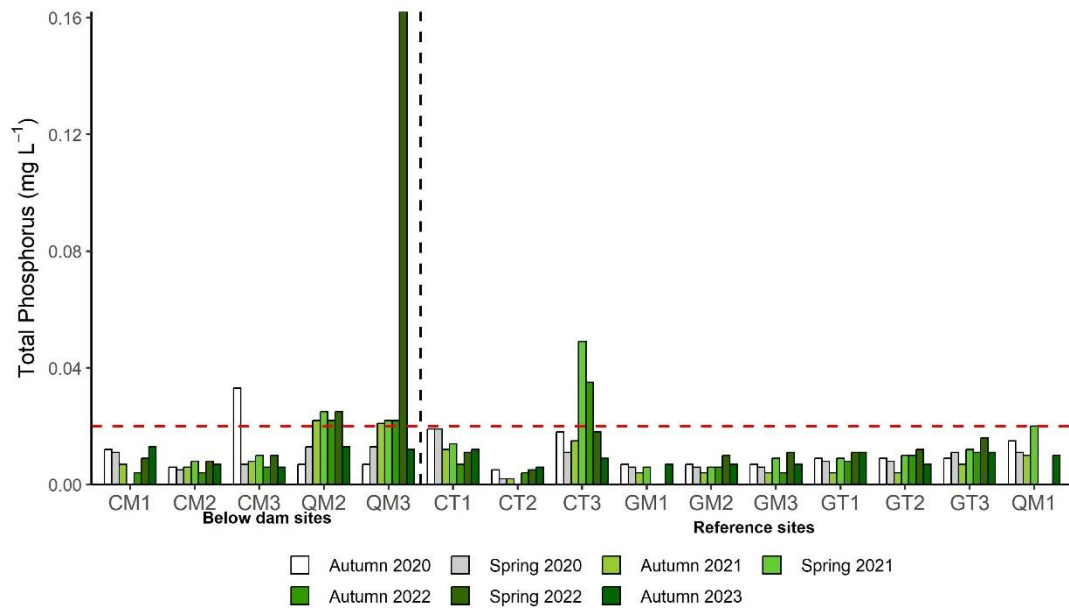
Total phosphorus concentrations at all sites from autumn 2020 to autumn 2023. Values below the minimum detectable limit of 0.01 mg L<sup>-1</sup> are shown at 0.005 mg L<sup>-1</sup>. The ANZECC/ARMCANZ (2000) guideline maximum concentration for total phosphorus is dashed line and shaded red.

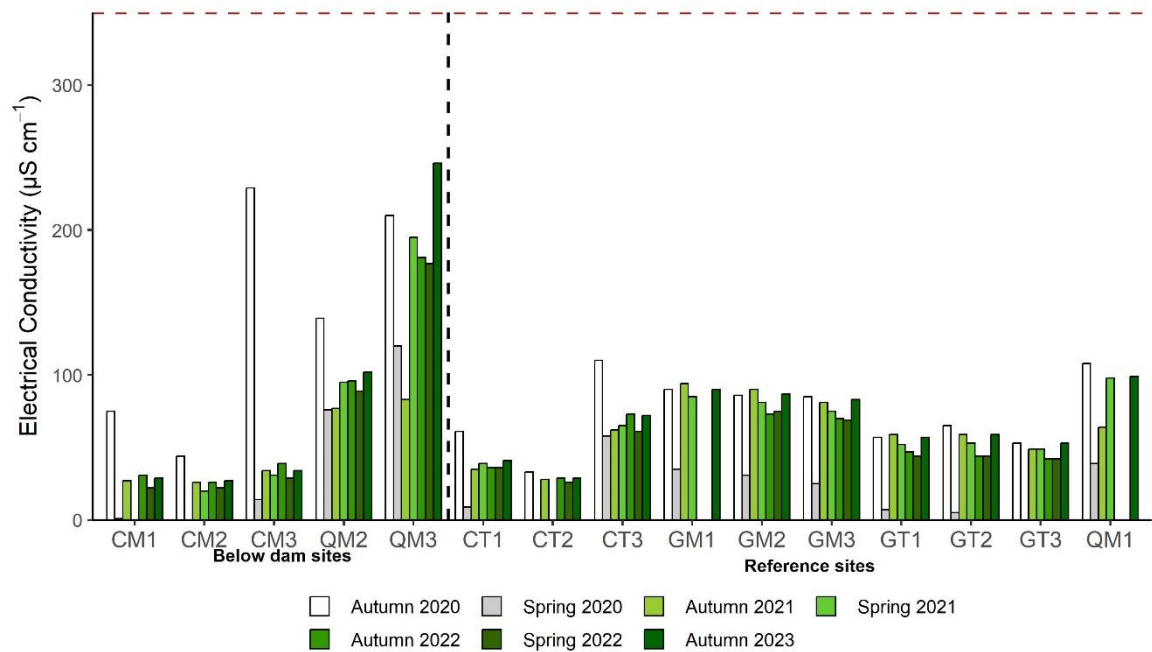
Electrical conductivity at all sites from autumn 2020 to autumn 2023. The ANZECC/ARMCANZ (2000) guideline for maximum electrical conductivity is dashed line and shaded red.

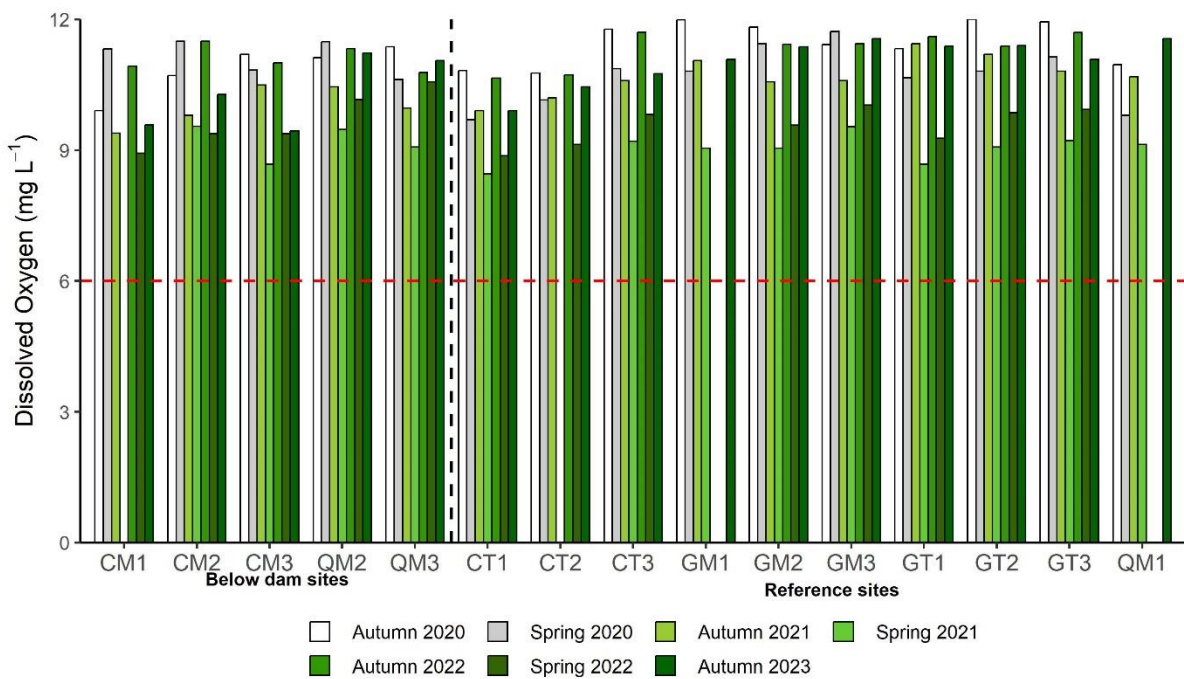
Dissolved oxygen concentration at all sites from autumn 2020 to autumn 2023. The minimum guideline for dissolved oxygen is dashed line and shaded red (Environment Protection Regulation SL2005-38).
