BIOLOGICAL RESPONSE TO FLOWS DOWNSTREAM OF CORIN, BENDORA, COTTER, AND GOOGONG DAMS

Autumn 2014

Prepared for ACTEW Water

ACTEW Water - Water Quality Monitoring Program

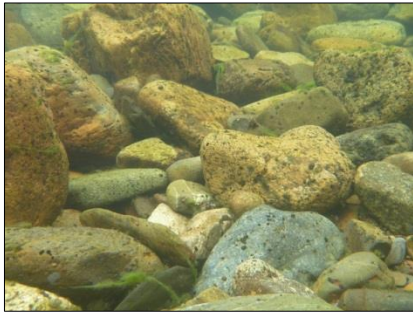
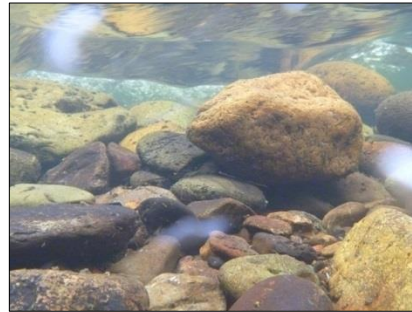
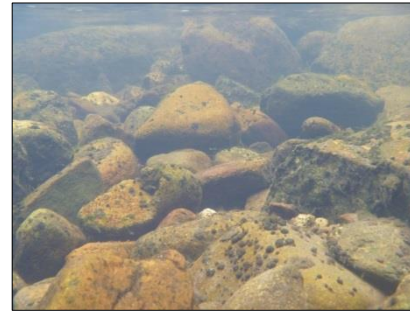
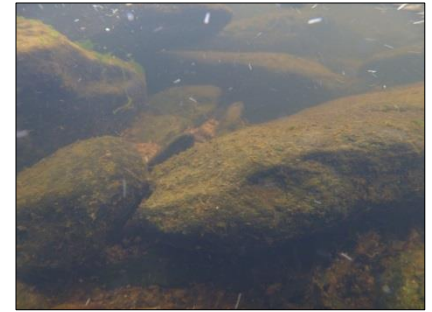
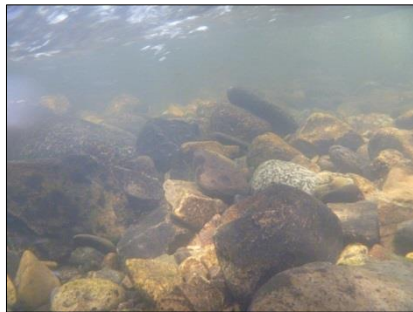
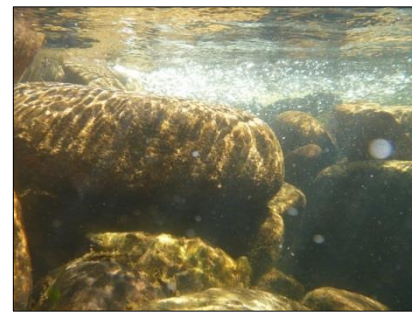
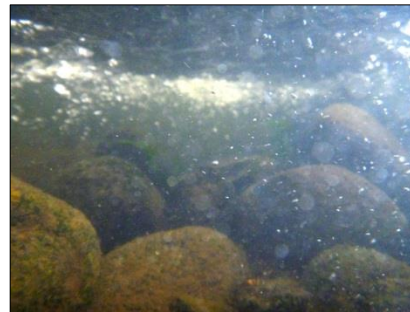
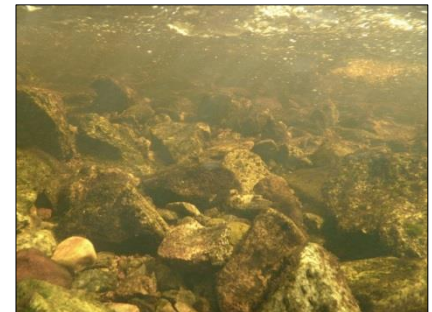
Figure 3. Filamentous algae cover of riffle bed sediments at below dam test sites and corresponding reference sites on the Goodradigbee and Queanbeyan Rivers in autumn 2014.

- All below dam test sites met the environmental flow ecological objective of <20% filamentous algae cover of riffle habitats. This is likely a result of high flow velocities below Corin and Googong Dams prior to sampling scouring excess algae from the streambed, and low phosphorus concentrations across all test sites limiting algae growth. [Click here for more information](#)

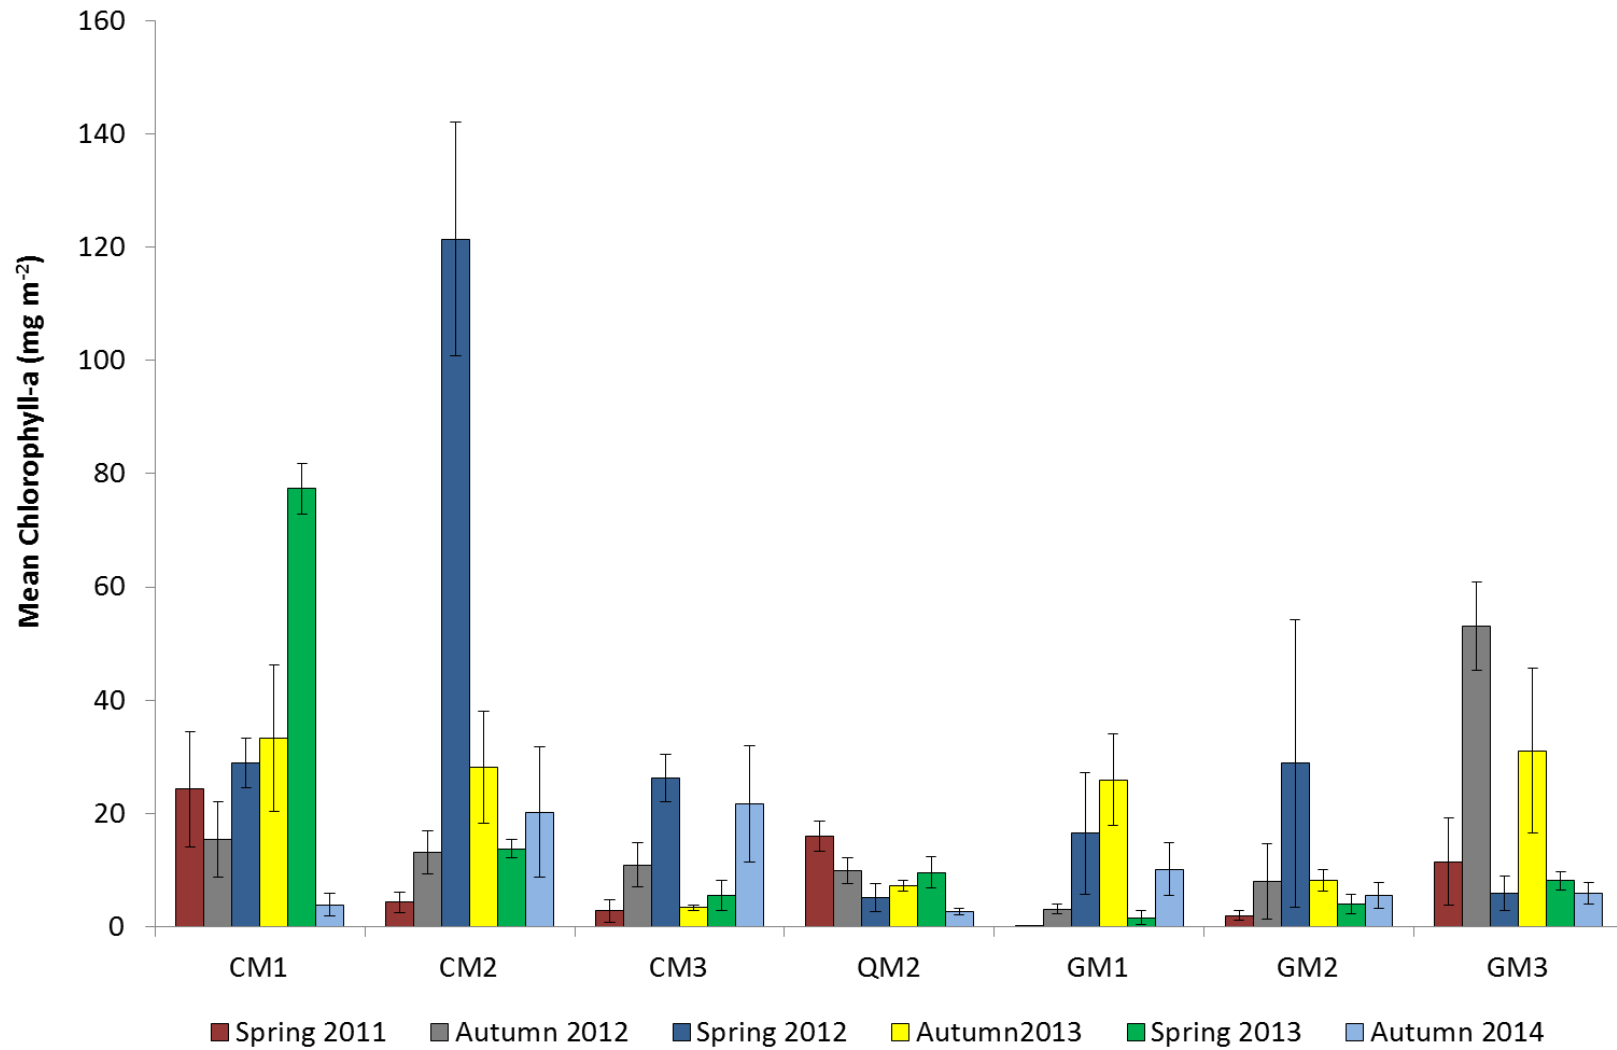
Figure 5: Mean chlorophyll-a ($\mu\text{g m}^{-2}$) at below dam test sites and reference sites on the Goodradigbee River from spring 2011 to autumn 2014. Error bars represent +/- 1 standard error.

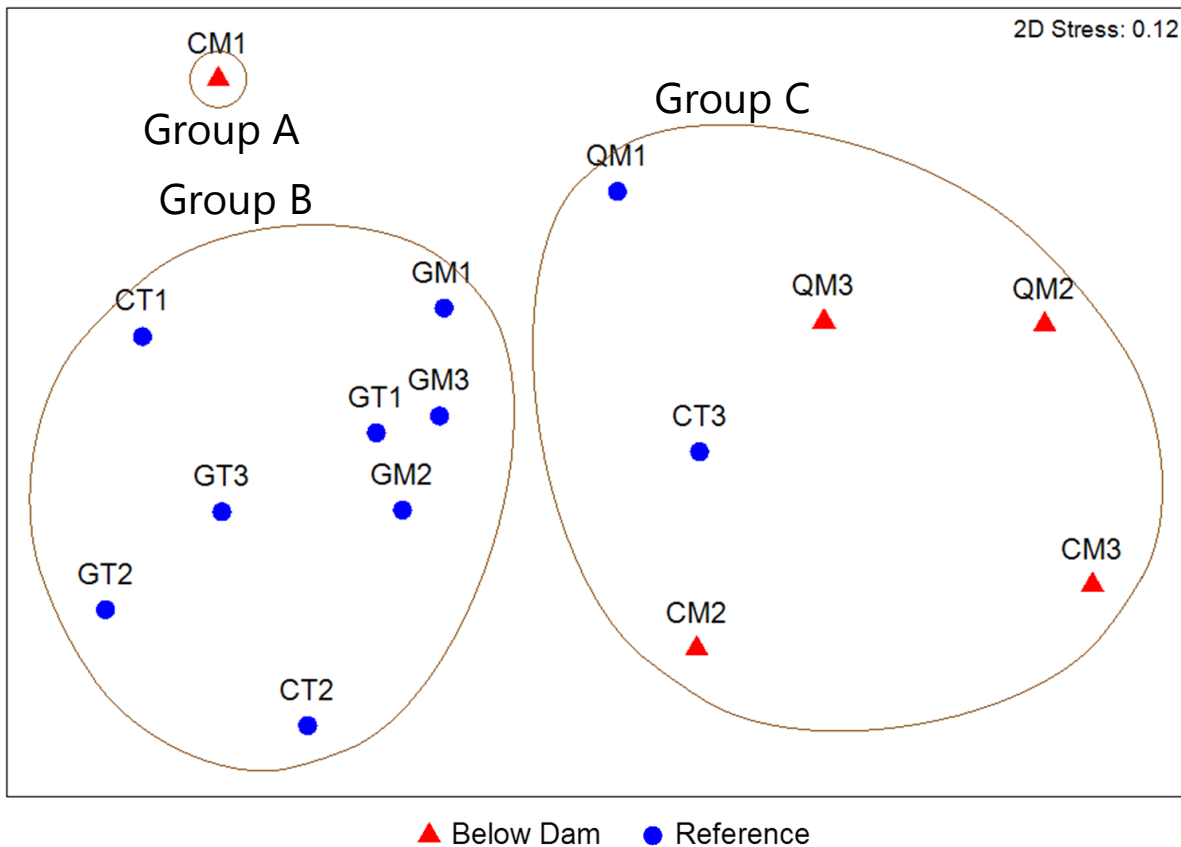
Figure 7. MDS ordination of 60% similarity between macroinvertebrate samples collected in autumn 2014 for the Below Dams Assessment Program. Similarity based on macroinvertebrate relative abundance.

Cluster analysis based on the relative abundance of macroinvertebrate taxa identified three groups of sites at 60% similarity (Figure 7). Site CM1 was not similar to any of the other sites and grouped separately as Group A. Group B comprised all of the Goodradigbee River reference sites, and all of the Cotter and Goodradigbee River tributary sites, except for site CT3. Sites in this group were characterised by relatively high abundances disturbance-sensitive and flow-favouring taxa such as Leptophlebiidae and Gripopterygidae compared to groups A and C (Appendix 2). Group C comprised below dam test sites (CM2, CM3, QM2, and QM3), and also the Queanbeyan River reference site QM1 and Cotter River tributary site CT3 (Figure 7). Compared to other groups, group C was defined by higher abundances of Simuliidae and other disturbance tolerant taxa such as Oligochaeta and Chironomidae (Appendix 2).

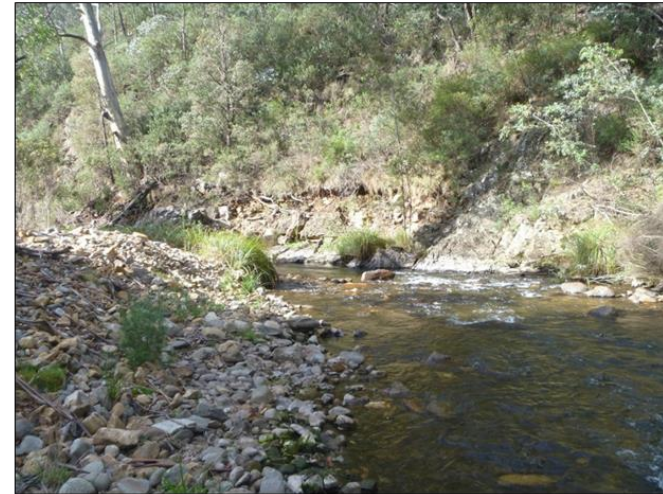
Downstream of Corin Dam

Environmental flow ecological objective	Spring 2013	Autumn 2014	Objective met?
AUSRIVAS band A	Band B	Band A	Yes
<20% filamentous algae cover in riffle habitat	<10%	<10%	Yes

Temp. (°C)	EC (µs cm ⁻¹)	pH	D.O. (mg l ⁻¹)	Turbidity (NTU)	Alkalinity (mg l ⁻¹)	NH ₃ -N (mg l ⁻¹)	NO _x (mg l ⁻¹)	TN (mg l ⁻¹)	TP (mg l ⁻¹)
16.3	32	6.7	9.8	1.1	6	0.009	0.01	0.19	0.009

Cotter River test site CM1 below Corin Dam was the only site with an improved biological condition in autumn 2014, and was assessed as similar to reference condition for the first time since the spring 2009 assessment (Table 7; Harrison et al 2011). An extended period of relatively high flow volume and variability in the months preceding autumn 2014 sampling is likely to have contributed to the improved biological condition at this site by reducing algal biomass and more favourable habitat and resource conditions for a variety of macroinvertebrates.

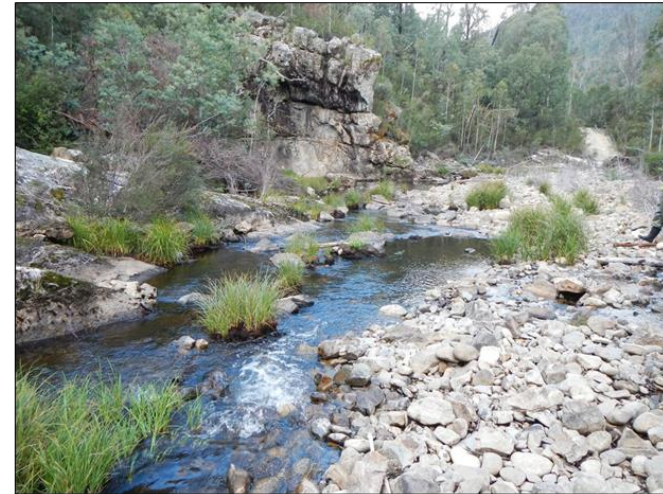
CM2 – Autumn 2014

Downstream of Bendora Dam

Environmental flow ecological objective	Spring 2013	Autumn 2014	Objective met?
AUSRIVAS band A	Band A	Band B	No
<20% filamentous algae cover in riffle habitat	<10%	<10%	Yes

Test sites CM2 below Bendora Dam and CM3 below Cotter Dam were both assessed as biologically impaired in autumn 2014 (Table 7) and therefore failed to meet the environmental flow ecological objective of AUSRIVAS band A. The macroinvertebrate assemblages at these sites differed from those of reference sites primarily because of a higher abundance of filter-feeding Simuliidae (Black Fly) and Hydropsychidae (Caddis Fly) larvae at the below dam sites. Such filter-feeding taxa are commonly found in greater abundance downstream of impoundments where fine particulate food sources are abundant and the downstream transport of coarser organic material has been interrupted (Ward and Stanford 1983).

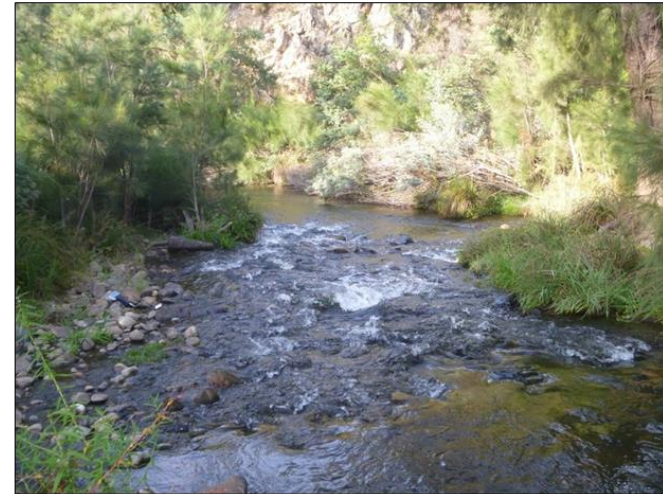
CM3 – Autumn 2014

Downstream of Cotter Dam

Environmental flow ecological objective	Spring 2013	Autumn 2014	Objective met?
AUSRIVAS band A	Band A	Band B	No
<20% filamentous algae cover in riffle habitat	<10%	<10%	Yes

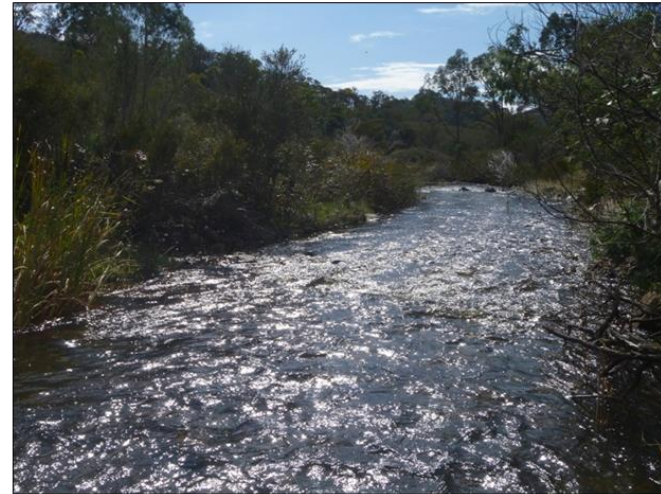
QM2 – Autumn 2014

Downstream of Googong Dam

Environmental flow ecological objective	Spring 2013	Autumn 2014	Objective met?
AUSRIVAS band A	Band A	Band B	No
<20% filamentous algae cover in riffle habitat	<10%	<10%	Yes

Queanbeyan River test sites QM2 and QM3 had declined from reference condition (AUSRIVAS band A) in spring 2013 to biologically impaired (AUSRIVAS band B) in autumn 2014, while the upstream reference site QM1 remained in reference condition (Table 7). A minor flood event (877 ML d^{-1}) occurred in the Queanbeyan River on the 6th and 7th of April, 16 days before autumn 2014 sampling (Figure 2). It is likely that this disturbance would have influenced instream macroinvertebrate communities in the Queanbeyan River, and while reference site QM1 is likely to have recovered relatively quickly because the community is more resistant/adapted to flood disturbances, recovery

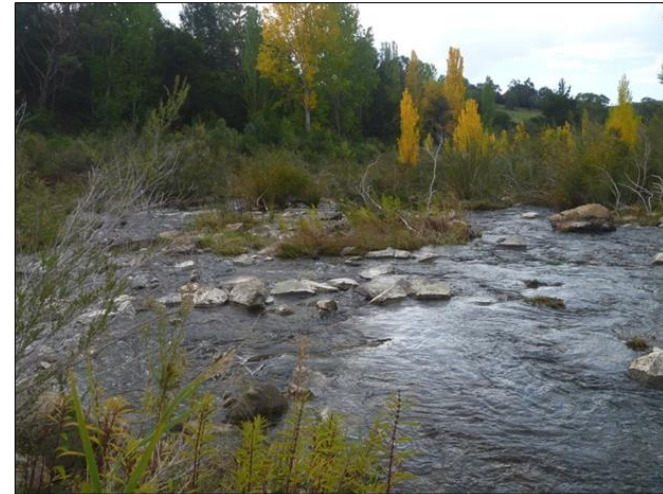
QM3 – Autumn 2014

2 km Downstream of Googong Dam

Environmental flow ecological objective	Spring 2013	Autumn 2014	Objective met?
AUSRIVAS band A	Band A	Band B	No
<20% filamentous algae cover in riffle habitat	<10%	<10%	Yes

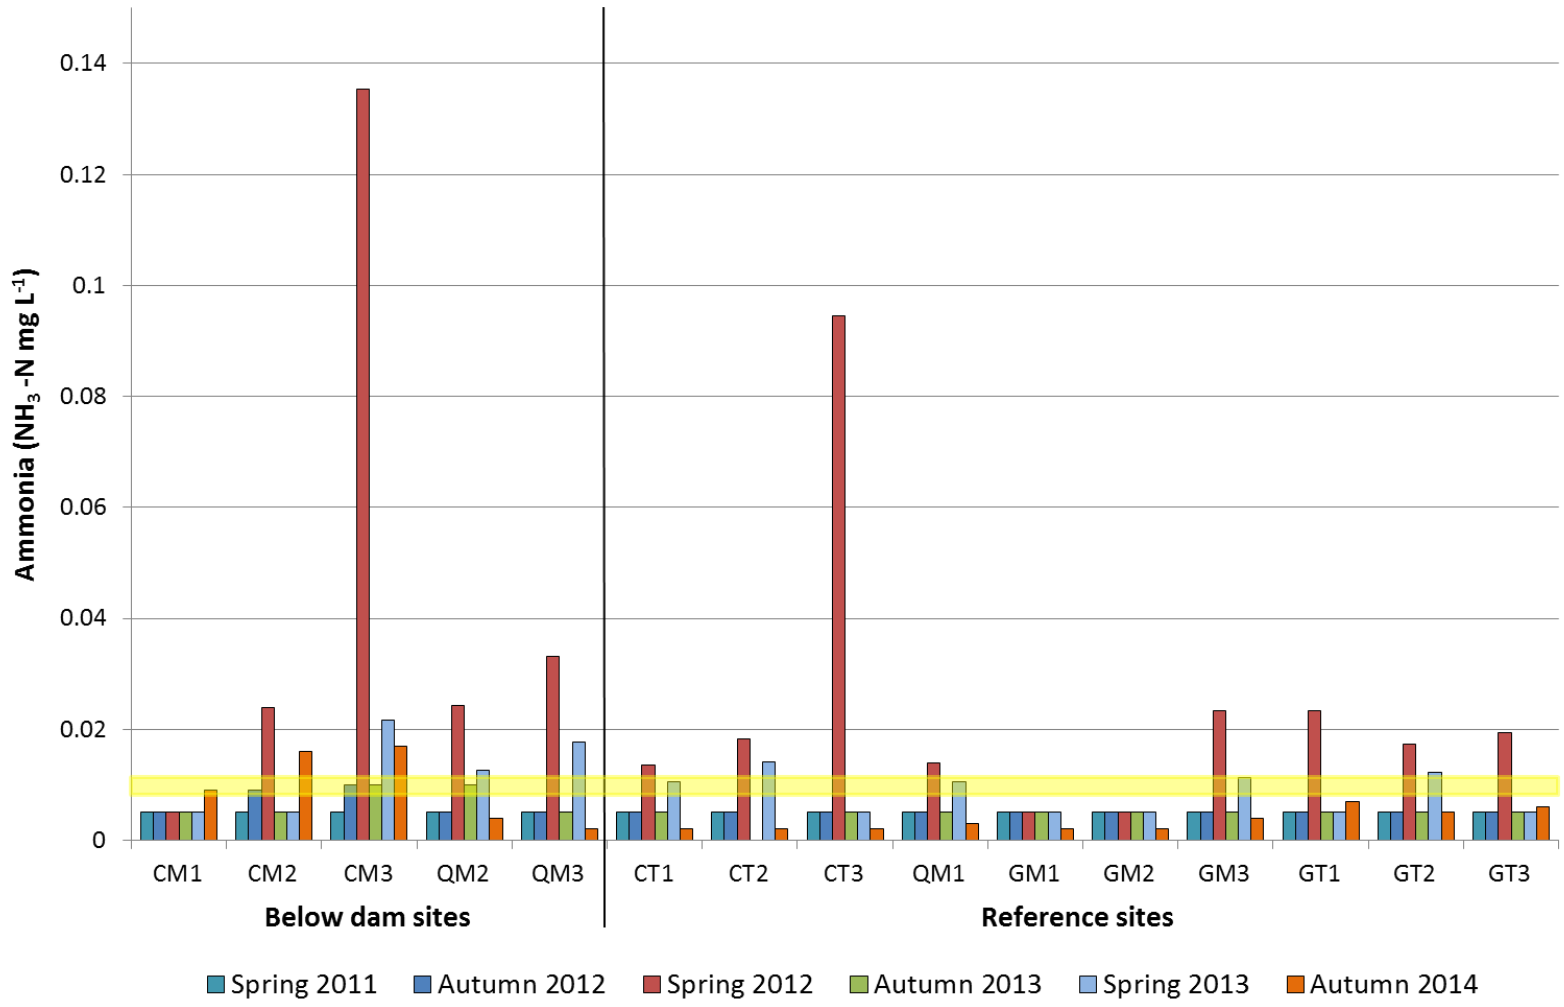
Ammonium (NH₄⁺) concentration at all sites from spring 2011 to autumn 2014. Values below the minimum detectable limit of 0.01 mg L⁻¹ are shown at 0.005 mg L⁻¹. The ANZECC/ARMCANZ (2000) guideline concentration for ammonium (NH₄⁺) is shaded yellow.

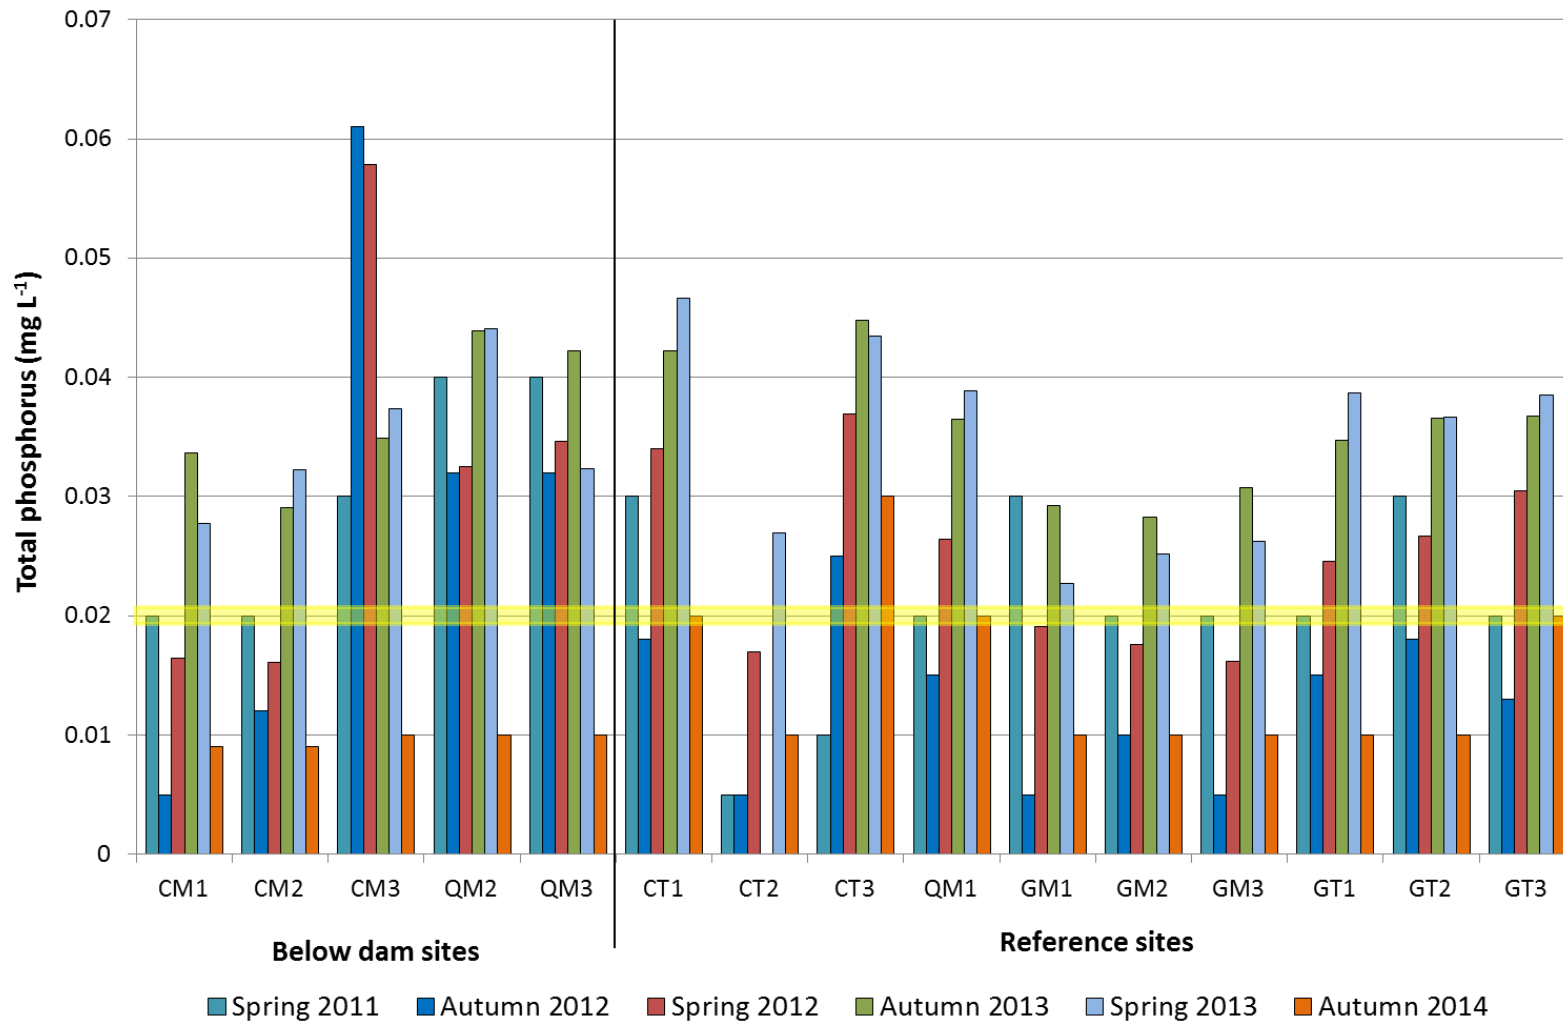
Total phosphorus concentrations at all sites from spring 2011 to autumn 2014. Values below the minimum detectable limit of 0.01 mg L⁻¹ are shown at 0.005 mg L⁻¹. The ANZECC/ARMCANZ (2000) guideline concentration for total phosphorus is shaded yellow.

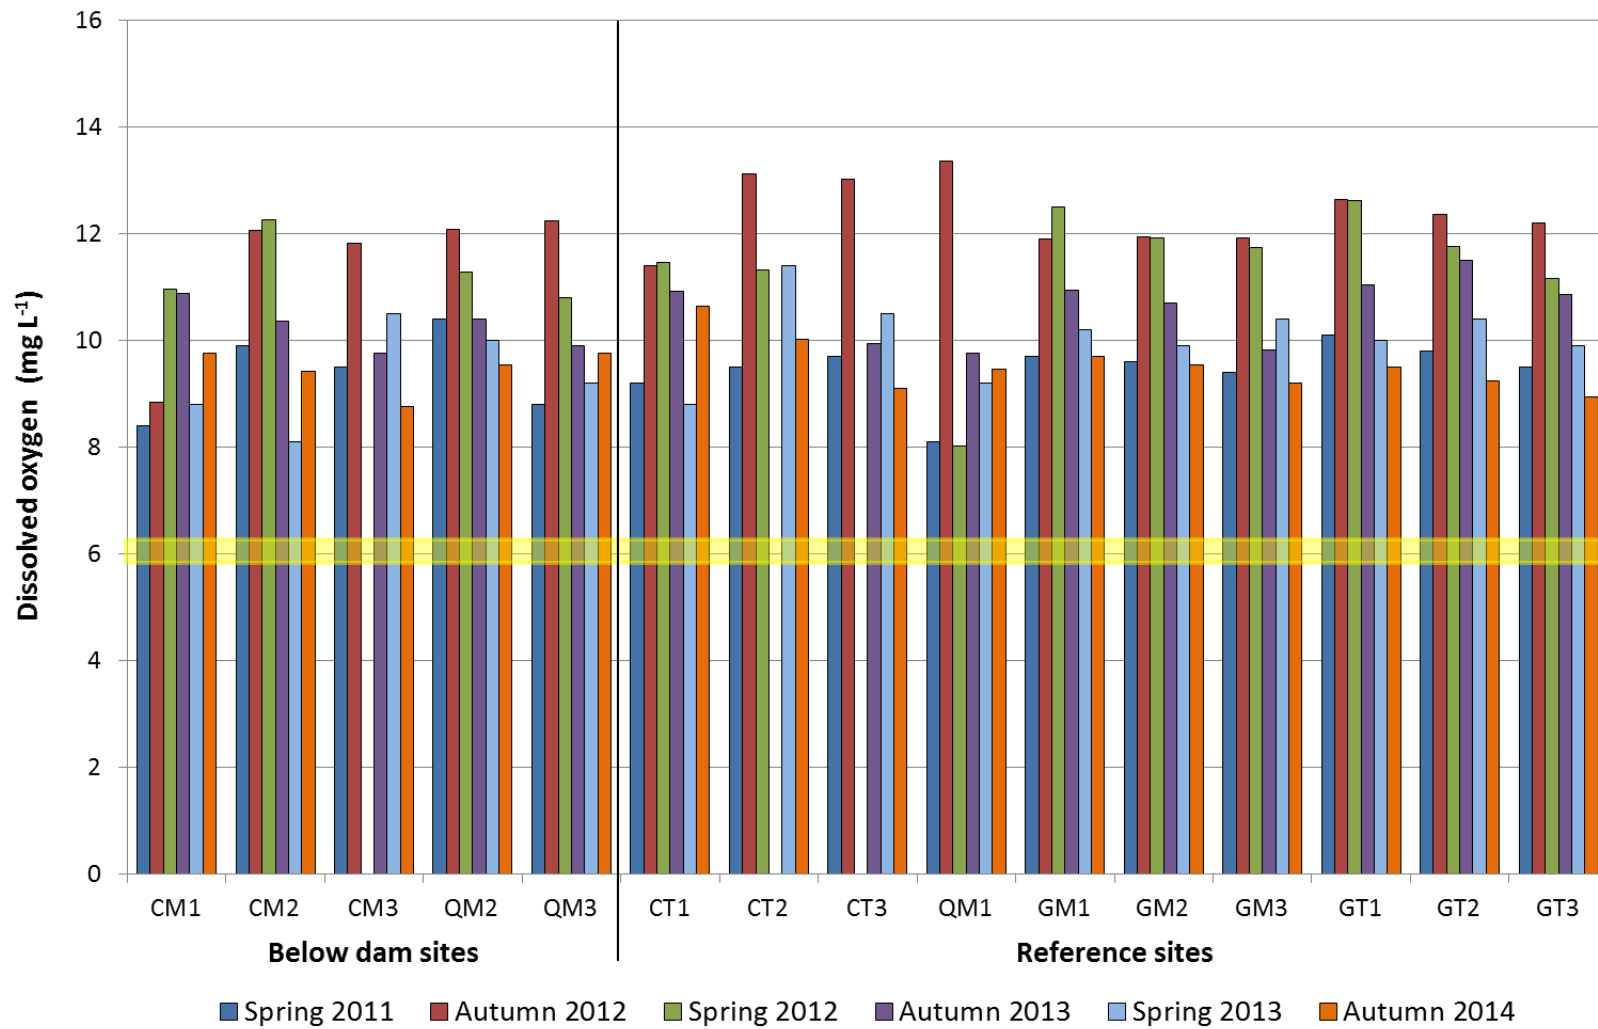
Dissolved oxygen concentration at all sites from spring 2011 to autumn 2014. The minimum guideline for electrical conductivity is shaded yellow (Environment Protection Regulation SL2005-38).
