UNIVERSITY OF
CANBERRA

BIOLOGICAL RESPONSE TO FLOWS DOWNSSTREAM OF CORIN, BENDORA, COTTER AND GOOGONG DAMS

Autumn 2015

Report to Icon Water

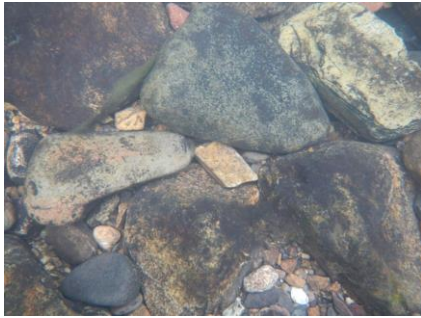
Site CM1

Figure 3. Filamentous algae cover of riffle bed sediments at below dam test sites and corresponding reference sites on the Goodradigbee and Queanbeyan Rivers in autumn 2015.

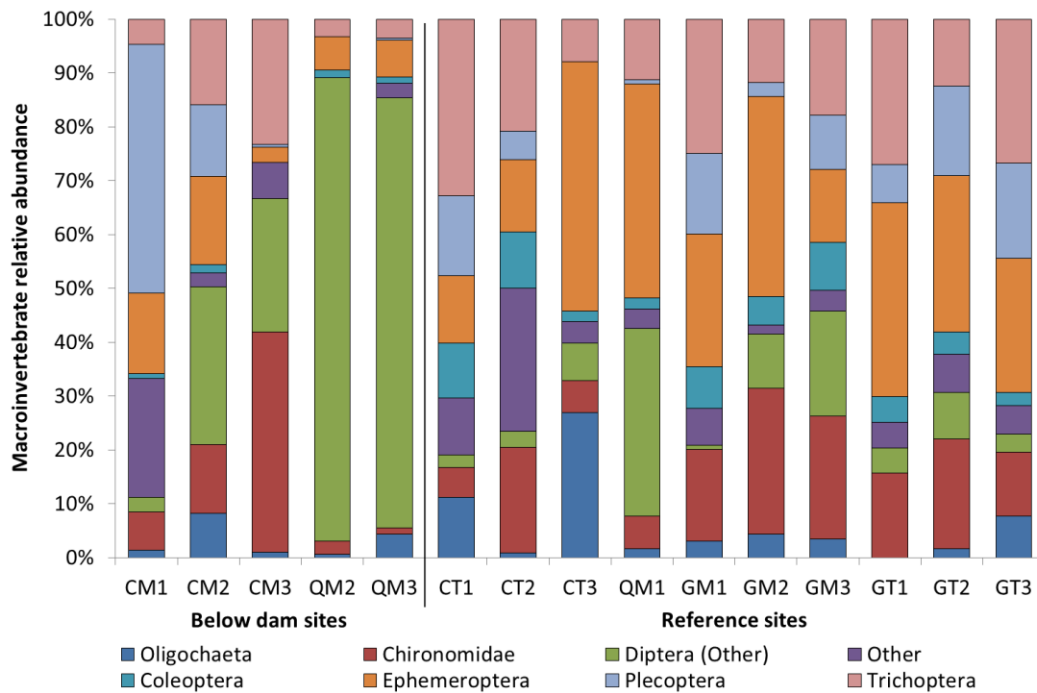
The ratio of environmentally tolerant [Oligochaeta](#) and [Chironomidae](#) (OC) taxa to more sensitive [Ephemeroptera](#), [Plecoptera](#), and [Trichoptera](#) (EPT) taxa was variable across all sites (Figure 6). Tolerant OC taxa were less prevalent at below dam test sites than at reference sites, with the exception of site CM3 below Cotter Dam which was the only site where OC taxa outnumbered EPT taxa (Figure 6). Filter feeding [Simuliidae](#) comprised 86% of the sub-sample at Queanbeyan River test site QM2 and 80% at QM3 (Diptera (other) category in Figure 7 and Appendix 2).

Figure 7: Relative abundance of macroinvertebrate taxonomic groups from samples collected in autumn 2015.

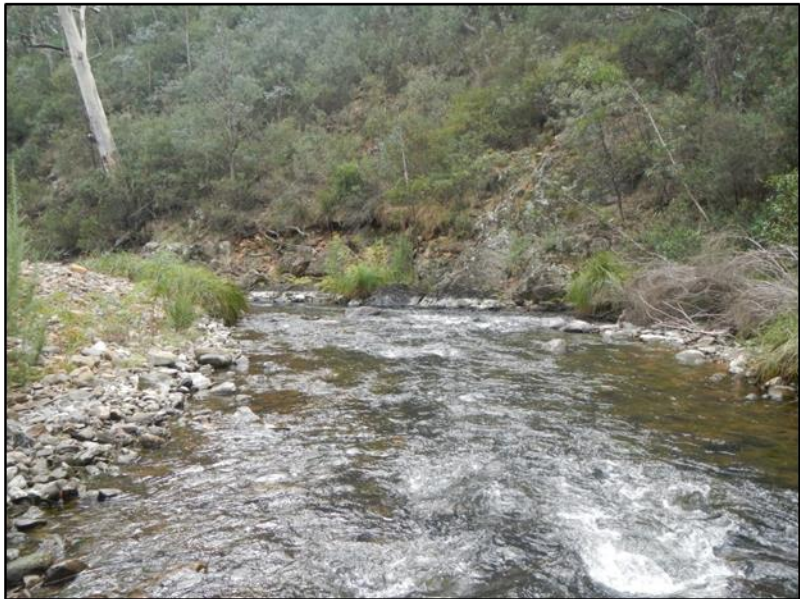
Downstream of Corin Dam

Environmental flow ecological objective	Spring 2014	Autumn 2015	Objective met?
AUSRIVAS band A	Band B	Band B	No
<20% filamentous algae cover in riffle habitat	25%	10%	Yes

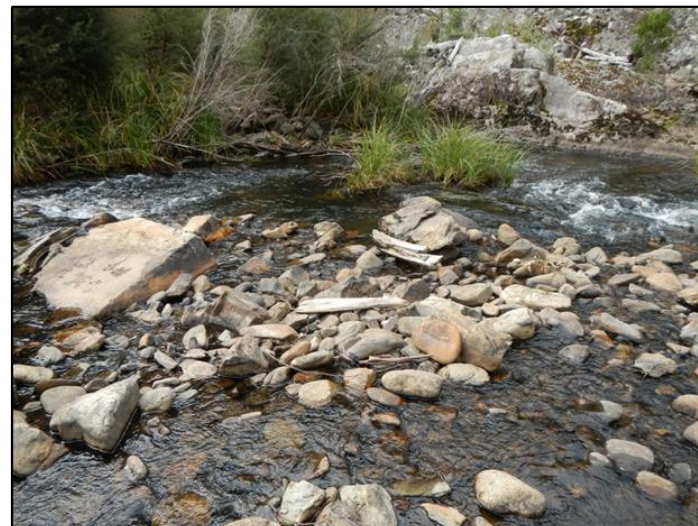
Downstream of Bendora Dam

Environmental flow ecological objective	Spring 2014	Autumn 2015	Objective met?
AUSRIVAS band A	Band A	Band A	Yes
<20% filamentous algae cover in riffle habitat	10%	<10%	Yes

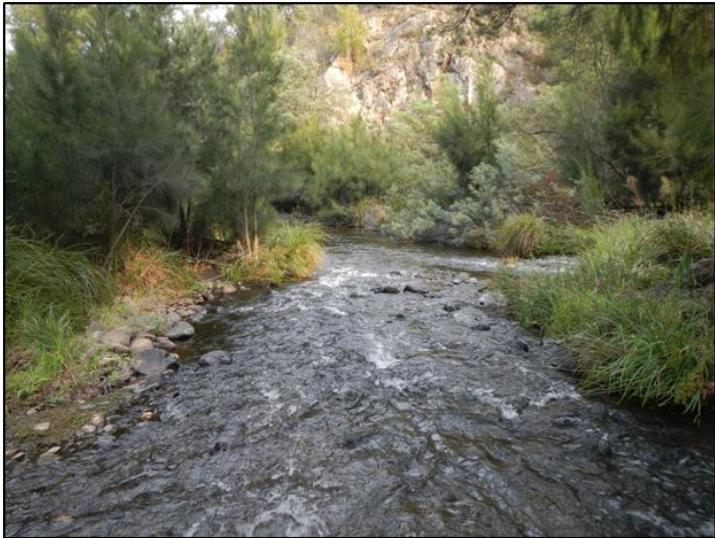
Downstream of Cotter Dam

Environmental flow ecological objective	Spring 2014	Autumn 2015	Objective met?
AUSRIVAS band A	Band B	Band B	No
<20% filamentous algae cover in riffle habitat	<10%	<10%	Yes

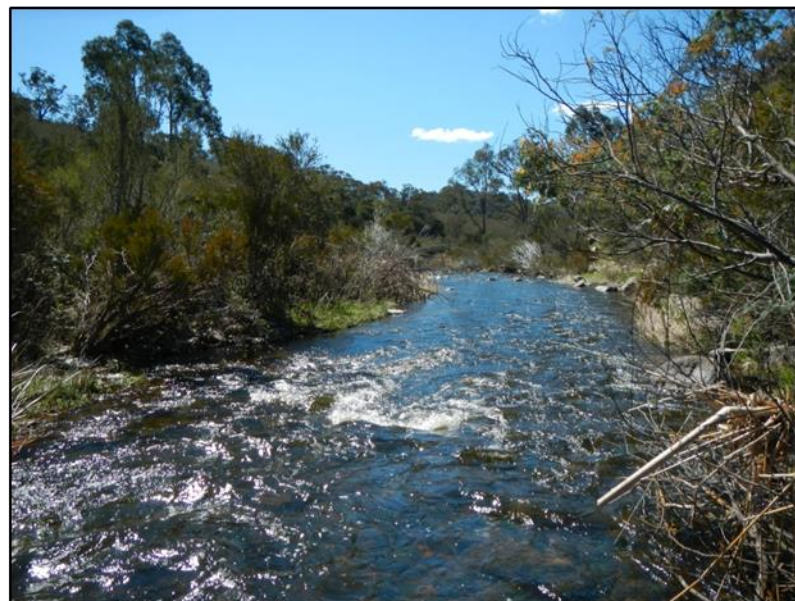
Downstream of Googong Dam

Environmental flow ecological objective	Spring 2014	Autumn 2015	Objective met?
AUSRIVAS band A	Band A	Band C	No
<20% filamentous algae cover in riffle habitat	10%	<10%	Yes

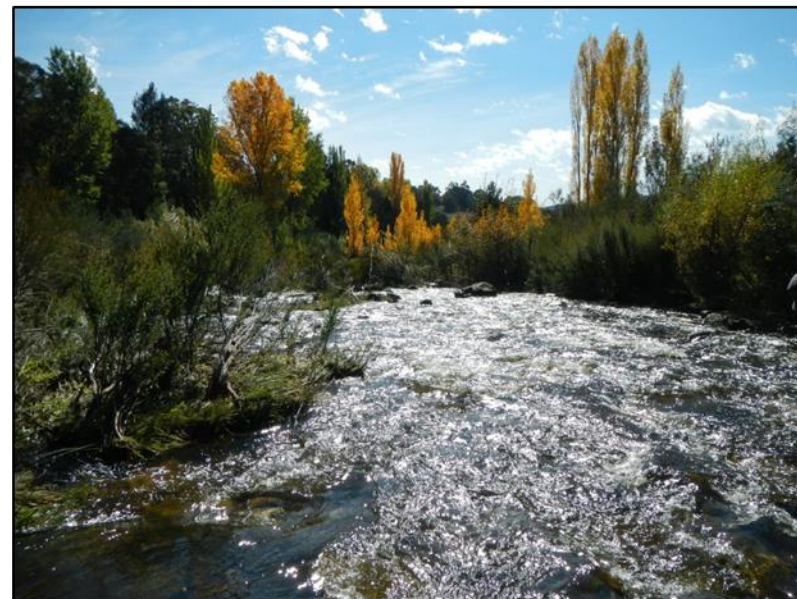
2km Downstream of Googong Dam

Environmental flow ecological objective	Spring 2014	Autumn 2015	Objective met?
AUSRIVAS band A	Band B	Band C	No
<20% filamentous algae cover in riffle habitat	<10%	<10%	Yes

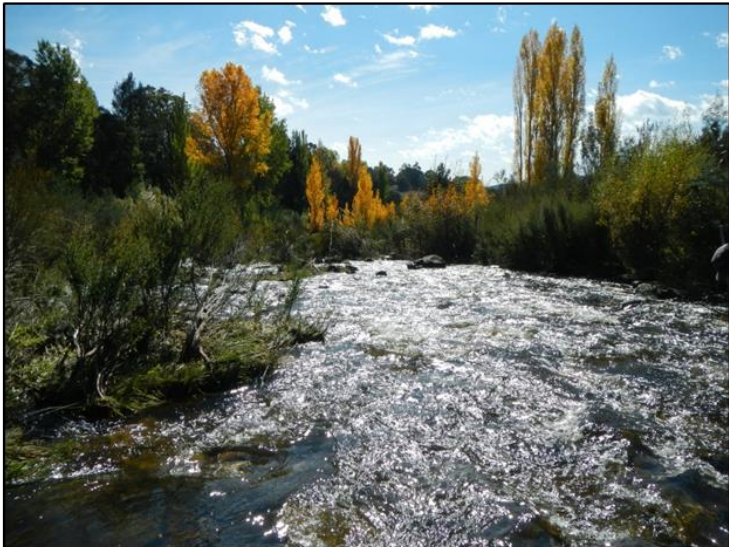
2km Downstream of Googong Dam

Environmental flow ecological objective	Spring 2014	Autumn 2015	Objective met?
AUSRIVAS band A	Band B	Band C	No
<20% filamentous algae cover in riffle habitat	<10%	<10%	Yes
