BIOLOGICAL RESPONSE TO FLOWS DOWNSTREAM OF CORIN, BENDORA, COTTER AND GOOGONG DAMS

Autumn 2016

Report to Icon Water

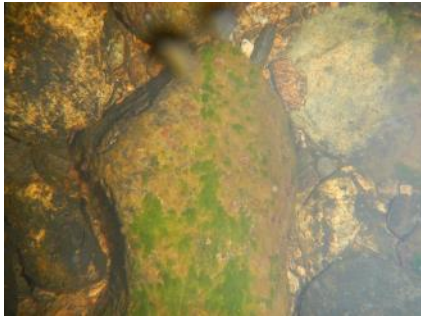
Site CM1

Figure 3. Filamentous algae cover of riffle bed sediments at below dam test sites and corresponding reference sites on the Goodradigbee and Queanbeyan Rivers in autumn 2016.

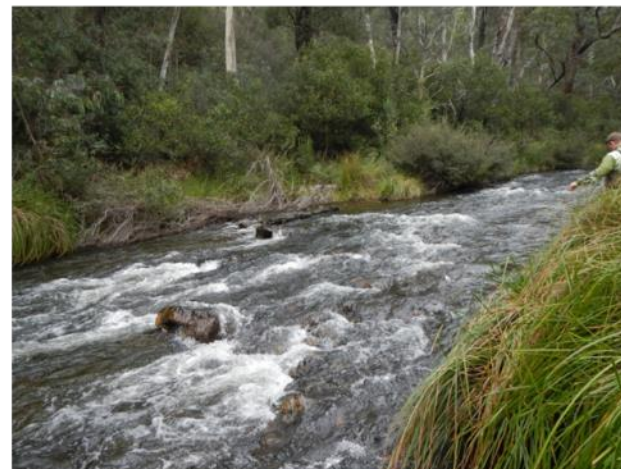
Downstream of Corin Dam

Environmental flow ecological objective	Spring 2015	Autumn 2016	Objective met?
AUSRIVAS band A	Band B	Band B	No
<20% filamentous algae cover in riffle habitat	20%	10%	Yes

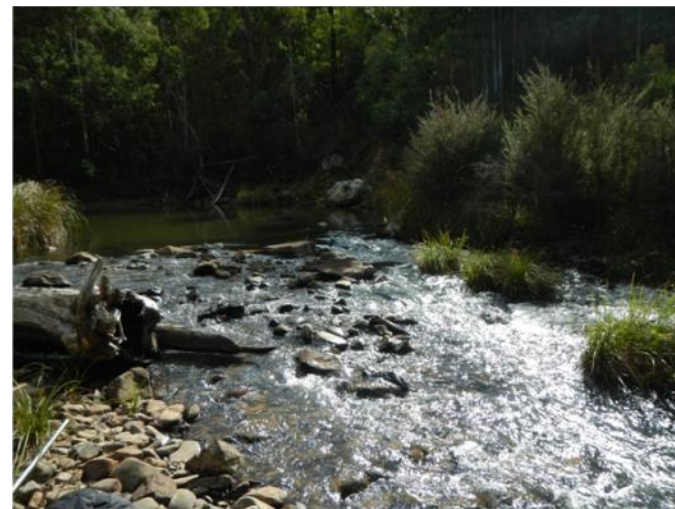
Downstream of Bendora Dam

Environmental flow ecological objective	Spring 2015	Autumn 2016	Objective met?
AUSRIVAS band A	Band A	Band A	Yes
<20% filamentous algae cover in riffle habitat	<10%	<10%	Yes

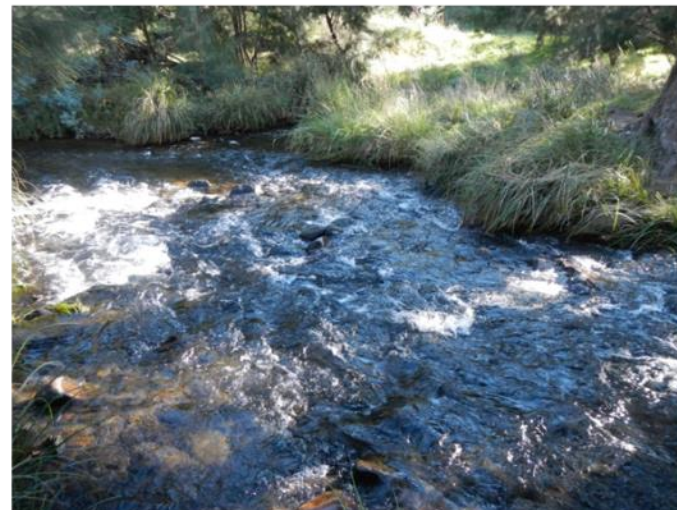
Downstream of Cotter Dam

Environmental flow ecological objective	Spring 2015	Autumn 2016	Objective met?
AUSRIVAS band A	Band B	Band A	Yes
<20% filamentous algae cover in riffle habitat	15	<10%	Yes

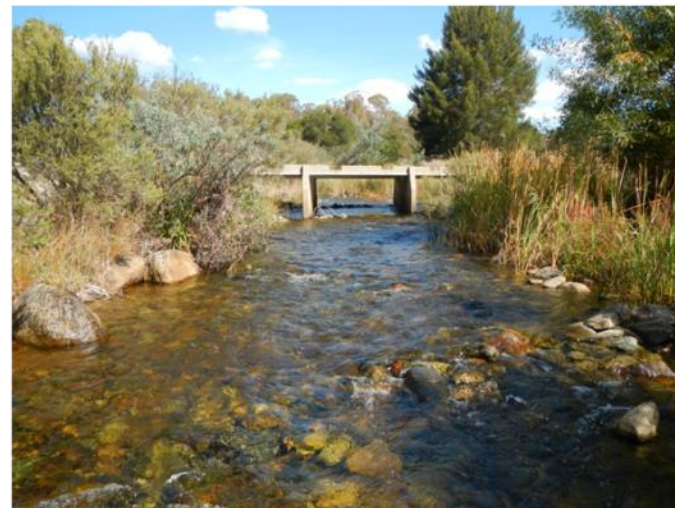
Downstream of Googong Dam

Environmental flow ecological objective	Spring 2015	Autumn 2016	Objective met?
AUSRIVAS band A	Band B	Band B	No
<20% filamentous algae cover in riffle habitat	<10%	10%	Yes

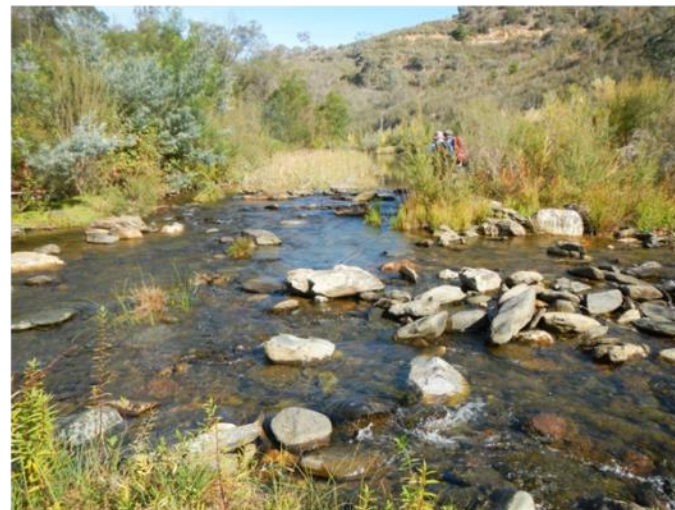
2km Downstream of Googong Dam

Environmental flow ecological objective	Spring 2015	Autumn 2016	Objective met?
AUSRIVAS band A	Band A	Band B	No
<20% filamentous algae cover in riffle habitat	10%	<10%	Yes
