BIOLOGICAL RESPONSE TO FLOWS DOWNSTREAM OF CORIN, BENDORA, COTTER AND GOOGONG DAMS

Annual report August 2017

Report to Icon Water

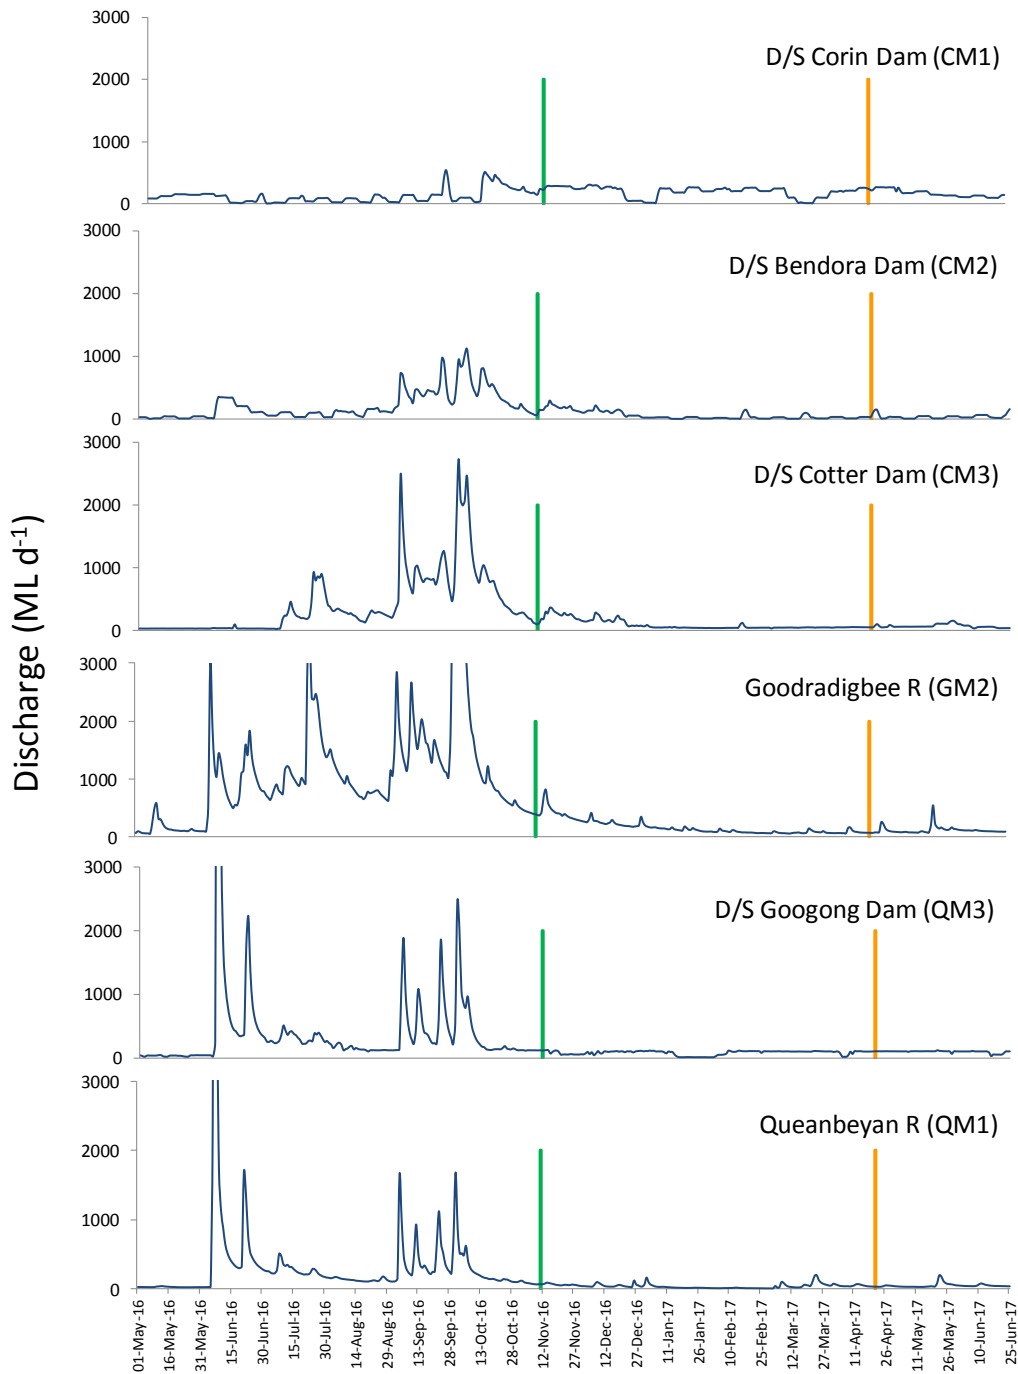
Figure 2. Mean daily discharge below Corin (CM1, station 410752), Bendora (CM2, station 410747), and Cotter (CM3, station 410700) Dams and in the Goodradigbee River (GM2, station 410088) and Googong Dam (QM3, station 410760) and the Queanbeyan River upstream of Googong Reservoir (QM1, station 410781) from 1st May 2016 to 25th July 2017. Green bar corresponds to spring 2016 sampling and orange bar corresponds to autumn 2017 sampling. Note: Discharge at QM1 and QM3 on the 6th June 2016 peaked at 14360 and 13374 ML d⁻¹, respectively. Discharge peaked at GM2 at 6920 ML d⁻¹ on the 5th of October 2016.

Generally, a wet winter and spring resulted in an increase in discharge for most sites prior to the 2016 spring assessment. This was largely reversed for the autumn 2017 assessment where low flow conditions prevailed for the six months prior to sampling for most sites. For the spring 2016 assessment cumulative mean daily discharge at each of the below dam test sites and in the Goodradigbee River between May 2016 and the November 2016 sampling was much higher (+430 – 860%) to that of the preceding autumn 2015 assessment with the exception of CM1 which had a 23% reduction (Figure 2; Broadhurst 2016). The six months preceding the 2016 spring monitoring had a higher cumulative mean daily flow than the previous spring by 74 – 290 %. Following a wet winter and spring in 2016 there was a reduction of between 56 – 76 % in cumulative discharge in the six months prior to the autumn 2017 sampling, with the exception of CM1 which recorded a 107% increase in cumulative discharge.

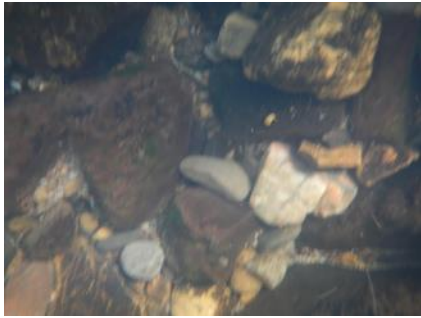
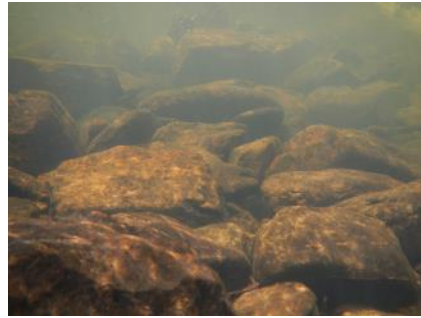
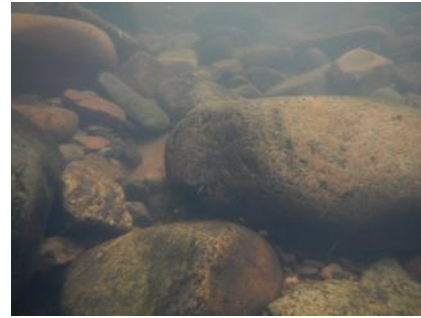
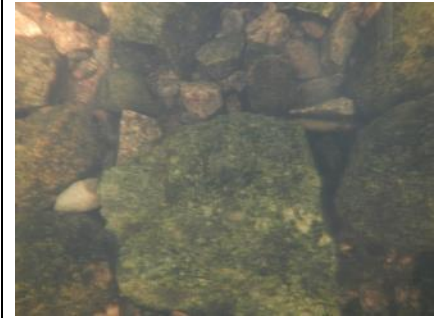
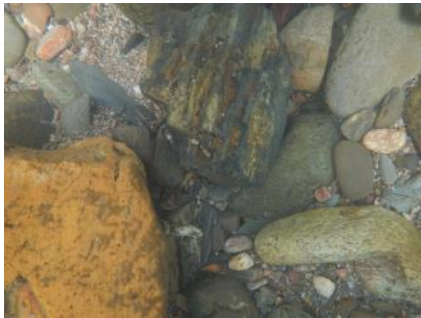
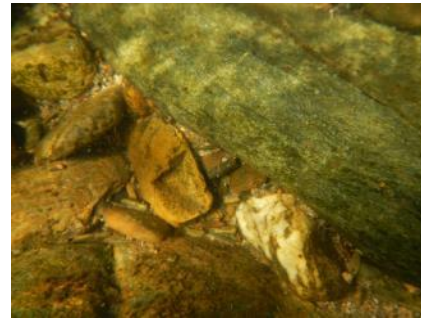
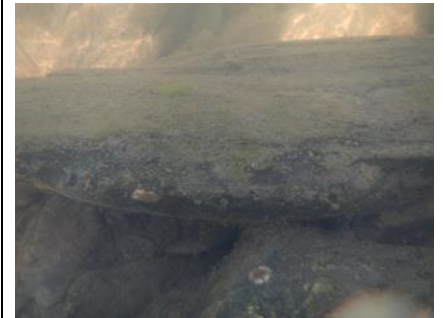
Figure 3. Filamentous algae cover of riffle bed sediments at below dam test sites and corresponding reference sites on the Goodradigbee and Queanbeyan Rivers in **spring 2016**.

- All test and reference sites met the environmental flow ecological objective of <20% cover of filamentous algae in riffle habitats, except for the middle reference site on the Goodradigbee River (GM2) in spring 2016 and test site below Corin Dam and reference site above Googong Reservoir (QM1). [Click here for more information](#)

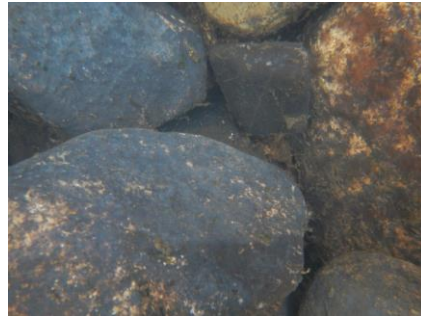
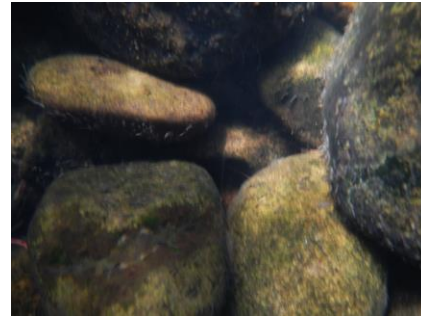
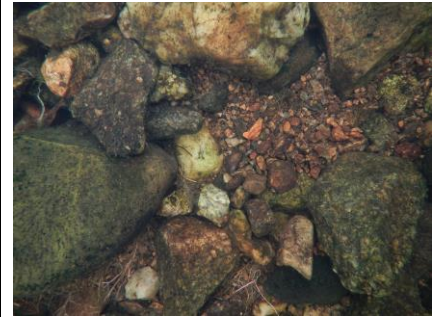
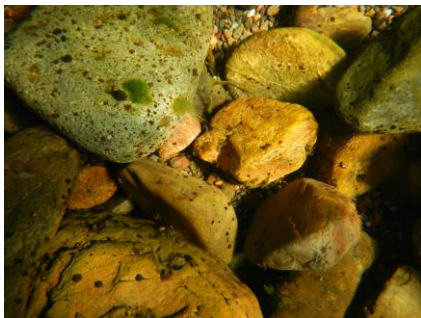
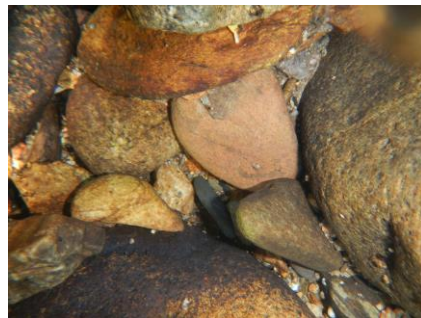
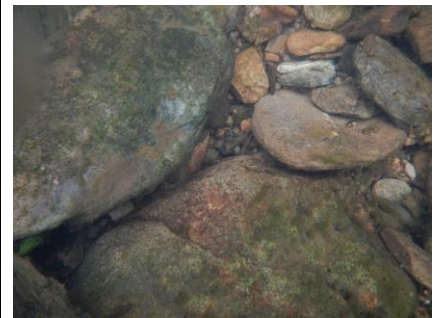
Figure 4: Filamentous algae cover of riffle bed sediments at below dam test sites and corresponding reference sites on the Goodradigbee and Queanbeyan Rivers in autumn 2017.

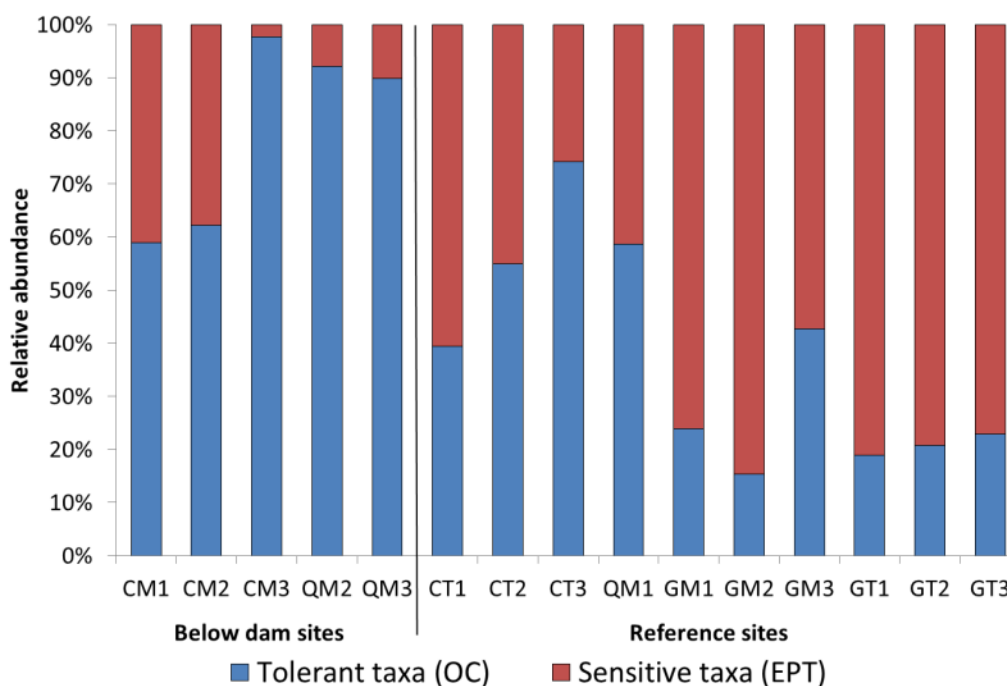
Figure 7. Relative abundance of environmentally tolerant (OC) taxa compared with environmentally sensitive (EPT) taxa from samples collected in **spring 2016**.

The ratio of environmentally tolerant [Oligochaeta](#) and [Chironomidae](#) (OC) taxa to more sensitive [Ephemeroptera](#), [Plecoptera](#), and [Trichoptera](#) (EPT) taxa was variable across all sites (Figure 7, Figure 8) for both spring 2016 and autumn 2017 assessments. Tolerant OC taxa were extremely dominant (> 80%) at below dam test sites below Cotter Dam (CM3) and below Googong Dam (QM2 and QM3) (Figure 7) in spring 2016, whereas environmentally sensitive taxa were extremely dominant (>75%) in same sites in autumn 2017 (Figure 8). Environmentally tolerant taxa comprised greater than 50% at Cotter River test sites CM1 and CM2 and reference tributaries CT2 and CT3 in spring 2016 (Figure 7). However, environmentally sensitive taxa comprised greater than 50% at Cotter River test sites CM1 and CM2 and reference site CT3 in autumn 2017 (Figure 8). Cotter tributary site on Burkes Creek (CT2) comprised >50% environmentally tolerant taxa in spring 2016 and autumn 2017 (Figure 7 and Figure 8). All reference sites in the Goodradigbee Catchment were dominated by environmentally sensitive

taxa in both spring 2016 and autumn 2017 assessments (Figure 7, Figure 8, Figure 9 and Figure 10). In spring 2016 assessment site CM3 below Cotter Dam was dominated by large numbers of [Orthocladiinae](#) (Figure 9 and Appendix 2), whereas in autumn 2017, reference site CT2 (Burkes Creek) was dominated by [Chironomidae](#) (Figure 10). Filter feeding [Simuliidae](#) comprised > 60% of the sub-sample at Queanbeyan River test site QM3 (Figure 9 and Appendix 2) in spring 2016. Below dams tests sites had very low relative abundances of environmentally sensitive taxa [Ephemeroptera](#), compared to reference sites (Figure 9, Figure 10 and Appendix 2) for both spring 2016 and autumn 2017.

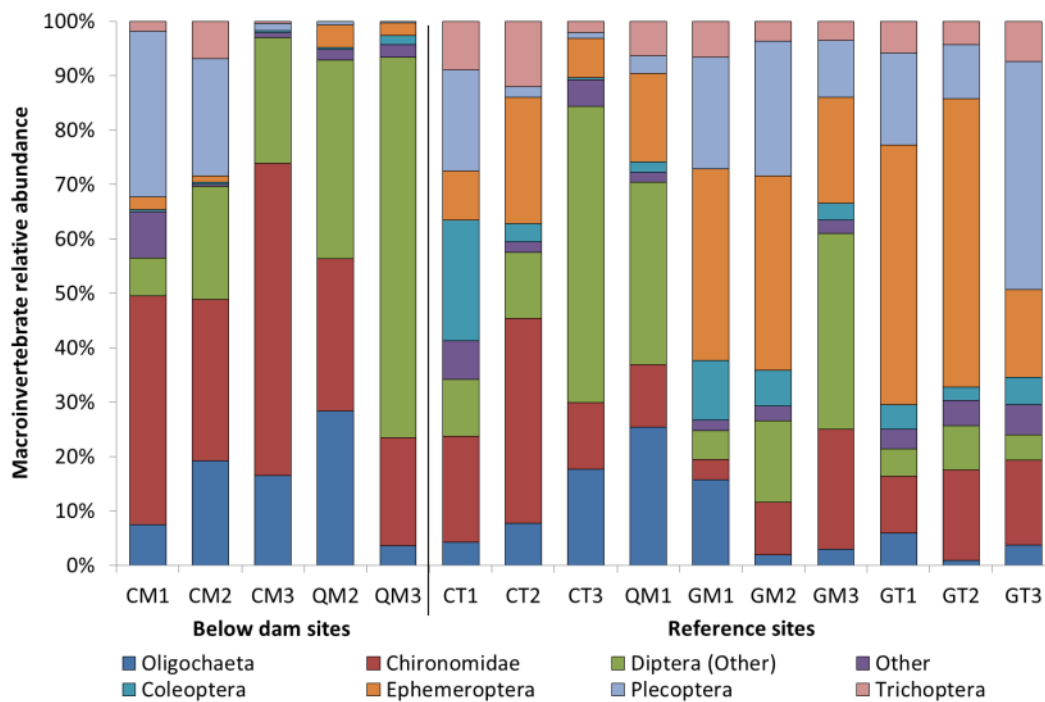
Figure 9: Relative abundance of macroinvertebrate taxonomic groups from samples collected in **spring 2016**.

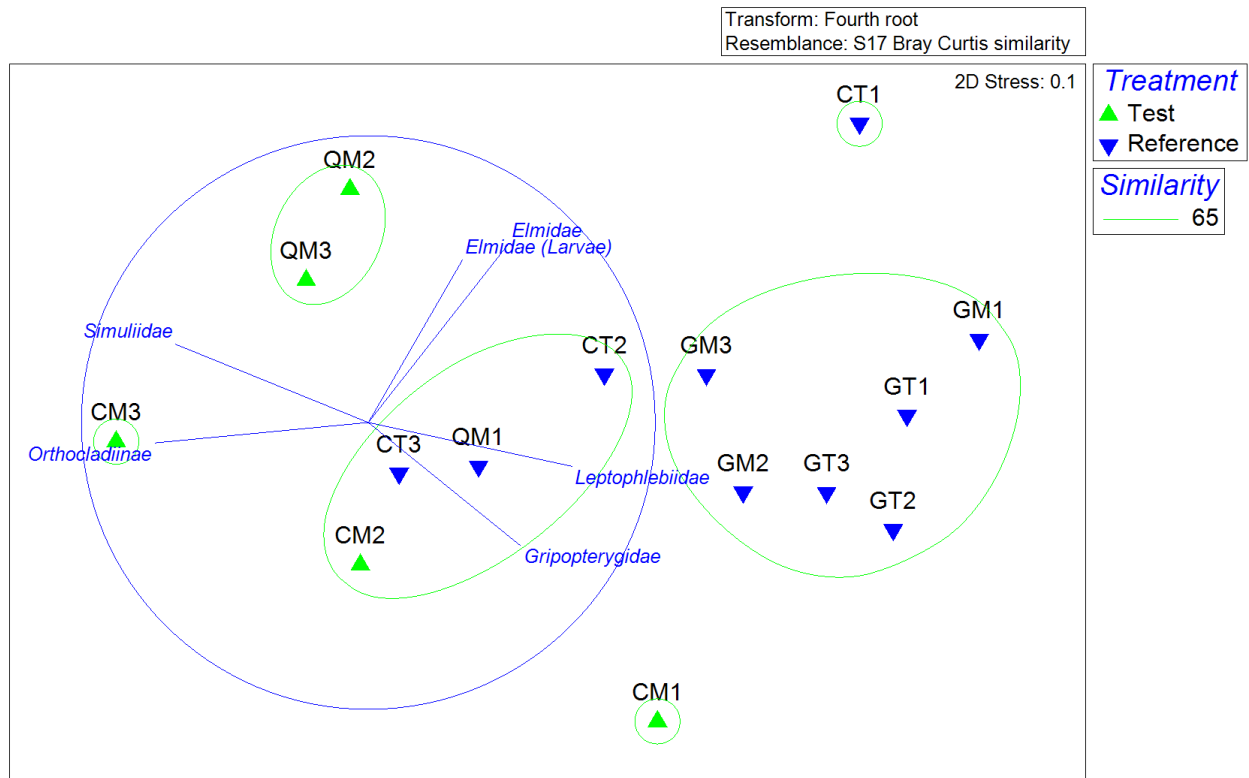
Figure 11. MDS ordination of 65% similarity between macroinvertebrate samples collected in **spring 2016** for the below dams assessment program (green oval lines). Similarity is based on macroinvertebrate relative abundance. Macroinvertebrate taxa with Pearson correlations greater than 0.65 (i.e. taxa that discriminate between the groups of sites) are overlaid on the MDS ordination. The closer the blue line for each taxa is to the edge of the blue circle the greater the correlation.

Cotter River test site CM2 grouped out with reference sites QM1, CT2 and CT3 (Figure 11) in spring 2016 and CM1 in autumn 2017 (Figure 12).

Queanbeyan River test sites QM2 and QM3 had macroinvertebrate assemblages that were dissimilar to all other sites. This was primarily because of the higher relative abundance of more environmentally tolerant [Simuliidae](#), [Oligochaeta](#) and [Orthoclaudiinae](#) at these sites compared to sites which had greater relative abundances environmentally sensitive taxa [Leptophlebiidae](#) and [Gripopterygidae](#) (Figure 11; Appendix 2) in spring 2016 assessment. The reference site Kangaroo Creek (CT1) a tributary to Cotter River had macroinvertebrate assemblage dissimilar to all other sites in spring 2016 (Figure 11) and got a diverse relative taxa abundance in autumn 2017 assessment (Figure 12; Appendix 2).

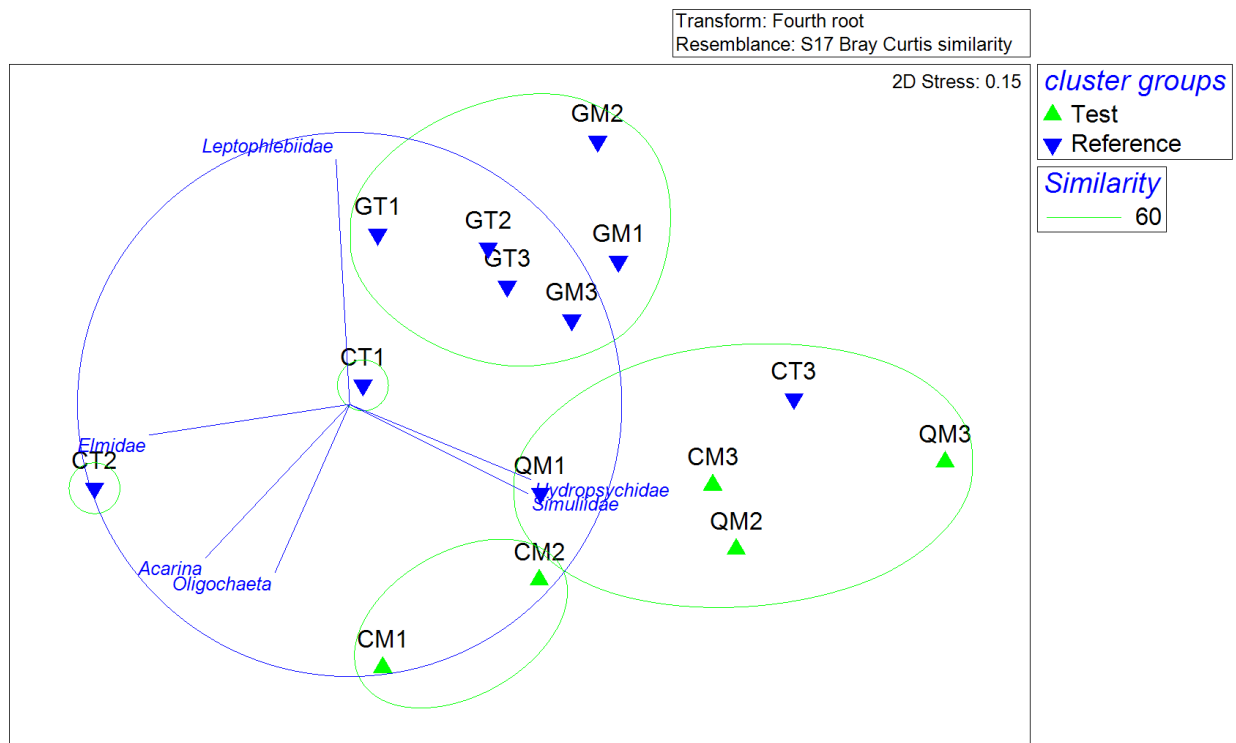
Figure 12. MDS ordination of 60% similarity between macroinvertebrate samples collected in **autumn 2017** for the below dams assessment program (green oval lines). Similarity is based on macroinvertebrate relative abundance. Macroinvertebrate taxa with Pearson correlations greater than 0.60 (i.e. taxa that discriminate between the groups of sites) are overlayed on the MDS ordination. The closer the blue line for each taxa is to the edge of the blue circle the greater the correlation.

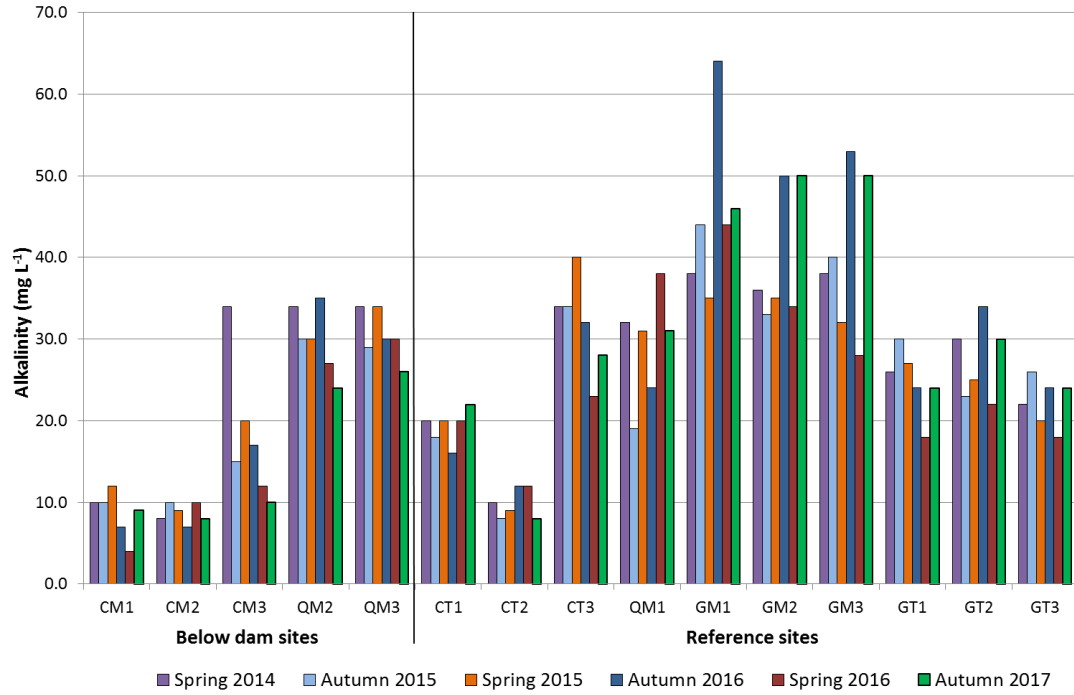
Alkalinity at all sites from spring 2014 to autumn 2017.
