Biological response to flows downstream of Corin, Bendora, Cotter and Googong Dams

Spring 2013

Report produced for ACTEW Water

ACTEW Water - Water Quality Monitoring Program

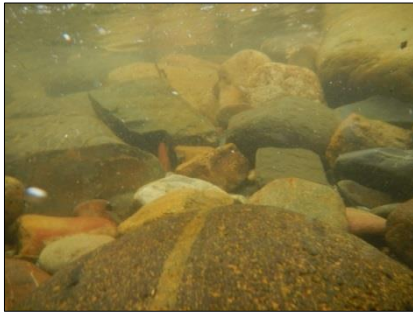
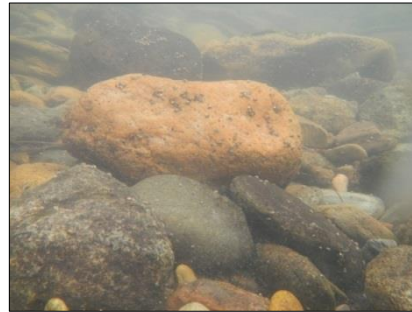
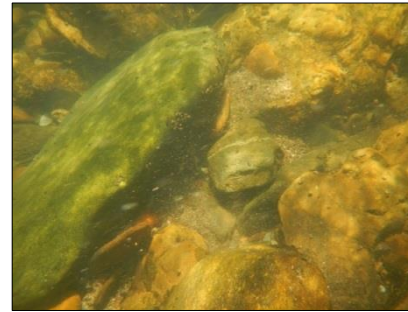
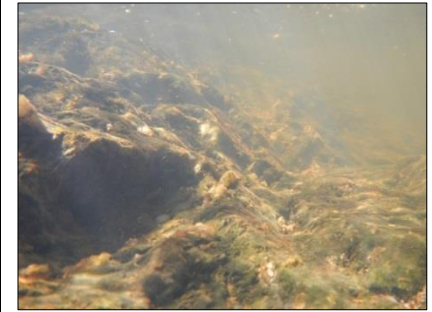
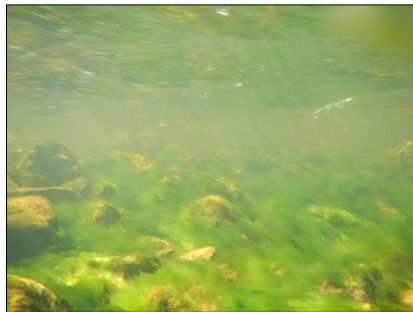
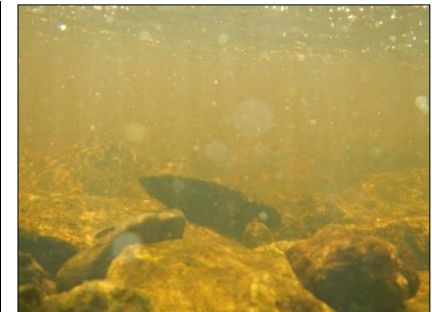
Figure 3. Filamentous algae cover of riffle bed sediments at below dam test sites and corresponding reference sites on the Goodradigbee and Queanbeyan Rivers in spring 2013.

- Sites CM1 and CM2 below Corin and Bendora Dams did not meet the environmental flow ecological objective of <20% filamentous algae cover in the riffle habitat (ACT Government 2013). At site CM1 the high accumulation of filamentous algae may be a result of sampling at the end of the low-flow phase of the environmental flow cycle, and it is likely that the flow release following spring 2013 sampling would have scoured the majority of algal biomass from the river reach. [Click here for more information](#)

Estimations of periphyton/algae standing crop based on chlorophyll-a concentration analysis reflect field observations of filamentous algae cover, with the highest chlorophyll-a concentrations found below Corin Dam (CM1) (Table 6; Figure 3; Figure 5). Chlorophyll-a concentrations were significantly higher below Corin Dam than at each of the other sites ($F=11.39$; $DF=6,35$; $P<0.0001$); however, unlike AFDM, chlorophyll-a concentrations at site CM2 (below Bendora Dam) were not significantly higher than other sites (Figure 5).

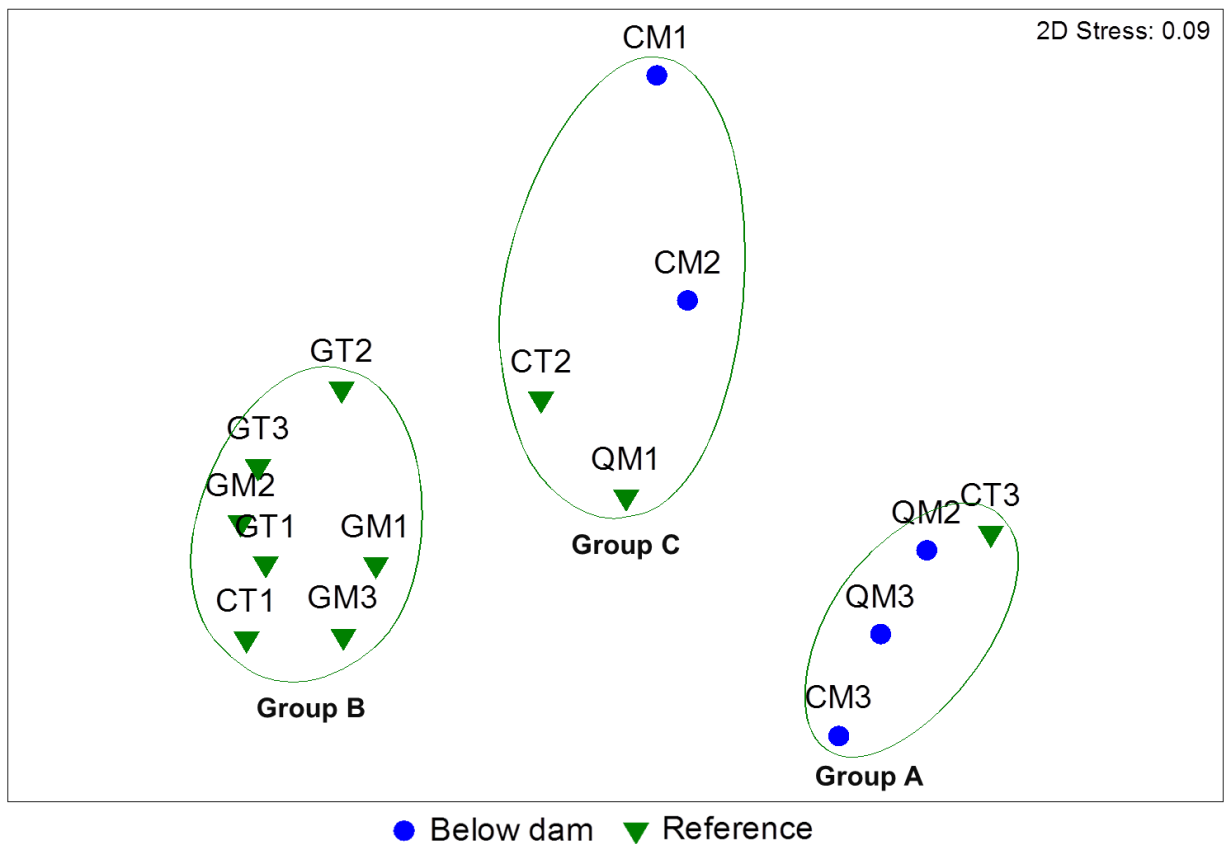
Cluster analysis based on the relative abundance of macroinvertebrate taxa identified three groups of sites at 60% similarity, which were significantly well separated (ANOSIM $p < 0.05$; $R > 0.93$) (Figure 7). Group A consisted of test sites QM2 and QM3 below Googong Dam and CM3 below Cotter Dam, and reference site CT3 on Paddys River. Sites in this group were characterised by higher abundances of Simuliidae, Oligochaeta and Chironomidae compared to groups B and C (Appendix 2). Group B consisted of the Goodradigbee River and tributary sites, and reference site CT1 on Kangaroo Creek. This group was defined by high abundances disturbance-sensitive and flow-favouring taxa compared to groups A and C (Appendix 2). Group C consisted of test sites CM1 below Corin Dam and CM2 below Bendora Dam, and reference sites CT2 on Burkes Creek and QM1 upstream of Googong Reservoir on the Queanbeyan River. Sites in group C had a lower relative abundance of Simuliidae and Orthocladinae taxa compared to group B sites, and had a lower relative abundance of Gripopterygidae compared to group A sites (Figure 7; Appendix 2).

Figure 7. MDS ordination of similarity between macroinvertebrate samples collected in spring 2013 for the Below Dams Assessment Program. Similarity based on macroinvertebrate relative abundance.

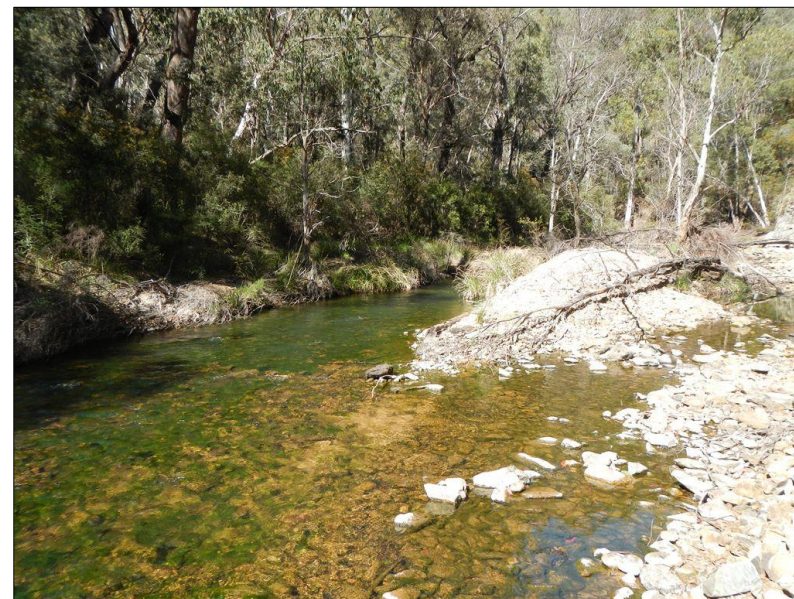
CM1 – Spring 2013

Environmental flow ecological objective	Autumn 2013	Spring 2013	Objective met?
AUSRIVAS band A	Band C	Band B	No
<20% filamentous algae cover in riffle habitat	<10%	80%	No

Cotter River test site CM1 below Corin Dam was the only test site that did not meet the environmental flow ecological objective of AUSRIVAS band A in spring 2013, despite improving in biological condition since autumn 2013 (Table 7). It is likely that the macroinvertebrate assemblage at this site was being impacted upon by the dense filamentous algae cover (approximately 80% cover in the riffle habitat) observed below Corin Dam during sampling, because it is an unpalatable food source for many taxa (Chester & Norris, 2006). Orthocladiinae midges which reside, feed and possibly avoid predation within large filamentous chlorophytes were also abundant downstream of Corin Dam (Chester & Norris, 2006)(Appendix 2).

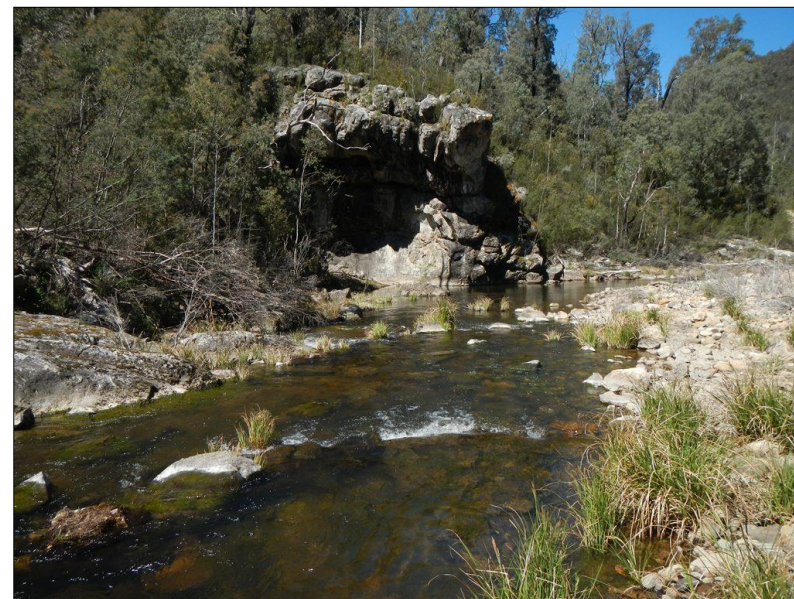
CM2 – Spring 2013

Environmental flow ecological objective	Autumn 2013	Spring 2013	Objective met?
AUSRIVAS band A	Band A	Band A	Yes
<20% filamentous algae cover in riffle habitat	<10%	20%	No

Test sites CM2 and CM3 on the Cotter River and sites QM2 and QM3 on the Queanbeyan River all met the ecological objective of AUSRIVAS band A assessment in spring 2013 (Table 7). The AUSRIVAS observed/expected taxa score at site CM2 below Bendora Dam had decreased from the top of band A in autumn to the bottom of the band in spring 2013 (Table 7). The current assessment is more consistent with previous assessment outcomes and highlights an ongoing minor biological impairment downstream of Bendora Dam, which may be the result of filamentous algae cover on the stream bed (similar to downstream of Corin Dam). Also similar to downstream of Corin Dam, Orthocladiinae midges were abundant (Appendix 2), which is most likely because of the quantity of filamentous algae on the stream bed.

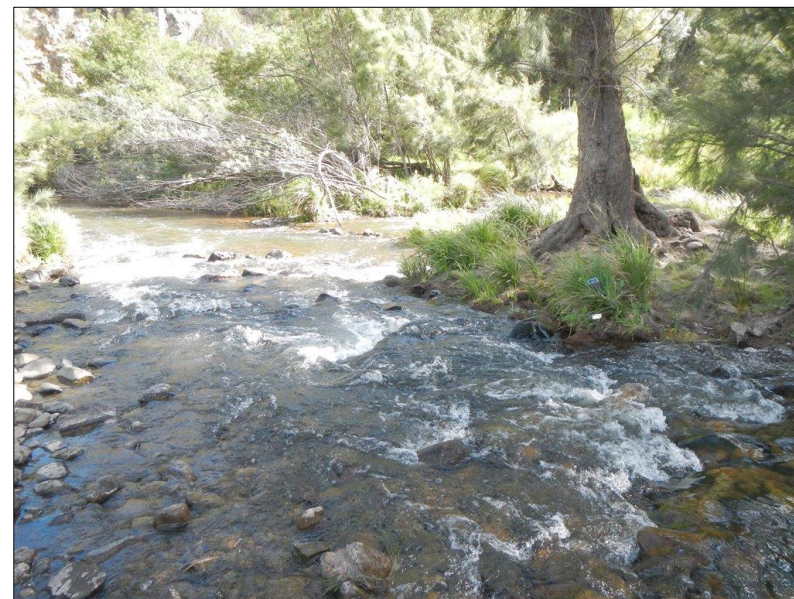
CM3 – Spring 2013

Environmental flow ecological objective	Autumn 2013	Spring 2013	Objective met?
AUSRIVAS band A	Band C	Band A	Yes
<20% filamentous algae cover in riffle habitat	<10%	<10%	Yes

Cotter River test site CM3 downstream of Cotter Dam was assessed as AUSRIVAS band A in spring 2013 for the first time since autumn 2008. The biological condition of this river reach has been highly variable over recent assessments (Table 7), which may be related to a change in the primary water

source for environmental flows coming from the Murrumbidgee River via the M2C transfer pipeline. Flushing flow releases from Cotter Dam prior to spring 2013 sampling may have contributed to the improved biological condition of the downstream river reach. Filter feeding Simuliidae continue to numerically dominate the macroinvertebrate assemblage at this site, indicating a high concentration of fine particulate organic material in the water column.

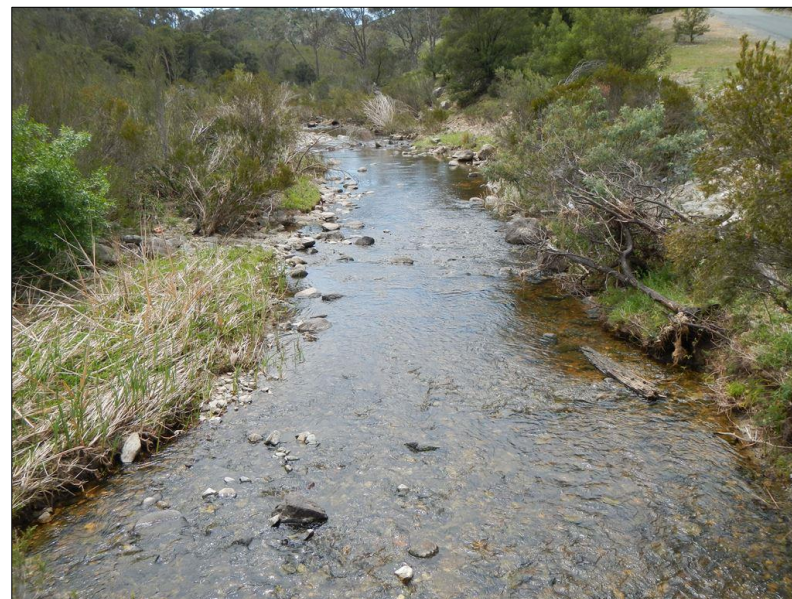
QM2 – Spring 2013

Downstream of Googong Dam

Environmental flow ecological objective	Autumn 2013	Spring 2013	Objective met?
AUSRIVAS band A	Band B	Band A	Yes
<20% filamentous algae cover in riffle habitat	<10%	<10%	Yes

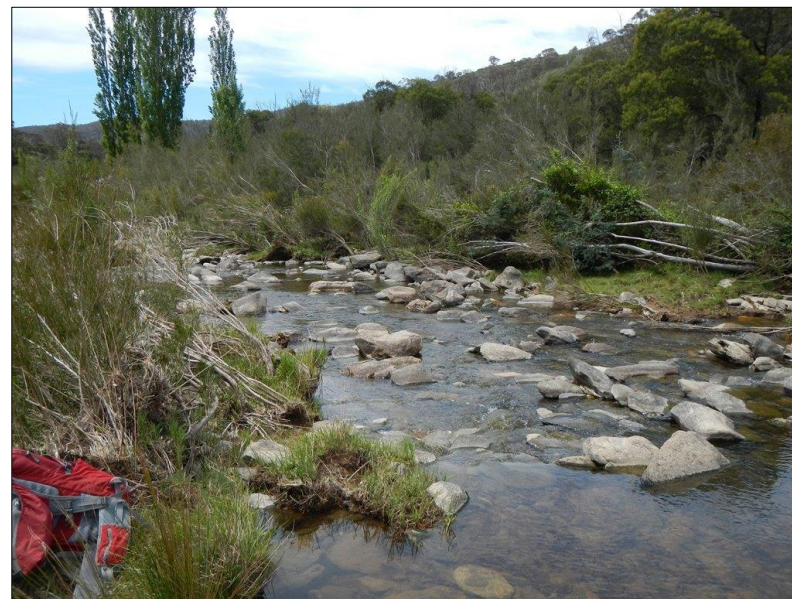
QM3 – Spring 2013

2 km Downstream of Googong Dam

Environmental flow ecological objective	Autumn 2013	Spring 2013	Objective met?
AUSRIVAS band A	Band B	Band A	Yes
<20% filamentous algae cover in riffle habitat	<10%	<10%	Yes
