BIOLOGICAL RESPONSE TO FLOWS DOWNSTREAM OF CORIN, BENDORA, COTTER AND GOOGONG DAMS

Spring 2016

Report to Icon Water

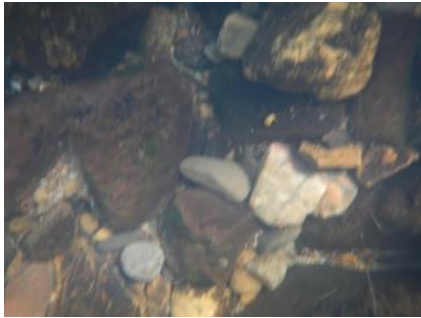
Site CM1

Figure 3. Filamentous algae cover of riffle bed sediments at below dam test sites and corresponding reference sites on the Goodradigbee and Queanbeyan Rivers in spring 2016.

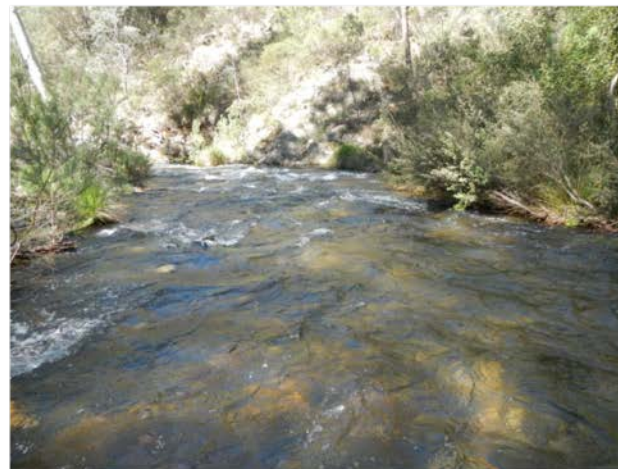
Downstream of Corin Dam

Environmental flow ecological objective	Autumn 2016	Spring 2016	Objective met?
AUSRIVAS band A	Band B	Band B	No
<20% filamentous algae cover in riffle habitat	10%	<10%	Yes

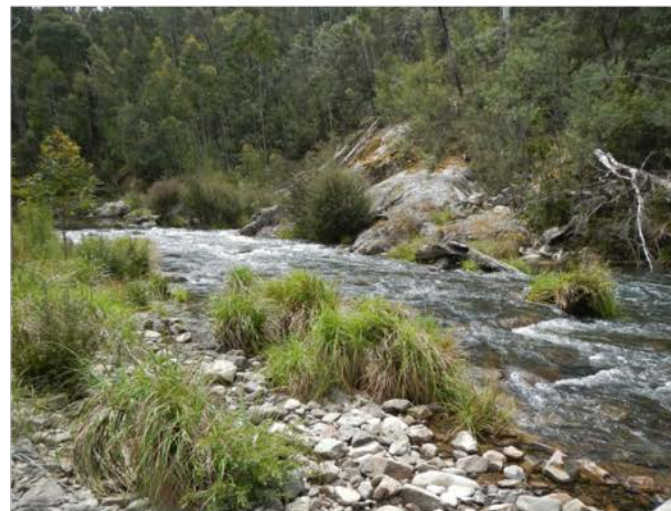
Downstream of Bendora Dam

Environmental flow ecological objective	Autumn 2016	Spring 2016	Objective met?
AUSRIVAS band A	Band A	Band A	Yes
<20% filamentous algae cover in riffle habitat	<10%	<10%	Yes

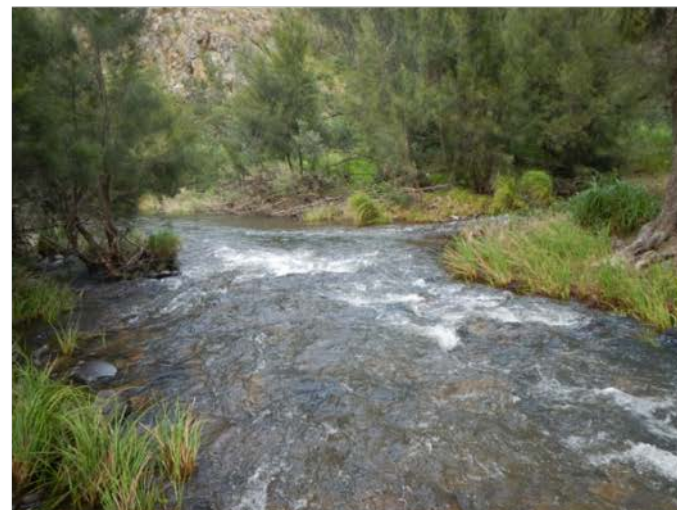
Downstream of Cotter Dam

Environmental flow ecological objective	Autumn 2016	Spring 2016	Objective met?
AUSRIVAS band A	Band A	Band C	No
<20% filamentous algae cover in riffle habitat	<10%	<10%	Yes

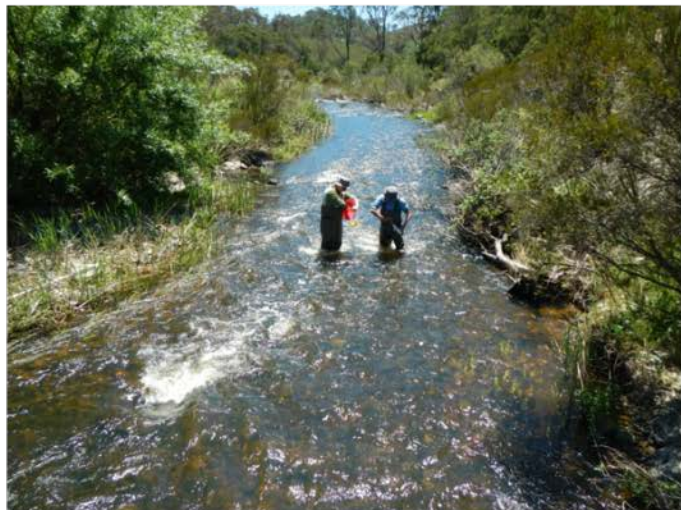
Downstream of Googong Dam

Environmental flow ecological objective	Autumn 2016	Spring 2016	Objective met?
AUSRIVAS band A	Band B	Band B	No
<20% filamentous algae cover in riffle habitat	<10%	<10%	Yes

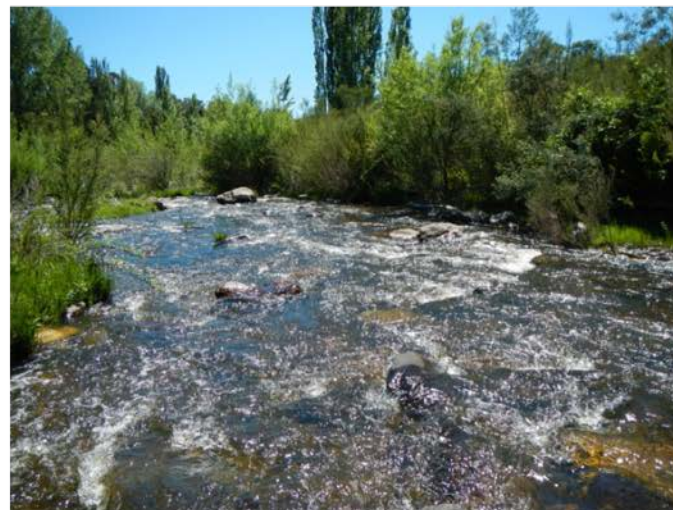
2km Downstream of Googong Dam

Environmental flow ecological objective	Autumn 2016	Spring 2016	Objective met?
AUSRIVAS band A	Band B	Band B	No
<20% filamentous algae cover in riffle habitat	10%	<10%	Yes
