BIOLOGICAL RESPONSE TO FLOWS DOWNSTREAM OF CORIN, BENDORA, COTTER AND GOOGONG DAMS

Spring 2019

Summary report to Icon Water

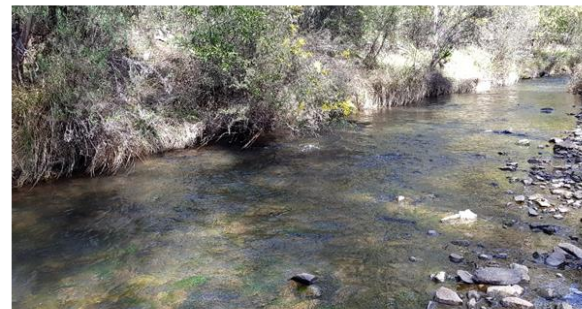
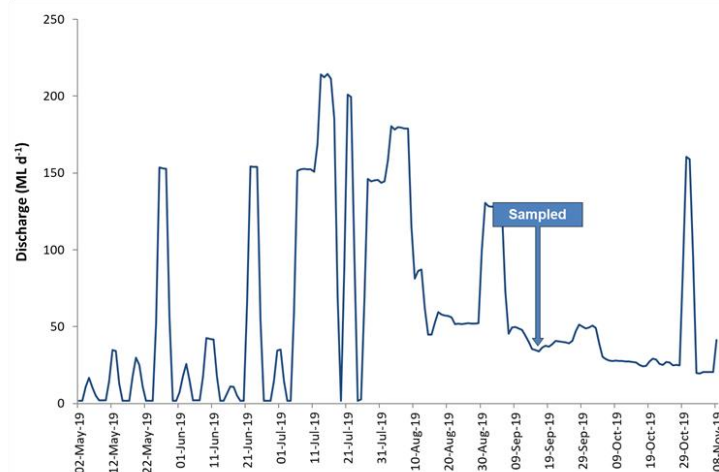
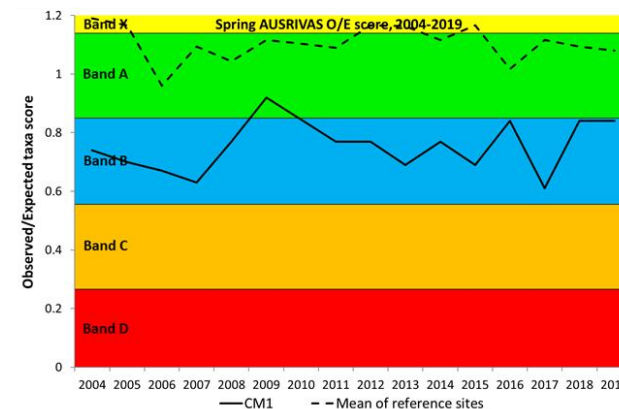
CM1 – Spring 2019

- Test site CM1 did not meet the environmental flow ecological objective of <20% cover of filamentous algae in riffle habitats. It is possible that low discharge resulted in lack of flow disturbance and an increase in filamentous algae growth.

Downstream of Corin Dam

Environmental flow ecological objective	Autumn 2019	Spring 2019	Objective met?
AUSRIVAS band A	Band B	Band B	No
<20% filamentous algae cover in riffle habitat	<10%	>20%	No

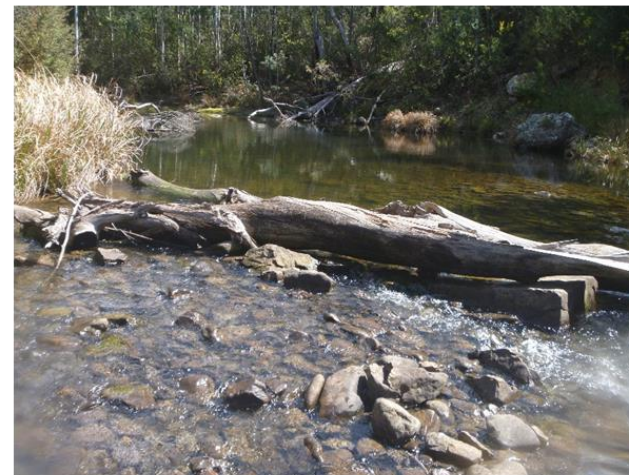
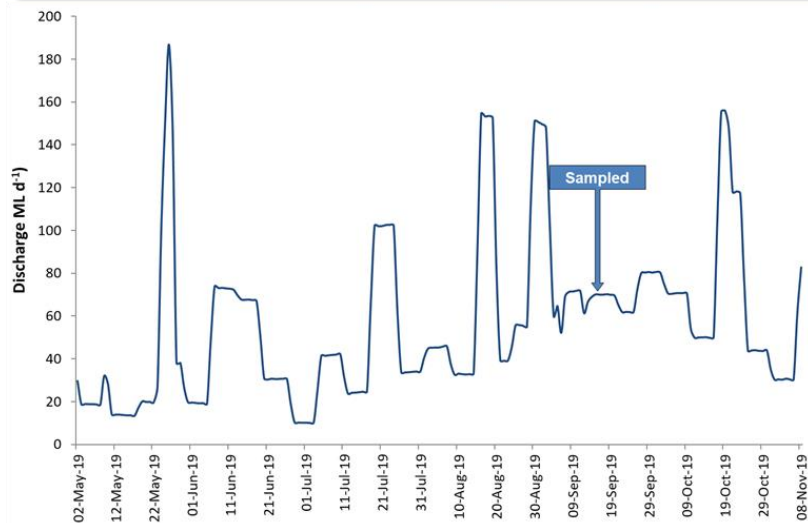
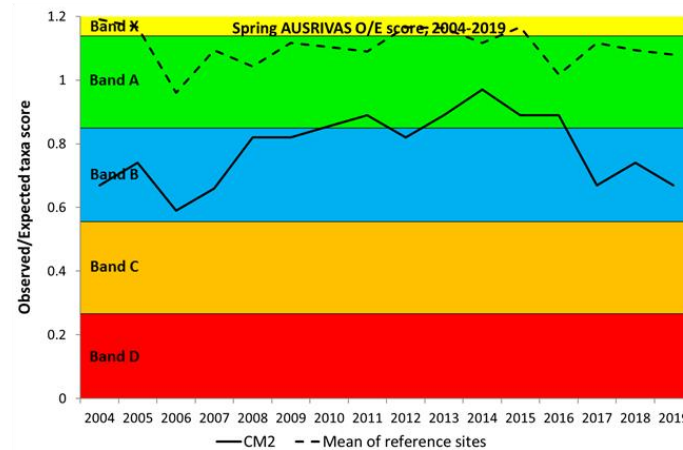
CM2 – Spring 2019

Downstream of Bendora Dam

Environmental flow ecological objective	Autumn 2019	Spring 2019	Objective met?
AUSRIVAS band A	Band B	Band B	No
<20% filamentous algae cover in riffle habitat	<10%	<10%	Yes

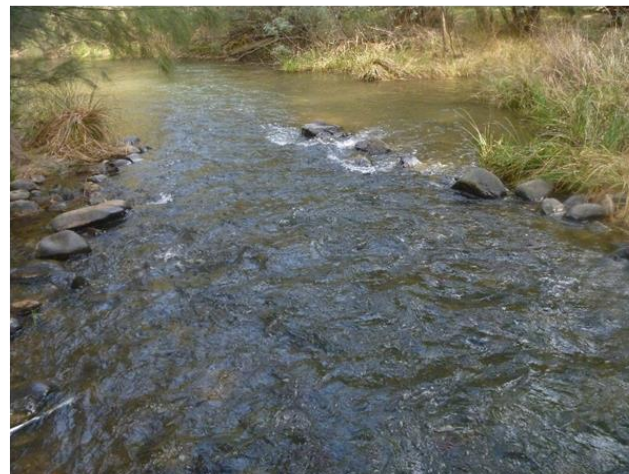
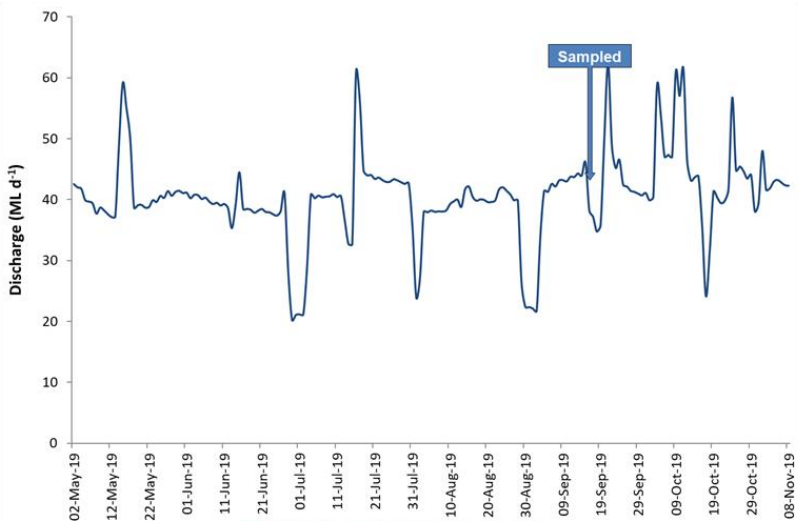
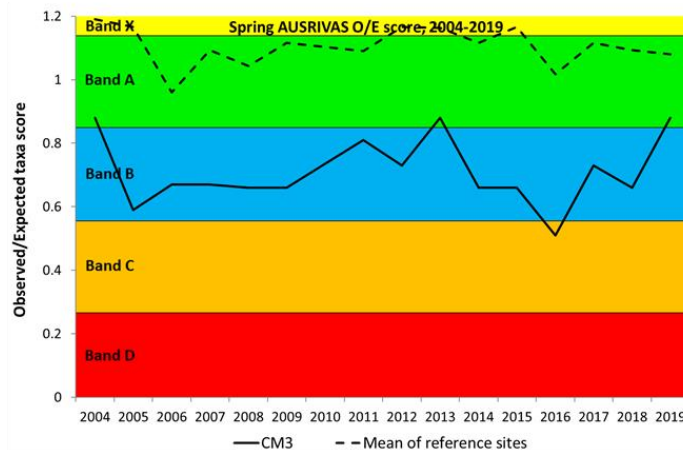
CM3 – Spring 2019

Downstream of Cotter Dam

Environmental flow ecological objective	Autumn 2019	Spring 2019	Objective met?
AUSRIVAS band A	Band C	Band A	Yes
<20% filamentous algae cover in riffle habitat	<10%	<10%	Yes

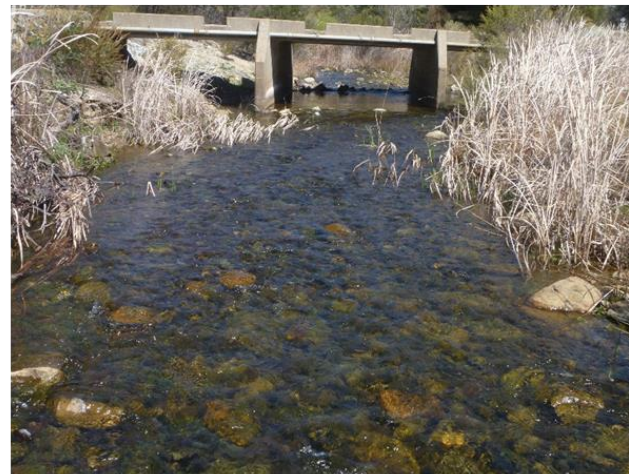
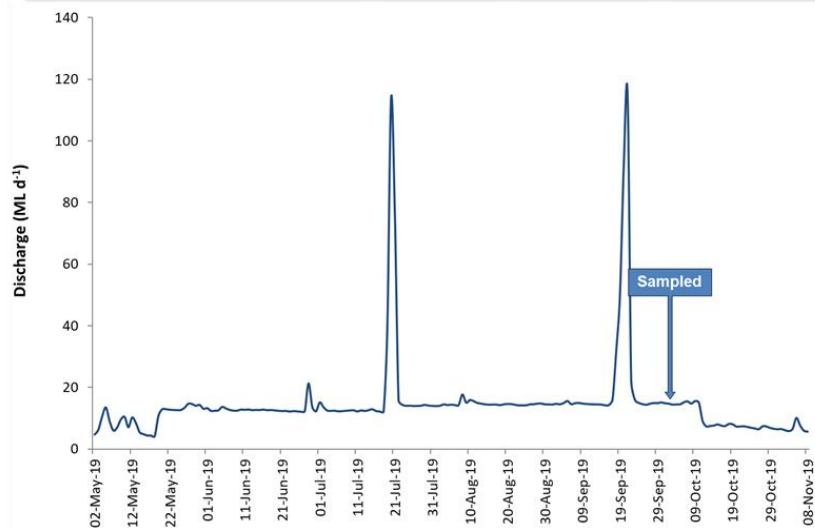
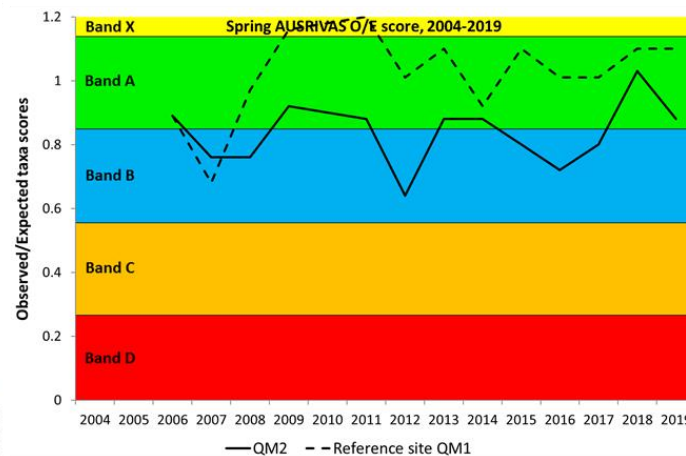
QM2 – Spring 2019

Downstream of Googong Dam

Environmental flow ecological objective	Autumn 2019	Spring 2019	Objective met?
AUSRIVAS band A	Band C	Band A	Yes
<20% filamentous algae cover in riffle habitat	<10%	<10%	Yes

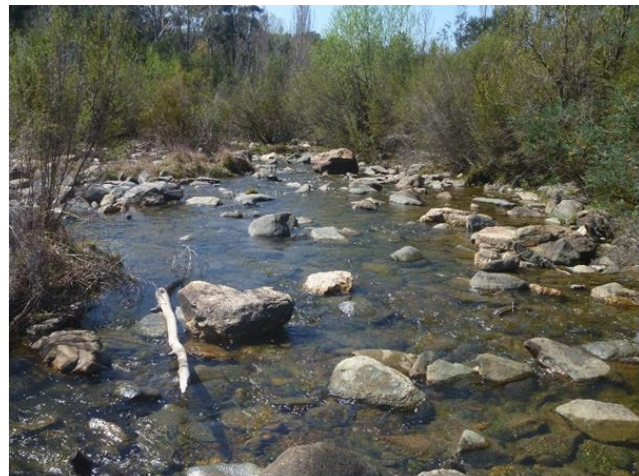
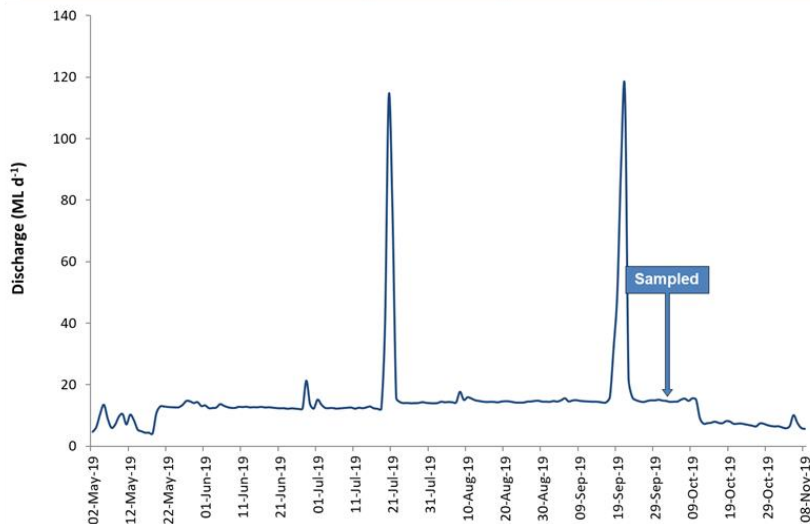
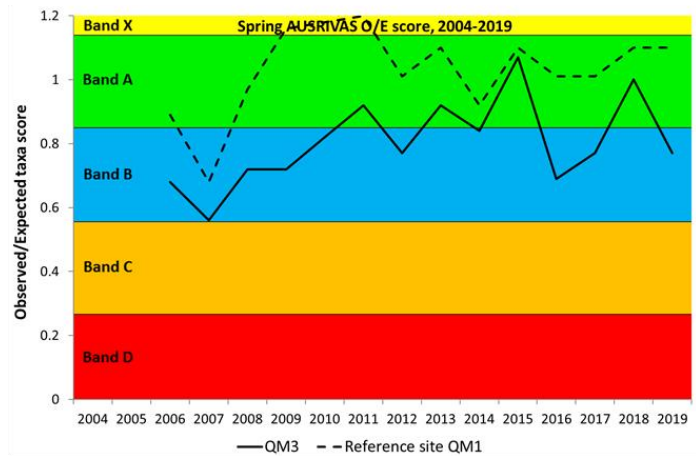
QM3 – Spring 2019

2km Downstream of Googong Dam

Environmental flow ecological objective	Autumn 2019	Spring 2019	Objective met?
AUSRIVAS band A	Band B	Band B	No
<20% filamentous algae cover in riffle habitat	<10%	<10%	Yes
