# BIOLOGICAL RESPONSE TO FLOWS DOWNS TREAM OF CORIN, BENDORA, COTTER AND GOOGONG DAMS

Spring 2015

Report to Icon Water

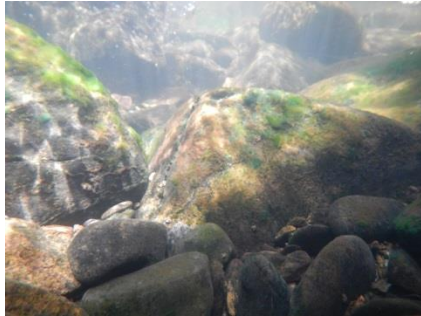
Figure 3. Filamentous algae cover of riffle bed sediments at below dam test sites and corresponding reference sites on the Goodradigbee and Queanbeyan Rivers in spring 2015.

- All test and reference sites met the environmental flow ecological objective of <20% cover of filamentous algae in riffle habitats. Site CM1 below Corin Dam was on the cusp of not meeting the filamentous algae cover objective. [Click here for more information](#)

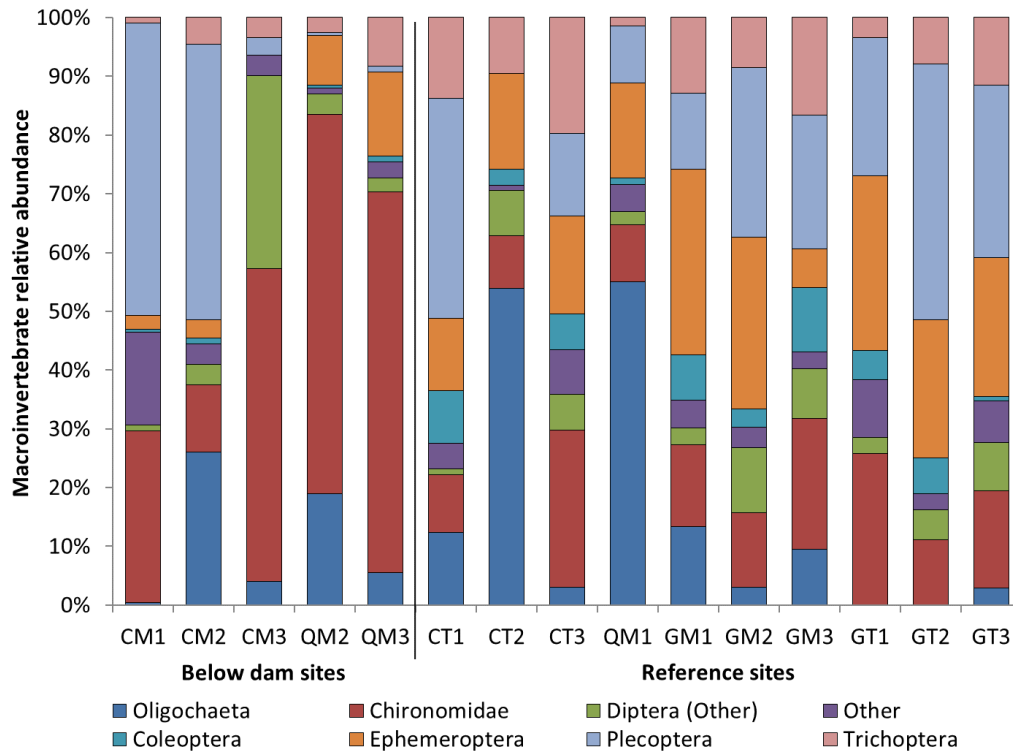
Figure 7: Relative abundance of macroinvertebrate taxonomic groups from samples collected in spring 2015.

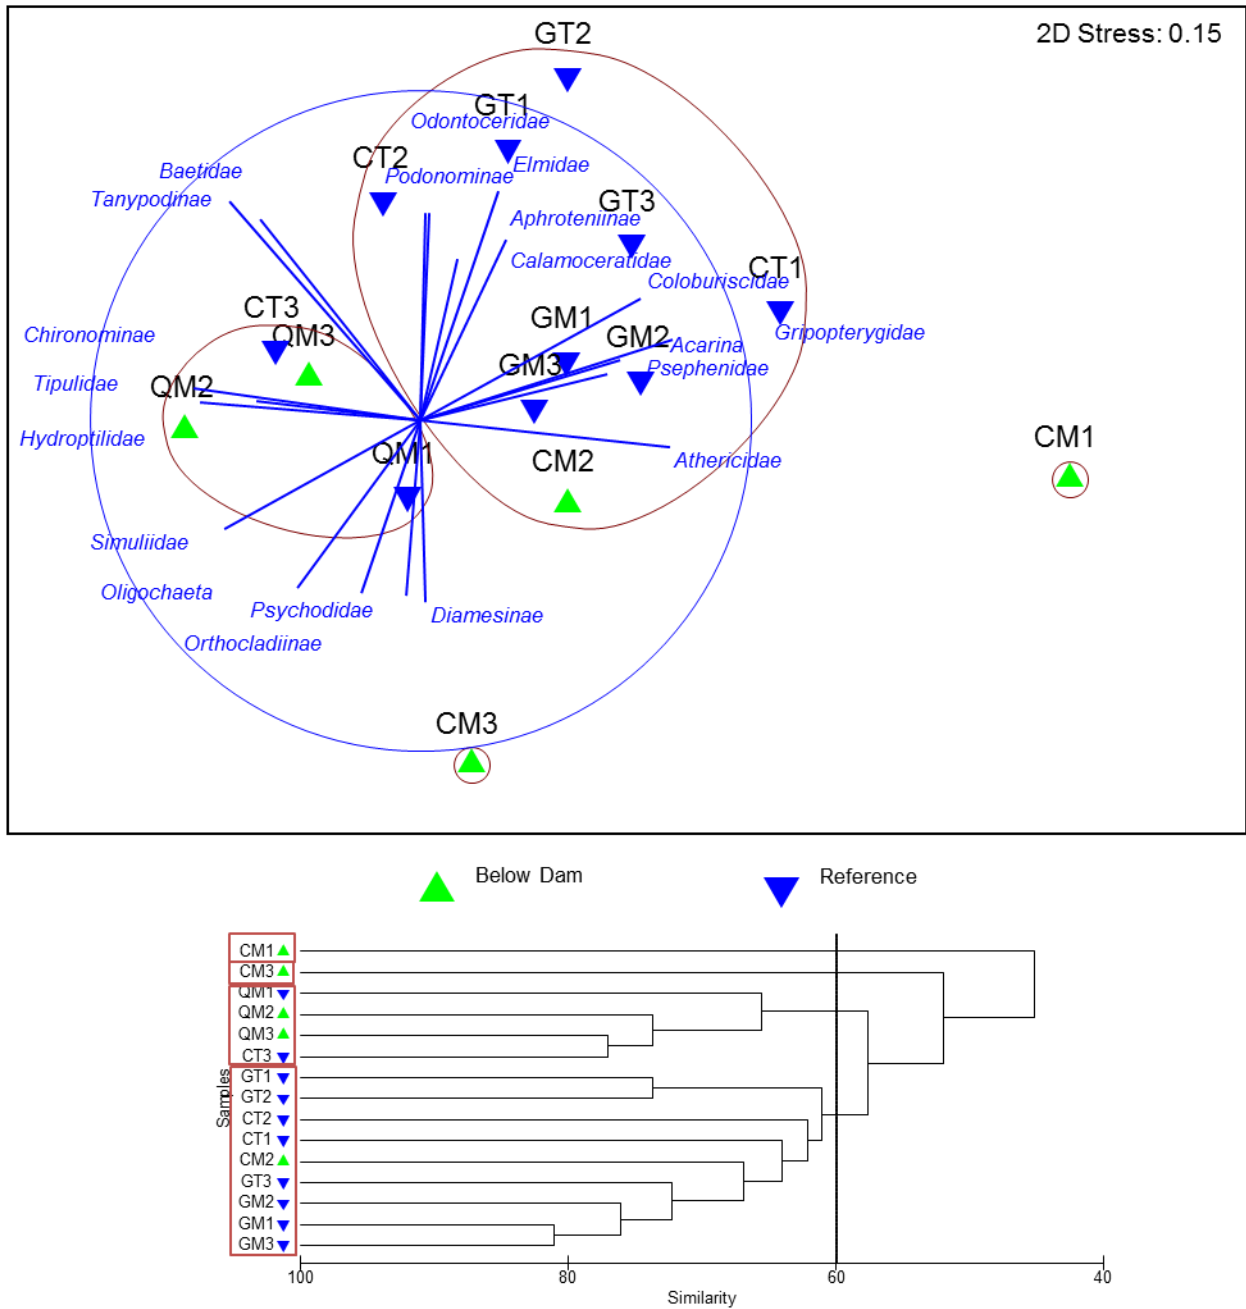
Cluster analysis based on the relative abundance of macroinvertebrate taxa identified two groups of sites at 60% similarity (Figure 8). Cotter River test sites CM1 (Corin Dam) and CM3 (Cotter Dam) had macroinvertebrate assemblages dissimilar to all other sites. The macroinvertebrate assemblage at test site CM2 below Bendora Dam grouped with each of the Goodradigbee River reference sites and Cotter River tributary site CT1 and CT2 (Figure 8).

Queanbeyan River test sites QM2 and QM3, grouped with the upstream Queanbeyan River reference site QM1 and Cotter River tributary site CT3. These sites had macroinvertebrate assemblages that were dissimilar to all other sites. This was primarily because of the higher relative abundance of [Simuliidae](#), [Chironominae](#), [Tanypodinae](#) and [Orthocladinae](#) taxa at these sites compared to other Goodradigbee and Cotter (except CM3) sites (which had greater relative abundances of taxa including [Gripopterygidae](#), [Coloburiscidae](#), and [Elmidae](#) (taxa shown in Figure 8 below with Pearson correlation greater than 0.5; Appendix 2).

Figure 8. MDS ordination (top) of 60% similarity determined by a cluster analysis (shown below MDS plot with defined groups outlined) between macroinvertebrate samples collected in spring 2015 for the below dams assessment program (red oval lines in the MDS plot). Similarity based on macroinvertebrate relative abundance. Macroinvertebrate taxa contributing to the differences between sites are shown on the plot. These taxa have Pearson correlations greater than 0.5.

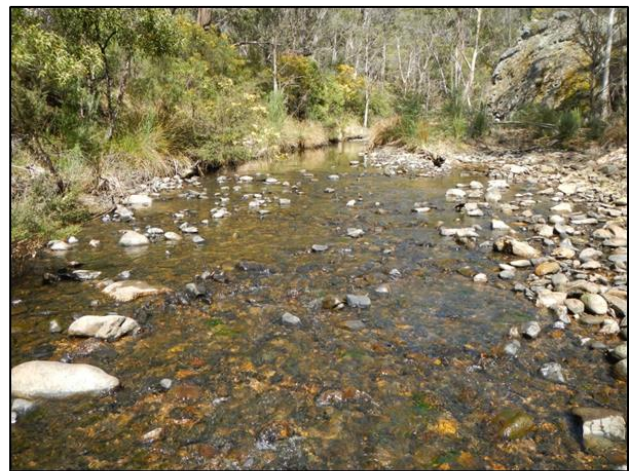
## Downstream of Corin Dam

Environmental flow ecological objective	Autumn 2015	Spring 2015	Objective met?
AUSRIVAS band A	Band B	Band B	No
<20% filamentous algae cover in riffle habitat	10%	20%	Yes

Cotter River test sites below Corin and Cotter Dams (CM1 and CM3) have remained biologically impaired since the previous assessment and therefore failed to meet the environmental flow ecological objective of AUSRIVAS band A. Site CM1 downstream of Corin Dam was assessed as significantly impaired. Over the last two years this site has regularly been assessed as band B. Therefore, the current assessment is within the biological condition experienced over the last two years.

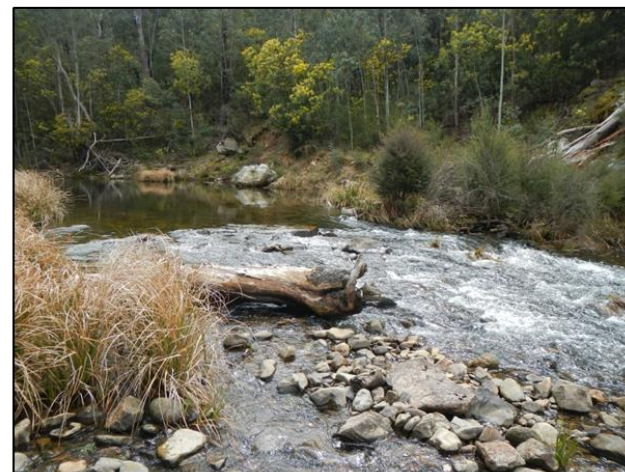
## Downstream of Bendora Dam

Environmental flow ecological objective	Autumn 2015	Spring 2015	Objective met?
AUSRIVAS band A	Band A	Band A	Yes
<20% filamentous algae cover in riffle habitat	<10%	<10%	Yes

Site CM2 downstream of Bendora Dam achieved the environmental flow ecological objective of AUSRIVAS band A in spring 2015 (Table 7). This site has been assessed as band A since spring 2014 and macroinvertebrate assemblage at this site was similar to that of the three reference sites on the Goodradigbee River (Figure 8). Therefore, the river flows downstream of Bendora Dam have been effective at maintaining a macroinvertebrate community similar to reference condition.

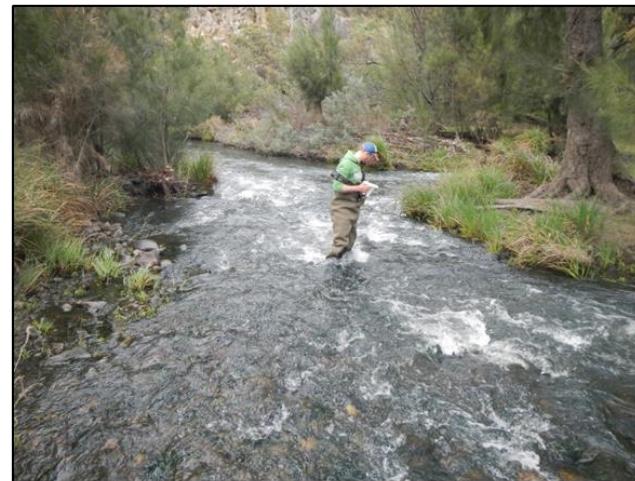
## Downstream of Cotter Dam

Environmental flow ecological objective	Autumn 2015	Spring 2015	Objective met?
AUSRIVAS band A	Band B	Band B	No
<20% filamentous algae cover in riffle habitat	<10%	15%	Yes

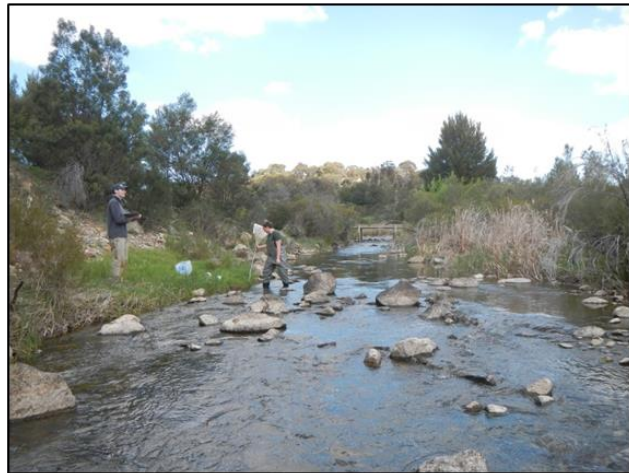
## Downstream of Goongong Dam

Environmental flow ecological objective	Autumn 2015	Spring 2015	Objective met?
AUSRIVAS band A	Band C	Band B	No
<20% filamentous algae cover in riffle habitat	10%	10%	Yes

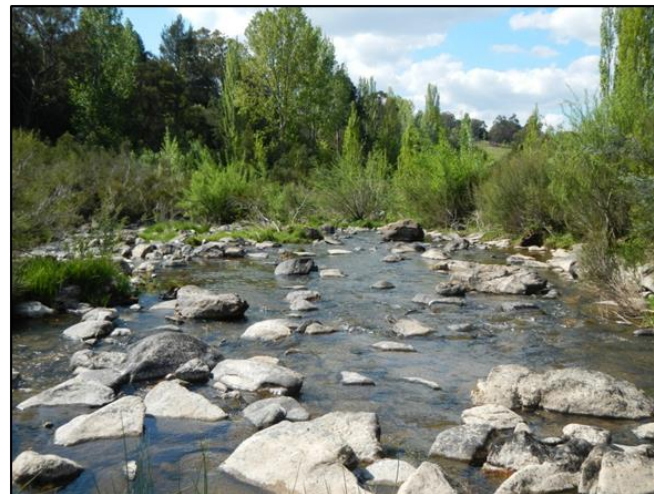
## 2km Downstream of Googong Dam

Environmental flow ecological objective	Autumn 2015	Spring 2015	Objective met?
AUSRIVAS band A	Band C	Band A	Yes
<20% filamentous algae cover in riffle habitat	<10%	<10%	Yes
