**ADDENDUM: COTTER CATCHMENT ACTION FOR CLEAN WATER (ACWA)
PLAN**

**Bushfire and erosion risk assessment in the Cotter River Catchment:
risk framework and options for management**

August 2020

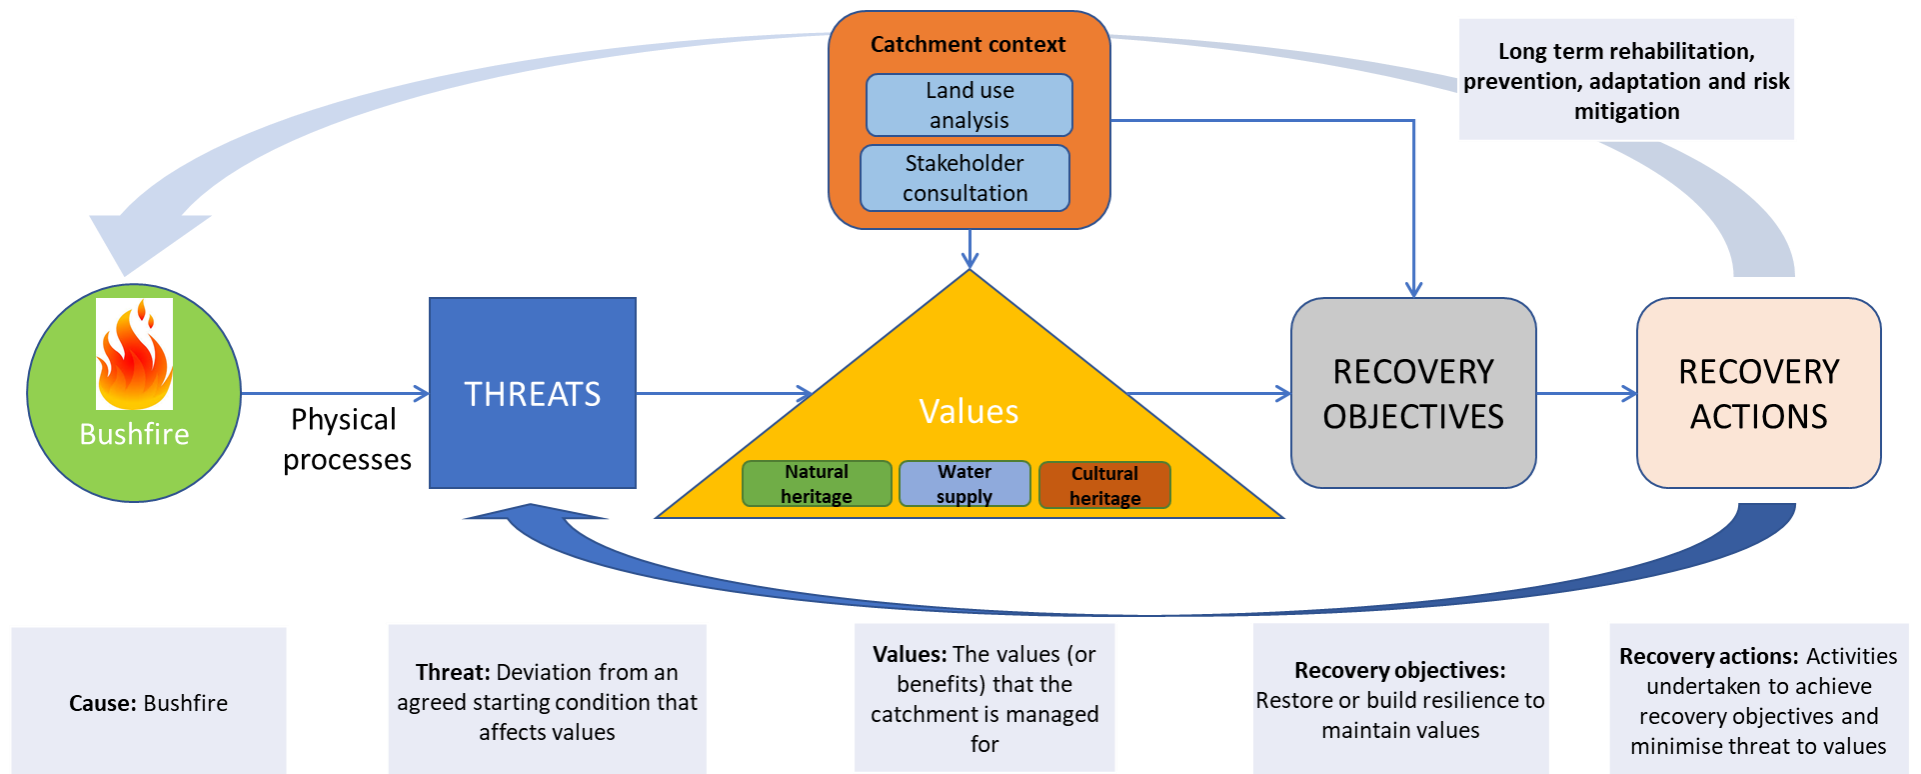
Figure 1. Bushfire recovery framework. The threats are described with an expanded schematic in Figure 2.

The framework applied to the development of a bushfire recovery plan considers risks and impacts related to natural disasters or emergency events in terms of **Values, Threats** and **Causes**, and is summarised in Figure 1. Under this framework, the Values of the catchment (e.g. water for potable use, biodiversity) may be impacted by Threats (e.g. soil erosion, loss of habitat, etc.) because of bushfire. **Recovery Objectives** are critical to the framework and depend upon the relationship between the values of the catchment and the anticipated future values of the catchment, in the event of a bushfire. In this framework we assumed the values and management objectives remain unchanged in the event of a bushfire. **Recovery Actions** reflect Recovery Objectives and are directed towards managing and mitigating the Threats and, in the long-term, managing the processes that result in bushfire.

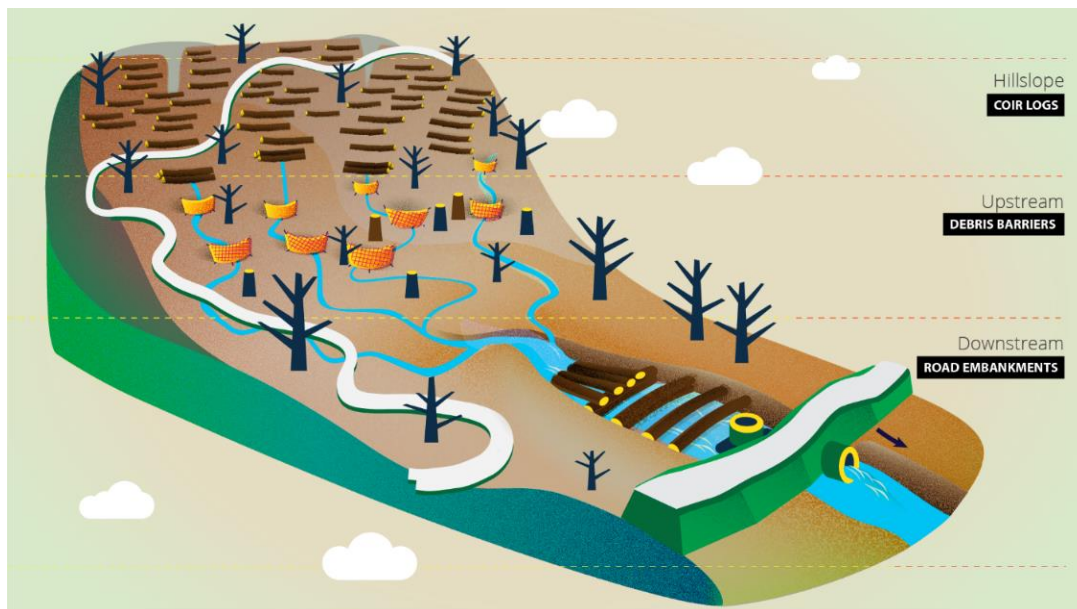
Figure 9. Techniques for erosion and sediment control in burned catchments. If appropriate, wood mulch or wood-shred can be used together with coir logs for a more intensive intervention strategy.

Use of check dams and small ponds to provide opportunities for fine sediment to settle/deposit prior to reaching the water offtake. In-channel structures such as log jams and road embankments reduce flow velocities and provide opportunities for water to pond, resulting in sediment settling out of the flow (Verstraeten & Poesen, 2000).

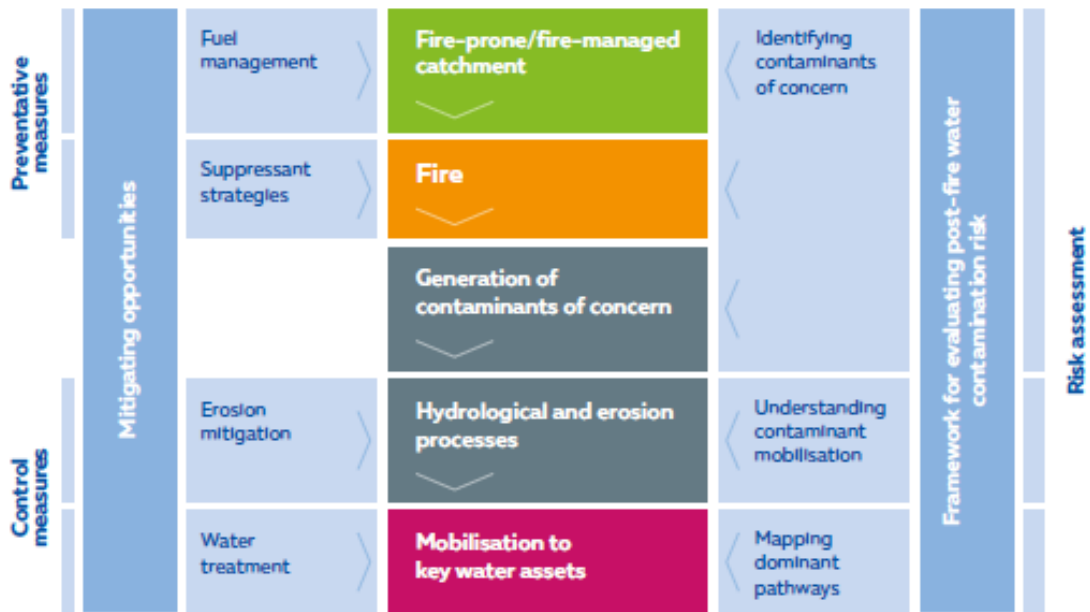
Figure 11. Framework for predicting post-fire contamination risk. From Nunes et al (2018)

In designing and prioritising monitoring and research activities, the framework in Figure 11 provides some guidance on the different aspects of risk and the mitigation measures that can be implemented. Ultimately, any investment in monitoring and research should be embedded in and inform the well-established four-phase disaster management approach of prevention (planning), preparedness, response and recovery (Canning et al, 2020).
