BIOLOGICAL RESPONSE TO FLOWS DOWNSTREAM OF CORIN, BENDORA, COTTER AND GOOGONG DAMS

Spring 2018

Summary report to Icon Water

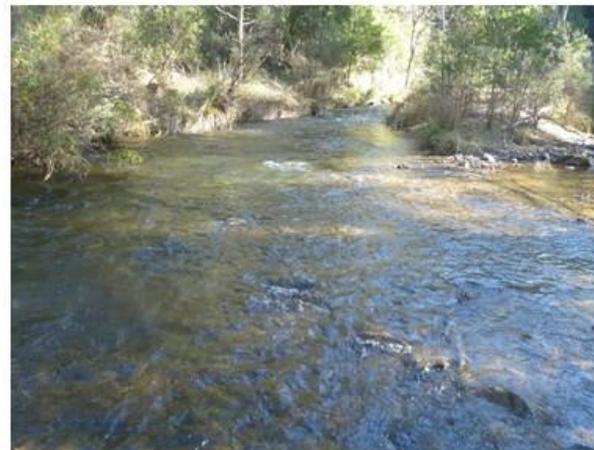
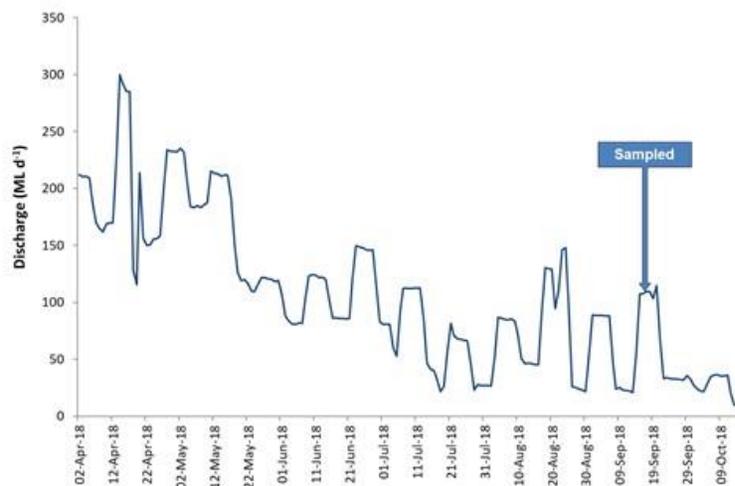
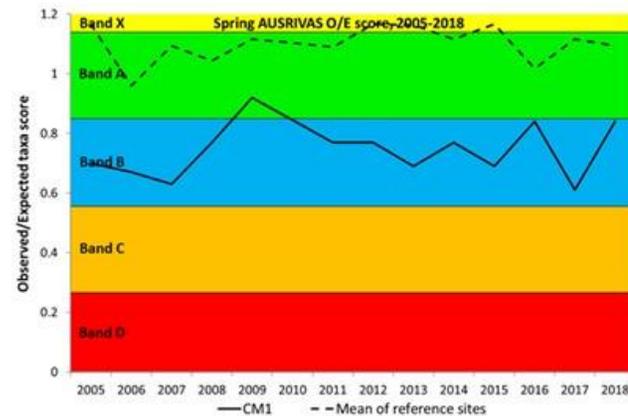
CM1 – Spring 2018

Downstream of Corin Dam

Environmental flow ecological objective	Autumn 2018	Spring 2018	Objective met?
AUSRIVAS band A	Band B	Band B	No
<20% filamentous algae cover in riffle habitat	<20%	<20%	Yes

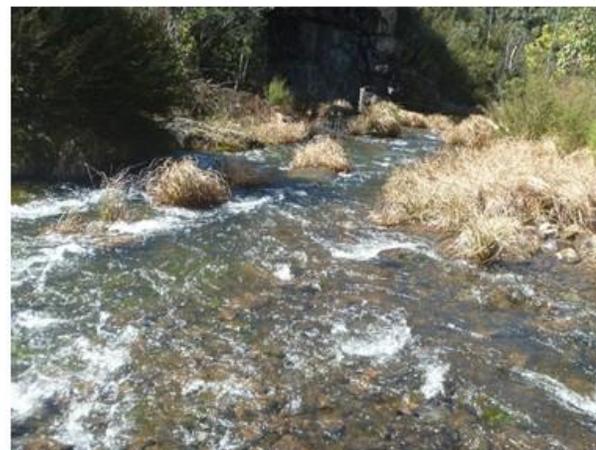
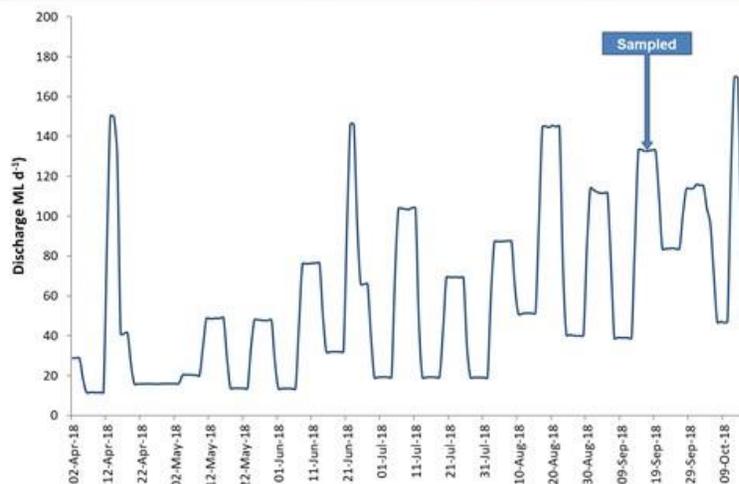
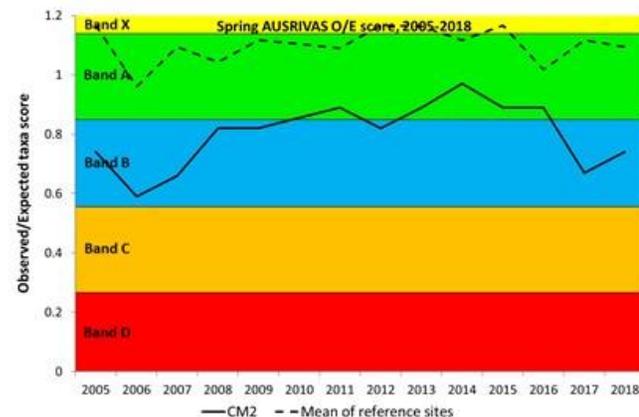
CM2 – Spring 2018

Downstream of Bendora Dam

Environmental flow ecological objective	Autumn 2018	Spring 2018	Objective met?
AUSRIVAS band A	Band B	Band B	No
<20% filamentous algae cover in riffle habitat	<10%	<10%	Yes

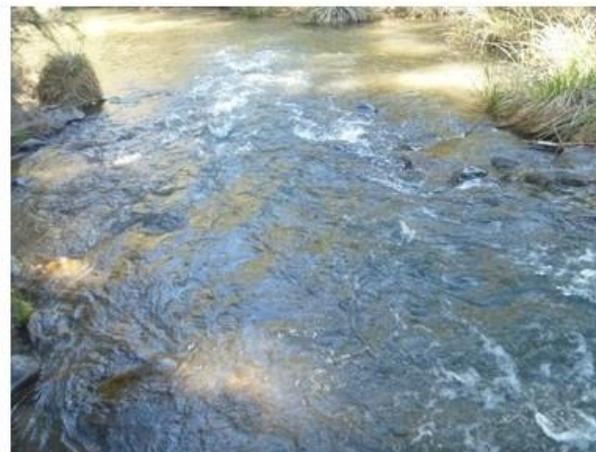
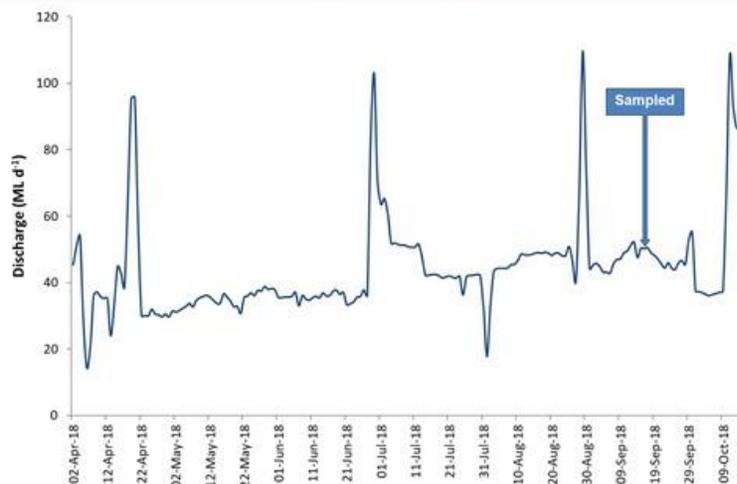
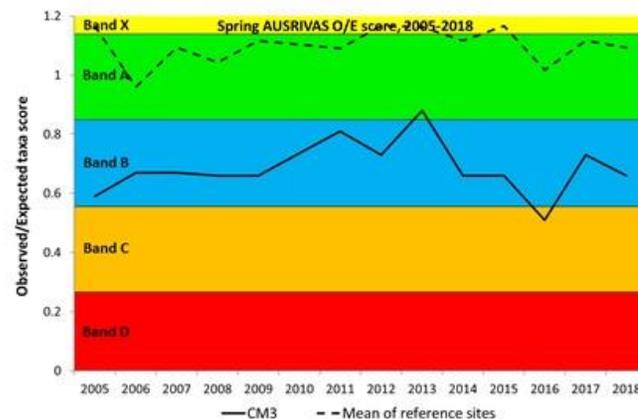
CM3 – Spring 2018

Downstream of Cotter Dam

Environmental flow ecological objective	Autumn 2018	Spring 2018	Objective met?
AUSRIVAS band A	Band B	Band B	No
<20% filamentous algae cover in riffle habitat	<10%	<20%	Yes

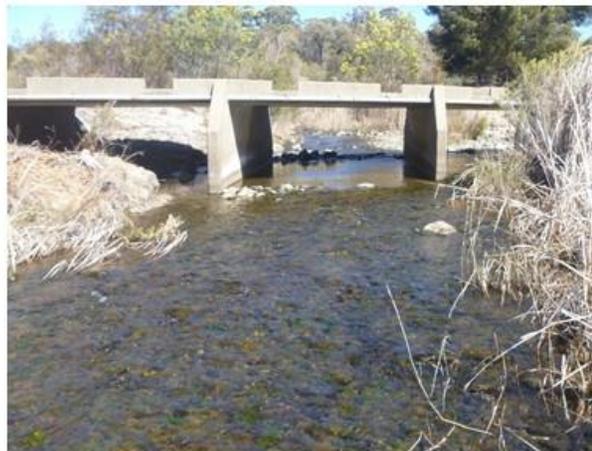
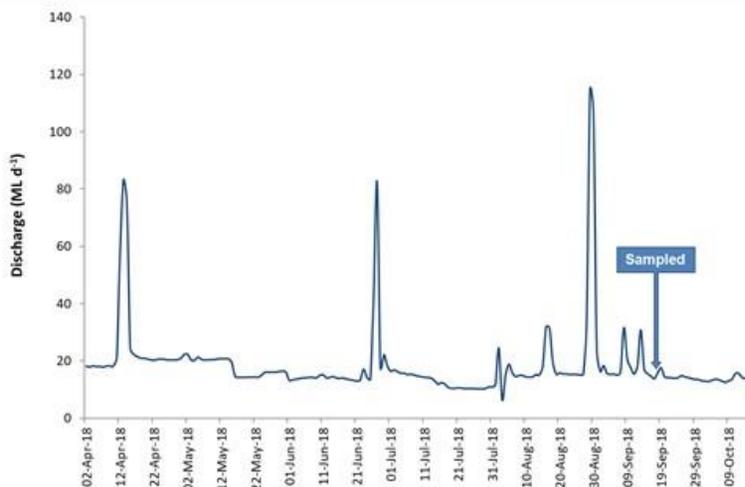
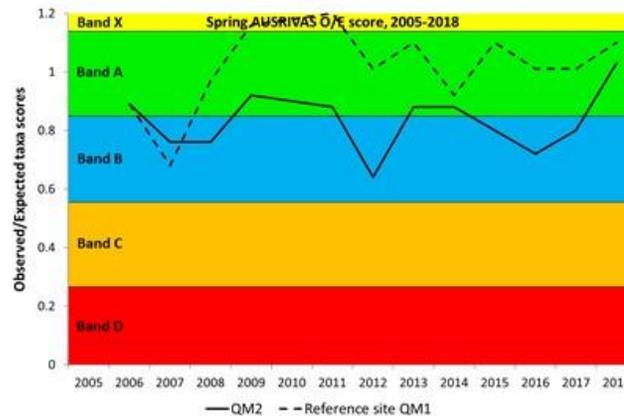
QM2 – Spring 2018

Downstream of Googong Dam

Environmental flow ecological objective	Autumn 2018	Spring 2018	Objective met?
AUSRIVAS band A	Band B	Band A	Yes
<20% filamentous algae cover in riffle habitat	<10%	>20%	No

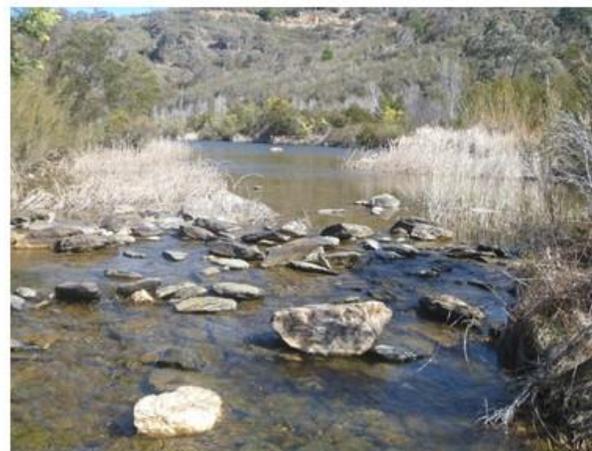
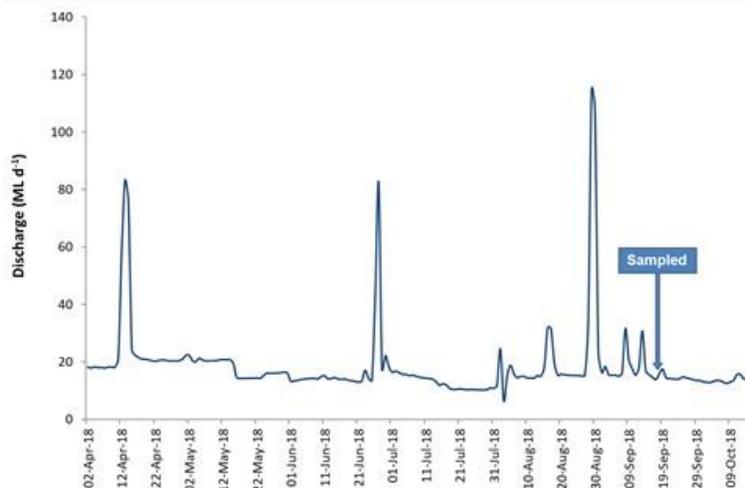
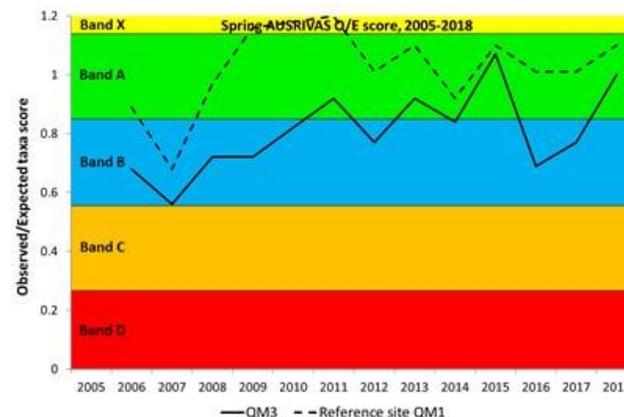
QM3 – Spring 2018

2km Downstream of Googong Dam

Environmental flow ecological objective	Autumn 2018	Spring 2018	Objective met?
AUSRIVAS band A	Band C	Band A	Yes
<20% filamentous algae cover in riffle habitat	<10%	<10%	Yes
