FINAL REPORT:

Googong Dam catchment Actions for Clean Water Plan

December 2018

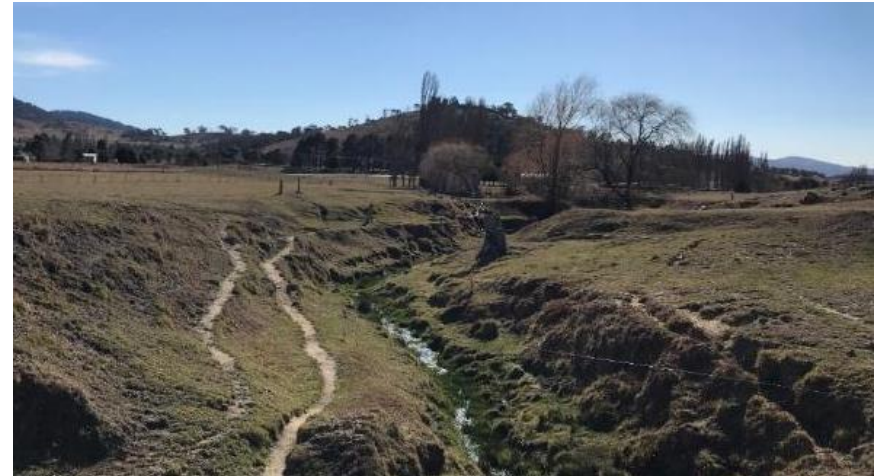
The site photo (right) show a section of the reach immediately upstream and downstream of Badgery Road. The reach appears to have undergone significant deepening due to incision into the highly erodible soils. The area is almost completely devoid of vegetation due to post 1800s clearing for agricultural purposes. Although there are still some incision processes occurring within the low flow channel, the mid to upper banks appear of low grade, apart from some isolated areas of active gully erosion due to stock impacts.

Site MZ1a Looking downstream from Badgery Road bridge

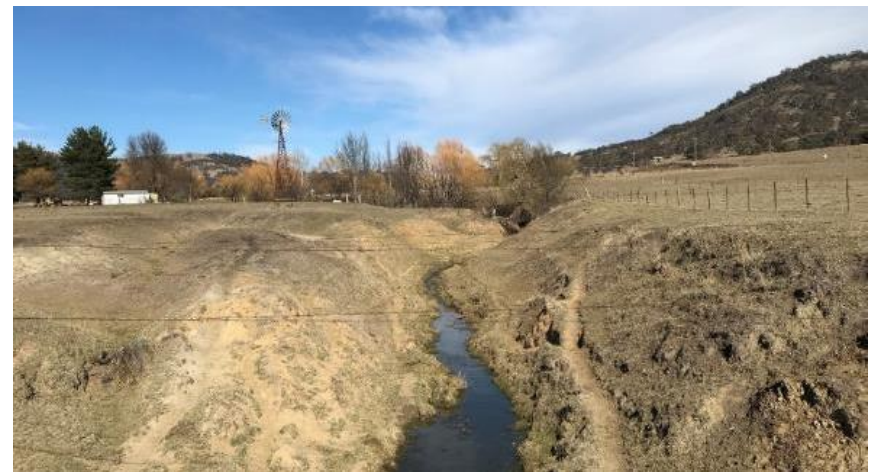
Site MZ1b Looking upstream from Badgery Road bridge

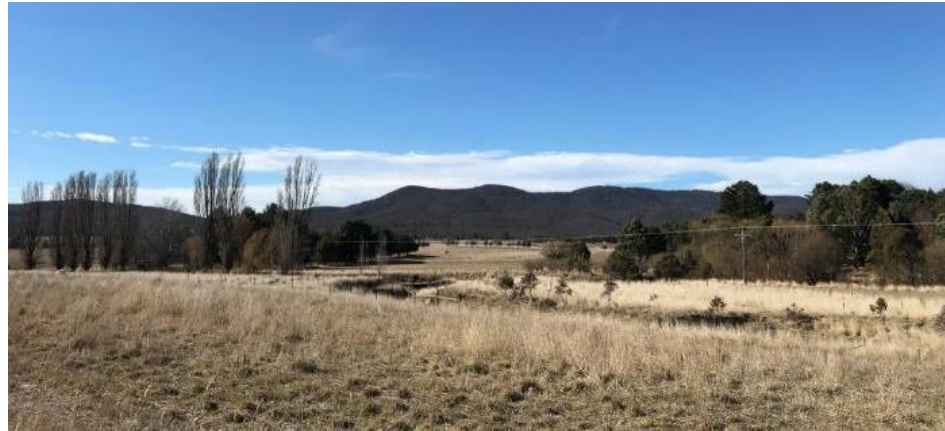
Site MZ1b is located along a tributary of the above-mentioned main Burra Creek tributary where it crosses under Williamsdale Road. The reach is shown in Figure 31 (Appendix E) and was initial classed as having moderate instabilities which in turn resulted in it being classed as having a *high* channel erosion risk. However, following the ground field assessment of the reach it was identified that the instabilities within the reach were better classed as minor instabilities which lowered the channel erosion risk to moderate. The photos below show a section of the reach immediately upstream and downstream of Williamsdale Road. The reach appears to be largely stable upstream of the crossing, however, beyond this short section and further up the valley, near vertical unstable banks were identified. It is thought that backwater effects from the road crossing and subsequent vegetation establishment (mainly willows) in the accumulated sediments dropping out of the water column has stabilised this particular section. However, this is not representative of the whole reach. Looking downstream of the Williamsdale Road crossing it can be seen that the channel has undergone deepening and is now widening. Again, the area is almost completely devoid of vegetation due to post 1800s clearing for agricultural purposes. There is some grass coverage on the upper banks and revegetation has been attempted. This reach is more representative of the reach as a whole, which has been classified as having a moderate channel erosion risk.

*Site MZ1b looking downstream of Williamsdale Road towards confluence with main tributary.
Note some revegetation effort*

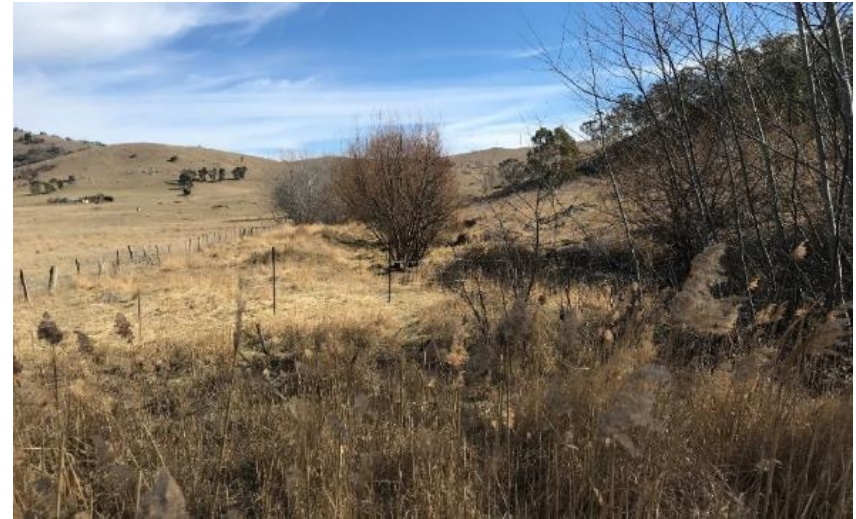
Site MZ1b looking upstream of Williamsdale Road

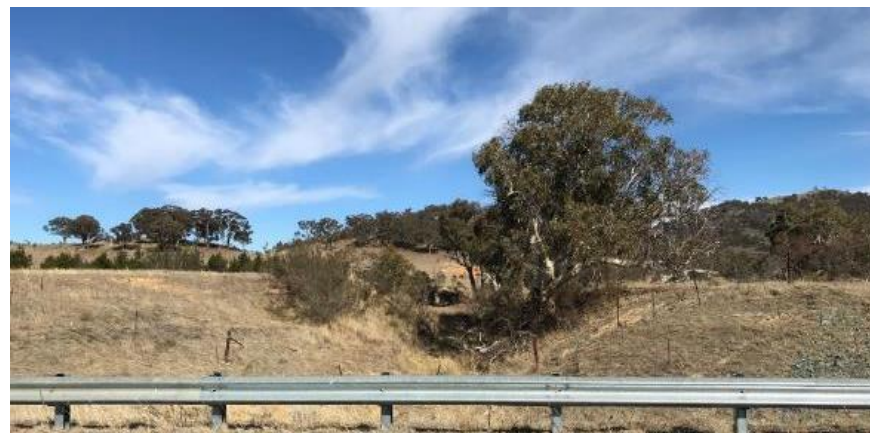
Site MZ2a is located along the southern tributary within the wider priority management zone 2 area where it crosses MacDiarmid Road. The site was initially classed as having moderate instabilities, which in turn resulted in it being classed as having a *high* channel erosion risk. However, following on the ground field assessment of the reach it was identified that the instabilities within the reach were better classed as minor, which lowered the channel erosion risk to *moderate*. The figures to the right and below show a section of the reach immediately upstream and downstream of MacDiarmid Road. The reach appears to be largely stable upstream of the crossing, however, beyond this short section and further up the valley, near vertical unstable banks were identified (exposed red/orange soil banks in photos). It is thought that backwater effects from the road crossing has helped in stabilizing this particular section, which is not representative of the whole reach. Looking downstream of the MacDiarmid Road it can be seen that the channel has undergone deepening and widening with some near vertical 3 m banks. Immediately downstream of the crossing, stabilisation works have been implemented in the form of large rock beaching protection in order to prevent undercutting of the road.

Site MZ2a looking upstream of MacDiarmid Road

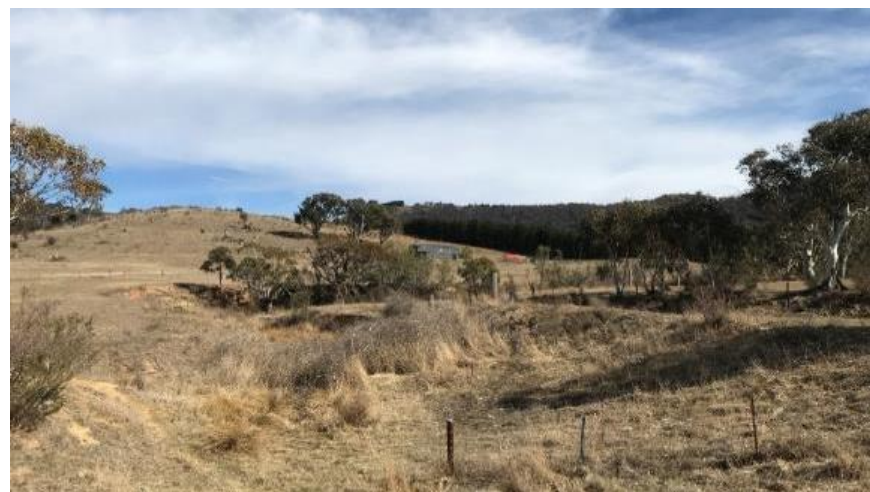
Site MZ2b is located along the northern tributary within the wider priority management zone 2 area where it crosses MacDiarmid Road. The site was initially classed as having moderate instabilities, which in turn resulted in it being classed as having a *high* channel erosion risk. However, following on the ground field assessment of the reach, it was identified that the instabilities within the reach were better classed as minor, which lowered the channel erosion risk to *moderate*. The figures to the right and below show a section of the reach immediately upstream and downstream of MacDiarmid Road. The reach appears to be largely stable upstream of the crossing, however, beyond this short section and further up the valley near vertical unstable banks were identified. It is thought that backwater effects from the road crossing has helped in stabilizing this particular section, which is not representative of the whole reach. Looking downstream of the MacDiarmid Road it can be seen that the channel has undergone some deepening and widening, however not as much as the southern tributary at site MZ2a. There is some sediment accumulation along the left bank downstream of the culvert that has been held in place by what appear to be recent stabilisation works in the form of large rock beaching protection.

Site MZ2b looking upstream of MacDiarmid Road

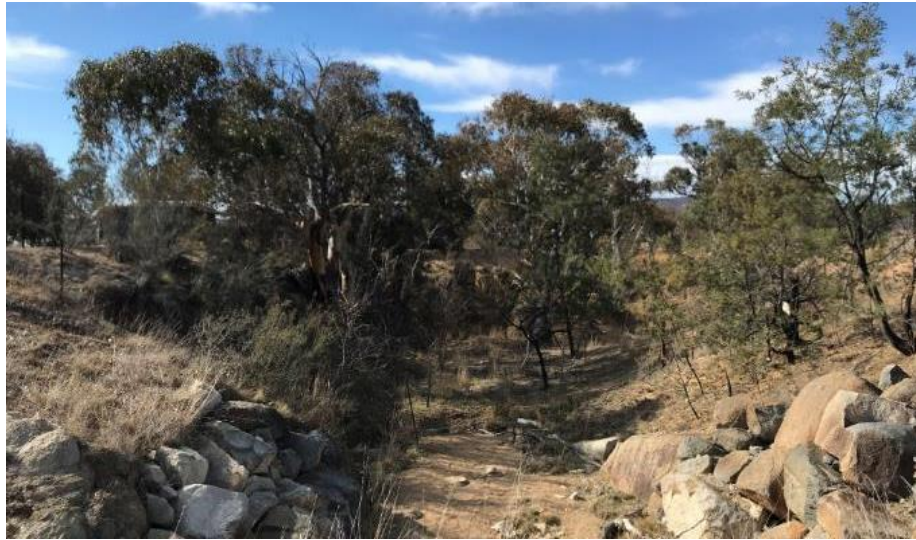
Site MZ2a looking downstream of MacDiarmid Road

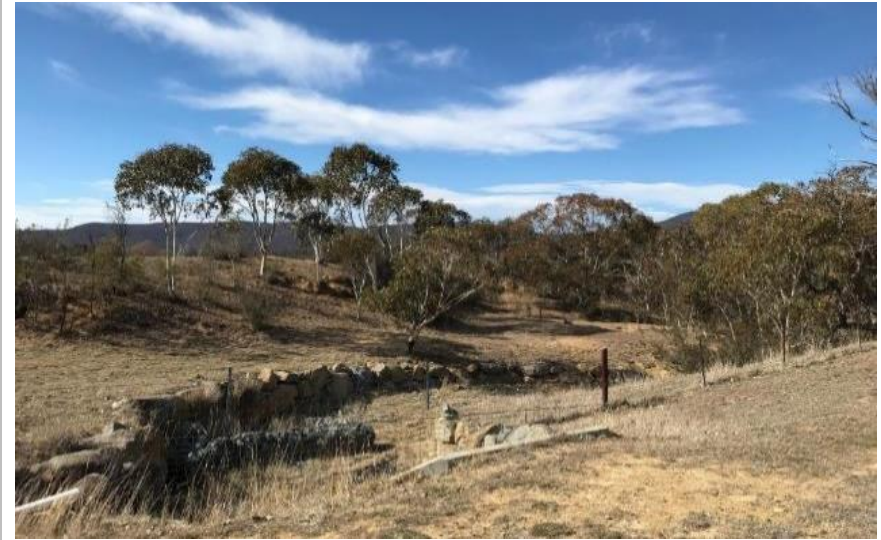
Site MZ2b looking downstream of MacDiarmid Road

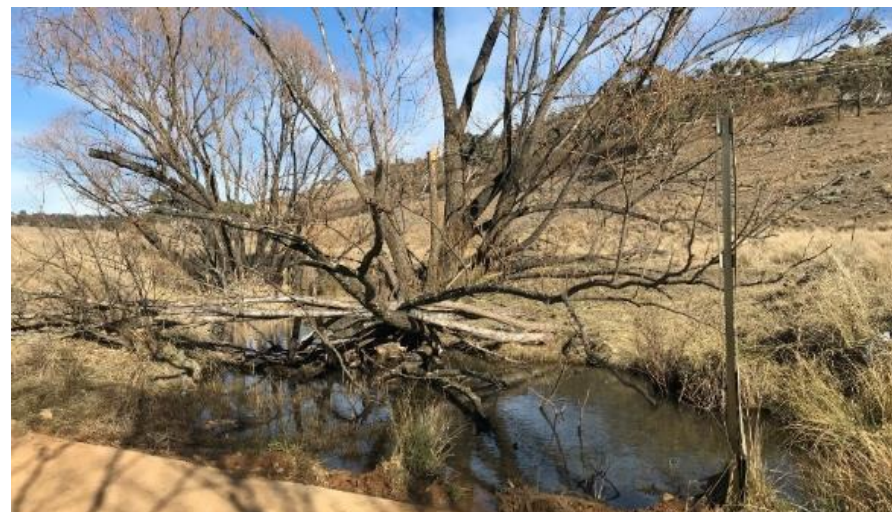
From the road crossing looking upstream (photo on right) it can be seen that this reach is stable, most probably in part due to the crossing preventing the head cut from migrating any further upstream. Figure below right looking downstream of the crossing indicates deepening (downstream of the crossing is approximately 2m lower than the upstream side) and widening has occurred. Just downstream of the crossing erosion is exacerbated as this is the location of the confluence for two main tributaries and a further unmapped tributary.

Site MZ5a looking upstream from Burra Road crossing

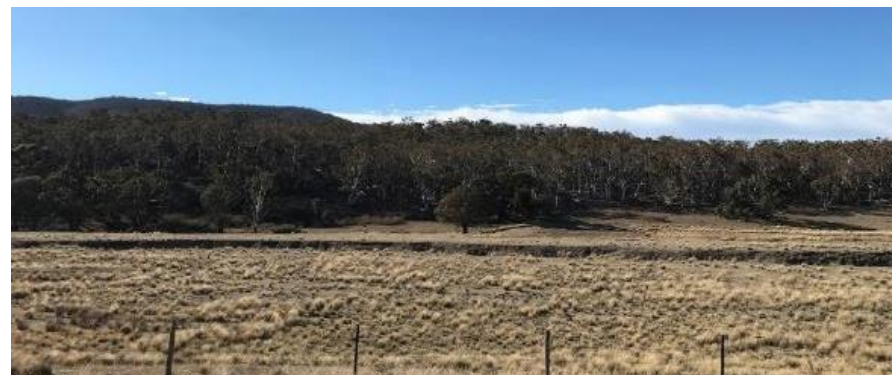
Examining the photos taken from site MZ5b it can be seen that there are unstable near vertical banks all throughout this reach. The soils in the area consisted of highly dispersible clayey sands interspersed with sands and gravels. There were also notable outcrops of hard bedrock, probably granites. The extent of this bedrock throughout the system is unable to be determined without a more thorough field investigation with access to more of the reach.

Site MZ5b looking from Burra road towards Cassidy's Creek. Note eroding right bank running through centre of picture. Estimates based on banks upstream and from lidar puts this bank at 3-5m vertical.

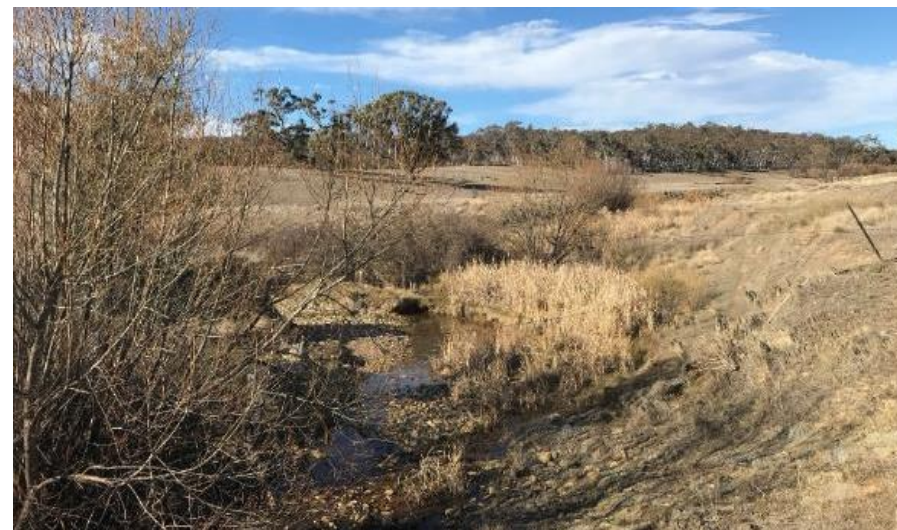
Looking downstream from the Burra Creek crossing it could be seen that there were some instabilities overall, with some near vertical banks on the outside bends. Soils in this area were highly dispersible interspersed with sands and larger gravels and cobbles/boulders. Bedrock outcrops were also present in the base of the channel in areas.

Site MZ5c Burra Creek looking upstream from Burra Road crossing

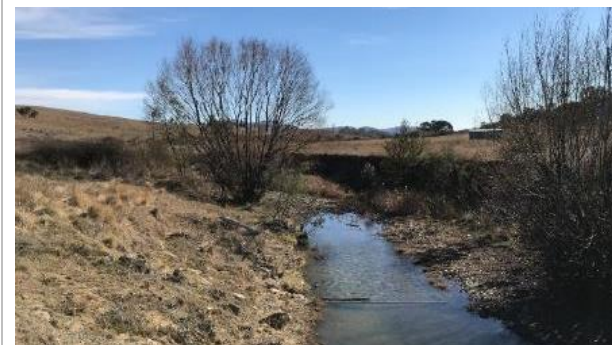
Site MZ5c Burra Creek looking downstream from Burra Road crossing

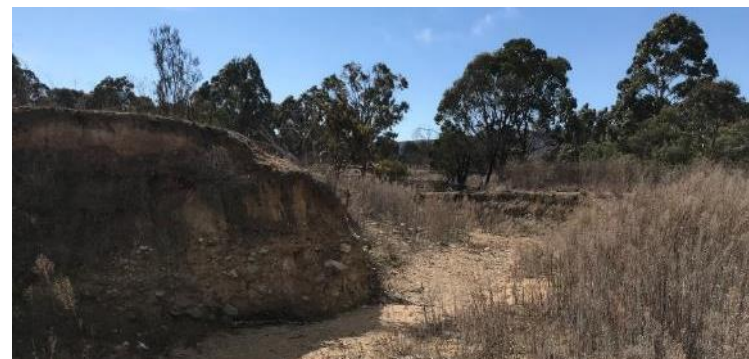
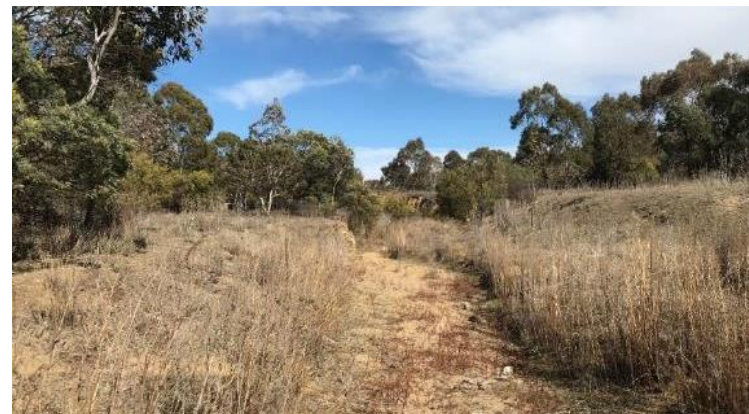
Site MZ6a

Looking upstream (lower photo) it can be seen that there is a wide floodplain but again in the distance is some near vertical banks indicating erosion on a bend. It should be noted that this tributary outfalls to a smaller dam (that is not part of the main Googong Reservoir) before entering Googong Reservoir. Although this dam would act as a sediment sink for some eroded material entering from upstream, finer sediments are still likely to pass through the system and during high flow events the sediment loads of all fractions will be high.

As well as the identified channel erosion management zones there are large areas of hillslope erosion that should be managed by changes in land use practices.

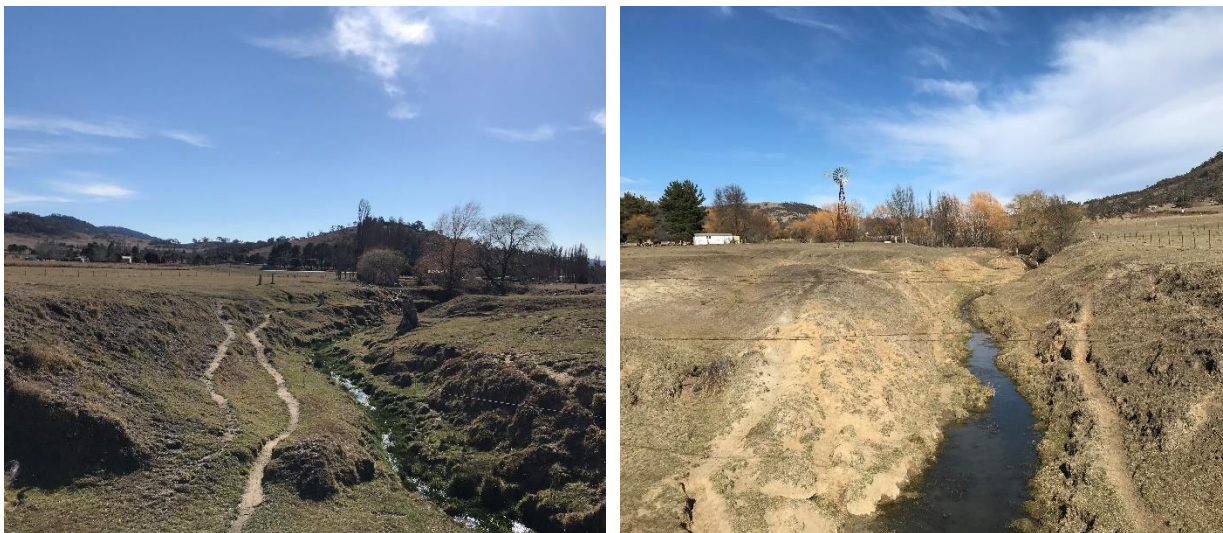
The impacts of stock on waterways in the priority management zones, and in particular the effect they are having on increased sediment supply to the downstream receiving system, were apparent during the field inspections. Direct structural damage and weakening of the banks caused by stock together with the destruction of riparian vegetation was observed throughout the management zones.

Evidence of unrestricted stock access, causing bank instabilities and therefore acting as sources of sediment within the management zones, are shown below in Figure 12.

Figure 12. Example of stock impacted waterways within Googong catchment. Note informal tracks along banks

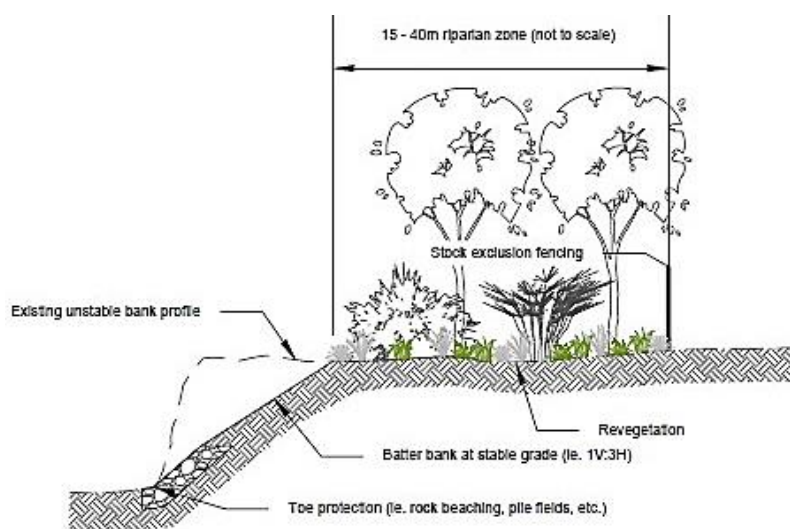
Figure 14. Option 2 - Stock exclusion, isolated bank reprofiling, isolated toe protection and revegetation works

This option requires higher financial investment and higher ongoing maintenance requirements. However, by stabilising unstable banks directly and increasing the likelihood of riparian vegetation establishment, this option would have a much better chance of long-term success.

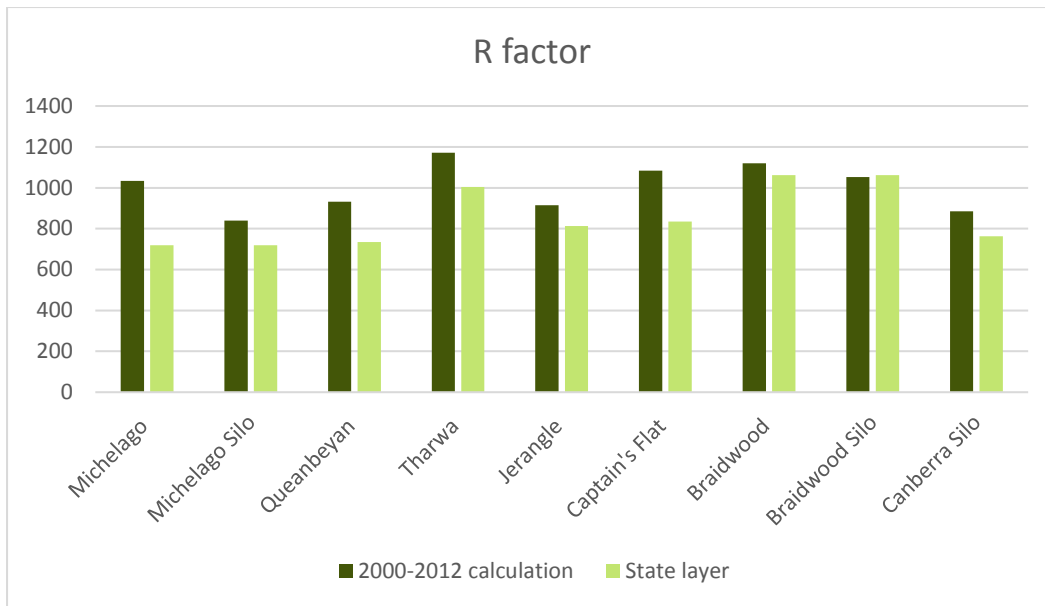
Figure 21. Comparison of R calculation methods for selected locations
