Annual Drinking Water Quality Report 2015–16

This report covers the period of 1 July 2015 to 30 June 2016.

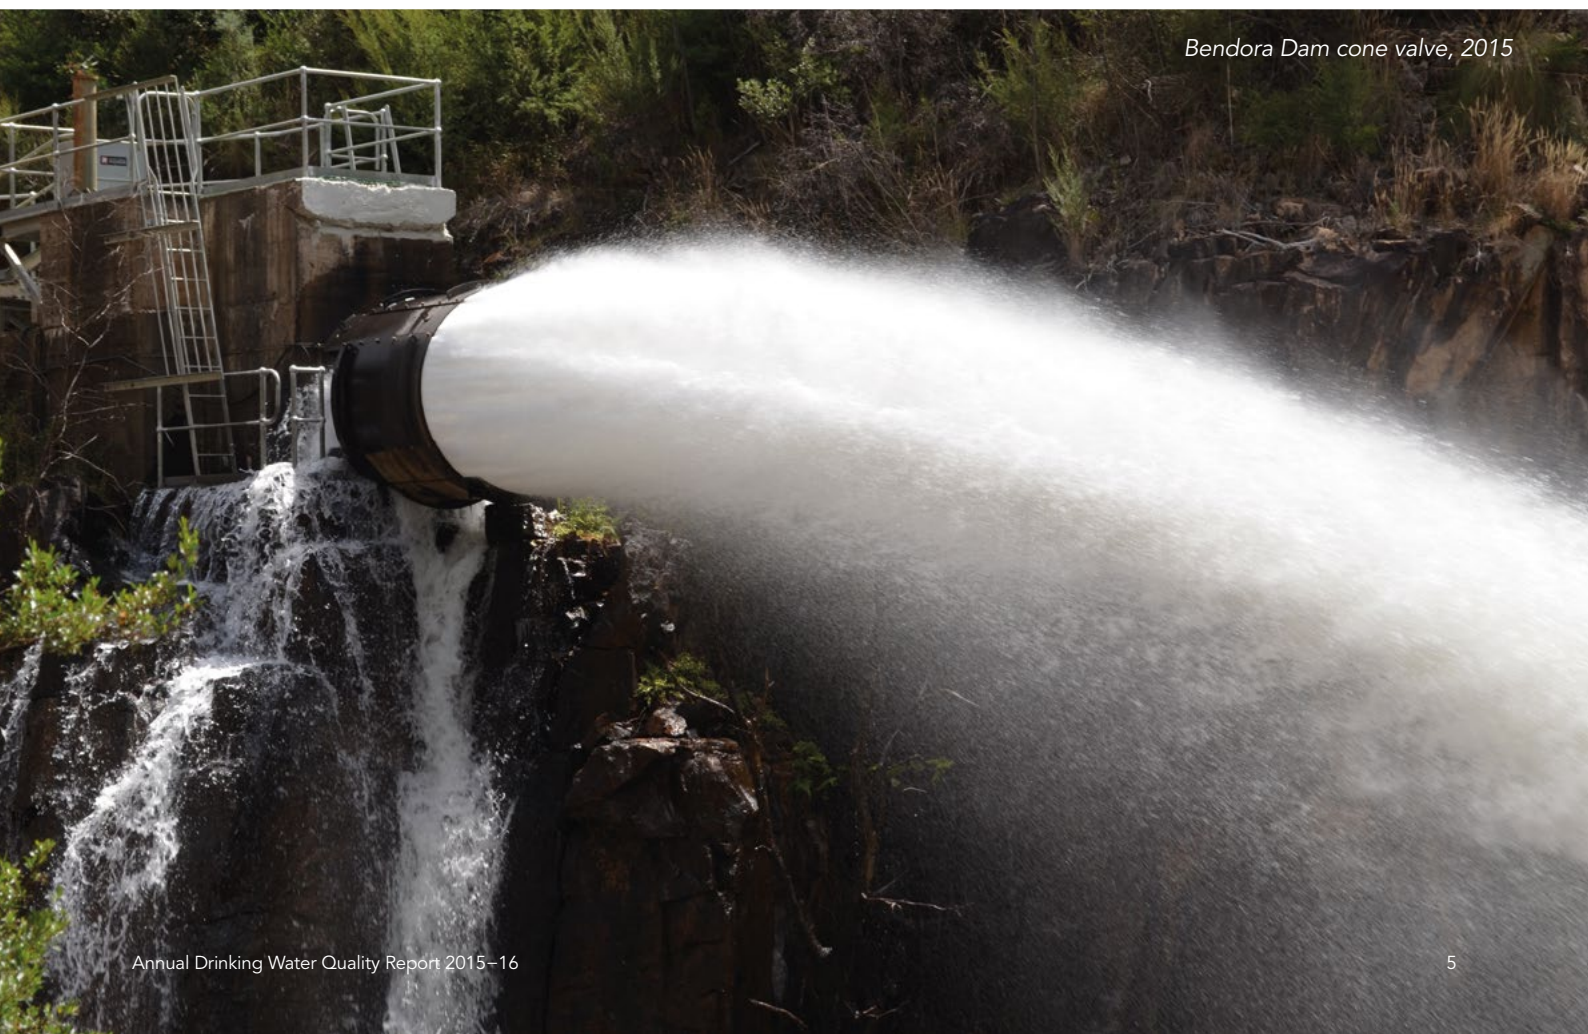
Bendora Dam cone valve, 2015

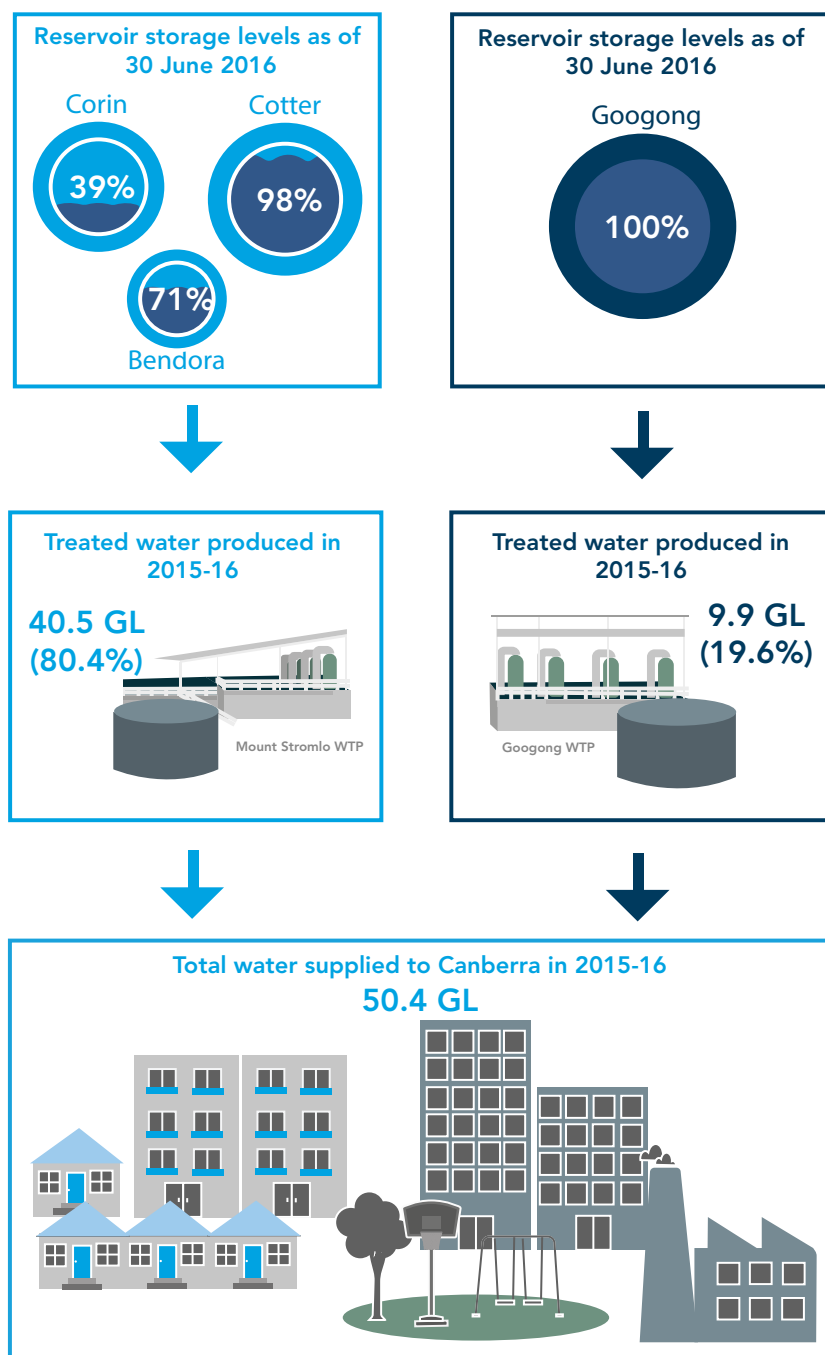
Figure 3-1 Reservoir storage levels and drinking water production for 2015–16

The Queanbeyan River catchment, located to the south-east of Canberra, contains both developed and impacted land, which includes forestry reserves, rural pasture and rural residential properties. NSW state agencies and local government councils regulate land planning and manage activities in this catchment. Parks and Conservation Services (PCS) manage the immediate area around the Googong reservoir and recreational access to the water body and foreshore. The Googong reservoir on the Queanbeyan River is the largest of the four water supply reservoirs and represents 43.0% of Canberra's storage capacity. At the end of June 2016 Googong reservoir was at 100% capacity. The Googong reservoir provided 19.6% of the water supplied to Canberra and Queanbeyan during 2015–16 (Figure 3-1).

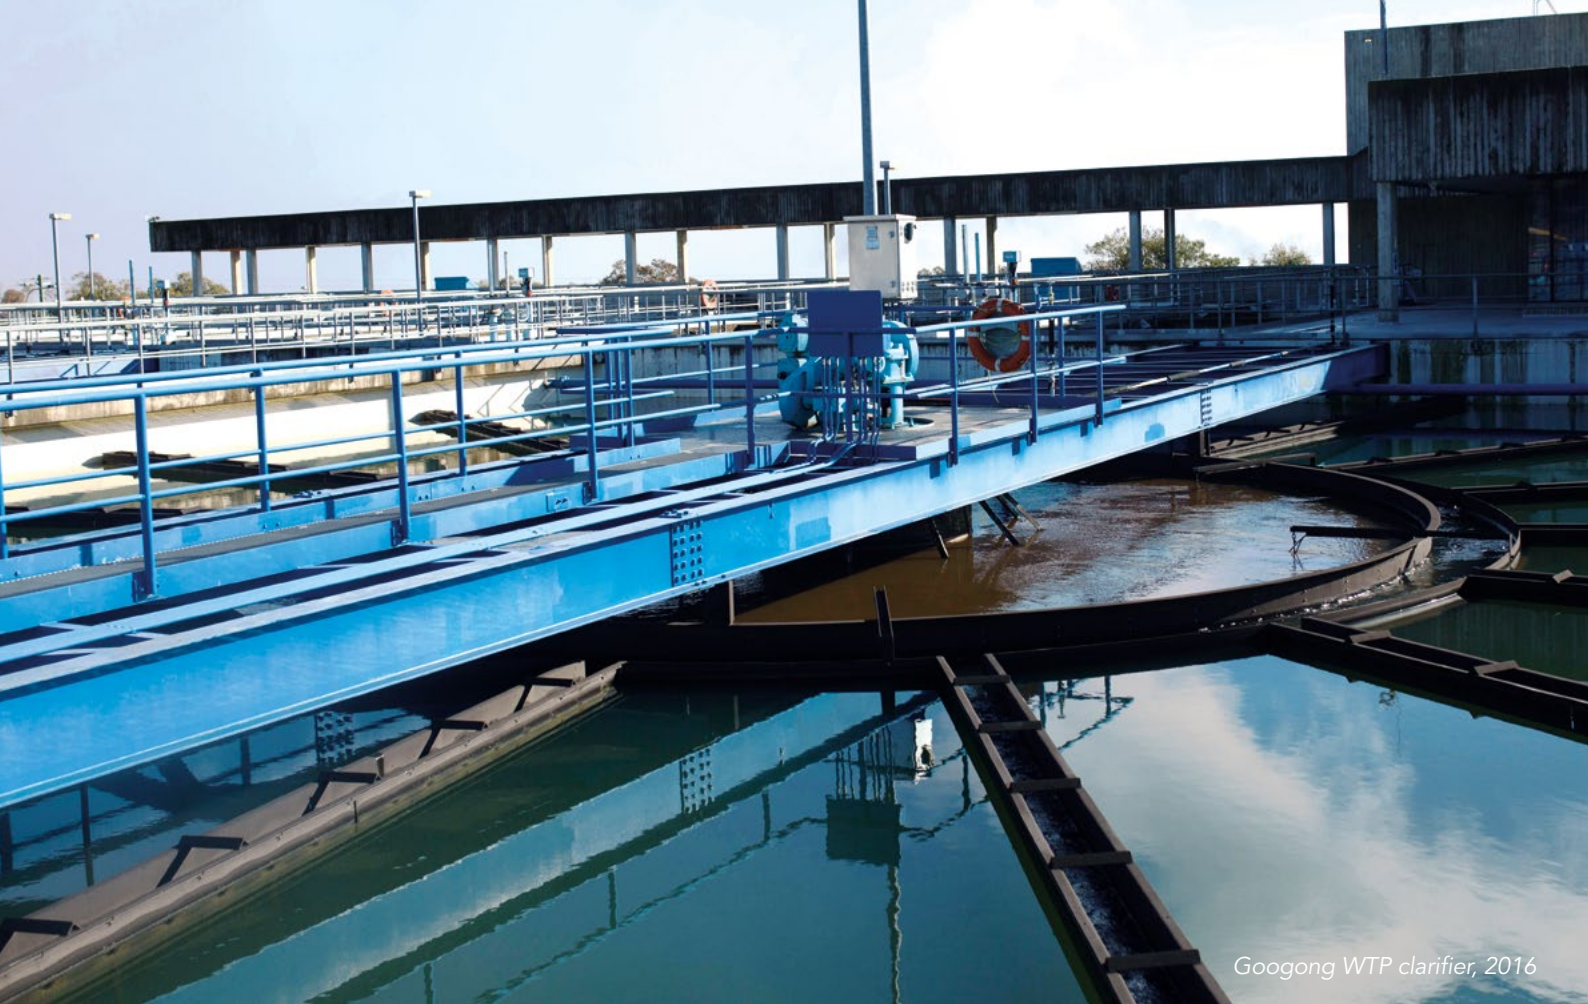
Googong WTP clarifier, 2016

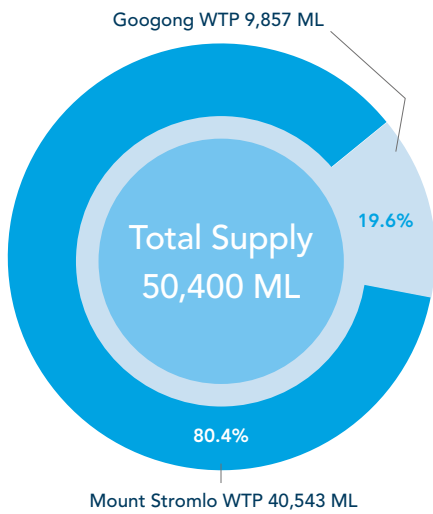
Figure 4-6 Total water produced by treatment plant during 2015–16

50,400 ML of water was produced during 2015–16 between the two WTPs, for distribution to the Canberra and Queanbeyan communities. The majority (80.4%) of the water produced was treated by the Mount Stromlo WTP.

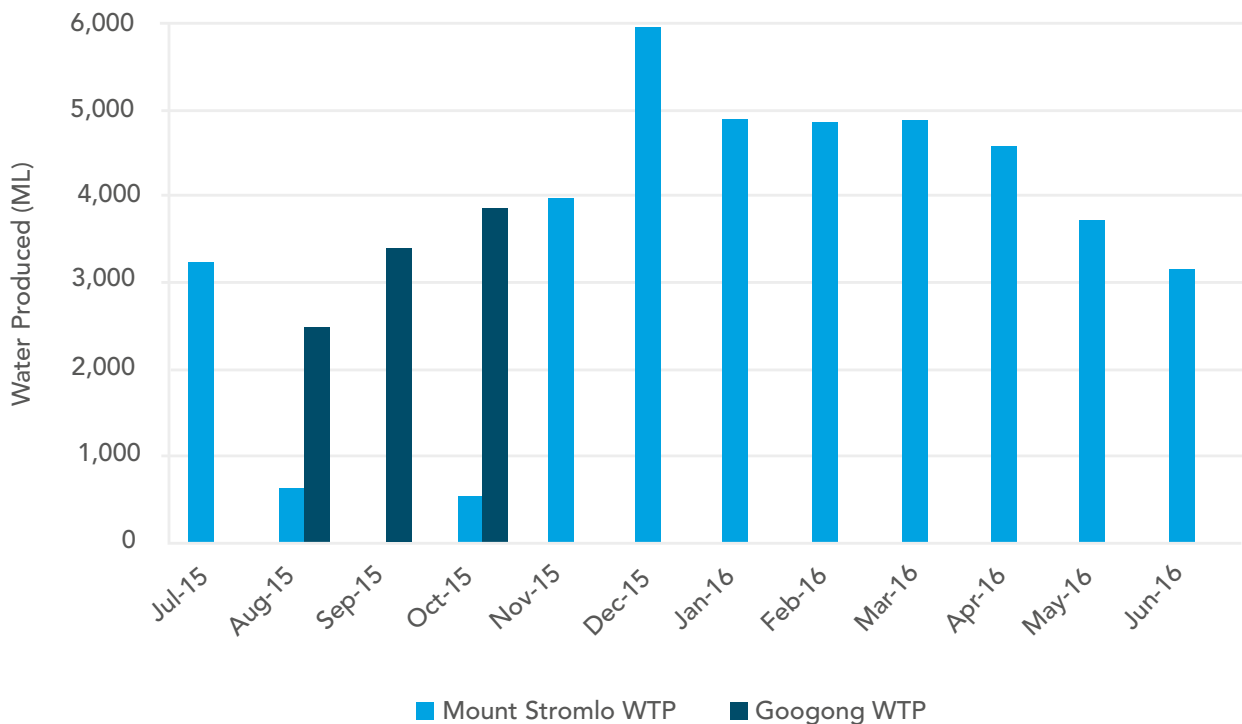
Figure 4-7 Monthly treated water production by WTP

A summary of WTP operations over the 2015–16 year is provided in the figures below.

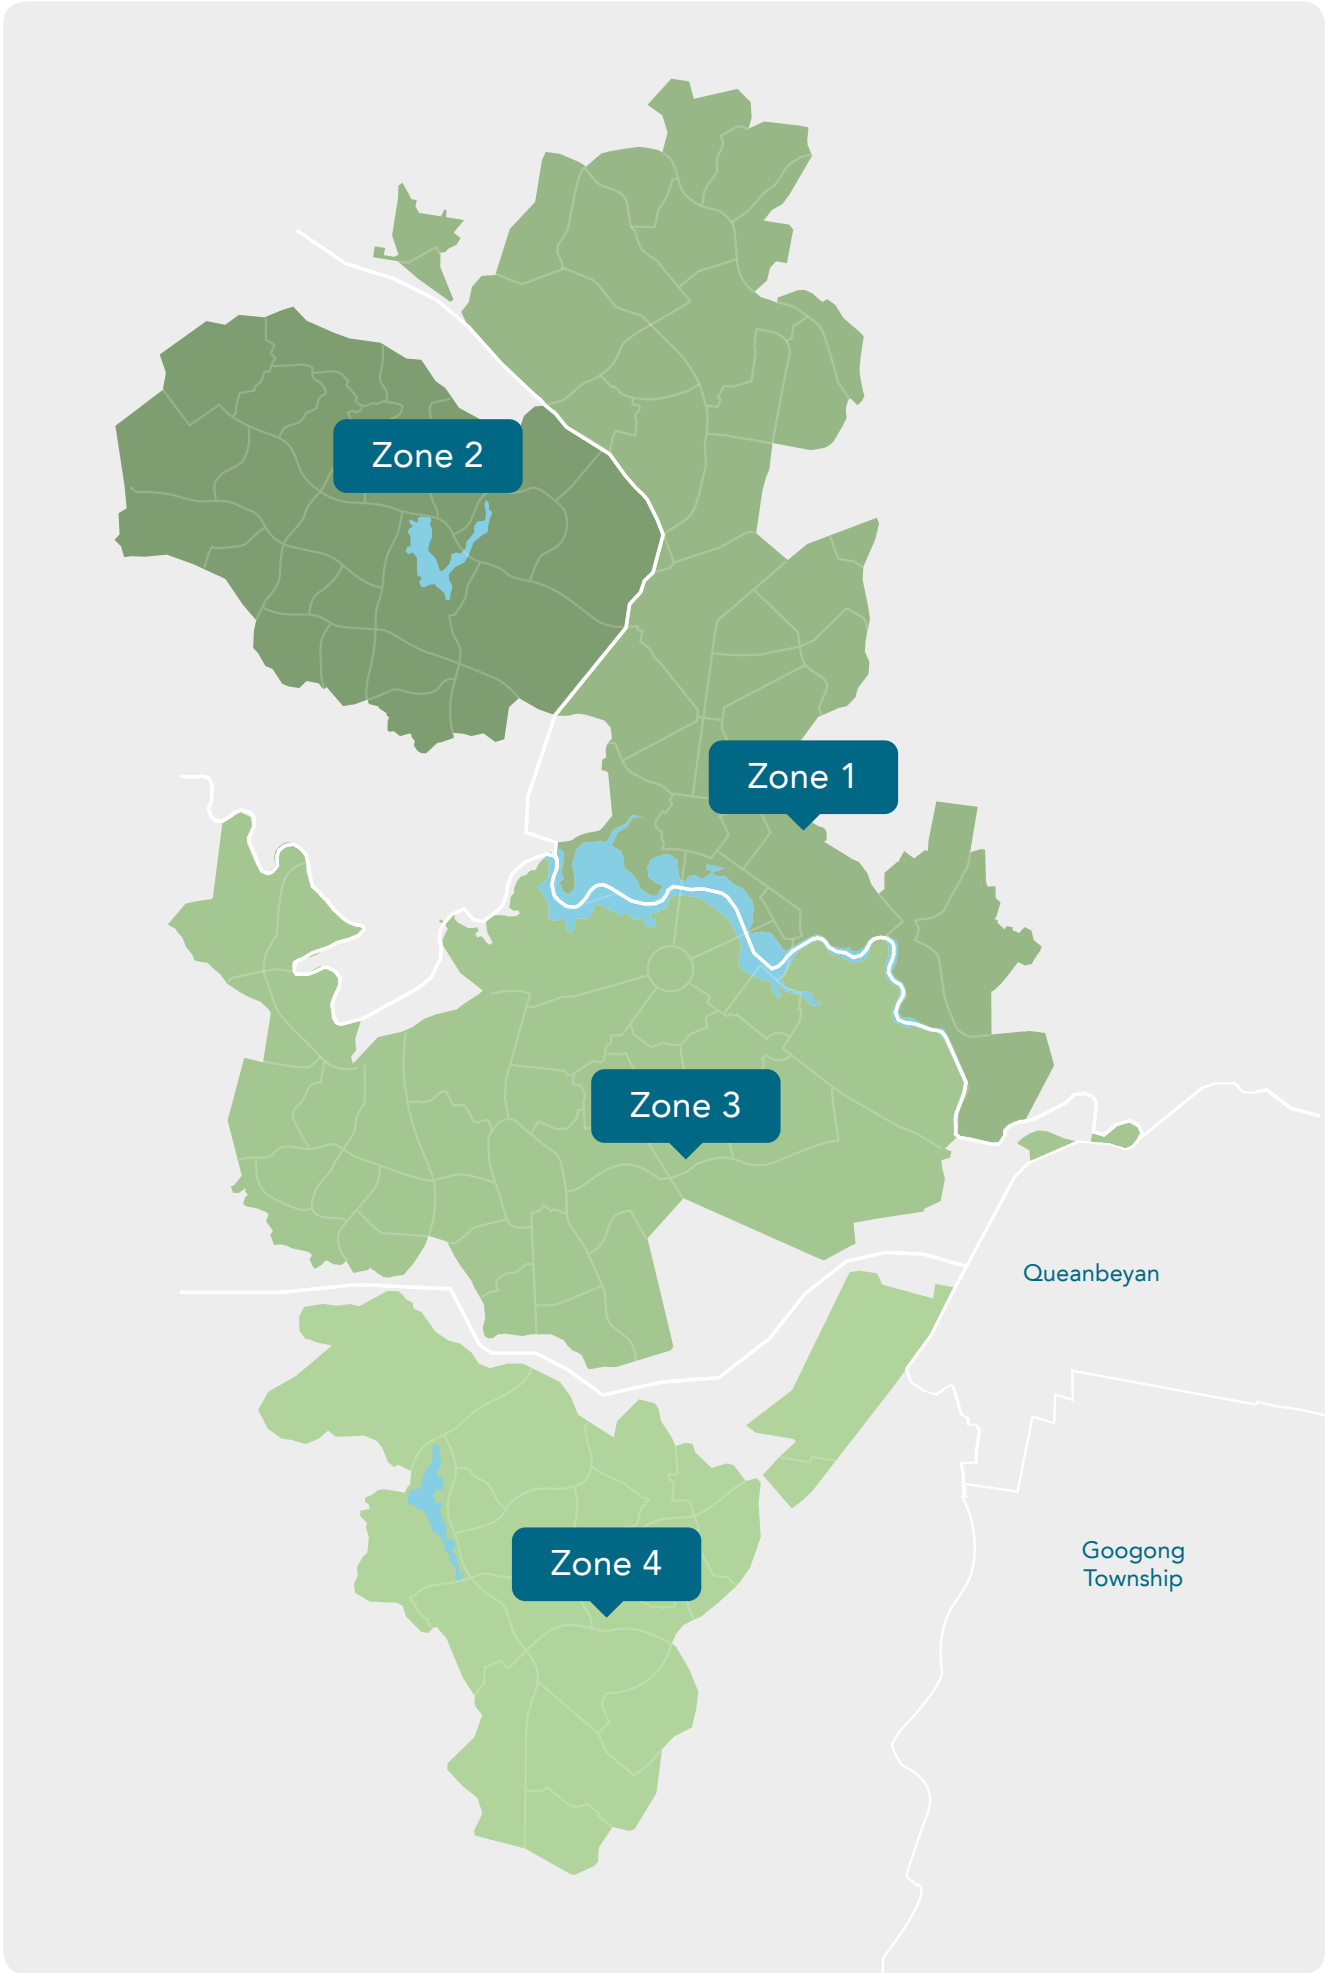
Figure 5-1 Water quality monitoring zone map

- Water quality zone 1 – North Canberra and Gungahlin
- Water quality zone 2 – Belconnen
- Water quality zone 3 – South Canberra, Woden and Weston Creek
- Water quality zone 4 – Tuggeranong
