Environmental Audit Report

ICON WATER

MURRUMBIDGEE TO GOOGONG WATER TRANSFER

6TH AUDIT (OEMP IMPLEMENTATION)

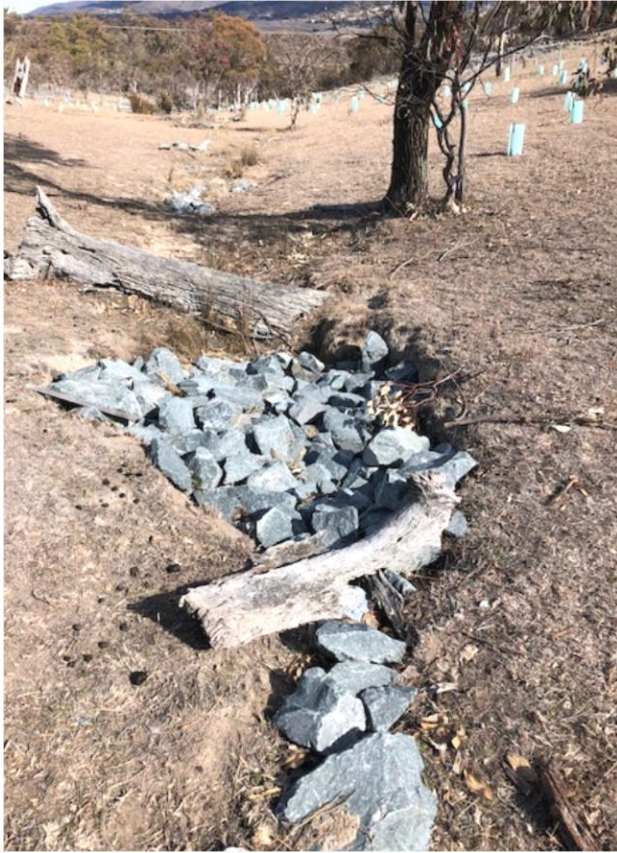
A detailed site inspection at the Offset Site was conducted. Areas visited included recent plantings along two water courses, recent erosion control efforts, the Bursaria plantings and the Swainsona translocation plots.

Clockwise from top left; gully erosion control; gully planting area; Box plot exclusion area; Swainsonia plot.

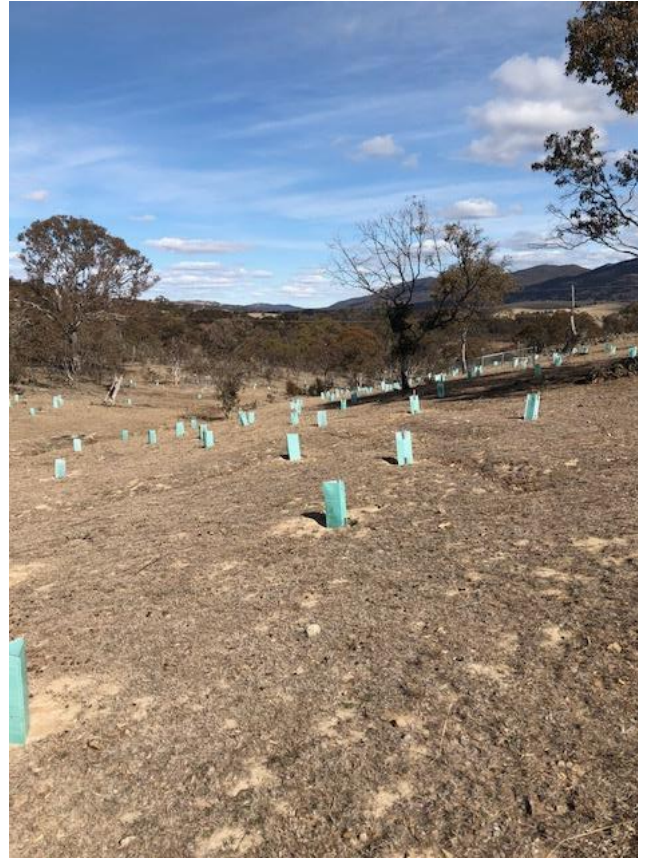
The site visit checked the planting at the Bursaria site and in the gully between the two formal offset areas (although it is noted that the whole property is managed regardless of the offset boundaries). The plantings are healthy but showing signs of being grazed.

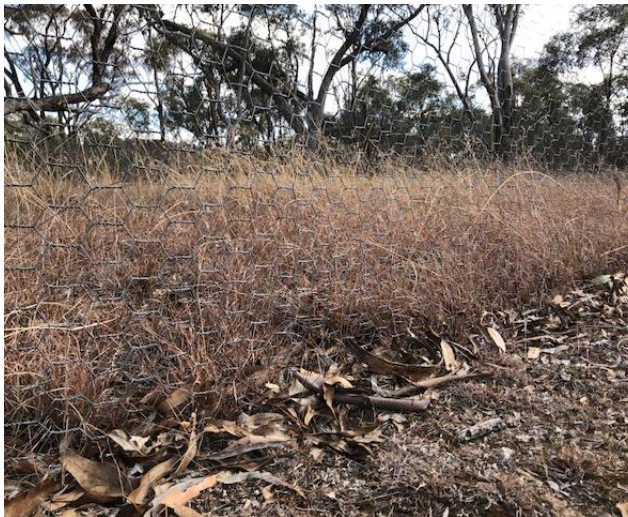
No.	Status	Comment
August 2016 Audit		
CAR 1 During the site inspection, it was observed that the fencing around the Swainsona relocation plot had not been reinstated, presumably after it was removed for the controlled burn in 2015.	Fencing was reinstated before close out of the 2016 audit.	The Swainsona relocation plots were inspected during the site visit on the 22/8/18 and fencing was found to be intact.

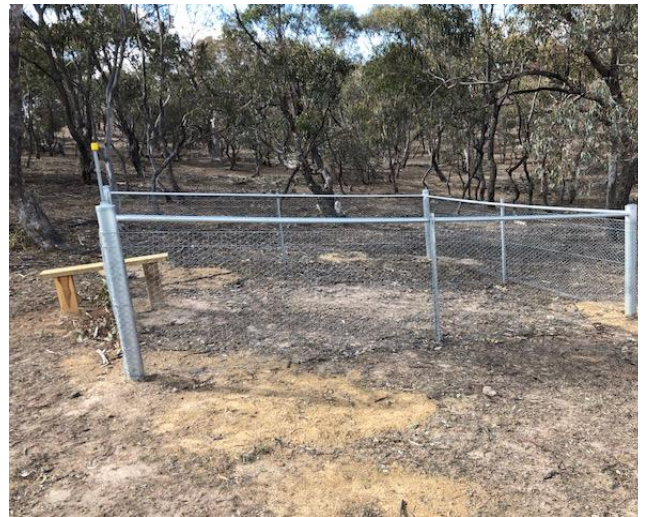
Box plot exclusion fences have been installed to monitor the pressures of grazing by native and exotic herbivores of the longer term. Dam drainage detention structures have also been installed allowing only gradual release to reduce water supply access supporting excess grazing. It was noted during the site visit that the site is heacily grazed and large numbers of Eastern Grey Kangaroos are present on the site. Plans are underway to determine whether culling of the Kangaroos is required.
