M2G Biodiversity Offset Monitoring Report

Autumn 2015

Prepared for
Icon Water

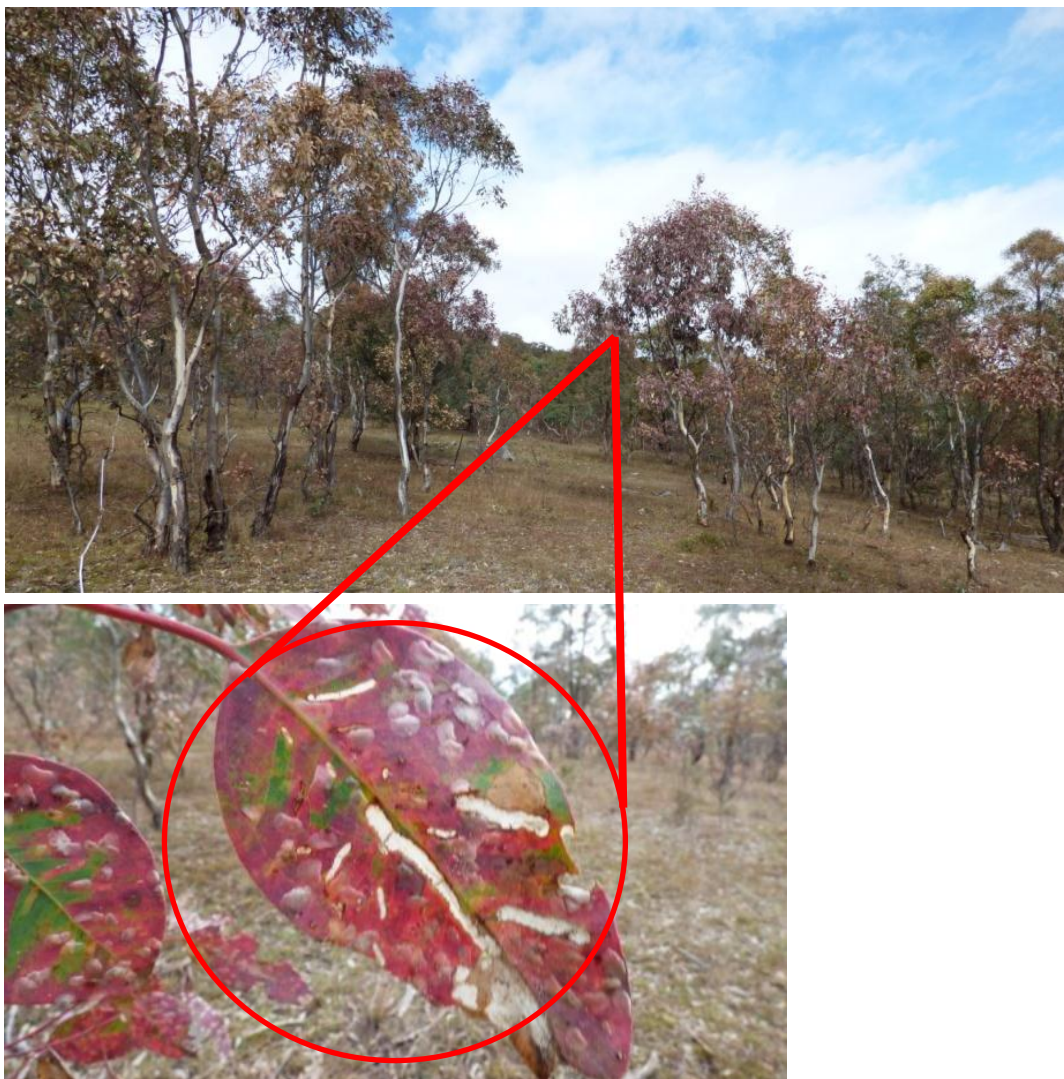
Figure 6: Lerps on a *Eucalyptus blakelyi* leaf and associated damage

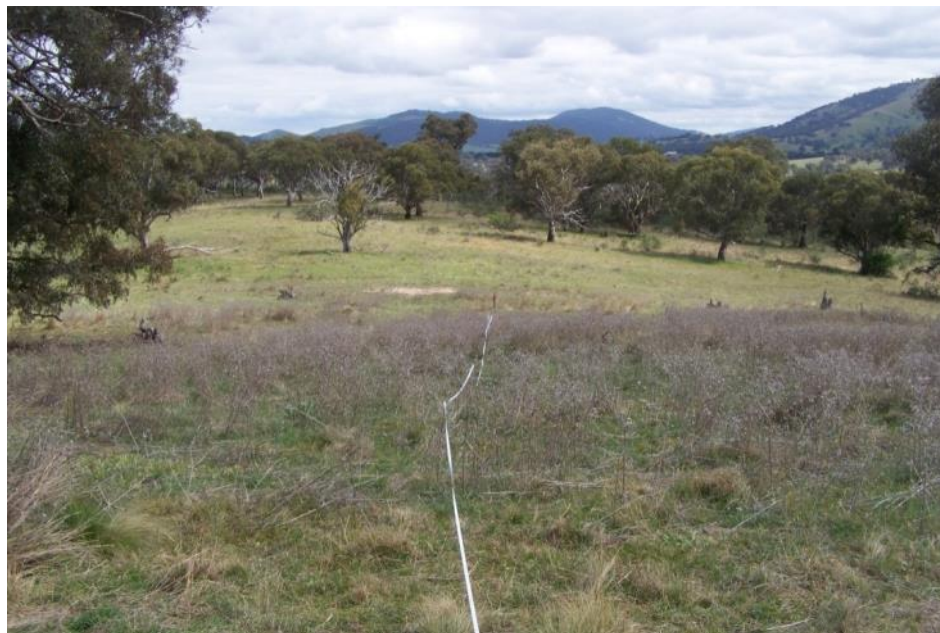
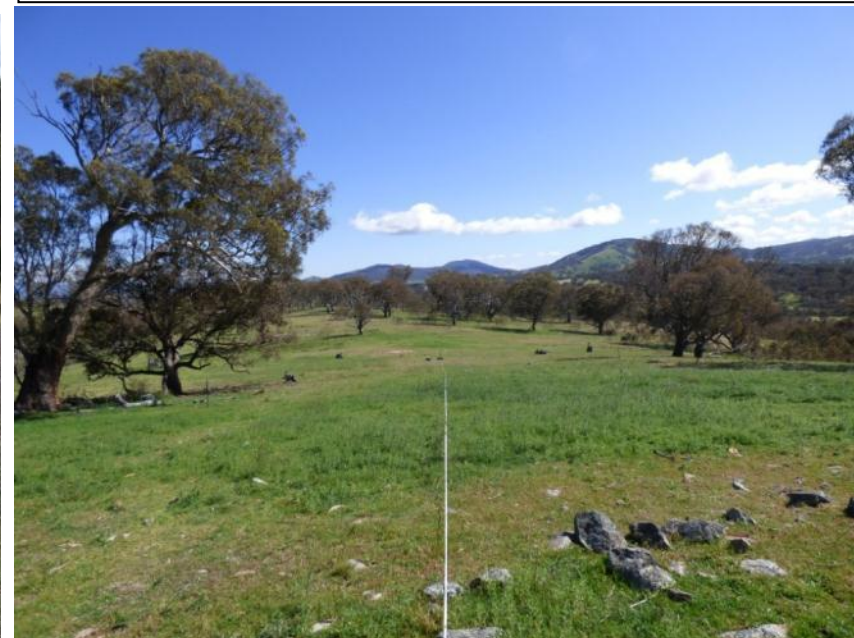
Figure 9: Monitoring Plot 1. (Left: Baseline monitoring photo, October 2011. Right: Monitoring photo April 2015)

Monitoring plot 1 is located within MU1A on the southern offset. The plot is composed of relatively lower condition Box-Gum Woodland. Few eucalypt saplings were observed in the vicinity of the plot but none were recorded in the plot or along the transect. Native species diversity was low-moderate (11 species), marginally more than recorded in the autumn 2013 surveys. 9 introduced species were recorded, with the number of species and cover being considerably higher than recorded during the baseline survey. *Carthamus lanatus* and *Trifolium subterraneum* dominate the plot. More frequent native species included *Austrostipa scabra*, *Bothriochloa macra* and *Carex inversa*. Fauna habitat features within MU1A have not changed noticeably since the baseline surveys. Native plant species richness, overstorey cover and the total length of fallen logs are well below benchmark values (Sharp & Milner 2014).

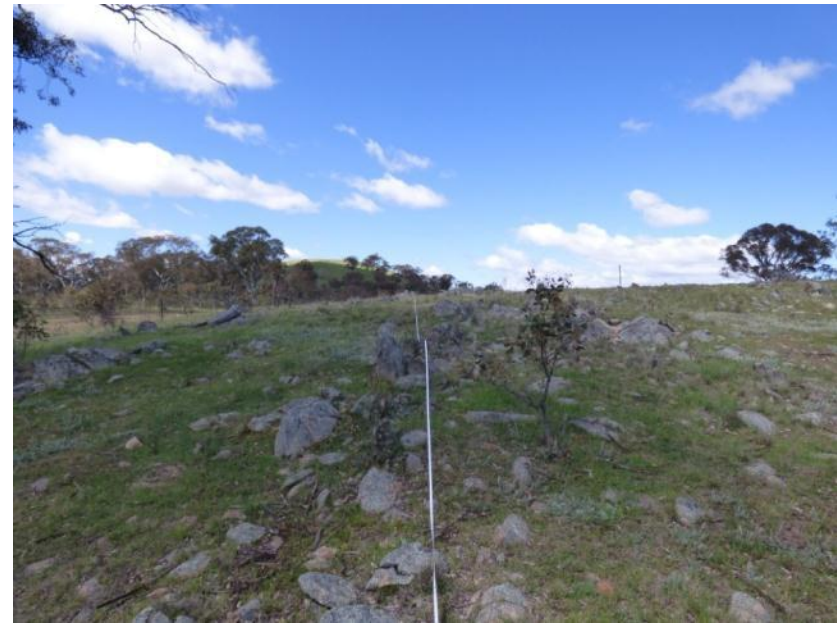
Figure 10: Monitoring Plot 2. (Left: Baseline monitoring photo, March 2012. Right: Monitoring photo April 2015)

Monitoring plot 2 is located within MU2B within the southern offset. It is situated on a rocky hill containing Pink-tailed Worm Lizard habitat. Outcropping and surface rocks constitutes over 10% of the ground cover. It contains relatively good condition mature Box-Gum Woodland with scattered eucalypt saplings present. A total of 33 native species were recorded within the plot, two (2) more than during the baseline surveys. Frequent native species include *Chrysocephalum apiculatum*, *Austrostipa bigeniculata* and *Bothriochloa macra*. 15 introduced species were recorded, which is five (5) more than recorded in autumn 2013. Fauna habitat features within MU2B have not changed noticeably since the baseline surveys. Native plant species richness is above benchmark values (Sharp & Milner 2014), however overstorey cover and the total length of fallen logs are well below.

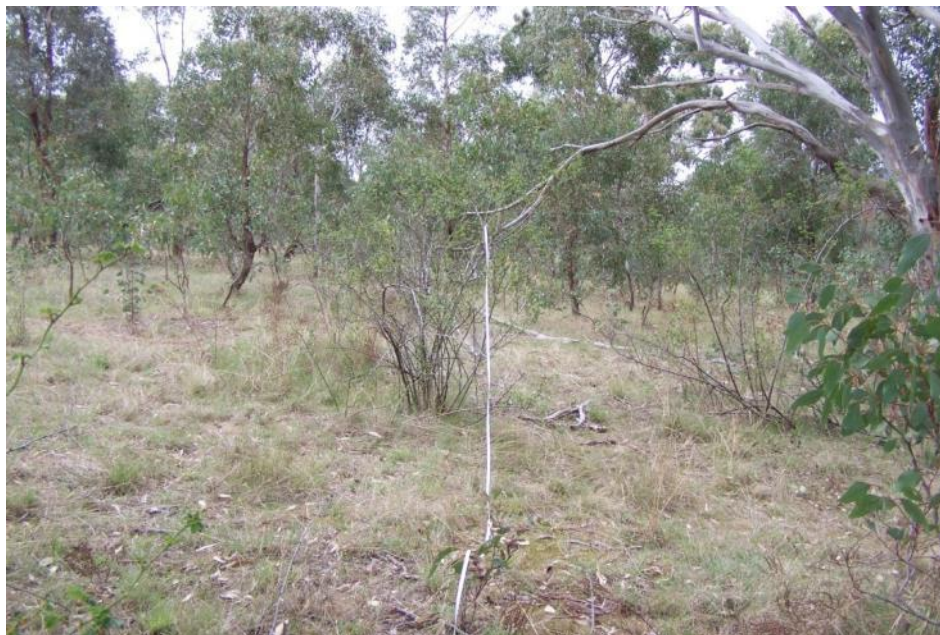
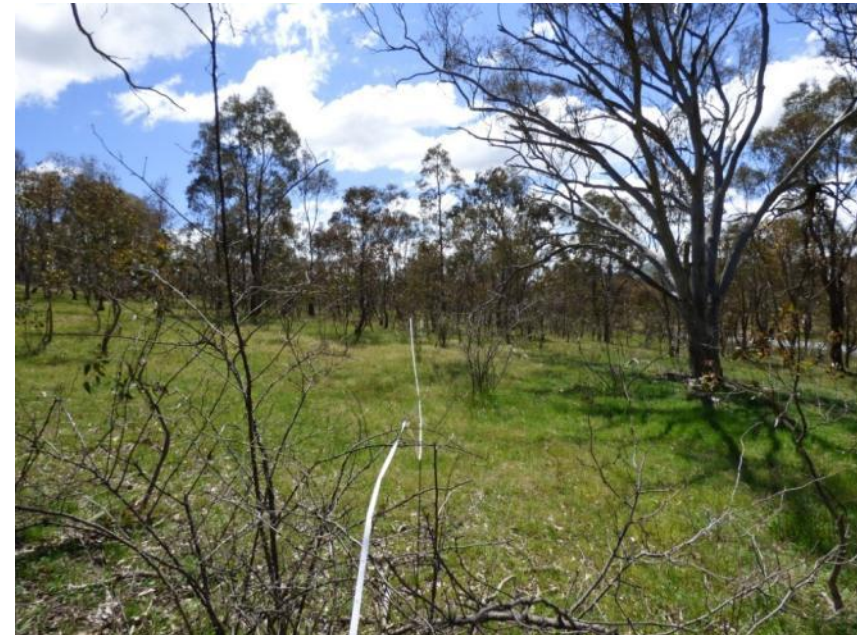
Figure 11: Monitoring Plot 3. (Left: Baseline monitoring photo, October 2011. Right: Monitoring photo April 2015)

Monitoring plot 3 is located within MU3 in the southern offset. The plot is located in moderate to good quality Box-Gum Woodland. A significant number of eucalypt saplings are present. A total of 38 native species were recorded within the plot, eight (8) more than during the autumn 2013 surveys. The understorey is dominated by *Themeda triandra*, with co-occurring native species having significantly lower cover values. The native mid-storey species *Bursaria spinosa* was present but rare. 22 introduced species were recorded, which was nine (9) more than that recorded in autumn 2013. Frequent weeds include *Aira* spp. and *Hypochaeris glabra*. Fauna habitat features within MU3 have not changed noticeably since the baseline surveys. Native plant species richness is above benchmark values (Sharp & Milner 2014), however overstorey cover and the total length of fallen logs are well below.

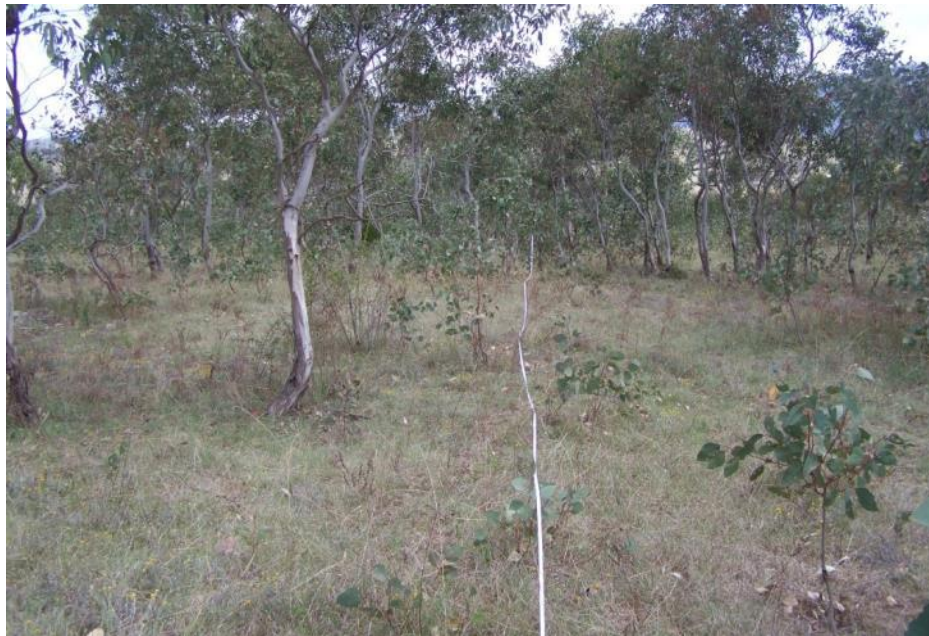
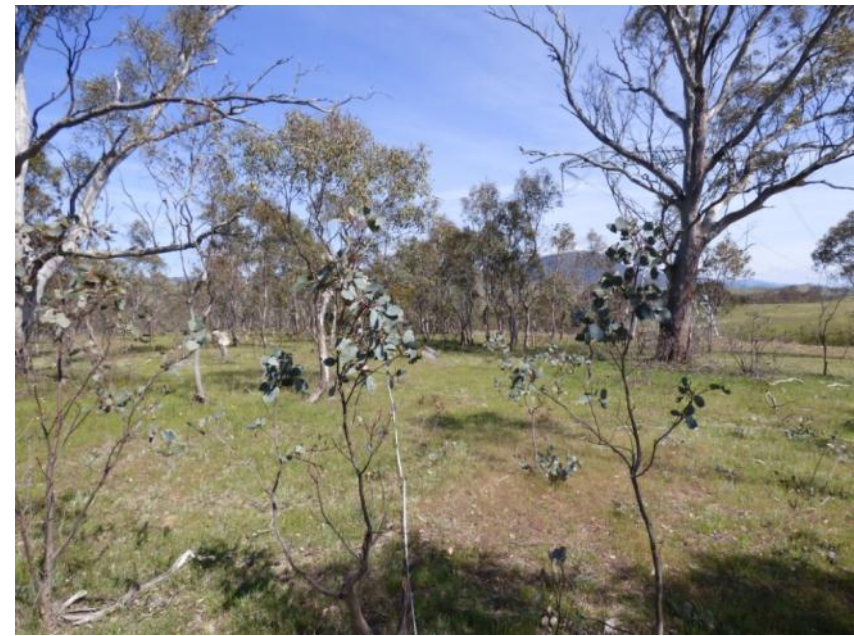
Figure 13: Monitoring Plot 5. (Left: Baseline monitoring photo, October 2011. Right: Monitoring photo April 2015)

Monitoring plot 5 is a control plot located in MU5. No management actions will occur within the boundaries of the plot. Plot 5 is located in moderate-good quality Box-Gum Woodland dominated by *E. blakelyi* with a significant amount of natural regeneration present. The plot supports a highly diverse understorey of graminoids and forbs with 37 native species recorded in autumn 2015, 10 species more than the autumn 2013 monitoring. The understorey is dominated by *Themeda australis* and *Chrysocephalum apiculatum*. 10 introduced species were recorded, which is a reduction of one since autumn 2013; however, no weed species currently has a cover value exceeding 5%. Fauna habitat features within MU5 have not changed noticeably since the baseline surveys. Native plant species richness is above benchmark values (Sharp & Milner 2014), however overstorey cover and the total length of fallen logs are well below.

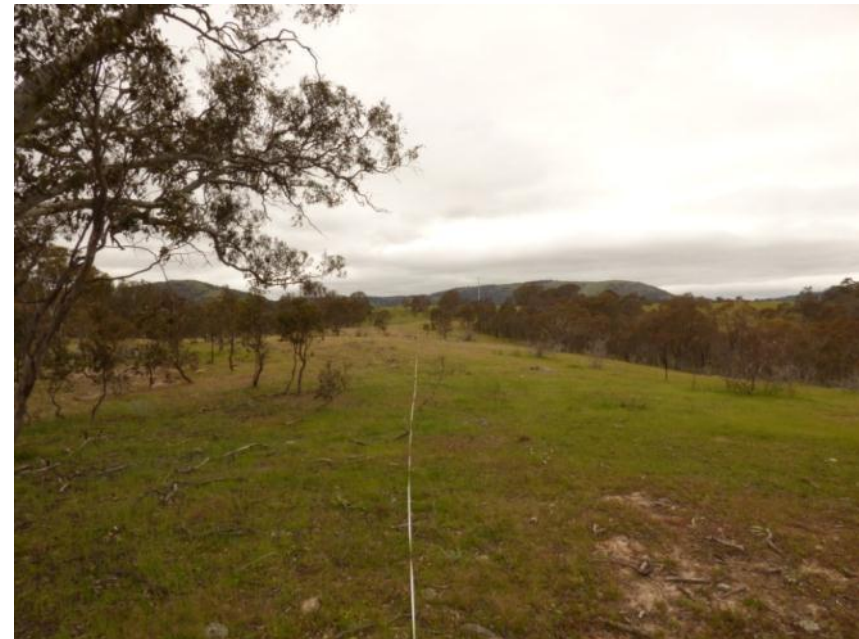
Figure 14: Monitoring Plot 6. (Left: Baseline monitoring photo, March 2012. Right: Monitoring photo April 2015)

Monitoring plot 6 is located in MU6, along the central ridge line of the property, in moderate-good quality Box-Gum Woodland dominated by *E. blakelyi*. The plot is situated in an intersection between the woodland and derived grassland forms of the ecological community. Various sized *E. blakelyi* saplings are present within the plot. The plot supports a diverse understorey of grasses and forbs with no species dominant. 35 native species were recorded in autumn 2015, compared with 21 species in the autumn 2013 monitoring. 13 introduced species were recorded, an increase of three (3) species since autumn 2013. Frequent weeds include *Trifolium arvense*, *Tolpis umbellata* and *Vulpia* spp. Fauna habitat features within MU6 have not changed noticeably since the baseline surveys. Native plant species richness is above benchmark values (Sharp & Milner 2014), however overstorey cover and the total length of fallen logs are well below.

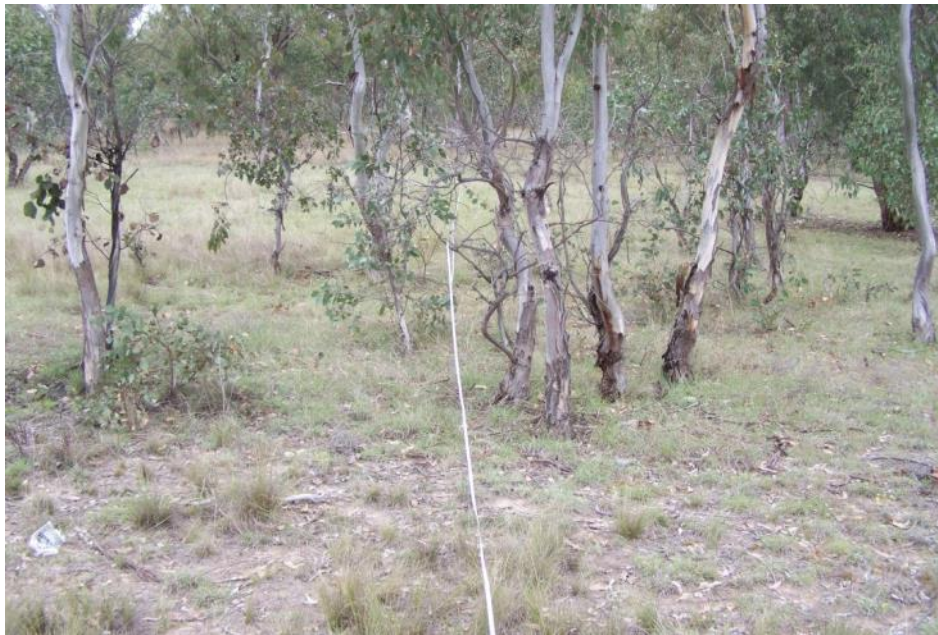
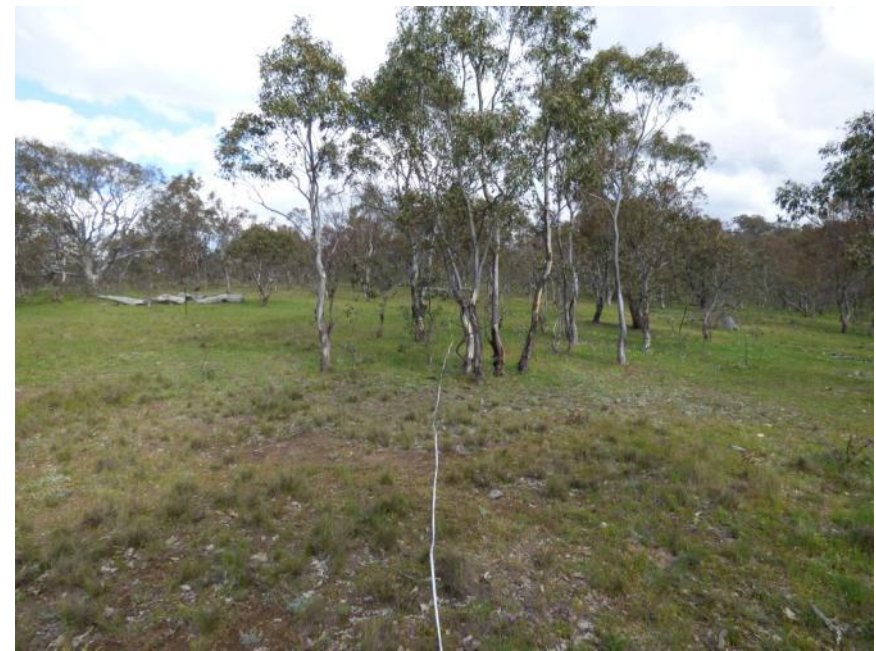
Figure 16: Monitoring Plot 8. (Left: Baseline monitoring photo, October 2011. Right: Monitoring photo April 2015)

Monitoring plot 8 is a control plot located in MU3. No management actions are proposed to occur within the bounds of the plot. The plot is located in good quality Box-Gum Woodland dominated by *E. blakelyi*. Various sized *E. blakelyi* saplings are present within the plot. The understorey species is dominated by *Themeda triandra* with a diverse range of co-occurring graminoids and forbs. 36 native species were recorded in autumn 2015, an increase of 10 species since the autumn 2013 surveys. 13 introduced species were recorded, seven (7) more than the number recorded in the baseline survey. Fauna habitat features have not changed noticeably since the baseline surveys. Native plant species richness is above benchmark values (Sharp & Milner 2014), however overstorey cover and the total length of fallen logs are well below.

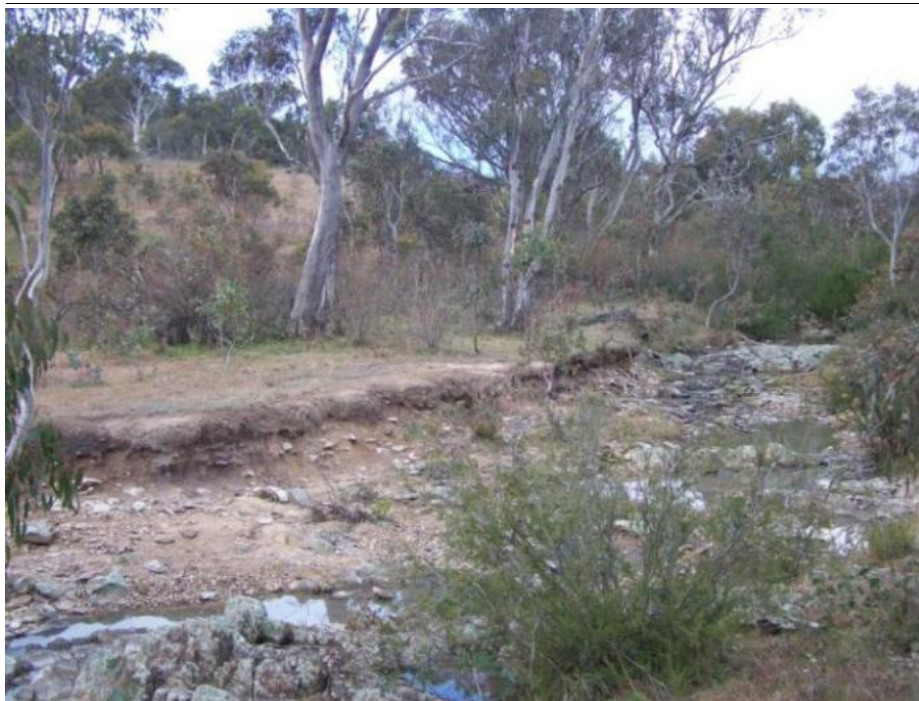
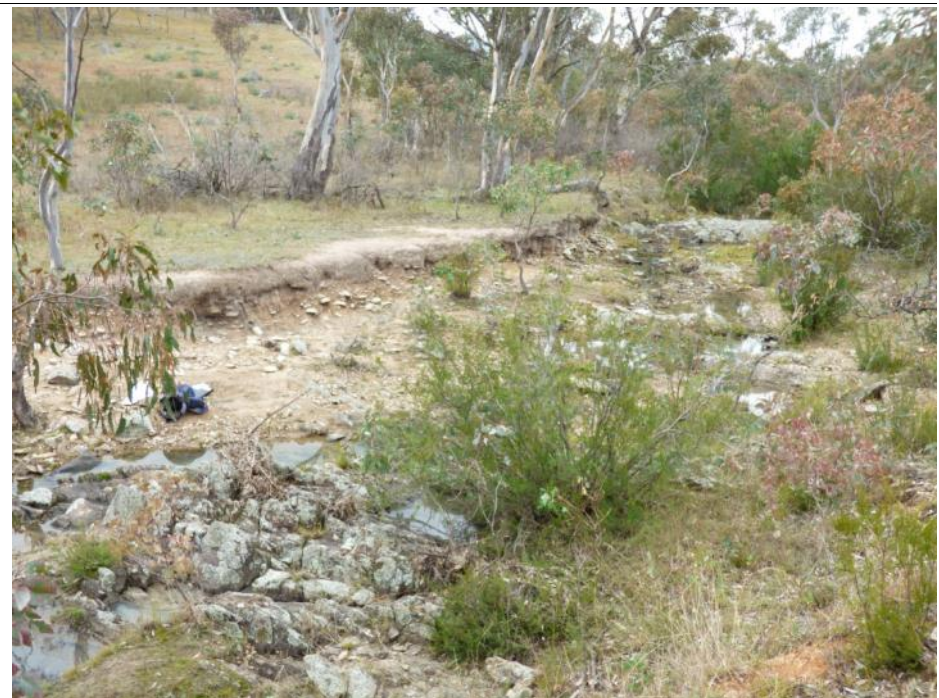
Erosion Point 8:

Two erosion points within the main drainage line in the northern offset may require some attention to stabilise the creek bank. It is recommended that various rehabilitation options be considered, however, these need to consider access, proximity to high voltage power lines, the local and downstream hydrology, as well as cost. The active erosion sites require on-going monitoring.

Action required: Targeted monitoring at photo point following >25mm/24hr period. Rehabilitation measures to increase bank stability such as plantings could be considered.
