M2G Offset Property Monitoring Report

Spring 2013

Prepared for
ACTEW Water

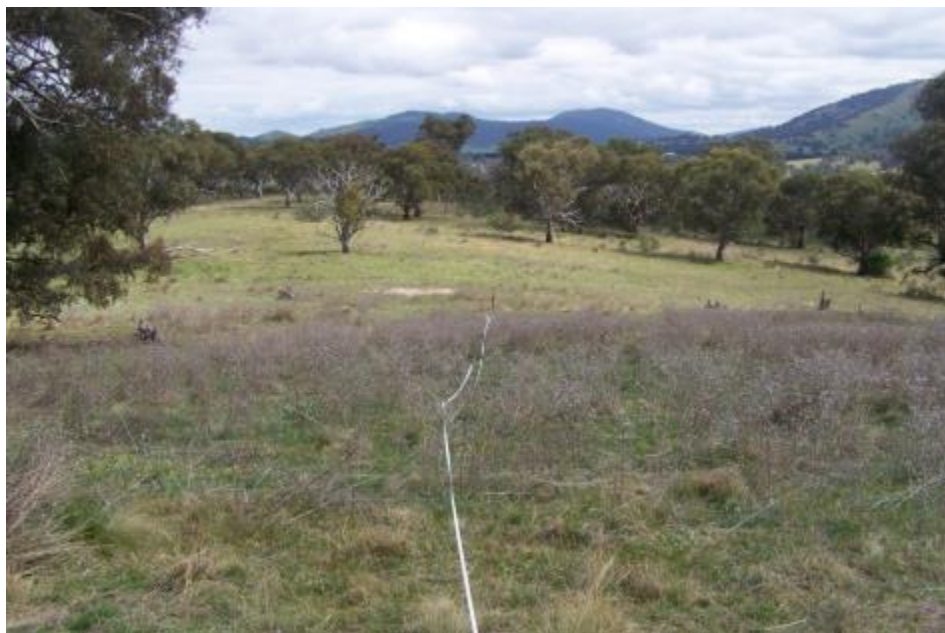
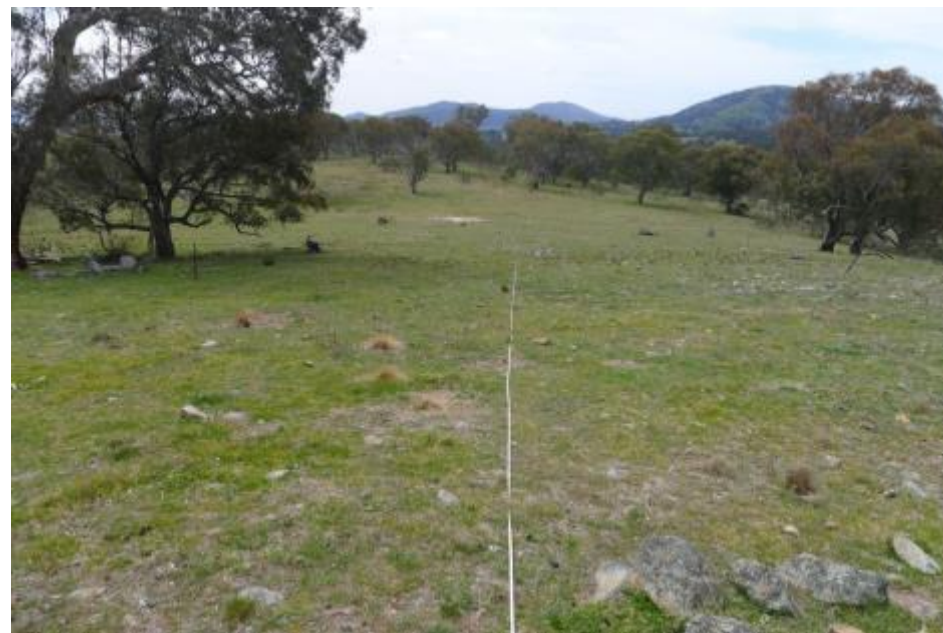
Figure 4: Monitoring Plot 1. (Left: Baseline monitoring photo, October 2011. Right: Monitoring photo October 2013)

Monitoring plot 1 is located within MU1 on the southern offset. The plot is composed of relatively lower condition Box-Gum Woodland. Natural regeneration of the overstorey (Eucalypts) was present with a low number of saplings observed. This is in comparison to no regeneration recorded during the baseline surveys. Native species diversity was low-moderate (18 species), but an increase compared to the baseline surveys. Despite lower native diversity, the plot was marginally dominated by native species. The dominant species included *Austrostipa* spp., *Microlaena stipoides* (Weeping Grass) and *Carex inversa* (Common Sedge). It was noted that several *Nassella trichotoma* (Serrated Tussock) have undergone recent control. Fauna habitat features have not changed noticeably since the baseline surveys.

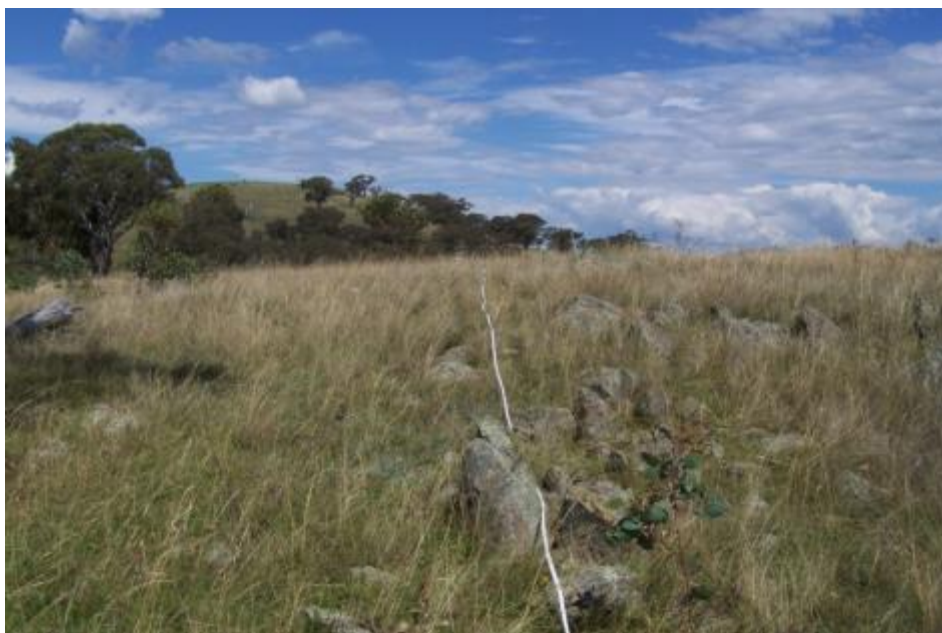
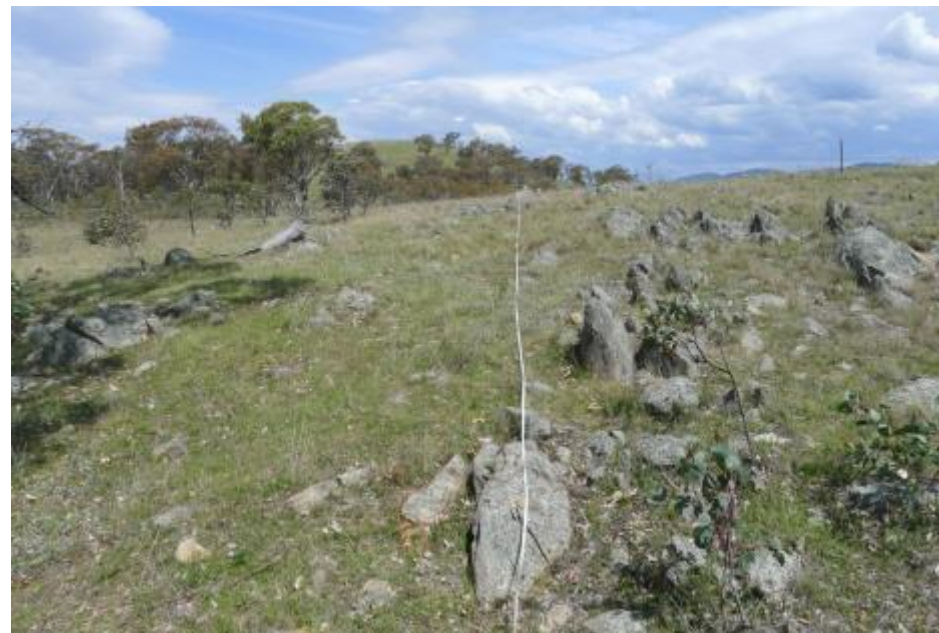
Figure 5: Monitoring Plot 2. (Left: Baseline monitoring photo, March 2012. Right: Monitoring photo October 2013)

Monitoring plot 2 is located within MU2 within the southern offset. It is situated on a rocky hill containing Pink-tailed Worm Lizard habitat. It contains relatively good condition mature Box-Gum Woodland with limited regeneration present. However, a regenerating *Cassinia* sp. individual was observed adjacent to the plot, for the first during the spring 2013 monitoring surveys. It contains a moderate to high diversity of native understorey species and is generally devoid of exotic grasses. Outcropping and surface rocks constitutes over 10% of the ground cover. The vegetative groundlayer is dominated by *Rytidosperma* spp., *Austrostipa* spp. and *Chrysocephalum apiculatum* (Common Everlasting). A total of 42 native species were recorded within the plot, an increase of 11 species compared to the baseline. Fauna habitat features have not changed noticeably since the baseline surveys.

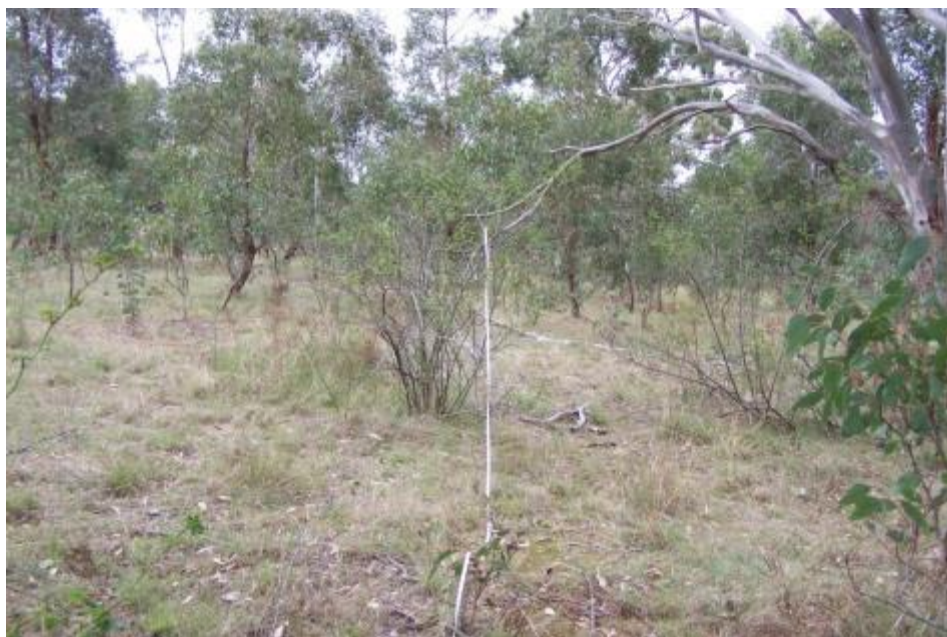
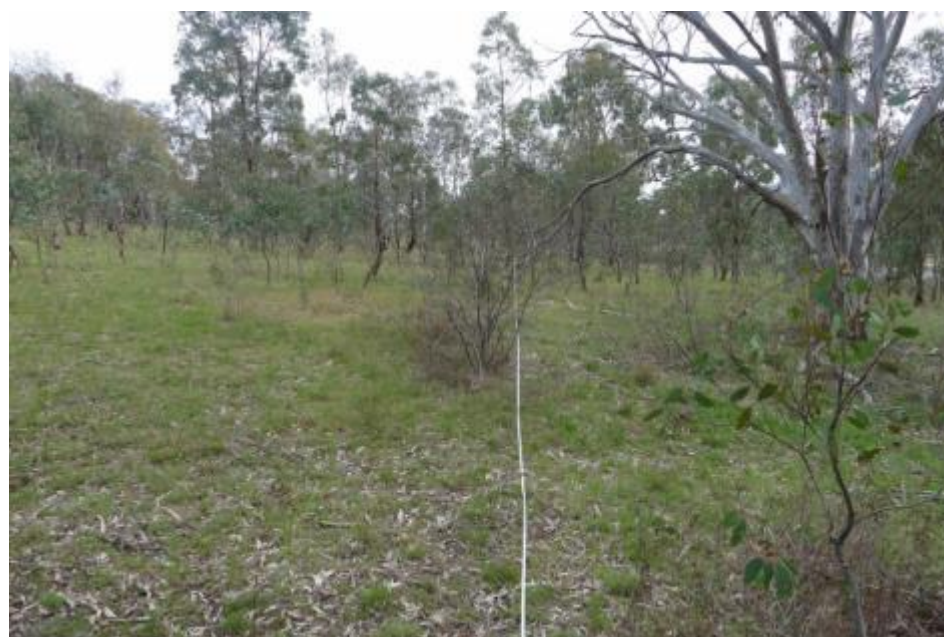
Figure 6: Monitoring Plot 3. (Left: Baseline monitoring photo, October 2011. Right: Monitoring photo October 2013)

Monitoring plot 3 is located within MU3 in the southern offset. The plot is located in moderate to good quality Box-Gum Woodland. The plot is dominated by mature *E. blakelyi* and a significant amount of natural regeneration is present. The spring 2013 surveys recorded diverse understorey with dominant species including *Themeda australis* (Kangaroo Grass), *Rytidosperma* spp. (Wallaby Grasses) and *Bothriochloa macra* (Red-leg Grass). The understorey has a high diversity of native species (49) which is a significant increase compared to the diversity recorded in the baseline monitoring surveys (27). Weed control activities were undertaken in 2012 and early 2013 targeting *Rosa rubiginosa* (Sweet Briar) with little regrowth observed. Native mid-storey species present include *Bursaria spinosa*. Fauna habitat features have not changed noticeably since the baseline surveys.

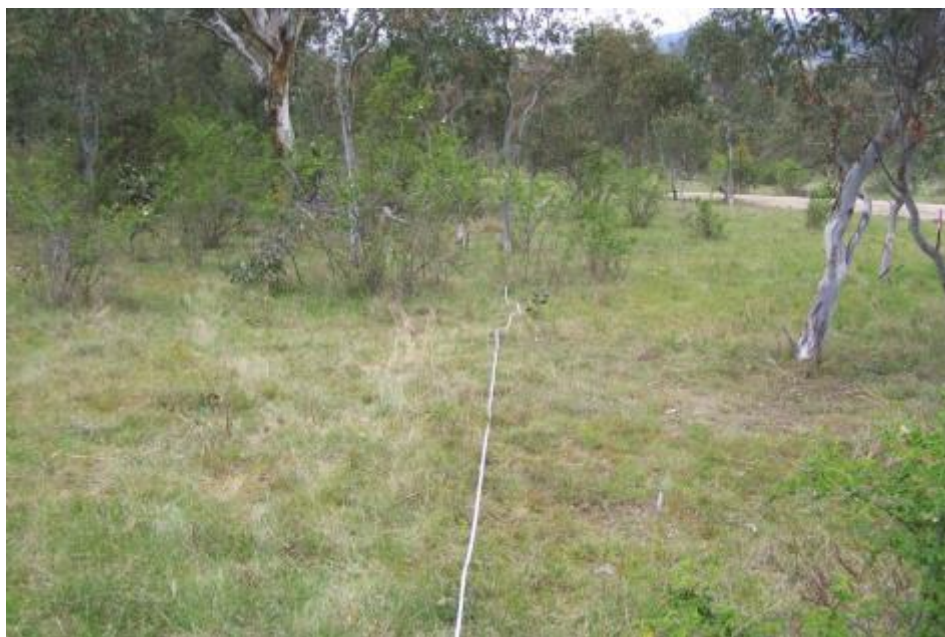
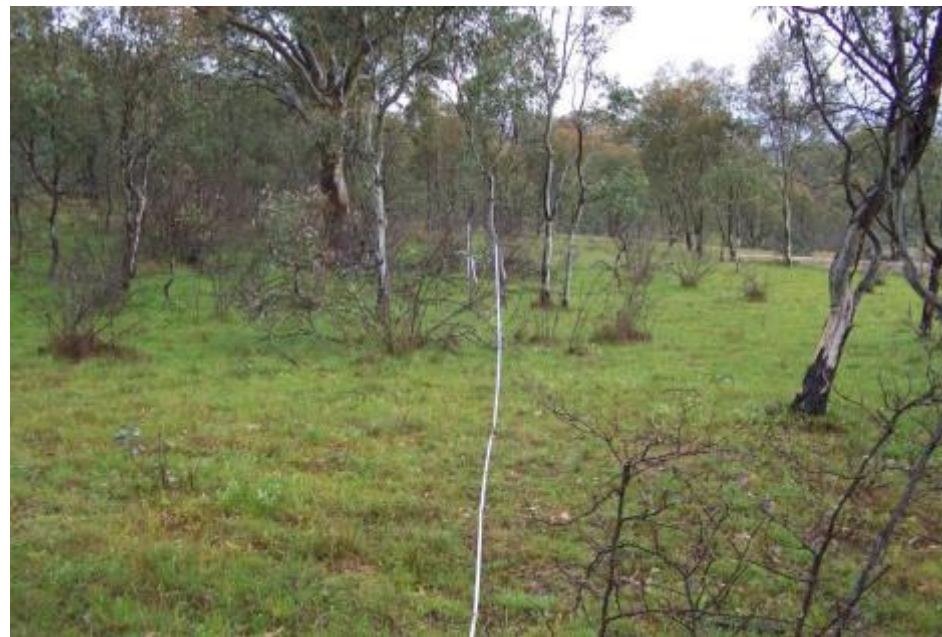
Figure 7: Monitoring Plot 4. (Left: Baseline monitoring photo, October 2011. Right: Monitoring photo October 2013)

Monitoring plot 4 is located in the northern offset in MU4. It is located in moderate to good quality Box-Gum Woodland dominated by *E. blakelyi*. The plot supports a moderately diverse understorey composed of 27 native species, slightly down on the diversity recorded during the 2012 surveys. This is likely a result of natural variation and the wet conditions preceding the 2012 surveys. The dominant species are *Themeda australis*, *Schoenus apogon* and *Haloragis heterophylla*. Woody weed control for *R. rubiginosa* is successful with little regrowth observed. A high level of regeneration exists within the management unit, particularly for *Eucalyptus* spp. and mid-storey species (such as *Cassinia* sp. and *Dodonaea viscosa* etc.) compared to the baseline monitoring conducted prior to the removal of grazing. Fauna habitat features have not changed noticeably since the baseline surveys.

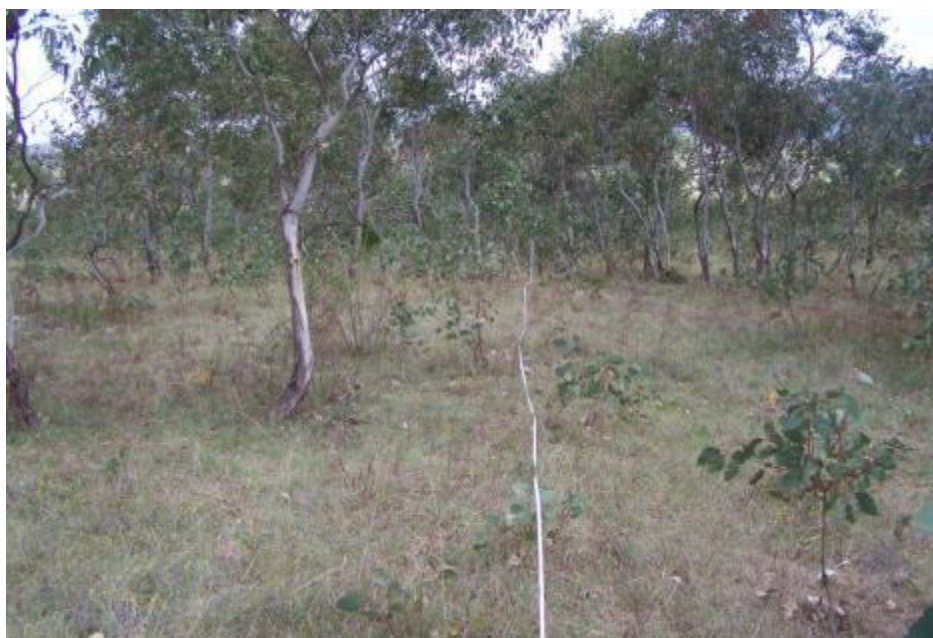
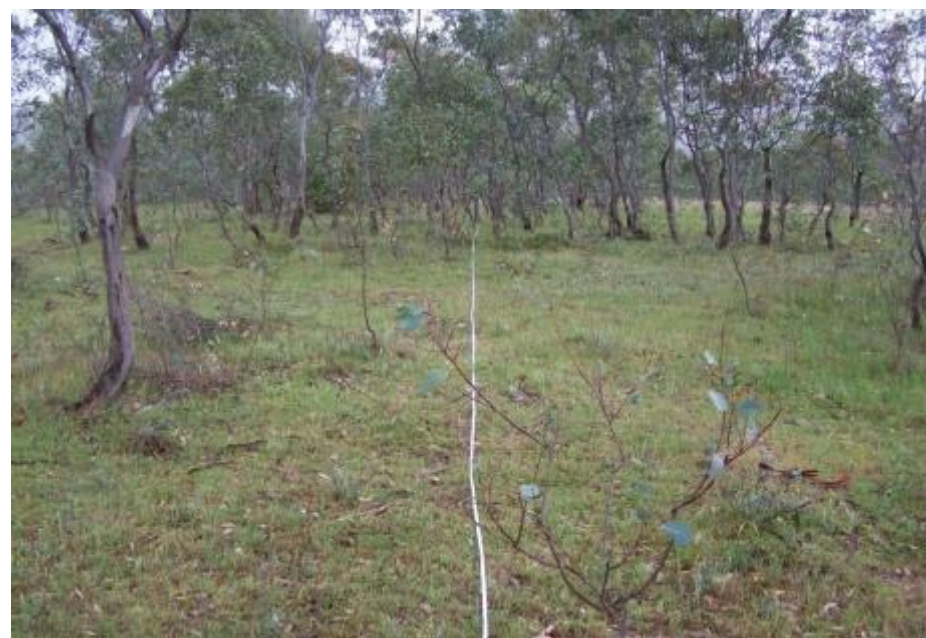
Figure 8: Monitoring Plot 5. (Left: Baseline monitoring photo, October 2011. Right: Monitoring photo October 2013)

Monitoring plot 5 is a control plot located in MU5. No management actions will occur within the boundaries of the plot. Plot 5 is located in moderate-good quality Box-Gum Woodland dominated by *E. blakelyi* with a significant amount of natural regeneration present. The monitoring plot supports a highly diverse understorey of grasses, herbs and forbs with 39 native species recorded in spring 2013. This is an increase on the baseline surveys but lower than the diversity recorded in spring 2012. This is likely a result of natural / seasonal variation and the wet conditions preceding the 2012 surveys. The understorey is known to support typically grazing intolerant species, such as *Swainsona sericea*, *Microseris lanceolata*, *Arthropodium minus* and *Microtis unifolia* (recorded spring 2012). Fauna habitat features have not changed noticeably since the baseline surveys.

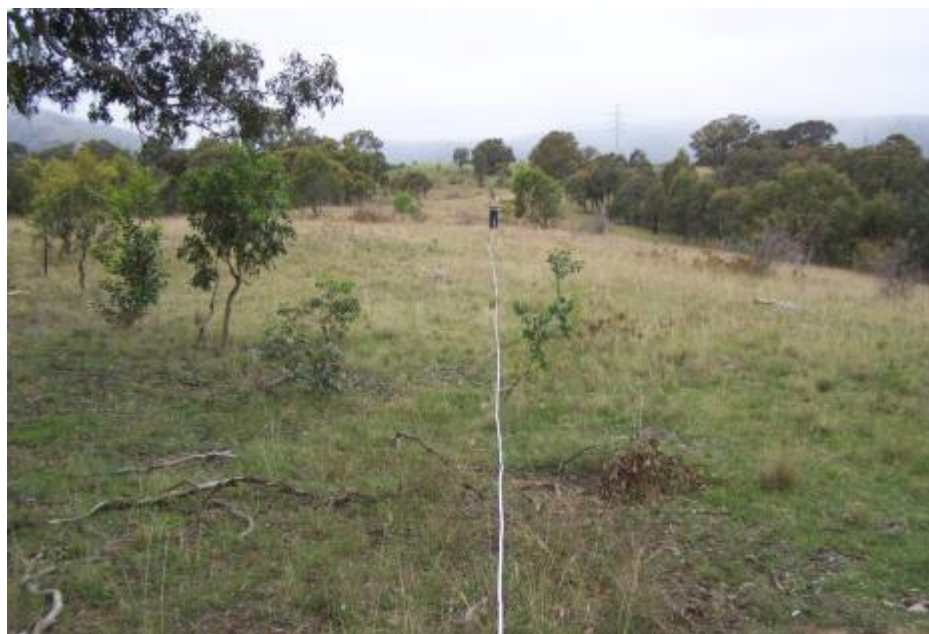
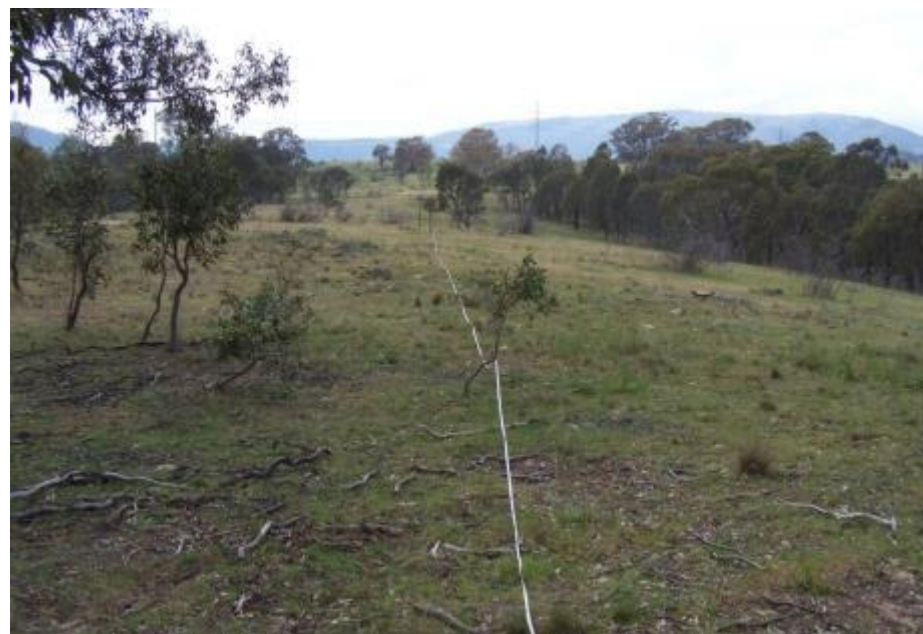
Figure 9: Monitoring Plot 6. (Left: Baseline monitoring photo, March 2012. Right: Monitoring photo October 2013)

Monitoring plot 6 is located in MU6 along the central ridge line, in moderate-good quality Box-Gum Woodland dominated by *E. blakelyi*. The plot supports a diverse understorey of grasses, herbs and forbs with 42 native species recorded in spring 2013, an increase on the baseline surveys. The plot also supports natural regeneration including native shrubs that will comprise the mid-storey. The understorey was dominated by native perennial tussock grasses including *Austrostipa* spp. and *Rytidosperma* spp. Sweet Briar was present at a low abundance in the plot and observed more broadly in the MU, with weed control mostly successful for these species. However, *Hypericum perforatum* (St John's Wort) was observed widely within the MU and requires follow-up control. Fauna habitat features have not changed noticeably since the baseline surveys.

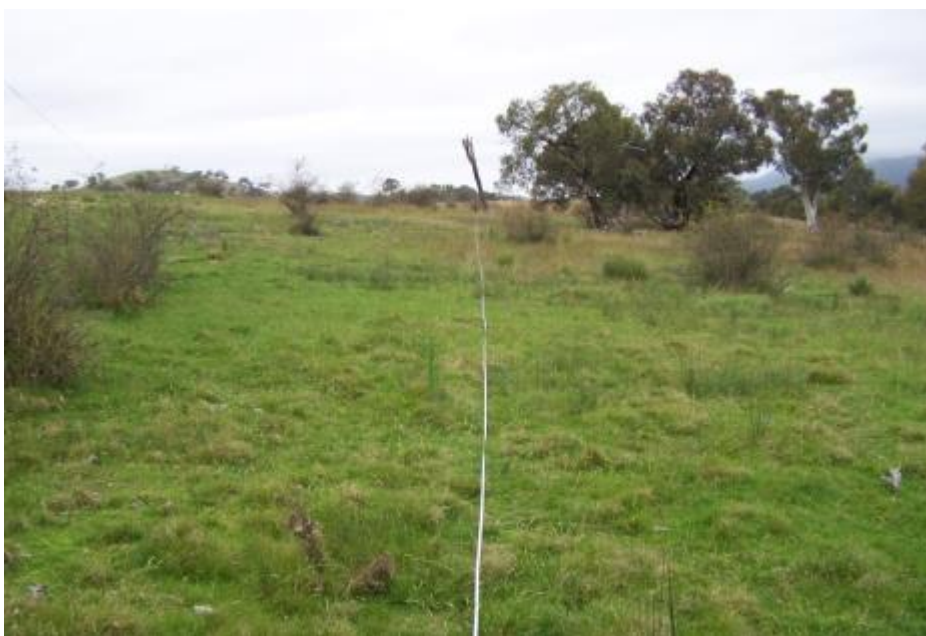
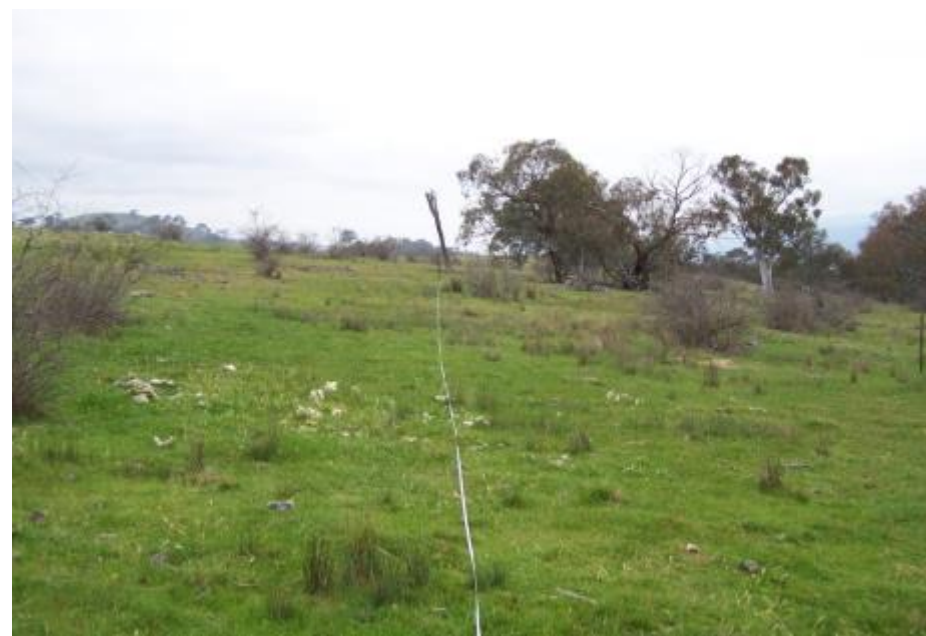
Figure 10: Monitoring Plot 7. (Left: Baseline monitoring photo, March 2012. Right: Monitoring photo October 2013)

Monitoring plot 7 is located within MU7 in the northern offset. The MU is composed of degraded Box-Gum Woodland dominated by *E. blakelyi*. Whilst no overstorey regeneration was recorded within the plot, regeneration of *E. blakelyi* was observed in the adjacent area for the first time. Native species diversity was low (18 species) in comparison with other monitoring plots but an increase compared to the baseline surveys (13 native species). Perennial vegetation is dominated by native species (sedges and rushes, *Carex* spp.); however, exotic annual vegetation cover was higher and accounts for the majority of the exotic understorey recorded in the table adjacent. Sheep were observed within MU7 in autumn 2013 and with residual grazing impacts present. Fauna habitat features have not changed noticeably since the baseline surveys.

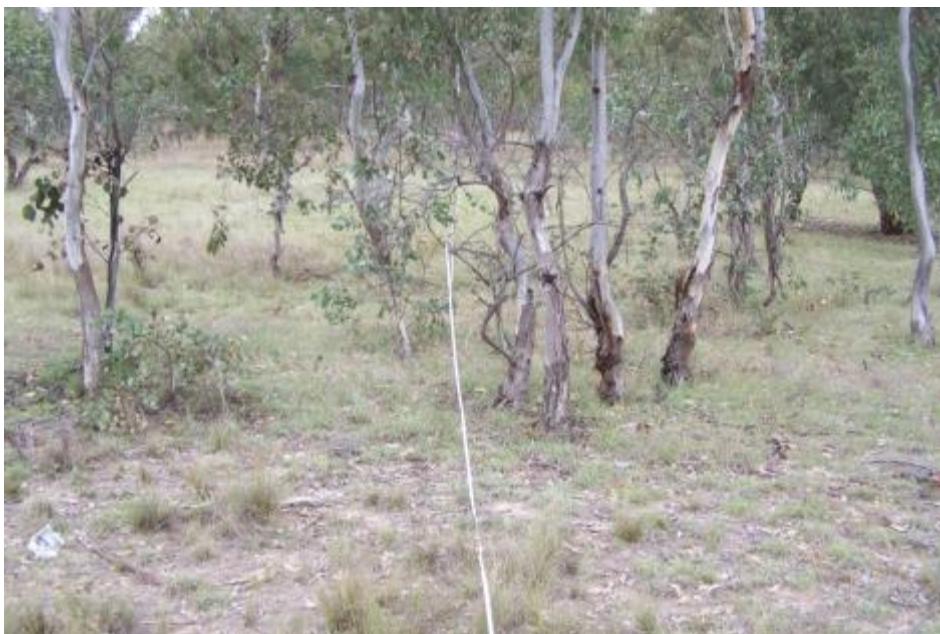
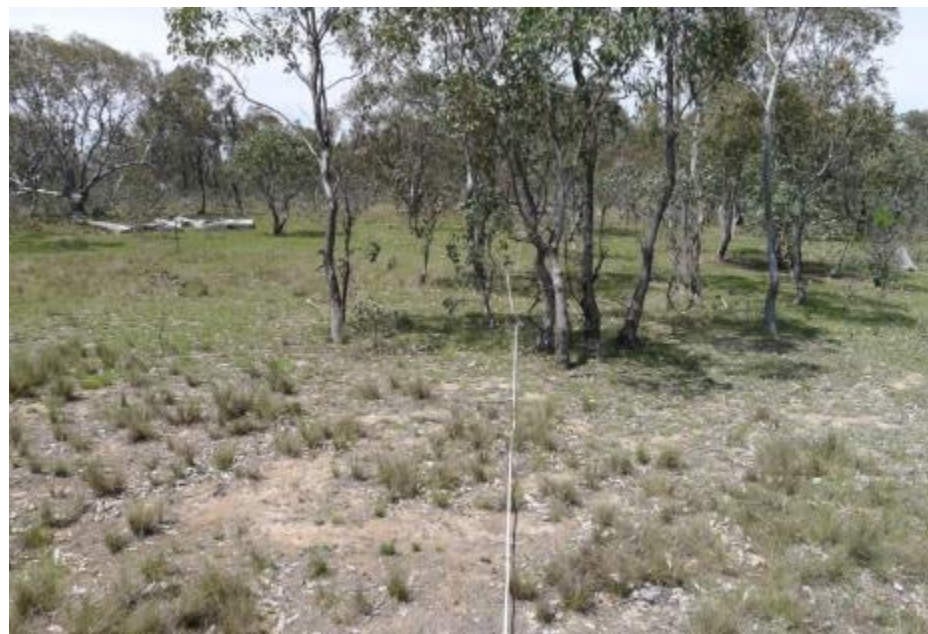
Figure 11: Monitoring Plot 8. (Left: Baseline monitoring photo, October 2011. Right: Monitoring photo October 2013)

Monitoring plot 8 is a control plot located in MU3. No management actions are proposed to occur within the bounds of the plot. The plot is located in good quality Box-Gum Woodland dominated by *E. blakelyi*. The plot supports a diverse understorey of grasses, herbs and forbs with 36 native species recorded in spring 2013, an increase from the baseline surveys, but a slight decrease from spring 2012 (41 species). This is likely a result of natural / seasonal variation and the wet conditions preceding the 2012 surveys. The dominant understorey species included *Themeda australis*, *Rytidosperma* spp. and *Chrysocephalum apiculatum*. Photo comparison shows a healthy understorey dominated by native species with good inter-tussock spacing. Fauna habitat features have not changed noticeably since the baseline surveys.

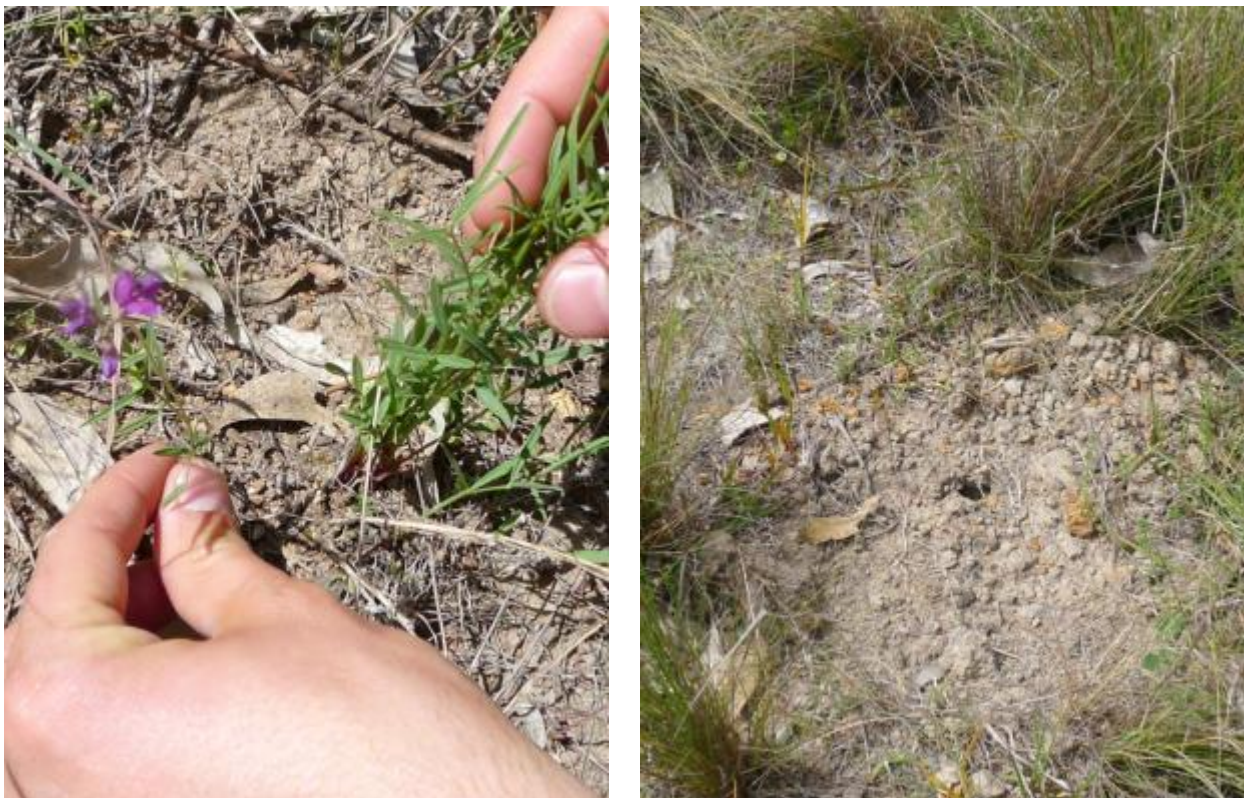
It was noted that individuals part of the 2013 plantings were not as developed prior to planting as those from the 2012 plantings, possibility contributing to the reduced survivorship observed. In addition, the use of water crystals did not seem to favour the translocation process. Planting sites were observed to contain cracking soils and holes. This was presumably created by the expansion of water crystals followed by the drying of the surrounding soils. In some cases, individuals had been exerted from their original planted positions.

Figure 17: Left; possible recruitment. Right; Soil cracking and hole from expanding water crystals

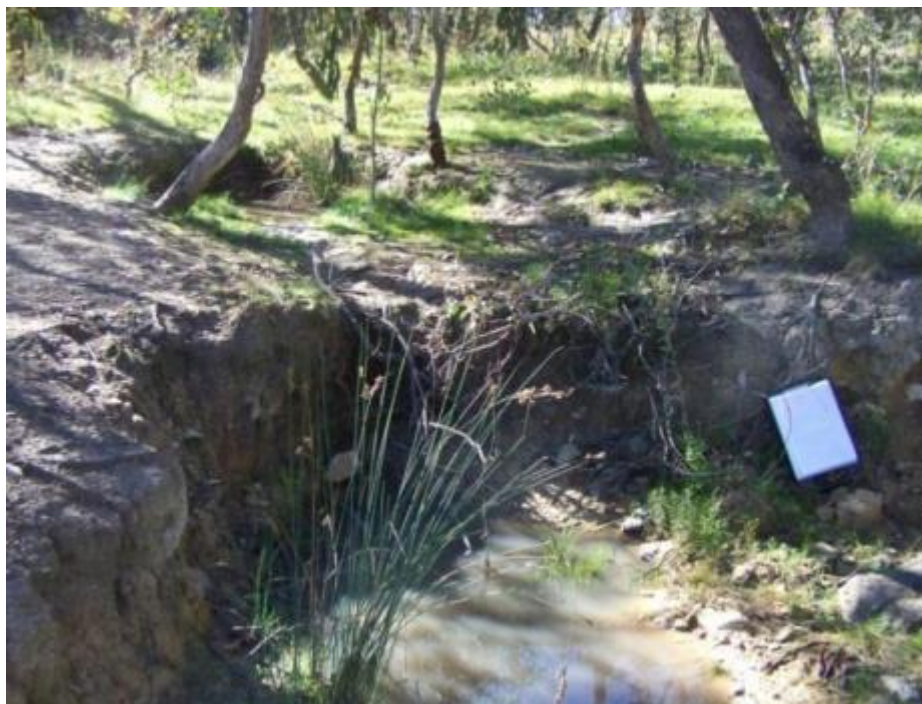
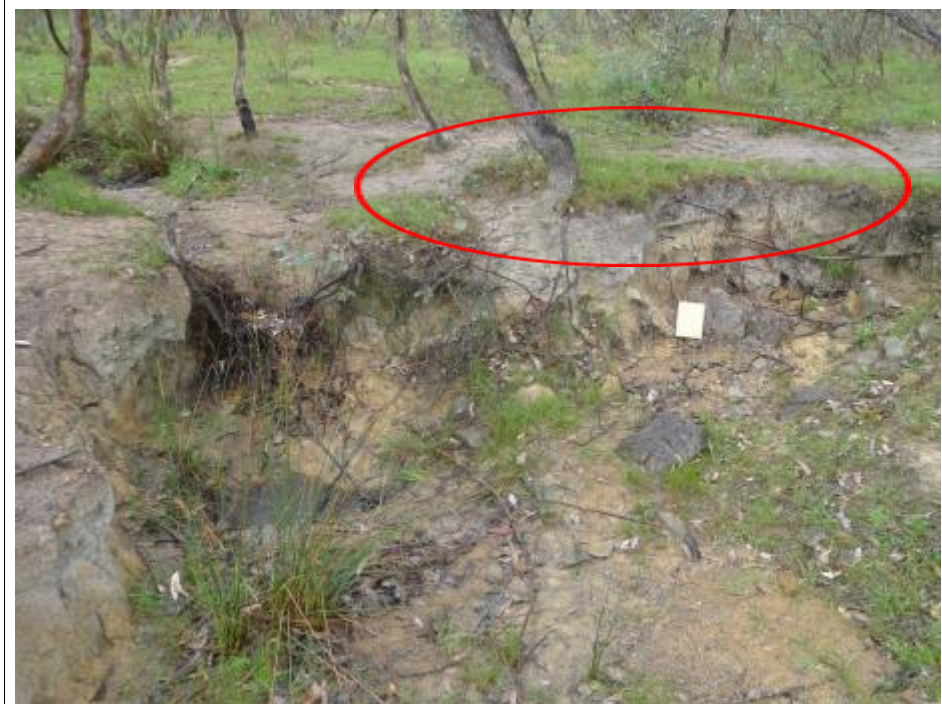
Erosion Point 2:

Note: Spring 2013 monitoring photo incorporates more of the erosion point on right hand-side of the photo.

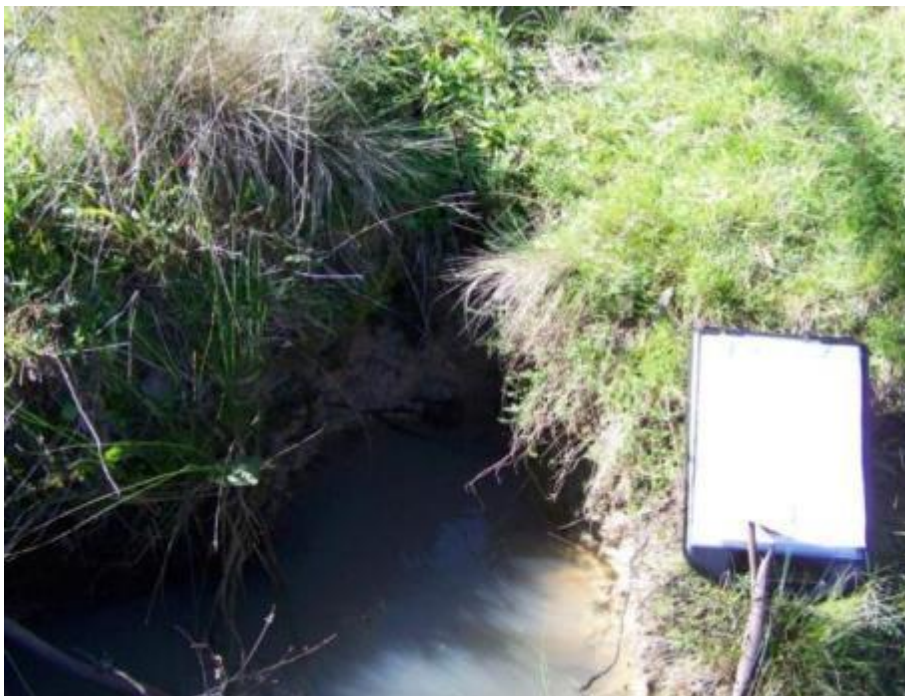
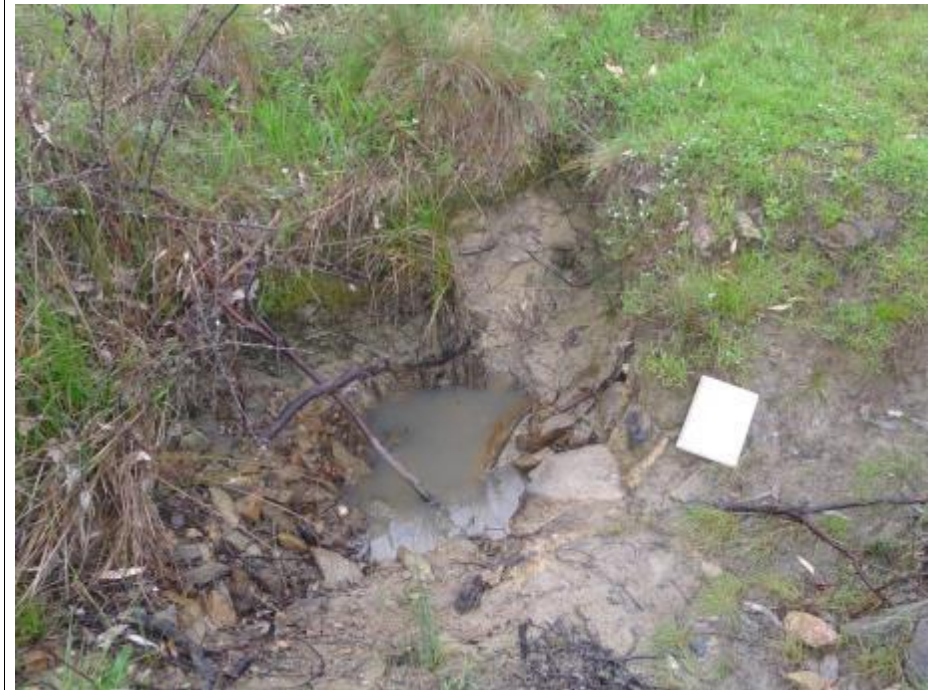
Note: There is a difference in the scale of the 2 photos. The right photo is zoomed out to incorporate a broader picture of the erosion point.

Autumn 2012

Spring 2013

Action required: Remove erosion point from future monitoring surveys.

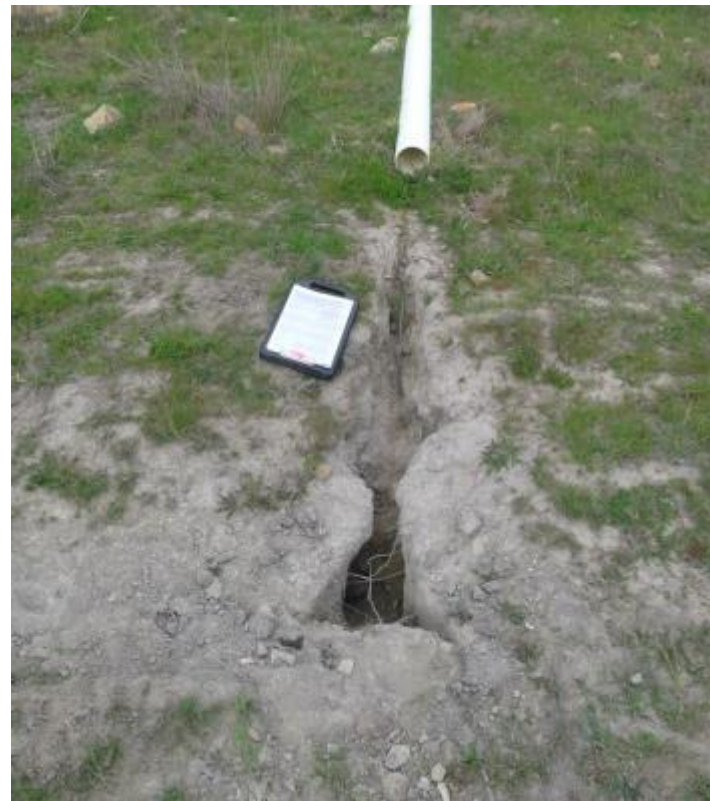
Baseline photo adjacent - Spring 2013

Action required: No action is required at this stage. Continual bi-annual monitoring.
