M2G Planting (Tree & Shrub) Monitoring Report

Construction Corridor (Autumn 2015)

Prepared for
Icon Water

July 2015

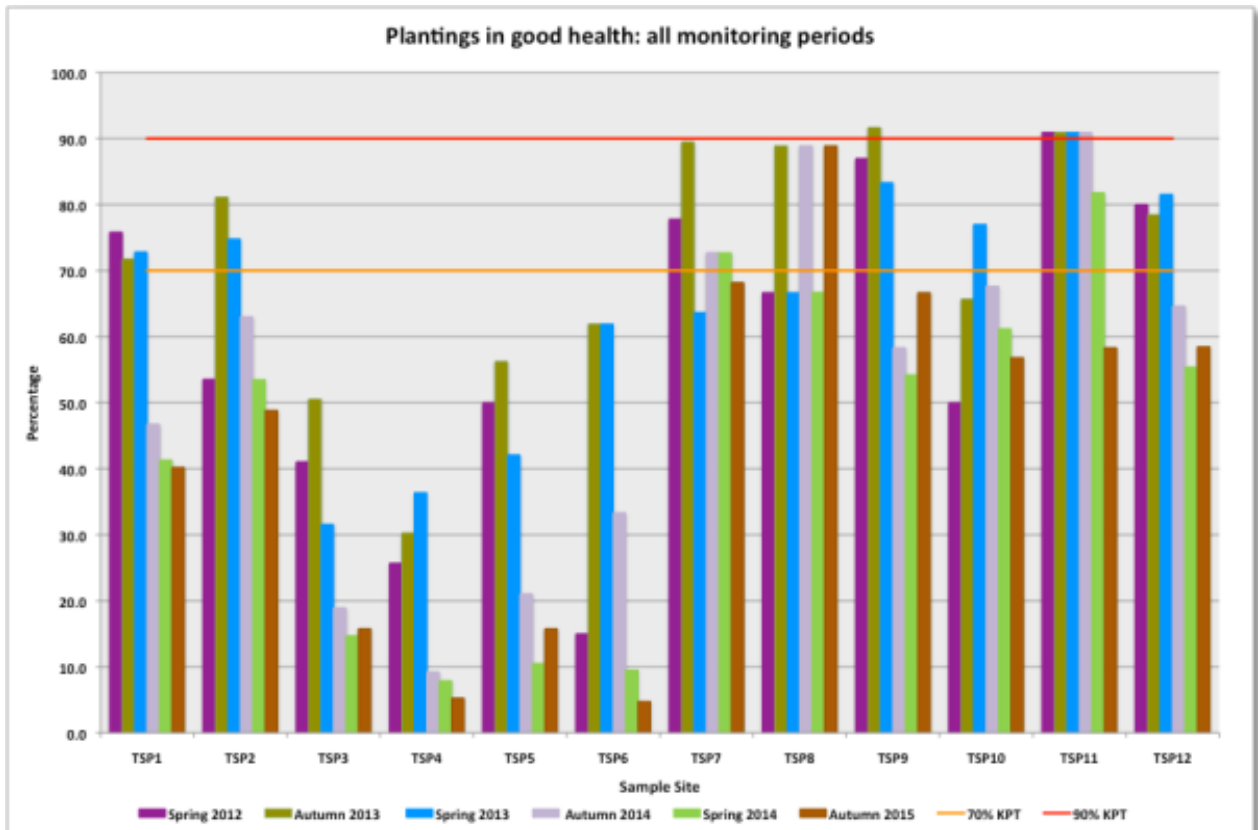
Chart 1: Proportion of plantings in good health at each site during all monitoring periods. ACT sites = TSP 1-6 and NSW sites = TSP 7-12.

Planting success was also differentiated by jurisdiction, with just **28.4%** of the plantings in the ACT (TSP1-6) in good health compared to **60.1%** of the plantings in NSW (TSP7-12) (**Chart 1**). While both the ACT and NSW sections had comparative increases in dead and missing specimens (about **15%**) the former totalled **286** plantings and the latter **78** plantings.

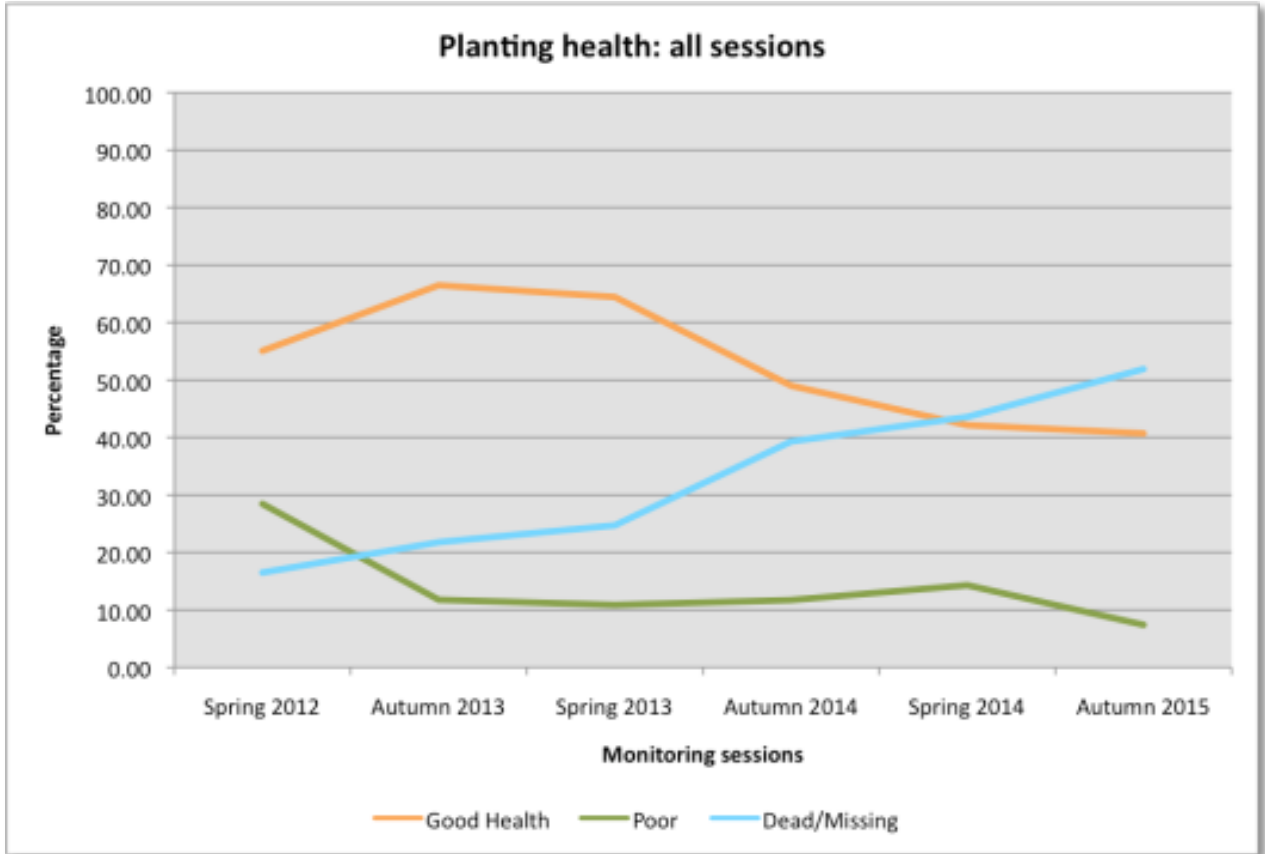
Chart 2: Cumulative planting health across all monitoring periods.

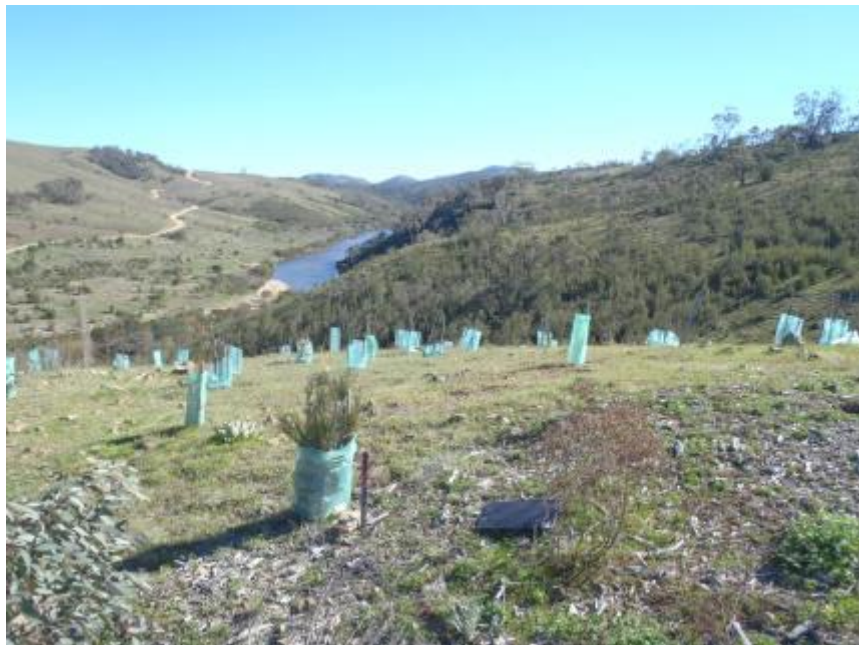
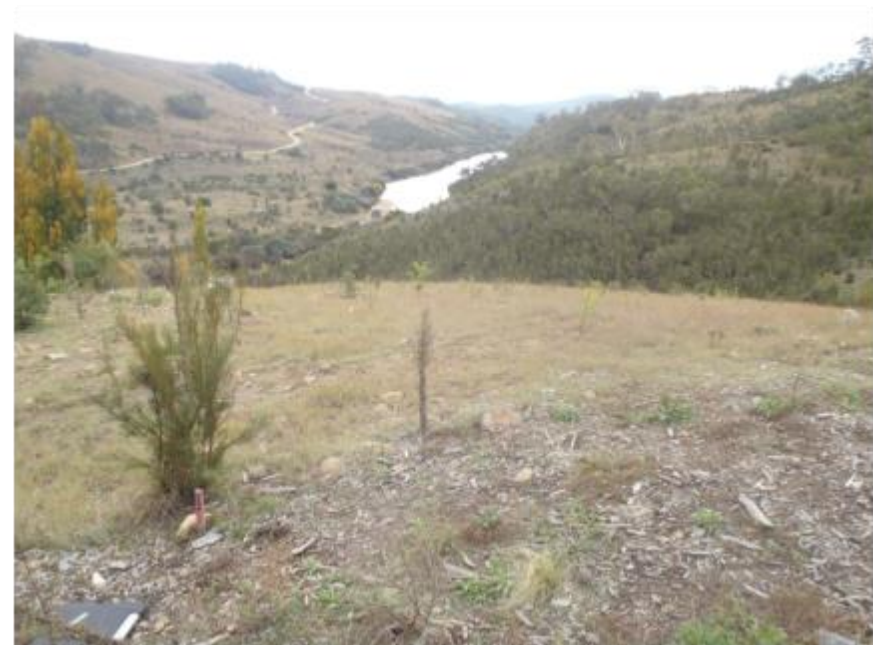
Plate 1: Monitoring Site TSP1. The image on the left is from spring 2014 and the right autumn 2015.

| Jurisdiction | ACT | TSP1 Situated within the Murrumbidgee River Corridor immediately W and NW of the HLPS, about 250 m from the LLPS. |
| Dead / Missing | 52 (32) | |

| Good | 37 (38) | Recommendation: Replace dead and missing specimens with a view to meeting a revised KPT of 70% |

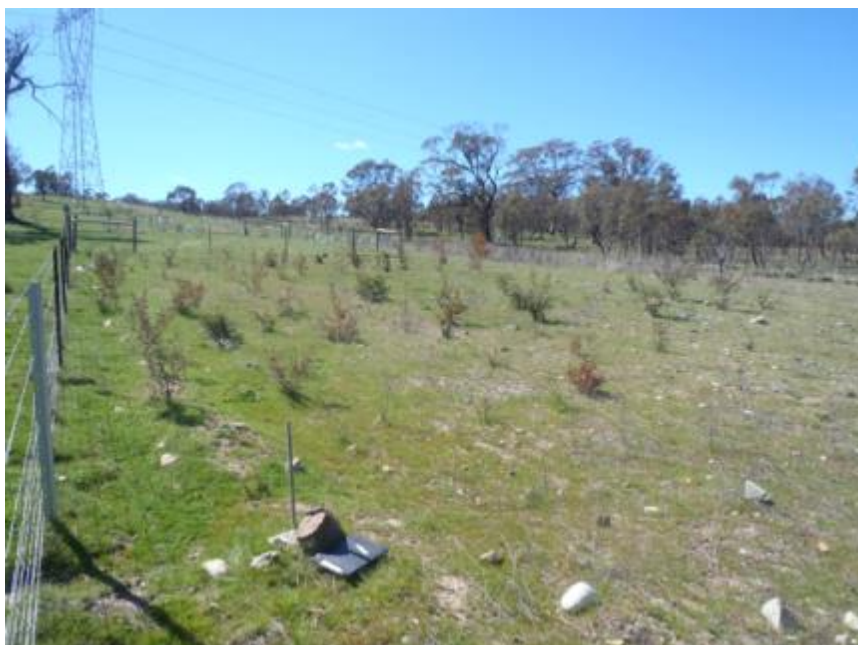
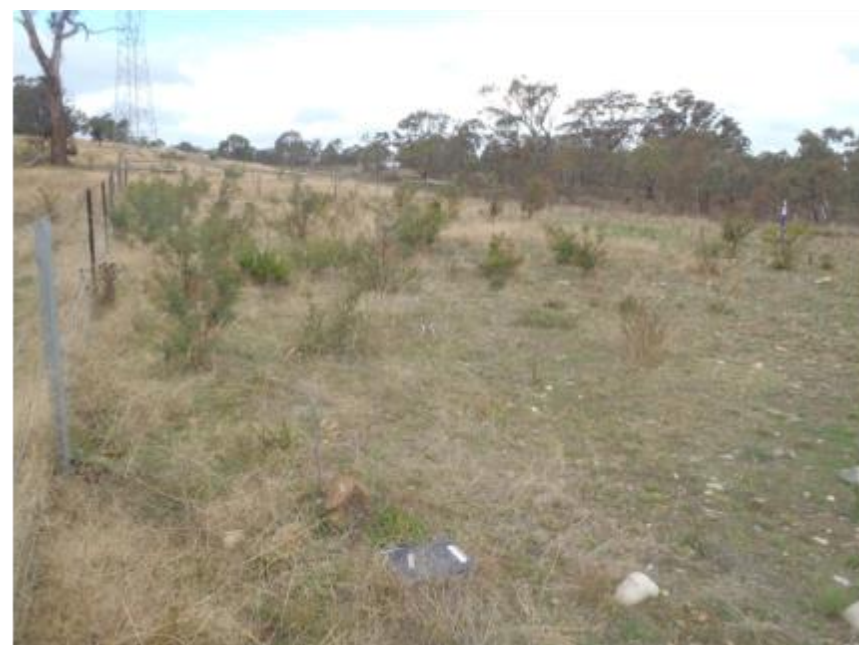
Plate 2: Monitoring Site TSP2. The image on the left is from spring 2014 and the right autumn 2015.

| Jurisdiction | ACT | <p>TSP2 is located within the Murrumbidgee River Corridor, about 1,025 m from the LLPS.</p> <p>Although specimen health continues to decline the rate of decline may have stabilised. Currently 48.8% of plantings were in good health compared to 53.5% during the previous spring 2014 session.</p> <p><i>Inset: TSP2 in spring 2012 - within 12 months of planting.</i></p> <p>Recommendation: Replace dead and missing specimens see previous</p> |
| Dead / Missing | 59 (41) | |

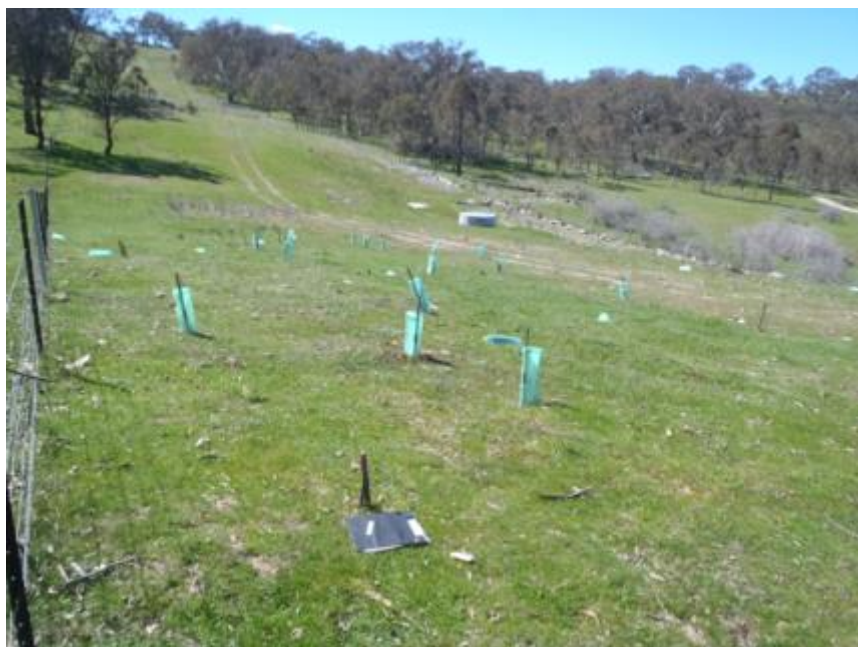
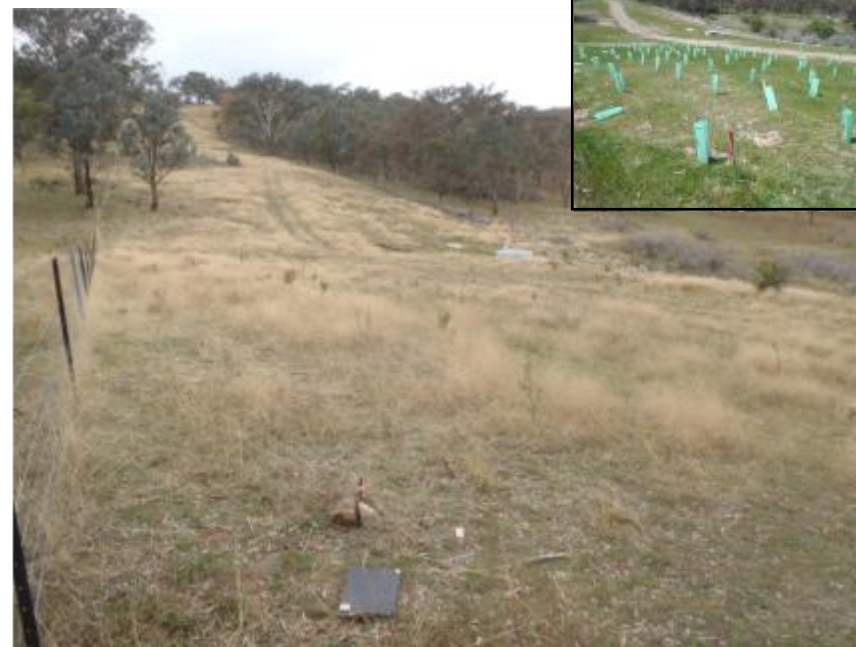
Plate 3: Monitoring Site TSP3. The image on the left is from spring 2014 and the right autumn 2015.

| Jurisdiction | ACT | <p>TSP3 is located within the Murrumbidgee River Corridor, about 1,350 m from the LLPS.</p> <p>Currently 15.8% of plantings are in good health - a slight increase on the previous spring 2014 session (14.7%). The majority of specimens are either dead or missing.</p> <p><i>Inset: TSP3 in spring 2012 -within 12 months of planting.</i></p> <p>Recommendation: Replace dead and missing specimens same words as previous and where applicable in following</p> |
| Dead / Missing | 76 (69) | |

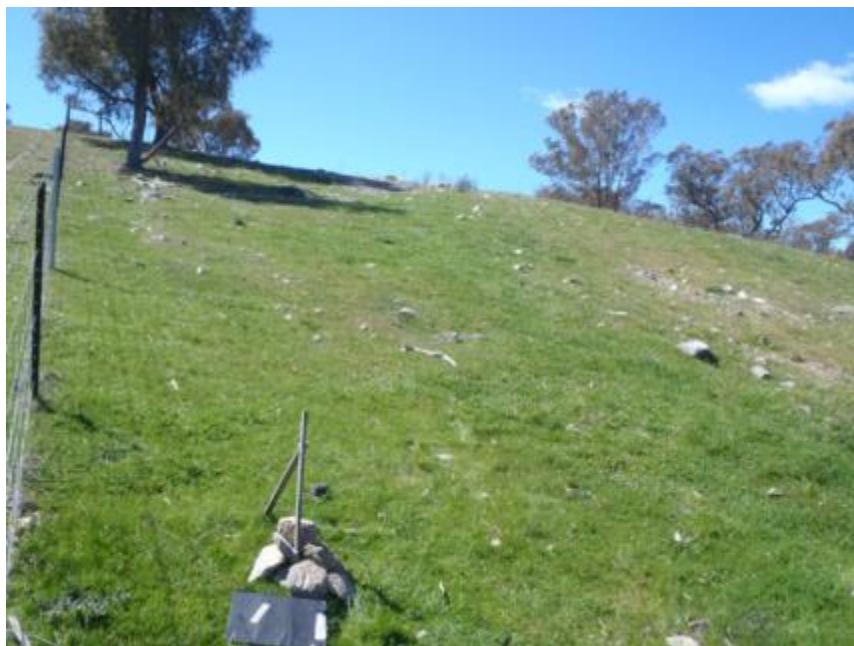
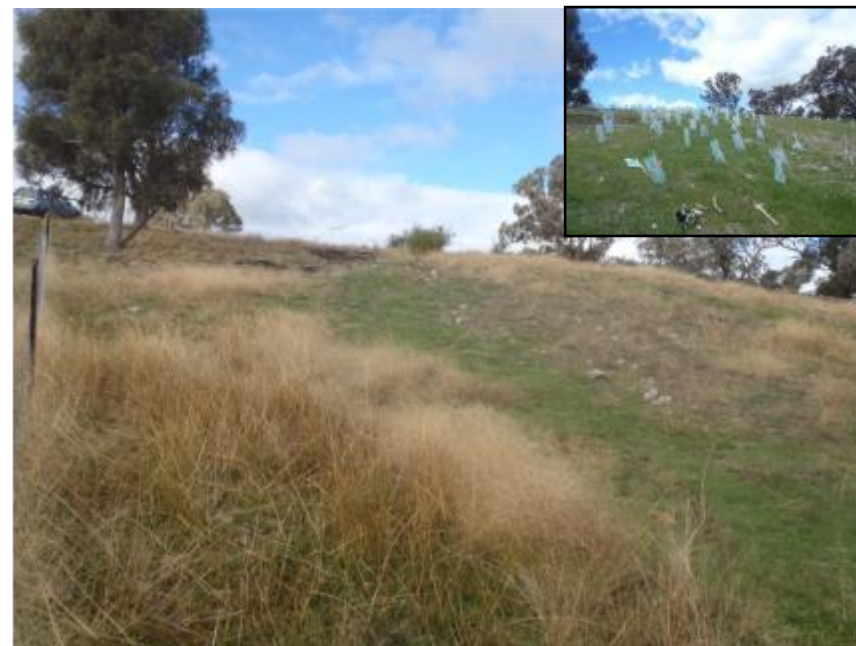
Plate 4: Monitoring Site TSP4. The image on the left is from spring 2014 and the right autumn 2015.

| Dead / Missing | 65 (63) | |

| Total plantings | 76 | Recommendation: Replace dead and missing specimens. |

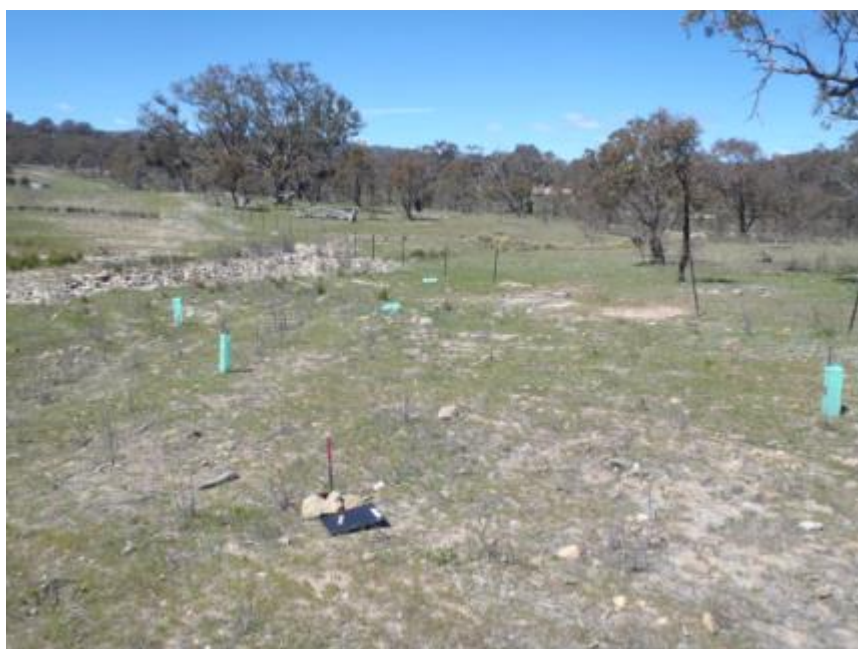
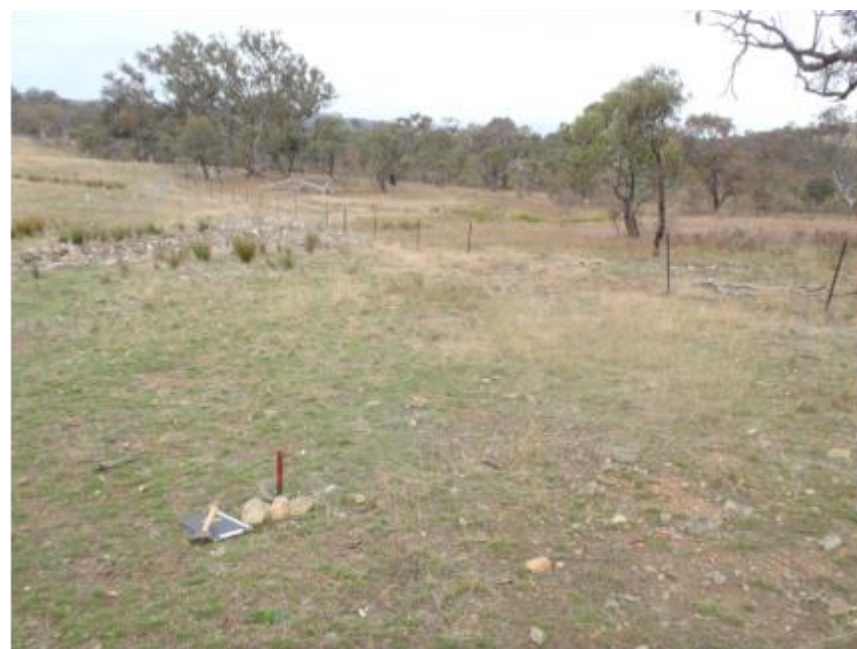
Plate 5: Monitoring Site TSP5. The image on the left is from spring 2014 and the right autumn 2015.

| Jurisdiction | ACT | TSP5 is located about 2,325 m from the LLPS within the ACT. Specimens in good health increased from 10.5% (in spring 2014) to 15.8% during the current survey, however, the increase was represented by just one specimen. The majority of plantings are either dead or missing. Recommendation: Replace dead and missing specimens |
| Dead / Missing | 16 (14) | |

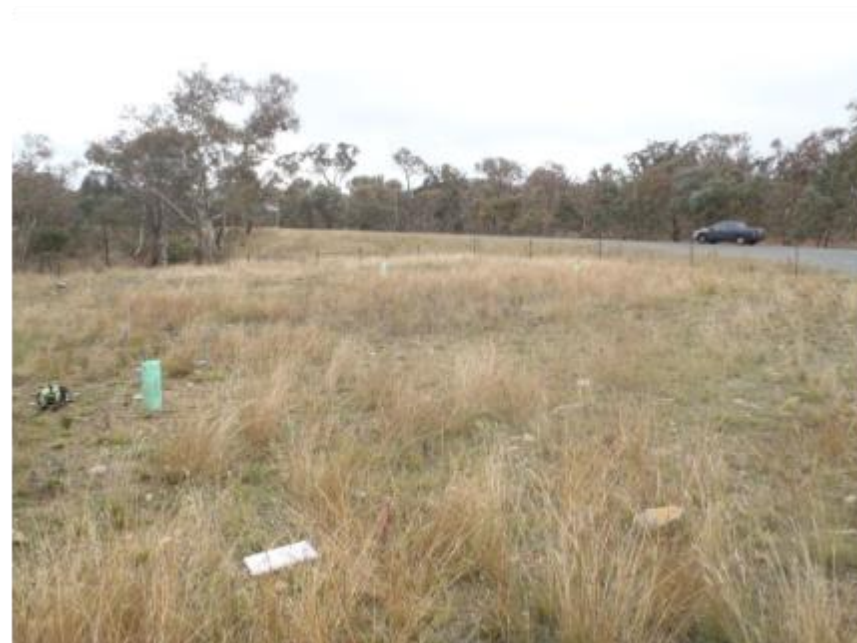
Plate 6: Monitoring Site TSP6. The image on the left is from spring 2014 and the right autumn 2015.

| Jurisdiction | ACT | <p>TSP6 is located about 2,650 m from the LLPS - west of and adjacent to the Monaro Hwy within the ACT.</p> <p>Planting success declined significantly after spring 2013, with just 1 specimen (4.8%) now remaining in good health.</p> <p>Natural recruitment of Yellow Box <i>Eucalyptus melliodora</i> and Blakely's Red Gum <i>E. blakelyi</i> was recorded nearby.</p> <p>Recommendation: Replace dead and missing specimens and improve maintenance (see Section 3.5 of the LRTEMP).</p> |
| Dead / Missing | 18 (14) | |

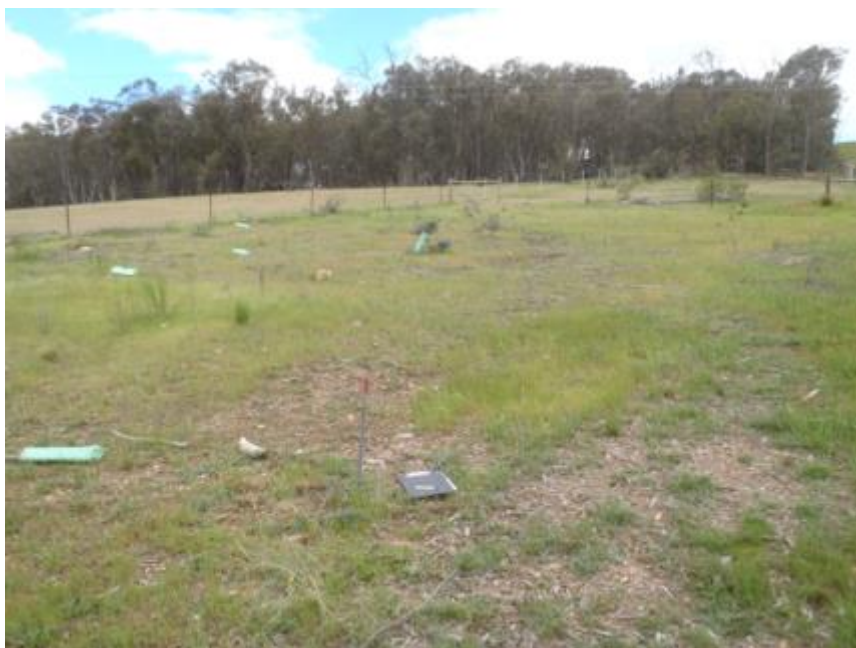
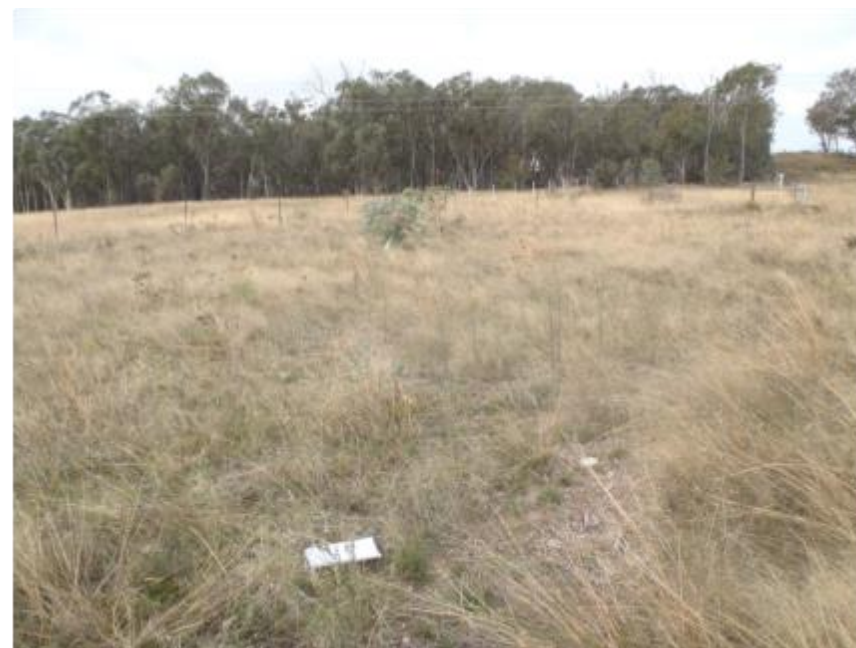
Plate 7: Monitoring Site TSP7. The image on the left is from spring 2014 and the right autumn 2015.

| Jurisdiction | NSW | TSP7 is located about 3,040 m from the LLPS within the Smith property, NSW. 68.2% of plantings were in good health compared to 72.7% during the previous spring 2014 session. <i>Note:</i> Sample site is separated in to two planting areas - northern and southern sides of the construction corridor. Natural recruitment of Yellow Box <i>Eucalyptus melliodora</i> , Apple Box <i>E. bridgesiana</i> and Broad-leaved Peppermint <i>E. dives</i> was observed east and west of this site. Recommendation: Replace dead and missing specimens (see Section 3.5 of the LRTEMP). |
| Dead / Missing | 7 (6) | |

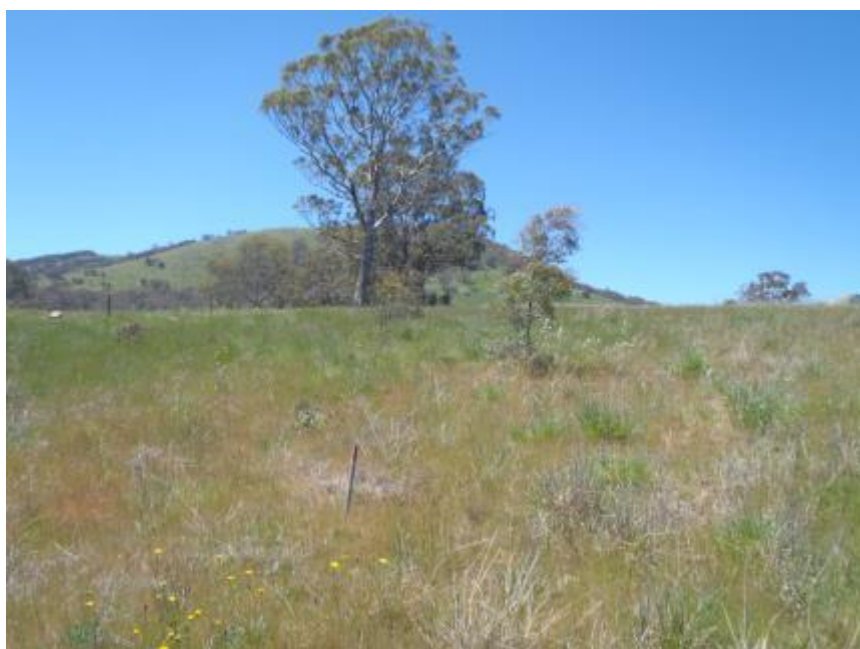
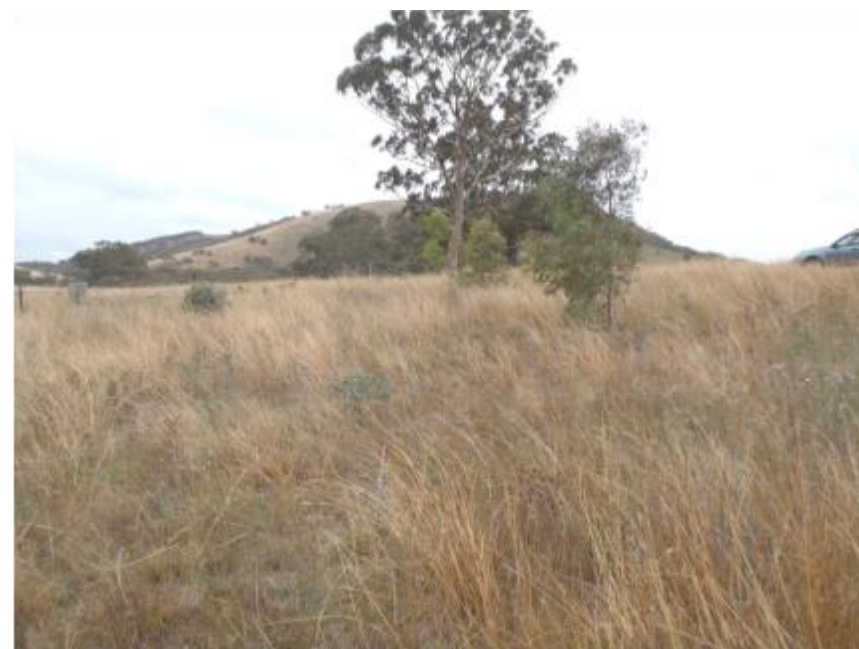
Plate 8: Monitoring Site TSP8. The image on the left is from spring 2014 and the right autumn 2015.

| Dead / Missing | 1 (1) | |

| Good | 8 (8) | Recommendation: Improve planting maintenance (see Section 3.5 of the LRTEMP). No further works required. |

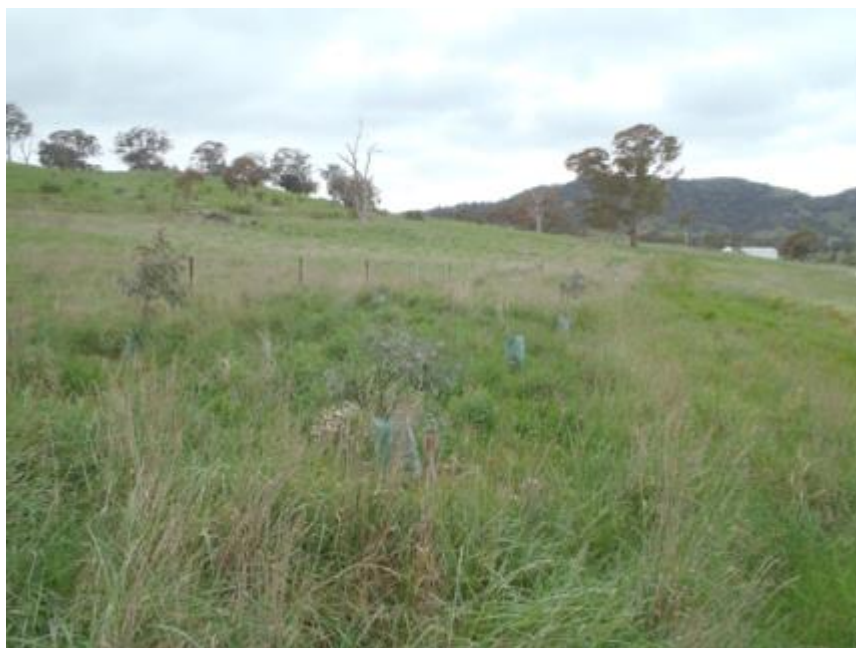
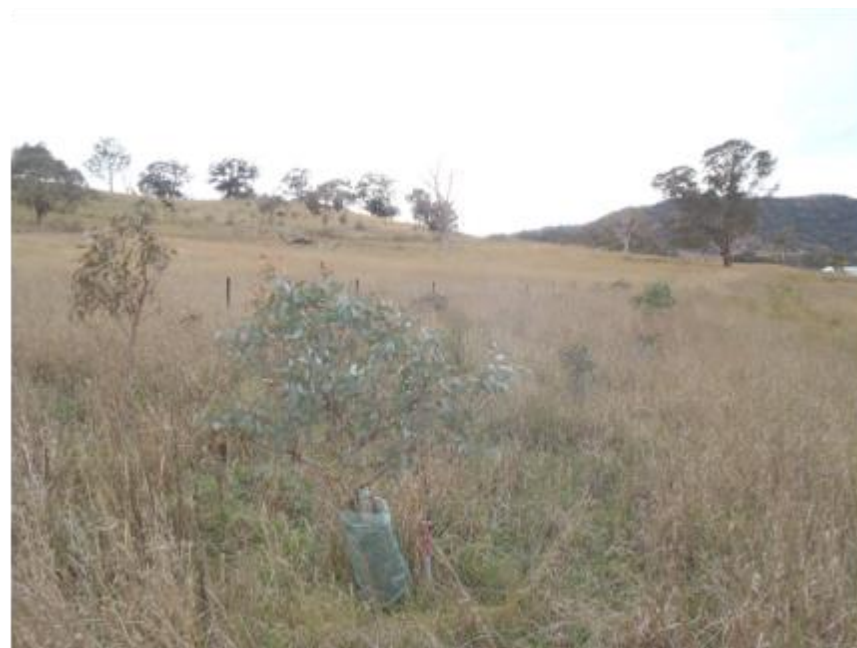
Plate 9: Monitoring Site TSP9. The image on the left is from spring 2014 and the right autumn 2015.

| Dead / Missing | 5 (1) | |

| Good | 16 (13) | Recommendation: Improve planting maintenance and replace trees and shrubs to meet revised KPT targets (see Section 3.5 of the LRTEMP). |

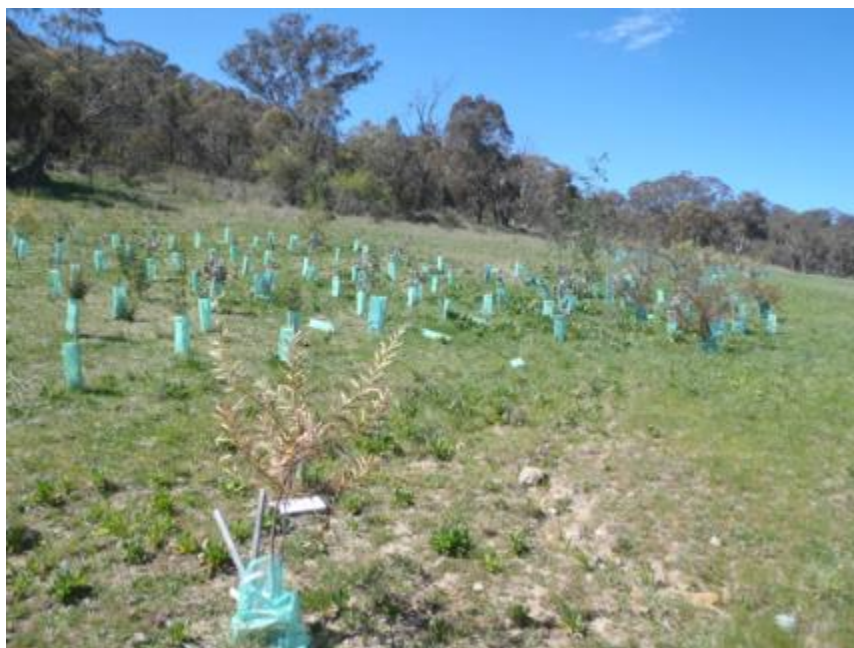
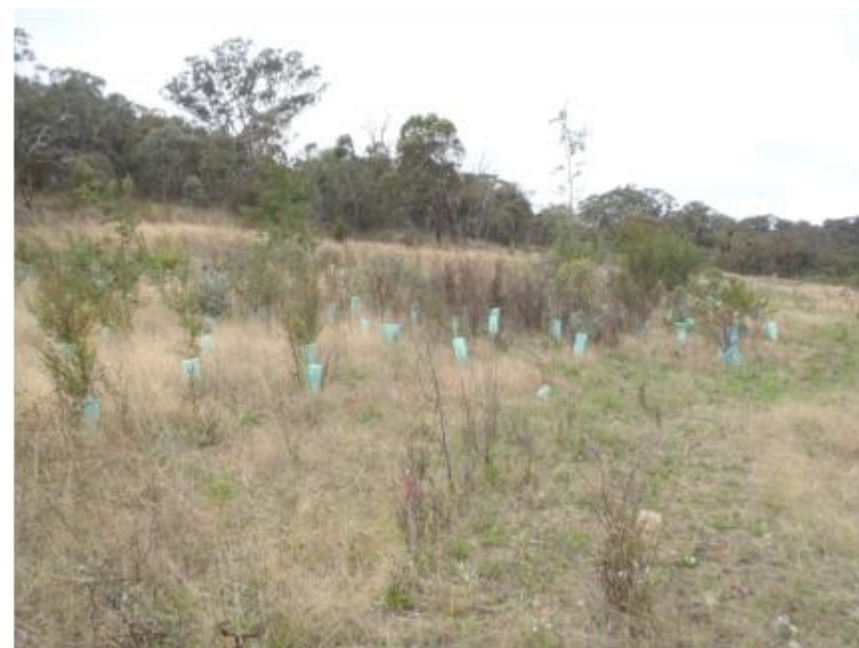
Plate 10: Monitoring Site TSP10. The image on the left is from spring 2014 and the right autumn 2015.

| Jurisdiction | NSW | <p>TSP10 is located about 6,425 m from the LLPS within the Johanson property, NSW.</p> <p>Planting health has declined to 56.8% from 61.2% in spring 2014. Some tree guards still remain choked with herbage that has resulted in the death and poor health of many plantings at this site.</p> <p>Recommendation: Replace dead and missing specimens and improve planting maintenance (see Section 3.5 of the LRTEMP).</p> |
| Dead / Missing | 42 (35) | |

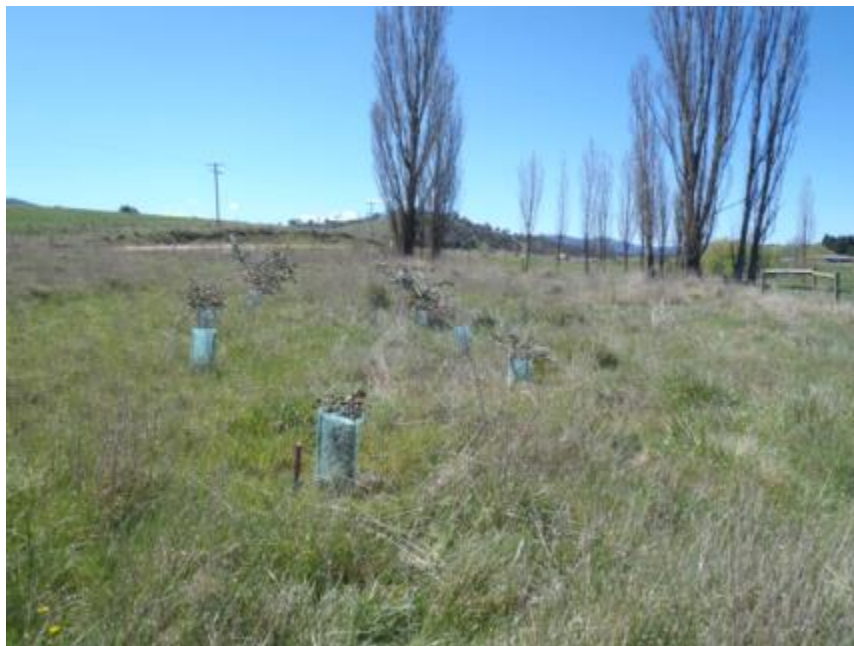
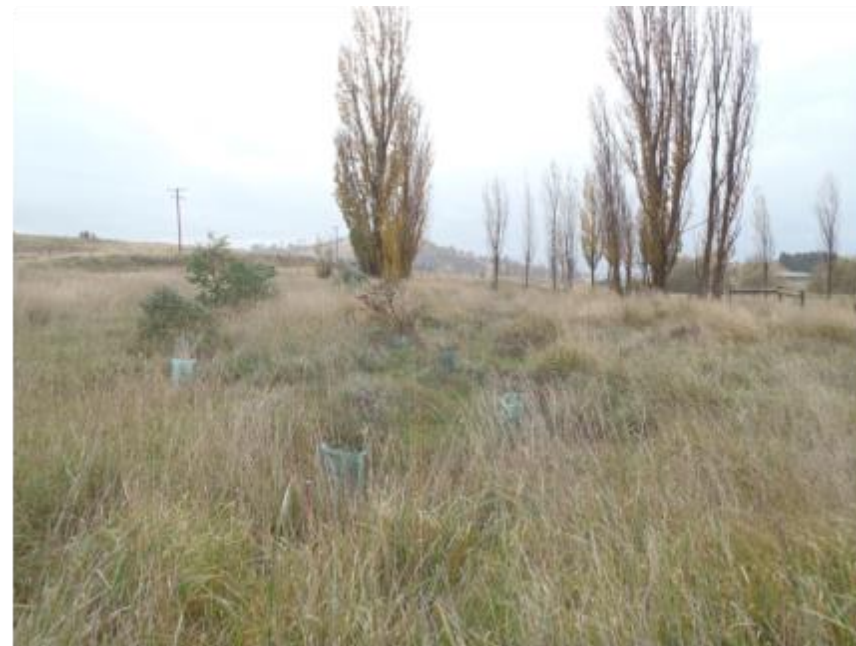
Plate 11: Monitoring Site TSP11. The image on the left is from spring 2014 and the right autumn 2015.

| Jurisdiction | NSW | <p>TSP11 is located about 9,300 m from the LLPS within the Latimer property, NSW.</p> <p>Currently, 58.5% of plantings were in good health, down from 81.8% in the previous spring 2014. This is a small sample site and the decline was represented by just 2 specimens. All surviving specimens exhibited vigorous growth. Some tree guards have become engulfed by competing pasture grasses, which may affect future planting success.</p> <p>Recommendation: Improve planting maintenance (see Section 3.5 of the LRTEMP).</p> |
| Dead / Missing | 2 (1) | |

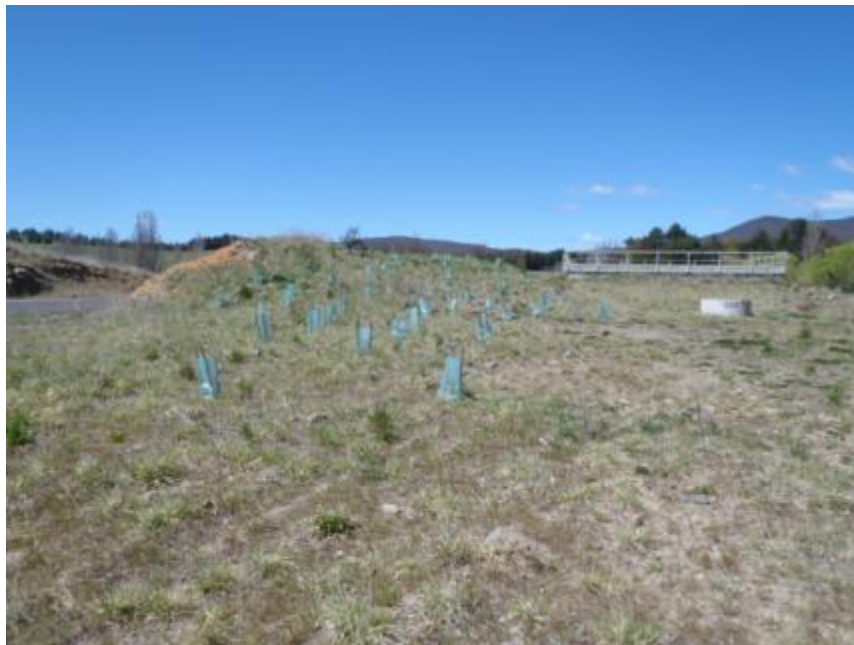
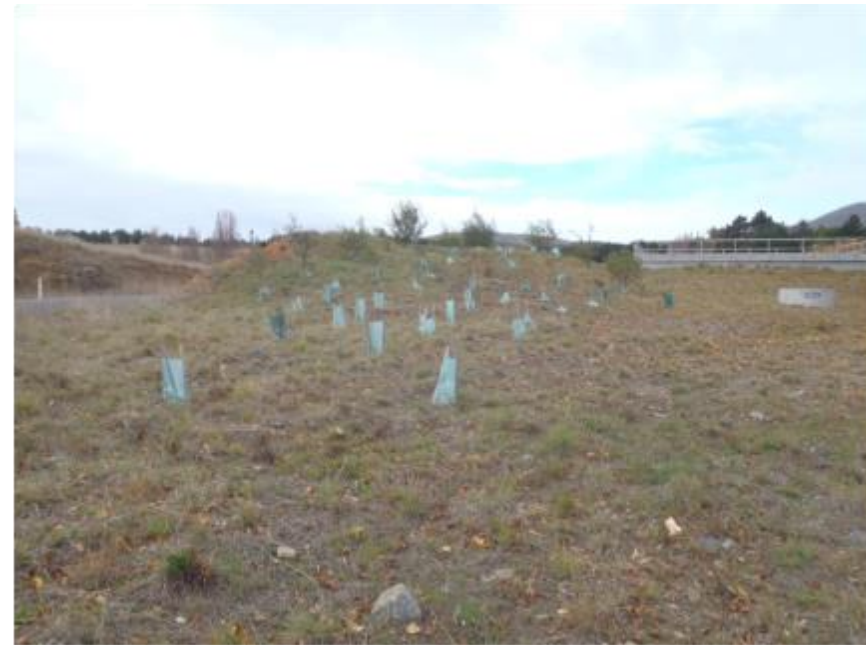
Plate 12: Monitoring Site TSP12. The image on the left is from spring 2014 and the right autumn 2015.

| No. of tree & shrub species planted | 4 | The proportion of plantings in good health rose marginally to 58.5% from 55.4% during the previous spring 2014 session. About 32% of specimens were either dead or missing. |
| Dead / Missing | 21 (21) | |

| Good | 38 (36) | Recommendation: Replace dead and missing specimens and improve planting maintenance (see Section 3.5 of the LRTEMP). |
