Icon Water
Murrumbidgee Ecological Monitoring Programme
Sentinel Monitoring - autumn 2015

August 2015

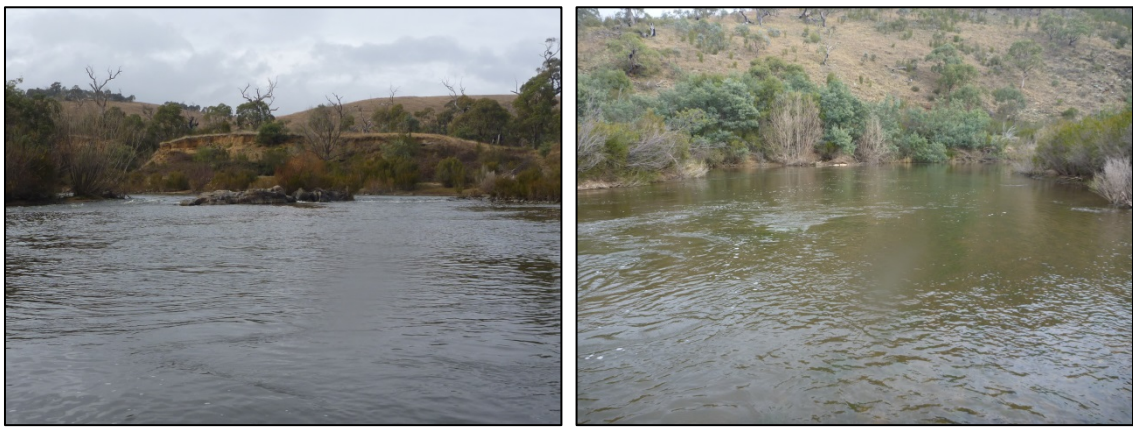
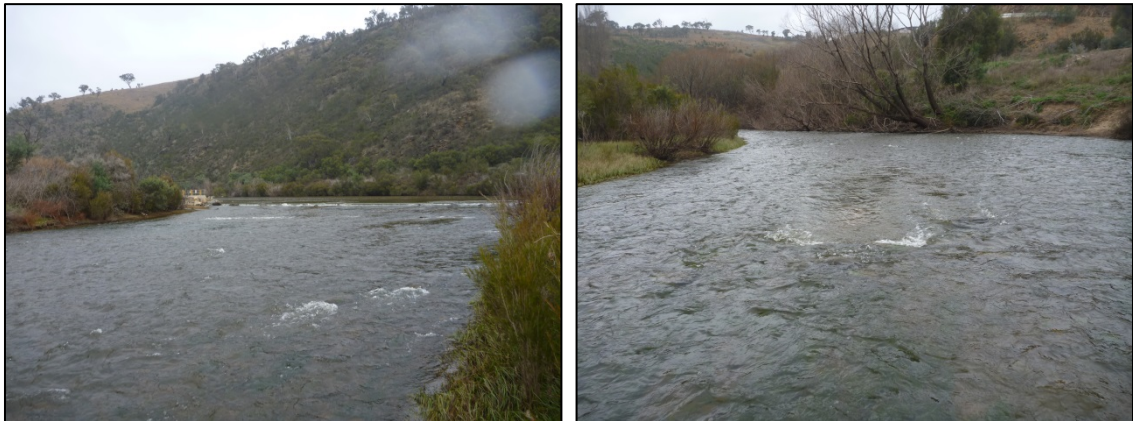
Plate 3-1. Photographs of the Angle Crossing sites during autumn 2015 sampling

MUR 18: Looking upstream (left) and downstream (right)

MUR 19: Looking upstream (left) and downstream (right)

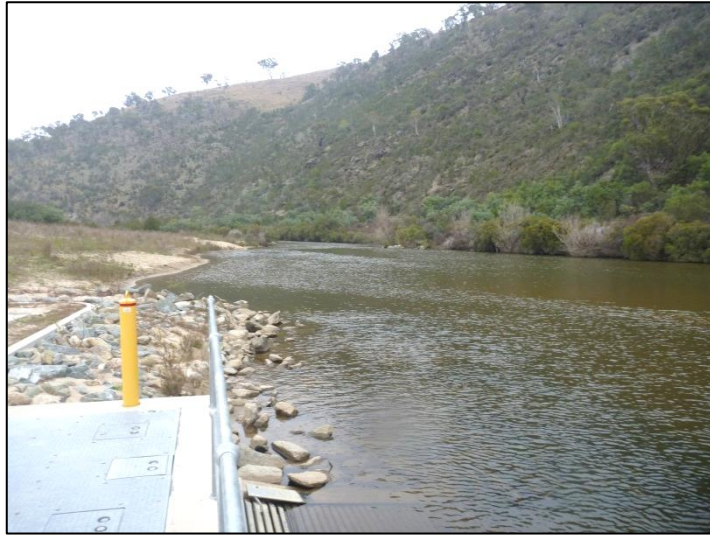
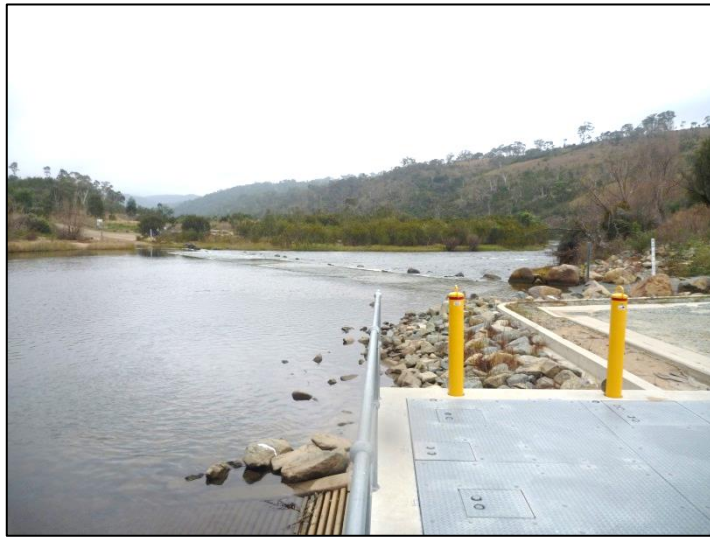
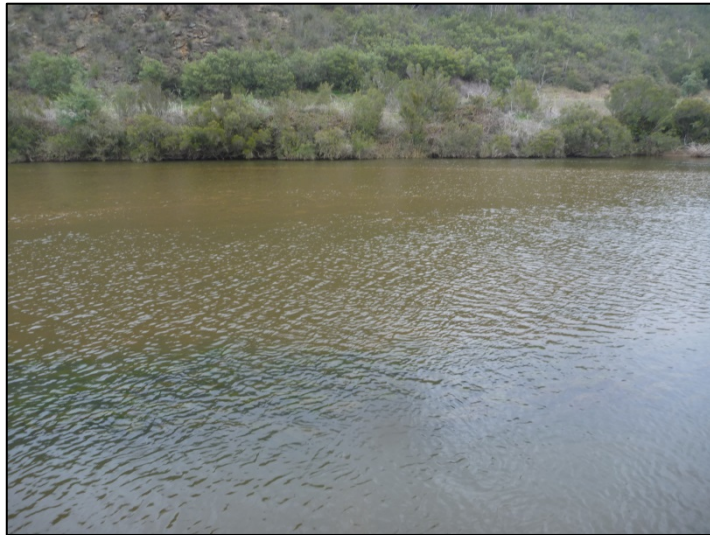
Plate 3-6. Geomorphology photo point 1 at Angle Crossing showing upstream (a), downstream (b) and across the channel (c)

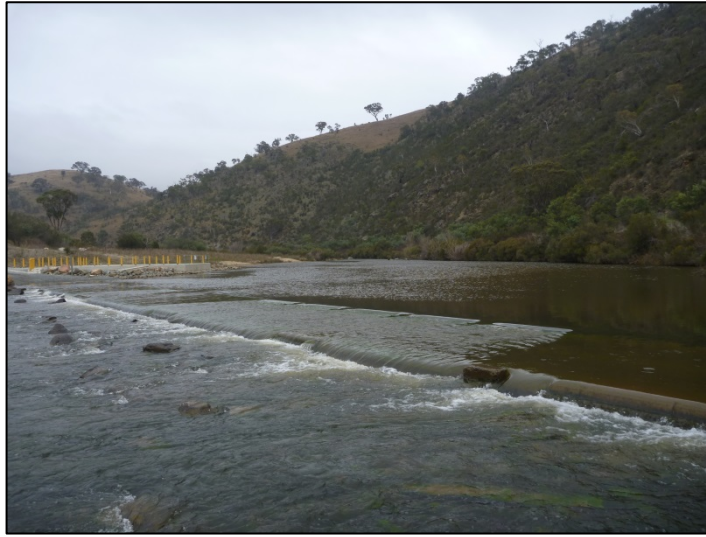
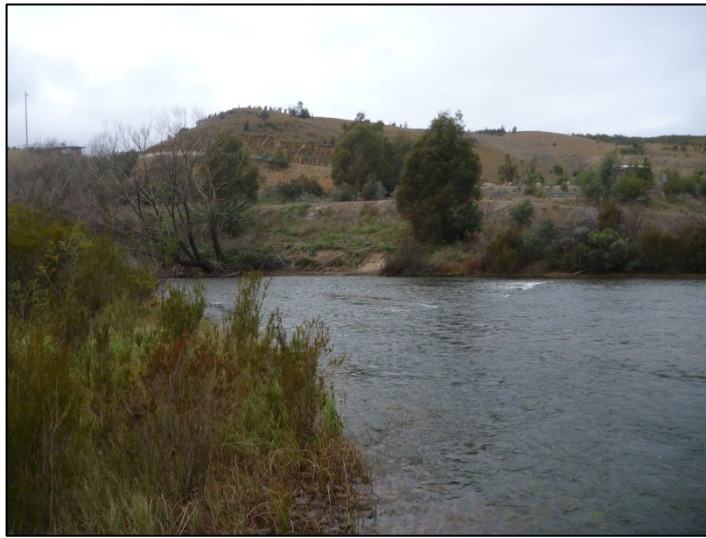
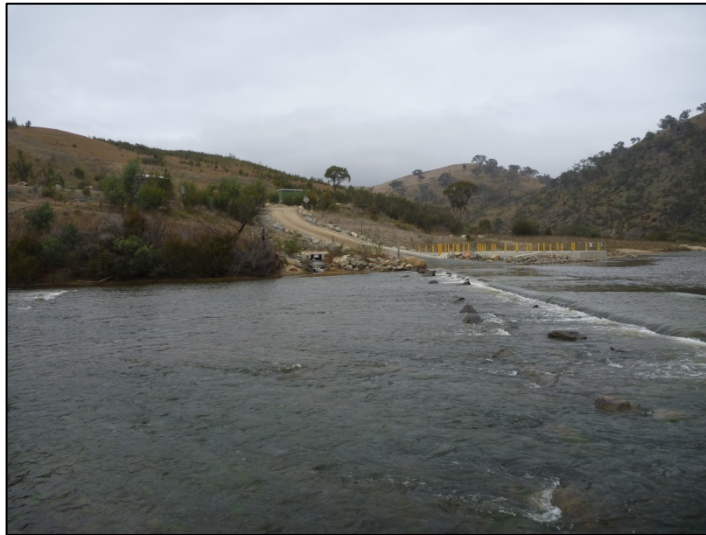
The most significant geomorphological feature at the M2G intake structure is the large dynamic pool directly adjacent to the structure itself. This pool fluctuates in depth and is highly influenced by changes in flow with deposition and sediment removal with scouring occurring during high flow events and deposition occurring at various stages of the hydrograph which continuously changes the structure of the pool and presence of bars (GHD, 2015c). Photo points 1 and 2 cover this area (Plate 3-6 and Plate 3-7 respectively). Potential deposition of sand deposits in the area immediately downstream of Angle Crossing is monitored through photo point 2 and 3 (Plate 3-7 and Plate 3-8 respectively).

Plate 3-7. Geomorphology photo point 2 at Angle Crossing showing upstream (a), downstream (b) and across the channel (c)

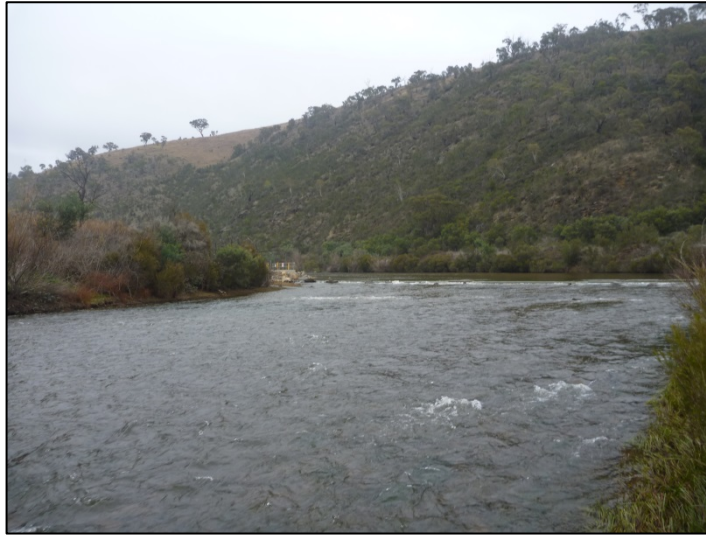
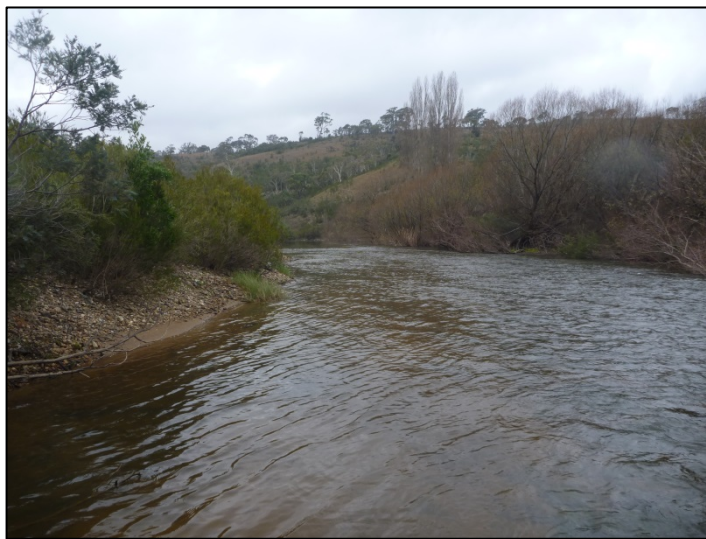
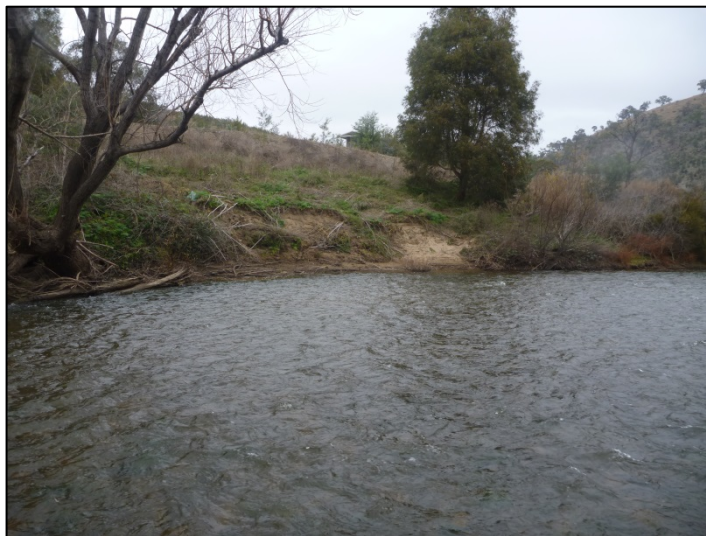
Plate 3-8. Geomorphology photo point 3 at Angle Crossing showing upstream (a), downstream (b) and across the channel (c)

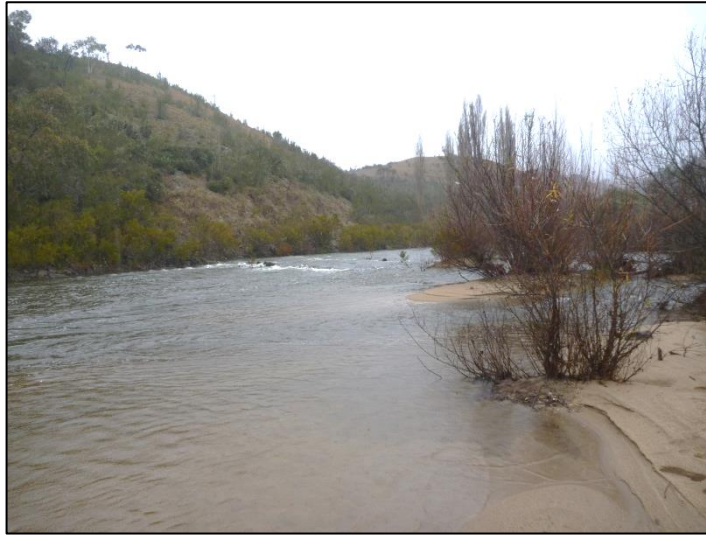
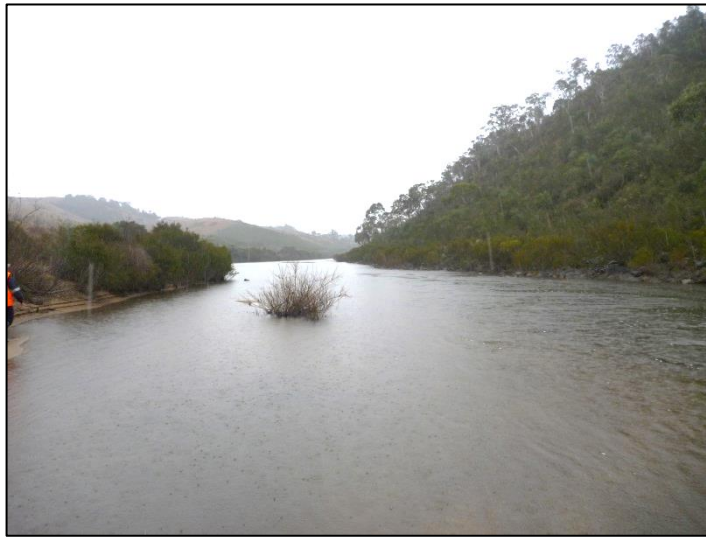
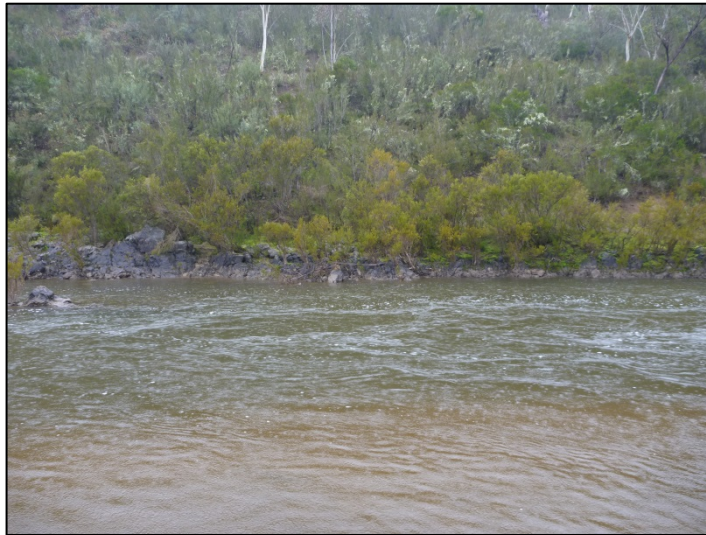
Change in the channel downstream of Angle Crossing has been previously identified, with removal of bars and deepening of the central channel (GHD, 2015). This reach downstream of Angle Crossing could potentially see increased sediment deposits and increased bar formation as a result of the abstraction decreasing flows. This section of river is monitored through photo point 4 and 5 (Plate 3-9 and Plate 3-10 respectively).

Plate 3-9. Geomorphology photo point 4 at Angle Crossing showing upstream (a), downstream (b) and across the channel (c)

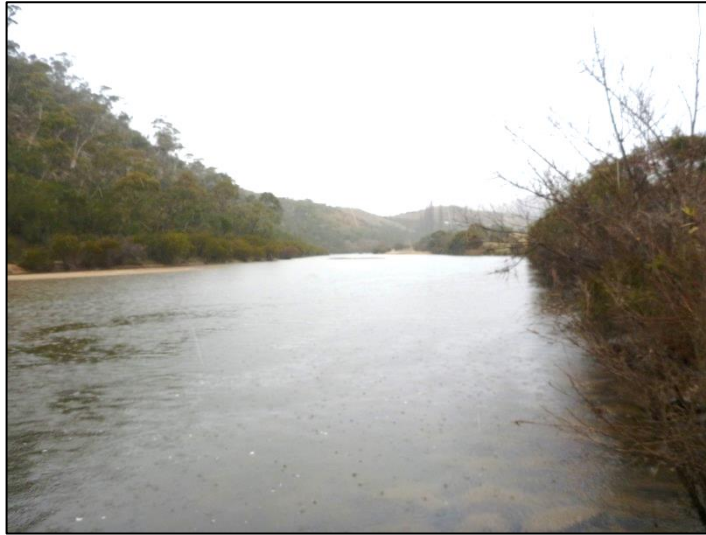
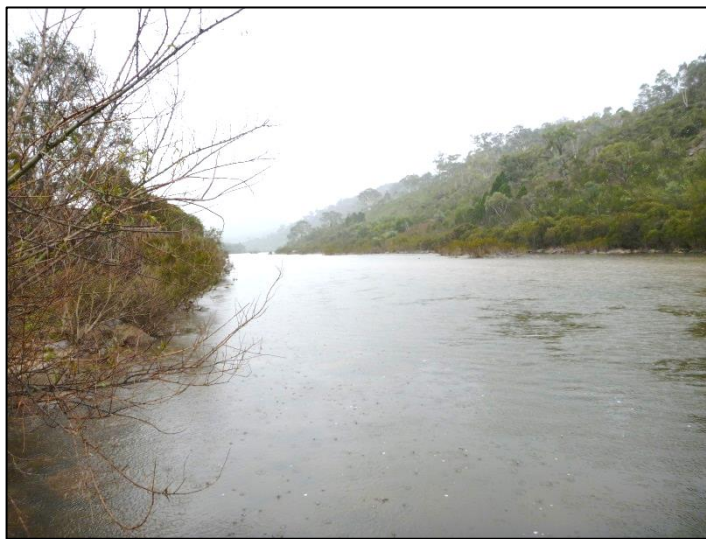
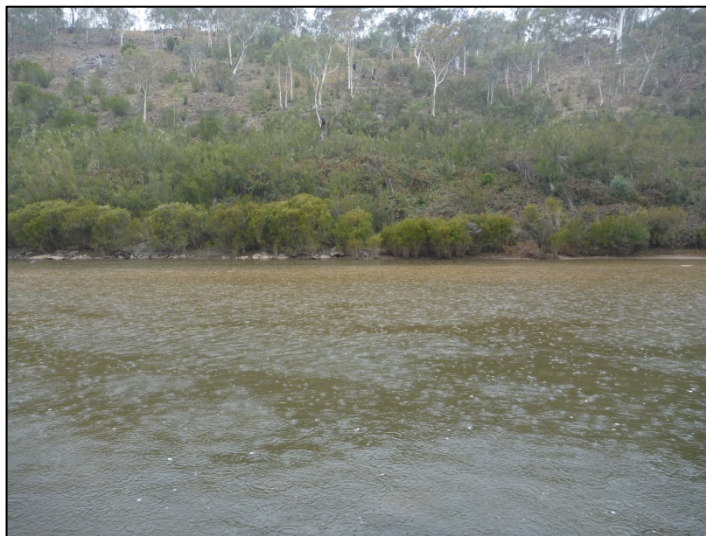
Plate 3-10. Geomorphology photo point 5 at Angle Crossing showing upstream (a), downstream (b) and across the channel (c)

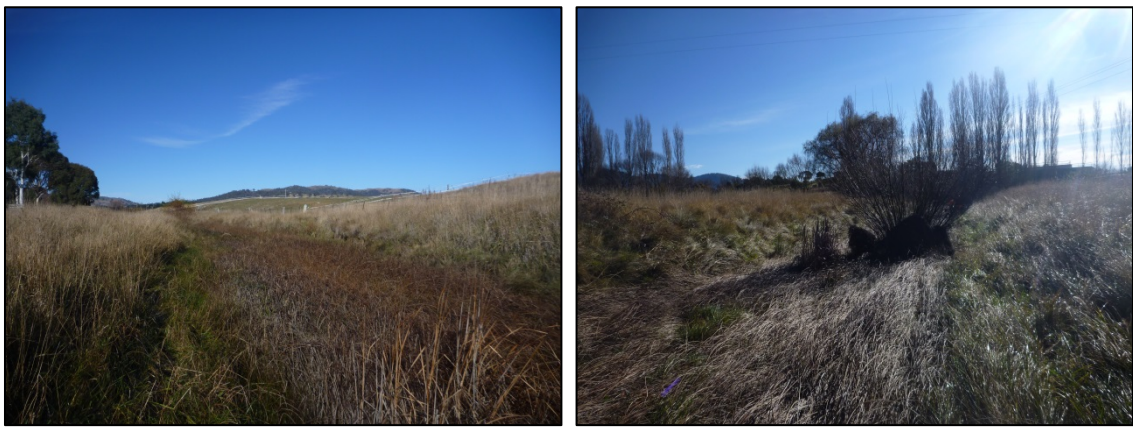
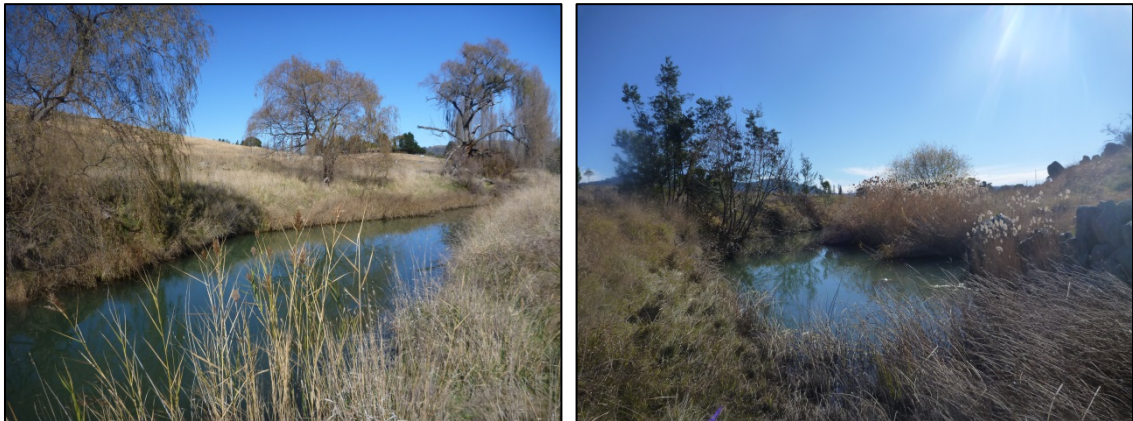
Plate 4-1. Photographs of the Burra Creek sites during autumn 2015 sampling

There was extensive emergent macrophyte die back at both sites (Plate 4-1), particularly *Schoenoplectus validus* at BUR 1c and *Phragmites australis* at BUR 2a. The riffle habitat at both sites was highly silted, with greater than 50% of the substrate size class at these sites being classed as silt. Full site summaries can be found in Appendix B. Habitat data are available in Appendix C.

BUR 1c: Looking upstream (left) and looking downstream (right)

BUR 2a: Looking upstream (left) and looking downstream (right)

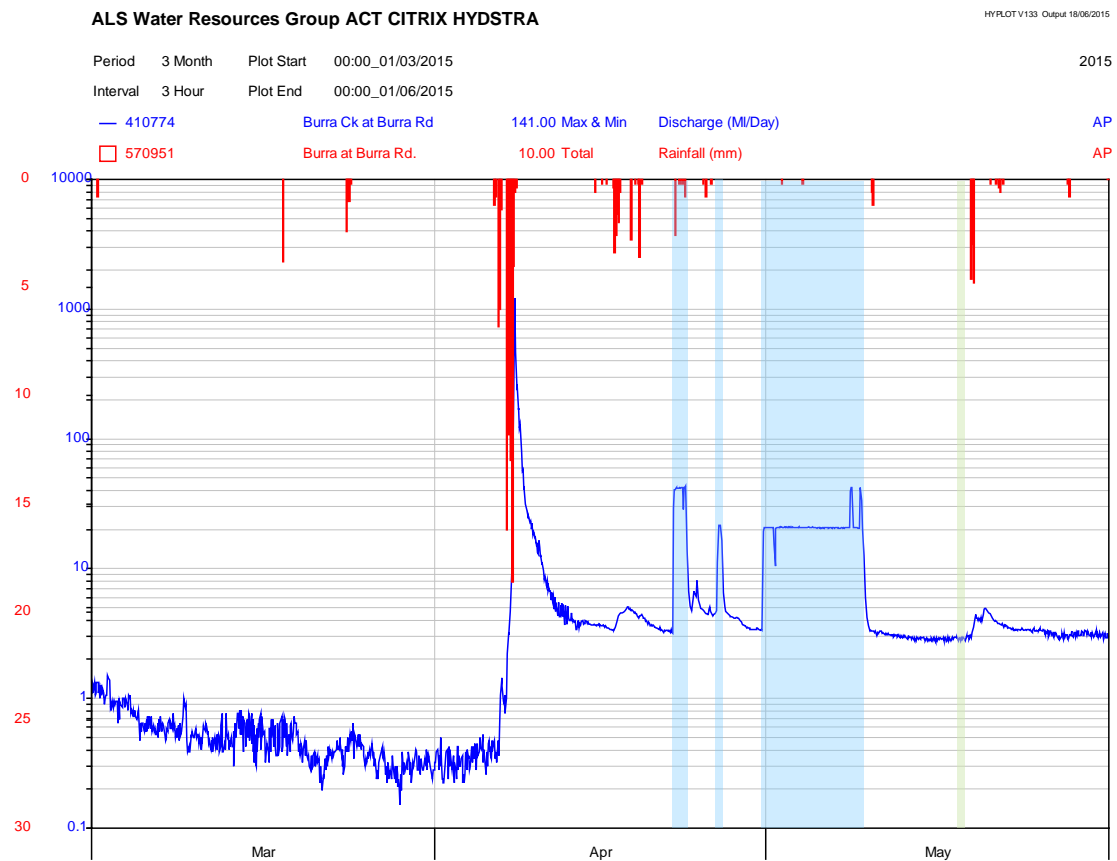
Figure 4-1. Hydrograph and rainfall from Burra Creek (410774) during autumn 2015

Note: The green shading indicates time of sampling, blue highlight indicates APPLE run.

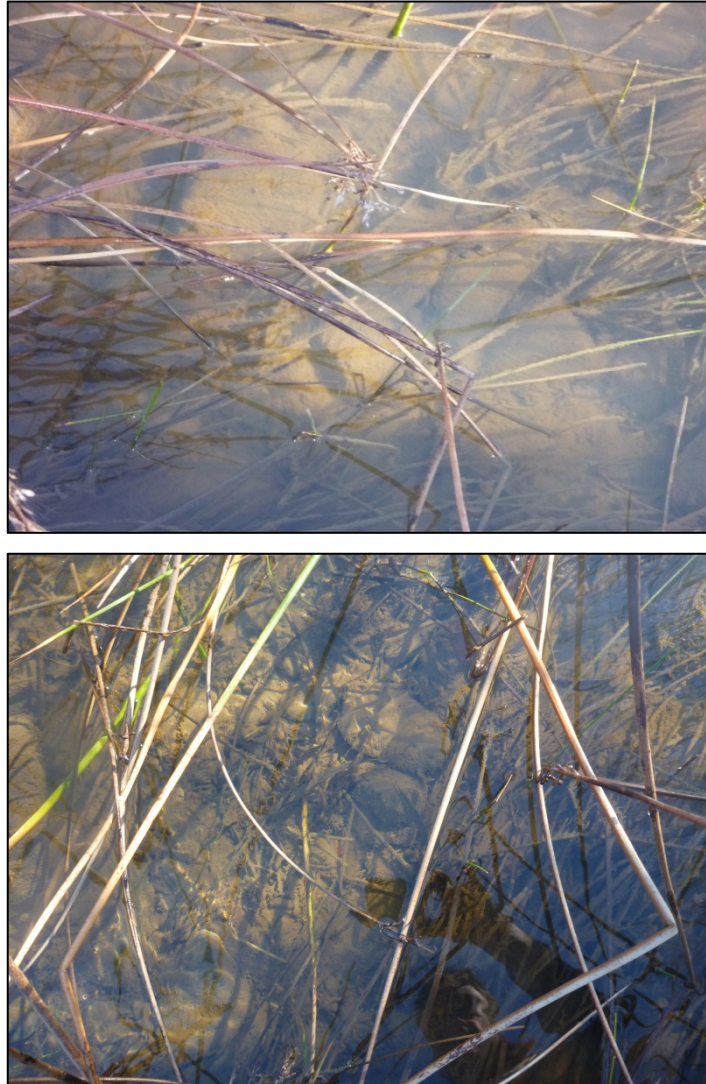
Plate 4-2. Periphyton coverage at BUR 1c

The periphyton coverage at BUR 1c was estimated at >90% for both the reach scale and riffle habitat using the AUSRIVAS assessment (Plate 4-2). There were some small sections of *Myriophyllum sp.* and *Eleocharis sp.* growth along the edge of the riffle habitat, while *Schoenoplectus validus* was dominant throughout the reach. The dominant substrate in the riffle habitat was cobbles and silt.

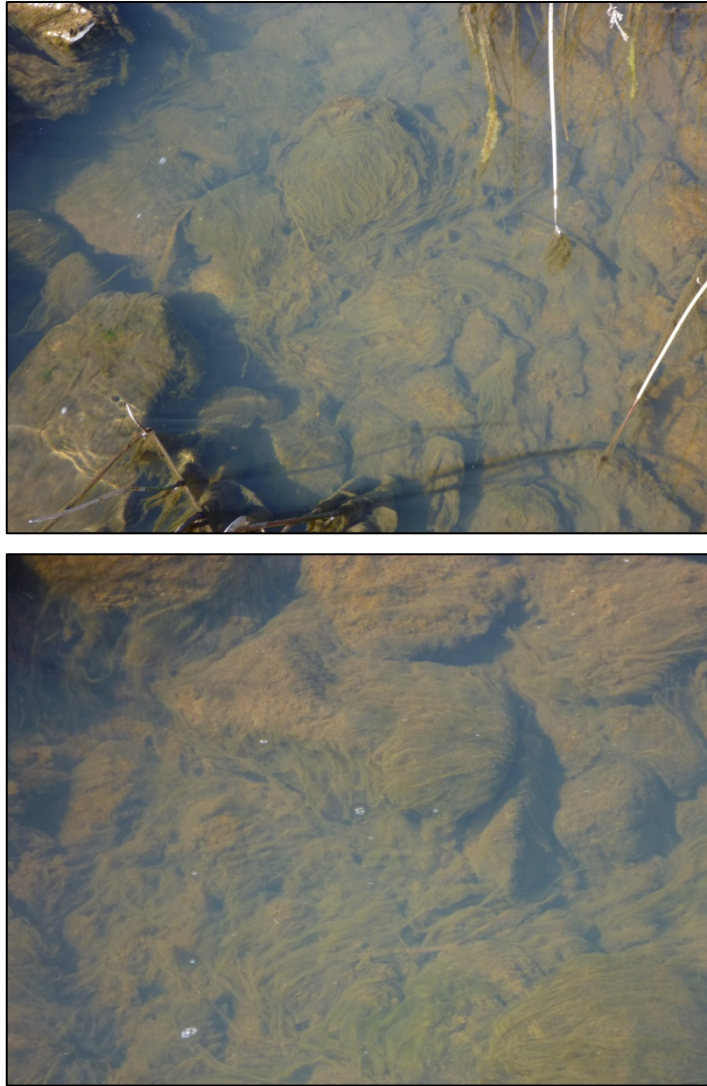
Plate 4-3. Periphyton coverage at BUR 2a

Periphyton coverage at BUR 2a was >90% at both the reach scale and riffle habitat specifically using the AUSRIVAS assessment (Plate 4-3). There were *Schoenoplectus validus* stands along the riffle margins, with minimal *Myriophyllum* sp. present. Filamentous algae growth throughout the reach was high covering the substrate and attaching to macrophytes. The dominant substrate was cobbles.

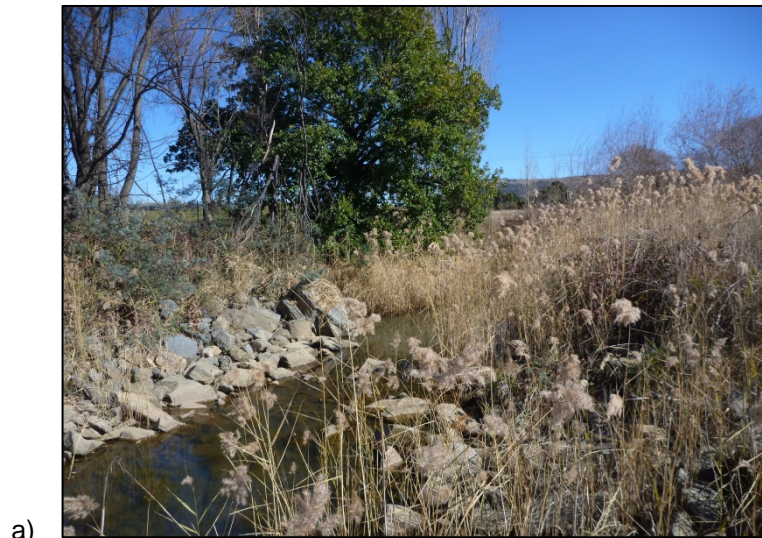
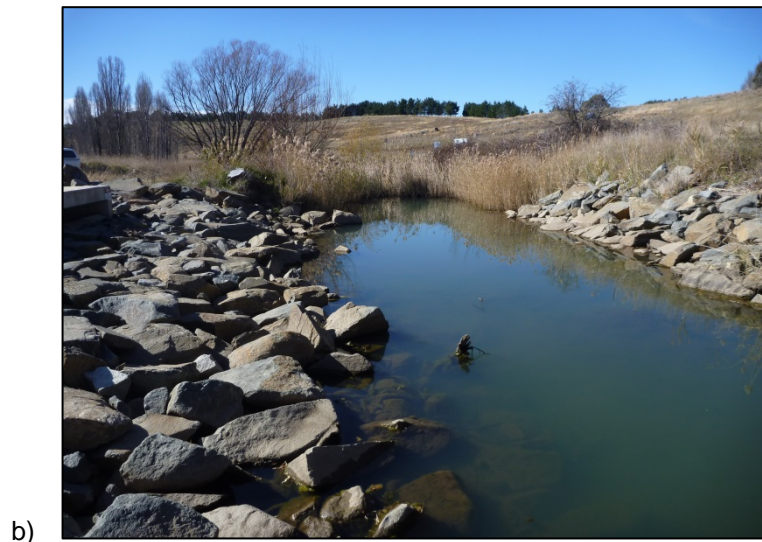
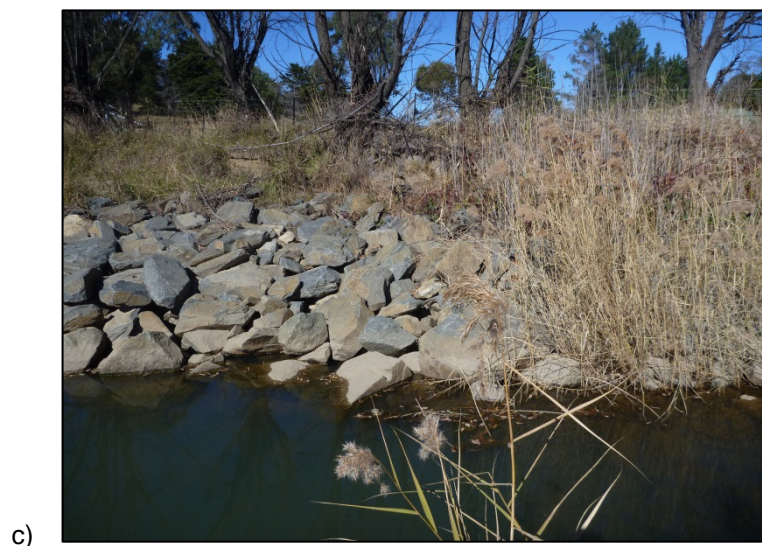
Few trees are present at BUR 2a. There is a large *Populus* sp. immediately downstream of the Williamsdale Road causeway on the edge of the channel and a couple of small *Salix* sp. (approximately 3 m) upstream of the causeway. The remaining terrestrial vegetation is dominated by pasture grasses and weeds. Instream vegetation is dominated by *Phragmites australis* (Common Reed), with large stands both upstream and downstream of the causeway. There are also some small patches of *Typha orientalis* (Broad leaf Cumbungi). Four vegetation photo points were identified at BUR 2 which are presented in Plate 4-4 through to Plate 4-7.

Plate 4-4. Vegetation extent photo point 1 at BUR 2 showing upstream (a), downstream (b) and across the channel (c)

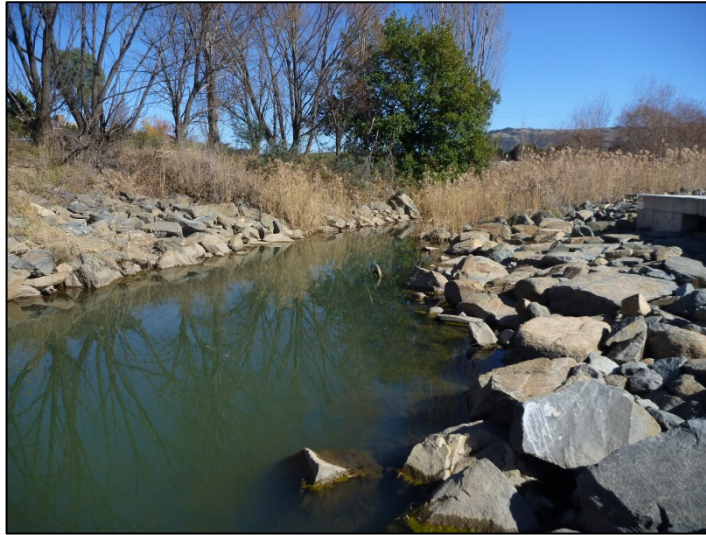
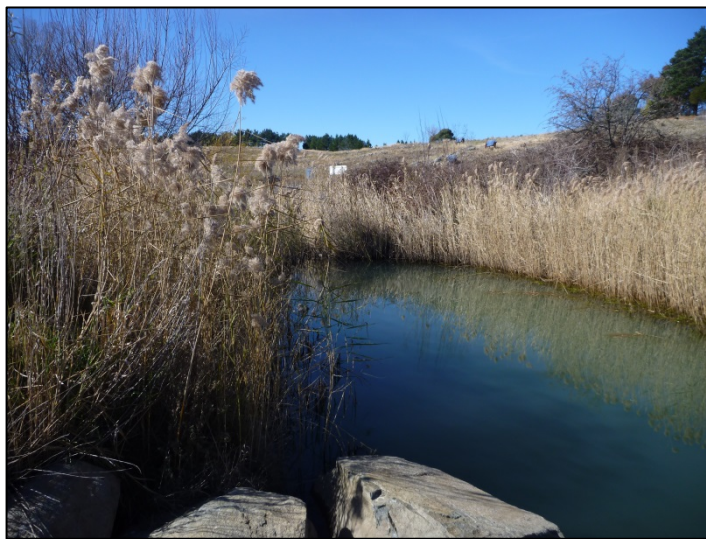
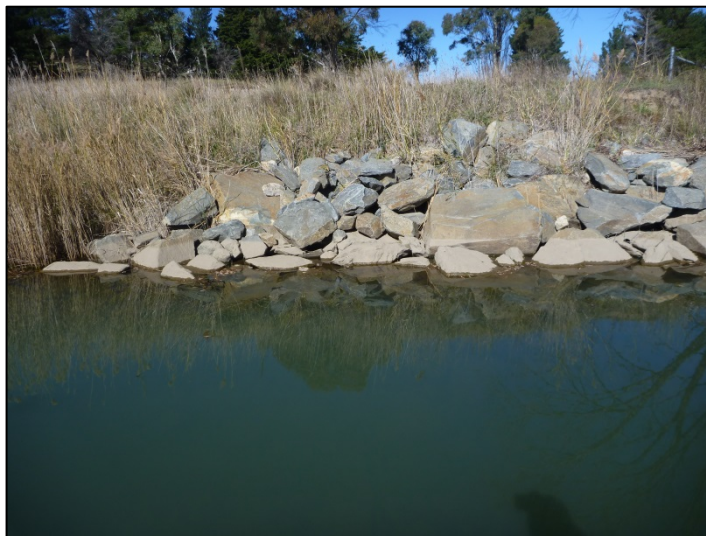
Plate 4-5. Vegetation extent photo point 2 at BUR 2 showing upstream (a), downstream (b) and across the channel (c)

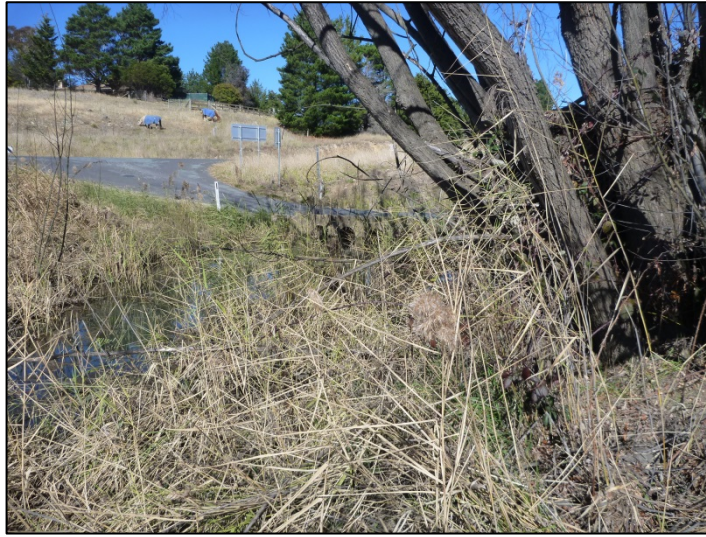
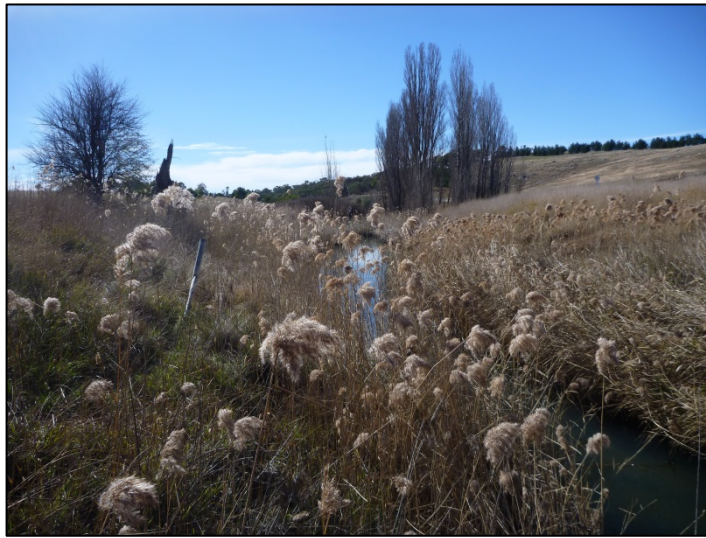
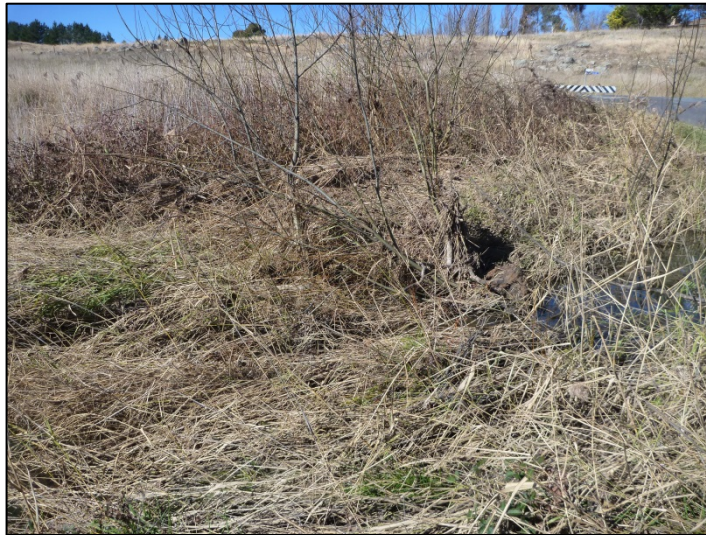
Plate 4-6. Vegetation extent photo point 3 at BUR 2 showing upstream (a), downstream (b) and across the channel (c)

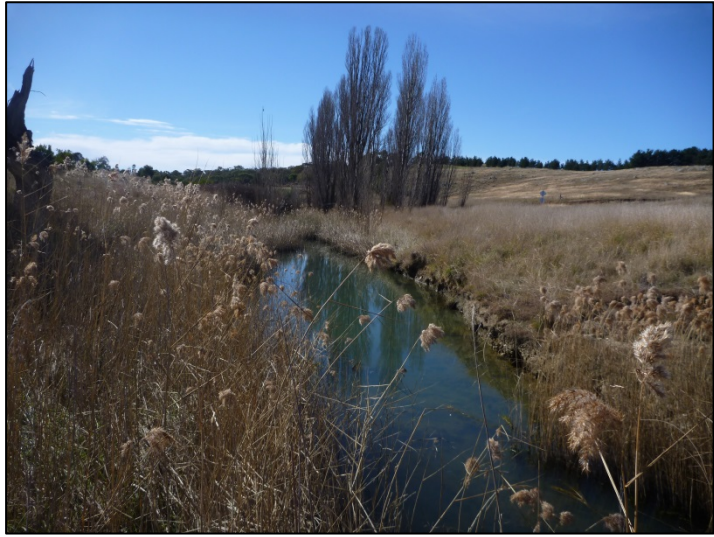
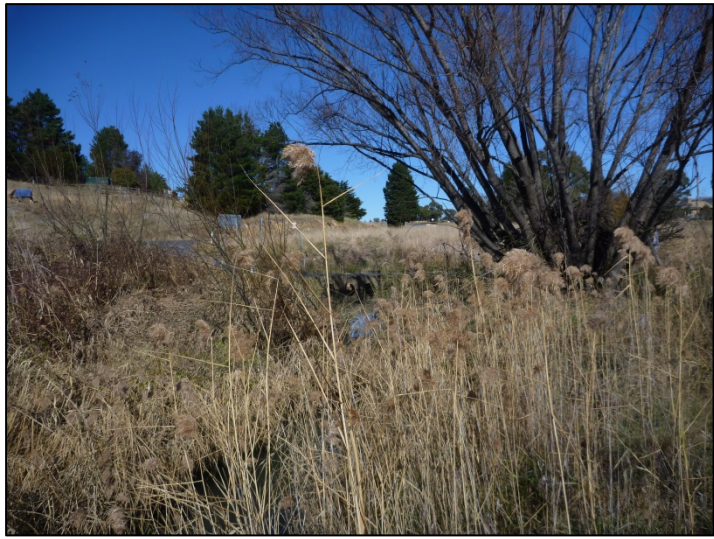
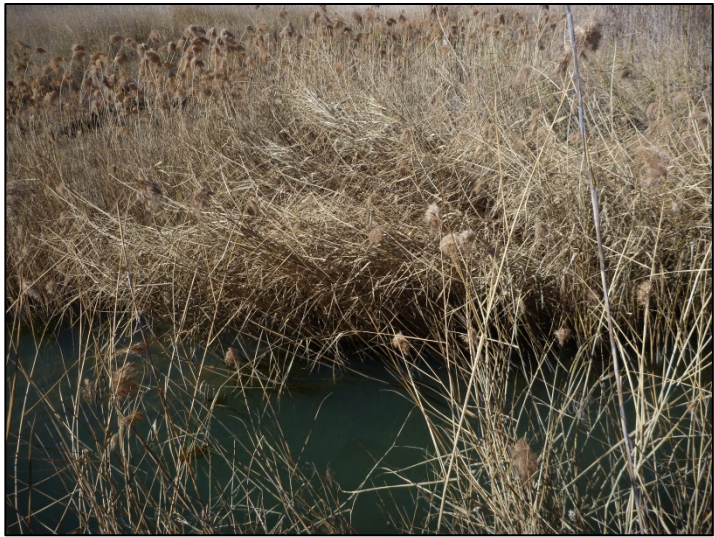
Plate 4-7. Vegetation extent photo point 4 at BUR 2 showing upstream (a), downstream (b) and across the channel (c)

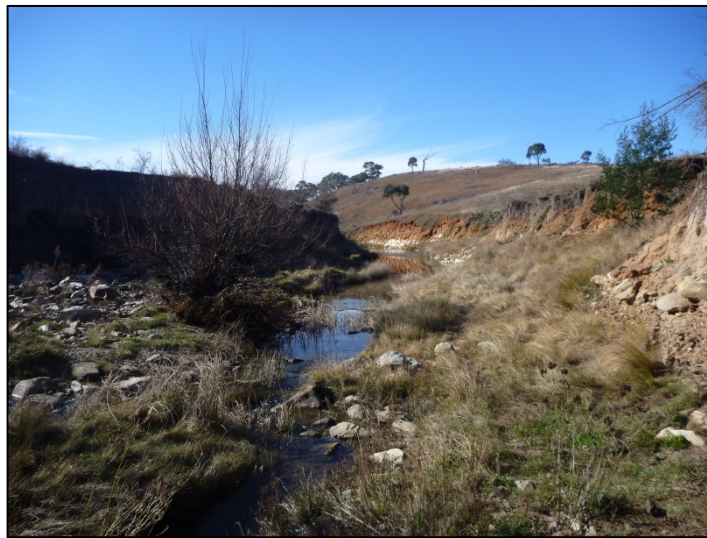
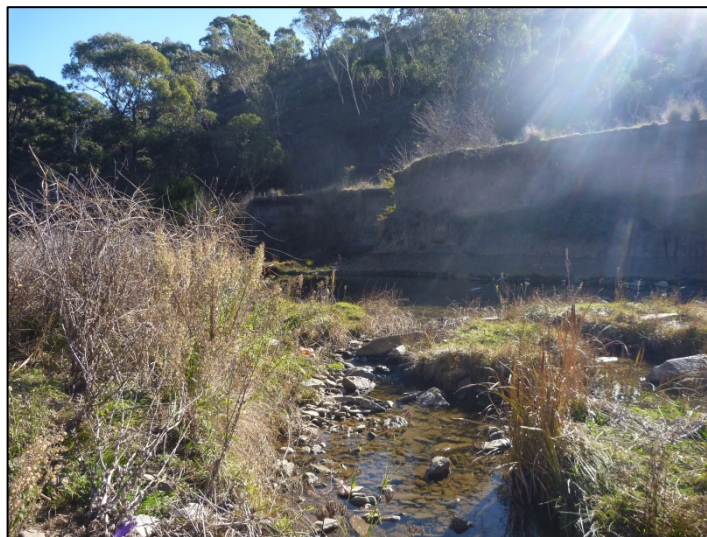
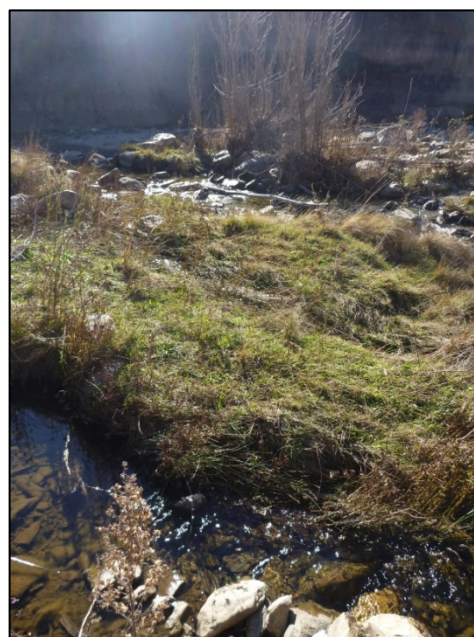
This site, similar to BUR 2 has few trees, restricting shading of the site to the steep banks. Some small *Salix* sp. are present on the left bank within the macro channel, while a single *Acacia dealbata* or Silver Wattle was present on the right bank. There is a large portion of the point bar along the water's edge which is covered by *Rubus fruticosus* (Blackberry), along with numerous thistle species and *Conyza* sp. (Fleabane). Large portions of the ground cover within the macro channel are covered in native grasses, predominantly *Poa* spp. There are stands of *Shoenoplectus validus* (Great Bulrush) along the water's edge, while there are infrequent small stands of *Typha orientalis* (Broad leaf Cumbungi). The three vegetation photo points for this site are shown in Plate 4-8, Plate 4-9 and Plate 4-10.

Plate 4-8. Vegetation extent photo point 1 downstream of pool 29 showing upstream (a), downstream (b) and across the channel (c)

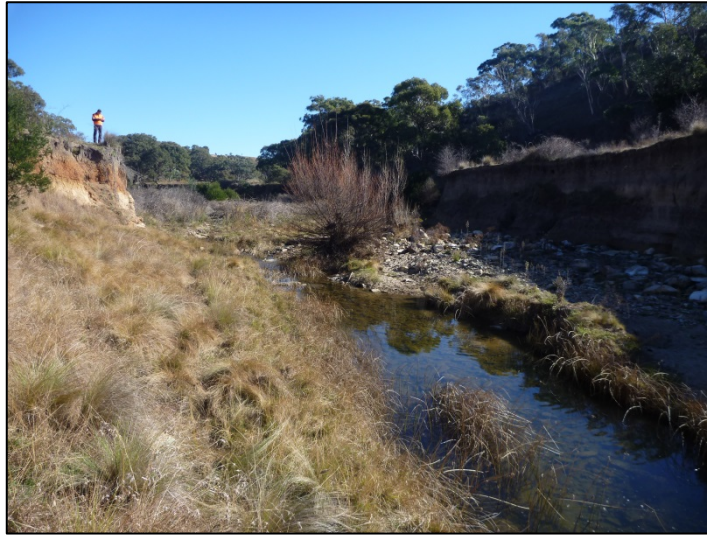
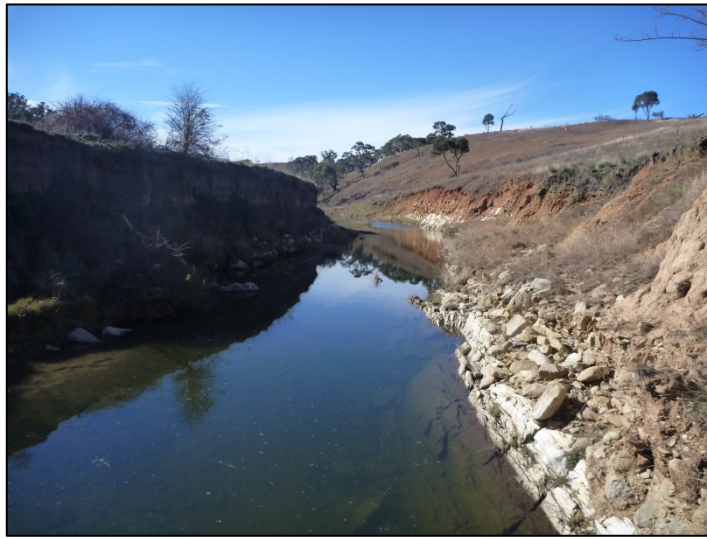
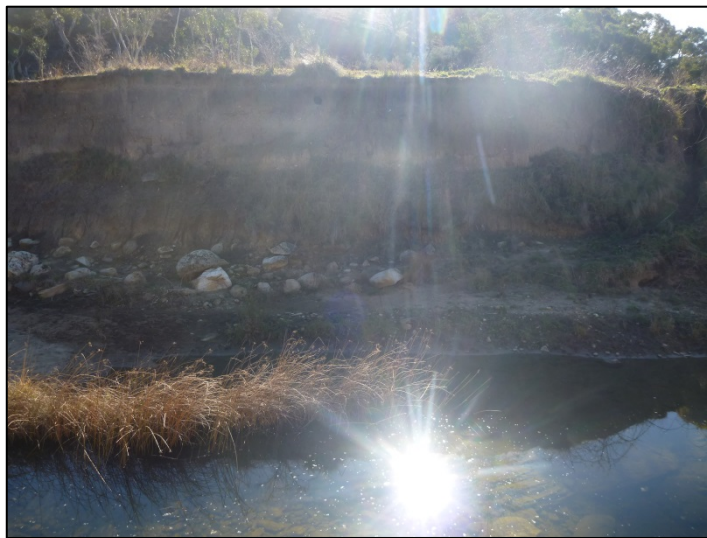
Plate 4-9. Vegetation extent photo point 2 downstream of pool 29 showing upstream (a), downstream (b) and across the channel (c)

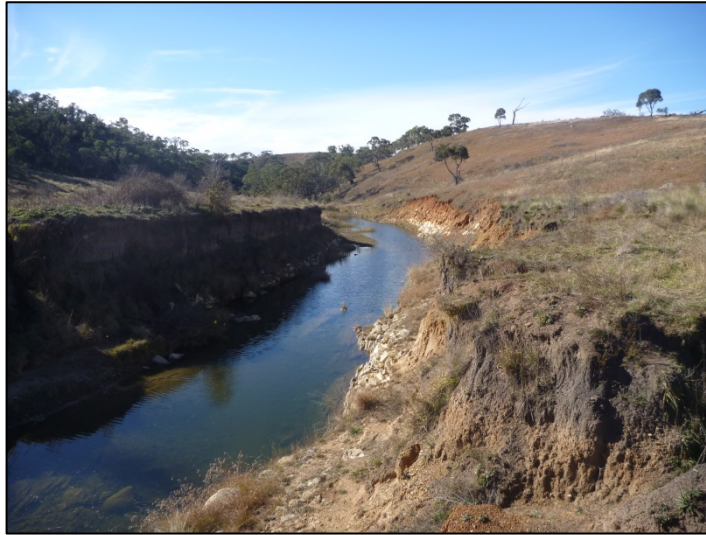
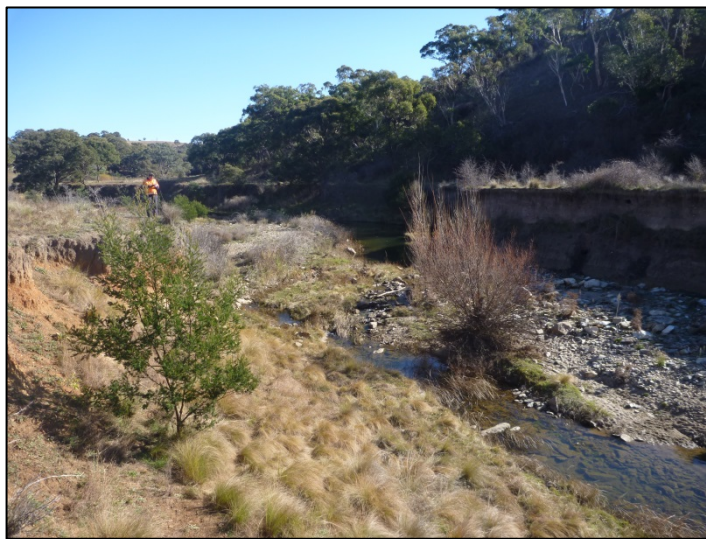
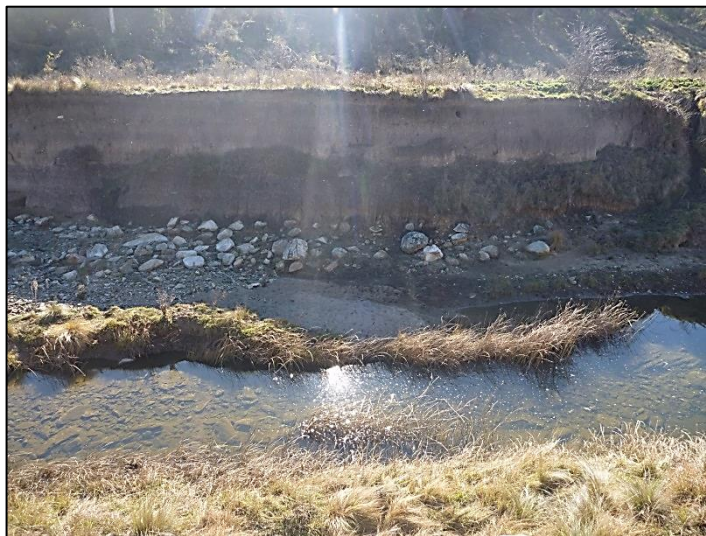
Plate 4-10. Vegetation extent photo point 3 downstream of pool 29 showing upstream (a), downstream (b) and across the channel (c)

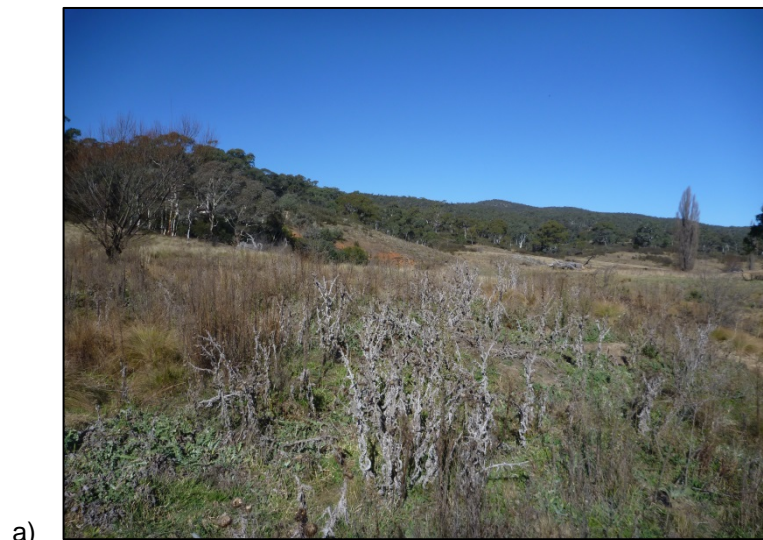
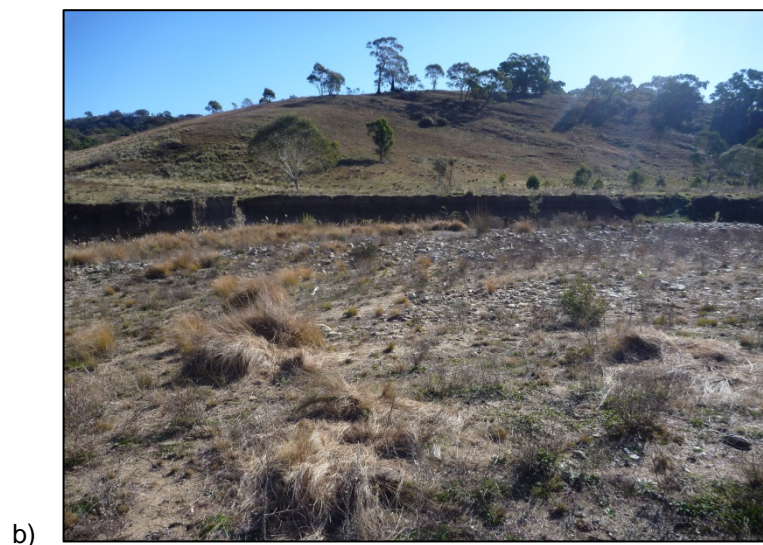
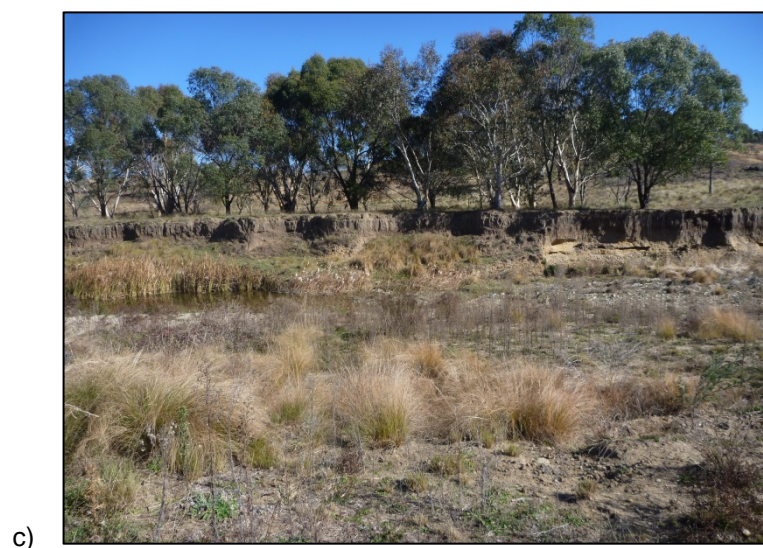
The upper banks of BUR 2c hold numerous large *Eucalyptus* spp. with a ground cover which has large numbers of native *Poa* spp. Within the macro channel at the upstream half of the site, the sparsely vegetated point bar consists of mostly weeds species and pasture grasses, predominantly *Conyza* sp. (Fleabane). The downstream half of the site is mostly vegetated with *Poa* spp. and pasture grasses line the banks, with infrequent small sections of *Rubus fruticosus* (Blackberry). The instream vegetation is present without being dominant with stands of *Phragmites australis* (Common Reed) and *Typha orientalis* (Broad-leaf Cumbungi), while *Schoenoplectus validus* (Great Bulrush) is also present in smaller patches. Four vegetation photo points have been identified for BUR 2c which are shown in Plate 4-11 through to Plate 4-14.

Plate 4-11. Vegetation extent photo point 1 at BUR 2c showing upstream (a), downstream (b) and across the channel (c)

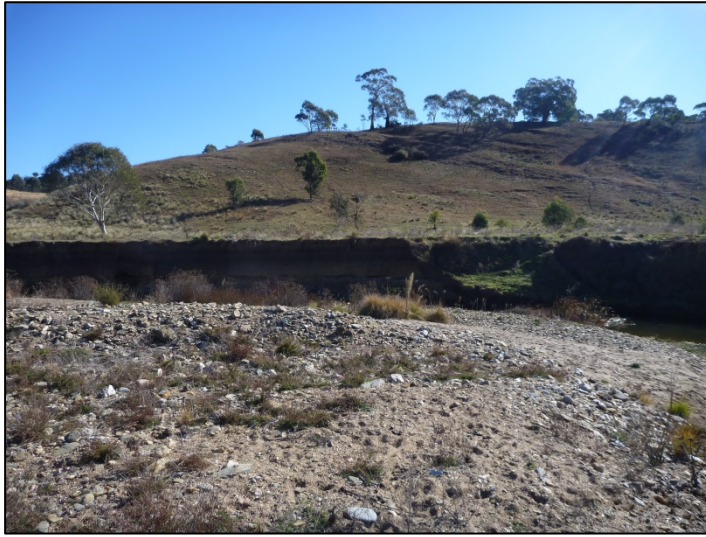
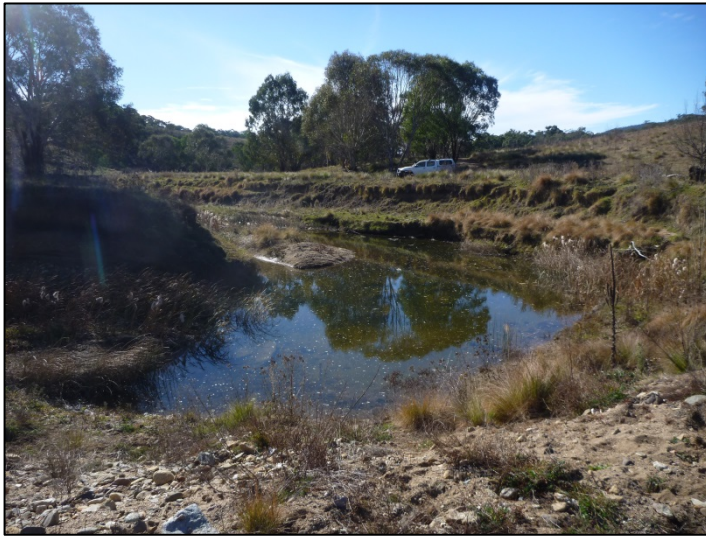
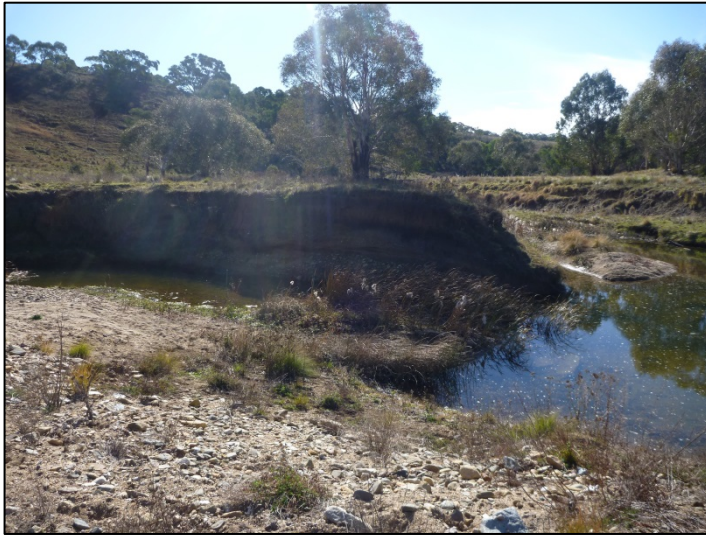
Plate 4-12. Vegetation extent photo point 2 at BUR 2c showing upstream (a), downstream (b) and across the channel (c)
