Icon Water
Murrumbidgee Ecological Monitoring Programme
Sentinel Monitoring - autumn 2015

August 2015

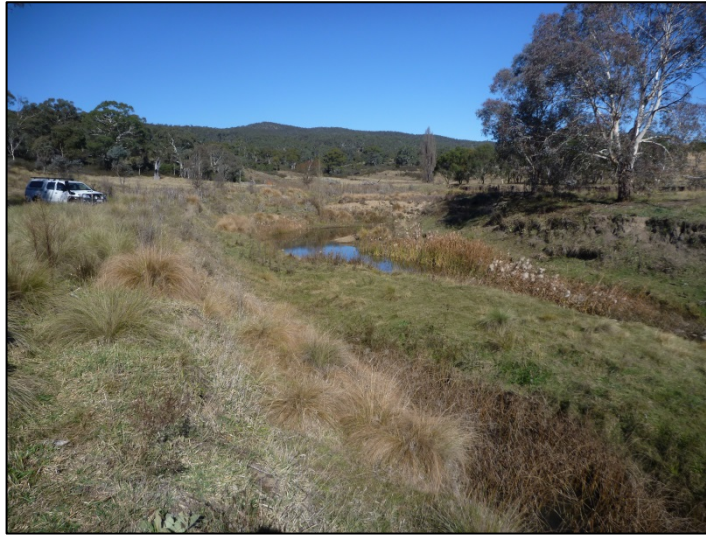
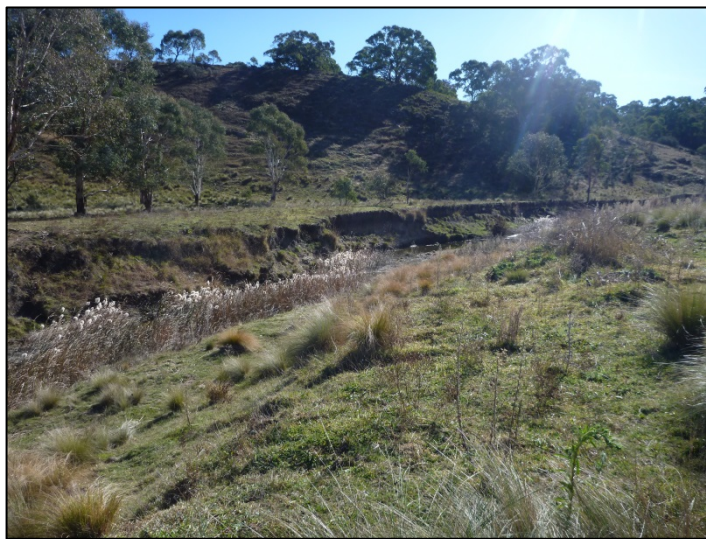
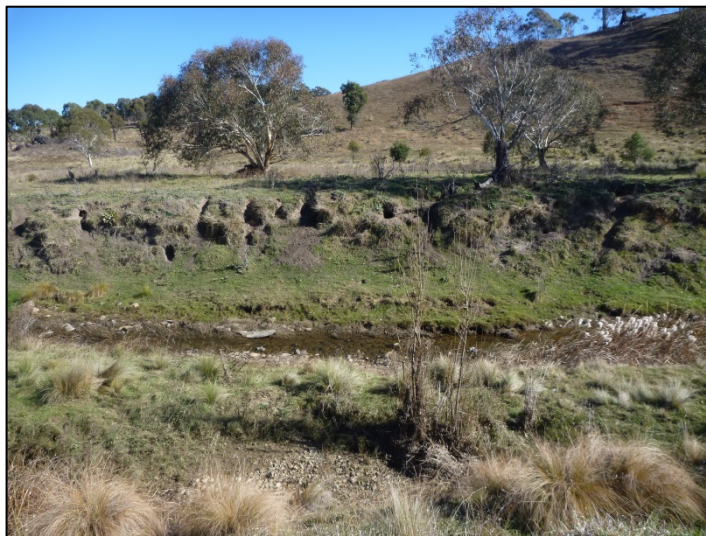
Plate 4-14. Vegetation extent photo point 4 at BUR 2c showing upstream (a), downstream (b) and across the channel (c)

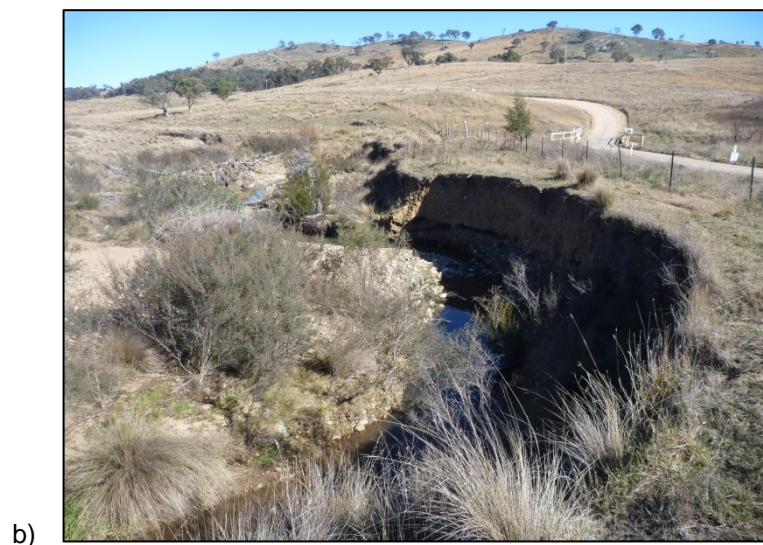
BUR 1a has a large macro channel, with a smaller inset low flow channel which follows mostly along the right hand side of the macro channel. Previous monitoring has shown sections of bank at BUR 1a show areas of erosion and slumping over a relatively short period, and minor movement of the preferential flow path during low flow periods (GHD, 2015c). There are also some small laterally attached bars in the downstream section of the site, which consist mainly of coarse material and pebbles. Three geomorphology photo points have been identified for monitoring at BUR 1c. The photos from these points can be found in Plate 4-15, Plate 4-16 and Plate 4-17 showing photo point 1, 2 and 3 respectively.

Plate 4-15. Geomorphology photo point 1 at BUR 1a showing upstream (a), downstream (b) and across the channel (c)

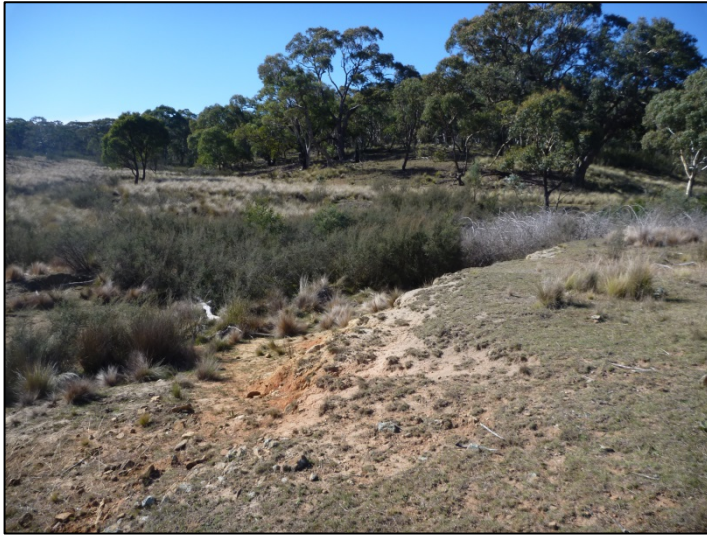
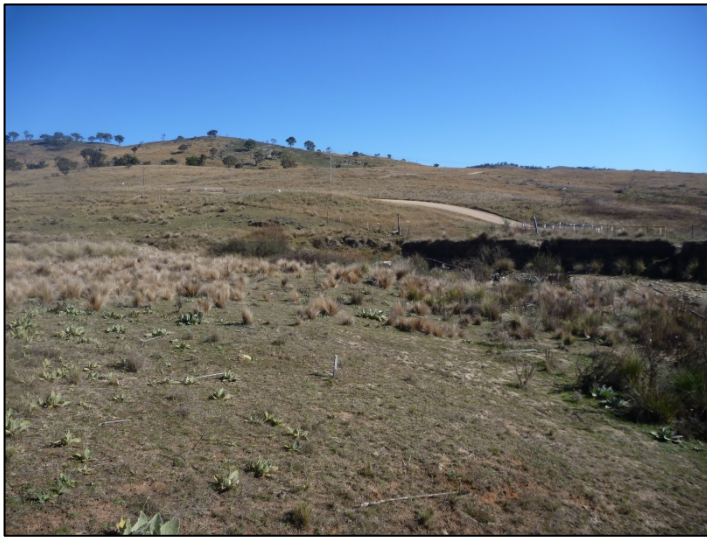
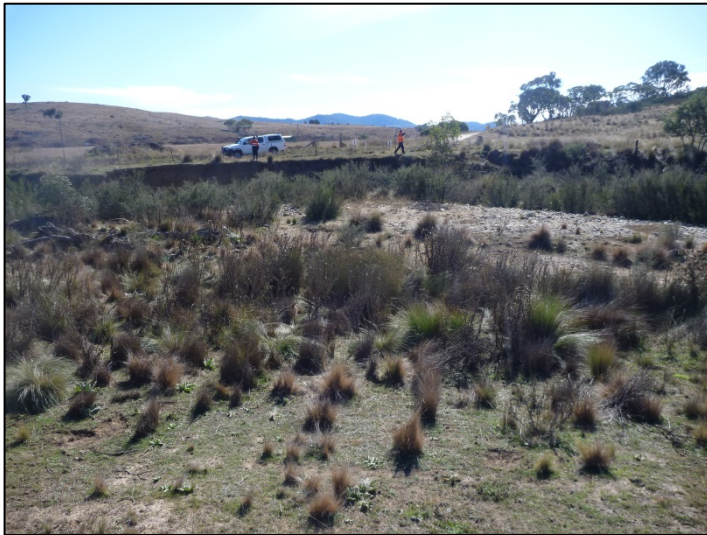
Plate 4-16. Geomorphology photo point 2 at BUR 1a showing upstream (a), downstream (b) and across the channel (c)

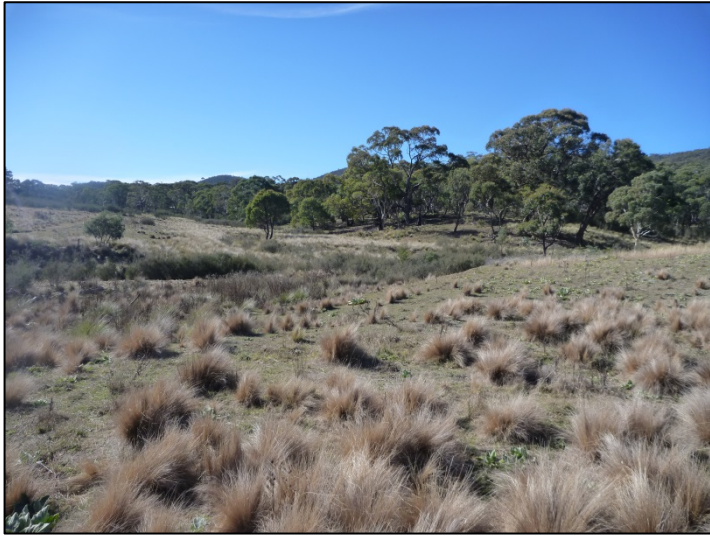
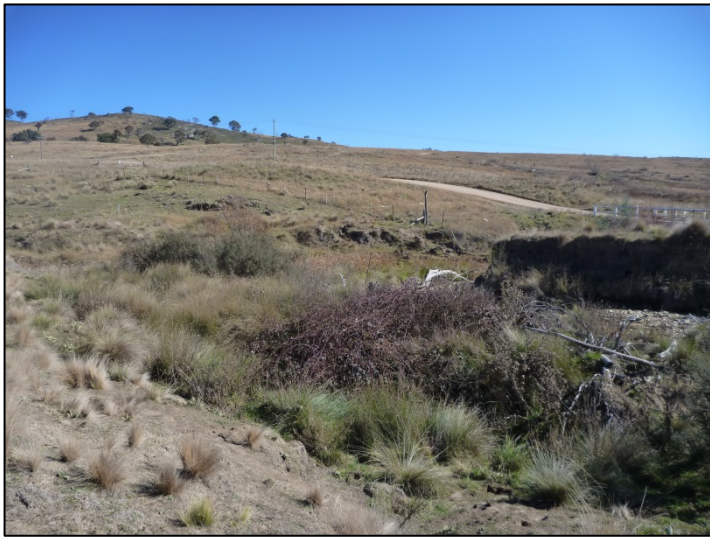
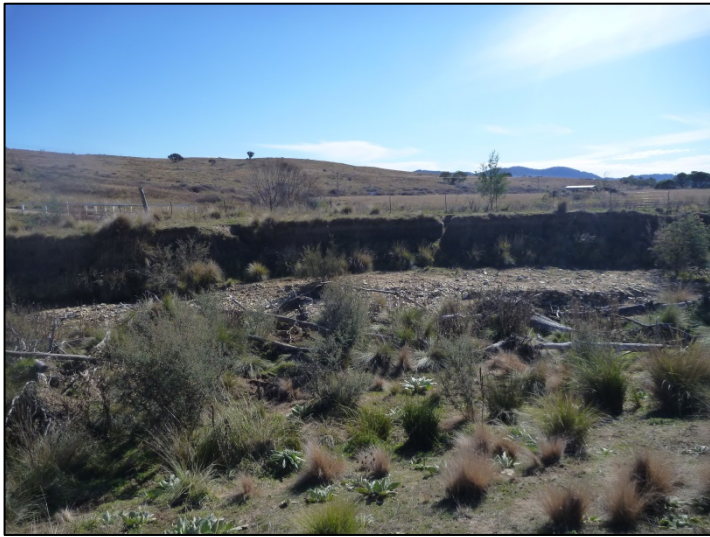
Plate 4-17. Geomorphology photo point 3 at BUR 1a showing upstream (a), downstream (b) and across the channel (c)

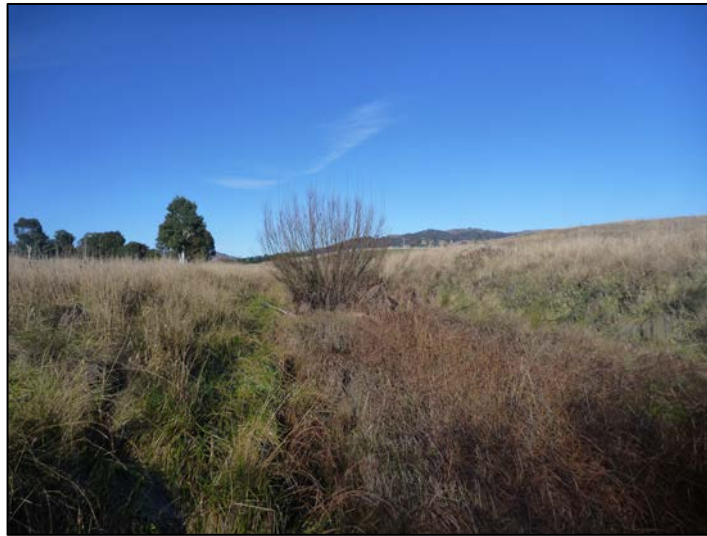
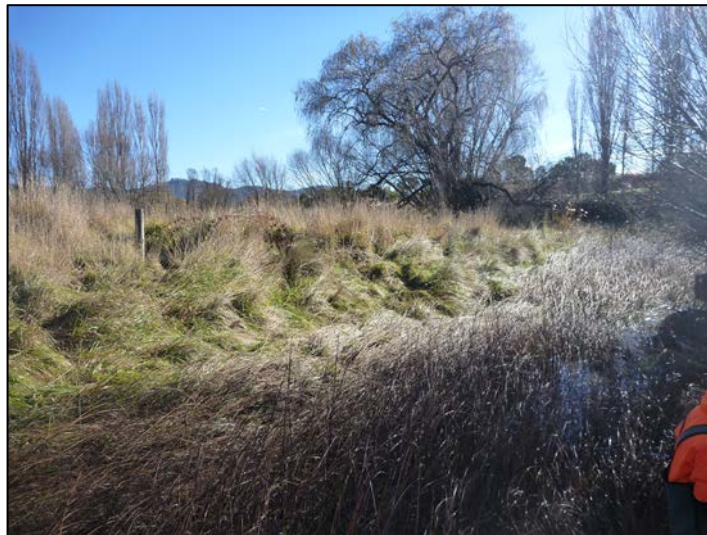
The reach at BUR 1c is unique amongst Burra Creek sites in that almost none of the bank area is un-vegetated. This reach of the creek has a very low sinuosity and few trees. Vegetation in this reach is dominated by grasses along both banks. There is a small sand bar located just downstream of the macroinvertebrate sample location. Due to this sites homogeneity only a single geomorphology photo point has been identified for this site, the photos from this point are presented in Plate 4-18.

Plate 4-18. Geomorphology photo point 1 at BUR 1c showing upstream (a) and downstream (b)

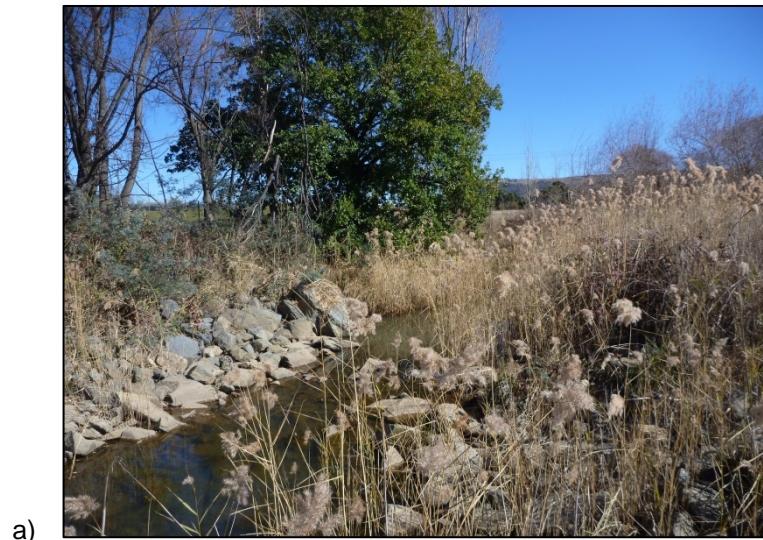
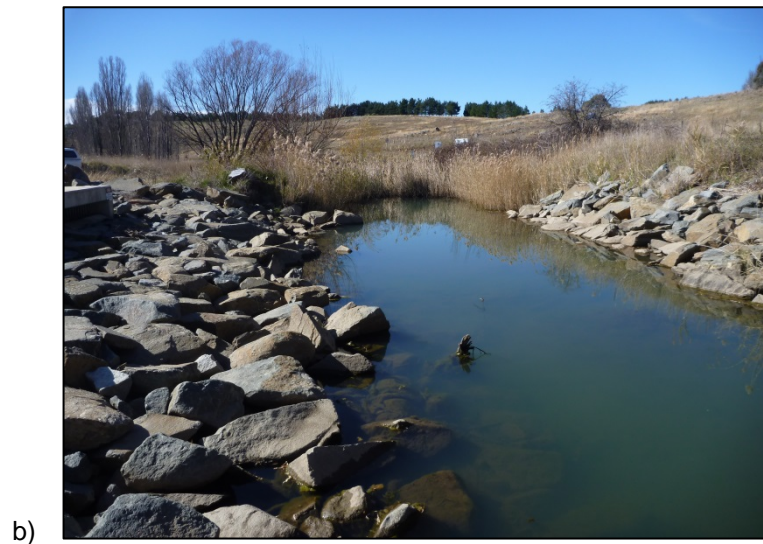
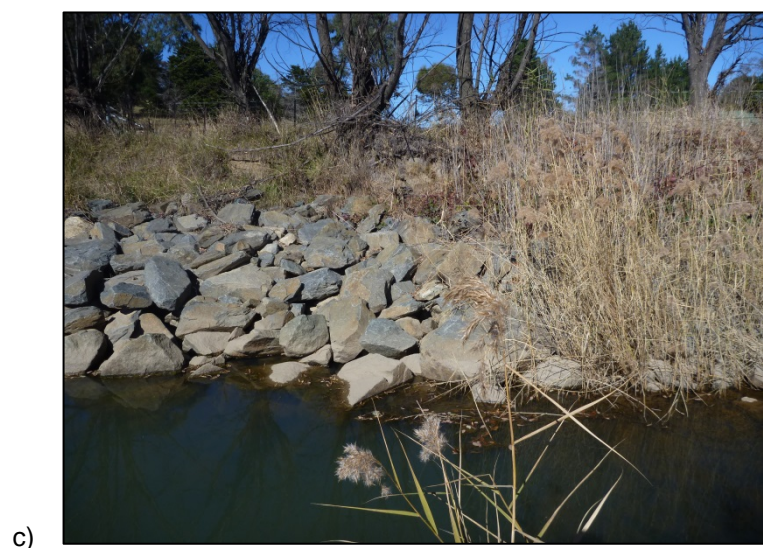
The area around the M2G discharge structure has been well protected from any changes in the pool and bank shape through the non-natural rock banks created to protect from the higher flow from the discharge. This upstream area is monitored by two geomorphology photo points which are presented in Plate 4-19 and Plate 4-20. Downstream of Williamsdale Road is highly vegetated, with a small drop off which could potentially erode towards the causeway. This downstream area is monitored by two geomorphology photo points which are presented in Plate 4-21 and Plate 4-22.

Plate 4-19. Geomorphology photo point 1 at BUR 2 showing upstream (a), downstream (b) and across the channel (c)

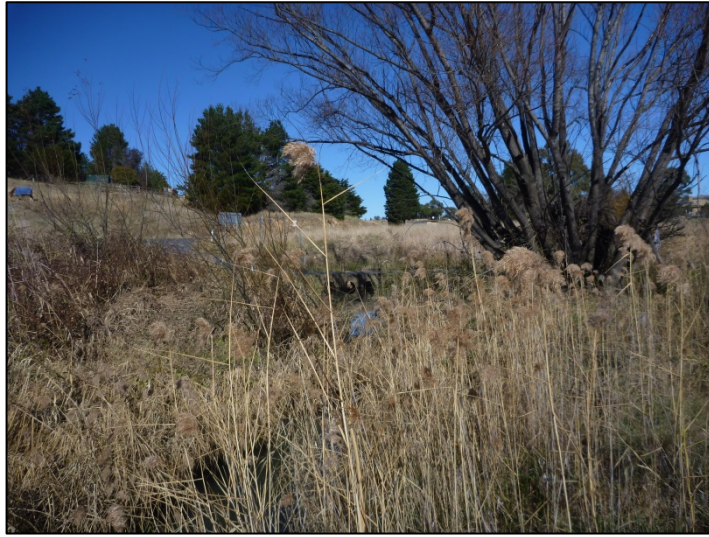
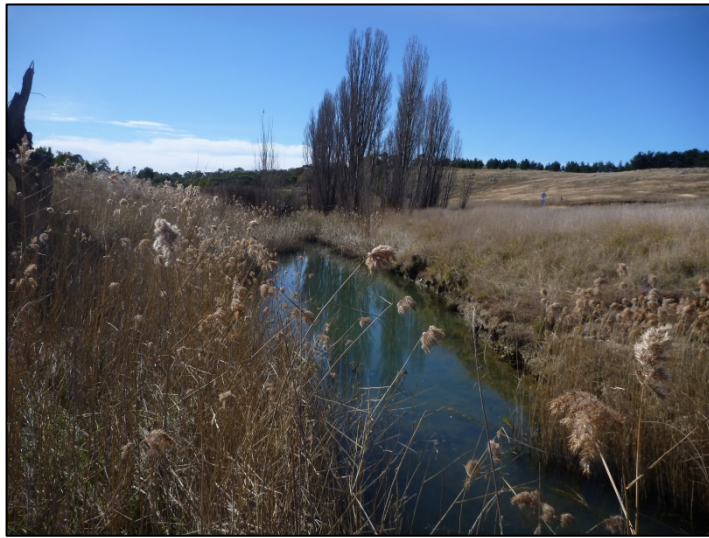
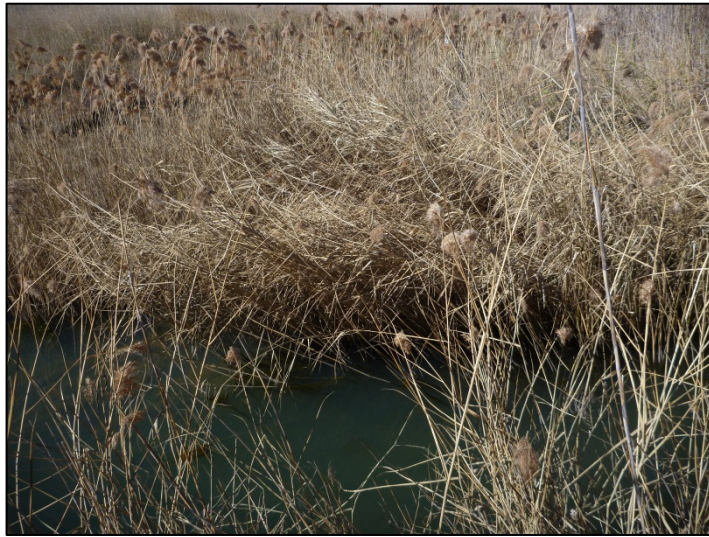
Plate 4-22. Geomorphology photo point 4 at BUR 2 showing upstream (a), downstream (b) and across the channel (c)

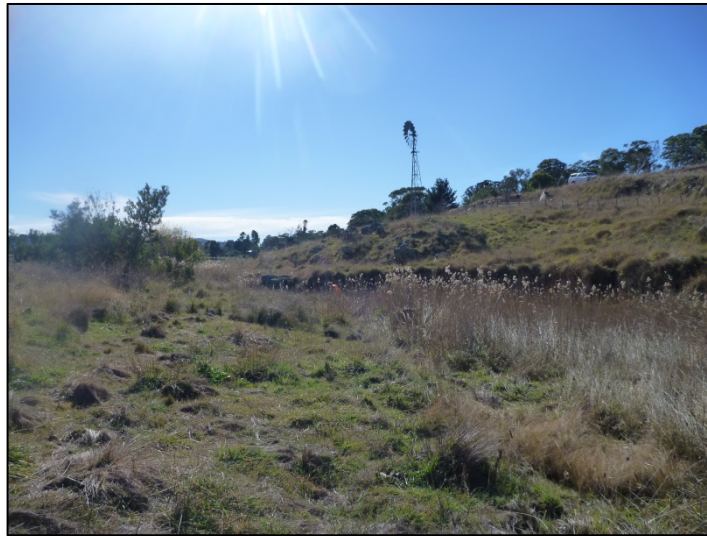
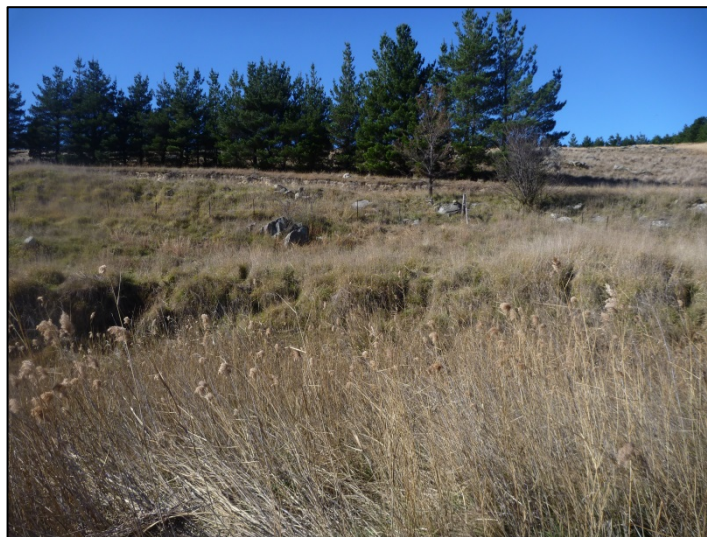
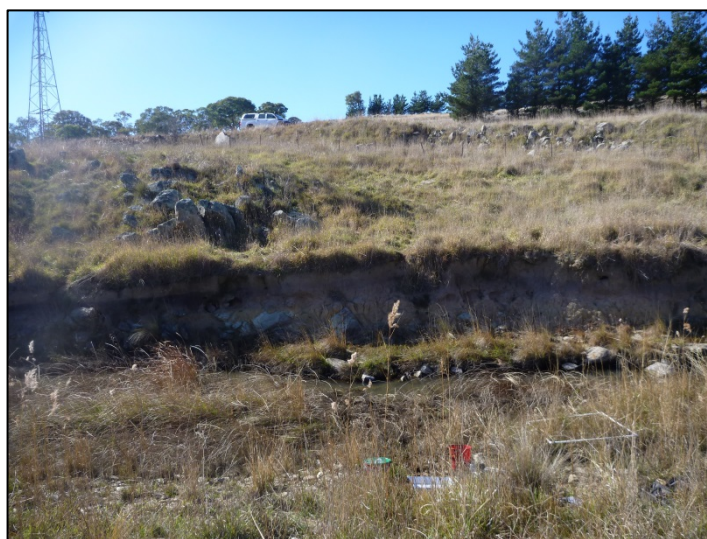
BUR 2a is located on a bend which has a steep un-vegetated bank on the right hand side. However, unlike sites like BUR 1a & 2c this bank has shown no signs of movement during previous monitoring (GHD, 2015c), likely due to its composition mostly being a hard packed clay material. The left bank slopes gradually to the top of bank which is mostly vegetated. There is a large pool at the downstream end of the site which has a large portion of bedrock, with a bedrock outcrop from the right bank also. The geomorphology photo points were identified for monitoring at BUR 2a, these are presented in Plate 4-23 and Plate 4-24.

Plate 4-23. Geomorphology photo point 1 at BUR 2a showing upstream (a), downstream (b) and across the channel (c)

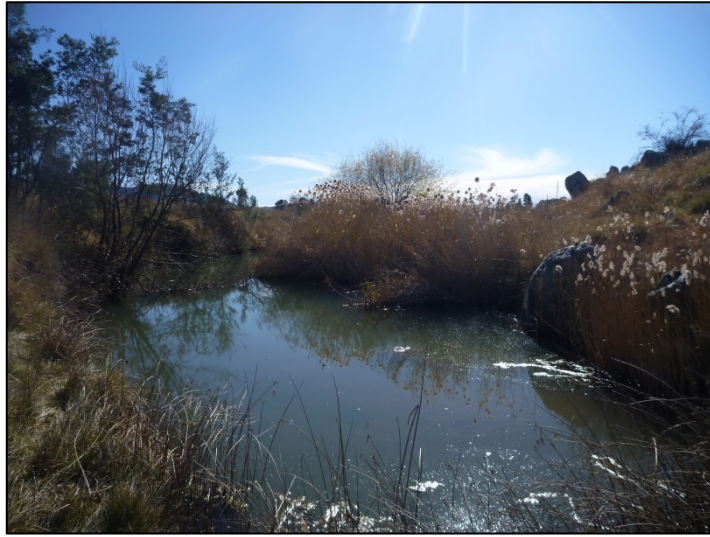
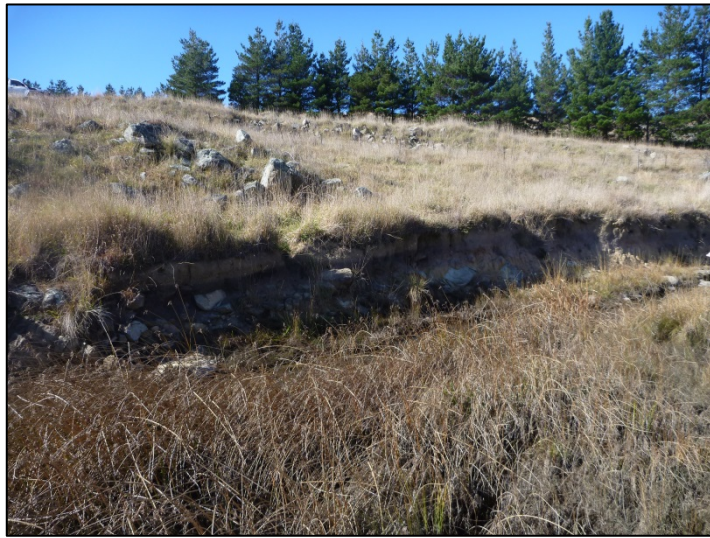
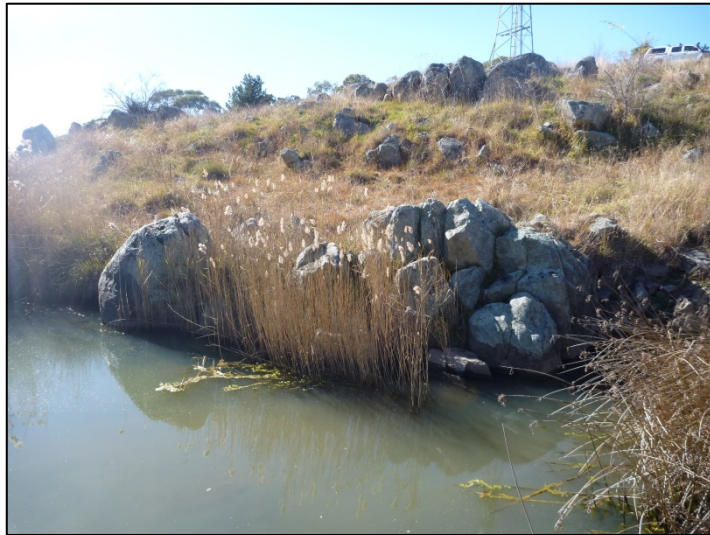
Plate 4-24. Geomorphology photo point 1 at BUR 2a showing upstream (a), downstream (b) and across the channel (c)

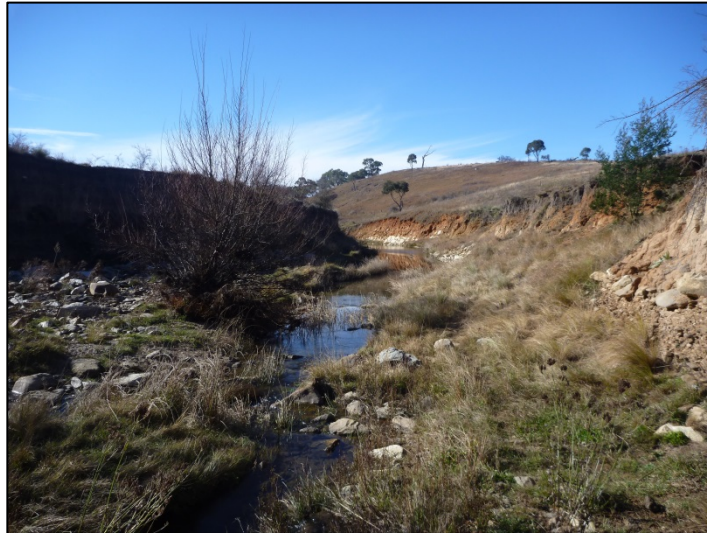
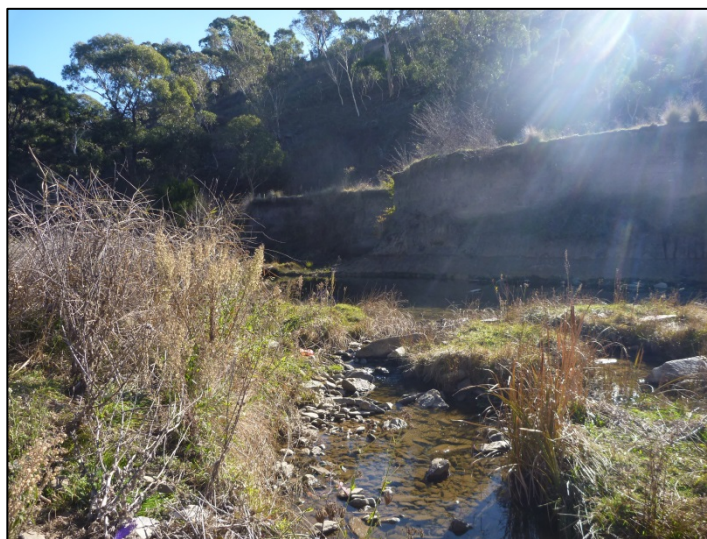
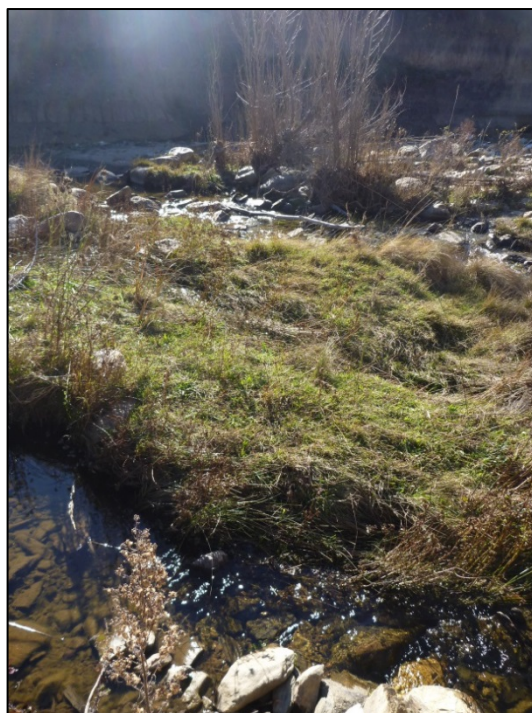
This site has a very large macro channel with steep banks approximately 3.5 – 4 m high. The left bank, upstream of the riffle habitat was assessed as having a high erosion potential (GHD, 2015c) as it is in the direct flow path during high flow events and is completely un-vegetated. On the inside of this bend is a large partially vegetated point bar which is made up of coarse sands, pebbles and cobbles. Three geomorphology photo points were identified to monitor this site and are presented in Plate 4-25, Plate 4-26 and Plate 4-27.

Plate 4-25. Geomorphology photo point 1 downstream of pool 29 showing upstream (a), downstream (b) and across the channel (c)

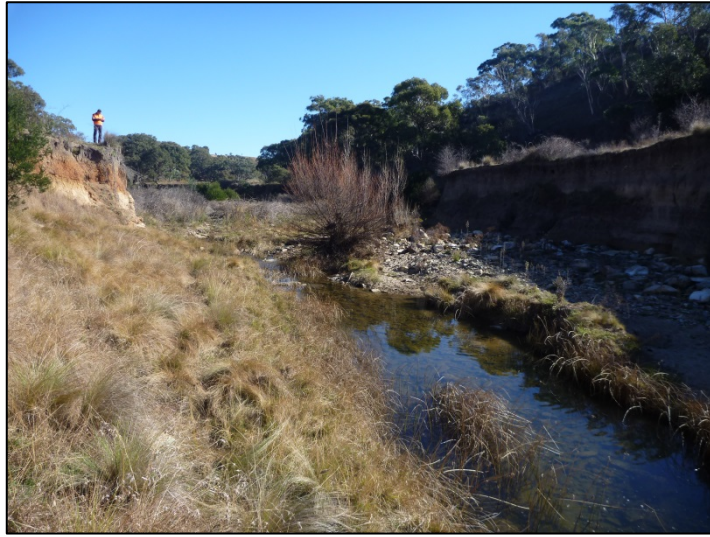
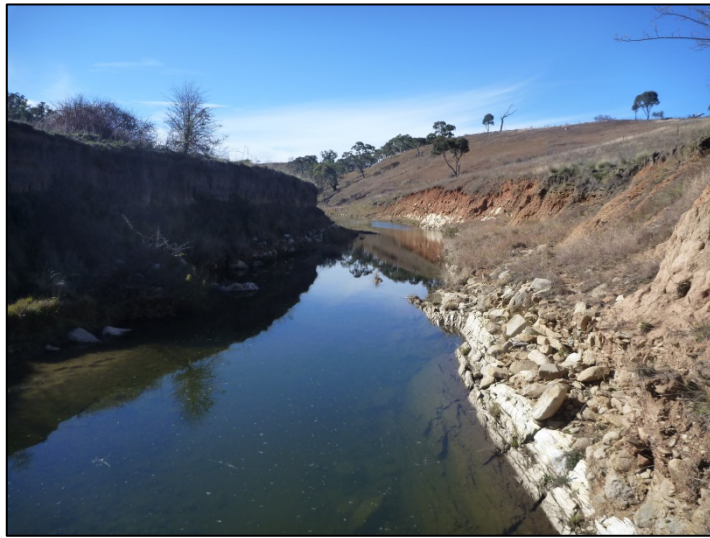
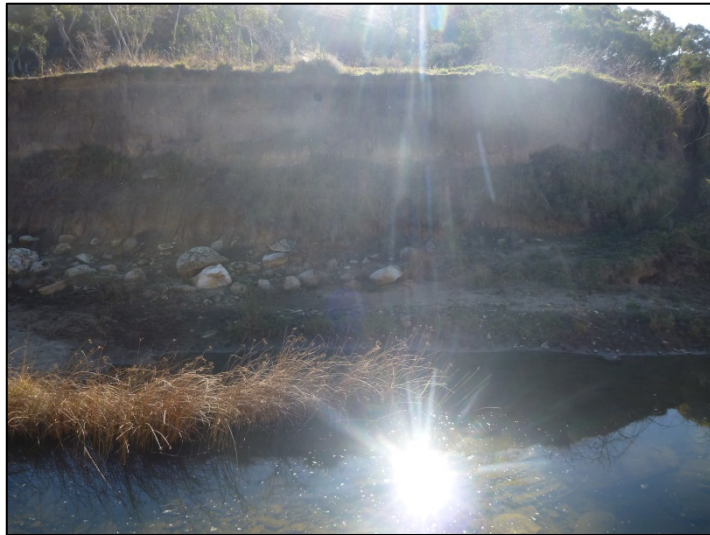
Plate 4-26. Geomorphology photo point 2 downstream of pool 29 showing upstream (a), downstream (b) and across the channel (c)

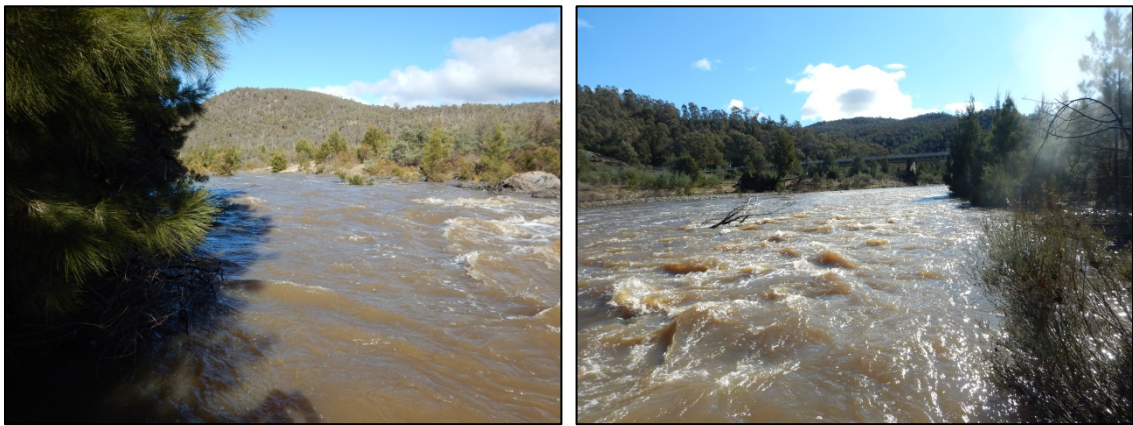
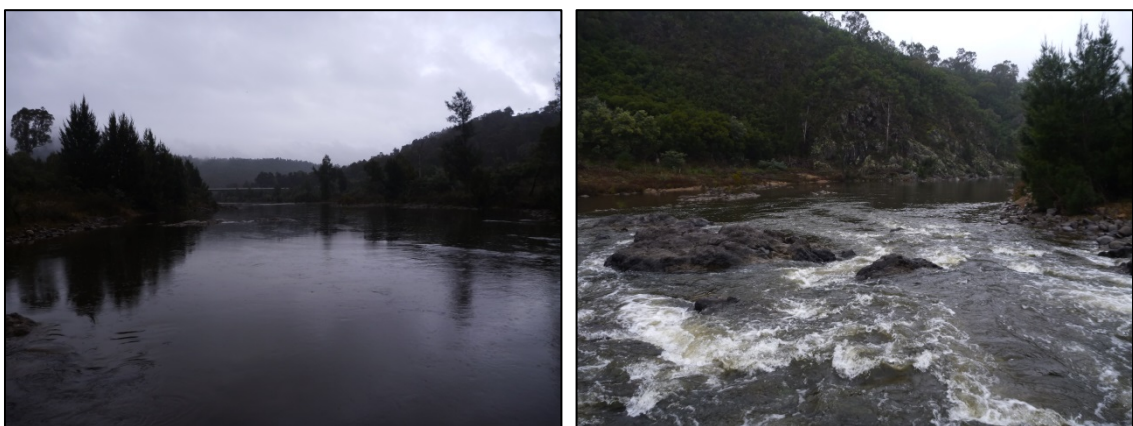
Plate 5-1. Photographs of the Murrumbidgee Pump Station sites during autumn 2015 sampling

Organic matter and debris was present in high volumes in the edge habitat at MUR 935, this was compared to MUR 28, which had a relative minimal amount of organic matter, consistent with previous sample runs. MUR 935 was sampled for the first time since autumn 2013, however, the general site morphology and riffle habitat are relatively unchanged since that time. Full site summaries can be found in Appendix B. Habitat data is available in Appendix C.

MUR 28: Looking upstream (left) and looking downstream (right)

MUR 935: Looking upstream (left) and looking downstream (right)

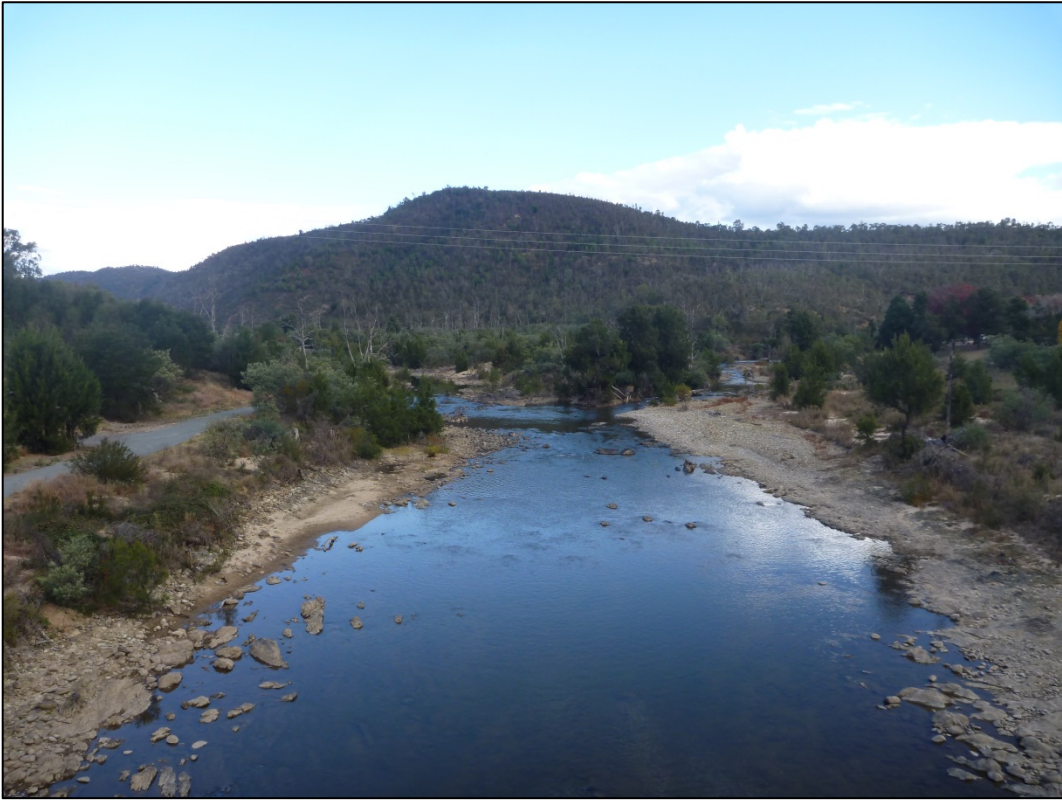
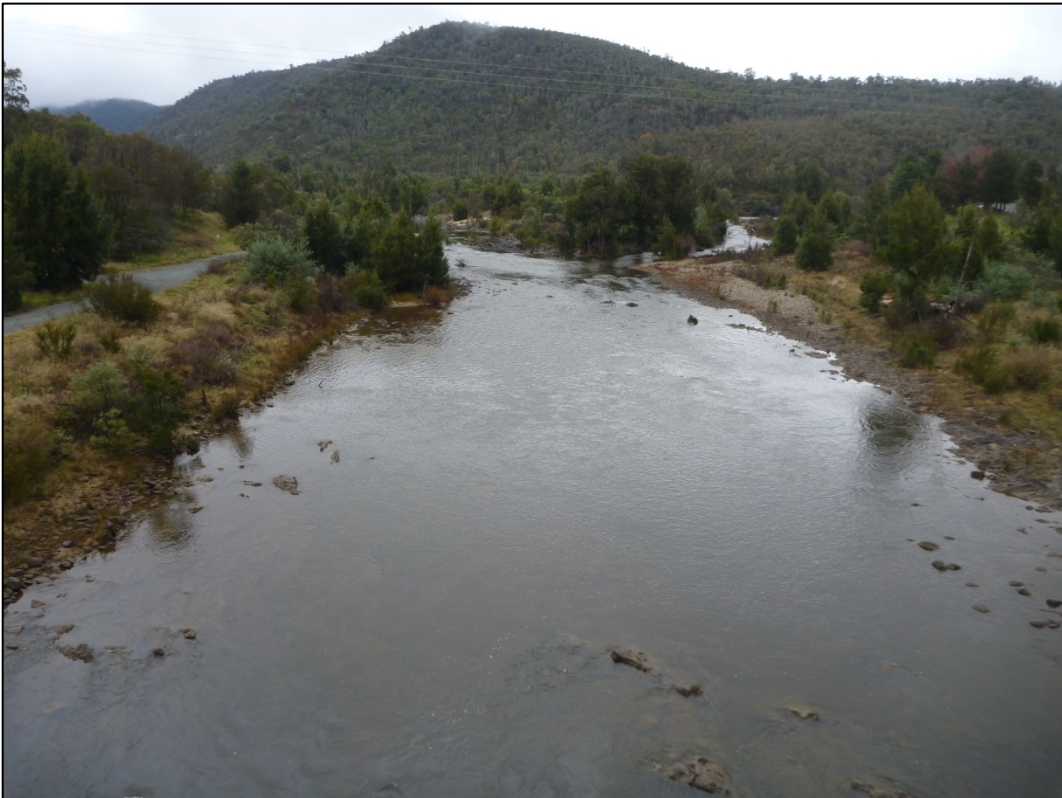
Plate 5-2. The Murrumbidgee River upstream of the Cotter Road bridge and the MPS in autumn 2013 (top) and 2015 (bottom)

2013 – 140 ML/d (8/5/2013)

2015 - 510 ML/d (19/5/2015)

Note: Flow is mean daily flow recorded at Mt. MacDonald (410738)

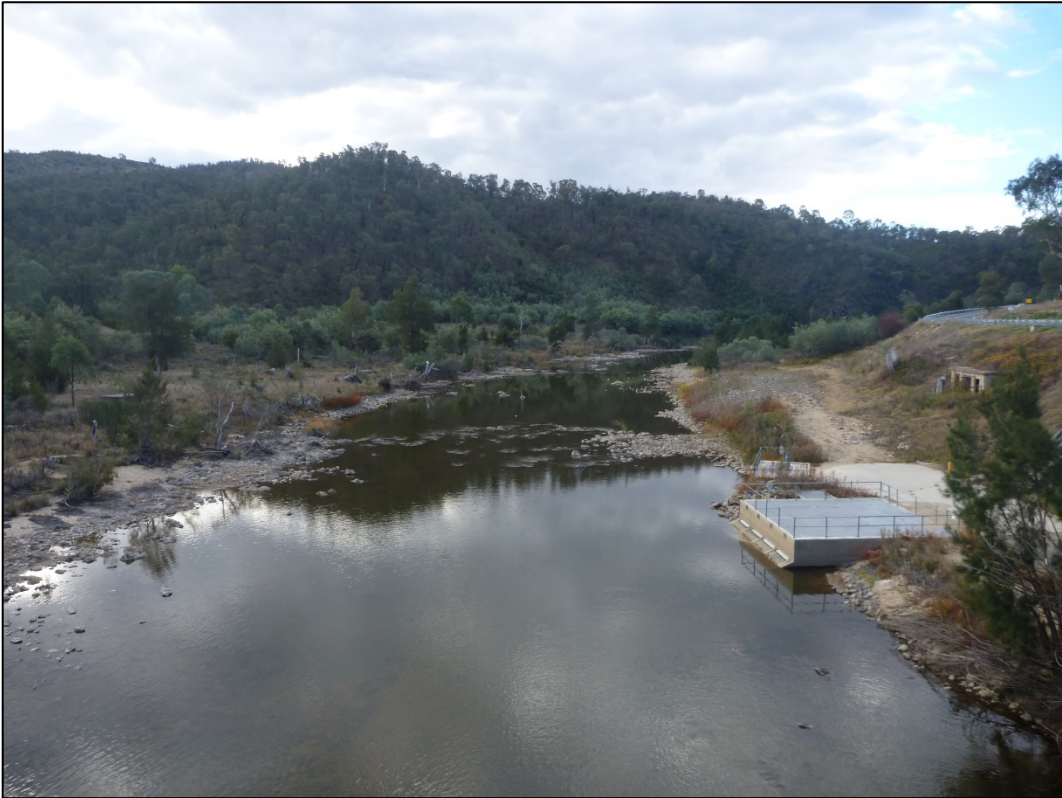
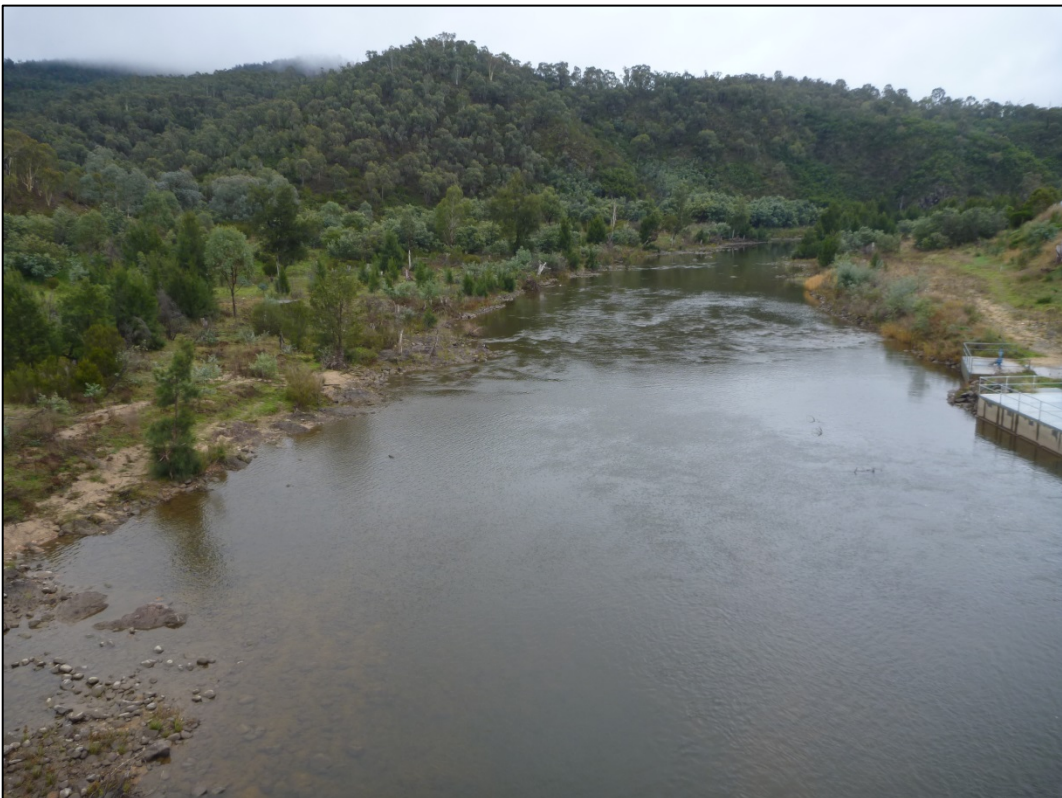
Plate 5-3. The Murrumbidgee River downstream of the Cotter Road bridge, MPS on the right bank, in autumn 2013 (top) and 2015 (bottom)

2013 – 140 ML/d (8/5/2013)

2015 - 510 ML/d (19/5/2015)
