Icon Water
Murrumbidgee Ecological Monitoring Program
Observation Report - Autumn 2019
Impact Monitoring Round 1

August 2019

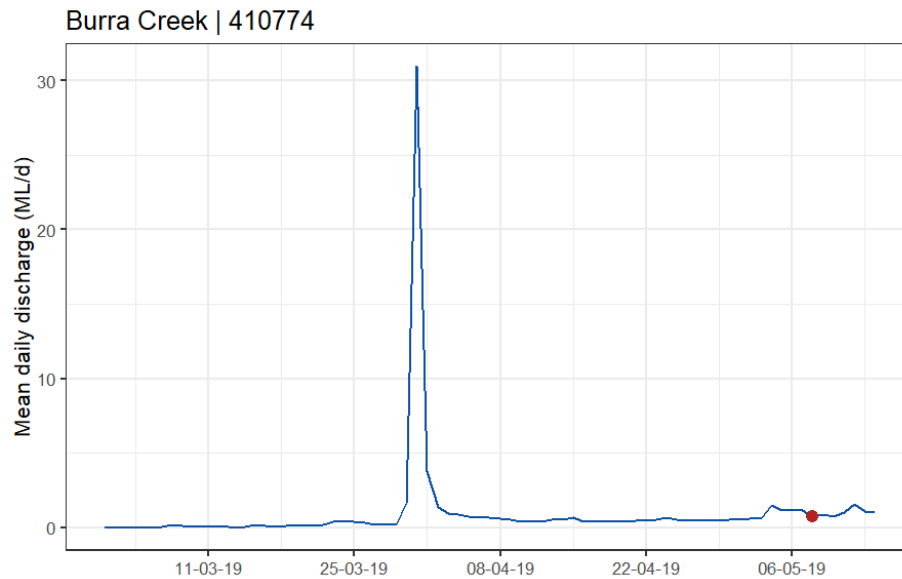
Figure 3. Hydrograph for Burra Creek at the Burra Weir (410774) for autumn 2019

There was a slight increase in flow (Figure 3) on the 4th and 5th of May following 17.8 mm of rainfall (recorded at Burra Creek: 570951). The maximum flow was 2.3 ML/d on the 4th of May which rapidly decreased to below 1 ML/d. Prior to this increase in flow, the last notable event was on the 31st of March when peak flow was 96.2 ML/d (30.9 ML/d mean daily flow) (Figure 3).

Note: the red point indicates when sampling was conducted

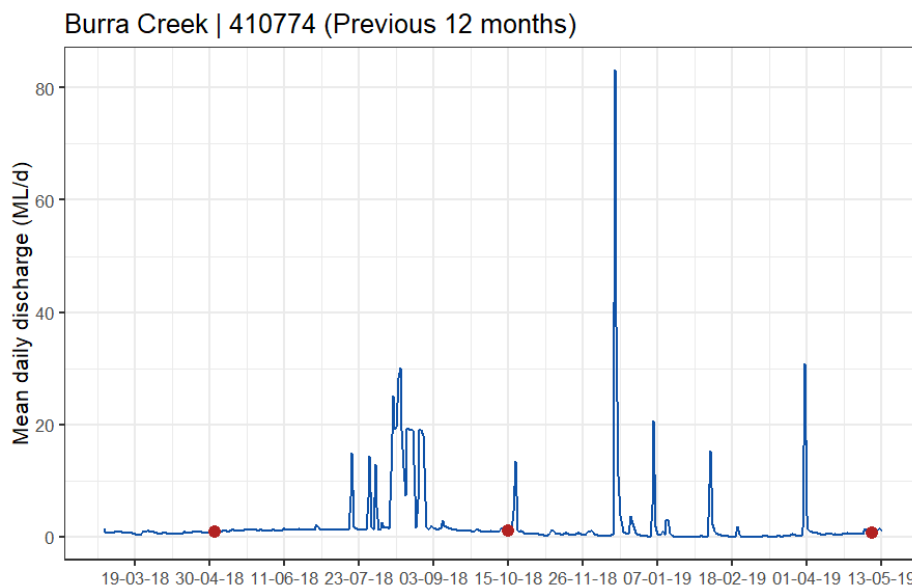
Figure 4. Hydrograph for Burra Creek at the Burra Weir (410774) for the past 12 months

Over the past twelve months there have been few high flow events, although there was one significant event on the 14th of December, which peaked at 832 ML/d resulting in a mean daily flow of 83.1 ML/d (Figure 4).

Note: the red point indicates when sampling was conducted

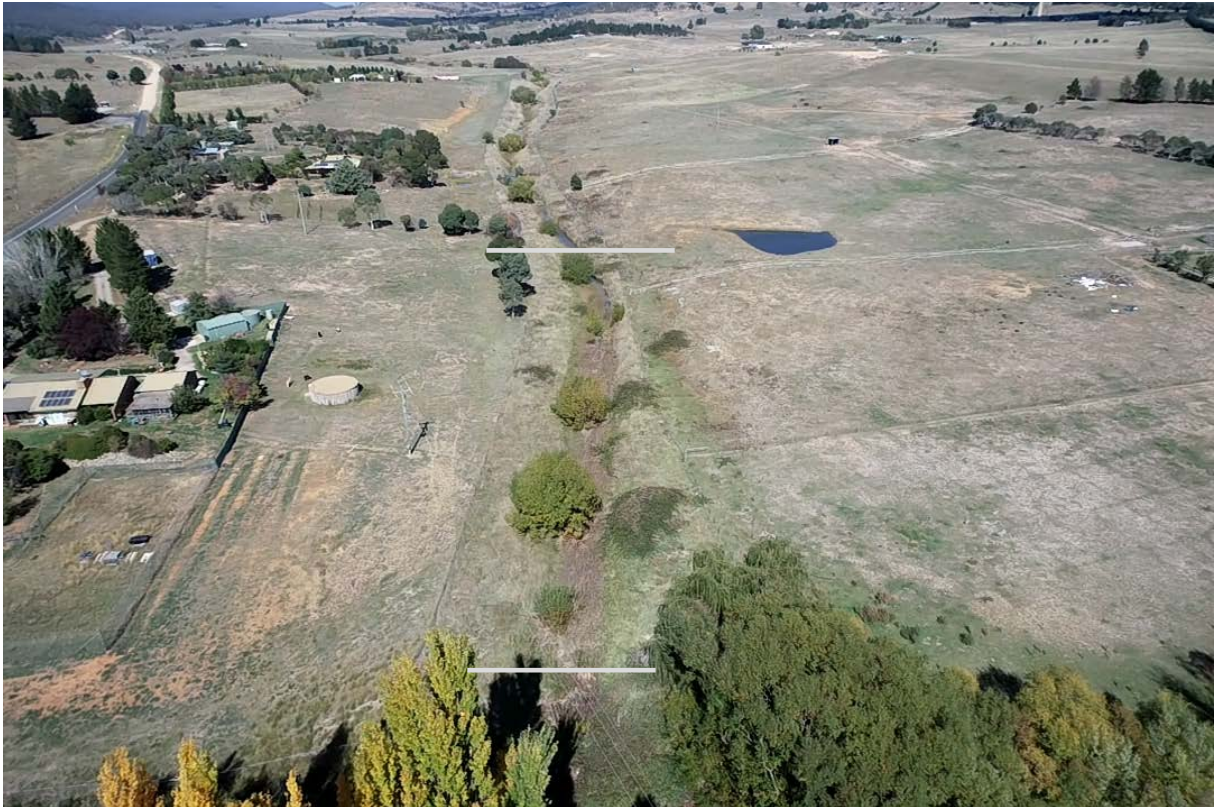
The conditions in Burra Creek were characterised by low flows. There was significant siltation on the Creek bed (see following photo plates), the channel was significantly encroached by macrophyte growth (Plate 2-1) (*Typha* spp., *Phragmites australis*, and Great Bulrush (*Schoenoplectus validus*)) and there was no riffle habitat at any of the monitoring sites, meaning that riffle samples were not collected.

Plate 2-1 Aerial view of macrophyte encroachment in Burra Creek*

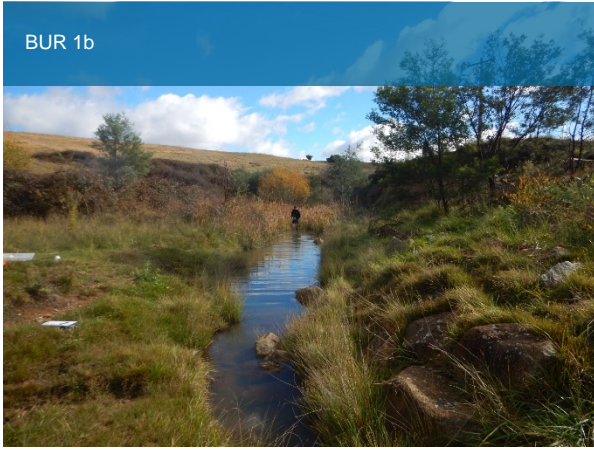
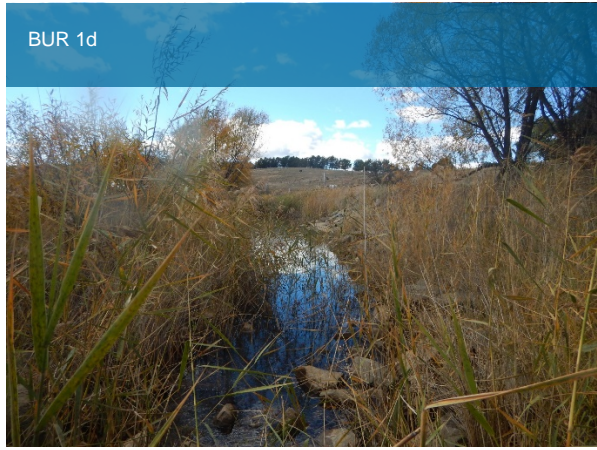
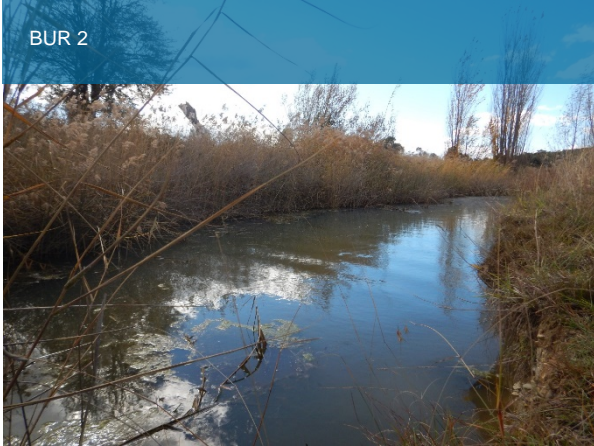
Plate 2-2. Photos of the Burra Creek macroinvertebrate sampling sites

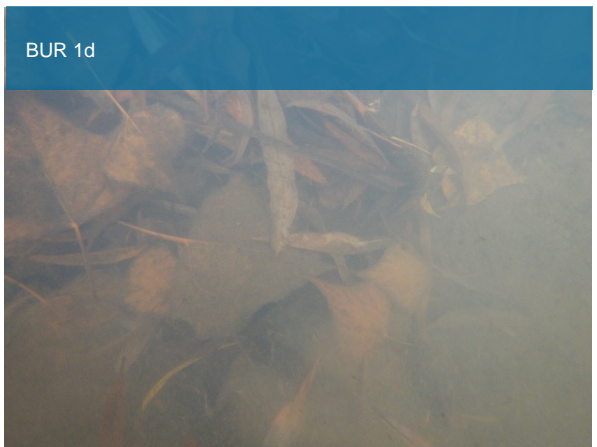
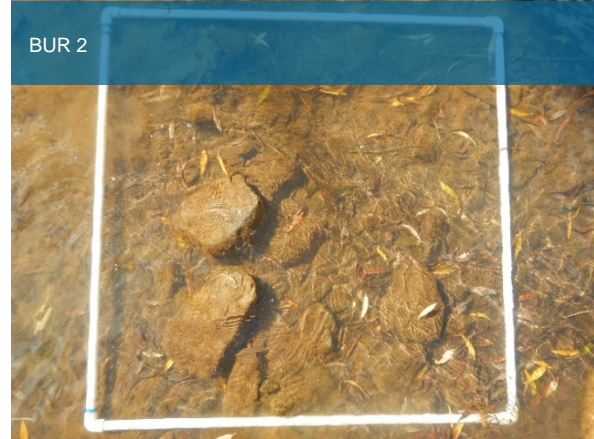
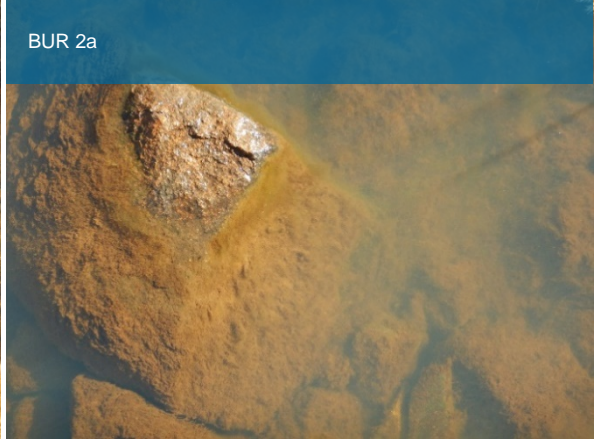
Plate 2-3 Photos of quadrat surveys in Burra Creek showing composition of the substrate

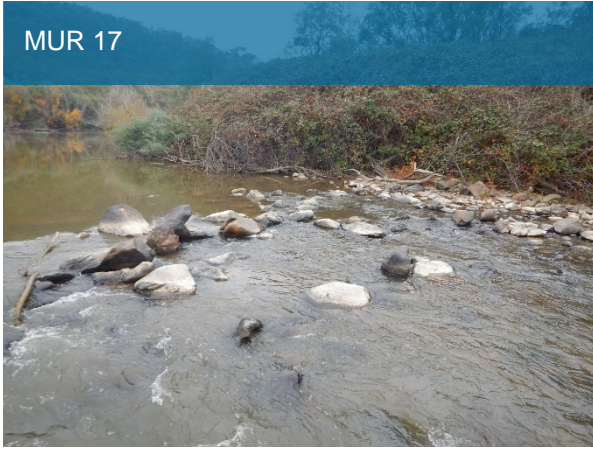
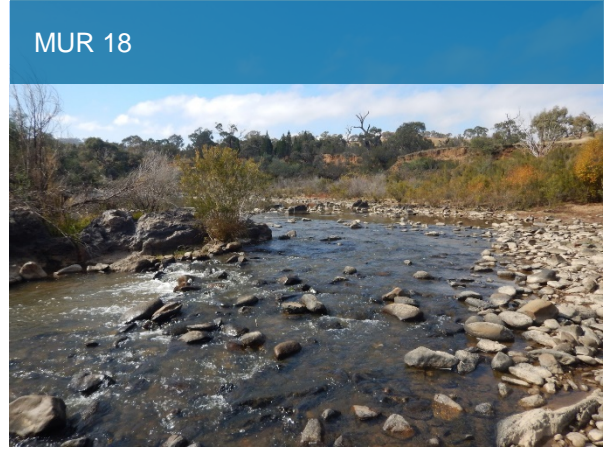
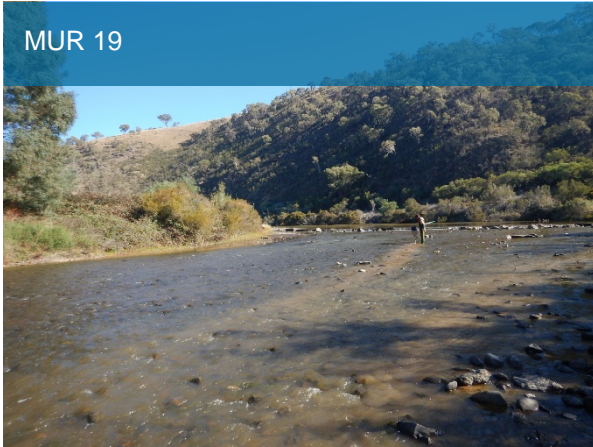
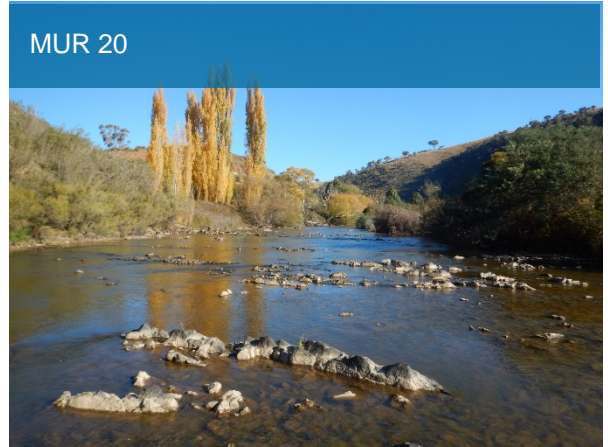
Algae growth and periphyton cover were classified as 35-65% cover at all sites. The dominant macrophyte species was *Myriophyllum* spp. which was highest at MUR 19 where it covered 65-90% of the channel (Plate 2-4).

Plate 2-4 Photos of the Murrumbidgee River sampling sites

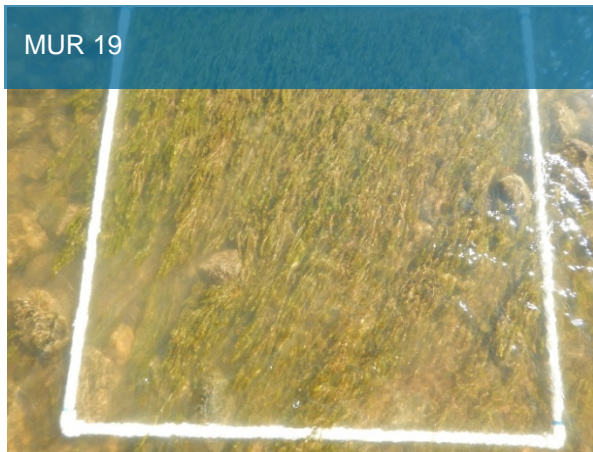
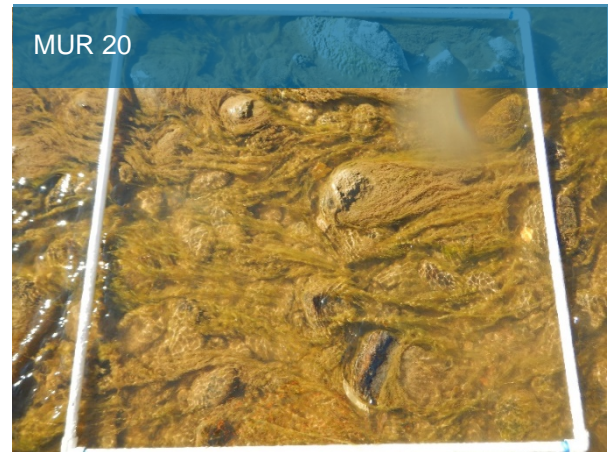
Plate 2-5 Photos of quadrat surveys in the Murrumbidgee River
