ACTEWAGL DISTRIBUTION MURRUMBIDGEE ECOLOGICAL MONITORING PROGRAM

PART 3: MURRUMBIDGEE PUMP STATION SPRING 2010

Client: ActewAGL Distribution
Project Title: Murrumbidgee Ecological Monitoring Program
Report Title: MEMP, Part 3: Murrumbidgee Pump Station
Document No: CN211063-4-S2010-4
Document Status: Final
Date of Issue: 26 July 2011
Comments:

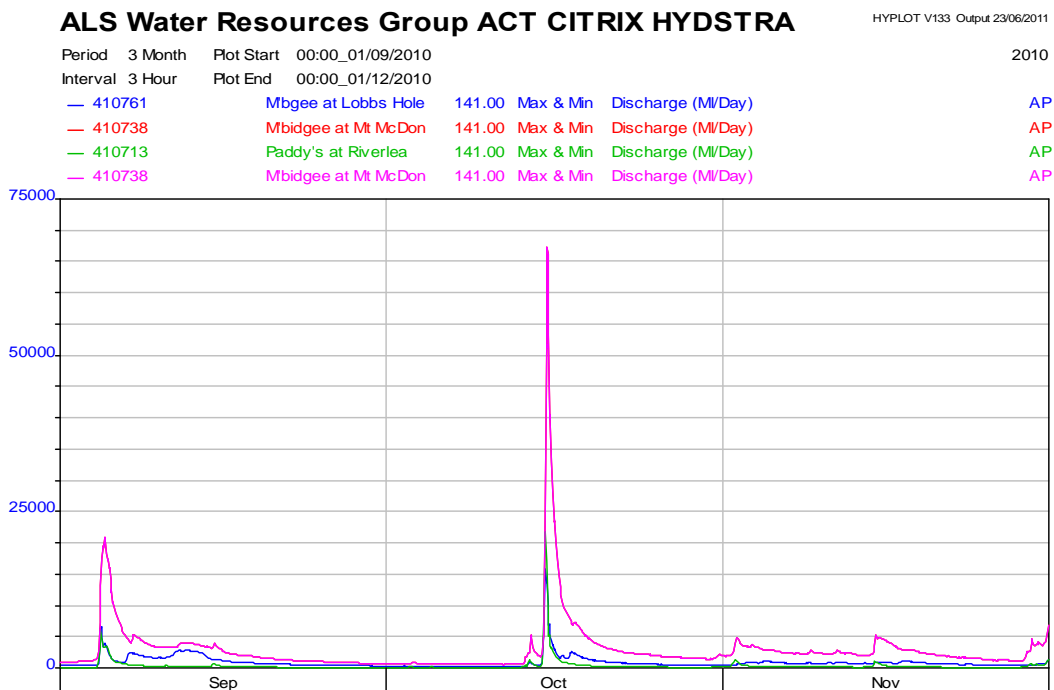
Figure 1: Murrumbidgee hydrograph for spring 2010.

The flows for the Murrumbidgee River upstream and downstream of MPS can be seen in the following figures for spring 2010. It can be seen from Figure 1 that there was a moderate event in both September and October. The much higher flow at Mt MacDonalld (410738) compared to Lobb's Hole (410761) indicates that significant inflow came from the Cotter catchment which increased the peak flow to 67,000 ML/d for the 15 October event.

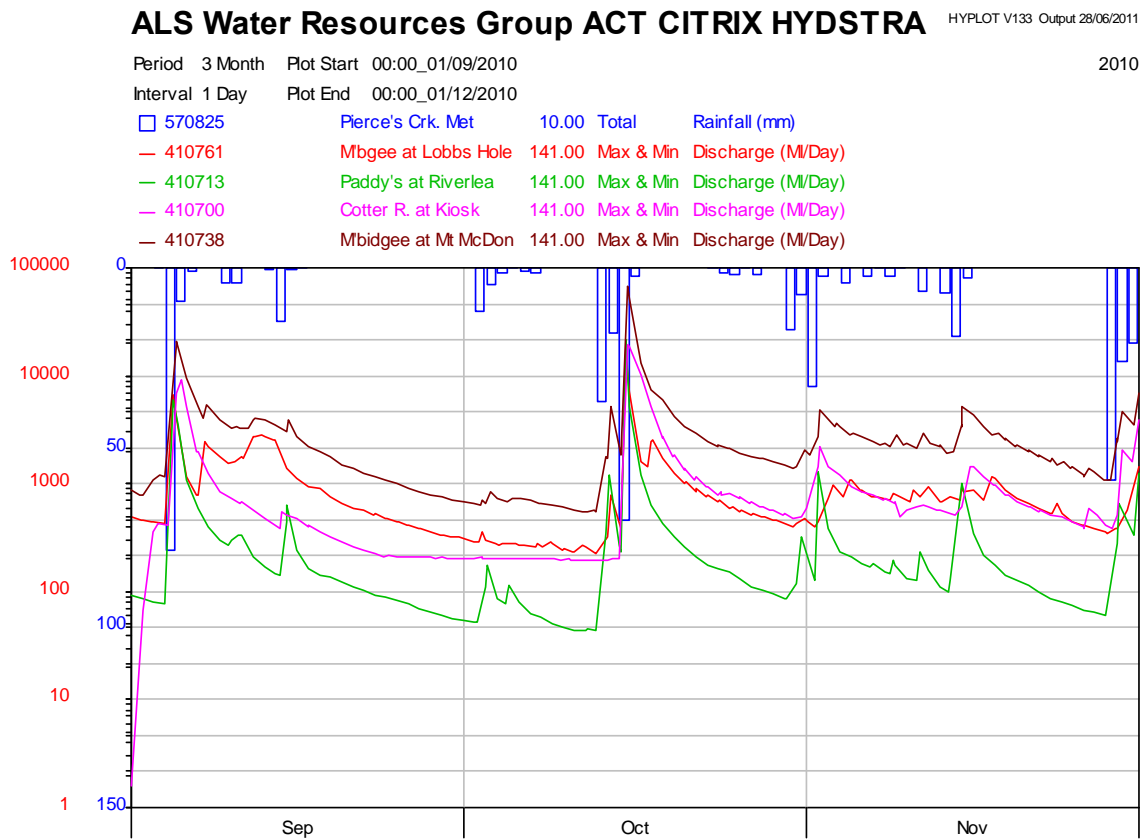
Figure 2: Murrumbidgee hydrograph for spring 2010 on a log scale with daily rainfall totals.

Daily rainfall during this period is plotted down from the top of the plot in Figure 2 in addition to a log plot for the flows. It can be seen that the daily total rainfall for the October event was actually less than the September event, but the preceding rainfall would have increased soil saturation levels inducing the higher October runoff.

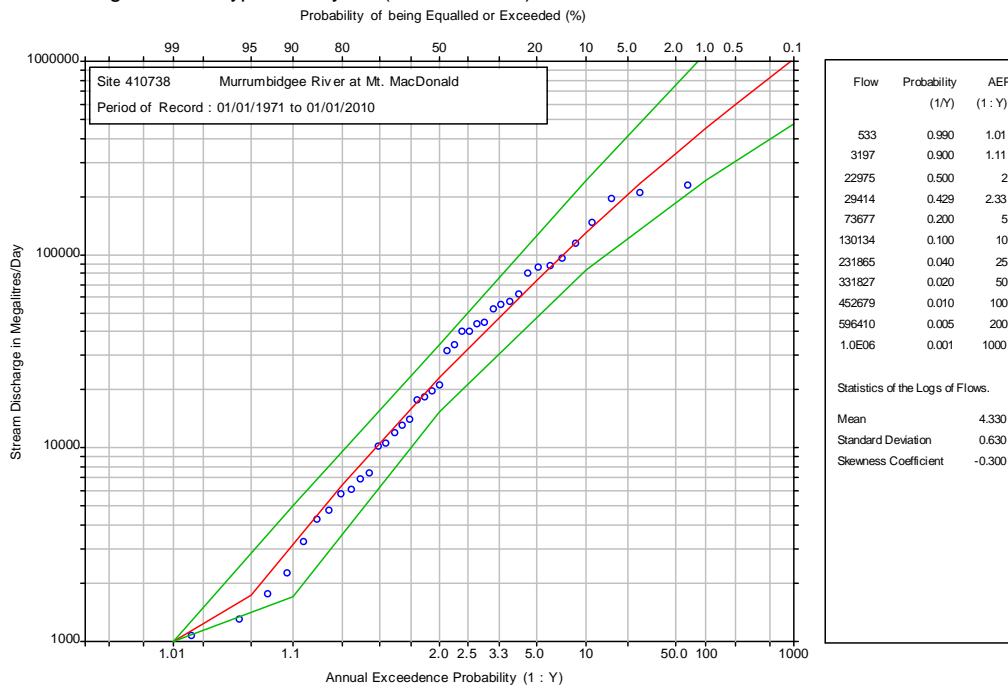
Figure 3: Annual Exceedence Probability versus discharge plot for Mt Macdonald.

The 15 October 2010 peak flow of 67,000 ML/d at Mt MacDonald (410738) is approximately a 1 in 5 year Average Recurrence Interval (ARI) event for the Murrumbidgee River at that location. The 4 September 2010 event peaked at 20,500 ML/d and is approximately a 1 in 2 year ARI event.

The ARI probability was determined using historical data in the ALS HYDSTRA data management system using a Log-Pearson Type III analysis. ARI can also be expressed as the Annual Exceedance Probability (AEP) and the probability versus flow is plotted in Figure 3.

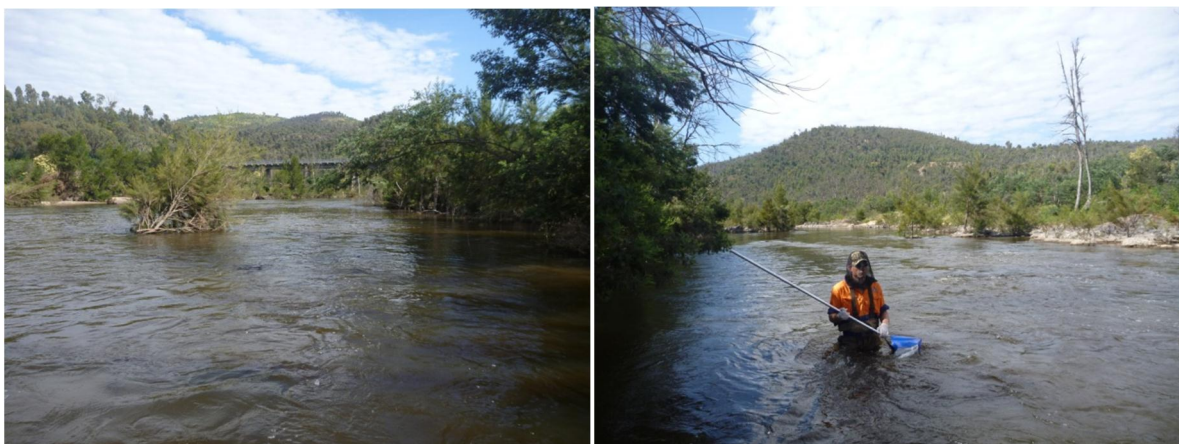
Several site visits were undertaken to attempt the MPS sampling program after a minimum of 2 weeks, however the continuing high depth of water prevented a sampling regime being undertaken. See photos below.

Plates 1 and 2: Murrumbidgee River upstream of Cotter River confluence looking toward Cotter Rd. bridge, and river depth in riffle zone too deep for sampling.

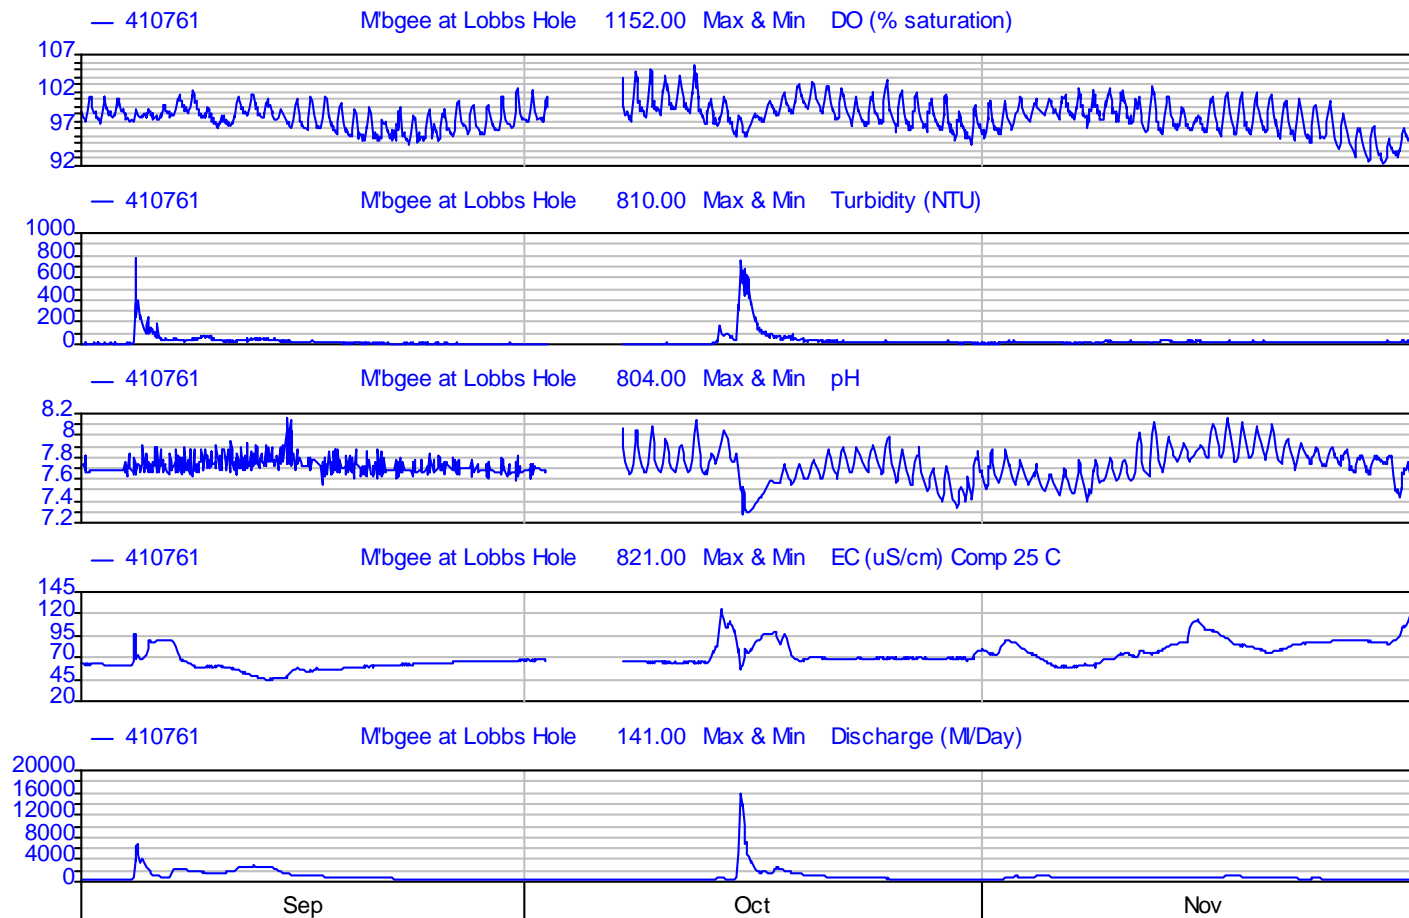
Figure 5: Spring 2010 in-situ water quality record for Lobbs Hole (410761).

Results indicate a consistent pH level and saturated dissolved oxygen levels, with elevated turbidity due to the size of the storm events in September and October. Electrical conductivity is lower than during previous low flow periods.

A plot of the continuous data for spring 2010 is shown in Figure 5 with a grab sample result for MUR 28 in Table 4. Consistent with previous season’s water sample results, Murrumbidgee River total nitrogen and total phosphorus levels are above the ANZECC (2000) guideline recommended values. These values are not just the result of high streamflow as they have also been above ANZECC guideline levels during previous normal and low flow periods.

High peak turbidity values in the brackets of the table are consistent with high sediment laden water during stormwater runoff peaks from upstream agricultural areas and gully erosion on hillsides. The high average turbidity values are consistent with ongoing, though gradually reducing, fine sediment in the water after an event.
