Icon Water
Murrumbidgee Ecological Monitoring Programme
Sentinel Monitoring - Spring 2015

February 2016

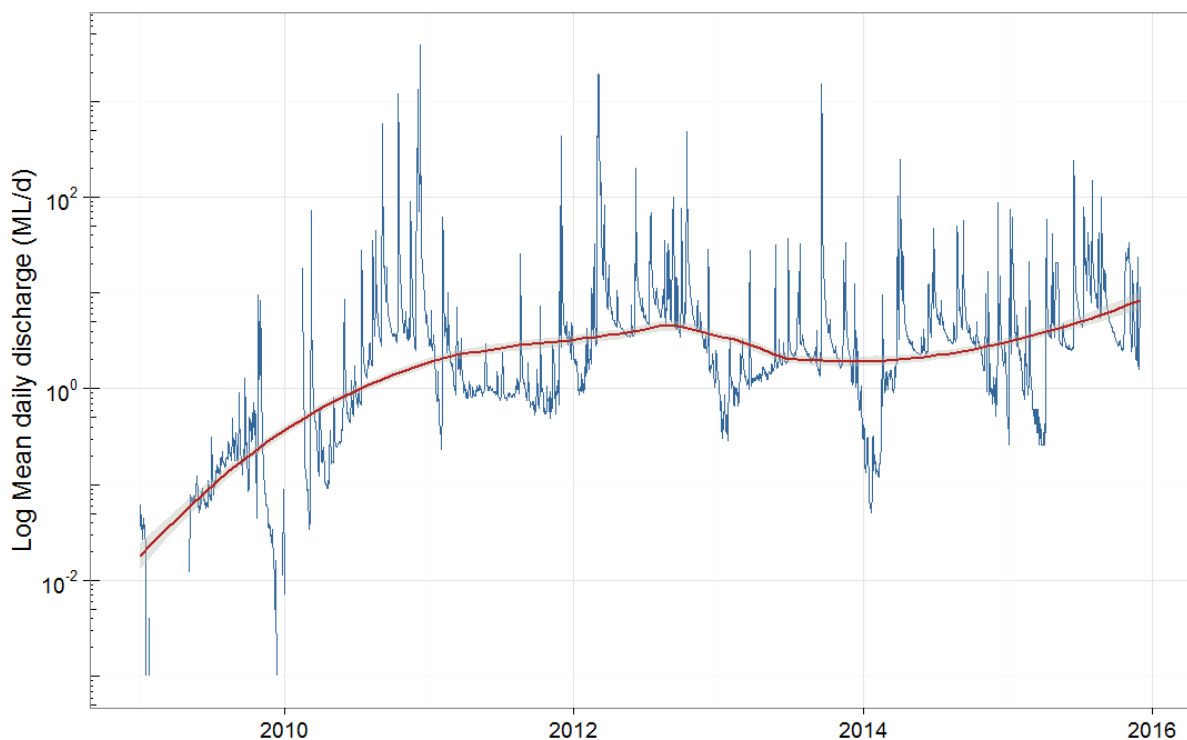
Flow conditions have varied considerably since the inception of the MEMP in late 2008 (Figure 1-4). In 2008 mean daily flow was 0.15 ML/d and this was followed by an equally dry year in 2009 when the mean daily flow was 0.18 ML/d. In early 2010 there were a few rainfall events and this pattern continued throughout most of the year resulting in an upward trend of daily mean flows, which reached 23.4 ML/d. 2011 was a moderately dry year and mean flows fell back to less than 5 ML/d until March 2012, which saw another period of large rainfall events. These rainfall events resulted in another upward trend in average flows until early spring 2012 (Figure 1-4). Summer in 2013/14 was the driest since 2010 although autumn rainfall balanced out the smoothing curve resulting in positive trend since September 2013. The overall trend since the beginning of 2014 has shown a gradual increase in daily mean flows (Figure 1-4). Summer flows in 2014/15 were considerably higher in Burra Creek compared to summer 2013/14 where average flows for the season were 5.95 ML/d and 1.22 ML/d respectively. Summer flows are an ecologically important consideration because summer is potentially a particularly stressful period for macroinvertebrates, especially in intermittent streams and these flows have the potential to strongly influence the dynamics and structure of macroinvertebrate communities.

Figure 1-4. Hydrograph of Burra Creek at the Burra Road weir (410774) from 2009 to November 2015

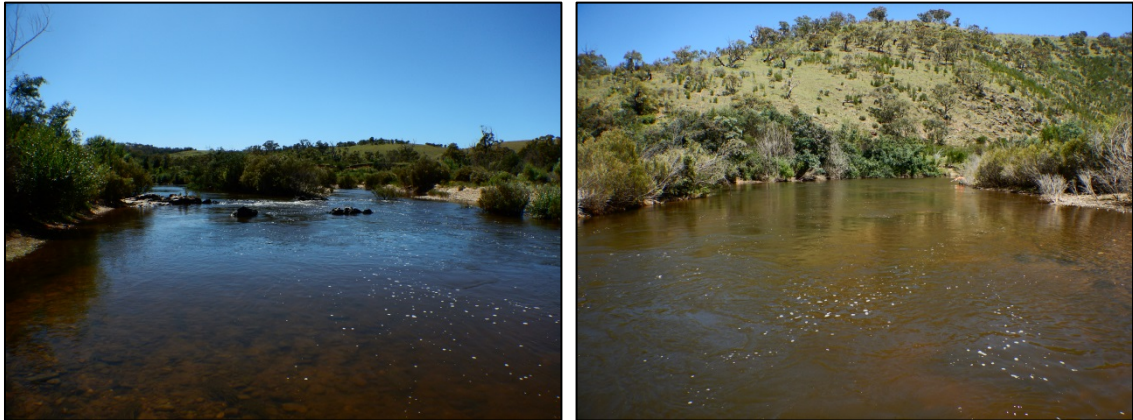
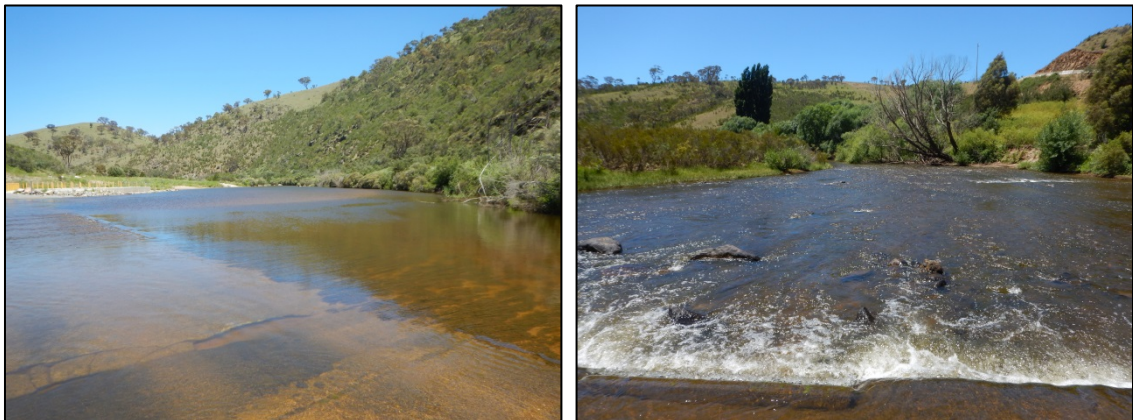
Plate 3-1. Photographs of the Angle Crossing monitoring sites at the time of sampling - spring 2015

Sampling of the Angle Crossing sites was conducted on the 24th November 2015. The weather on the day was fine and the maximum temperatures reached over 27°C (at Canberra Airport (BoM, 2015)). The flow in the Murrumbidgee River was receding following a small flow event in mid-November, and the mean daily flow on the day was 290 ML/d at the Lobb's Hole gauging station (410761). A single riffle and a single edge sample were collected at both the upstream and downstream sites (MUR 18 and MUR 19 respectively). Site photographs are presented in Plate 3-1. Like previous seasons, submerged macrophyte cover was high at both sites, but particularly at MUR 19, where the dominant macrophyte species was *Myriophyllum* sp.; small patches of filamentous algae were also present at MUR 19. Site summaries are presented in Appendix B and general habitat data is shown in Appendix C.

MUR 18: Looking upstream (left) and downstream (right)

MUR 19: Looking upstream (left) and downstream (right)

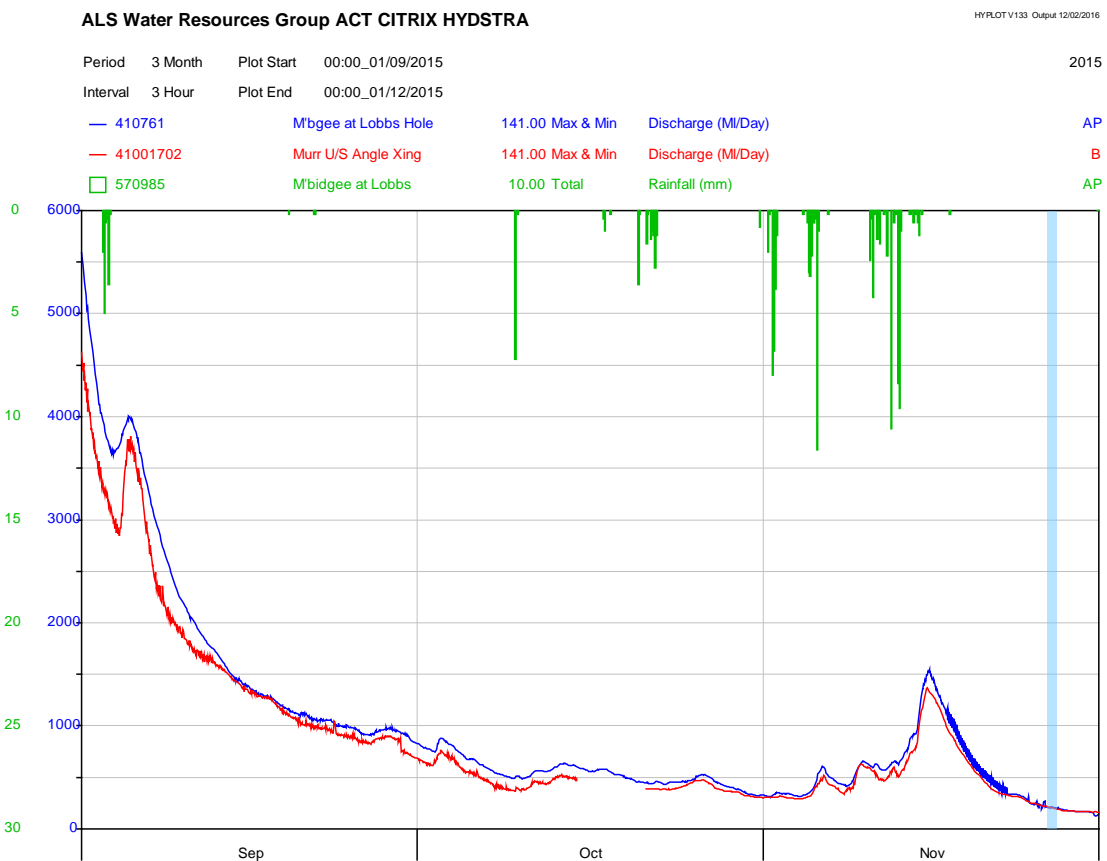
Flow during the spring period was characterised by a high flow event at the beginning of the season which peaked above 10,000 ML/d and receded over a three week period in September; which was followed by approximately three weeks of steady flow resulting from low rainfall during October. A small flow event of approximately 1,500 ML/d occurred in mid-November following the higher rainfall during the first half of the month (Figure 3-2). Flows during the final week of November (when sampling occurred) were the lowest of the entire spring period (mean flow of 200 ML/d during the final week of November at 410761). This follows a similar pattern to spring 2014 when there was a high flow event during August with flows generally receding throughout spring and through to the beginning of summer (Figure 3-3). Flow data at upstream Angle Crossing (41001702) was missing for a week during mid-October.

Figure 3-2. Spring 2015 hydrograph of the Murrumbidgee River upstream (41001702) and downstream (410761) of Angle Crossing

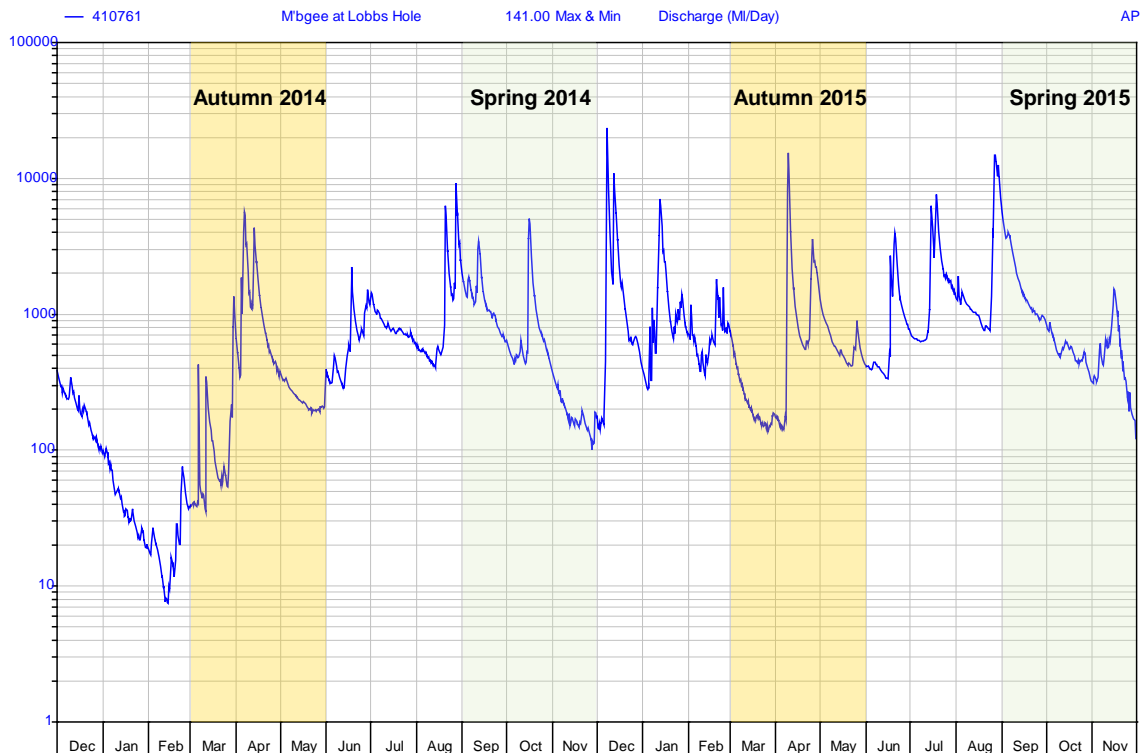
Figure 3-3. Hydrograph from Lobb’s Hole highlighting the past four sampling periods between December 2013 and November 2015

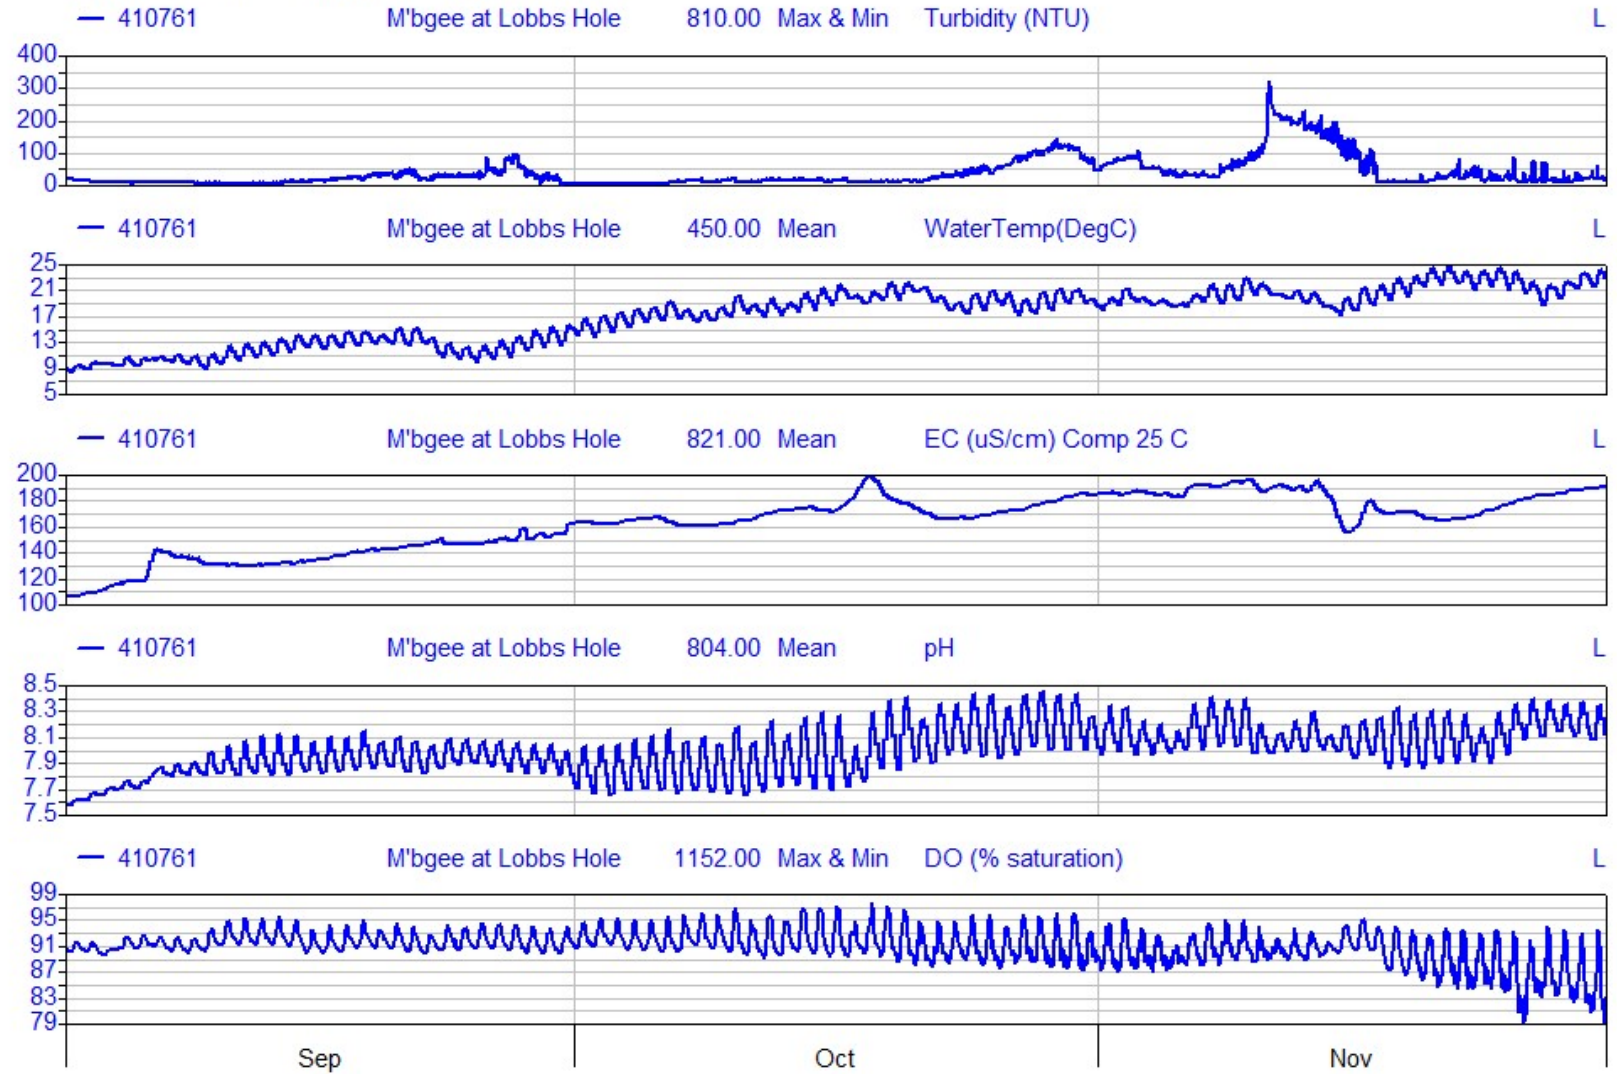
Figure 3-4. Continuous water quality records from Lobbs Hole (410761) for spring 2015

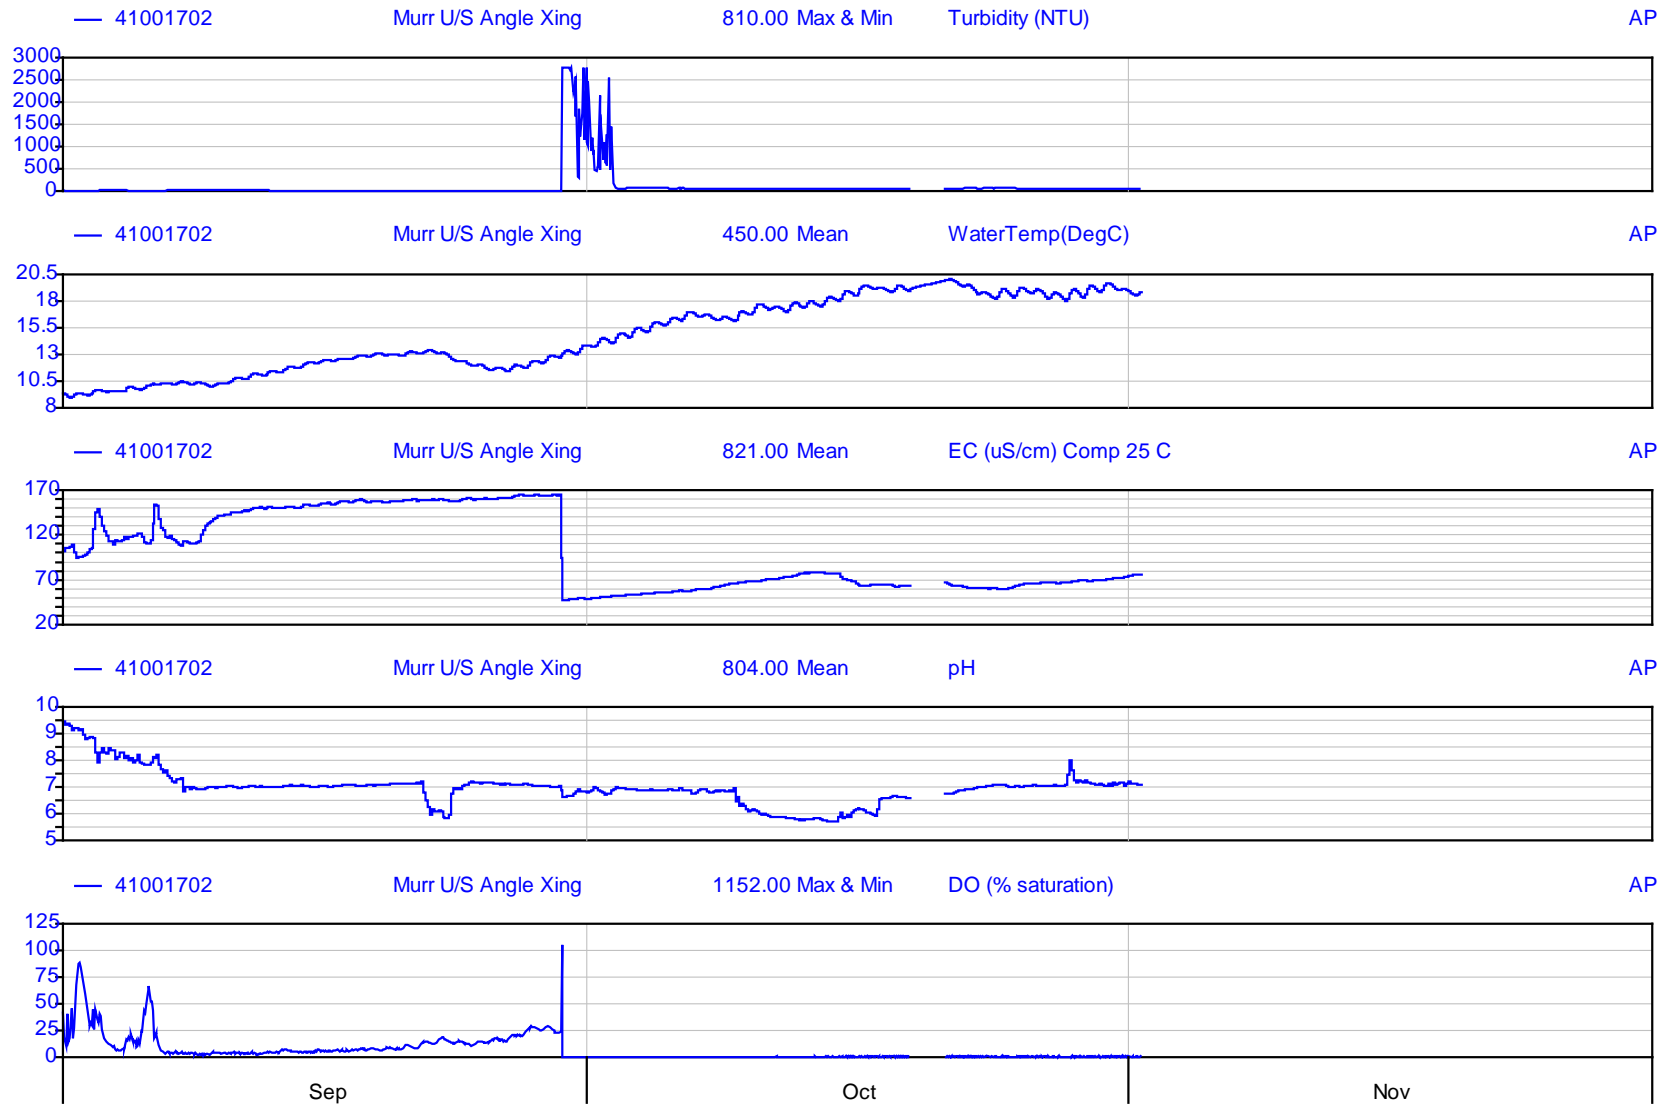
Figure 3-5. Continuous water quality records from upstream Angle Crossing (41001702) for spring 2015

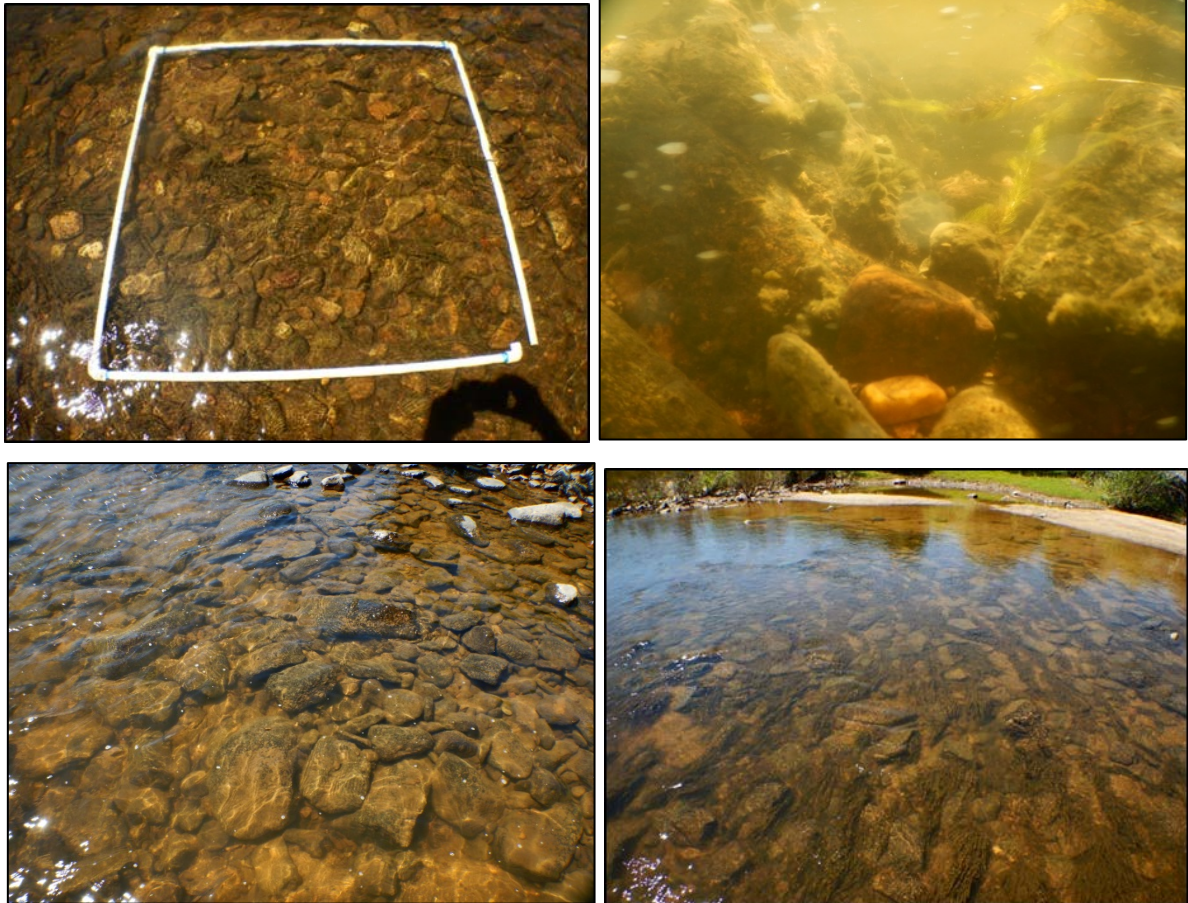
The periphyton coverage at MUR 18 was approximately 65-90% for the reach and 35-65% for the riffle habitat using the AUSRIVAS assessment method (Plate 3-2). There were large stands of the submerged macrophyte *Myriophyllum* sp. growing throughout the reach (as shown below in Plate 3-2 [bottom right]). The dominant substrate in the riffle habitat was cobble.

Plate 3-2. Photos showing the periphyton and macrophyte coverage in the reach and riffle at MUR 18

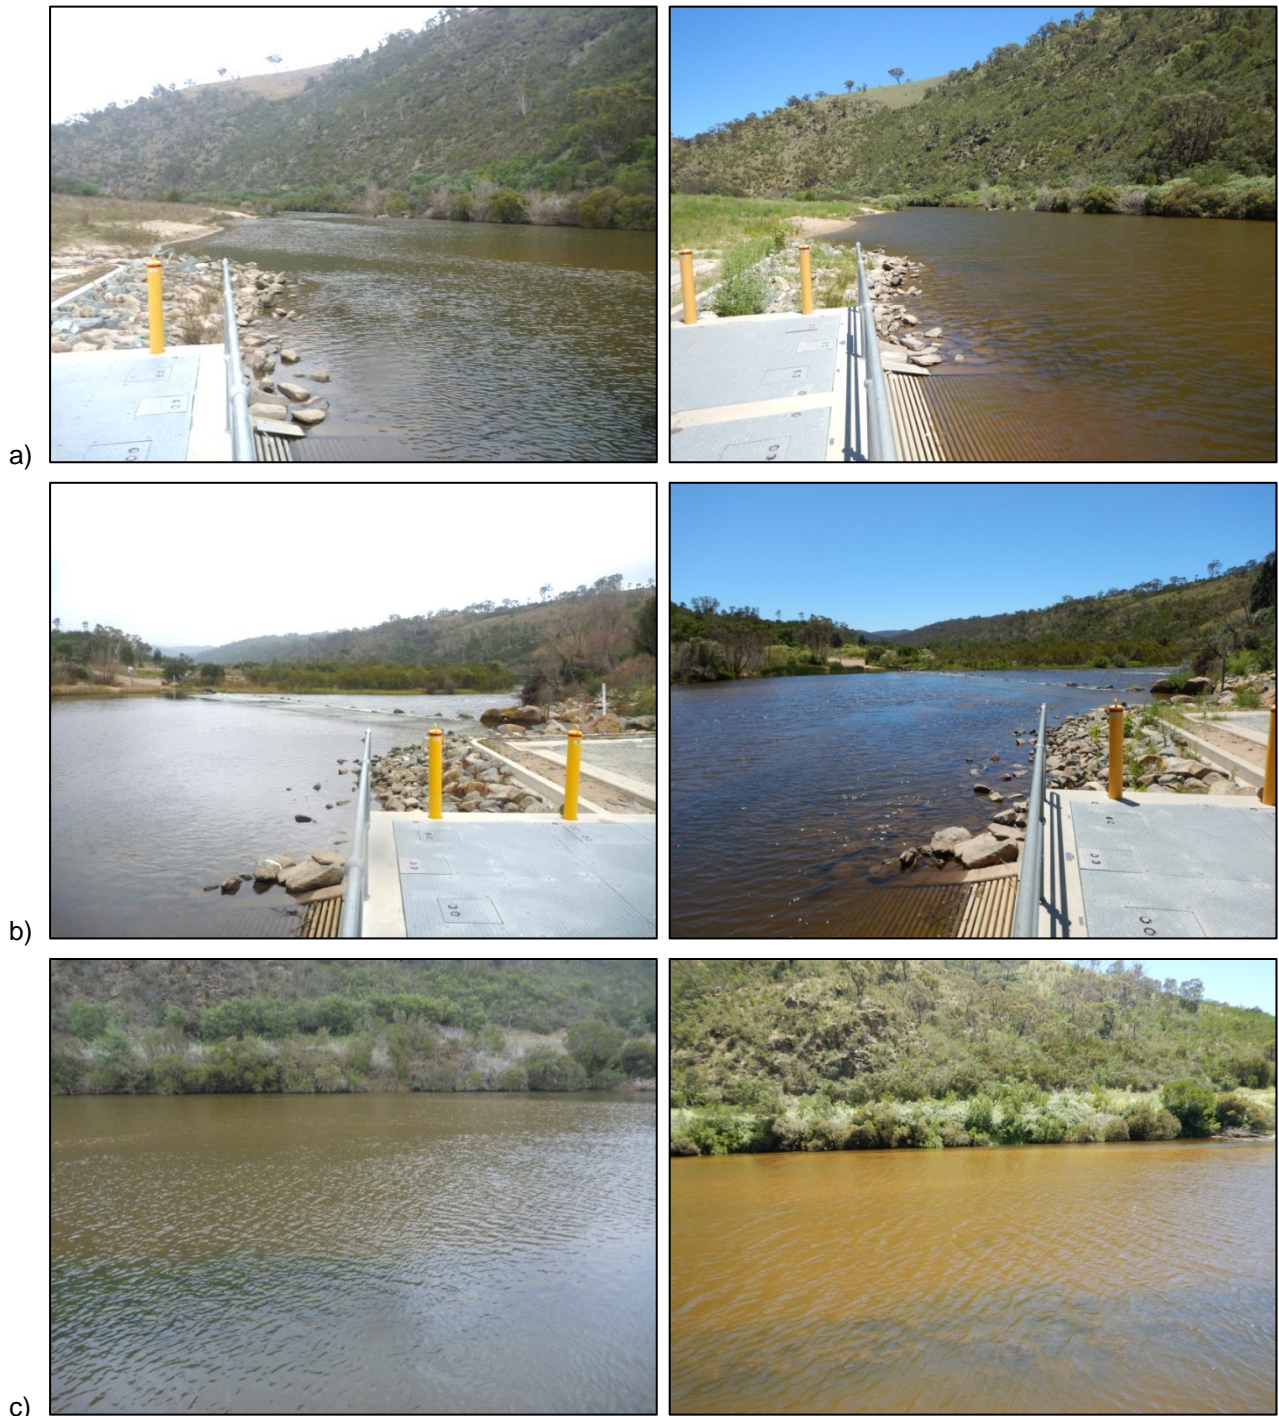
Geomorphological features at Angle Crossing have remained relatively unchanged compared to autumn 2015 (GHD, 2015). There appears to be small sections of increased erosion on the right bank next to the riffle habitat which is visible in Photo Point 2 (Plate 3-5). Outside of this small adjustment, not other changes were evident. The large longitudinal bar at Photo Point 5 (Plate 3-8) appears to have increased in size however, this is more likely due to the lower flow during sampling in spring 2015 compared to autumn 2015. A total of five photographs from five photo points were captured at Angle Crossing during spring 2015 and are presented in Plate 3-4 through to Plate 3-8.

Plate 3-4. Geomorphology photo point 1 at Angle Crossing showing upstream (a), downstream (b) and across the channel (c) during autumn 2015 (left) and spring 2015 (right)

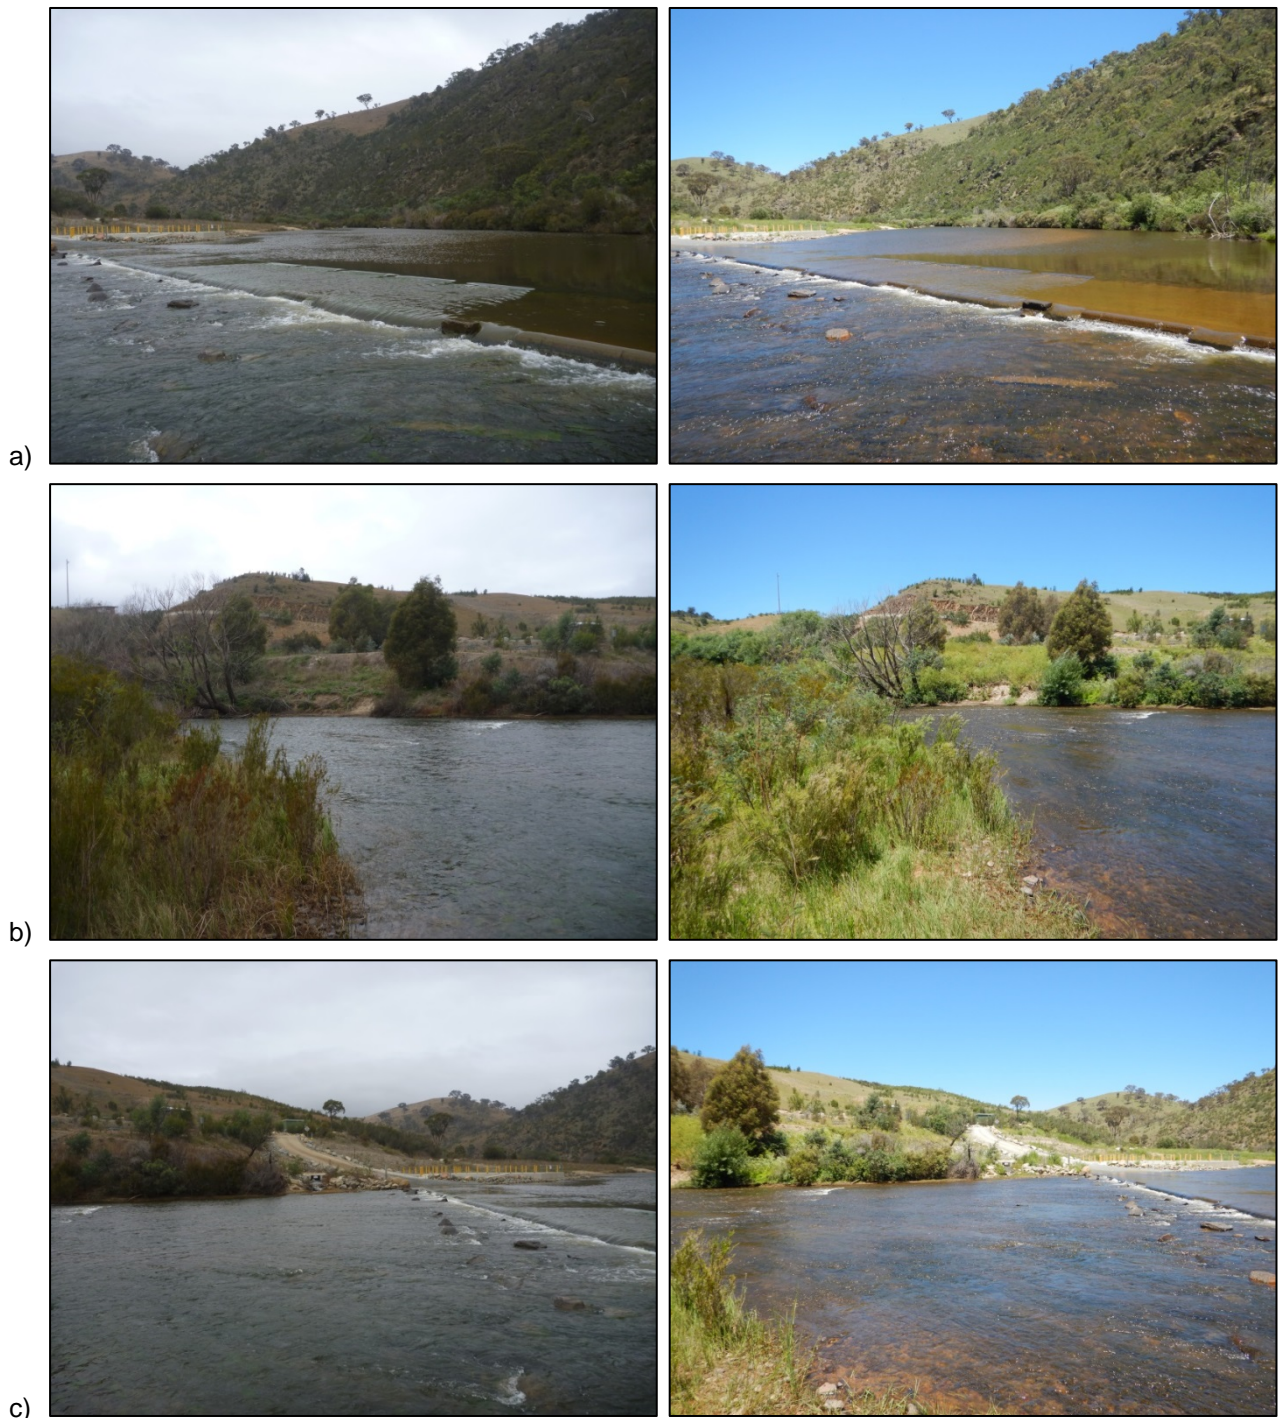
Plate 3-5. Geomorphology photo point 2 at Angle Crossing showing upstream (a), downstream (b) and across the channel (c) during autumn 2015 (left) and spring 2015 (right)

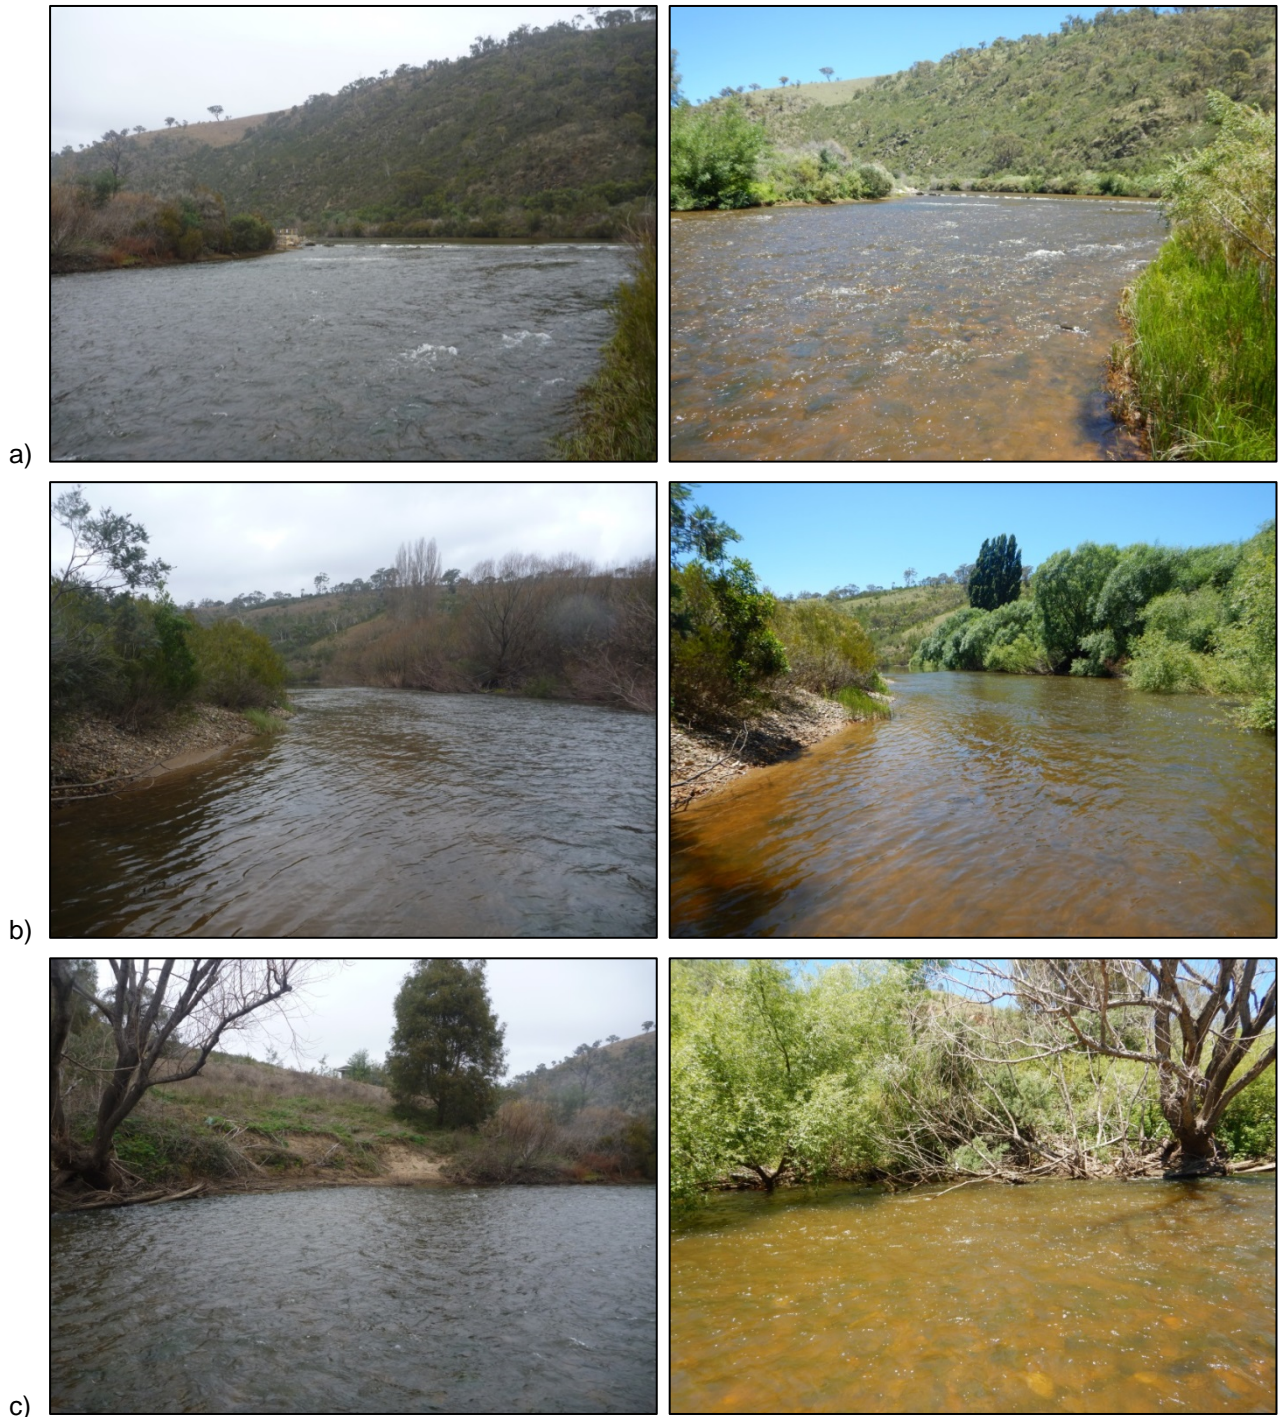
Plate 3-6. Geomorphology photo point 3 at Angle Crossing showing upstream (a), downstream (b) and across the channel (c) during autumn 2015 (left) and spring 2015 (right)

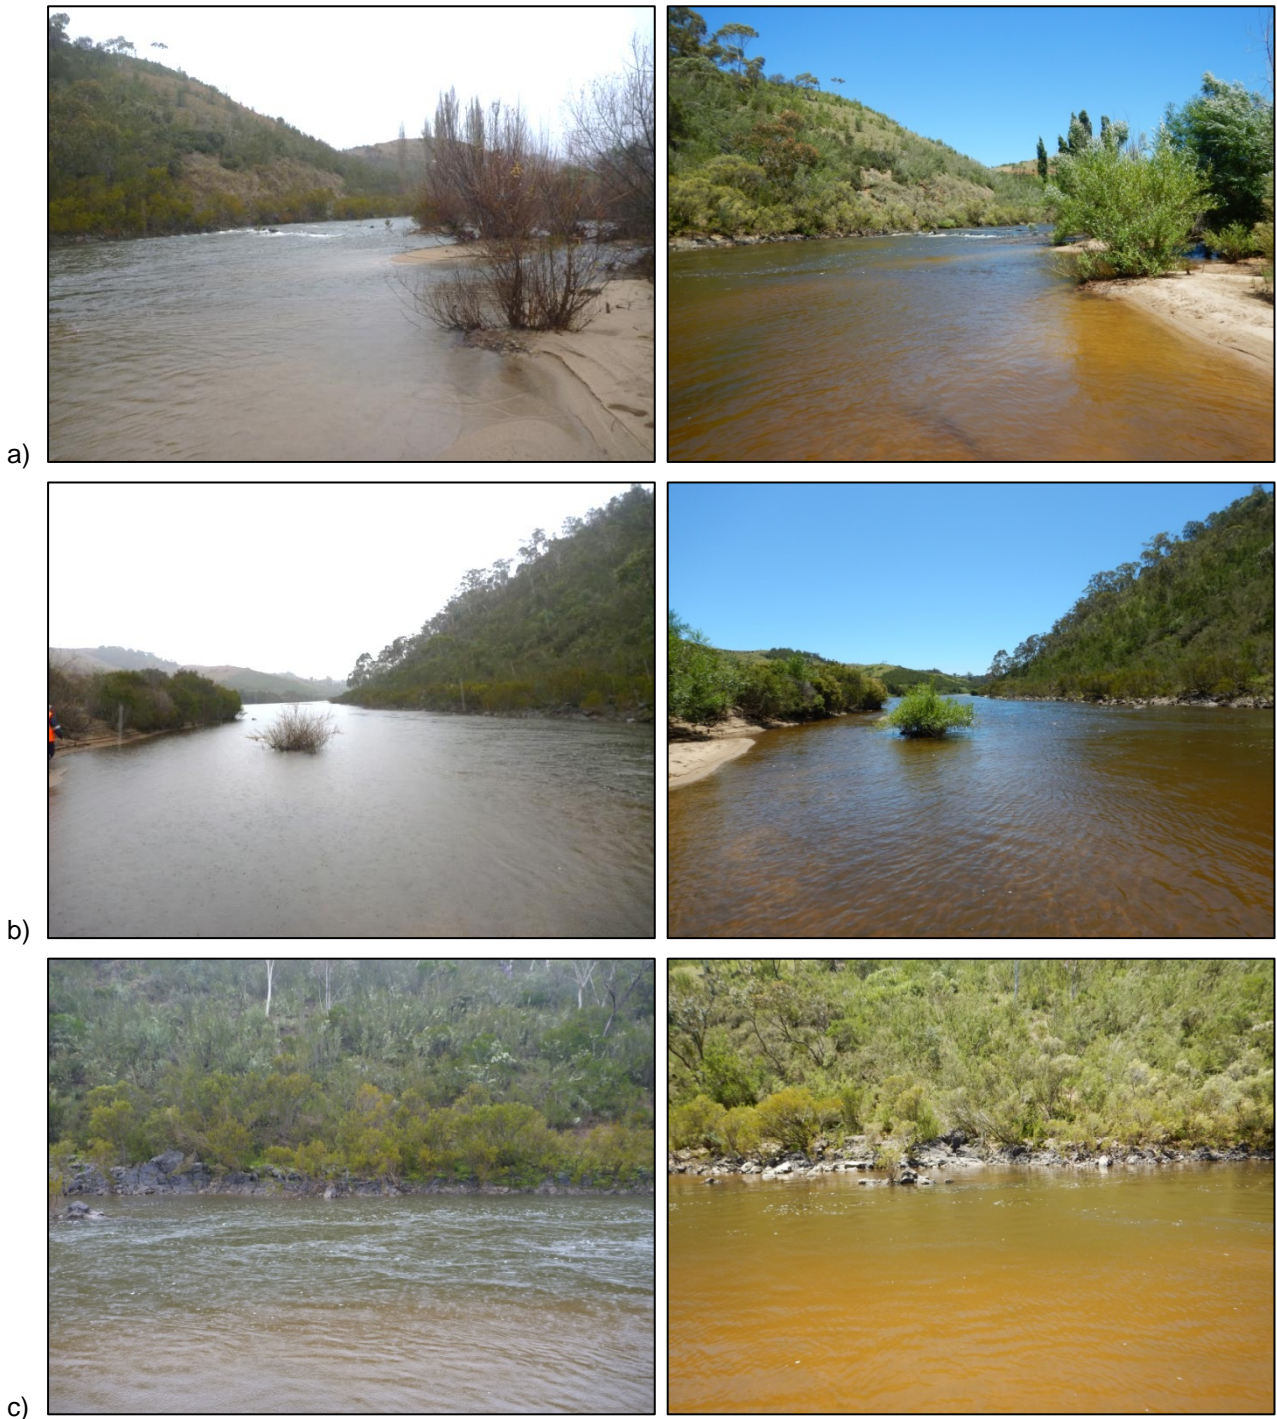
Plate 3-7. Geomorphology photo point 4 at Angle Crossing showing upstream (a), downstream (b) and across the channel (c) during autumn 2015 (left) and spring 2015 (right)

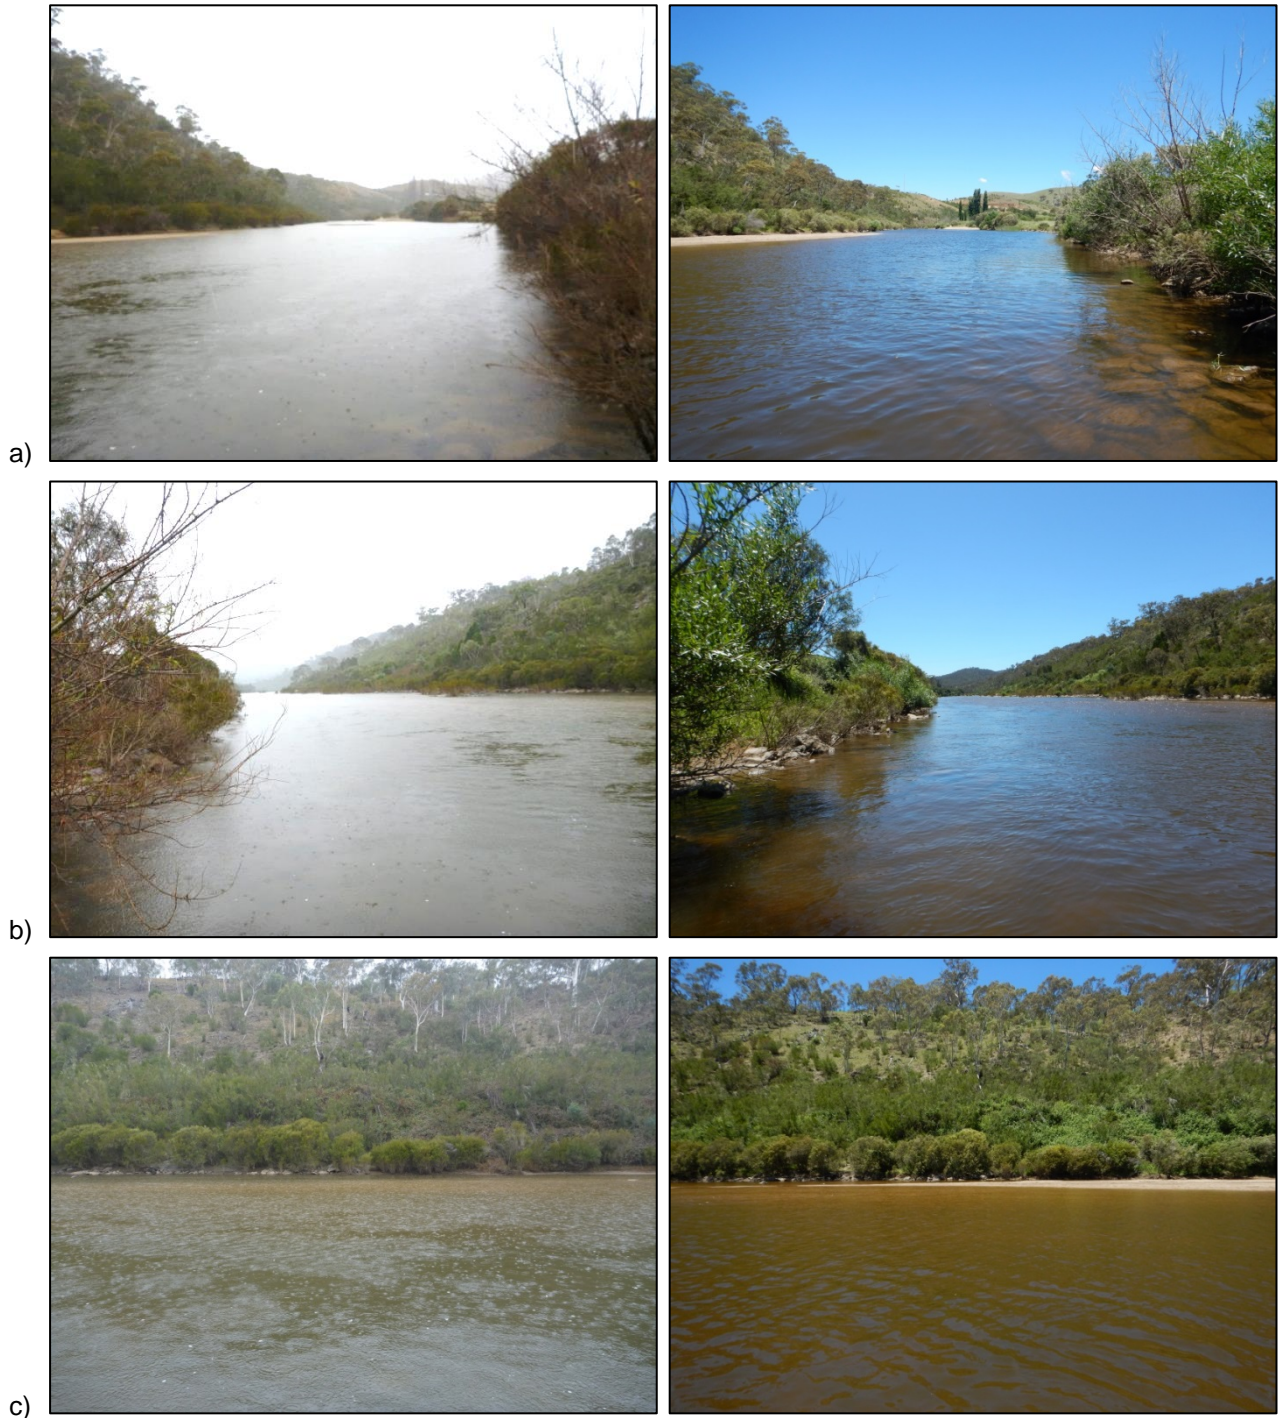
Plate 3-8. Geomorphology photo point 5 at Angle Crossing showing upstream (a), downstream (b) and across the channel (c) during autumn 2015 (left) and spring 2015 (right)

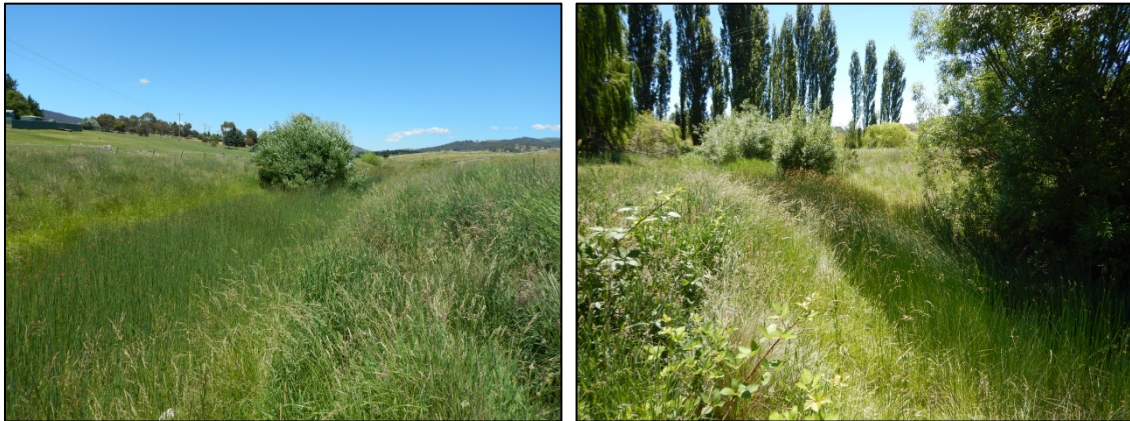
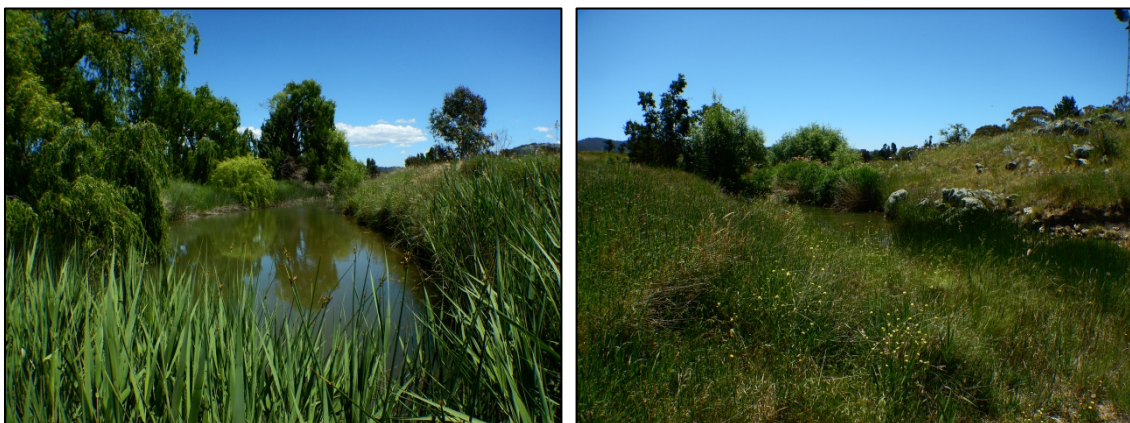
Plate 4-1. Photographs of the Burra Creek sites during spring 2015 sampling

Macrophyte growth was prolific at both Burra Creek sites during spring 2015. Great Bullrush (*Schoenoplectus validus*) was dominant at BUR 1c while there were a number of large stands of Common Reed (*Phragmites australis*) at BUR 2a. The riffle habitats at both sites were highly silted and provided very poor habitat quality compared to previous seasons. Site summaries can be found in Appendix B, while site habitat data is given in Appendix C.

BUR 1c: Looking upstream (left) and looking downstream (right)

BUR 2a: Looking upstream (left) and looking downstream (right)

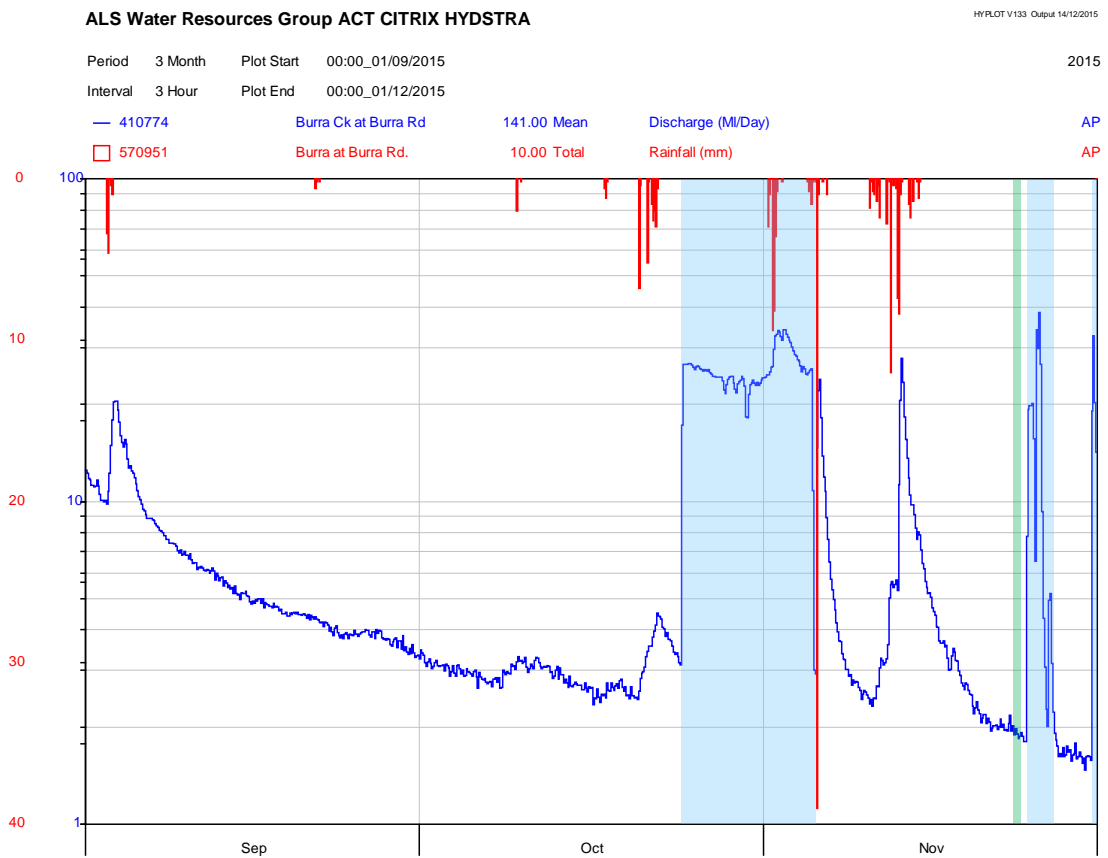
Surface flow in Burra Creek during spring 2015 was low, typically ranging between 2-4 ML/d (Figure 4-1). There were two periods of naturally increased flow during early-mid November where flow peaked between 20 and 30 ML/d. Outside of these natural events, flow increased during late October and twice in late November as a result of the APPLE runs of the M2G pipeline as highlighted in Figure 4-1. The period of sampling immediately prior to the second APPLE run is also highlighted in Figure 4-1. Rainfall during spring increased over the season and ranged from 10.4mm in September to 118.8mm in November, which was more than three times the rainfall which fell during September and October combined (Table 4-1). This is the highest November rainfall recorded since 2011 (Figure 4-3). The hydrograph for the previous two years (Figure 4-2) shows that flows leading into spring 2015 were considerably higher than those leading into spring 2014 (during July and August).

Figure 4-1. Hydrograph and rainfall from Burra Creek (410774) during spring 2015

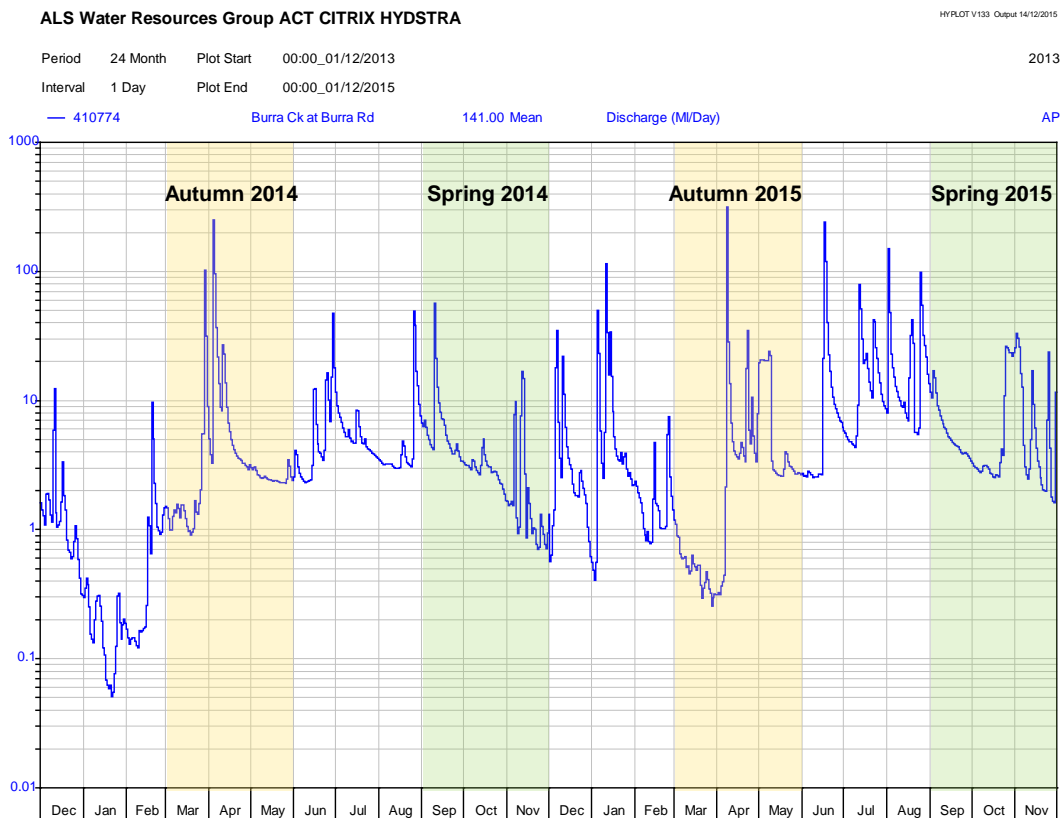
Figure 4-2. Burra Creek hydrograph highlighting the past four sampling periods between March 2014 and November 2015
