Icon Water
Murrumbidgee Ecological Monitoring Programme
Sentinel Monitoring - Spring 2015

February 2016

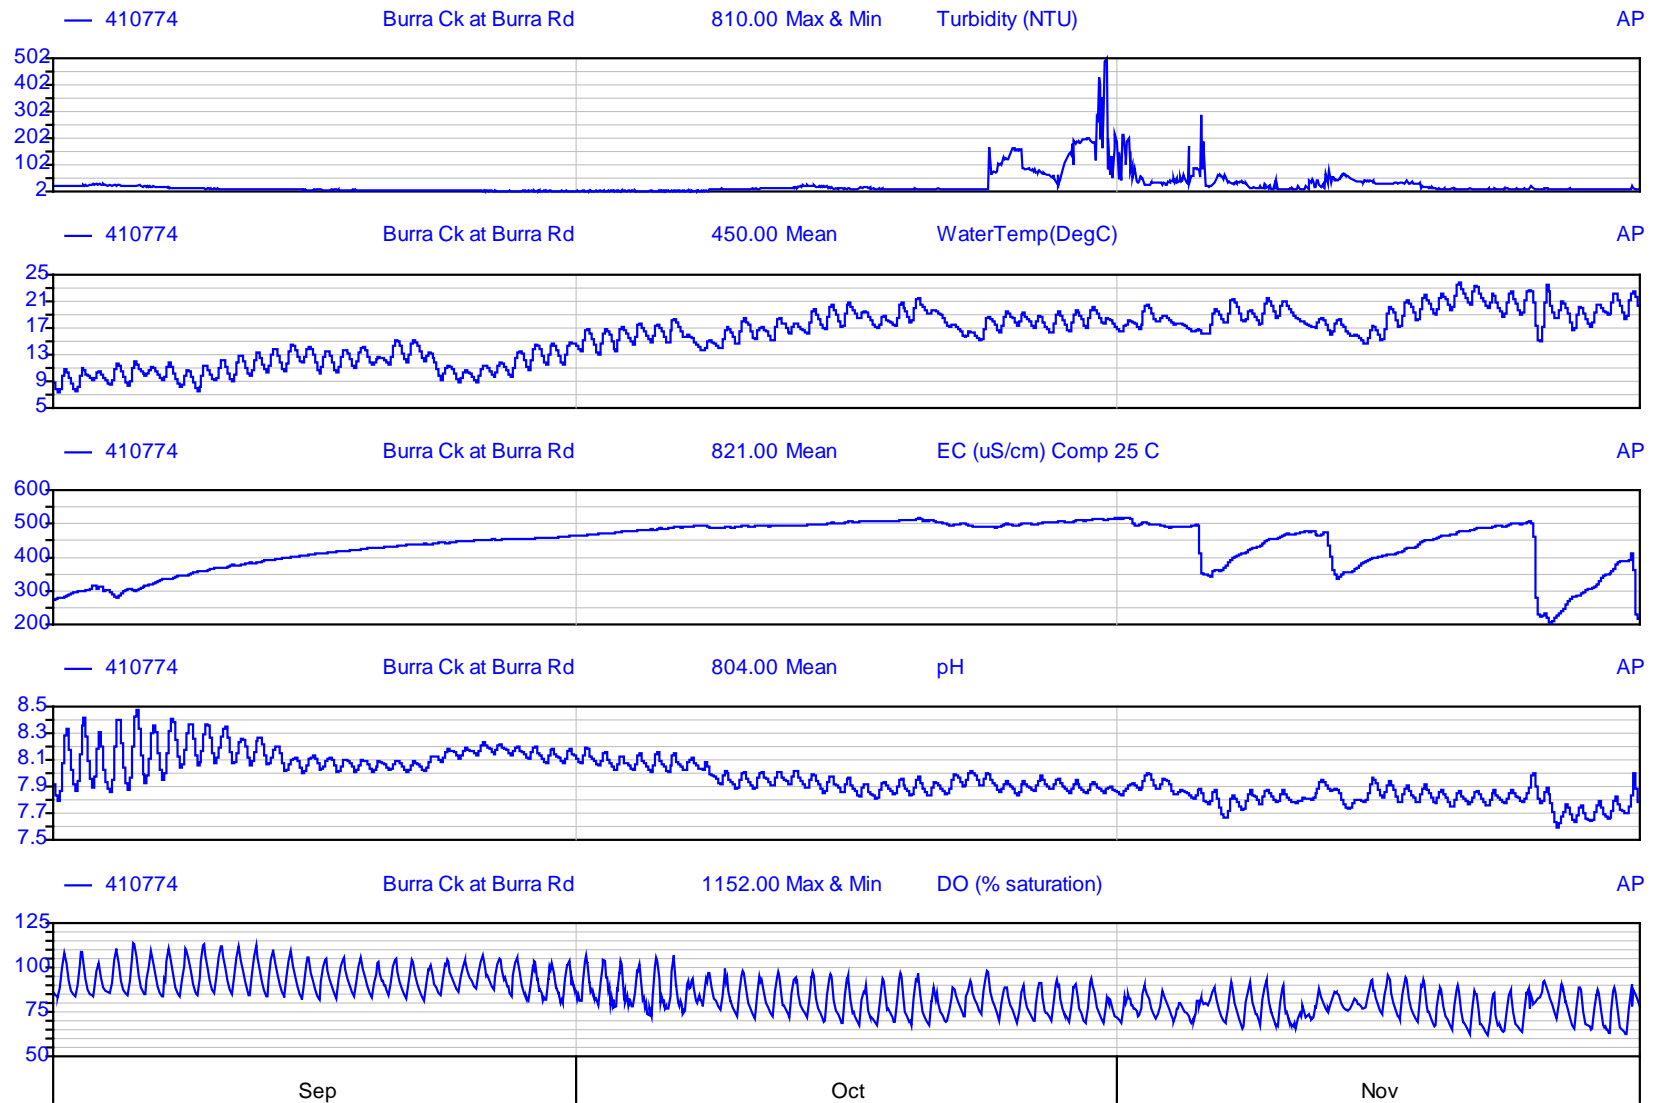
Figure 4-4. Continuous water quality records from Burra Creek (410774) during spring 2015

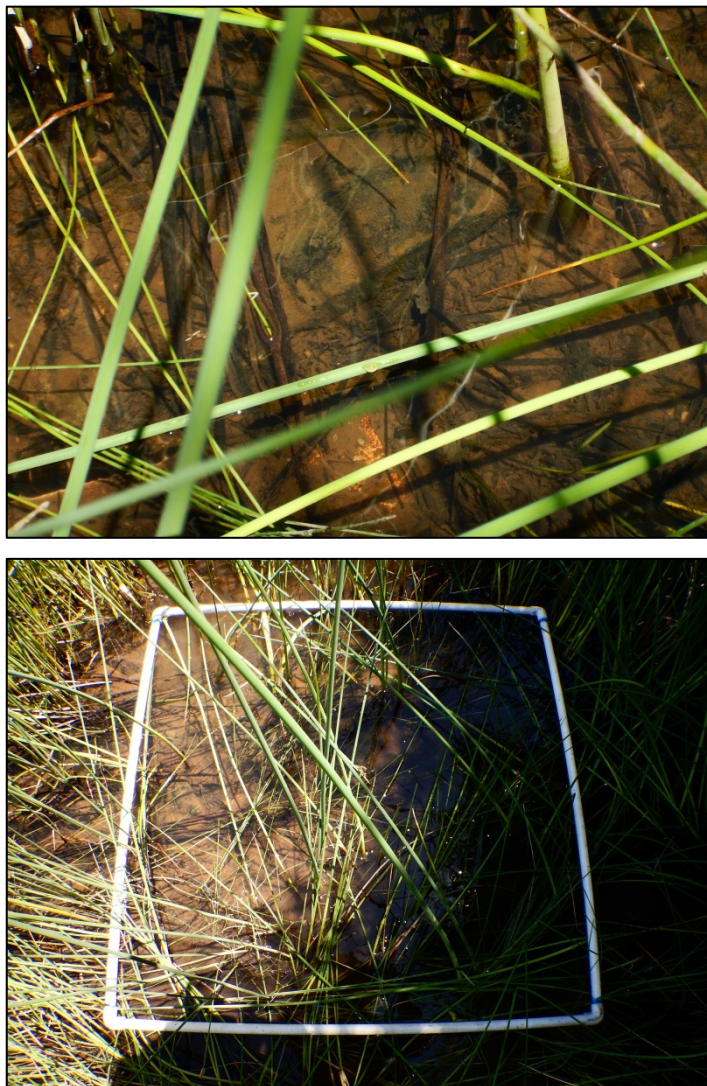
Plate 4-2. Periphyton coverage at BUR 1c

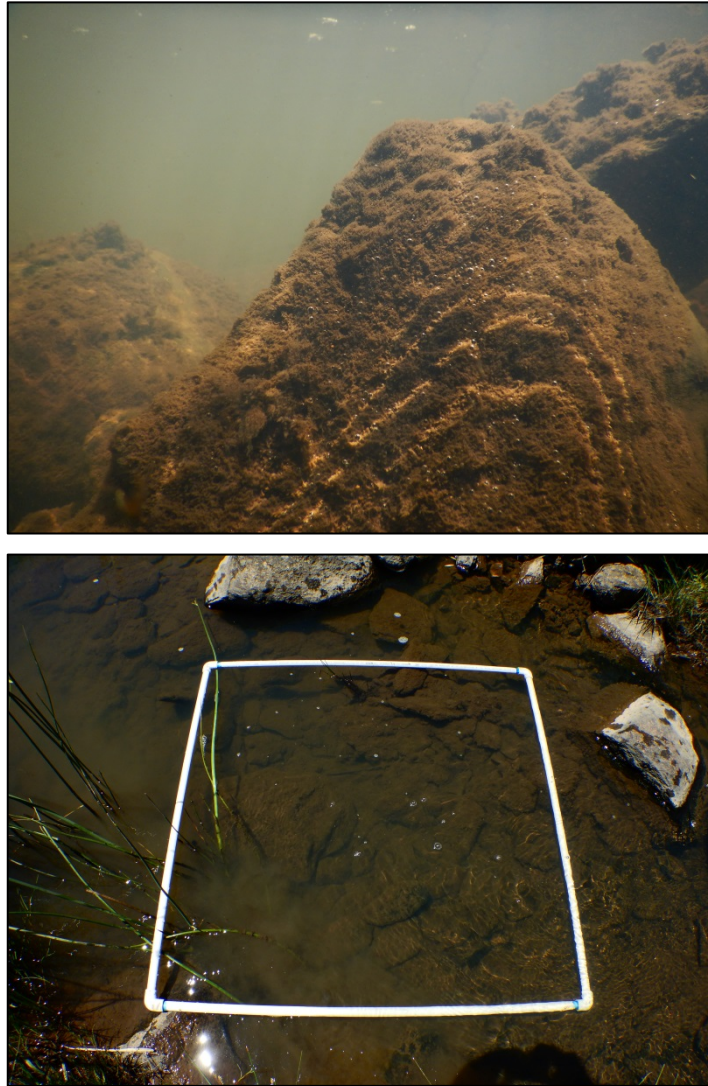
Plate 4-3. Periphyton coverage at BUR 2a

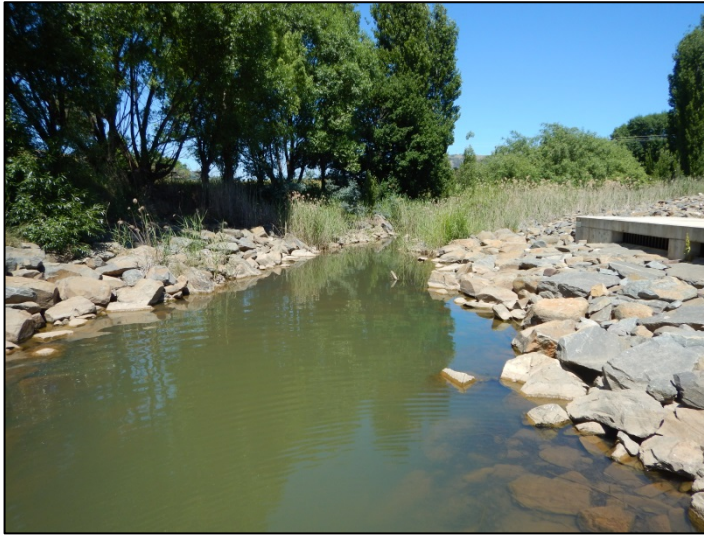
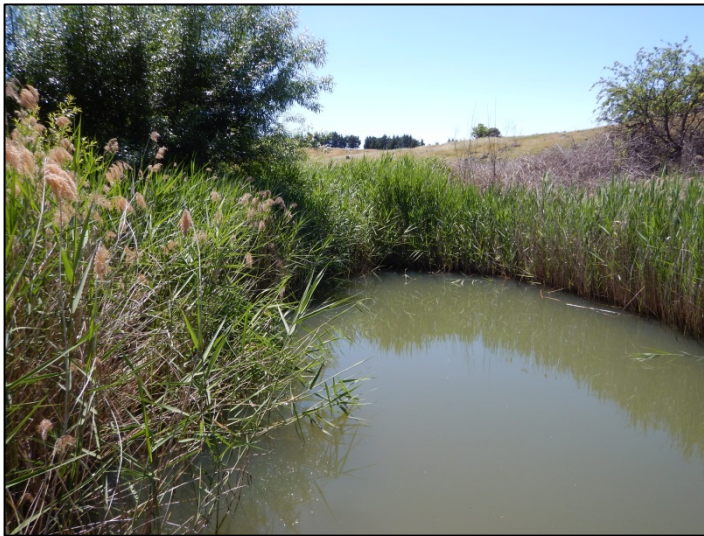
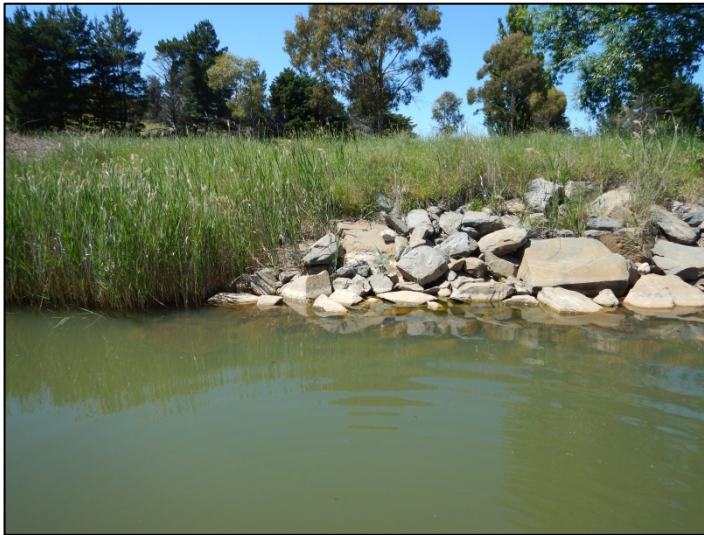
Plate 4-5. Vegetation extent photo point 2 at BUR 2 showing upstream (a), downstream (b) and across the channel (c)

There are a number of trees present at BUR 2. The large *Populus* sp. (Poplar) located immediately downstream of the causeway and a couple of young *Populus* sp. (approx. 3m tall) across the site were all displaying new growth from the spring period. There were high levels of macrophyte growth across the site, where *Phragmites australis* (Common Reed) was dominant throughout. There were large stands both upstream and downstream of the Williamsdale Road causeway, as can be seen in all of the photo points. Four vegetation photo points were collected at BUR 2 in spring 2015 and are presented in Plate 4-4 through to Plate 4-7.

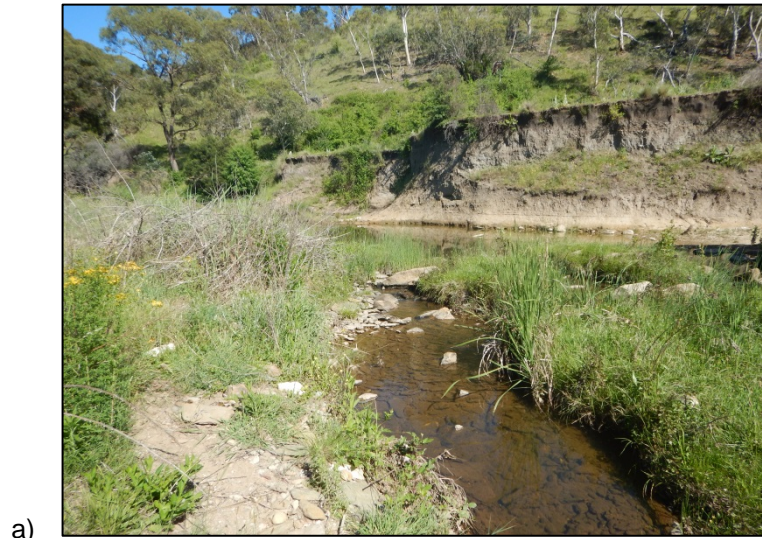
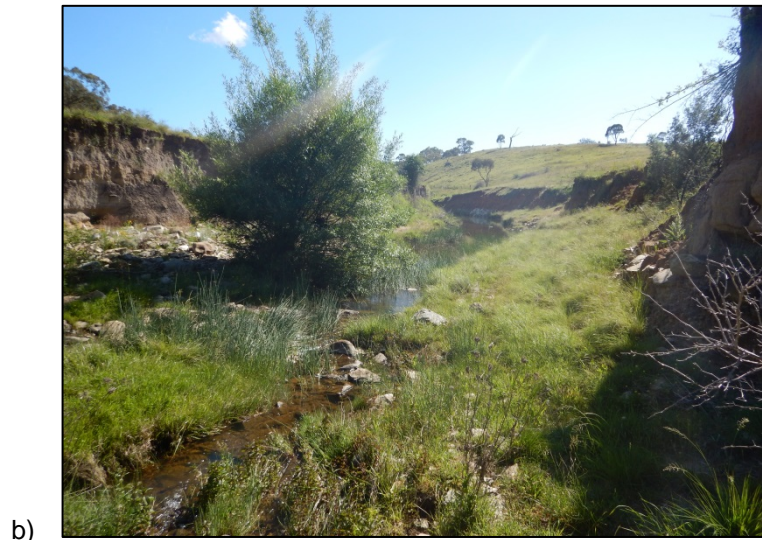
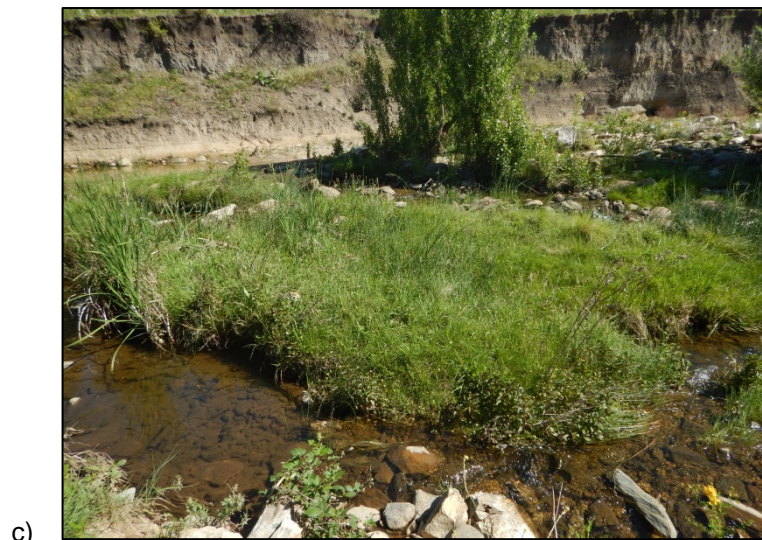
Plate 4-8. Vegetation extent photo point 1 downstream of pool 29 showing upstream (a), downstream (b) and across the channel (c)

The site downstream of Pool 29 has few large vegetated areas to provide shade. Three trees were present at the site, a native *Acacia dealbata* (Silver Wattle) on the right bank and introduced *Populus* sp. (Poplar) and *Salix* sp. (Willow) on the left bank. There are a considerable number of juvenile *Populus* sp. on the vegetated laterally attached bar on the left bank, approximately 30-40 cm high. The large vegetated bank-attached point bar on the right bank is dominated by weeds with dense patches of *Rubus fruticosus* (Blackberry) along the water's edge, and other common weeds across the bar including *Hypericum perforatum* (St. John's Wort), *Conyza* sp. (Fleabane), *Verbascum* sp. (Mullein) and various thistles. There is also considerable coverage by grasses, including native *Poa* spp. and introduced *Phalaris* sp. (Canary Grass) and *Paspalum dilatatum* (Caterpillar Grass), throughout the macro channel. Aquatic macrophytes showed significant growth within the reach with *Mentha x piperita* var. 'piperita' (Peppermint) common throughout the shallow riffle zone and small infrequent stands of *Typha orientalis* (Broad leaf Cumbungi) across the reach. *Schoenoplectus validus* (Great Bulrush) was common along the edges of the channel lining most of the creek. Three vegetation photo points were collected at the site downstream of Pool 29 during spring 2015 and are presented in Plate 4-8 through to Plate 4-10.

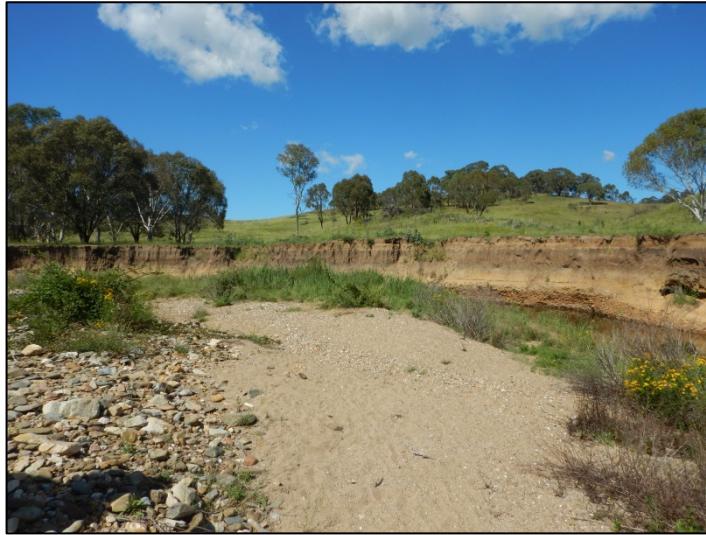
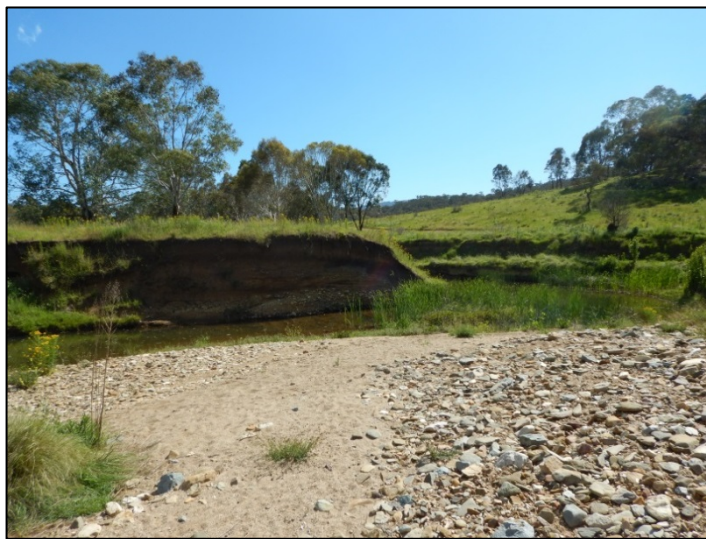
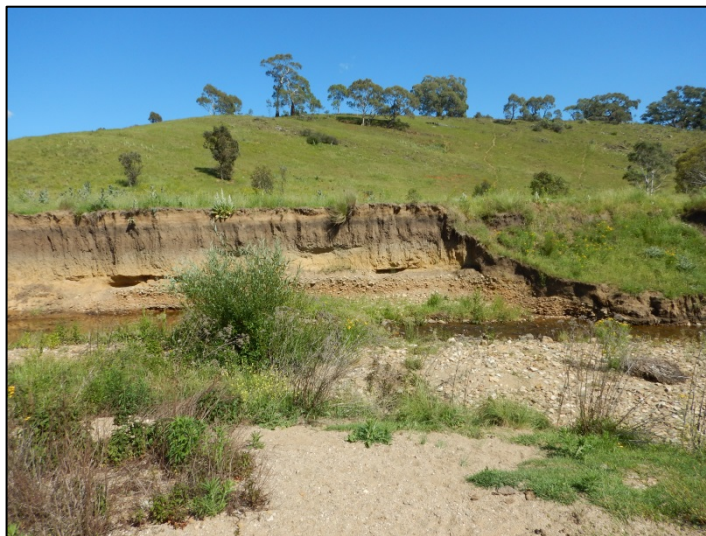
Plate 4-12. Vegetation extent photo point 2 at BUR 2c showing upstream (a), downstream (b) and across the channel (c)

While BUR 2c is surrounded by numerous large *Eucalyptus* spp. on the floodplain, there is minimal vegetation close to the creek to provide shading. Within the macro channel there are large sections covered by grasses, mostly *Poa* spp., while weeds such as *Verbascum* sp. (Mullein), *Hypericum perforatum* (St. John's Wort), *Rubus fruticosus* (Blackberry) and various thistle species are also frequent. Several small *Populus* sp. (Poplar) and *Salix* sp. (Willow) are present within the macro channel while two larger *Populus* sp. (approximately 3-4 m tall) are the largest vegetation within the channel. Instream vegetation is dominated by *Typha orientalis* (Broad leaf Cumbungi) with numerous large stands visible from all photo points, while *Schoenoplectus validus* (Great Bulrush) is also present in smaller patches. Four vegetation photo points were collected at BUR 2c during spring 2015 and are presented in Plate 4-11 through to Plate 4-14.

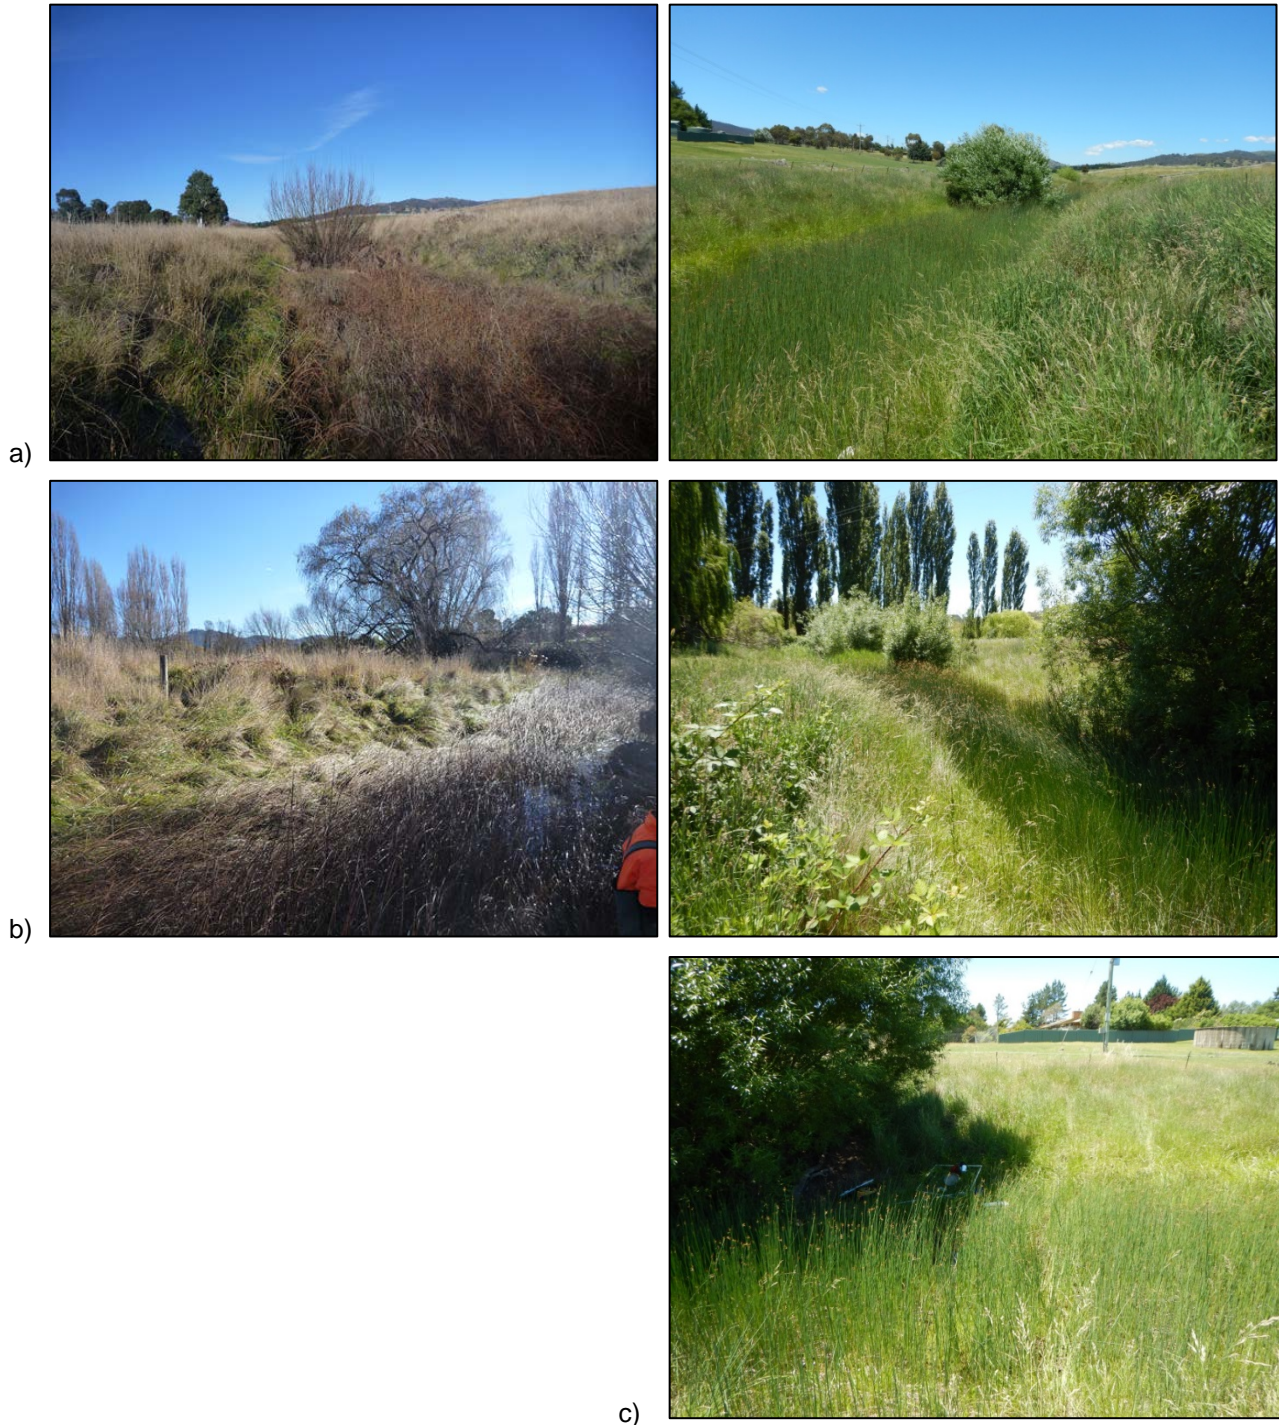
Plate 4-19. Geomorphology photo point 2 at BUR 1c showing upstream (a), downstream (b) and across the channel (c) during autumn 2015 (left) and spring 2015 (right)

Note: No autumn 2015 across channel photo is available.

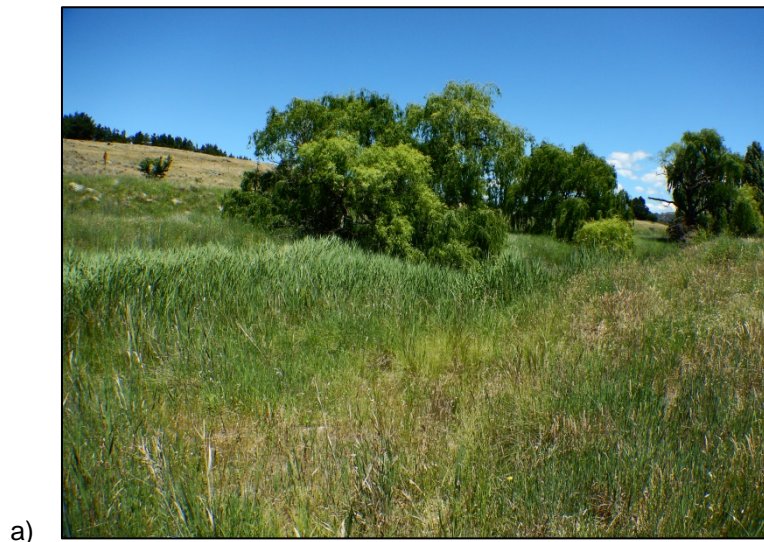
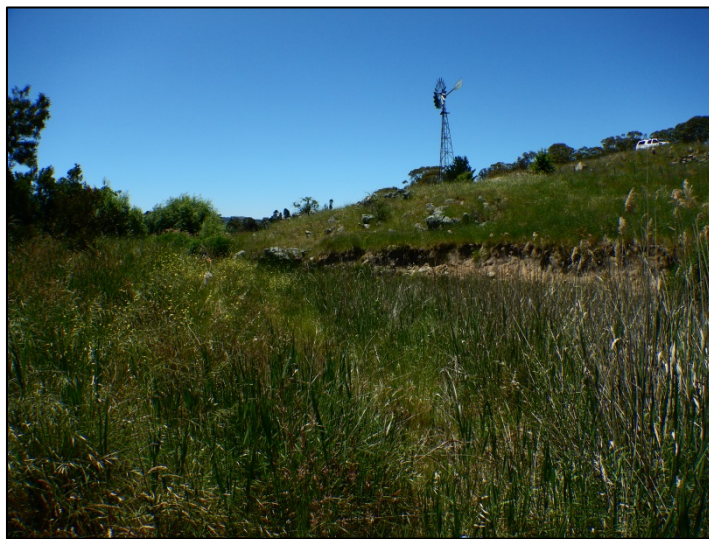
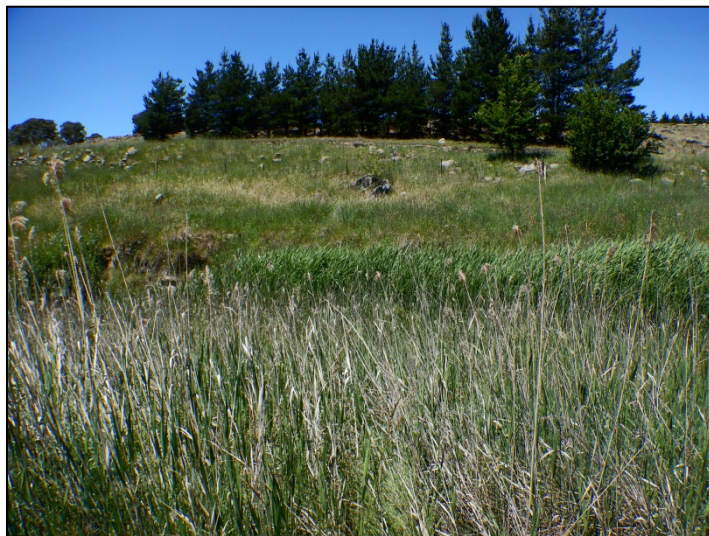
Plate 4-24. Geomorphology photo point 1 at BUR 2a showing upstream (a), downstream (b) and across the channel (c) during spring 2015

Note: This is the first time this photo point has been collected, so no autumn 2015 comparison photos are available.

Consistent with previous monitoring (GHD, 2015c) the steep right bank at BUR 2a has shown no signs of erosion. Similar to BUR 1c, this reach is a depositional zone with blanketing silt across all habitats. Four photo points were collected at BUR 2a during spring 2015 and are presented in Plate 4-24 through to Plate 4-27.

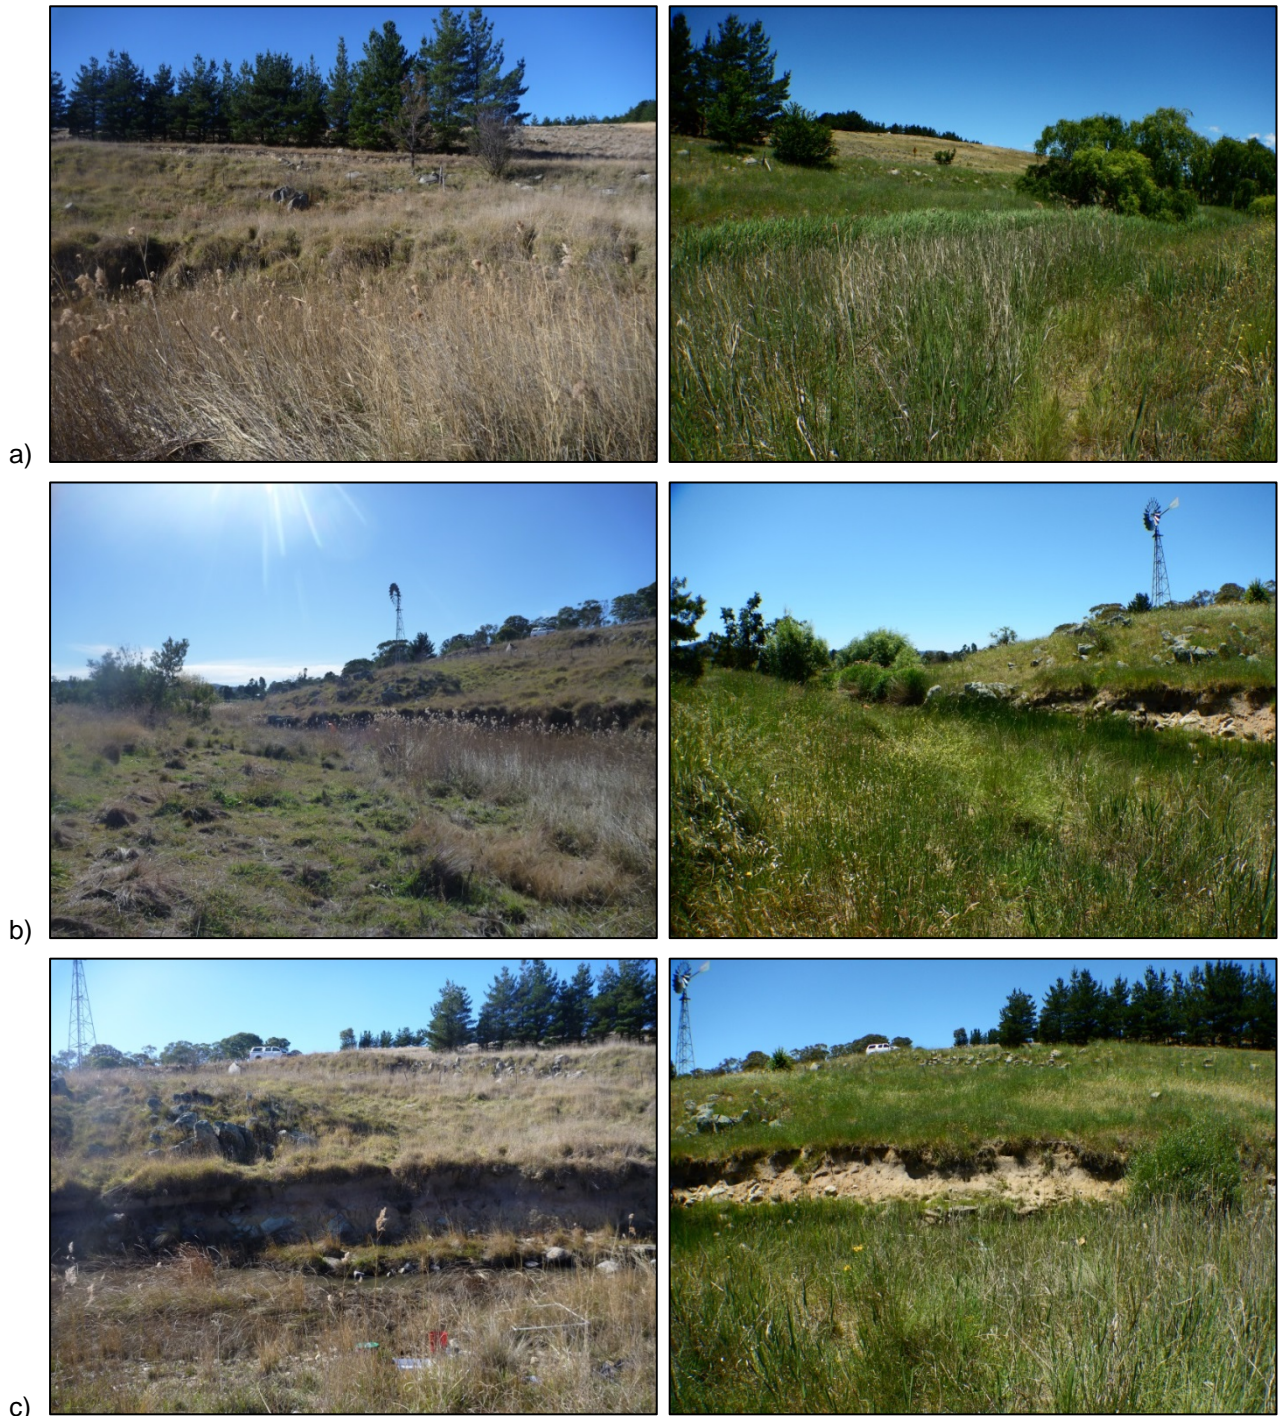
Plate 4-25. Geomorphology photo point 2 at BUR 2a showing upstream (a), downstream (b) and across the channel (c) during spring 2015

Note: This is the first time this photo point has been captured, so no autumn 2015 comparison photos are available.

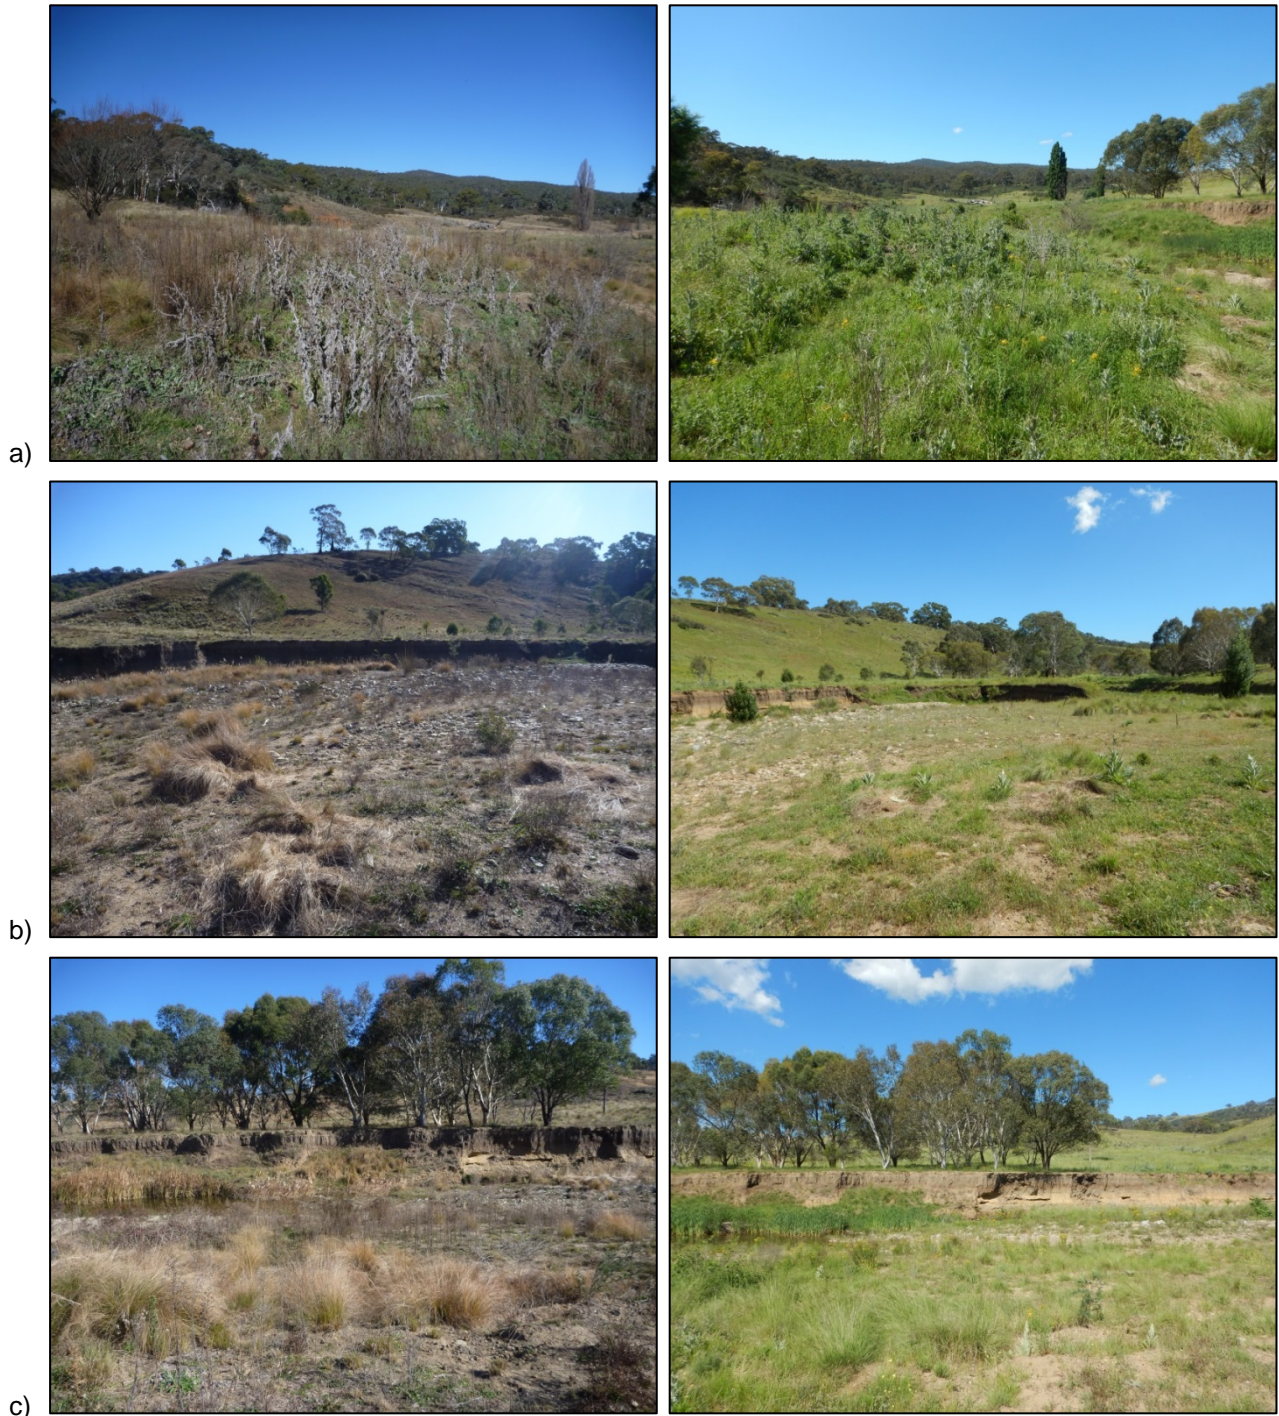
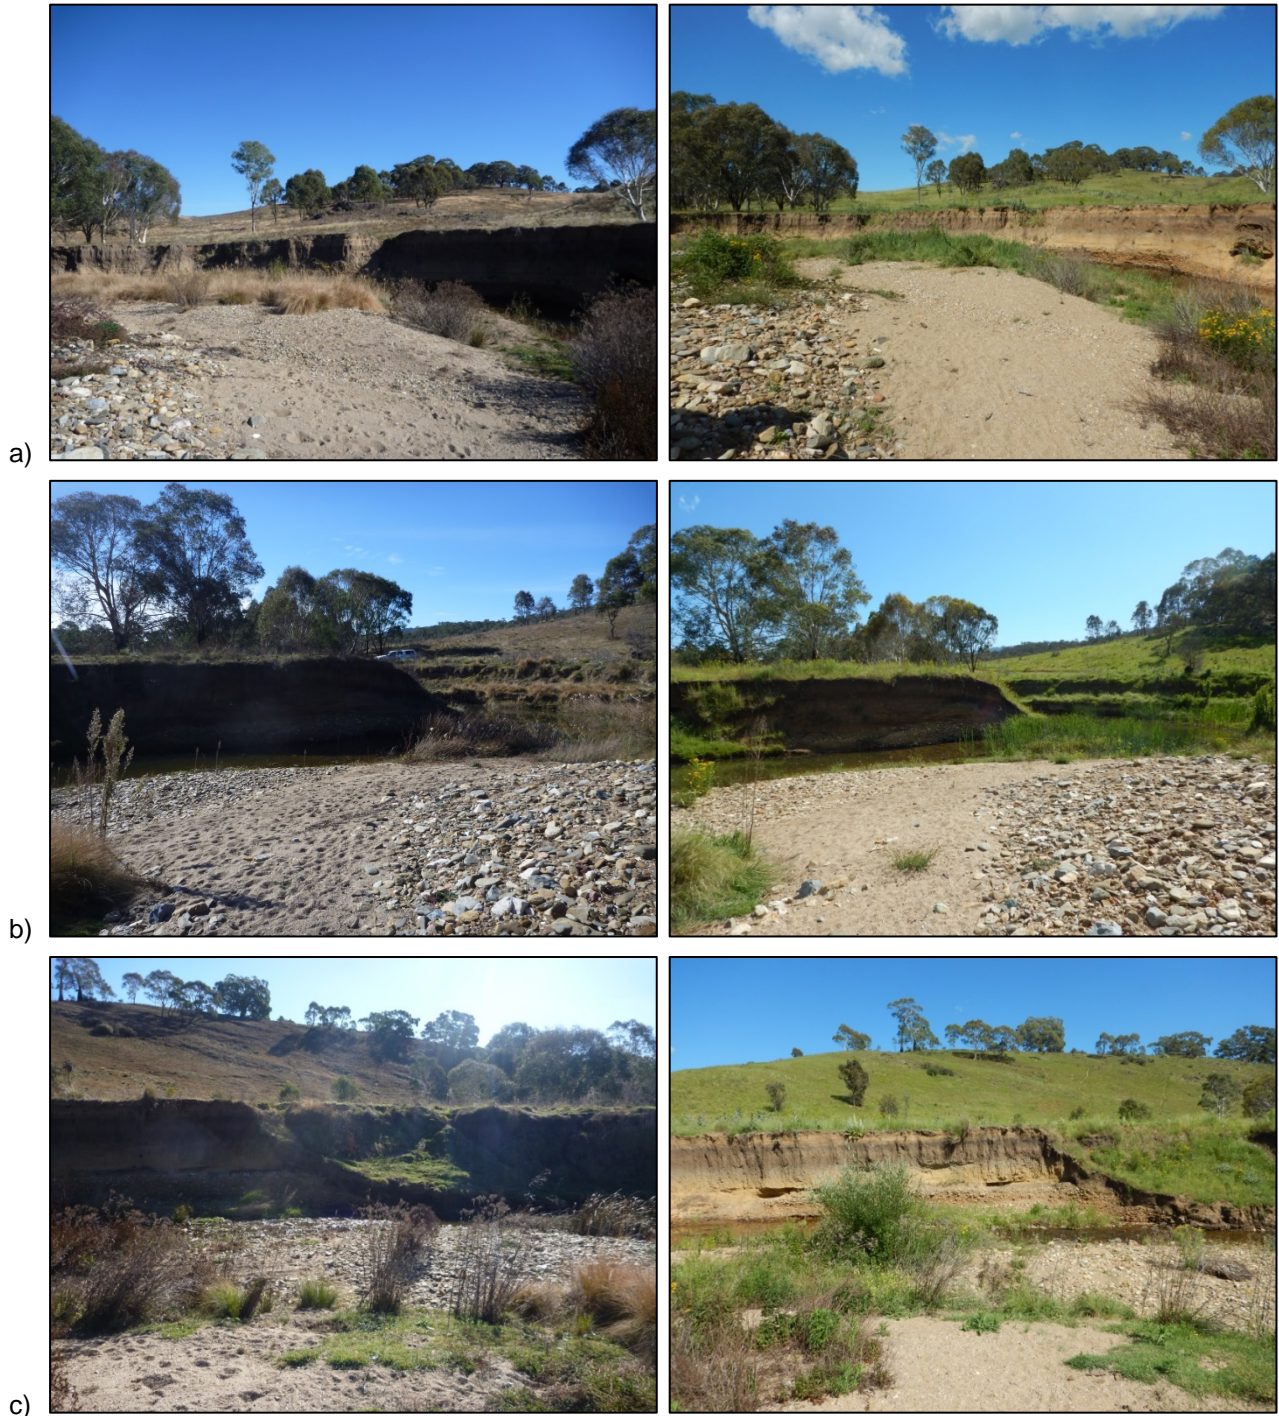
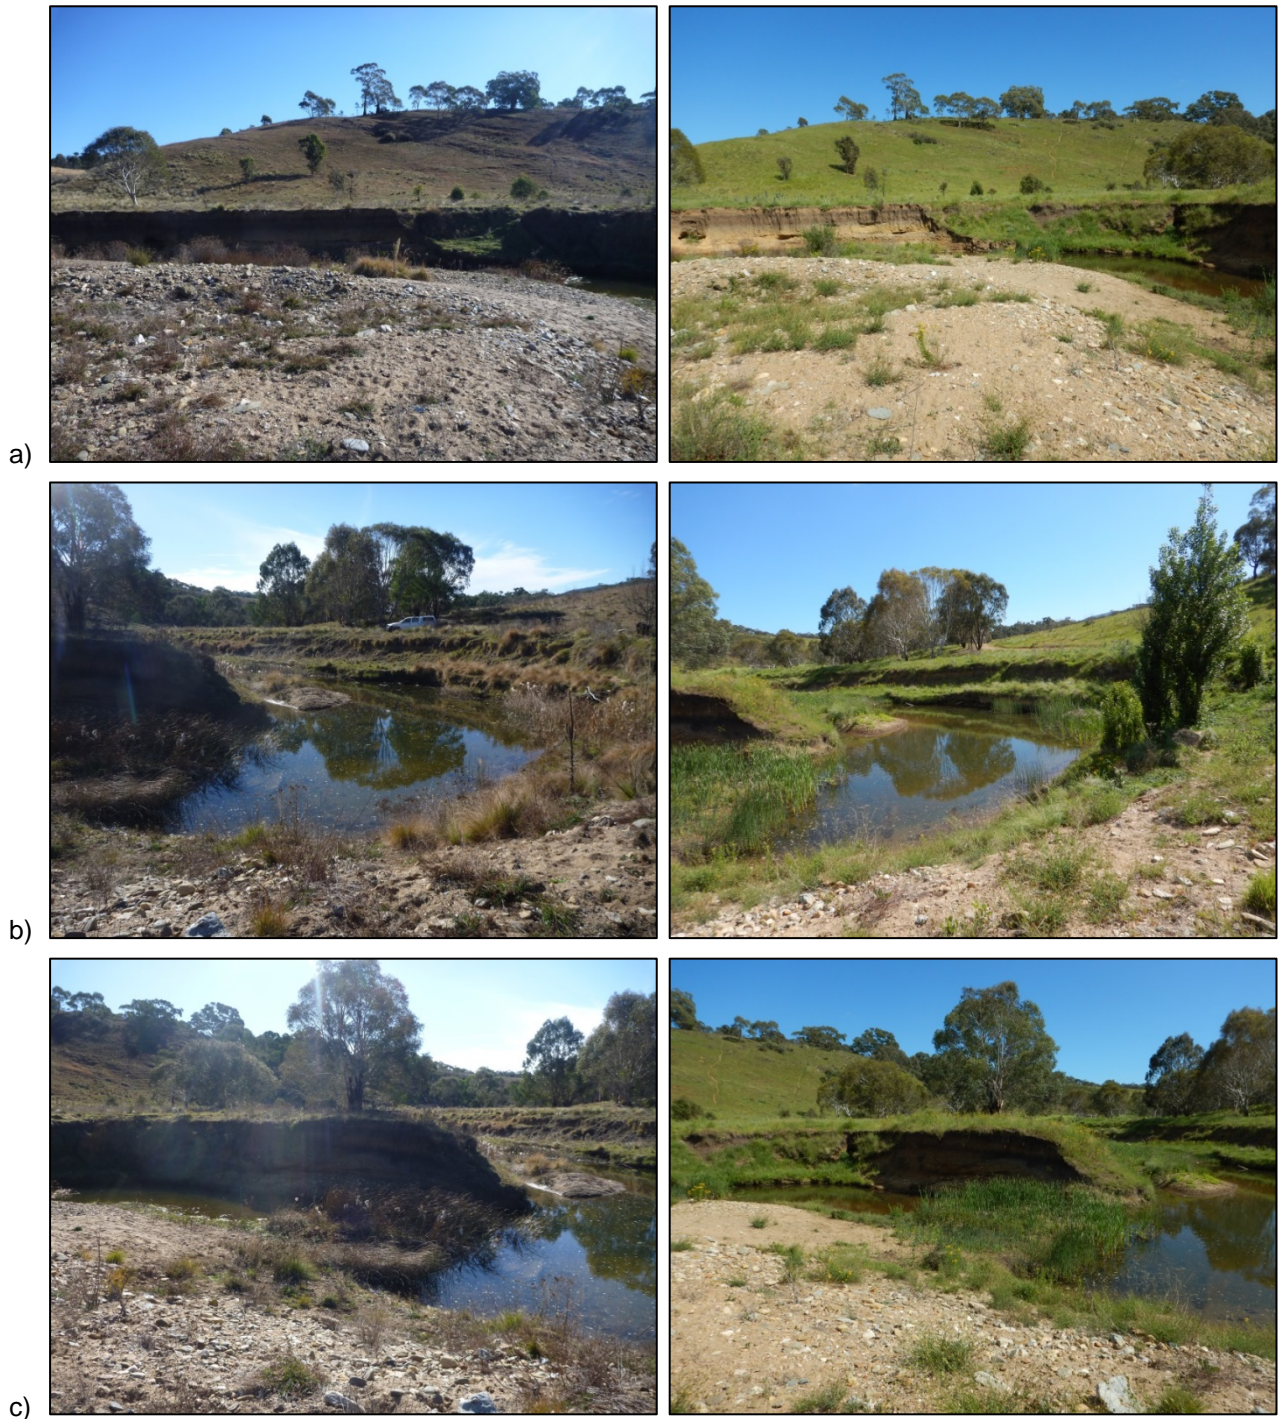
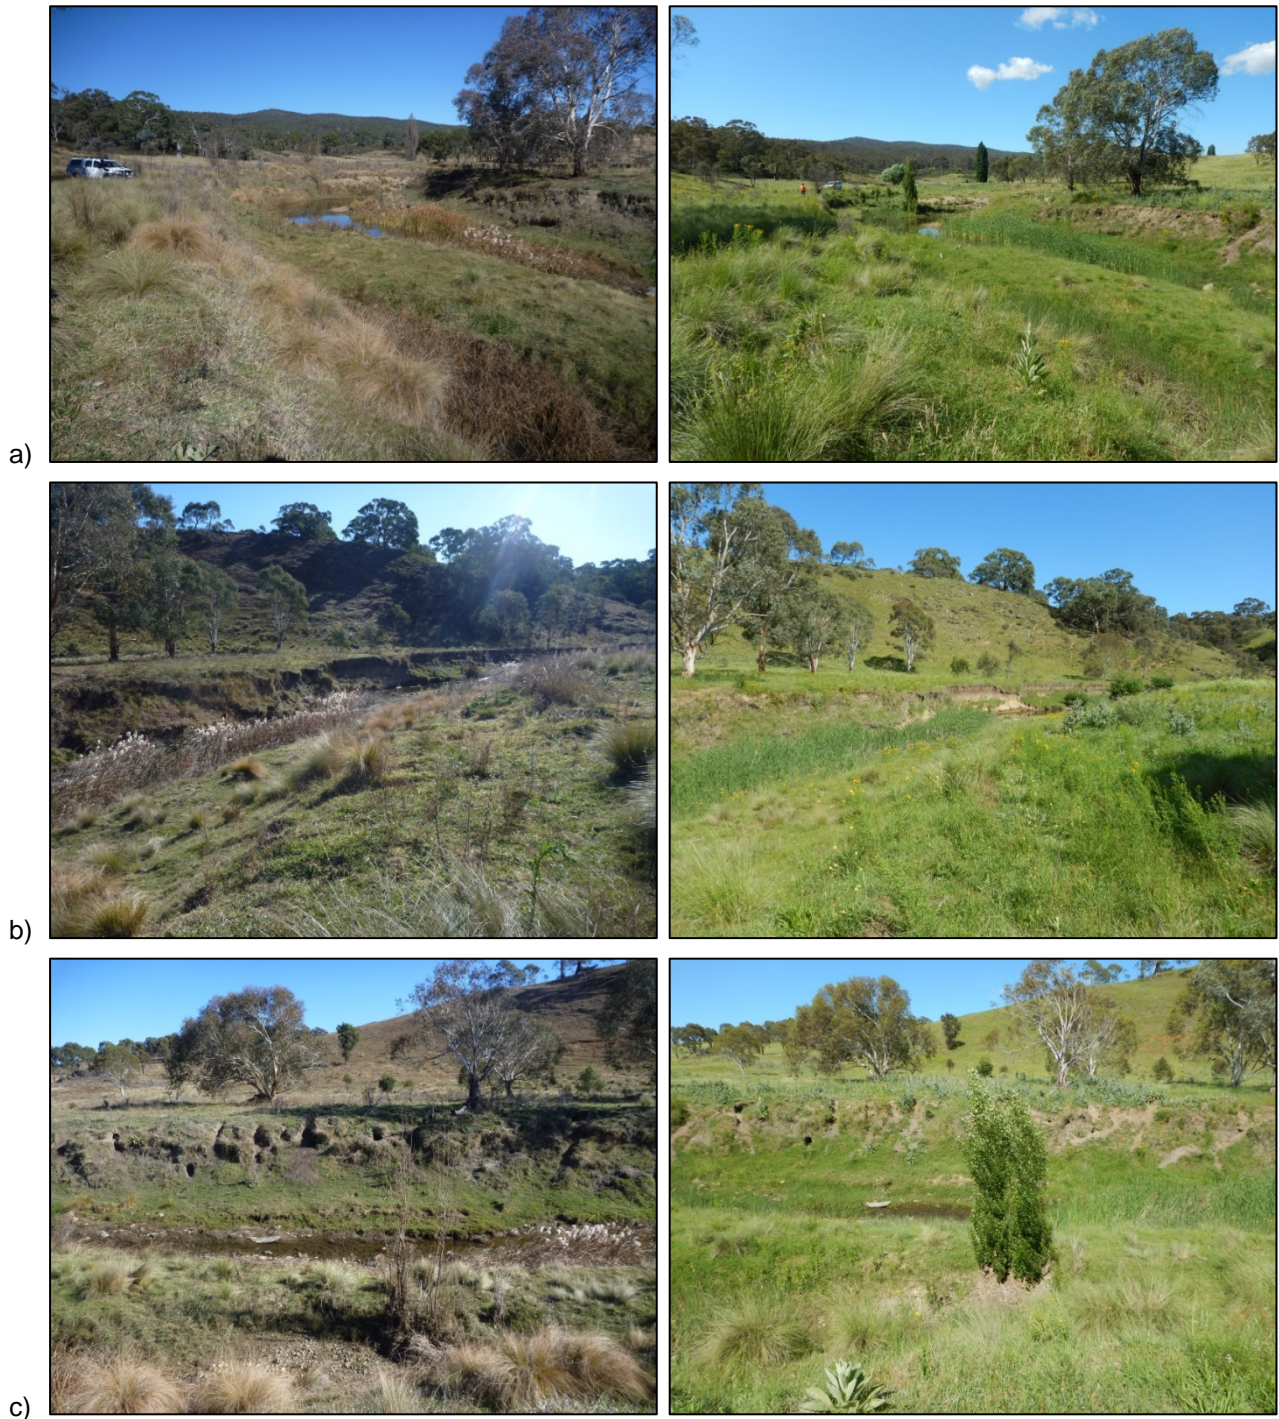
Plate 4-31. Geomorphology photo point 1 at BUR 2c showing upstream (a), downstream (b) and across the channel (c) during autumn 2015 (left) and spring 2015 (right)

Plate 4-32. Geomorphology photo point 2 at BUR 2c showing upstream (a), downstream (b) and across the channel (c) during autumn 2015 (left) and spring 2015 (right)

Plate 4-33. Geomorphology photo point 3 at BUR 2c showing upstream (a), downstream (b) and across the channel (c) during autumn 2015 (left) and spring 2015 (right)

Plate 4-34. Geomorphology photo point 4 at BUR 2c showing upstream (a), downstream (b) and across the channel (c) during autumn 2015 (left) and spring 2015 (right)

The only additional recommendation to those put forward in autumn 2015 (GHD, 2015e) is to install erosion pins at BUR 2c. In light of the recent bank movement at this site, it would be seen as a complimentary, quantitative method to determine actual rates of decline from this bank. Moreover, using this technique, measurements would be able to be made before and after natural events and before and after APPLE maintenance runs to isolate movement associated with those natural events compared to movement associated with the aforementioned APPLE maintenance runs. This method is cost effective and has been successfully developed for use in other catchments in the ACT.

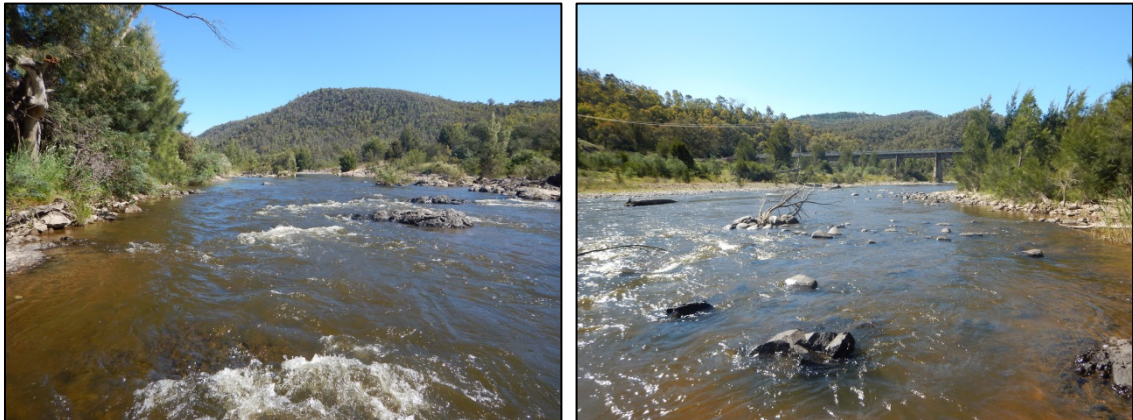
MUR 28: Looking upstream (left) and looking downstream (right)

Plate 5-1. Photographs of the Murrumbidgee Pump Station sites during spring 2015 sampling

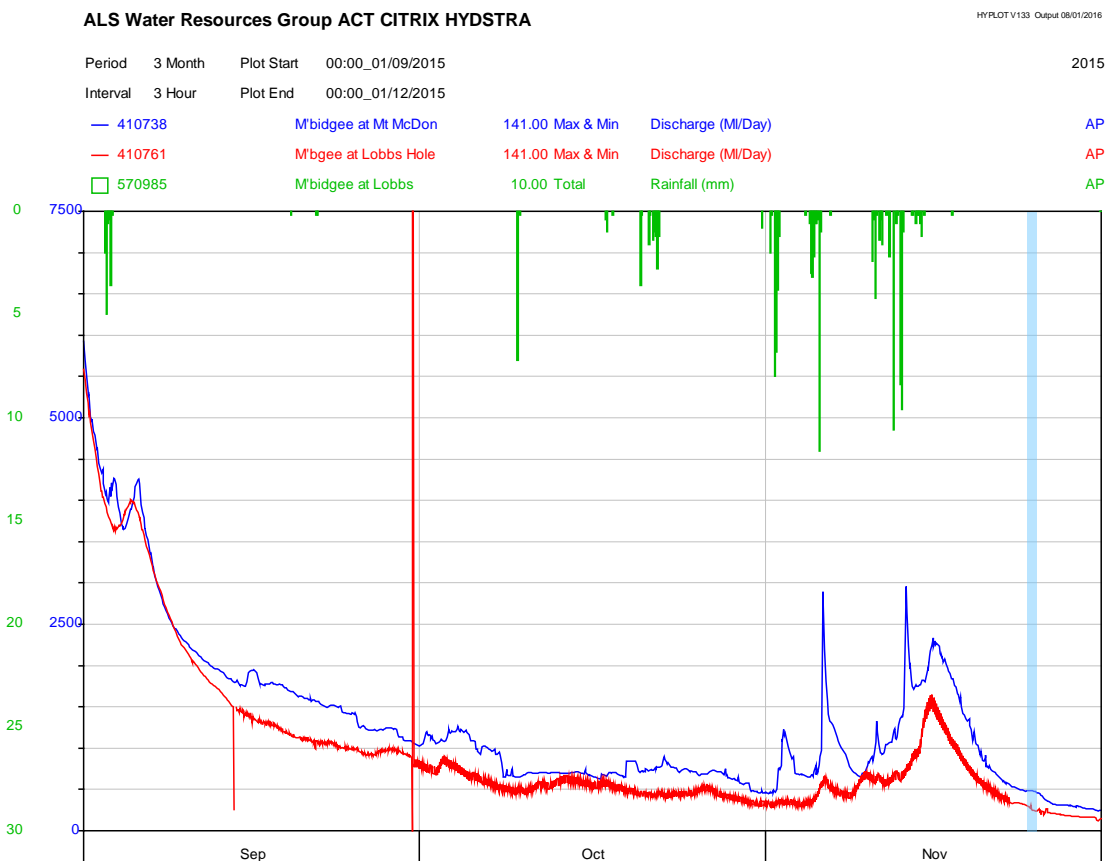
Figure 5-1. Autumn hydrograph of the Murrumbidgee River at Lobb's Hole (410761) and Mt. MacDonald (410738), including total rainfall for the Lobb's Hole gauge (570985) from spring 2015

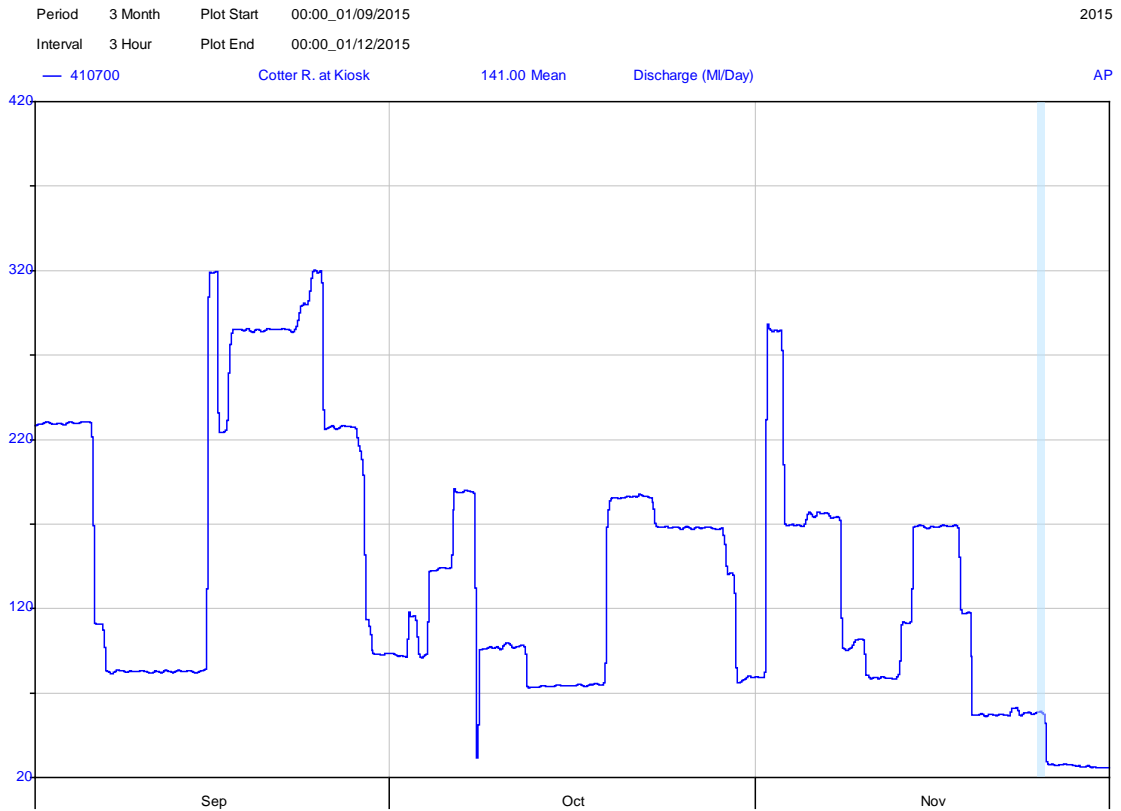
Figure 5-2. Hydrograph for the Cotter River downstream of the Cotter Dam (410700) for spring 2015
