Icon Water
Murrumbidgee Ecological Monitoring Programme
Sentinel Monitoring - Spring 2015

February 2016

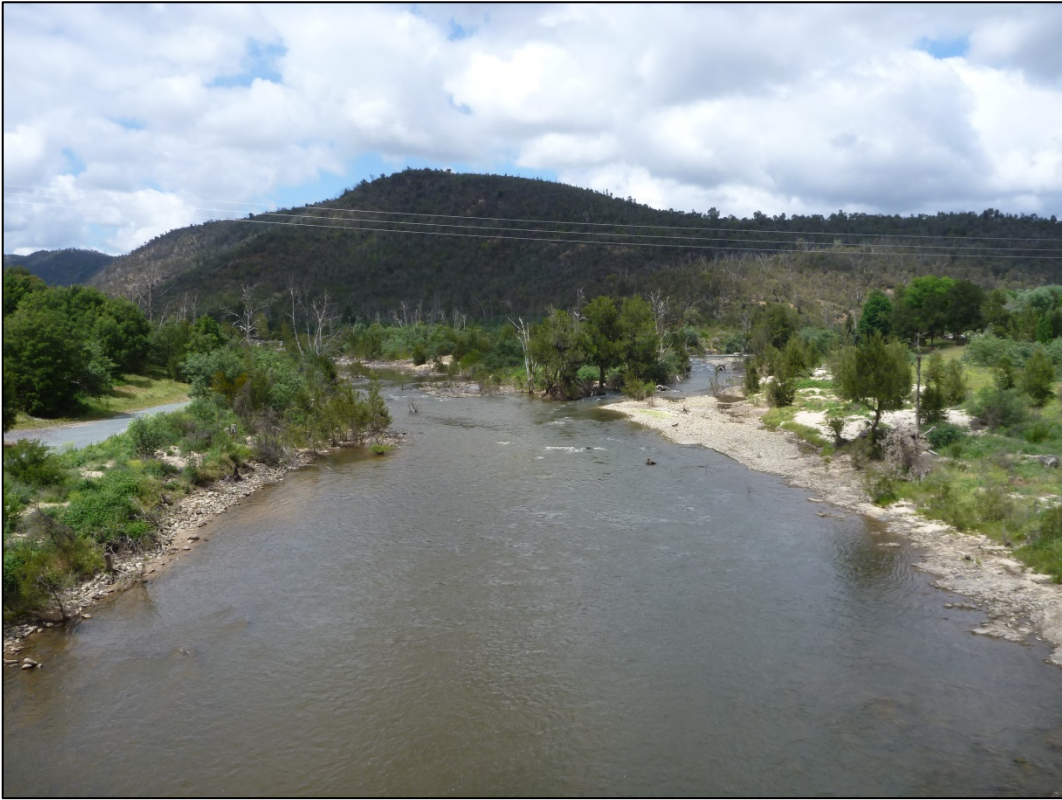
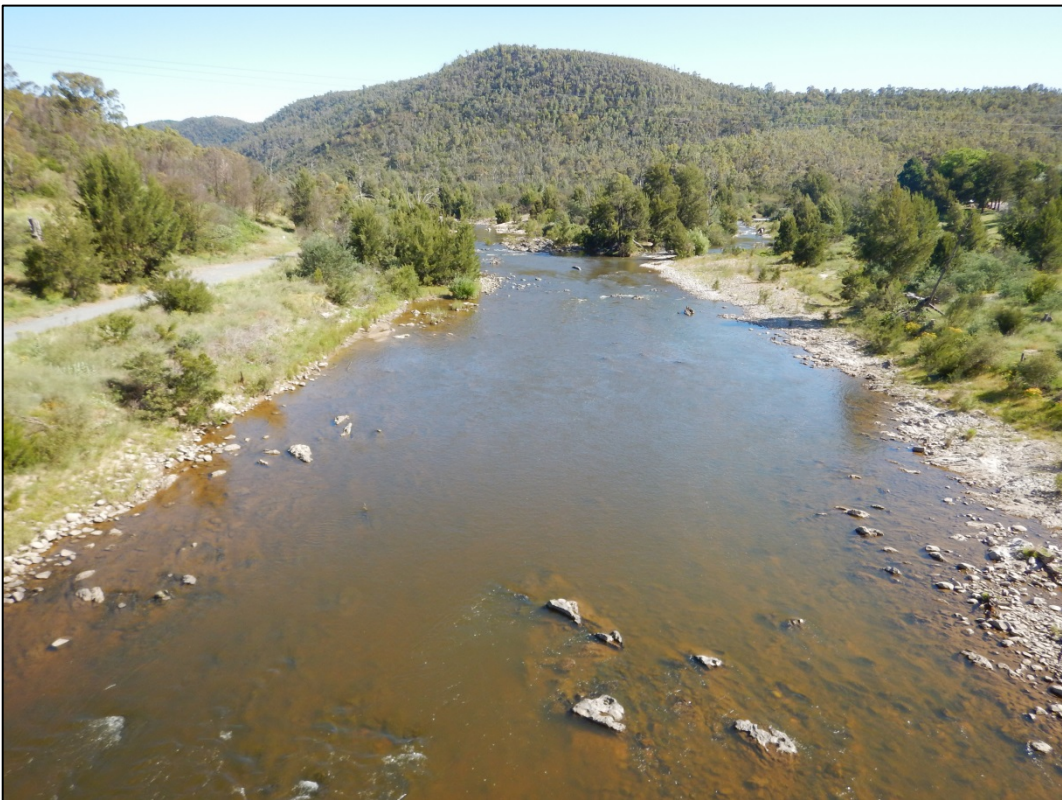
2012 – 1,200 ML/d (14/11/2012)

2015 – 470 ML/d (24/11/2015)

Plate 5-2. The Murrumbidgee River upstream of the Cotter Road bridge and the MPS in spring 2012 (top) and 2015 (bottom)

Note: Flow is mean daily flow recorded at Mt. MacDonald (410738)

Plate 5-2 and Plate 5-3 show the upstream and downstream views from the bridge at MPS, during spring 2015 sampling compared to the previous spring sampling period which occurred in 2012.

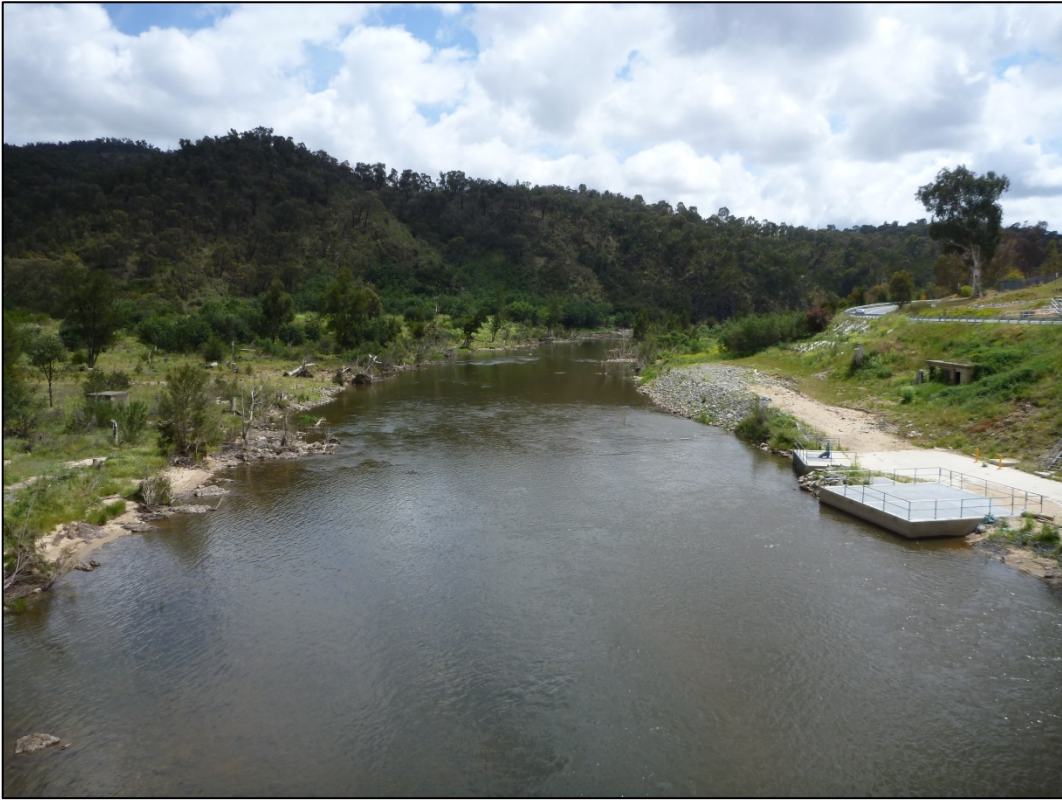
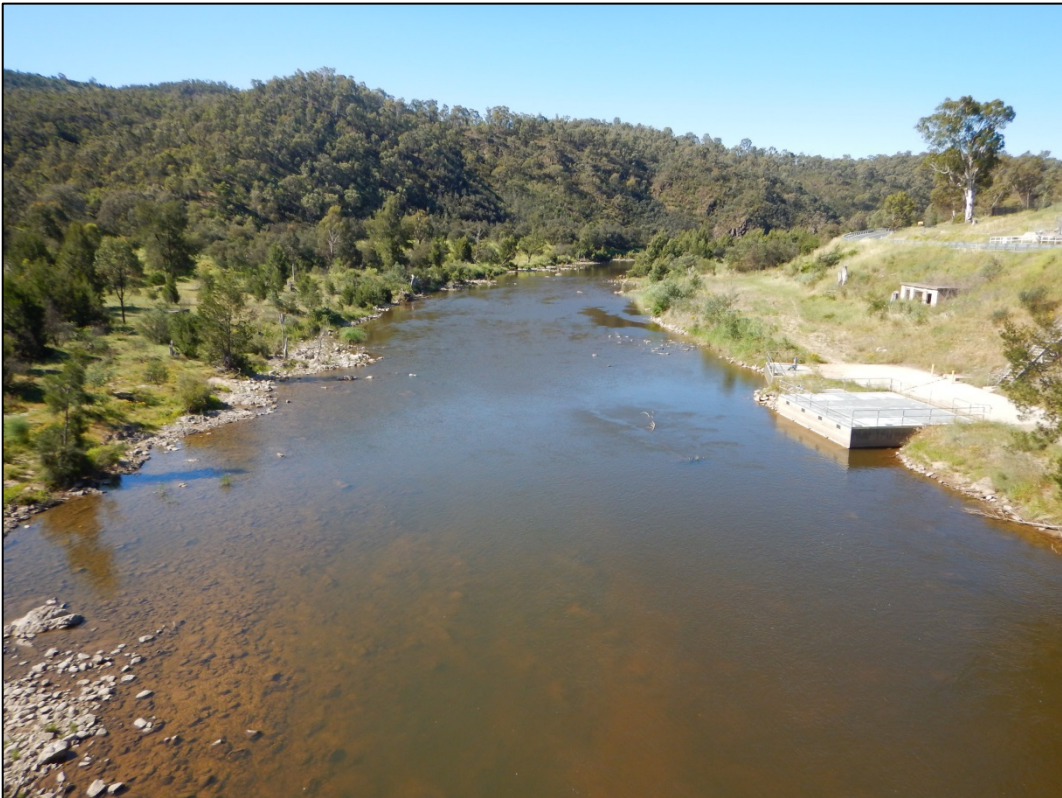
2012 – 1,200 ML/d (14/11/2012)

2015 – 470 ML/d (24/11/2015)

Plate 5-3. The Murrumbidgee River downstream of the Cotter Road bridge, MPS on the right bank, in spring 2012 (top) and 2015 (bottom)
