Icon Water

Murrumbidgee Ecological Monitoring Program Impact Monitoring - Autumn 2019 and Spring 2019

August 2020

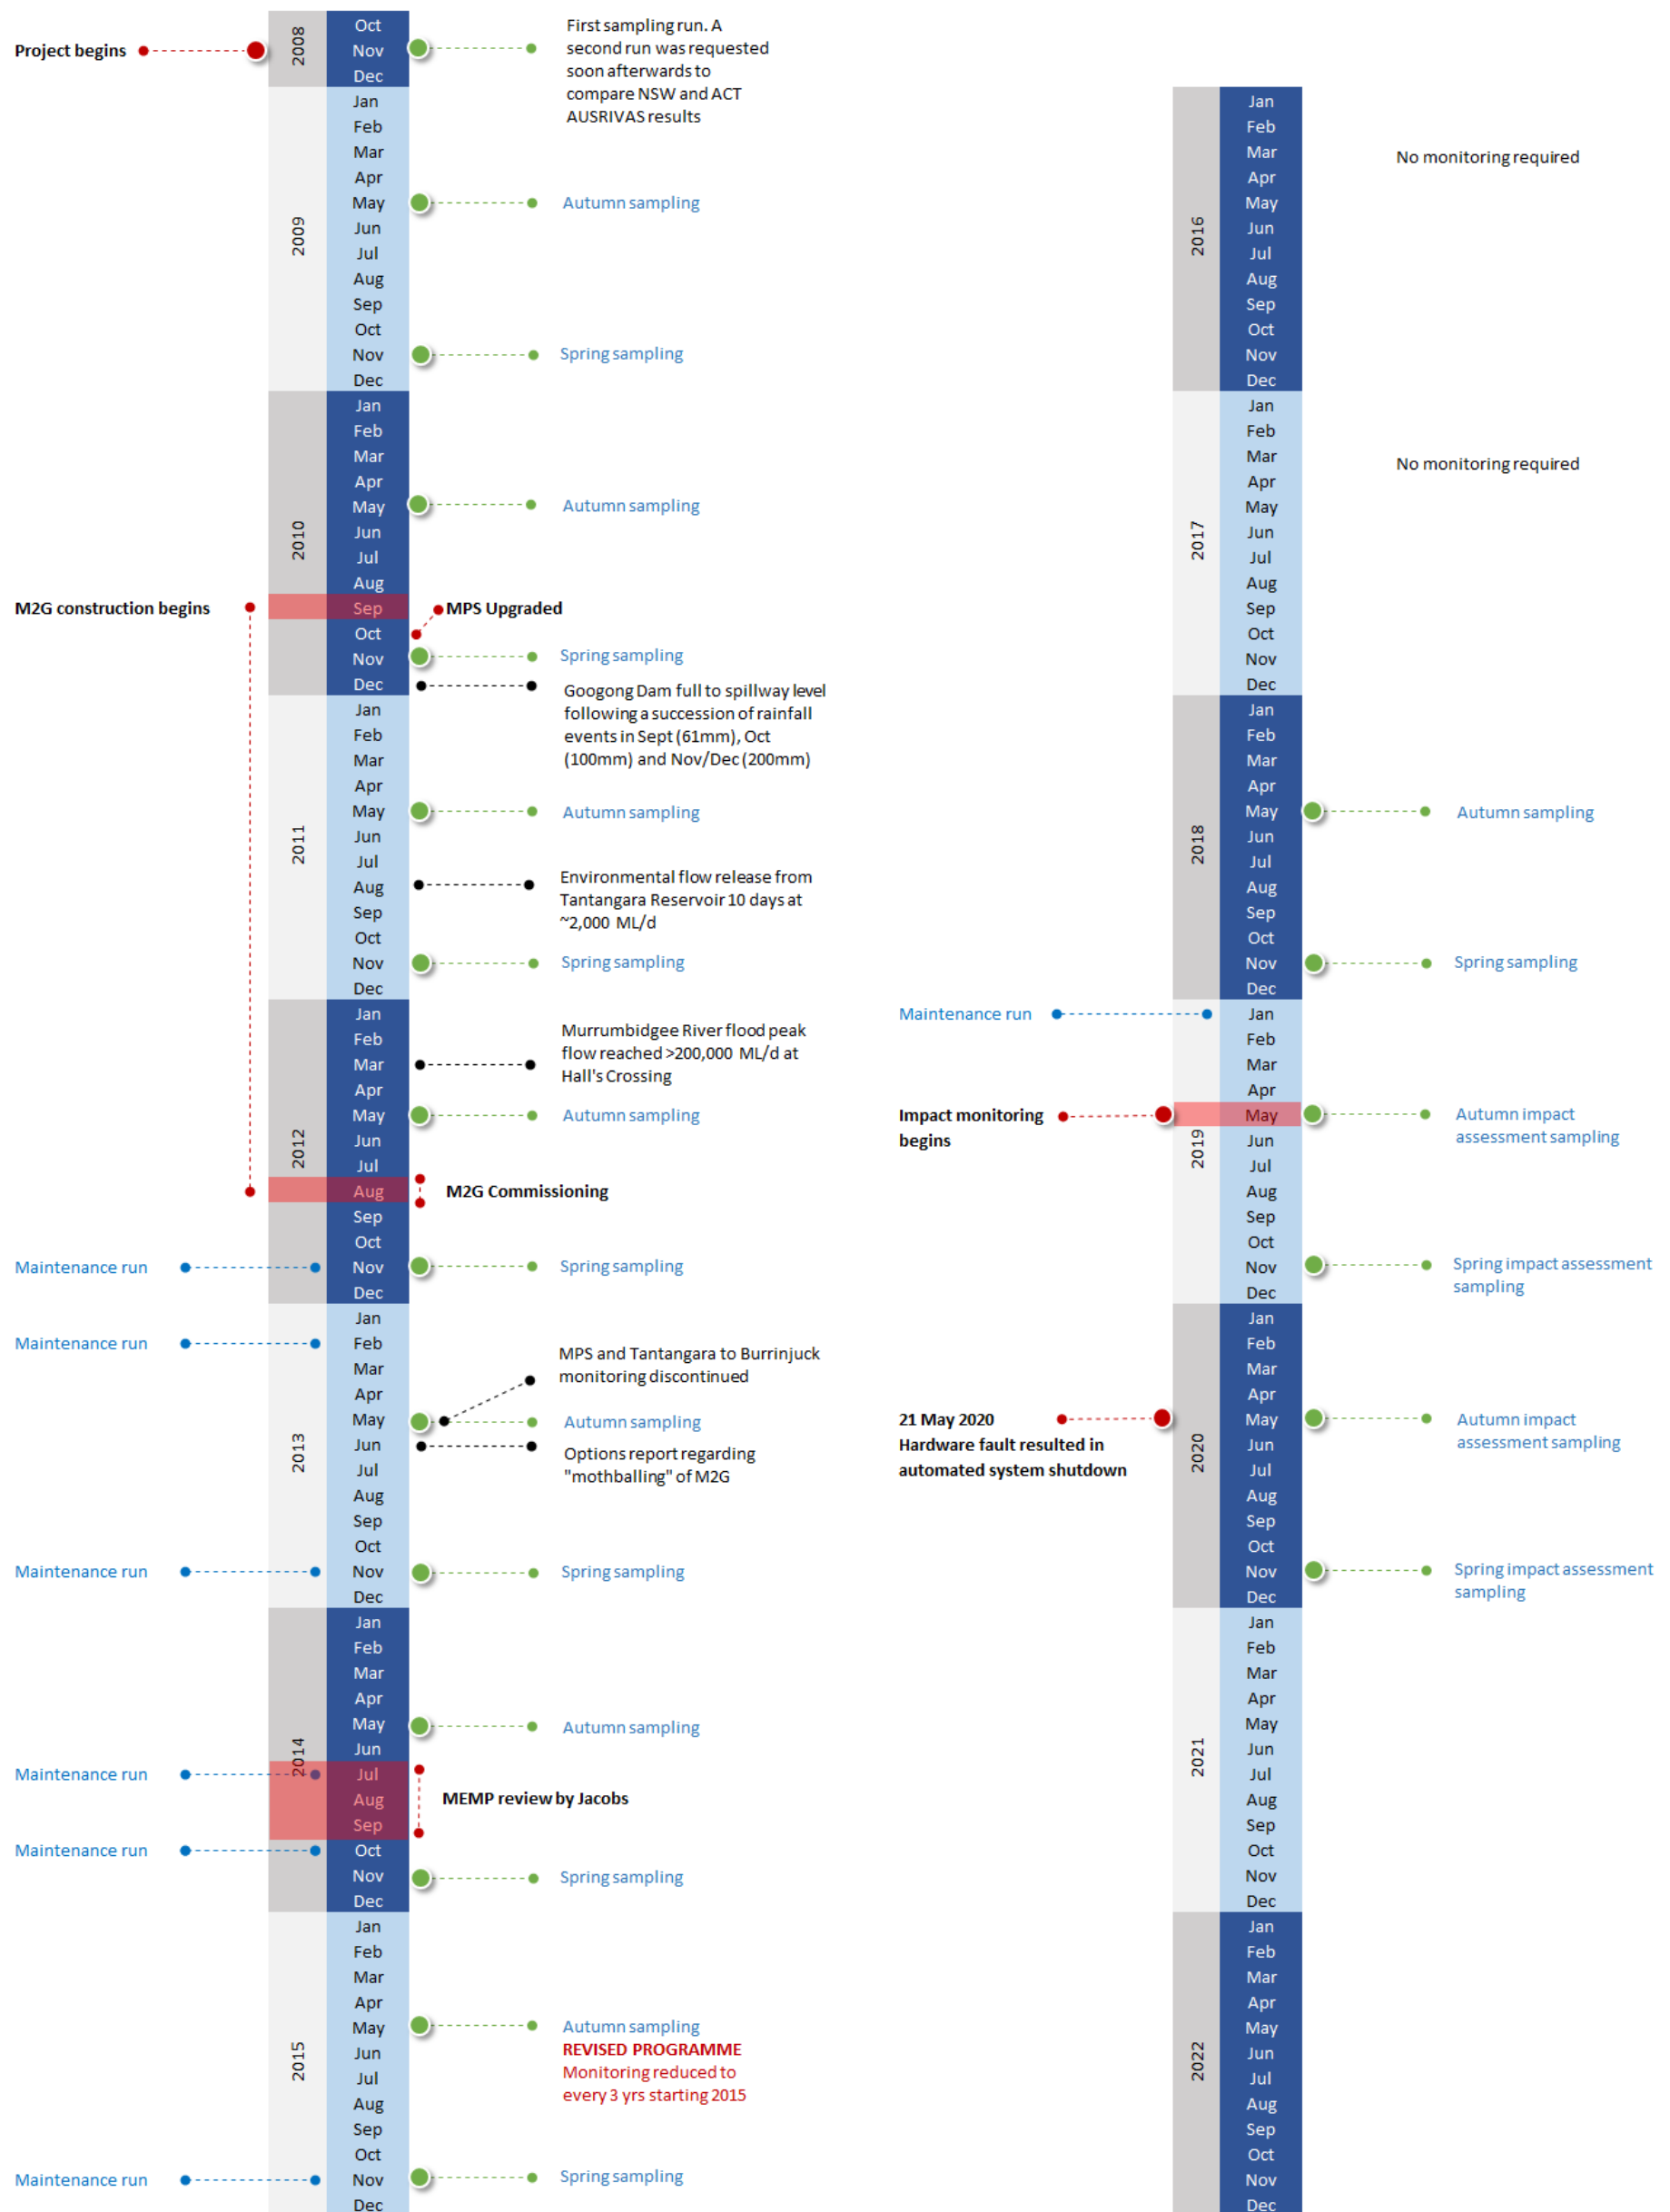
Figure 1-1. Schematic time line of the Murrumbidgee Ecological Monitoring Program

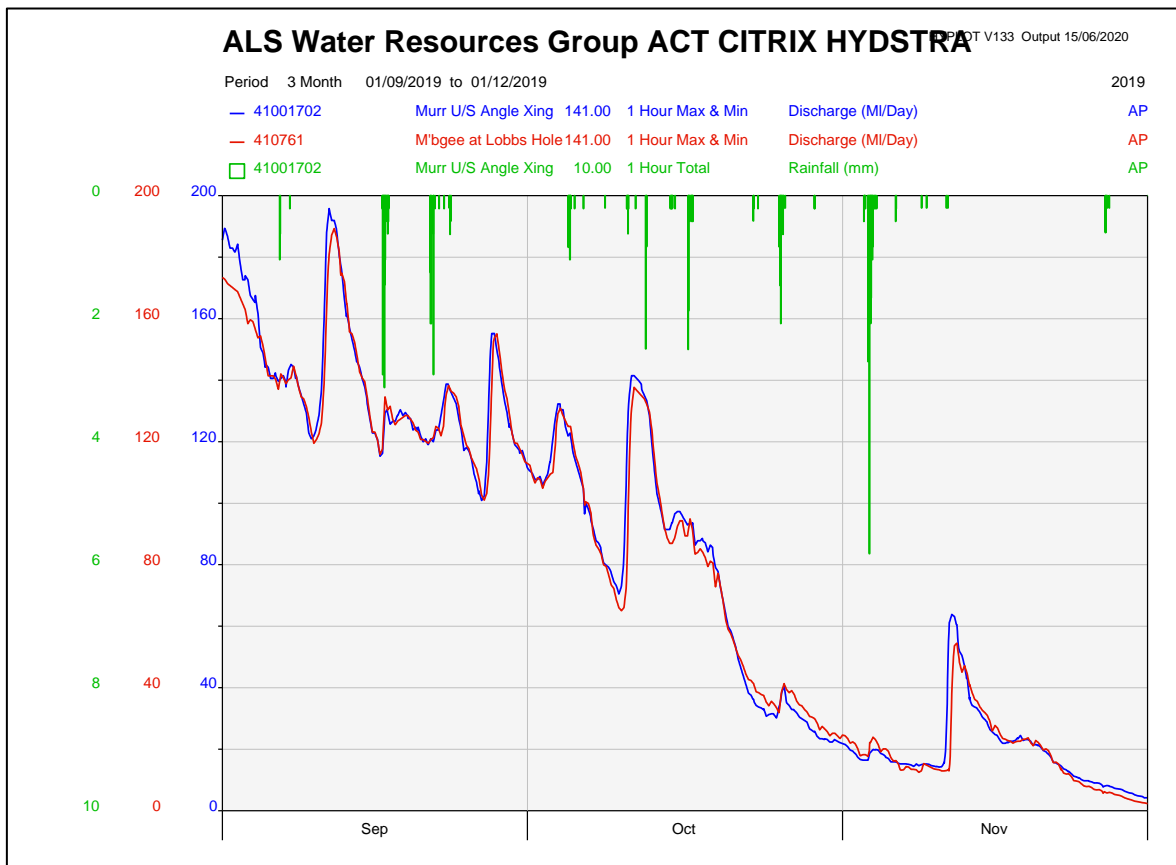
Figure 4-4. Spring 2019 rainfall and hydrograph of the Murrumbidgee River upstream (41004702) and downstream (410761) of Angle Crossing

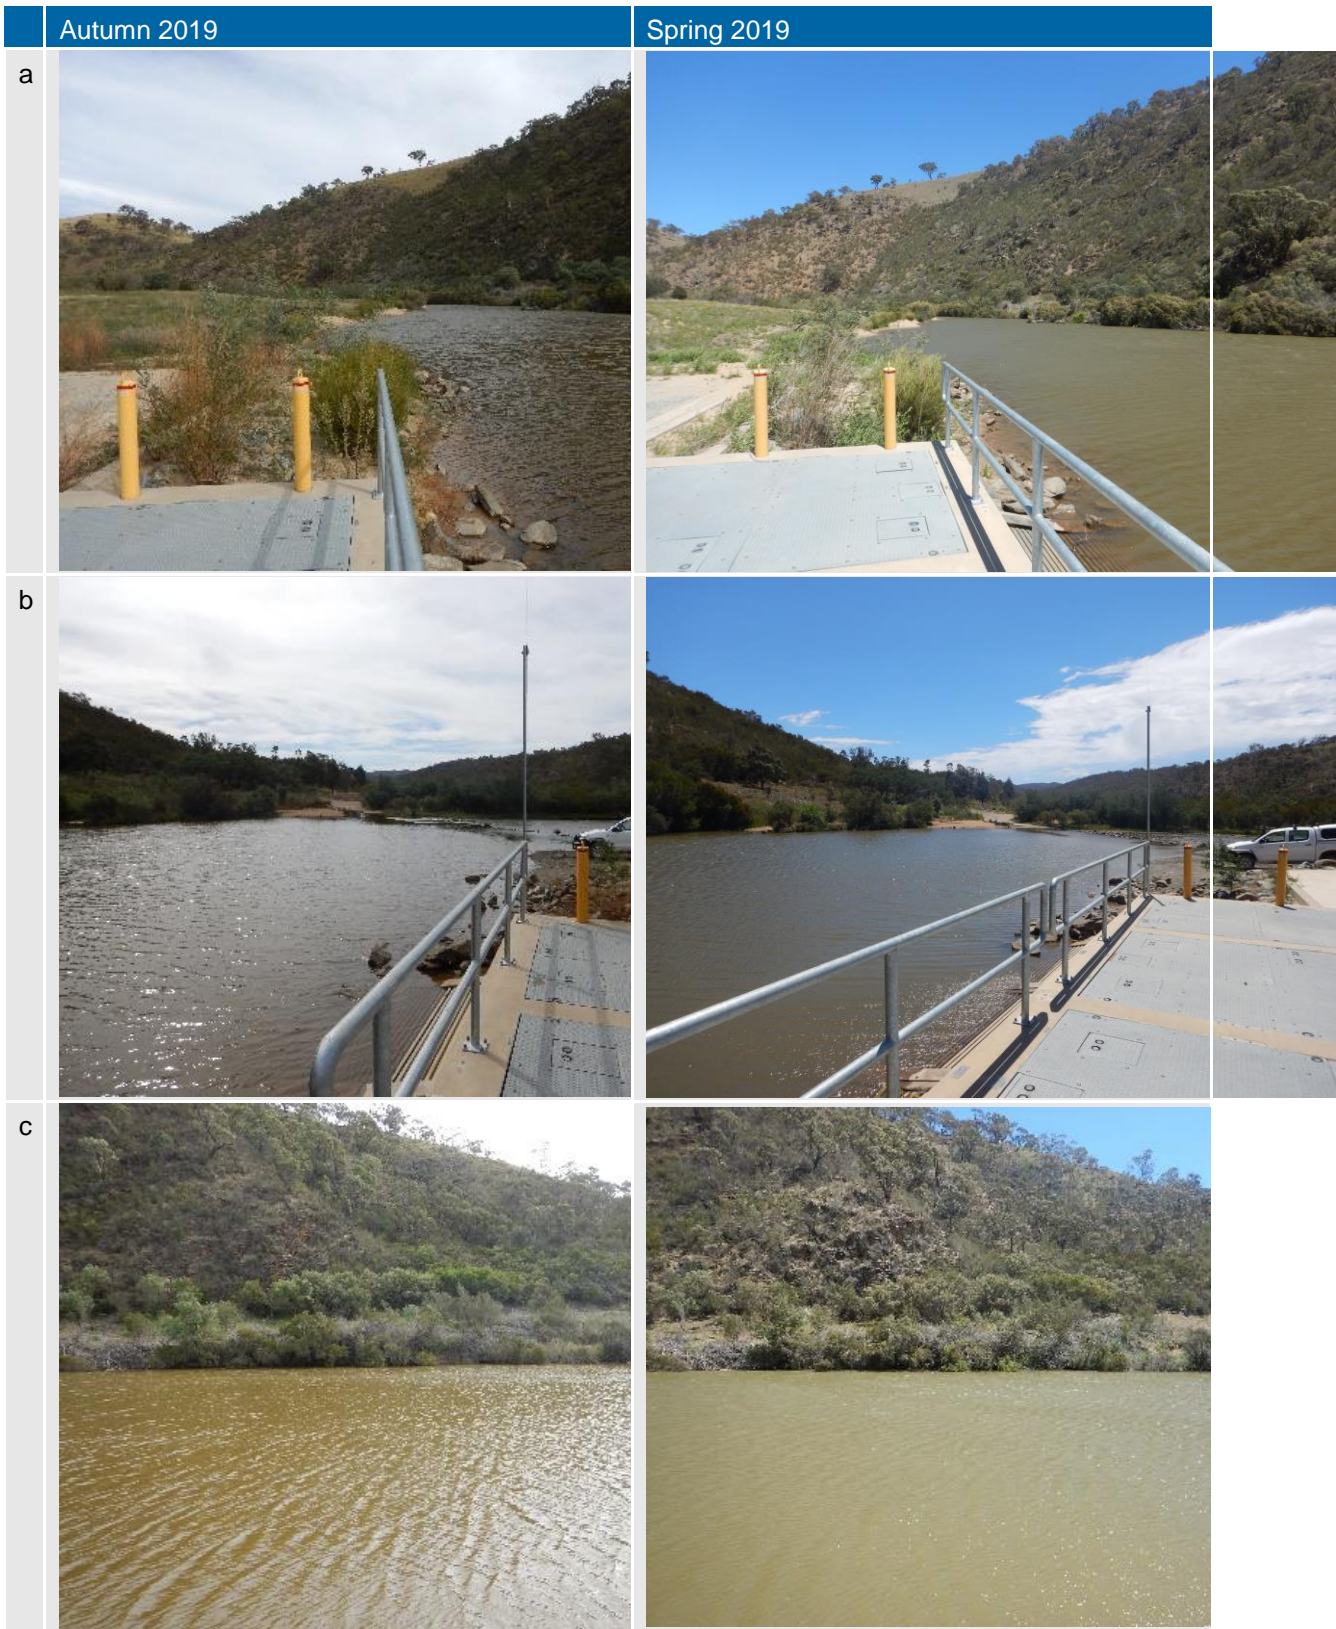
Plate 4-2. Geomorphology photo point 1 at Angle Crossing MUR 19 showing upstream (a), downstream (b) and across the channel (c) during autumn and spring 2019

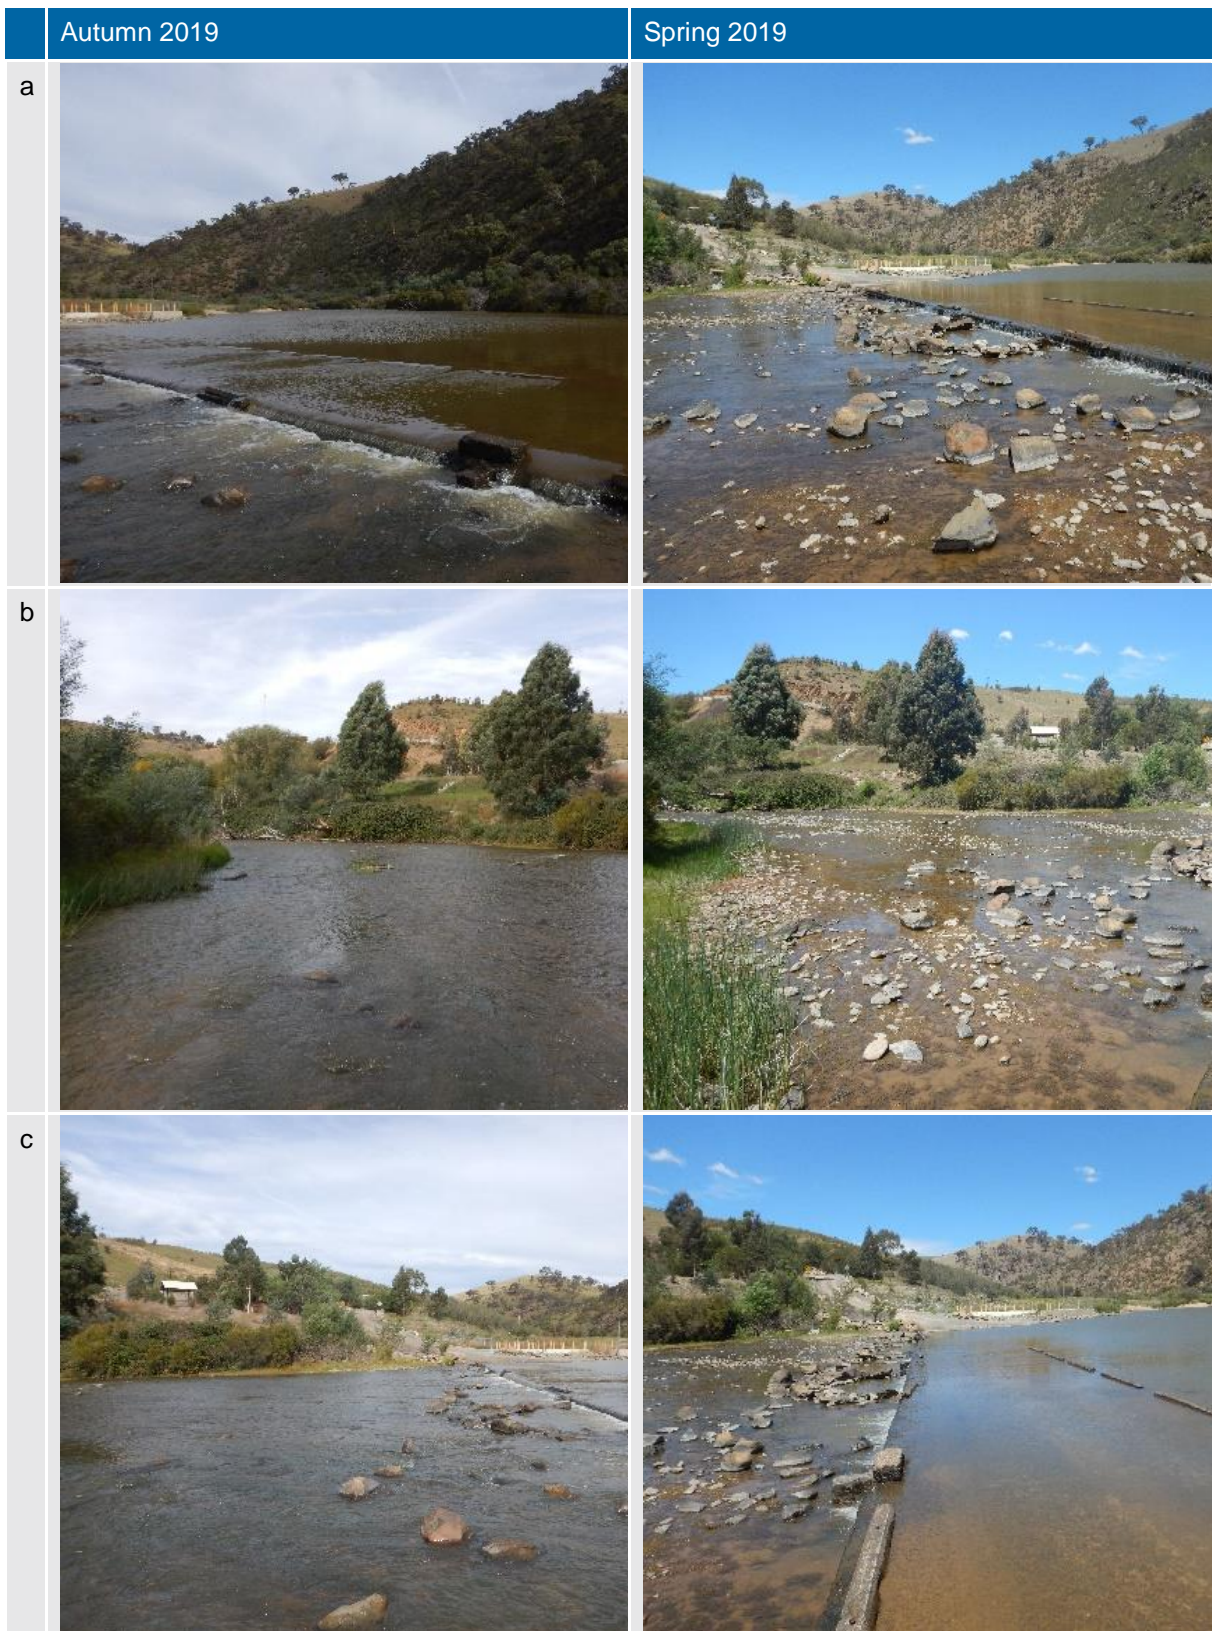
Plate 4-3. Geomorphology photo point 2 at Angle Crossing MUR 19 showing upstream (a), downstream (b) and across the channel (c) during autumn and spring 2019

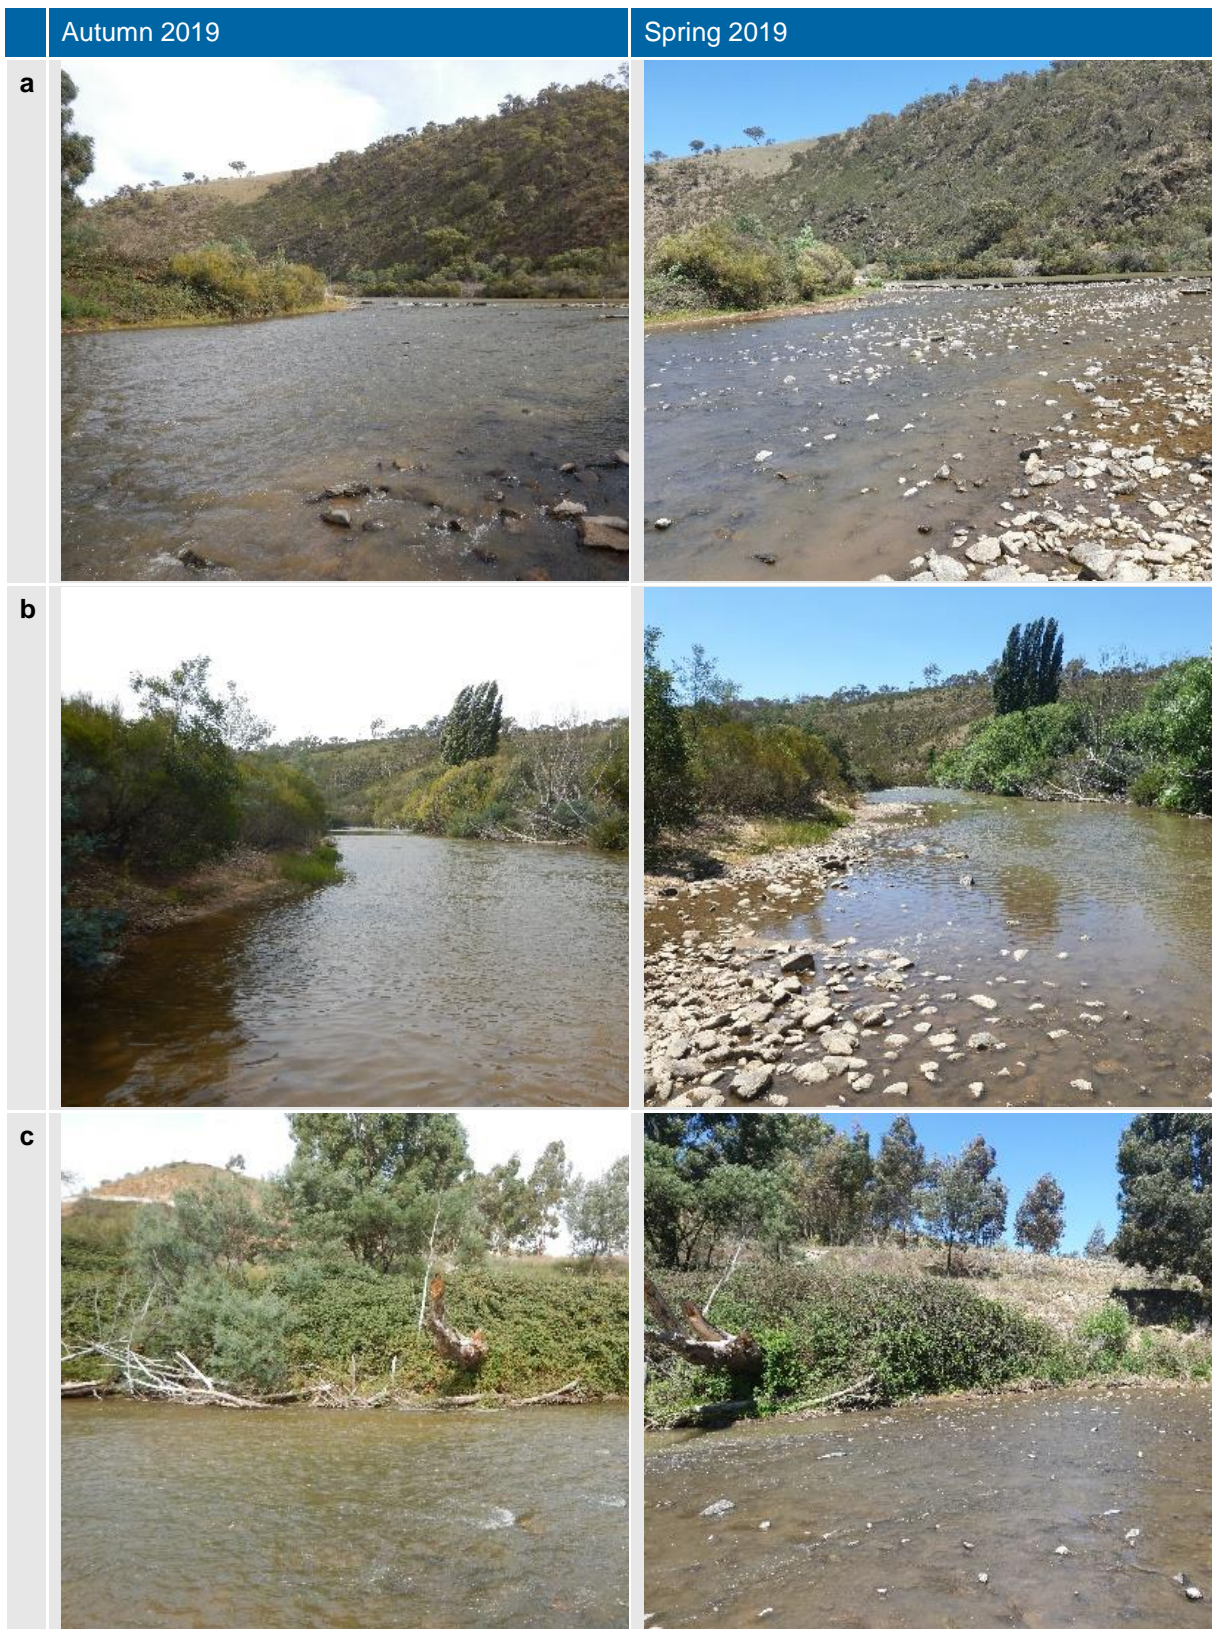
Plate 4-4. Geomorphology photo point 3 at Angle Crossing MUR 19 showing upstream (a), downstream (b) and across the channel (c) during autumn and spring 2019

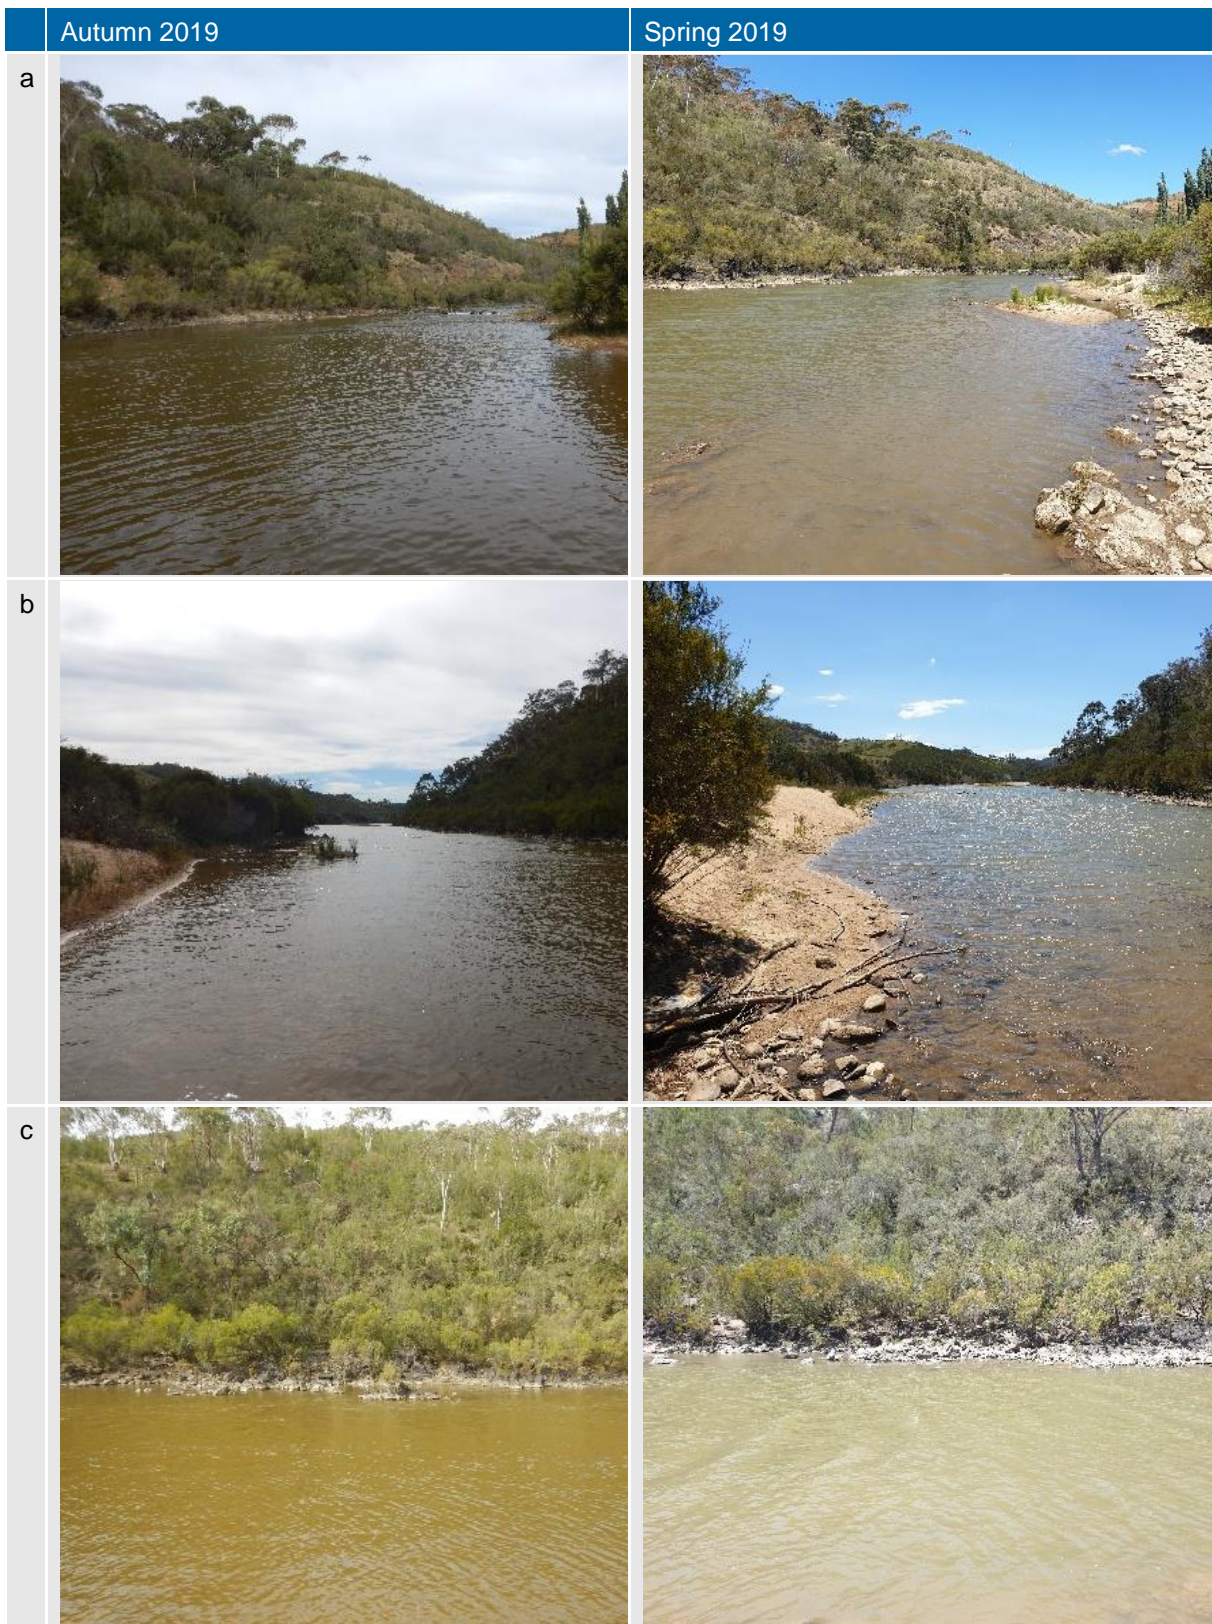
Plate 4-5. Geomorphology photo point 4 at Angle Crossing MUR 19 showing upstream (a), downstream (b) and across the channel (c) during autumn and spring 2019

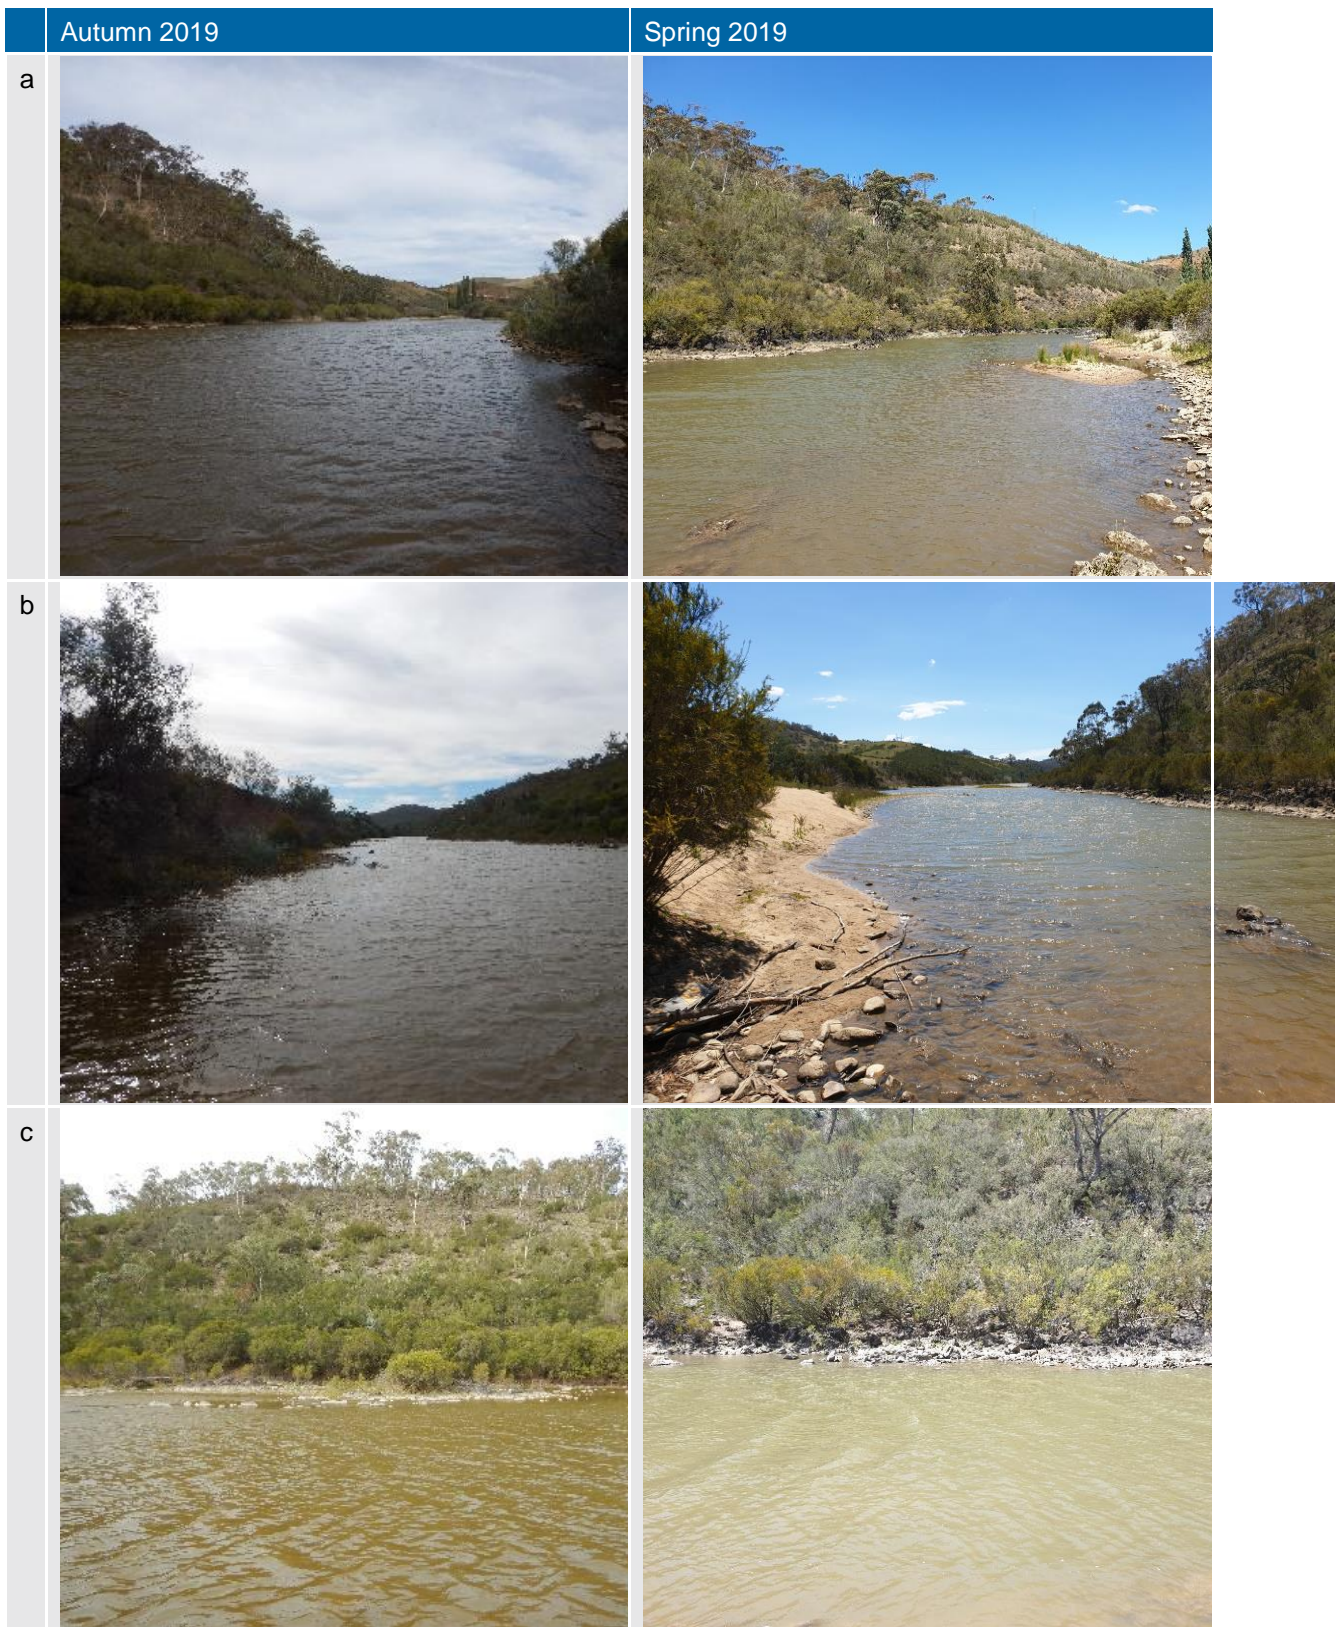
Plate 4-6. Geomorphology photo point 5 at Angle Crossing MUR 19 showing upstream (a), downstream (b) and across the channel (c) during autumn and spring 2019

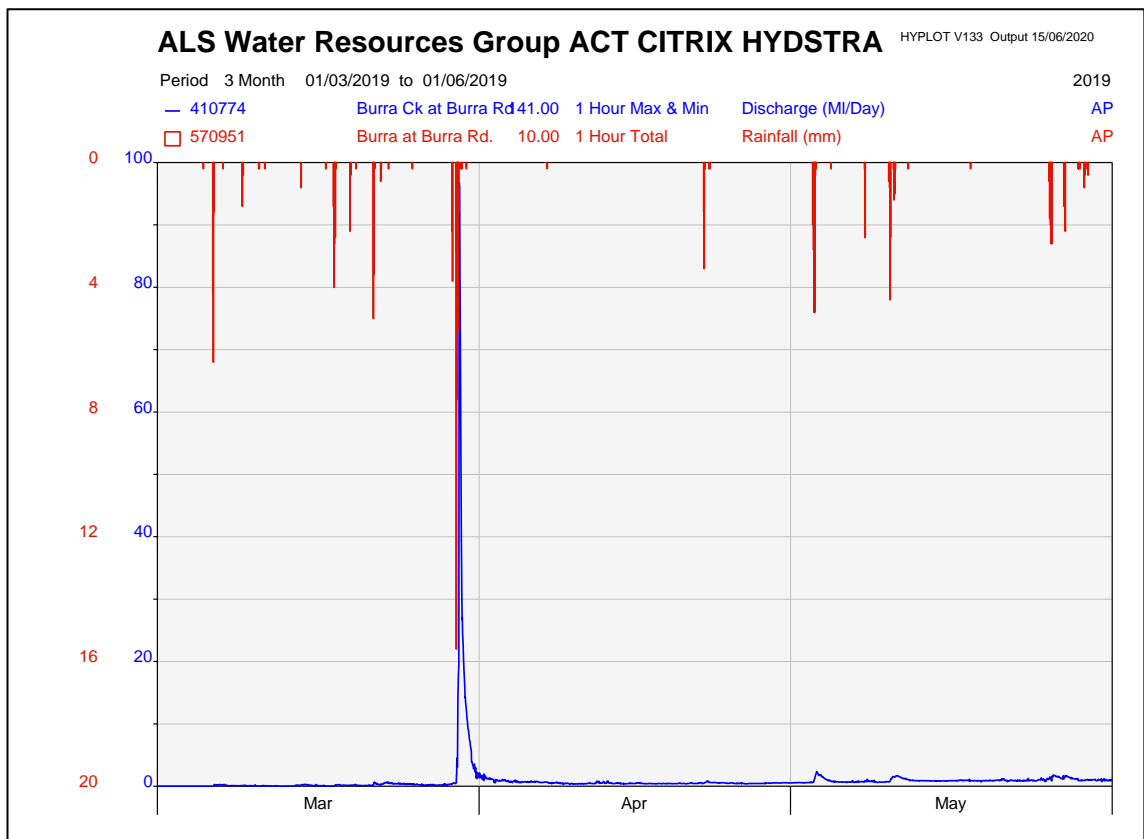
Figure 4-15. Autumn 2019 rainfall and hydrograph from Burra Creek (410774)

Burra Creek during 2019 was characterised by low flows in both autumn (max. mean daily flow 1.4 ML/d) and spring (max. mean daily flow 1.0 ML/d), with one major spike in March of approximately 92 ML/d, and two small peaks in September and November that were both approximately 2.7 ML/d (Figure 4-15 and Figure 4-16). During spring 2019, there was a decreasing trend in flow from September to November that is likely due to reduced rainfall (Table 4-8). Overall, flow during both autumn and spring 2019 were comparable to 2018 with the exception of the March spike.

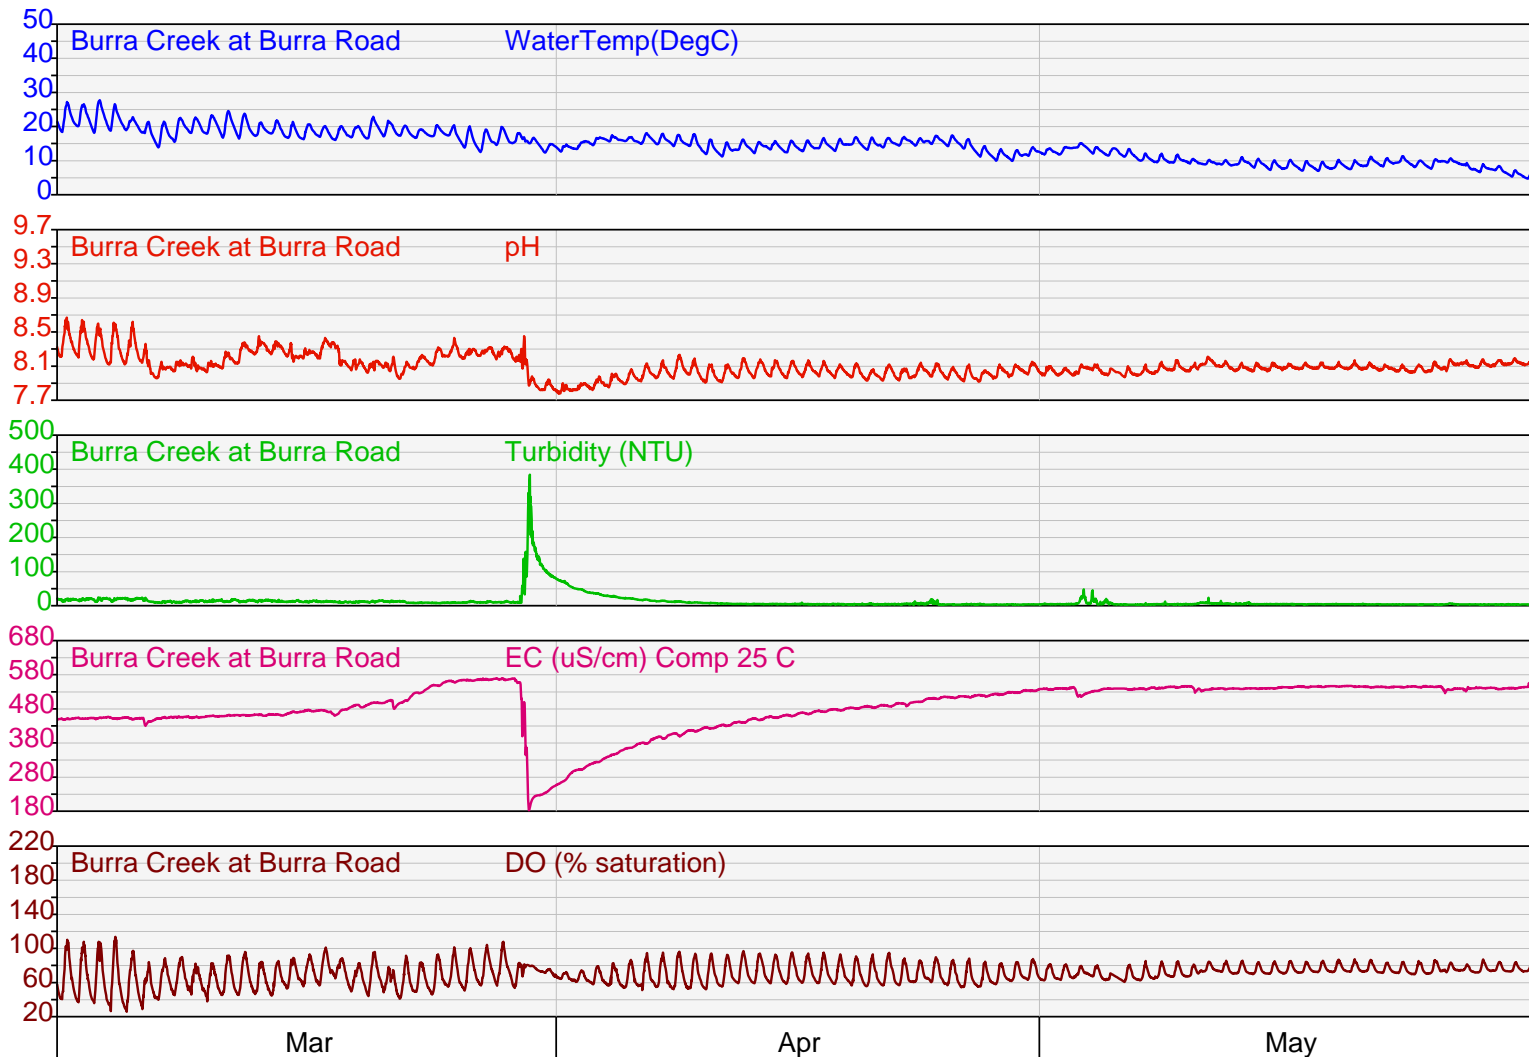
Figure 4-17. Continuous water quality records from upstream Burra Creek at Burra Road (410774) for autumn 2019

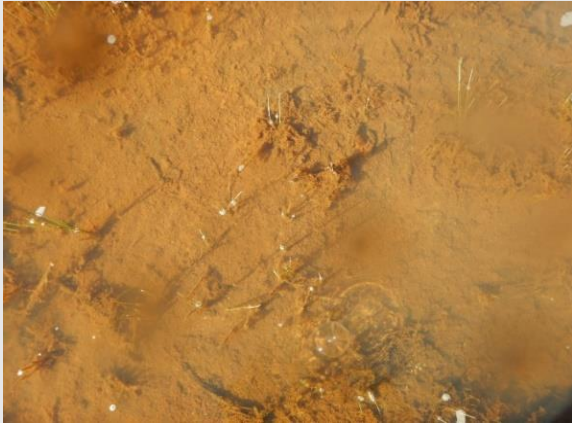
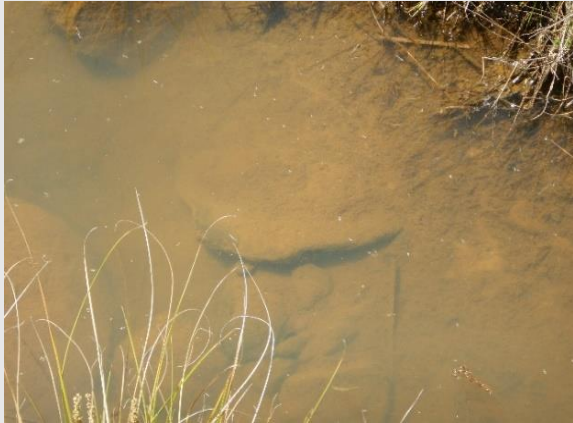
Site	Autumn 2019	Spring 2019
BUR 1b

Periphyton coverage in autumn and spring at BUR1b was both approximately 65-90% in the reach, and 65-90% in the edge habitat. No riffle was present in spring and the predominant macrophyte observed was *Typha sp.*

Plate 4-7. 3 Photos showing the periphyton coverage at Burra Creek sites in autumn and spring 2019

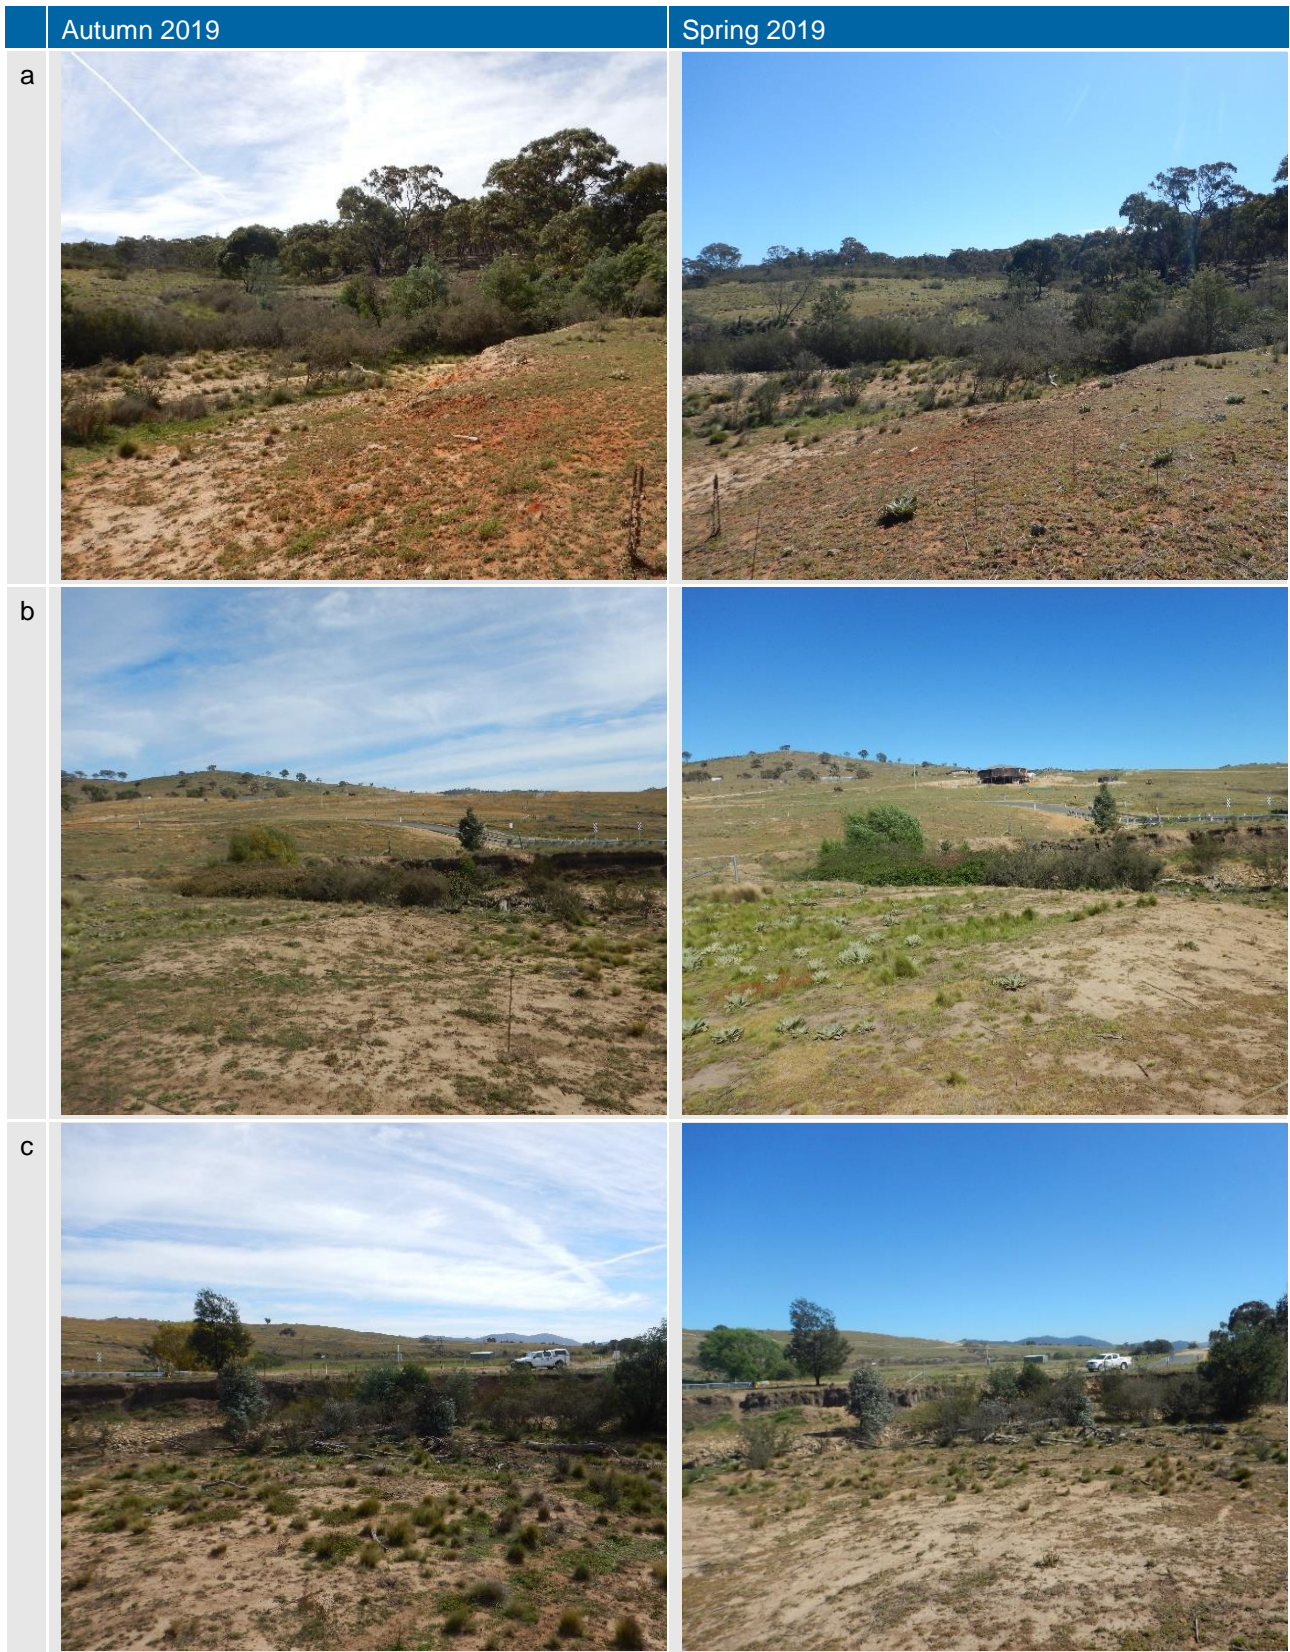
Plate 4-9. Geomorphology photo point 2 at BUR 1a showing upstream (a), downstream (b) and across the channel (c) during autumn and spring 2019

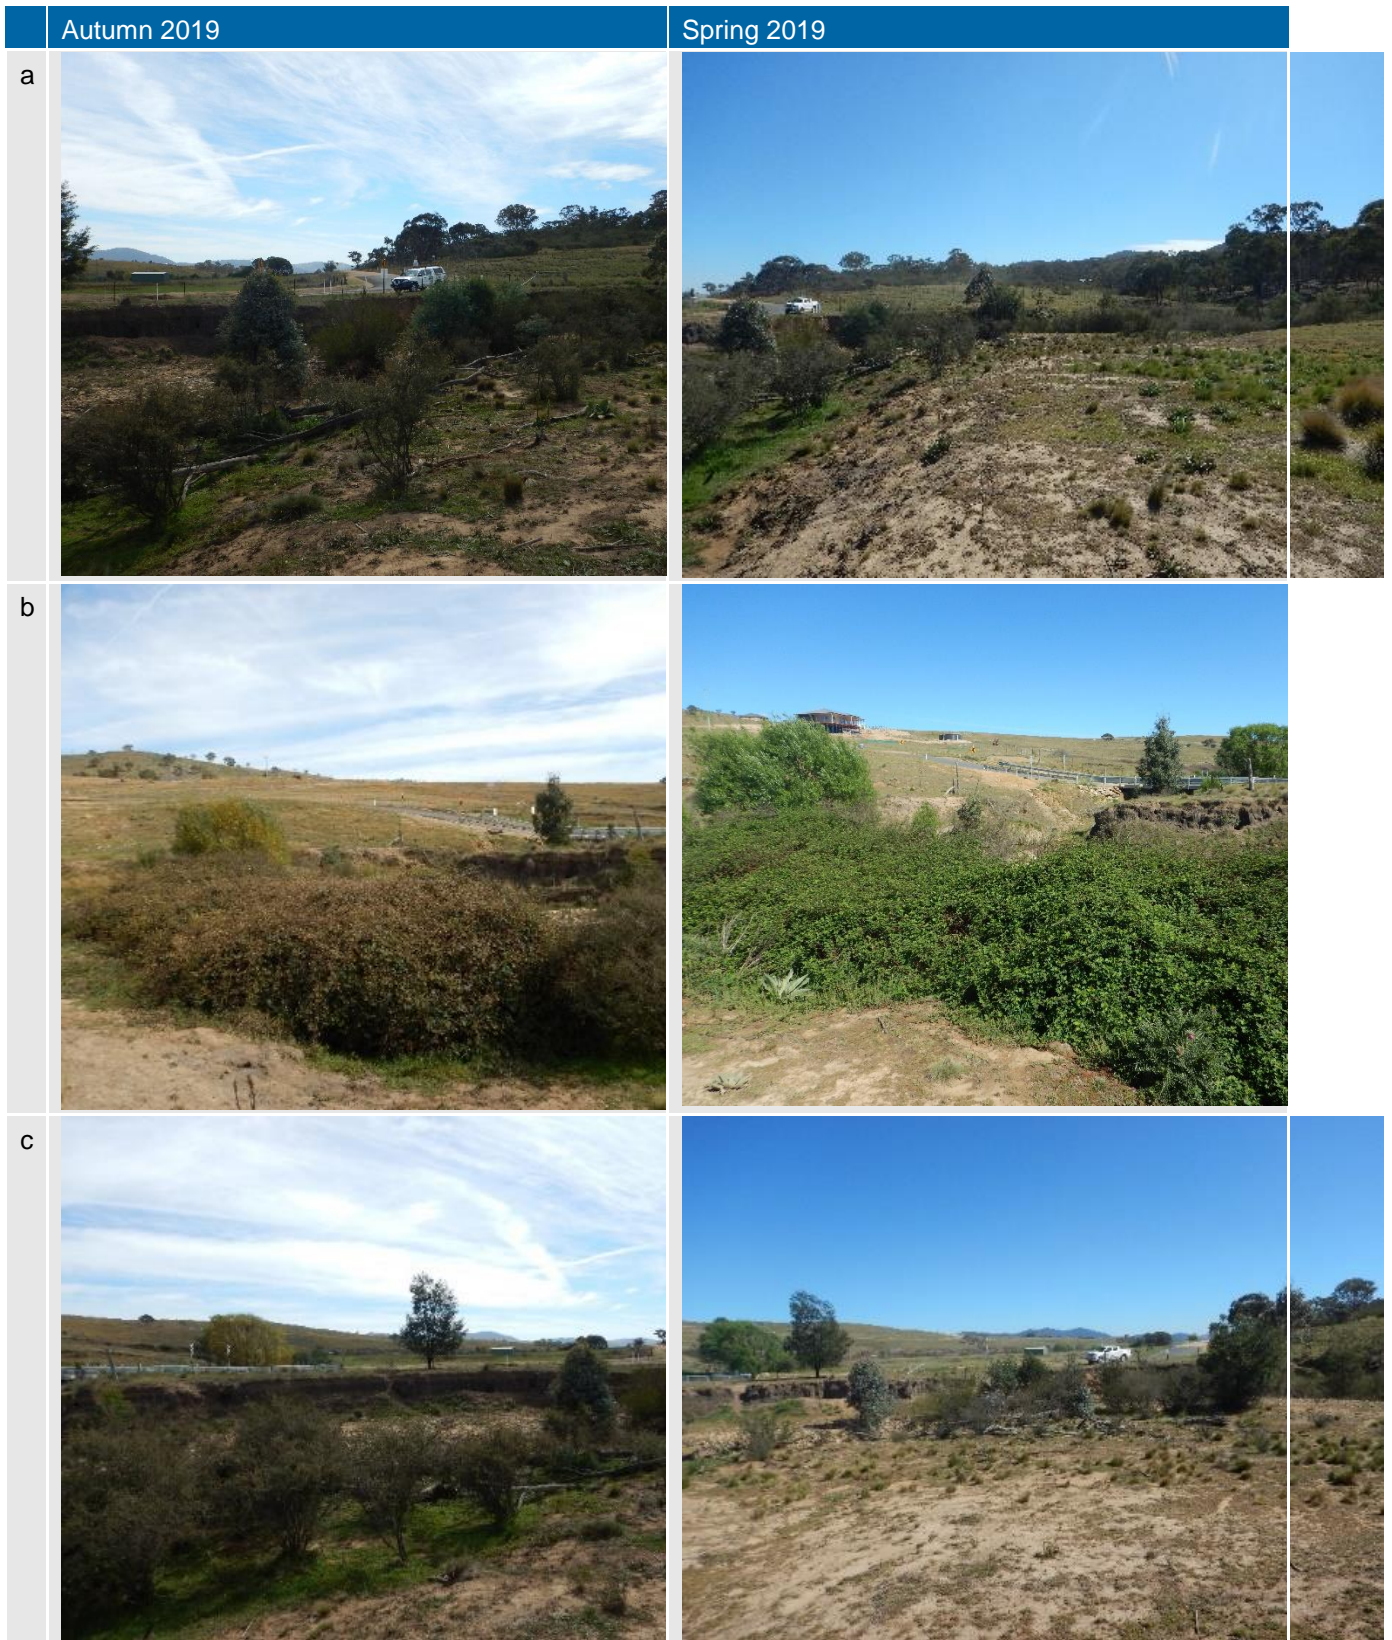
Plate 4-10. Geomorphology photo point 3 at BUR 1a showing upstream (a), downstream (b) and across the channel (c) during autumn and spring 2019
