Icon Water

Murrumbidgee Ecological Monitoring Program Impact Monitoring - Autumn 2019 and Spring 2019

August 2020

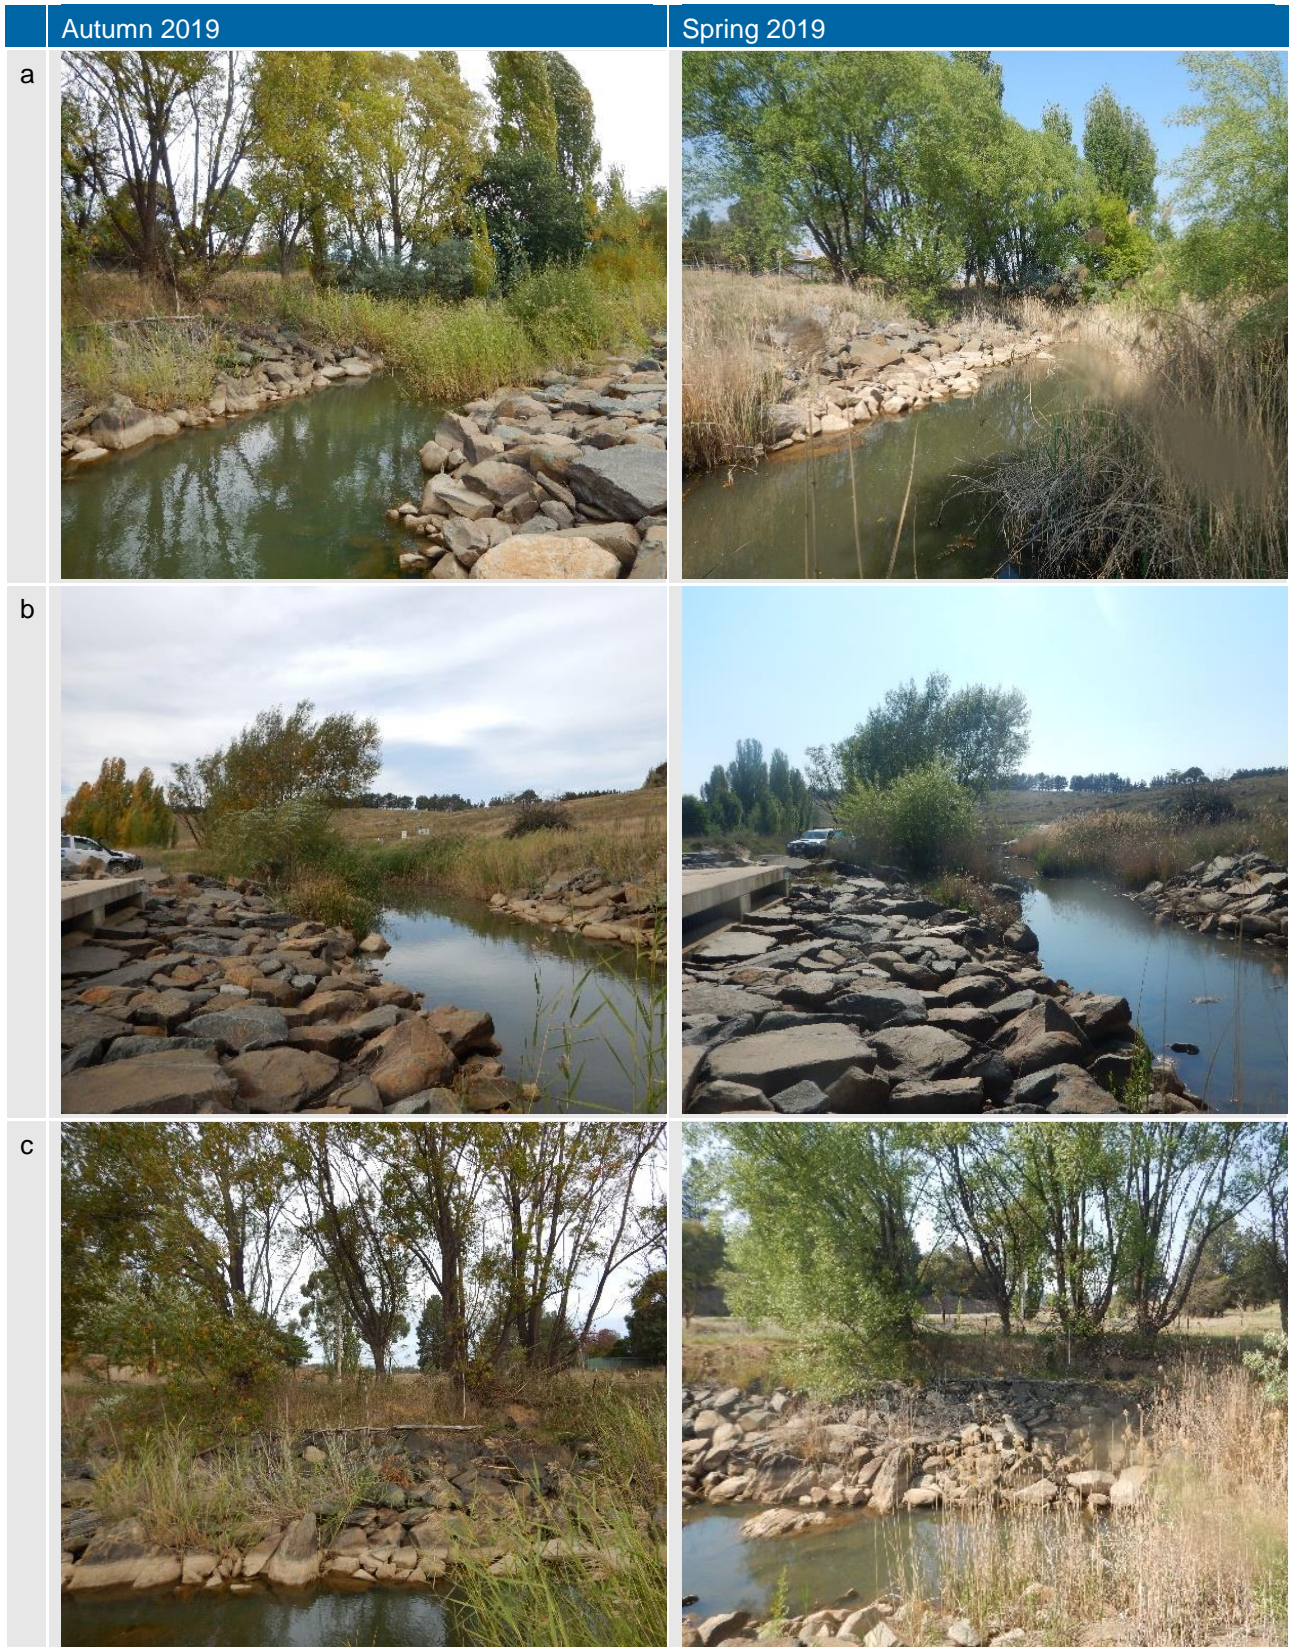
Plate 4-11. Vegetation extent and geomorphology photo point 1 at BUR 2 showing upstream (a), downstream (b) and across the channel (c) during autumn and spring 2019

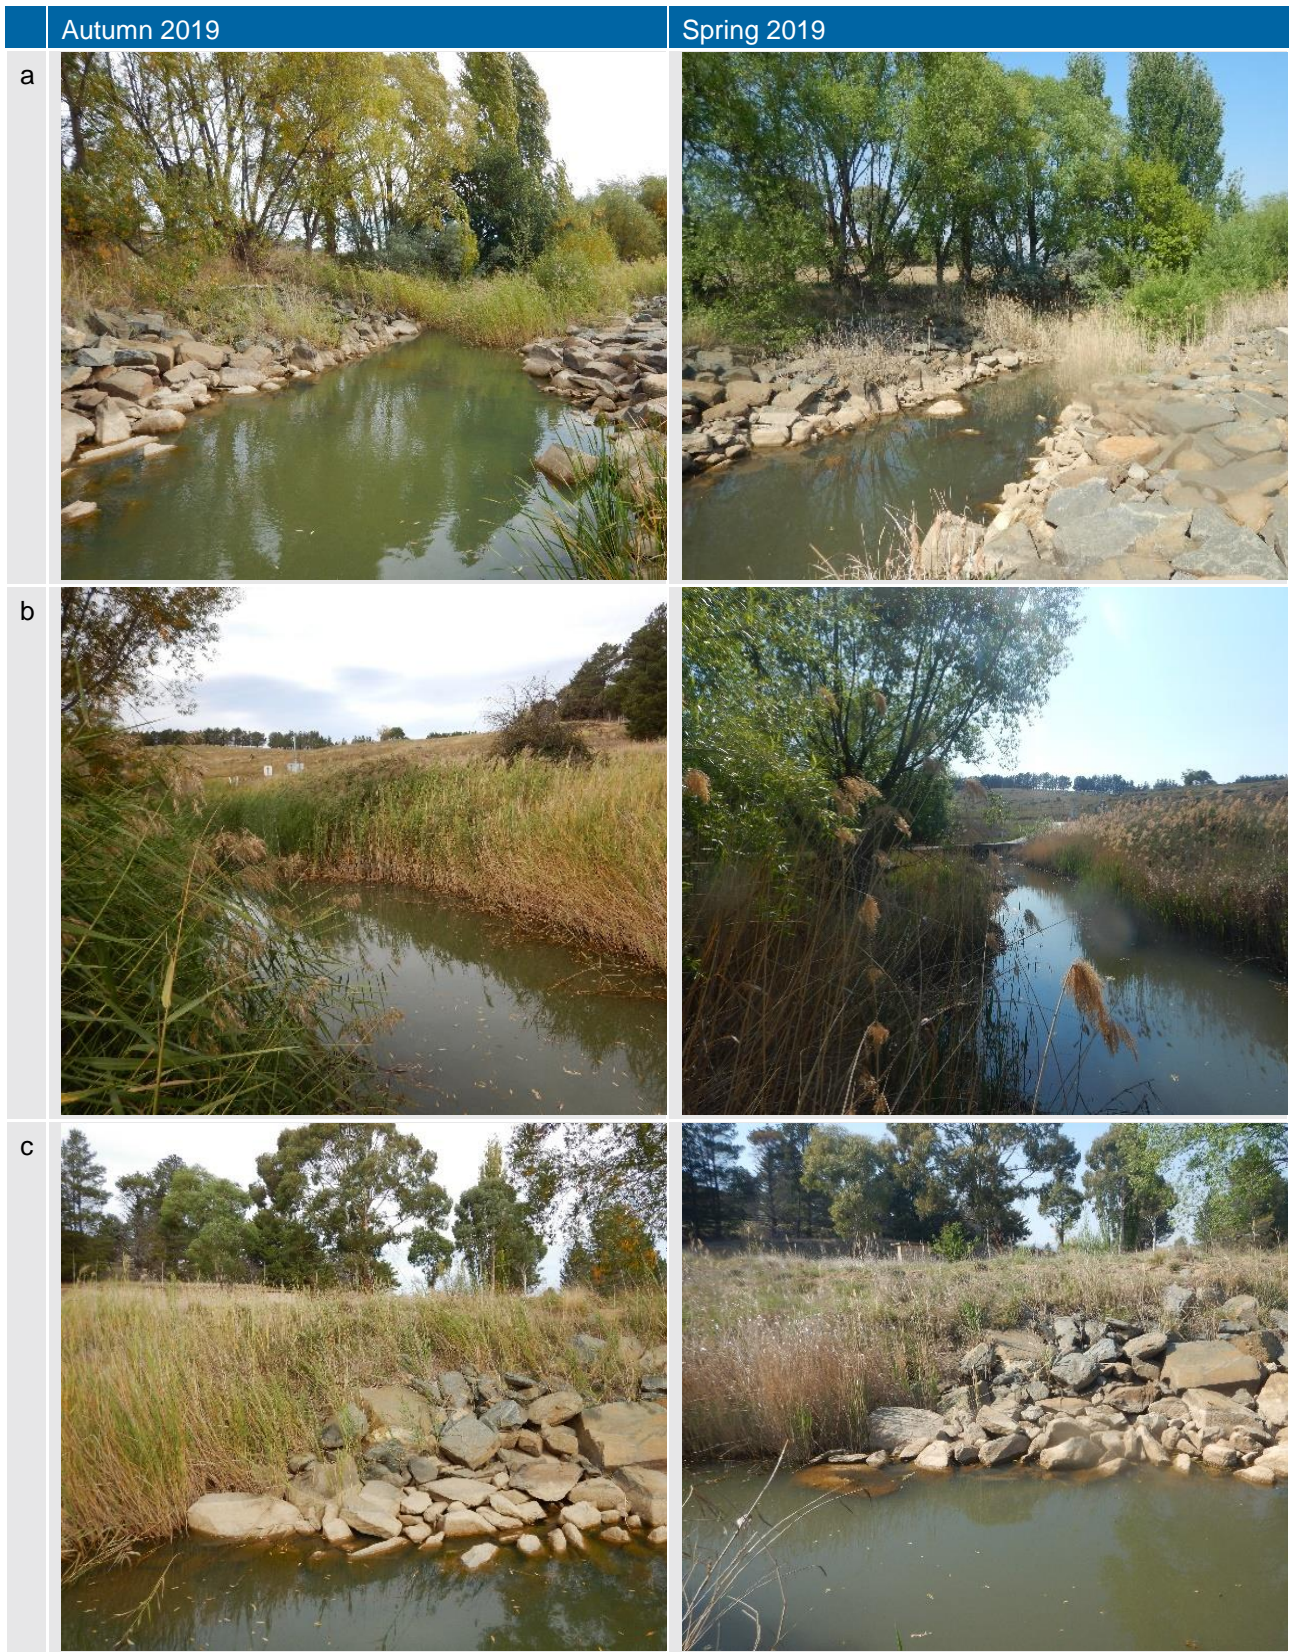
Plate 4-12. Vegetation extent and geomorphology photo point 2 at BUR 2 showing upstream (a), downstream (b) and across the channel (c) during autumn and spring 2019

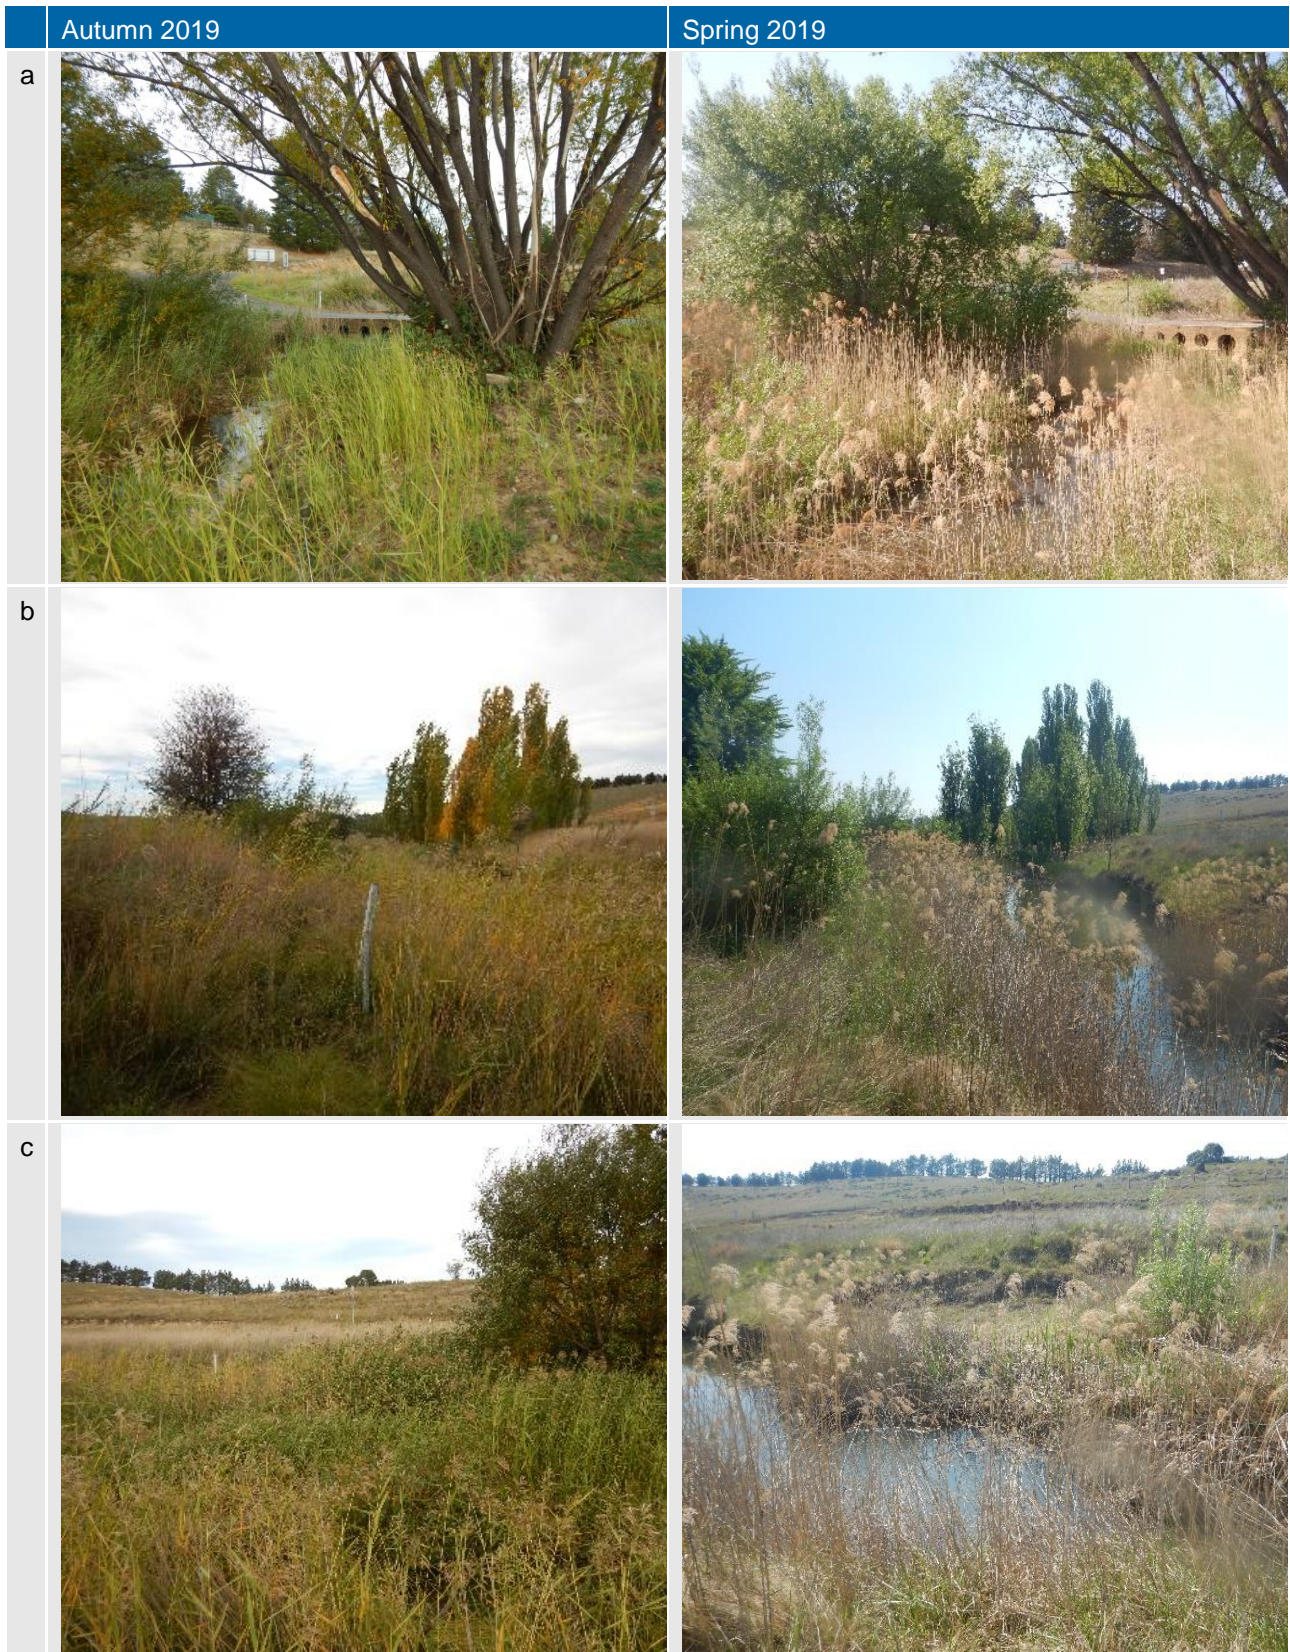
Plate 4-13. Vegetation extent and geomorphology photo point 3 at BUR 2 showing upstream (a), downstream (b) and across the channel (c) during autumn and spring 2019

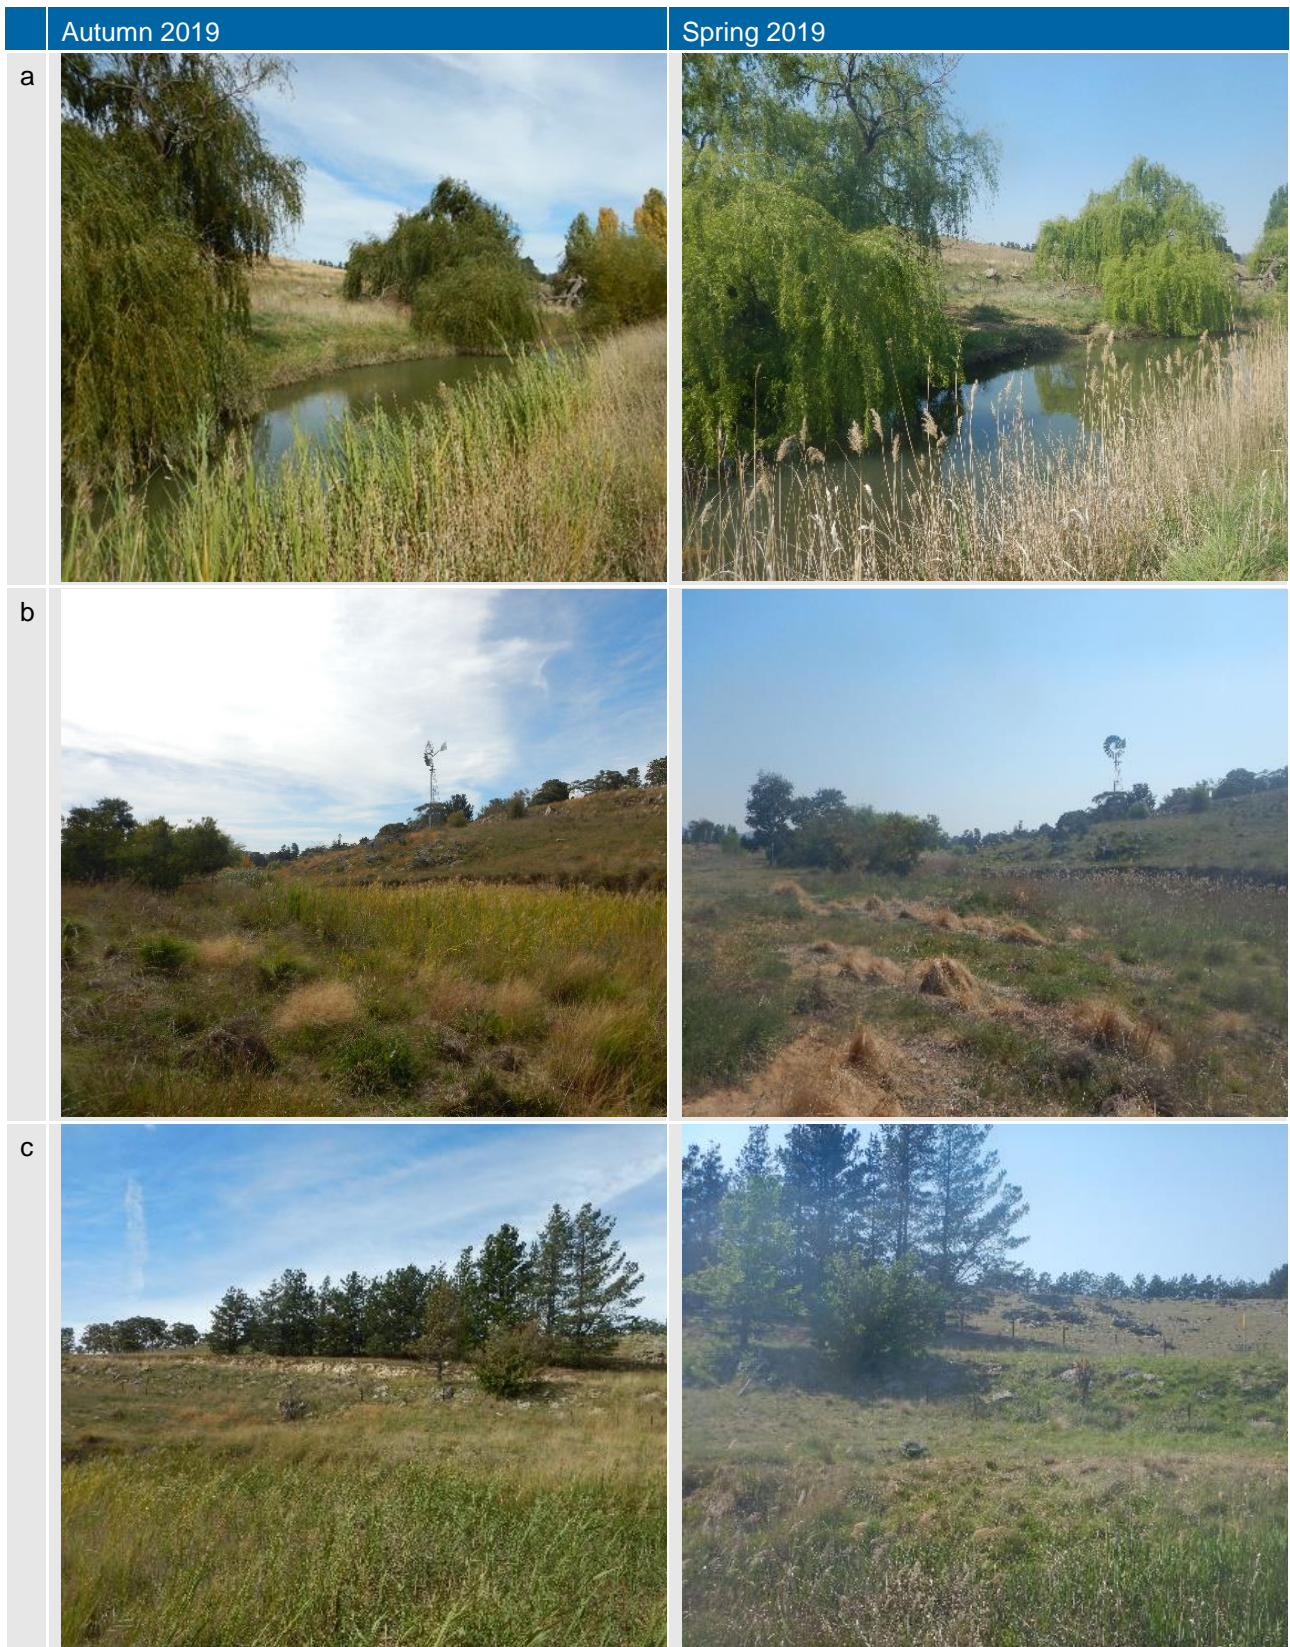
Plate 4-14. Geomorphology photo point 1 at BUR 2a showing upstream (a), downstream (b) and across the channel (c) during autumn and spring 2019

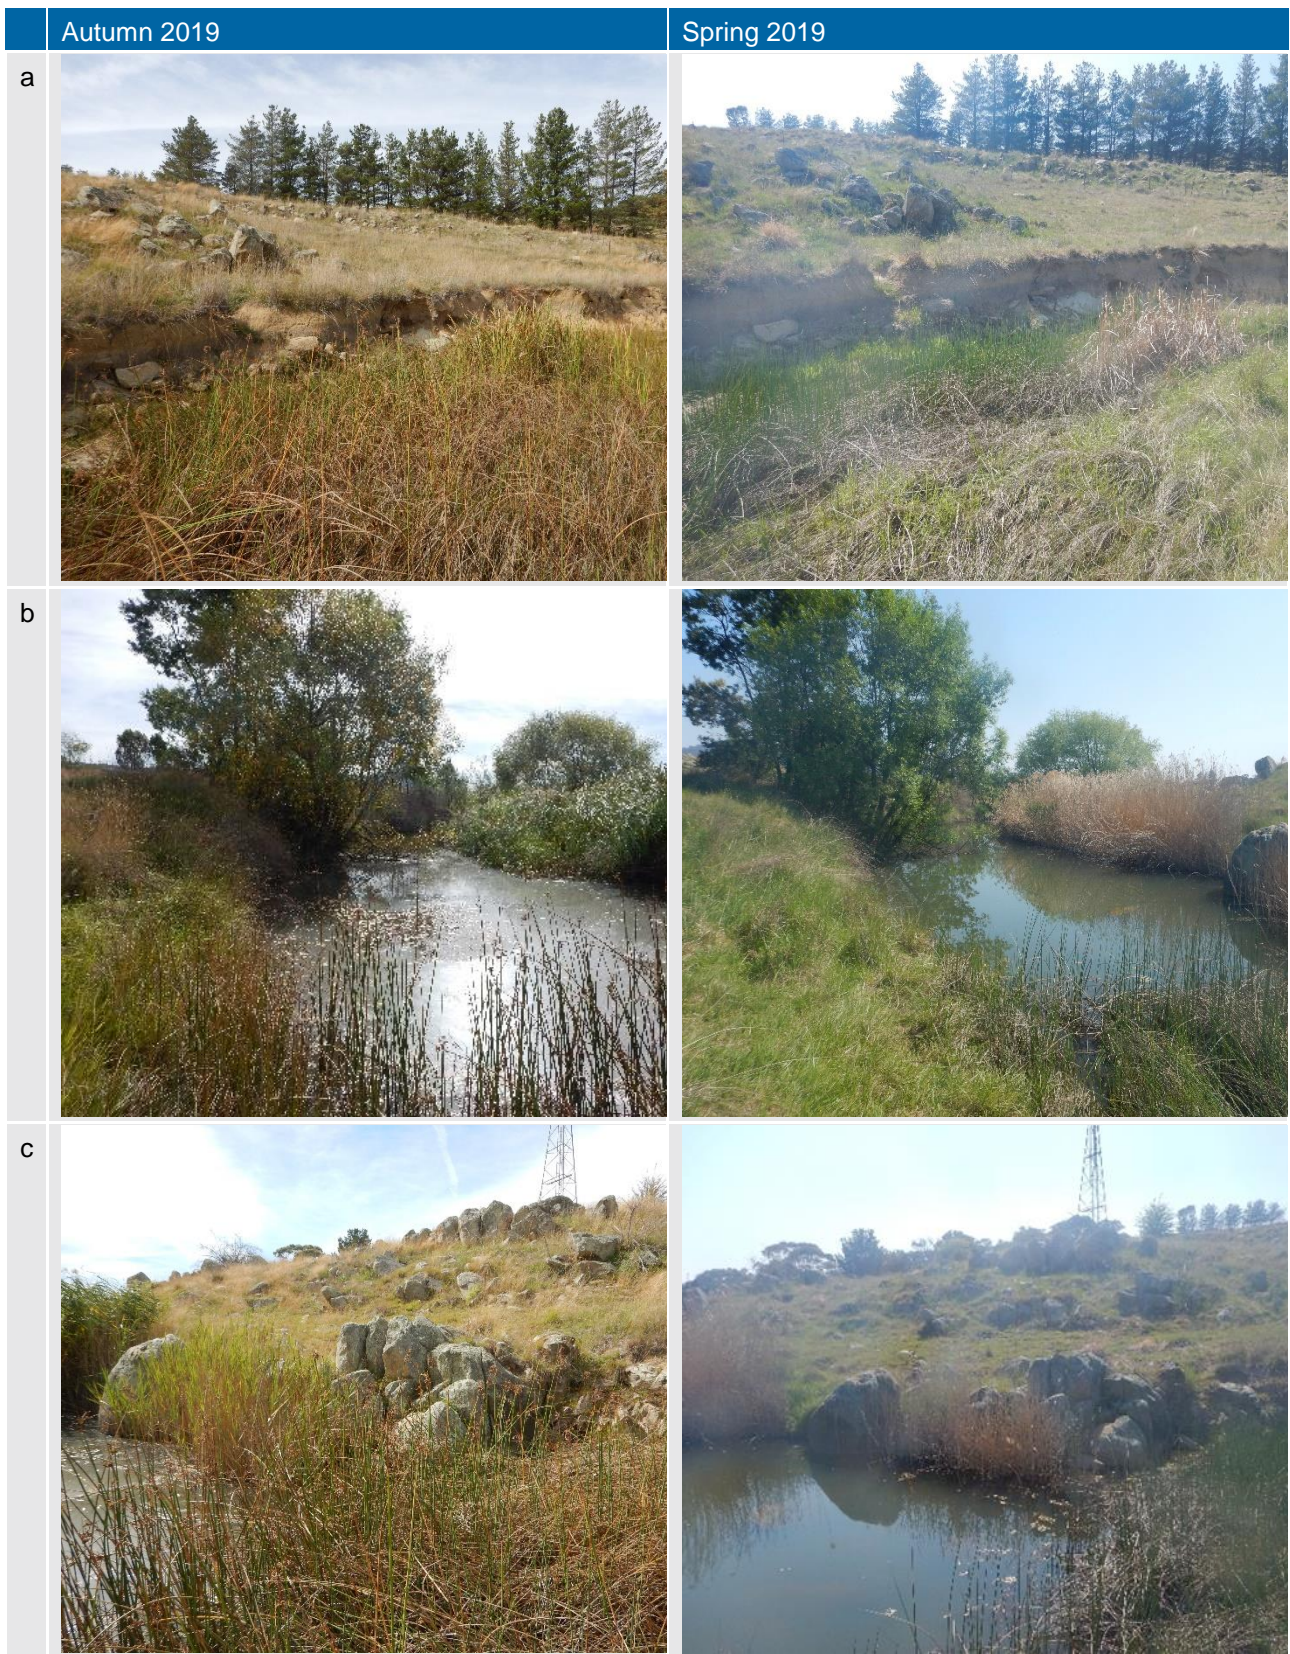
Plate 4-15. Geomorphology photo point 2 at BUR 2a showing upstream (a), downstream (b) and across the channel (c) during autumn and spring 2019

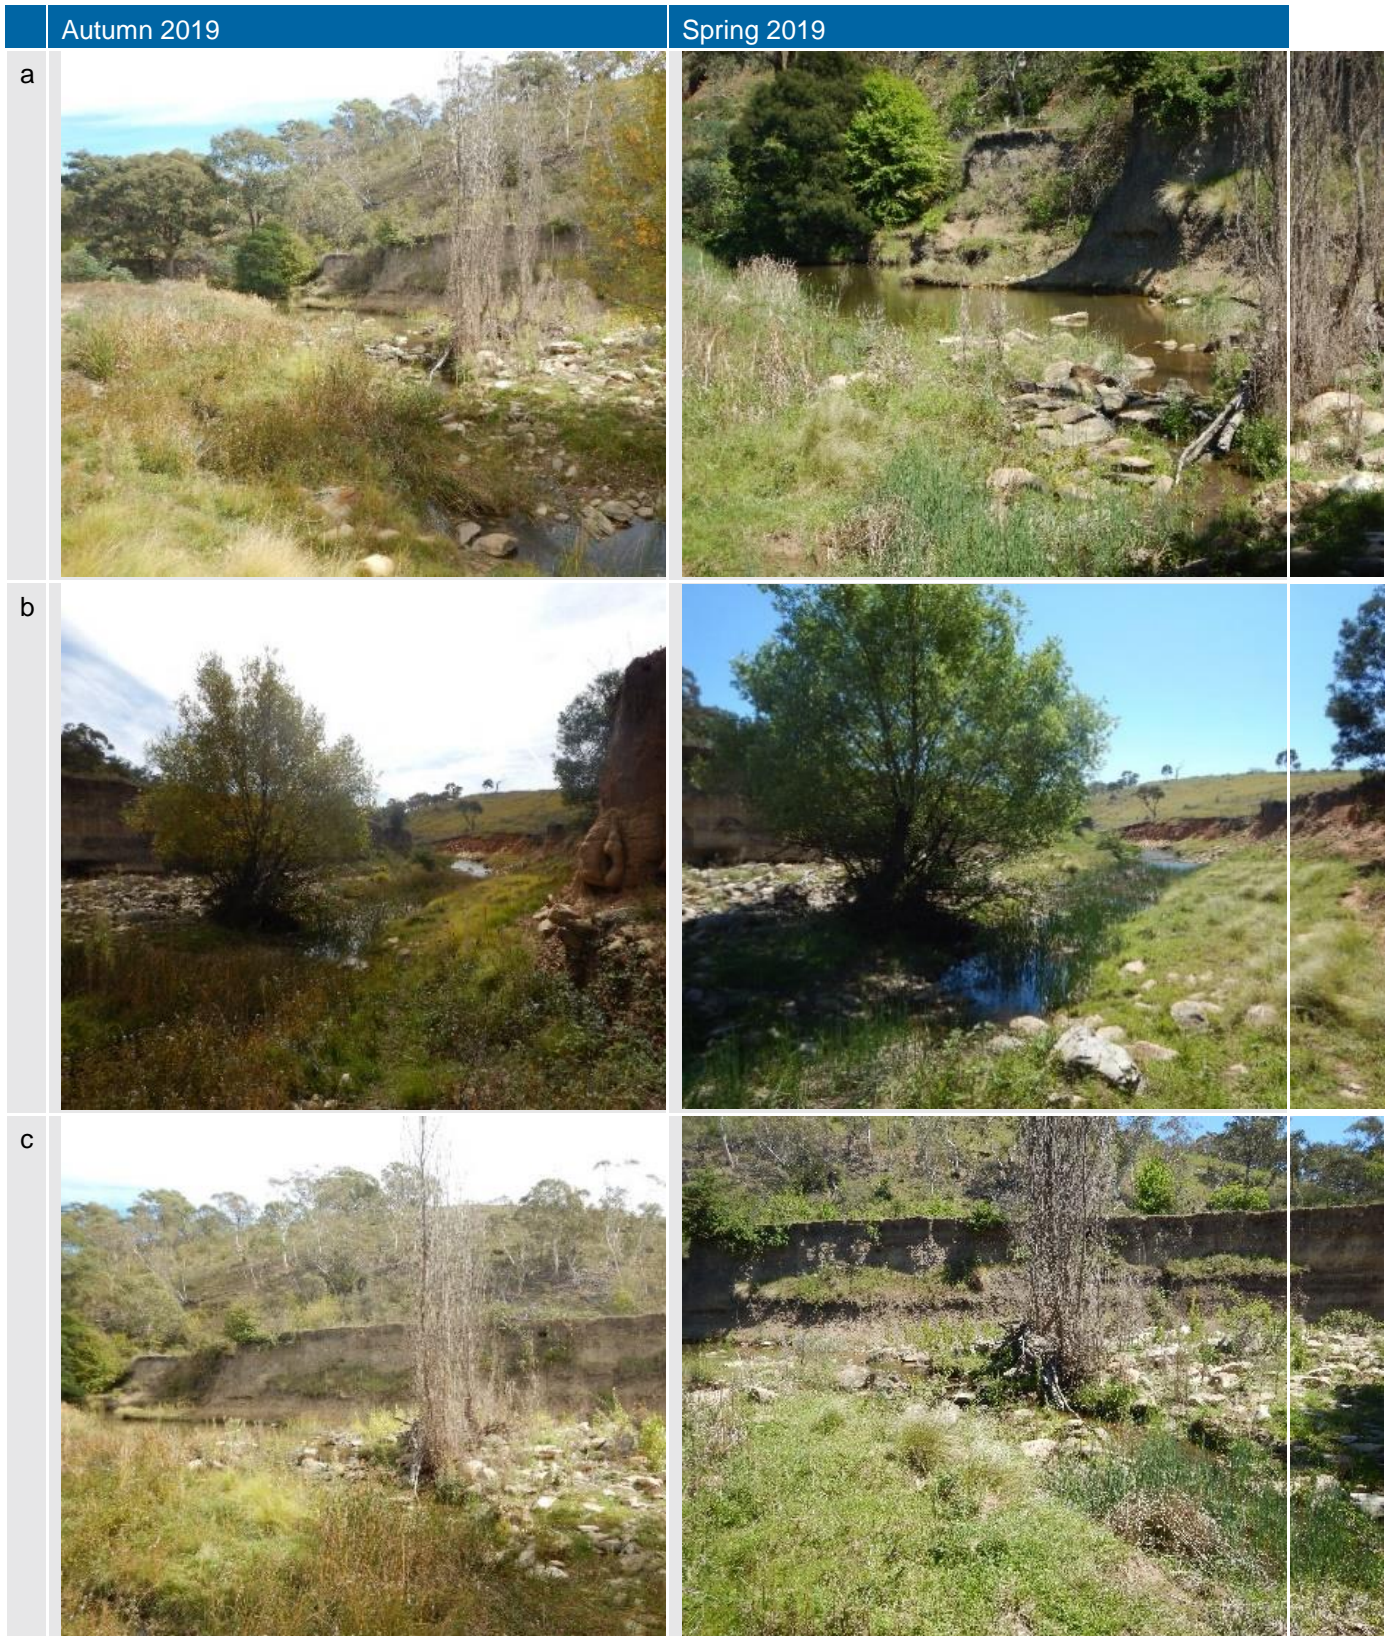
Plate 4-16. Vegetation extent and geomorphology photo point 1 downstream of pool 29 showing upstream (a), downstream (b) and across the channel (c) during autumn and spring 2019

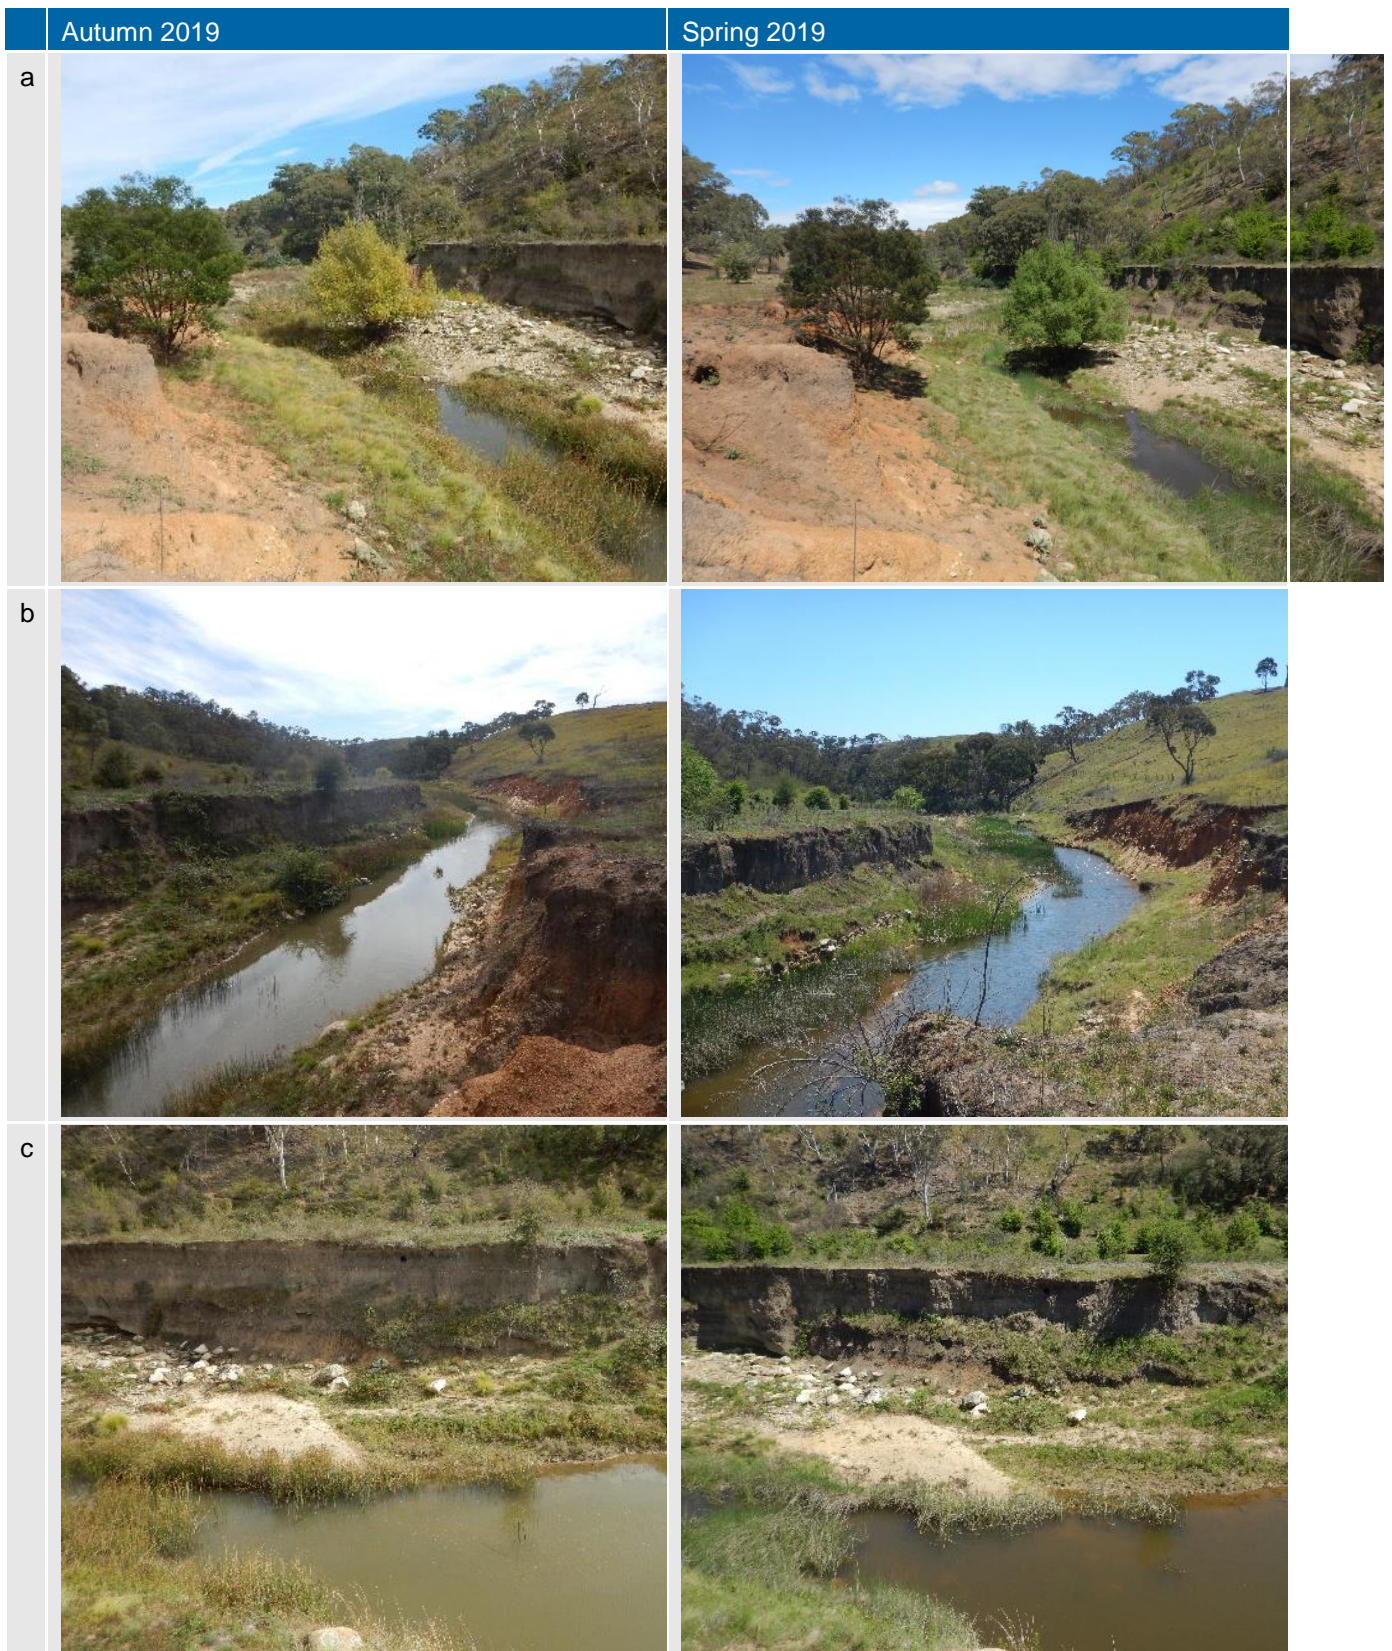
Plate 4-17. Vegetation extent and geomorphology photo point 2 downstream of pool 29 showing upstream (a), downstream (b) and across the channel (c) during autumn and spring 2019

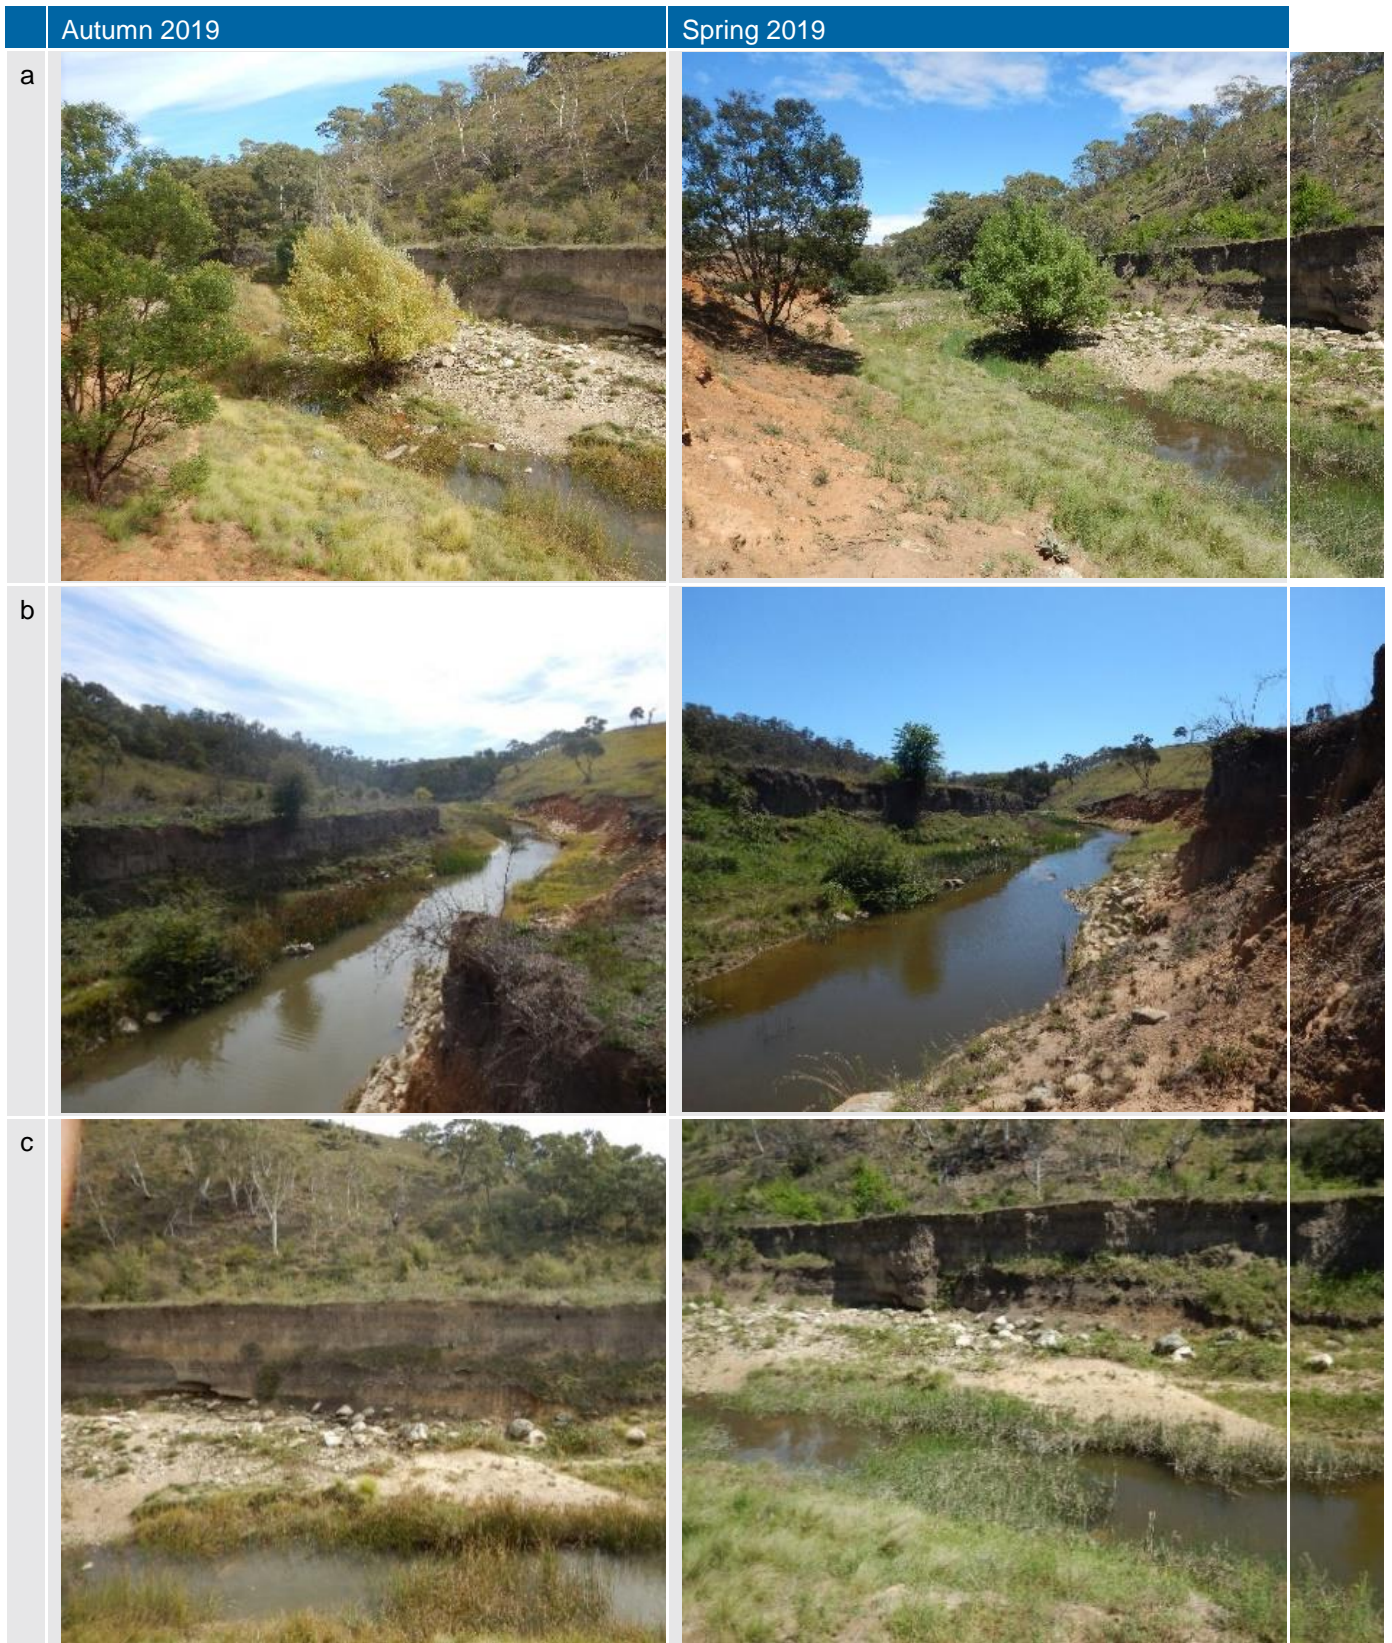
Plate 4-18. Vegetation extent and geomorphology photo point 3 downstream of pool 29 showing upstream (a), downstream (b) and across the channel (c) during autumn and spring 2019

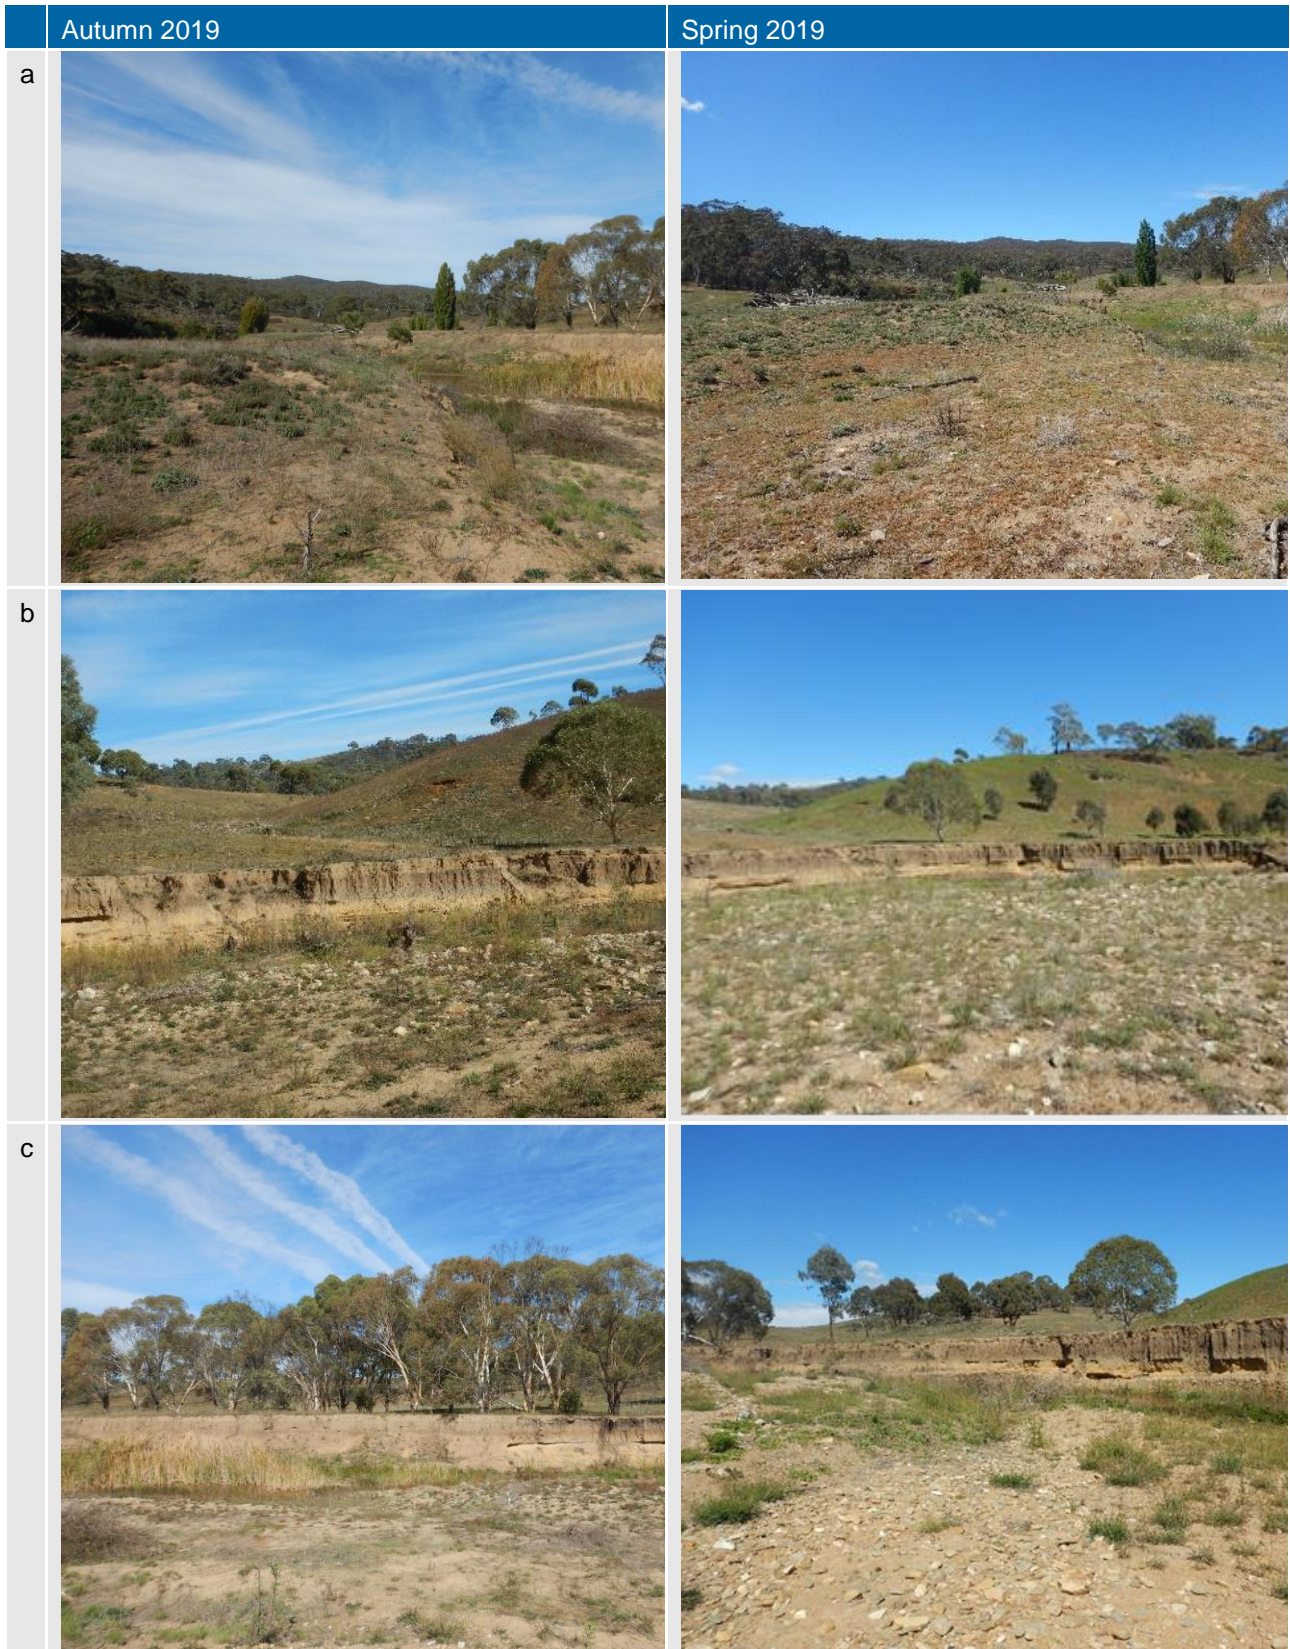
Plate 4-19. Vegetation extent and geomorphology photo point 1 at BUR 2c showing upstream (a), downstream (b) and across the channel (c) during autumn and spring 2019

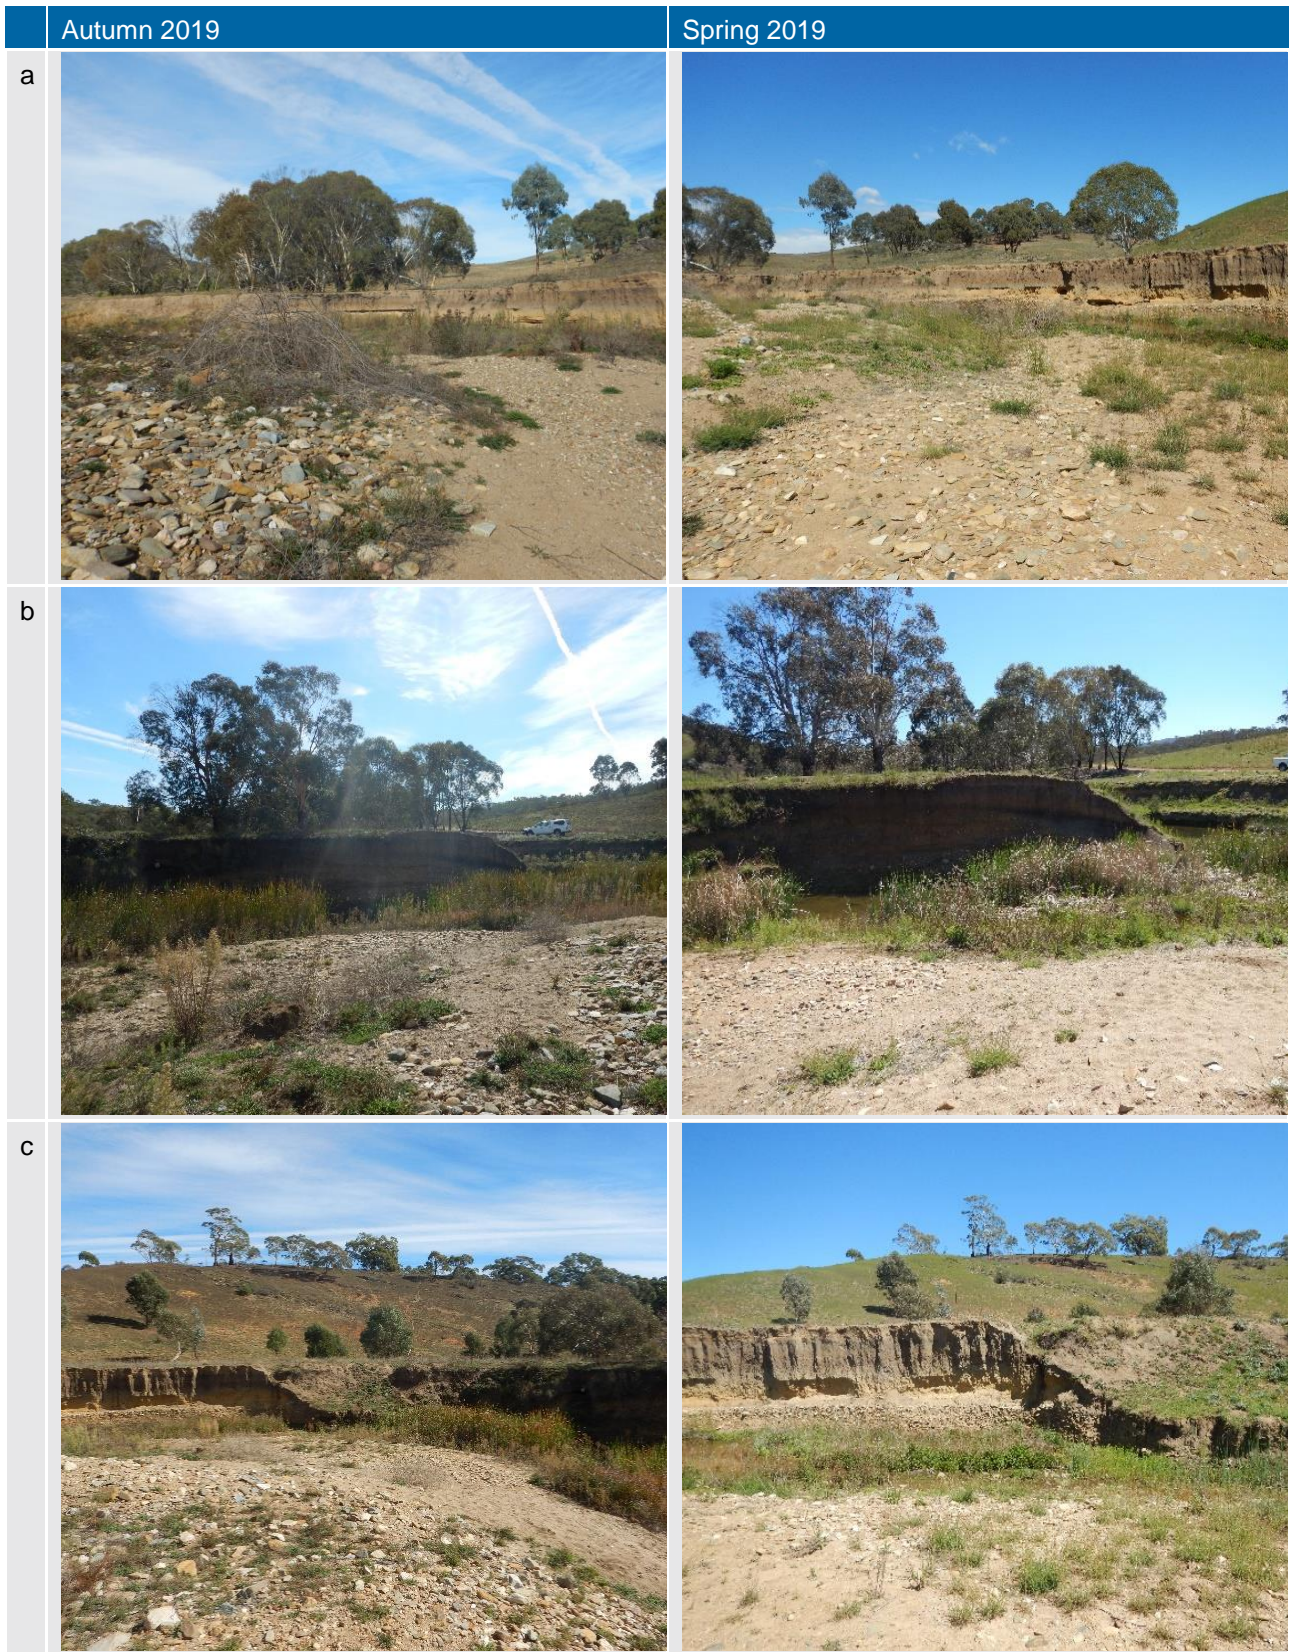
Plate 4-20. Vegetation extent and geomorphology photo point 2 at BUR 2c showing upstream (a), downstream (b) and across the channel (c) during autumn and spring 2019
