Icon Water

Murrumbidgee Ecological Monitoring Program Impact Monitoring - Autumn 2019 and Spring 2019

August 2020

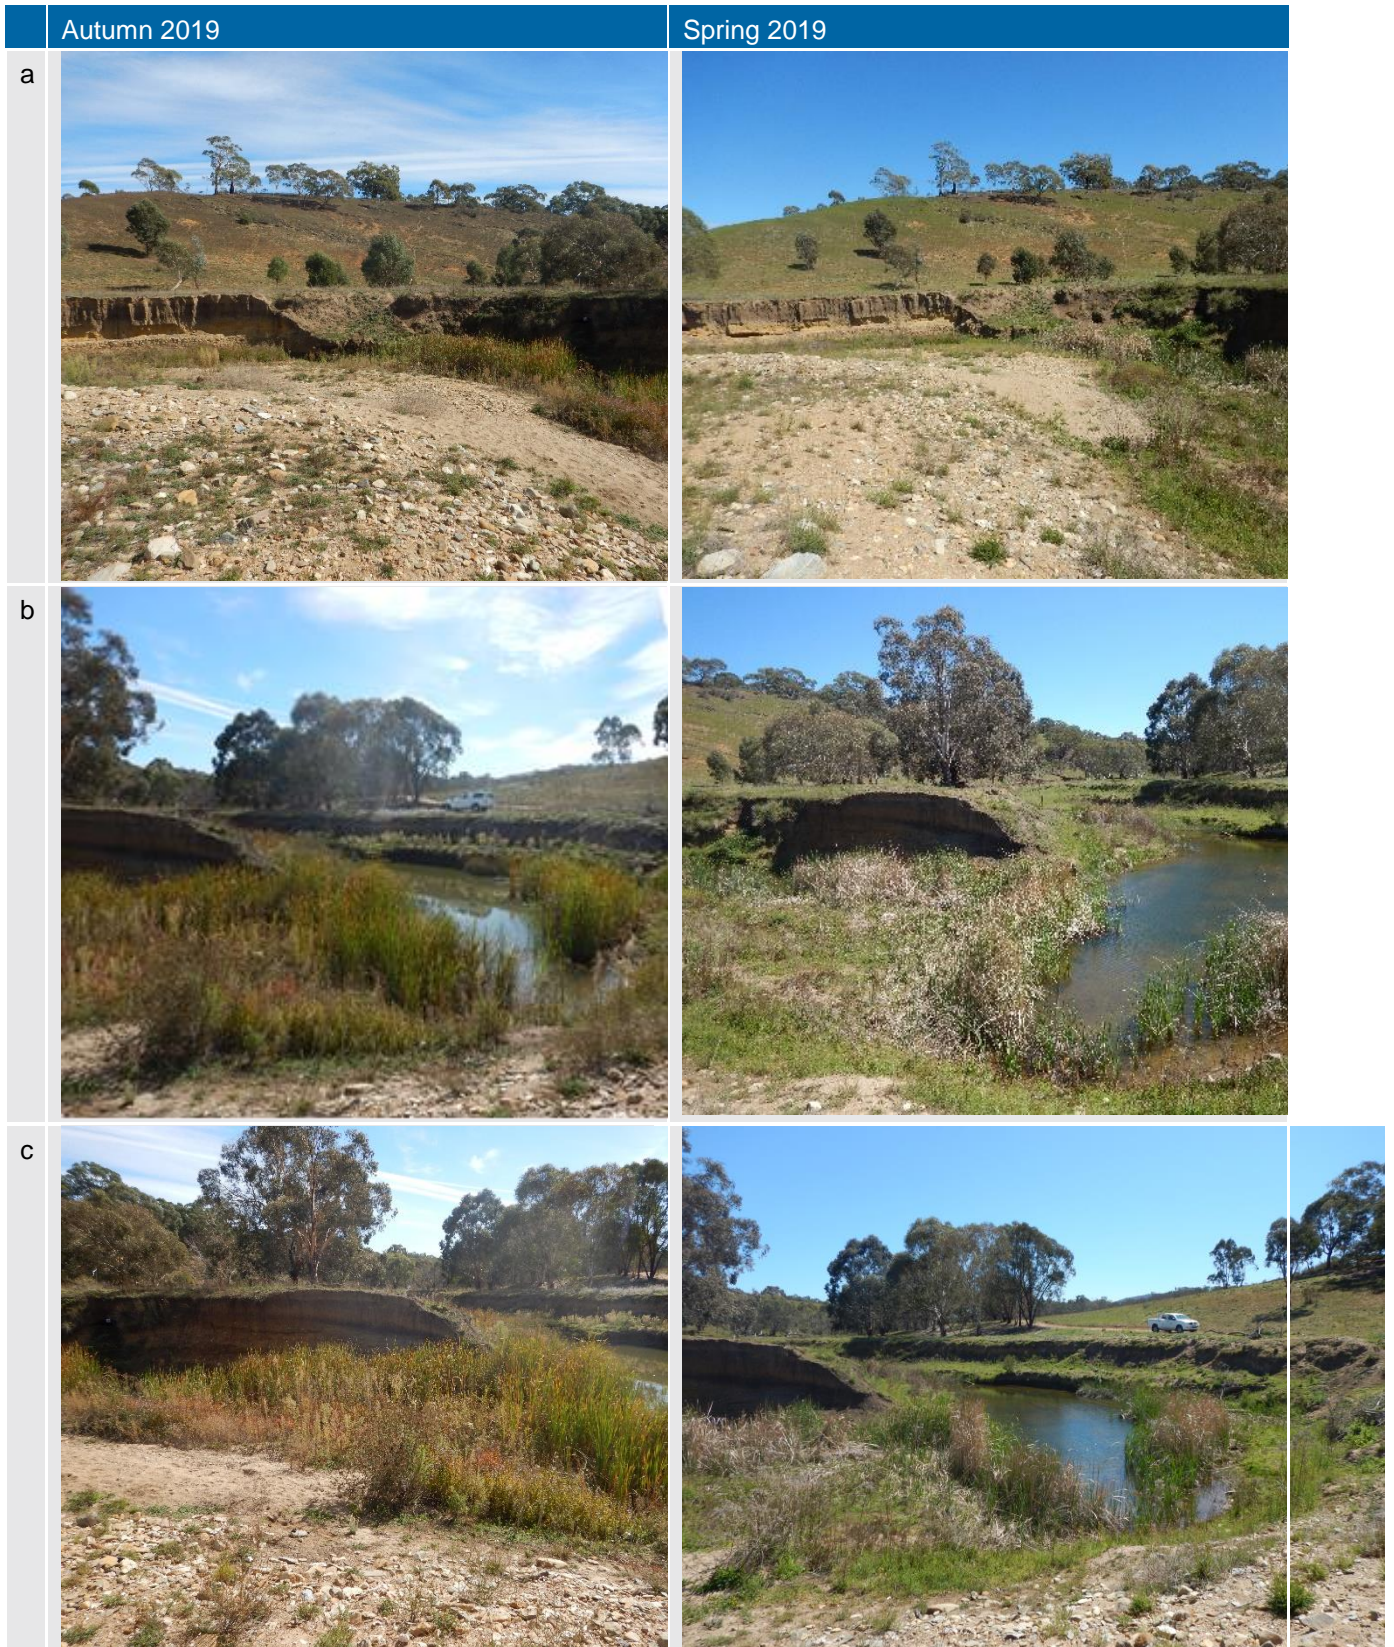
Plate 4-21. Vegetation extent and geomorphology photo point 3 at BUR 2c showing upstream (a), downstream (b) and across the channel (c) during autumn and spring 2019

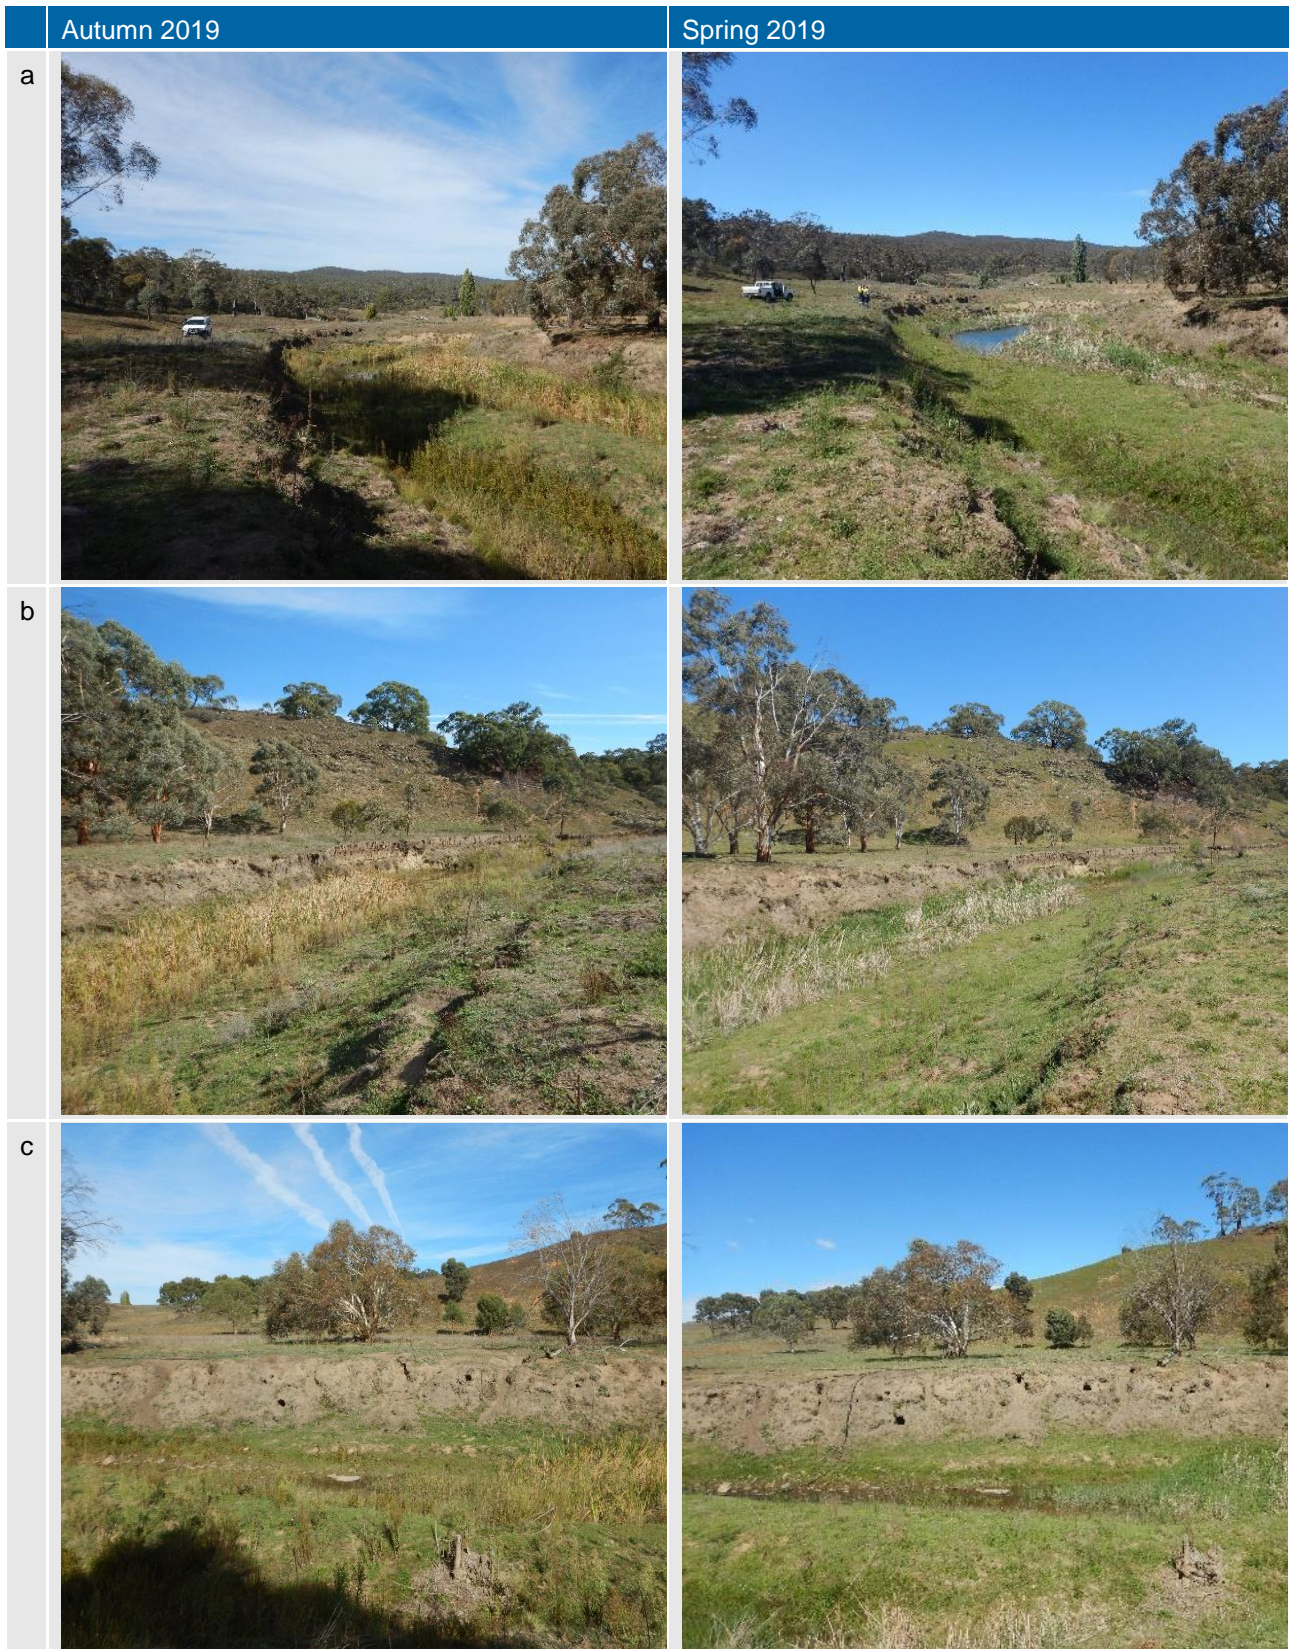
Plate 4-22. Vegetation extent and geomorphology photo point 4 at BUR 2c showing upstream (a), downstream (b) and across the channel (c) during autumn and spring 2019

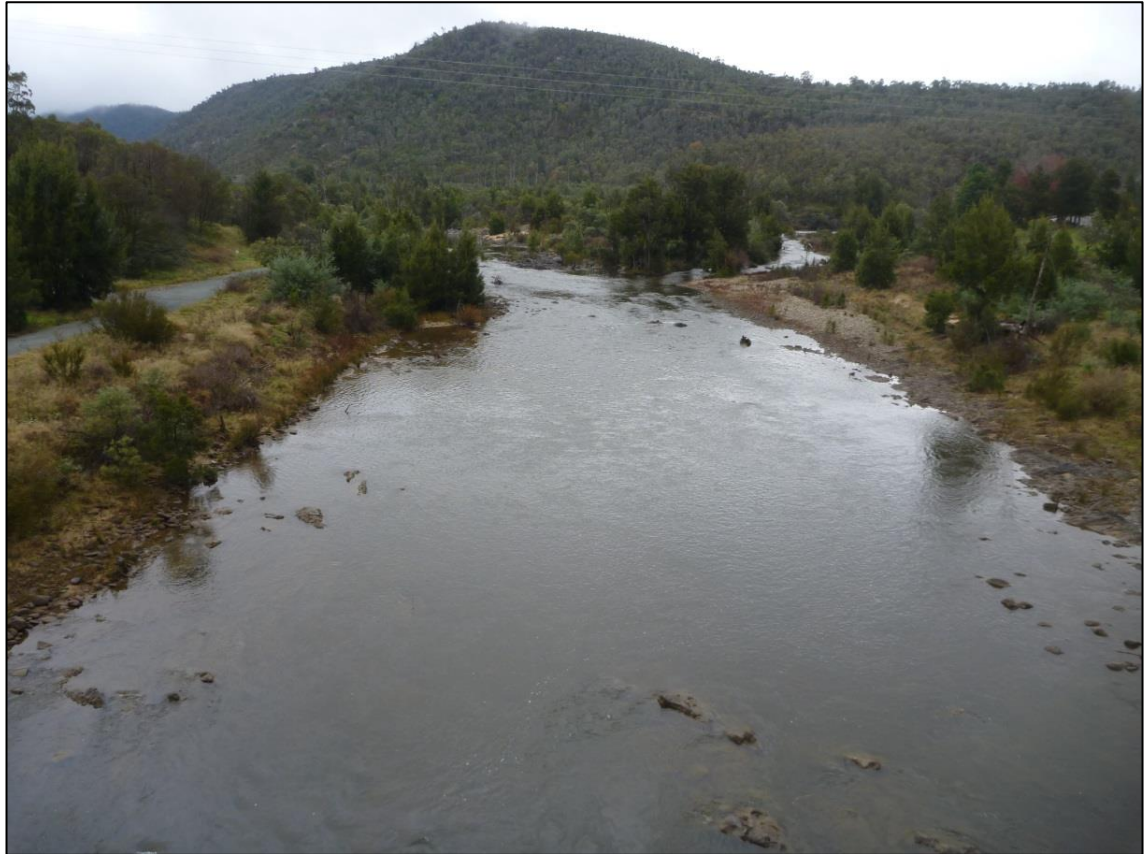
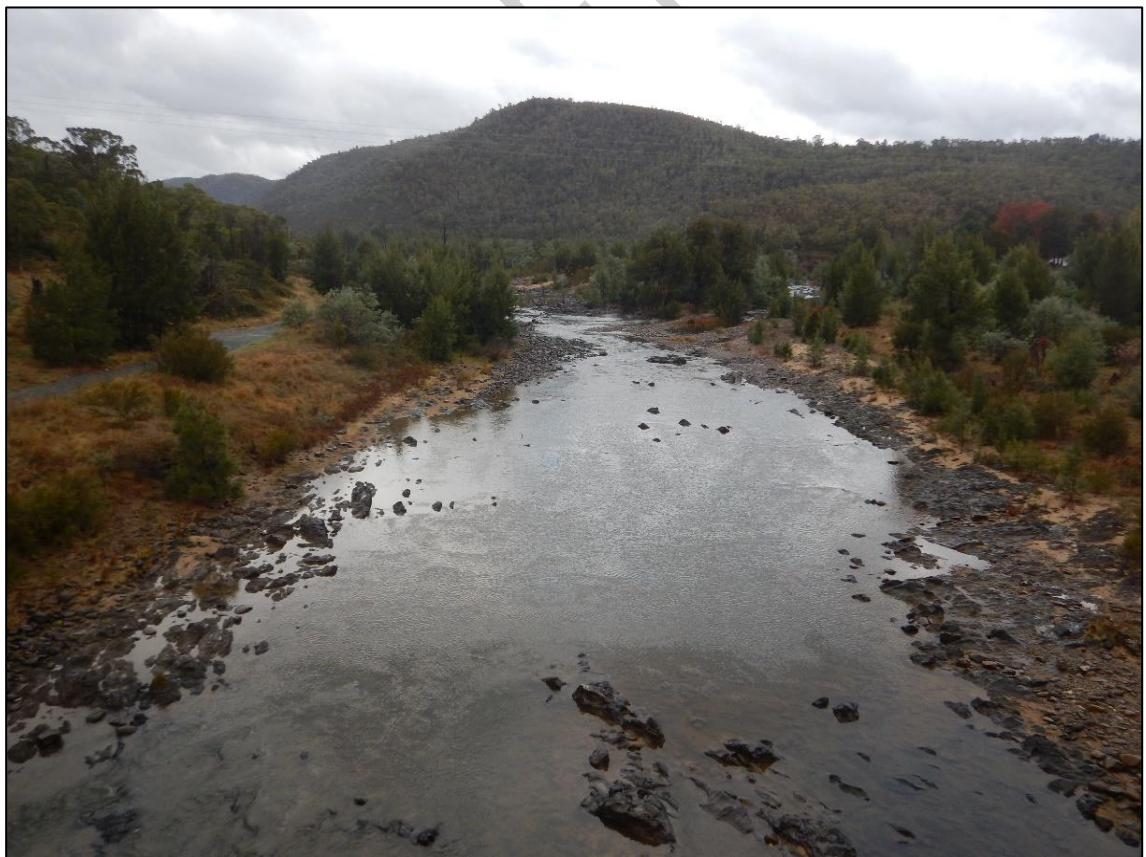
Figure 4-24. The Murrumbidgee River upstream of the Cotter Road bridge and the MPS in autumn 2015 (top – 510 ML/d) and 2018 (bottom – 108 ML/d). Flow is mean daily flow recorded at Mt. MacDonald (410738)

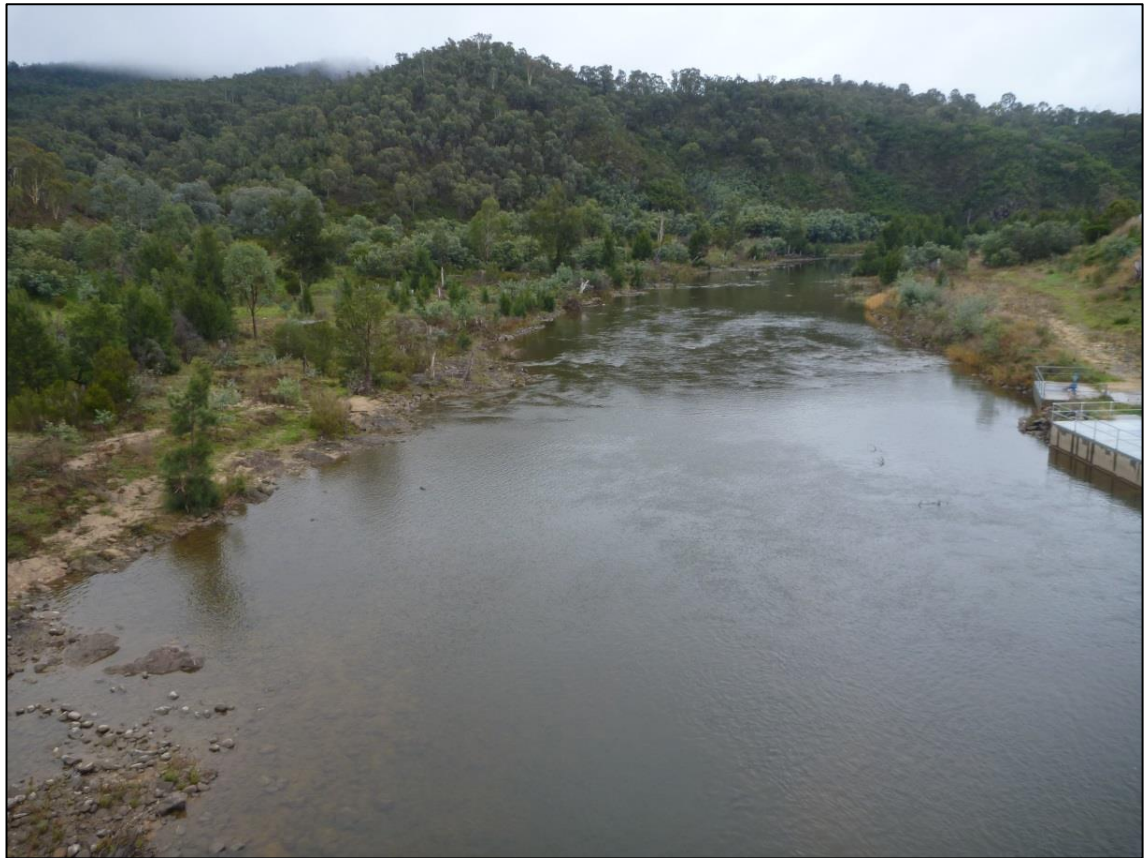
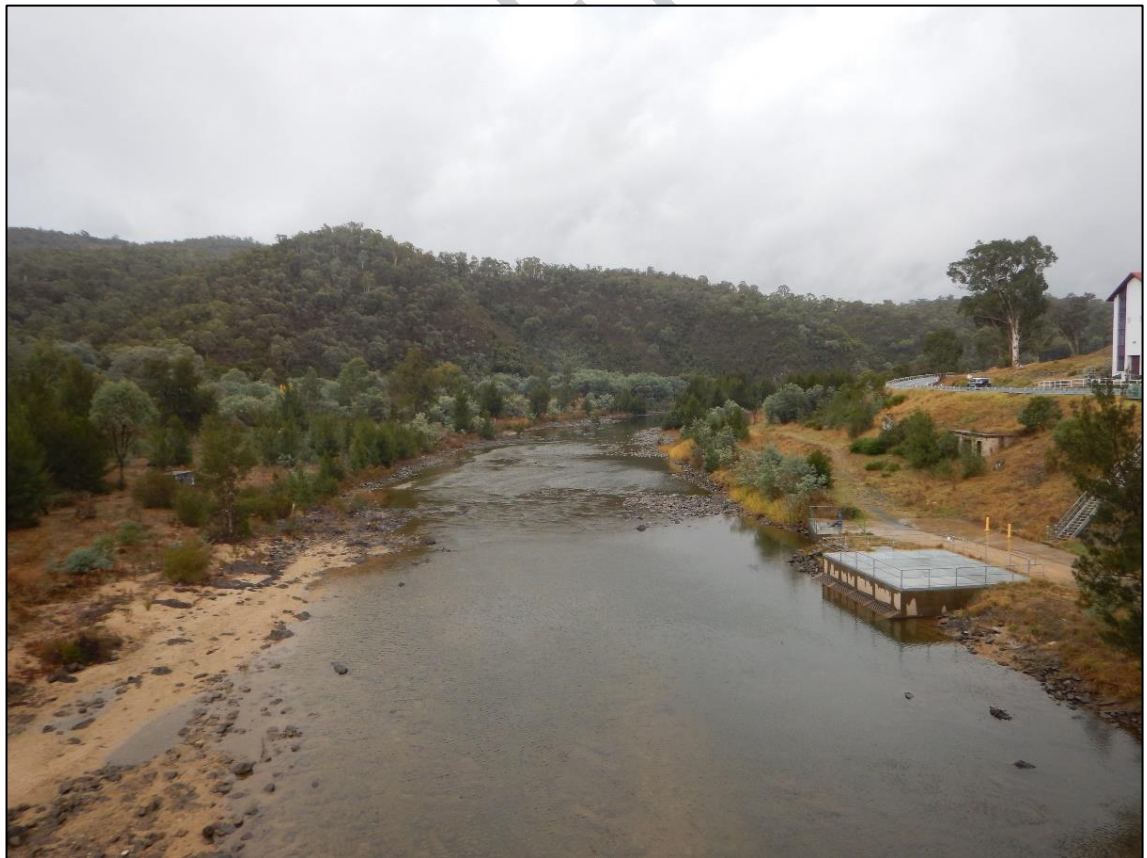
Figure 4-25. Murrumbidgee River downstream of Cotter Road bridge in autumn 2015 (top – 510 ML/d) and 2018 (bottom – 108 ML/d). Flow is mean daily flow recorded at Mt. MacDonald (410738)

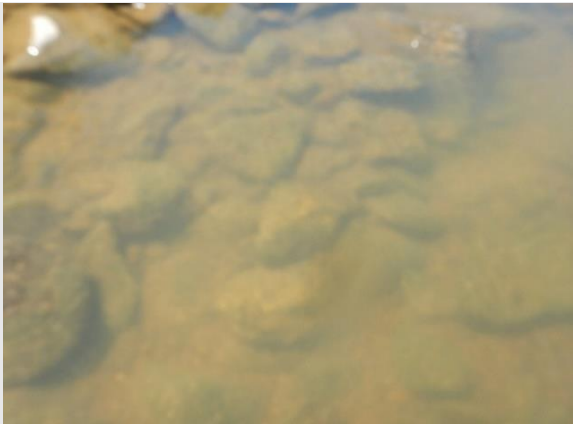
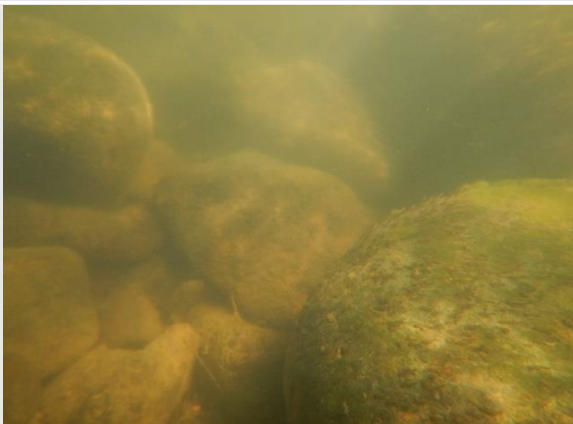
Plate 4-23. Photos showing periphyton coverage in the Murrumbidgee River

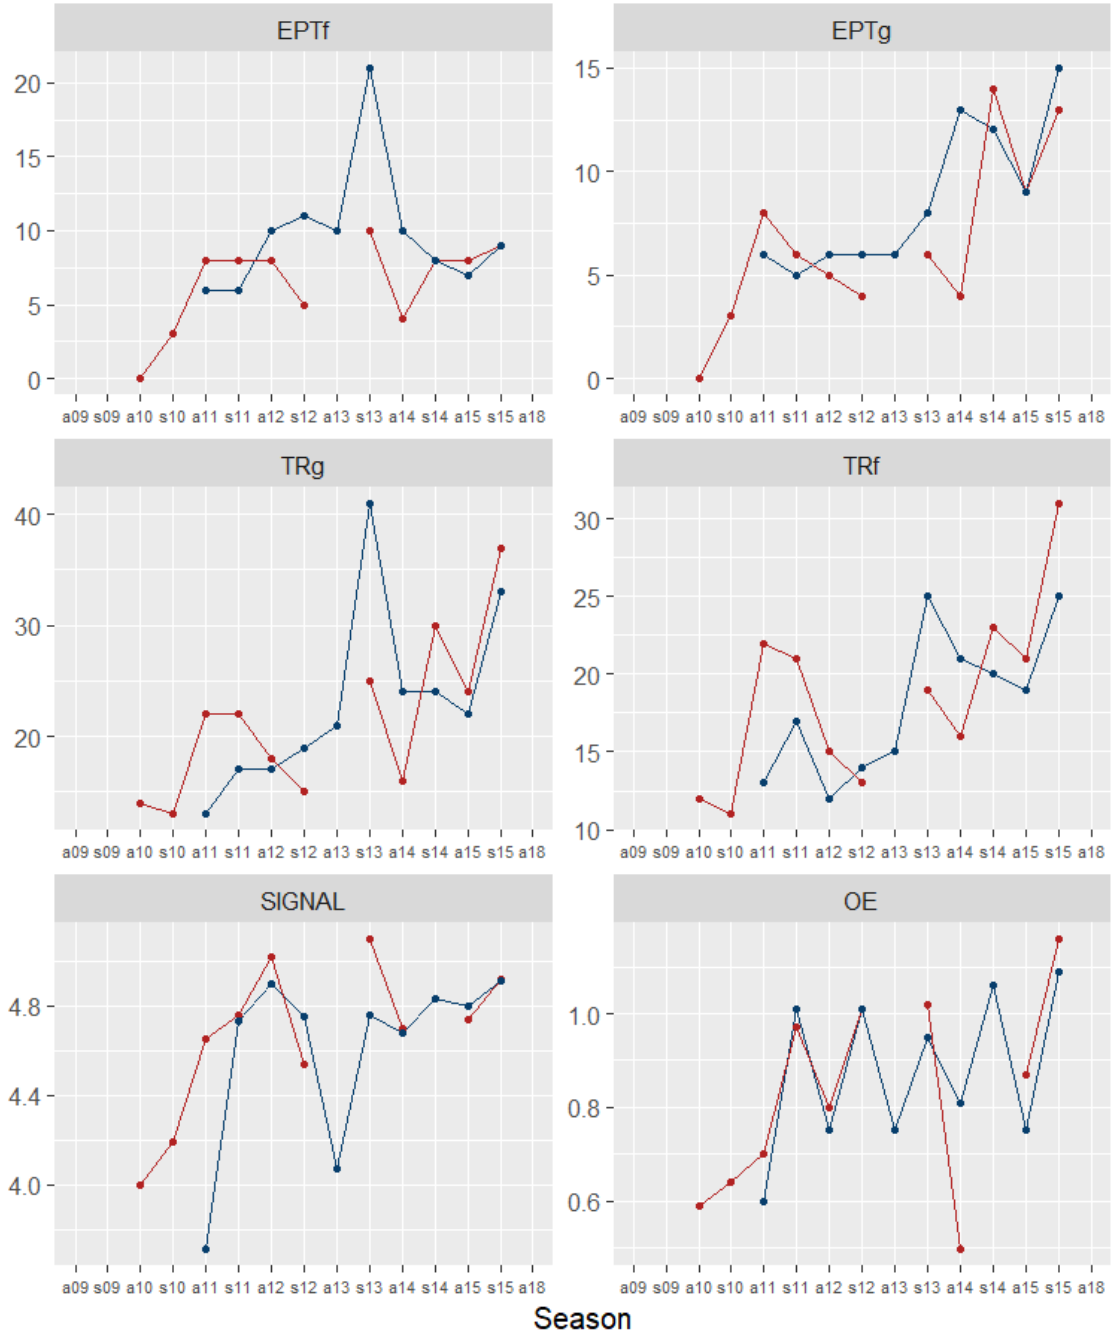
Burra Creek RIFFLE- Macroinvertebrate indices between autumn 2009 and autumn 2018
