Icon Water
Murrumbidgee Ecological Monitoring Program
Vegetation Assessment
2014

Executive summary

This report provides the details of the Burra Creek and Angle Crossing vegetation assessments, conducted in June-July 2014, at two sites upstream and two sites downstream of the M2G discharge structure and one site upstream and one site downstream of the intake structure.

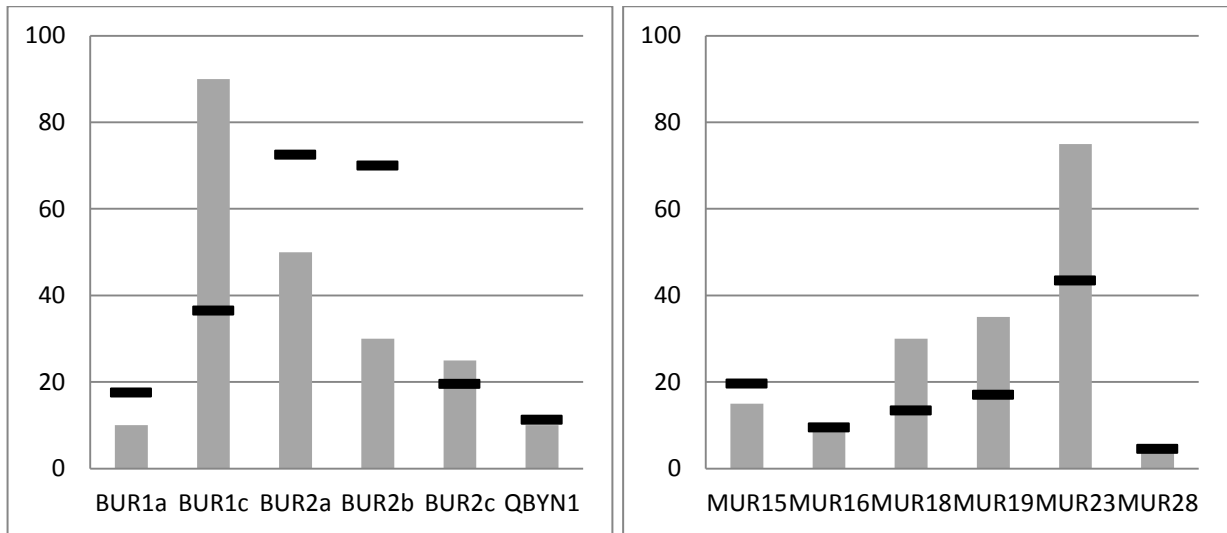
Figure 3-3. Instream vegetation cover (%) at Burra Creek and Angle Crossing sites during spring 2013 compared to historical means

Instream vegetation cover during spring 2013 was quite variable with some sites being recorded very close to historical means while other sites were more than 50% different compared to historical means (Figure 3-3). Spring results which deviated substantially from the means in Burra Creek were found at BUR 1c, 2a and 2b, with differences of 53.5, 22.5 and 40% respectively. The deviations from the means at Angle Crossing sites are lower than those recorded in Burra Creek, this is expected as the larger system size would create a much more stable environment for macrophyte establishment and growth. The larger deviations are 16.6, 18 and 31.6% at MUR 18, 19 and 23 respectively.

Note: Grey bars show current season results; black lines represent historical means.

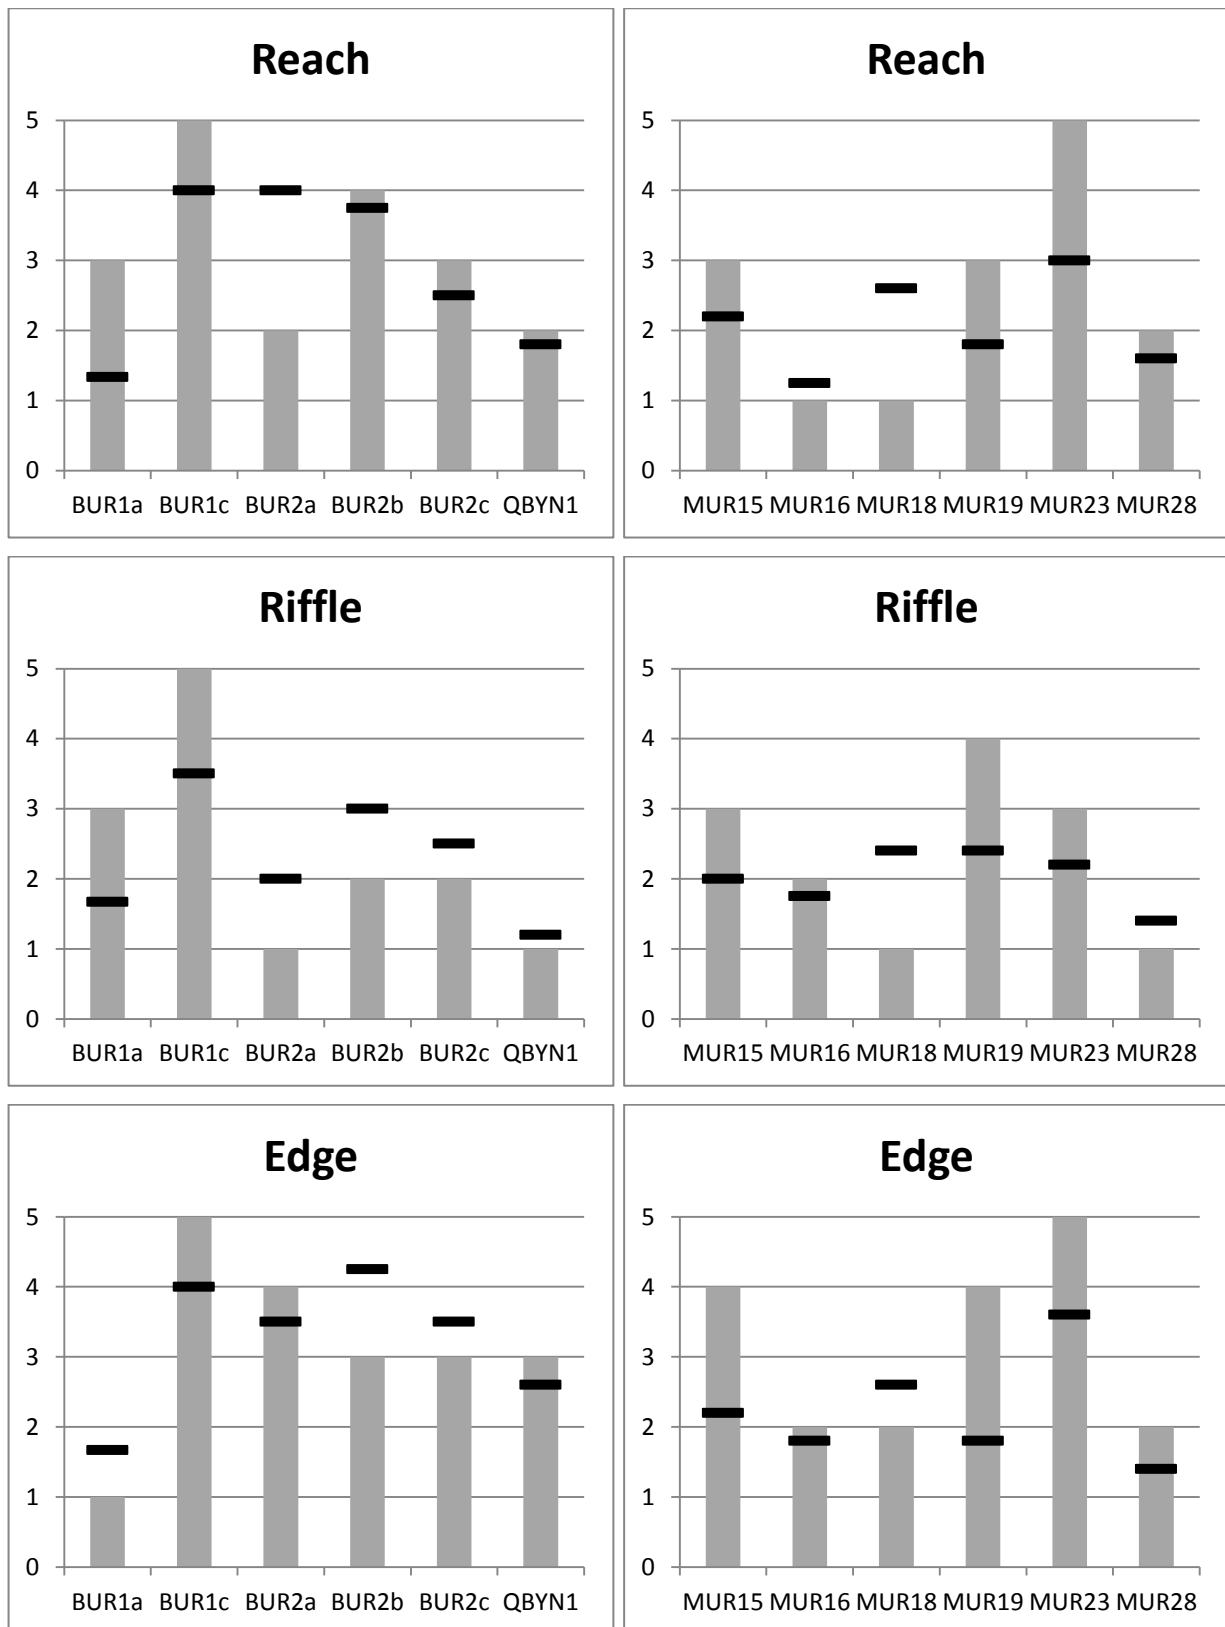
Figure 3-6. Instream vegetation recorded during autumn 2014 compared to historical means separated by location

Note: Grey bars show current season results; black lines represent historical means.

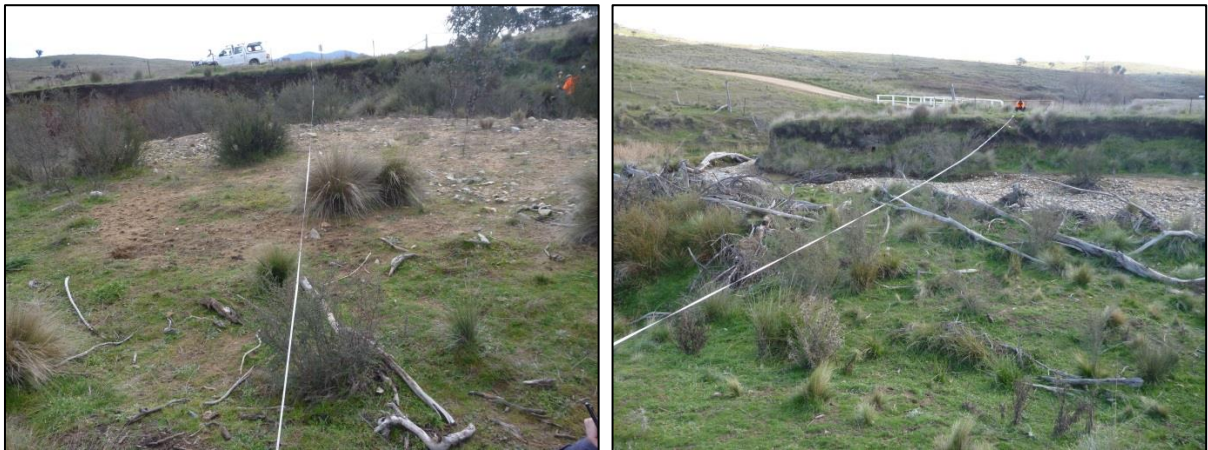
Plate 3-1. BUR 1a transect 1 (left) and transect 3 (right)

Vegetation at the site was predominantly grasses and sedges with species such as *Poa labillardieri*, *Paspalum sp.*, *Phalaris sp.*, *Hordeum leporinum*, *Carex appresa* and *Juncus usitatus*, with particular dominance on the right bank. Shrub vegetation was sparse with some sections of *Kunzea ericoides* and *Leptospermum phyllicoides* along the left bank. There were no trees recorded along any of the transects at this site. Disturbed areas on the left bank (likely from stock access) had been colonised by numerous weeds such as *Trifolium sp.*, *Carduus sp.*, *Acetosella vulgaris* and *Hypochaeris radicata*.

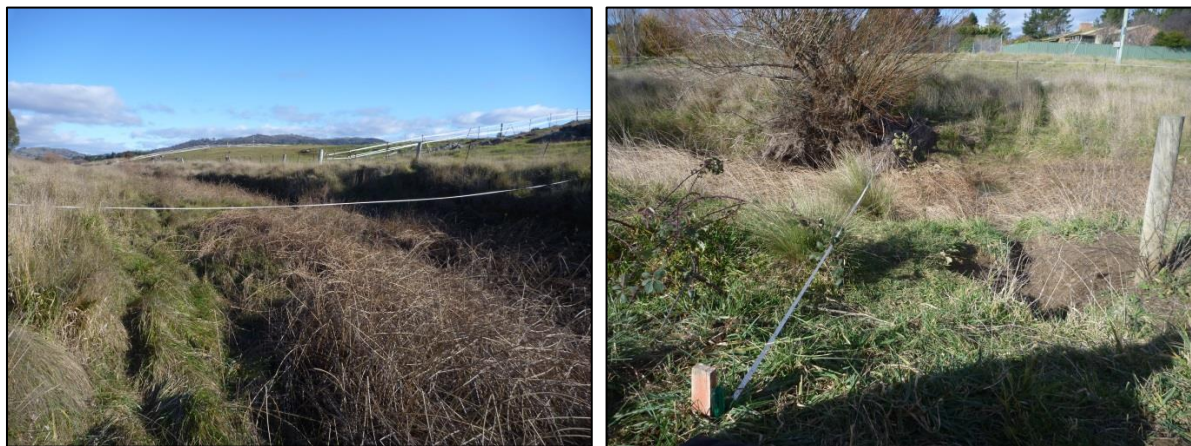
Plate 3-2. BUR 1c transect 1 (left) and transect 3 (right)

The vegetation coverage at BUR 1c was unique amongst the sites assessed during this study as it was dominated by grass species along both banks with aquatic macrophytes dominating all space within the creek channel itself. The only other vegetation are two *Salix sp.* at each end of the site, although only one of these trees was captured along one of the transects. There were no shrubs and very few forbs observed. Species richness was 23 at BUR 1c the lowest of all Burra Creek sites with 7 native species identified and 15 introduced species (1 species was not able to be identified to species level and therefore plant origin was unable to be determined) (Table 3-3). Although BUR 1c had the equal lowest native species richness of all Burra Creek sites it actually had the largest native percent coverage of with over 60% (Figure 3-11). BUR 1c also had the least bare ground of any site with less than 5% and the largest water cover, more than 20% (Figure 3-12). Site photos are presented in Plate 3-2.

The dominant grass species found along the banks at BUR 1c included the native *Poa labillardieri*, and introduced species *Phalaris minor* and *Paspalum dilatatum*. The dominant macrophytes within the channel itself were all native species and included *Schoenoplectus validus*, *Eleocharis atricha*, *Typha orientalis* and *Isolepis habra*. These macrophytes accounted for a large portion of the native species coverage at the site with *S. validus* alone accounting for almost 40% of the overall site coverage.

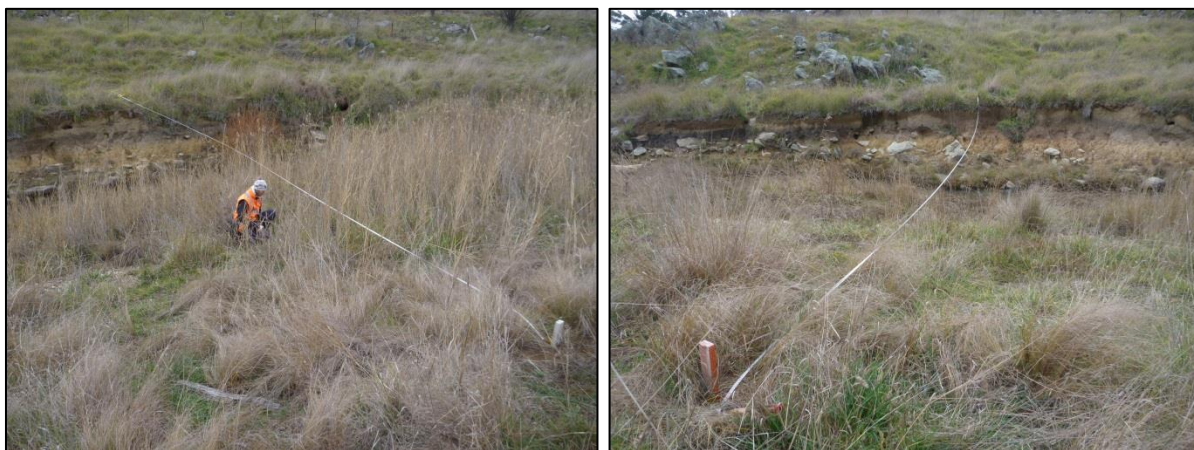
Plate 3-3. BUR 2a transect 2 (left) and transect 3 (right)

Vegetation at BUR 2a was dominated by *Phragmites australis*, particularly the upstream end of the site. The remaining coverage was grasses including the native *Paspalum distichum* and the introduced *Phalaris aquatic*, *Phalaris minor* and *Eragrostis curvula*. Diversity at BUR 2a was showed a species richness of 27 with 7 native species and 16 introduced species (4 species were not able to be identified to species level and therefore plant origin was unable to be determined) (Table 3-3). Although less than half of the species are native the dominance of the native macrophyte *Phragmites australis* has increased the coverage of native species at the site to over 50% compared to the coverage of introduced species (Figure 3-11), which is approximately 20% lower than during the 2011 assessment at this site (ALS, 2011). This decrease in native coverage since 2011 is likely due to increased levels of introduced grasses.

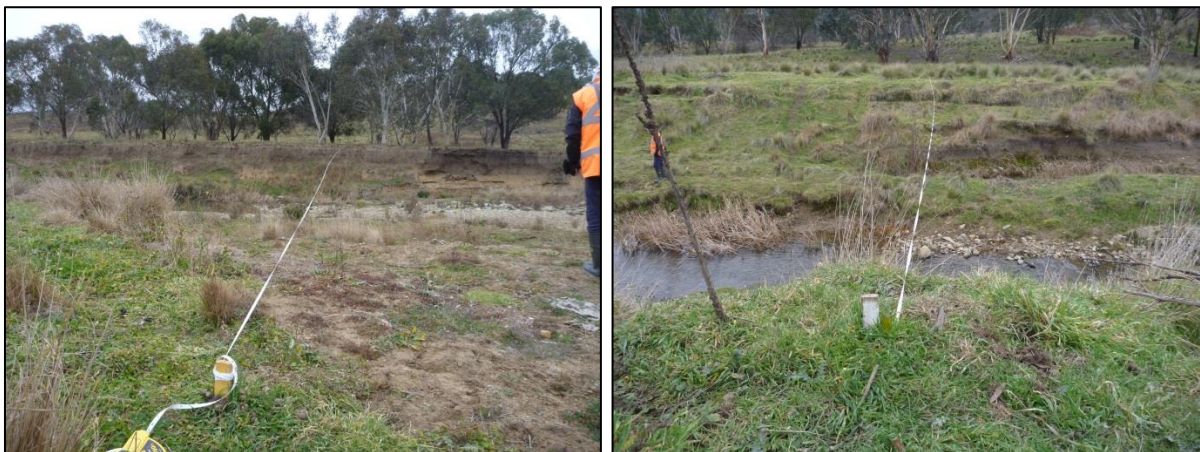
Plate 3-4. BUR 2c transect 1 (left) and transect 3 (right)

BUR 2c had the highest number of introduced species of all Burra Creek sites with 28 species observed, compared to 10 native species and an overall richness for the site of 42 (four species were not able to be identified to species level and therefore plant origin was unable to be determined) (Table 3-3). The dominance of introduced species is highlighted in Figure 3-11 which shows the coverage of native species at BUR 2c to be approximately 30%, which is the lowest cover of native species compared to introduced species of all sites. During the 2011 assessment native coverage was recorded at 80% (ALS, 2011), resulting in a decrease in native coverage by 50%. This change is due to an decrease in native grass coverage and replacement by opportunistic weed species, likely following disturbance by high flow events. Site photographs are presented in Plate 3-4.

While vegetation was dominated by forbs, BUR 2c was similar to BUR 1a as there was no overall dominant species at the site. As indicated by the introduced species richness introduced forbs were more abundant at this site than any other Burra Creek site. The more abundant of these species included *Medicago arabica*, *Acetosella vulgaris*, *Plantago lanceolata*, *Modiola caroliniana*, *Verbena bonariensis*, *Conyza bonariensis*, *Erodium cicutarium*, *Trifolium sp.* and *Hirschfeldia incana*. In-stream macrophytes were also quite diverse and included the native *Cyperus polystachyos*, *Eleocharis acuta*, *Isolepis habra*, *Schoenoplectus validus* and *Typha orientalis*, as well as the introduced *Mentha x piperita var. piperita* and *Veronica anagallis-aquatica*. *Eucalyptus spp.* were present at the site with *Eucalyptus pauciflora* observed on a single transect.

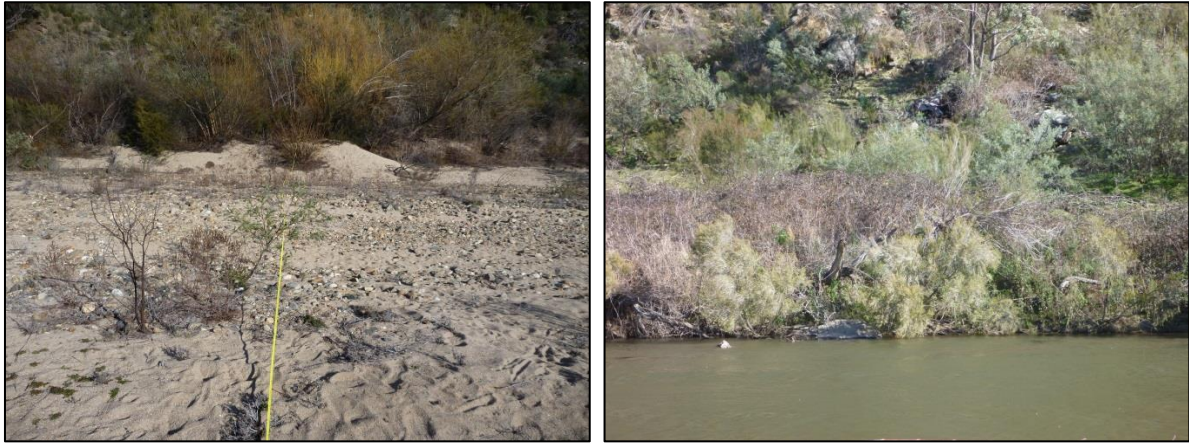
Plate 3-5. MUR 18 transect 1 (left) and opposite bank at the end of transect 2 (right) showing the blackberry infestation

MUR 18 was characterised by largesloping sand banks. This habitat is particularly unstable with roots held loosely in top sand, which results in many establishing plants being removed during inundation from high flow events. Site photos are shown in Plate 3-5.

Unlike the Burra Creek sites, trees were much more common at MUR 18 with the native *Acacia dealbata* and the introduced *Salix* sp. contributing significantly to bank stability along the water line. Native shrubs were also contributing significantly to bank stabilisation with established natives *Callistemon sieberi* and *Leptospermum phyllicoides* also found along the immediate shoreline, with some introduced *Rubus fruticosus* also along the lower bank.

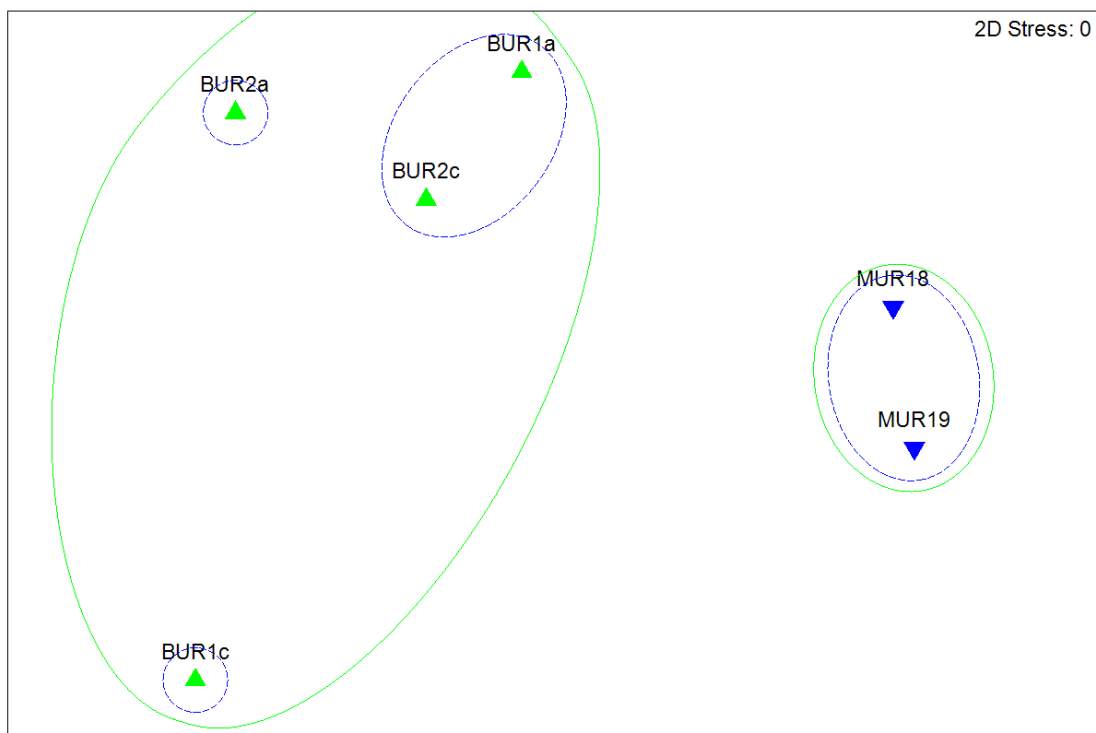
Figure 3-13. Non-metric multidimensional scaling of sites

NMDS plot shown in Figure 3-13 shows the separation of the Burra Creek sites and the Murrumbidgee sites. While this is not unexpected, the surprising result is the similarity of BUR 1a & 2c with greater than 40% similarity. These two sites share similar species richness with 20 species found at both sites and have a similar abundance of bare ground. This has changed since the assessment during 2011 when BUR 1a and 1c were more similar with BUR 2a & 2c separate. BUR 1c was unique in its species composition with such dominance of aquatic vegetation, when compared to other sites, but most of all compared to BUR 1a which showed the least aquatic vegetation of all Burra Creek sites.

Note: Green ellipses represent 20% similarity and the blue ellipses represent 40% similarity. Green points are Burra Creek sites and blue points are Murrumbidgee River sites.

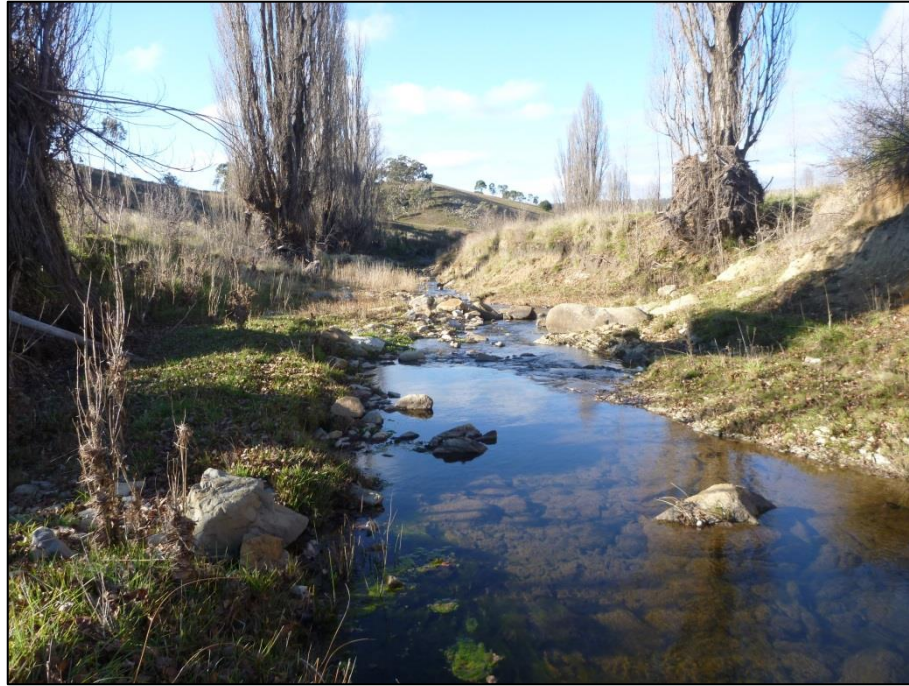
Populus sp. were common throughout the Zone with the downstream area (downstream of Pool 6) consisting mainly of *Eucalyptus* spp. *Rosa rubiginosa* was also present along the creek, while *Populus* sp. juveniles were common from pool 11 through to 13 (Plate 3-7).

Plate 3-7. Zone 1 at Pool 12 showing a juvenile *Populus* sp. on the left bank

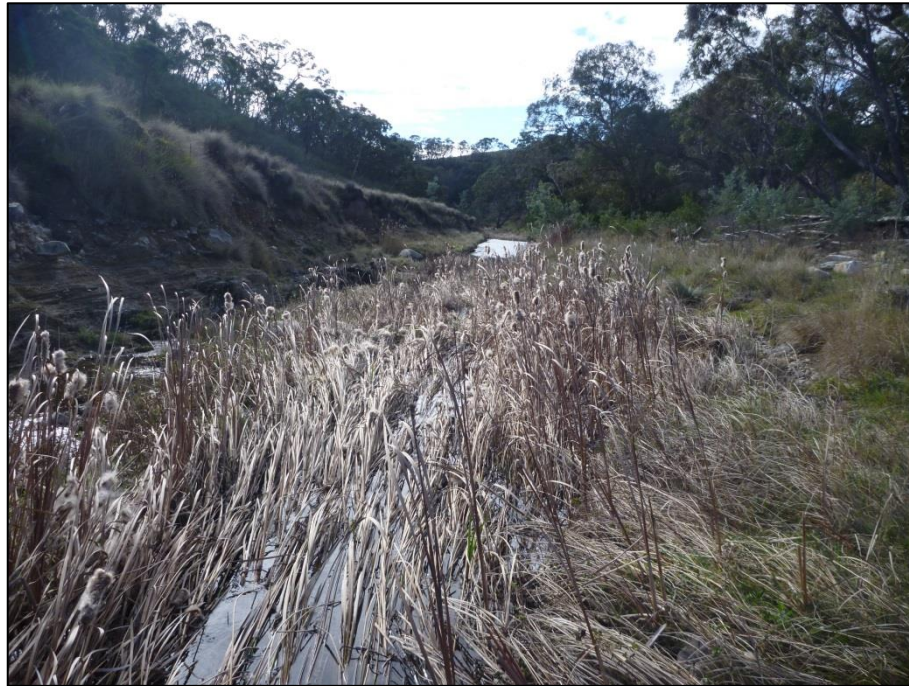
Plate 3-8. Zone 2 downstream of Pool 28 dominated by *Typha orientalis*

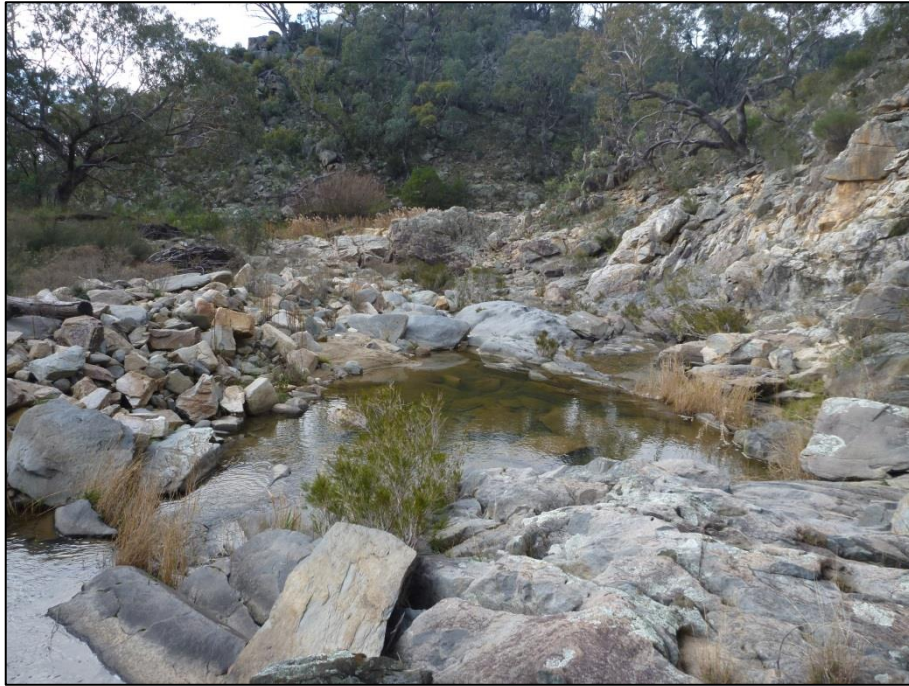
Plate 3-9. Bedrock and boulder dominated substrate in Zone 3

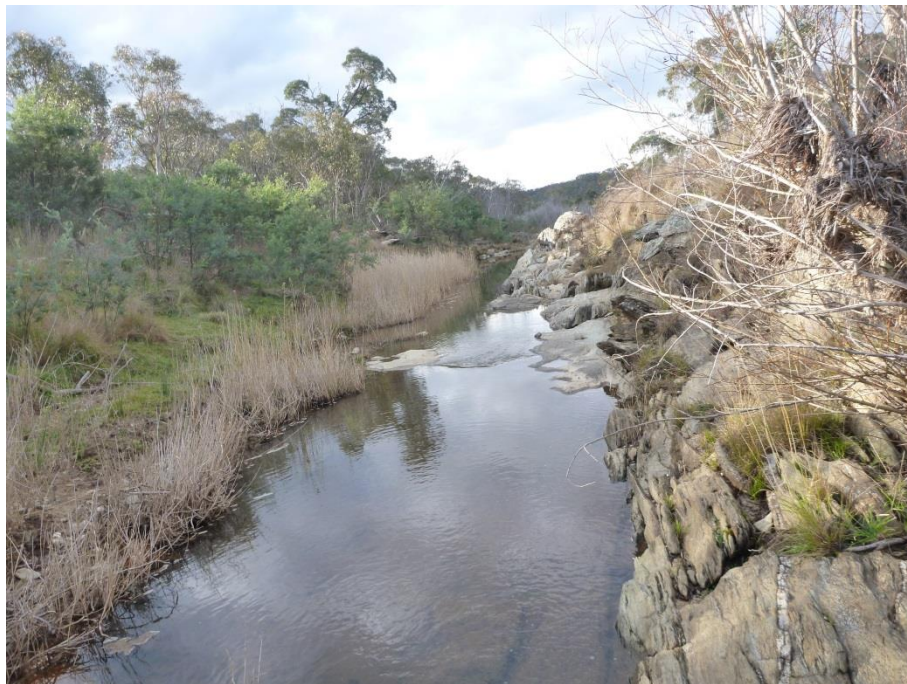
Plate 3-10. Bedrock pools with *Phragmites australis* inhabiting soft sediment sections in Zone 4

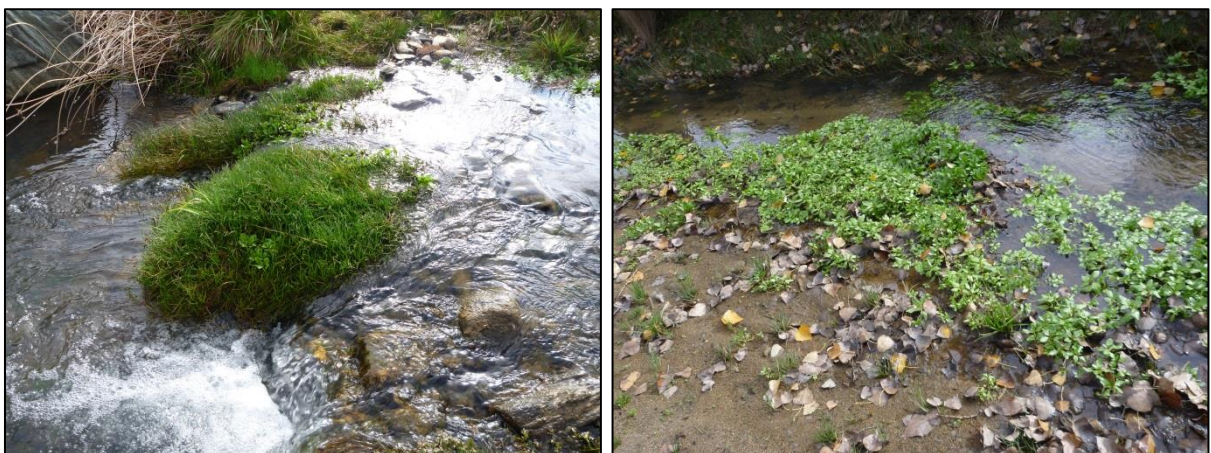
Plate 3-11. *Isolepis habra* (left) and *Callitriche stagnalis* (right) in Zone 5

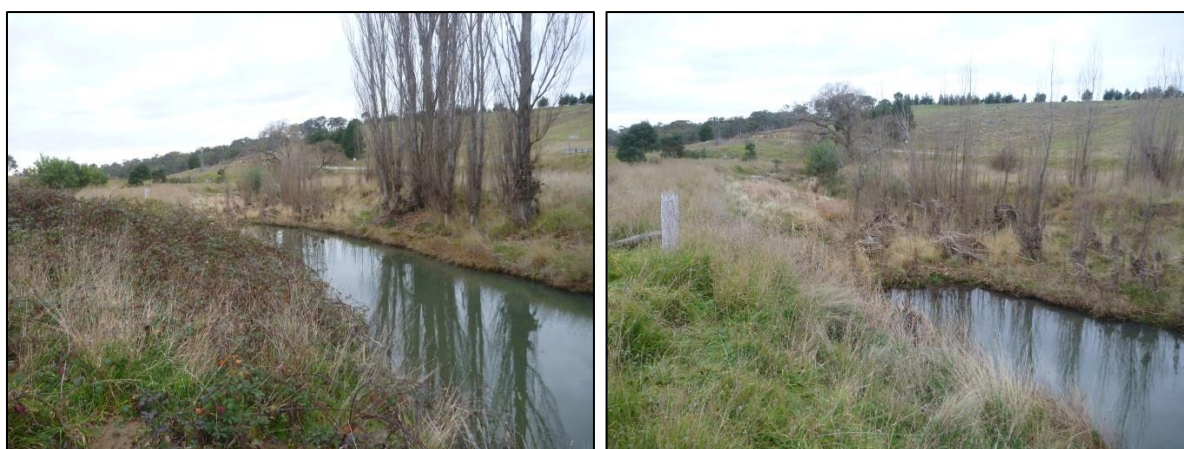
The upper riparian zone is characterised by steep banks along most of the Zone and is vegetated predominantly by pasture grasses, mainly *Phalaris* sp., *Paspalum* sp. and *Poa* spp., and a high diversity of weeds. Juvenile *Populus* sp. were common from pool 69A through to 69B. *Rubus fruticosus* infestations were noted around at the upstream area near to the discharge structure (Plate 3-12).

Plate 3-12. *Rubus fruticosus* (left) and juvenile *Populus* sp. around Pool 69B in the upstream section of Zone 6

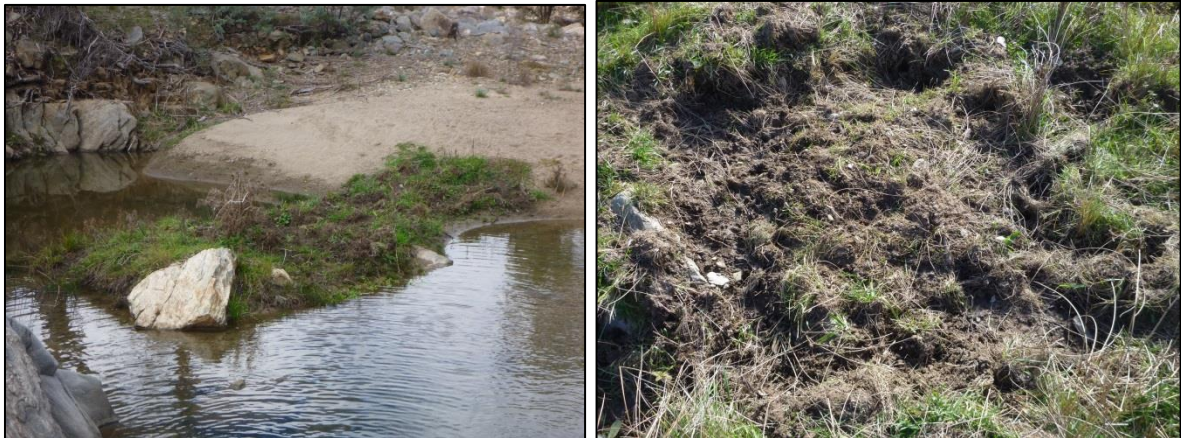
Plate 3-13. Evidence of feral pigs in Zone 3 (left) and Zone 2 (right)
