Icon Water MEMP

Impact monitoring – autumn 2020, spring 2020, autumn 2021

Icon Water Limited

28 October 2021

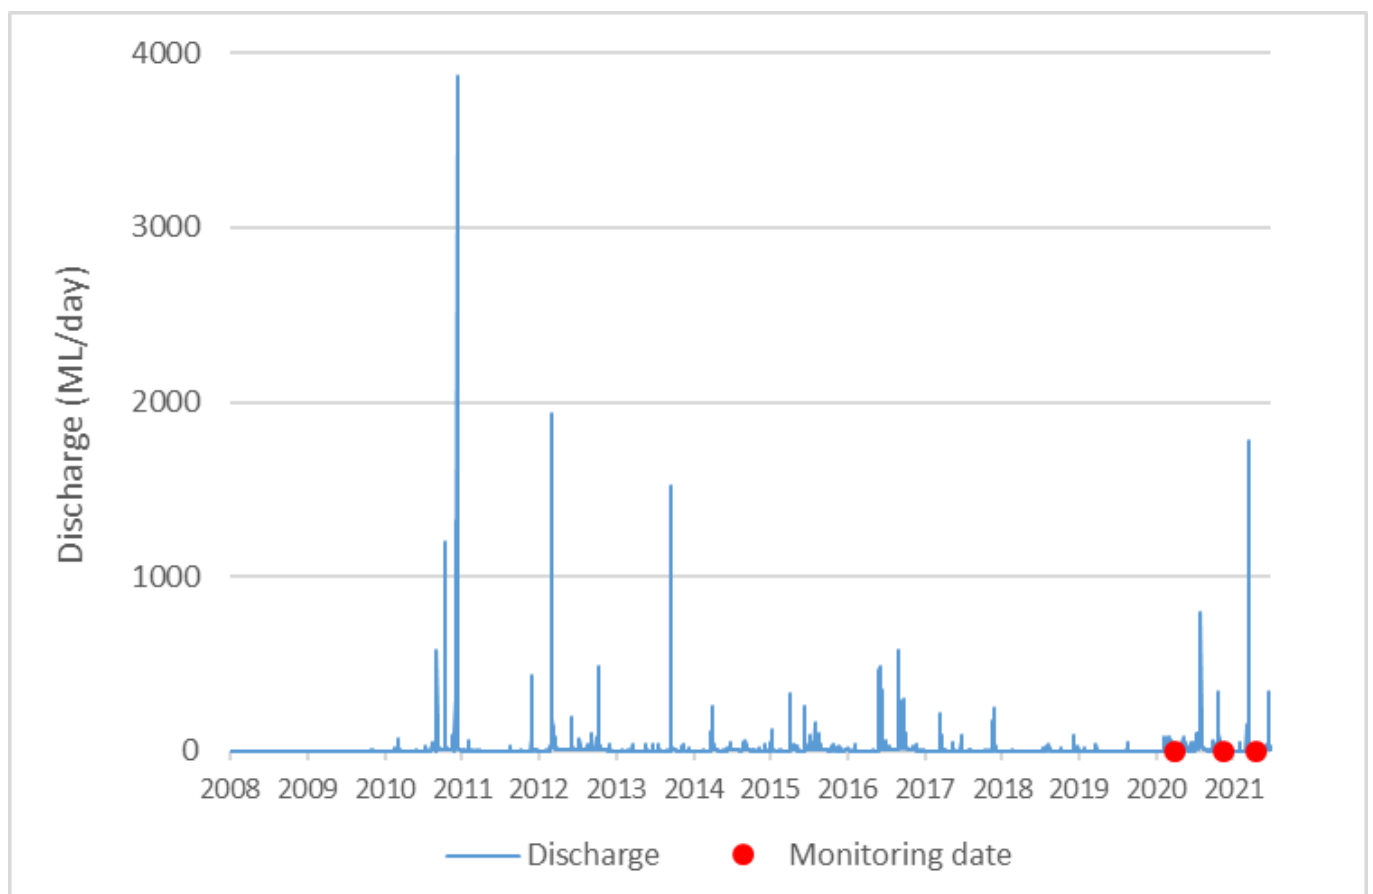
Figure 2-2 Discharge (ML/d) of Burra Creek at the Burra Road weir (410774) from January 2008 to July 2021

Flow have varied considerably since the inception of the MEMP in late 2008 (Figure 2-2). In 2008, mean daily flow was 0.15 ML/d and this was followed by an equally dry year in 2009 when the mean daily flow was 0.18 ML/d. In early 2010, the Millennium Drought broke and there were several high rainfall events throughout most of the year resulting in an upward trend of daily mean flows, which reached an average of 31.5 ML/d. While discharge was lower in 2011, flows increased in 2012 following high rainfall. Between 2013 and 2017 average annual flows ranged between 6.0 ML/d to 18.3 ML/d. The region was in drought between 2017 and 2019 and flows in Burra Creek reduced. During this period, there were few high flow events and summer in 2019 was the driest since 2009 (Figure 2-2). Drought broke in 2020 and flows increased in Burra Creek. The mean annual discharge for 2020 was 22.01 ML/d, the highest since 2012. Flows have been remained relatively higher in the first half of 2021.

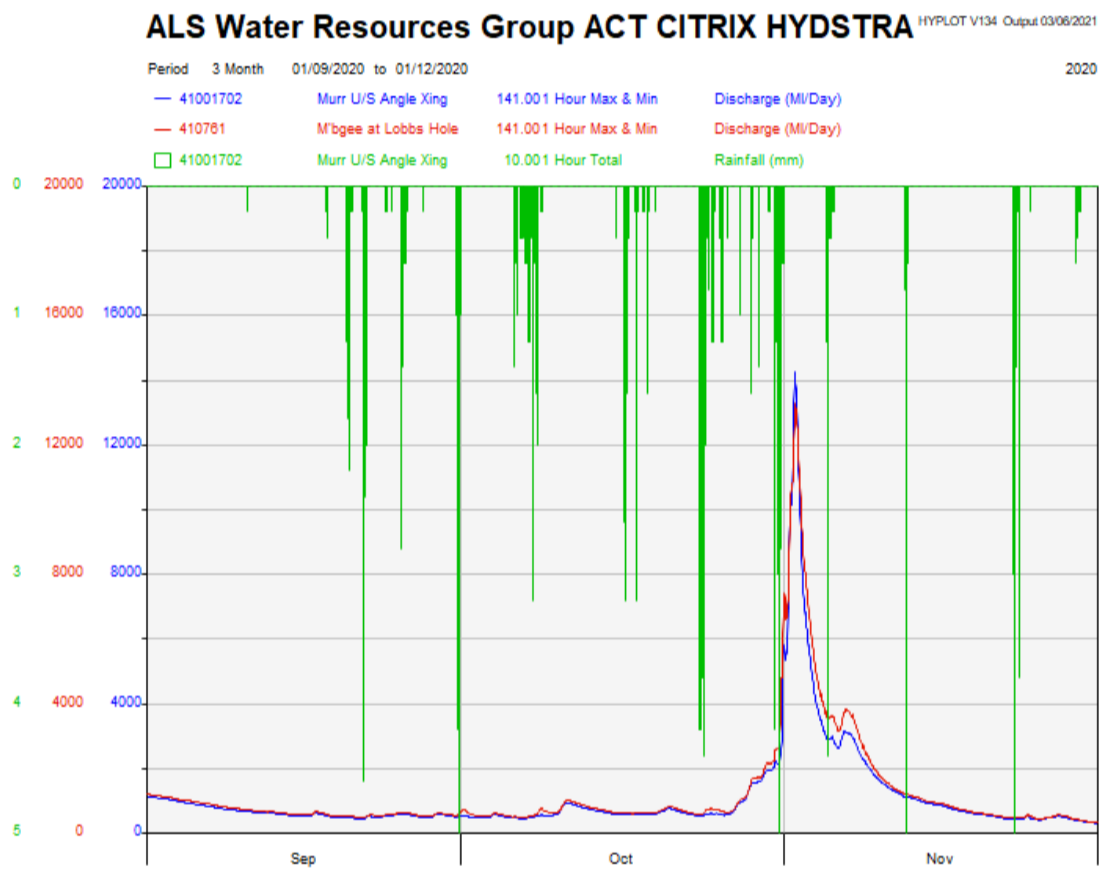
Figure 4-1 Rainfall and hydrographs of the Murrumbidgee River upstream (41004702) and downstream (410761) of Angle Crossing in autumn 2020 (top), spring 2020 (middle) and autumn 2021 (bottom)

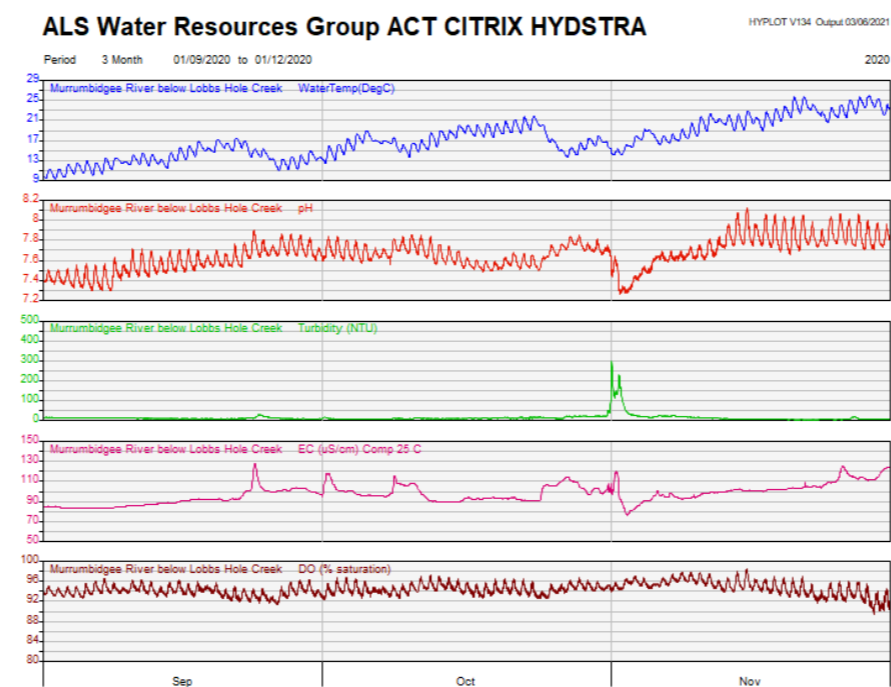
Figure 4-3 Continuous water quality records from Lobb's Hole (410761 - downstream Angle Crossing) for autumn 2020 (left), spring 2020 (middle) and autumn 2021 (right)

There was some indication pH varied throughout the Murrumbidgee River although it remained above the minimum ANZG (2018) guideline of 6.5 and rarely exceeded the maximum guideline of 8.0. There were some exceptions to this including during autumn 2020 when in April it increased above 8 at Lobb's Hole which was not observed upstream of Angle Crossing. The reasons for differences in pH upstream and downstream of the M2G abstraction point are not known but could be due to differences in site specific conditions such as the abundance of aquatic plants. During daytime hours photosynthesis can lead to increased DO while during the night DO is reduced and the proportion of carbon dioxide increased. Carbon dioxide (CO₂) is acidic and the sequestration of CO₂ during photosynthesis increases the pH of water which can carry over to daytime. There were also some occasions where pH rapidly decreased such as the start of November 2020, late March 2021 and May 2021 both upstream and downstream of the M2G abstraction point. These decreases are likely a dilution effect and correspond with periods of high flow.

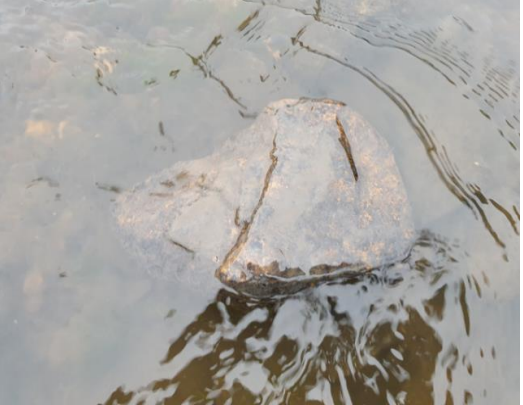
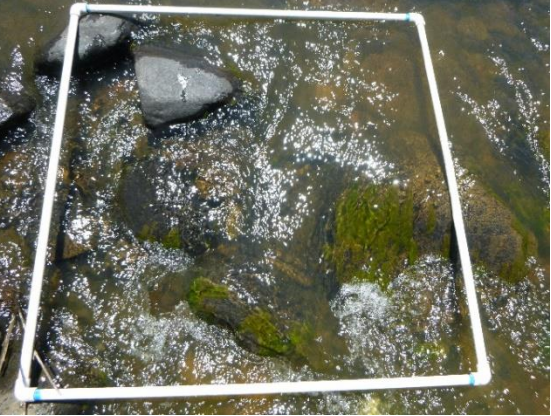
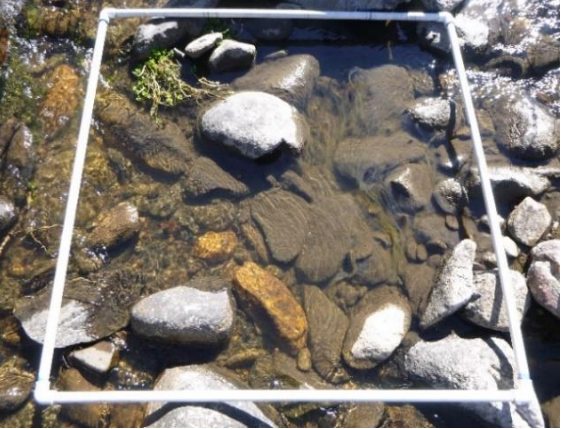
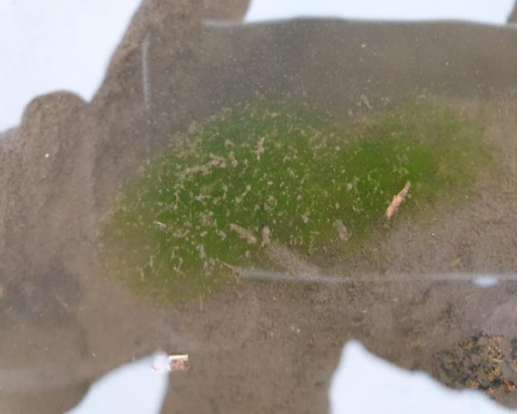
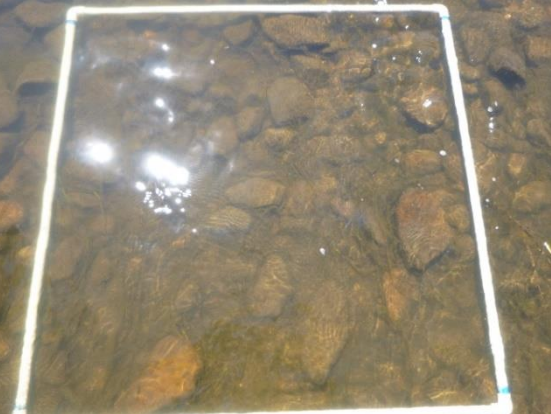
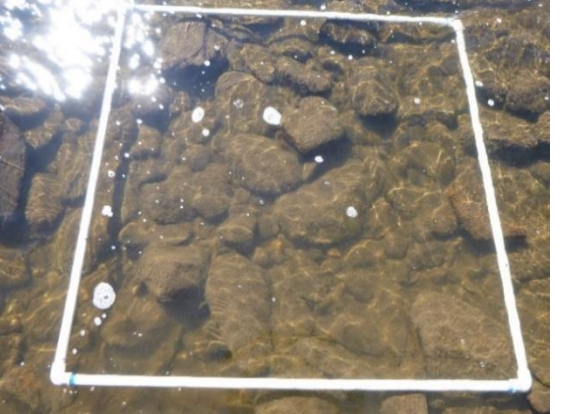
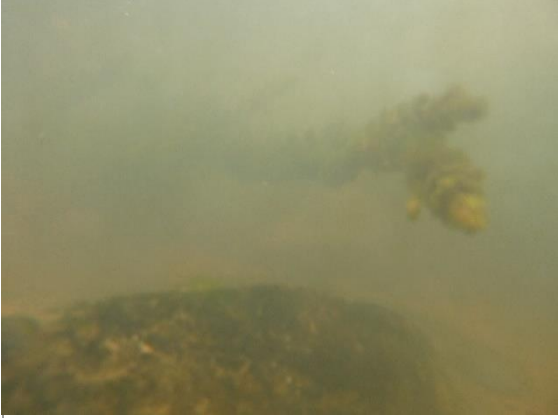
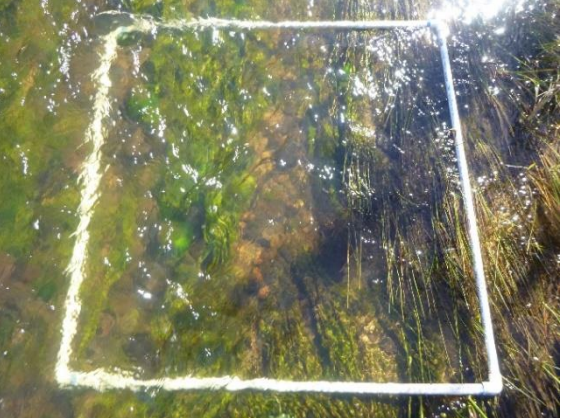
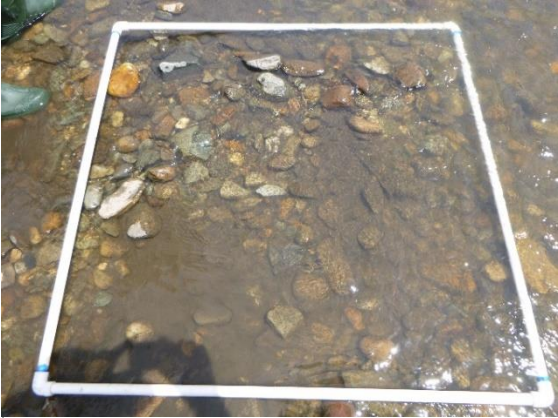
Plate 4-1 Photographs showing periphyton coverage in riffles of the Murrumbidgee River at M2G sites

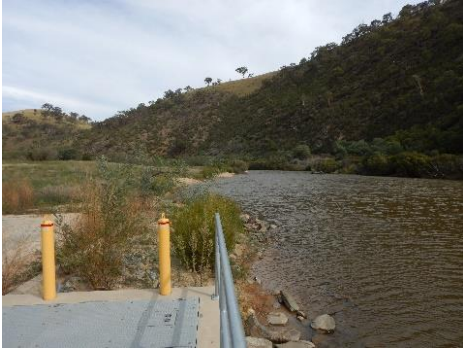
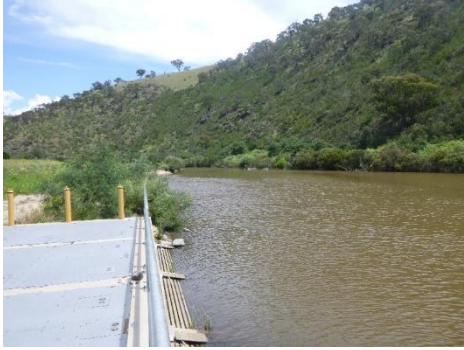
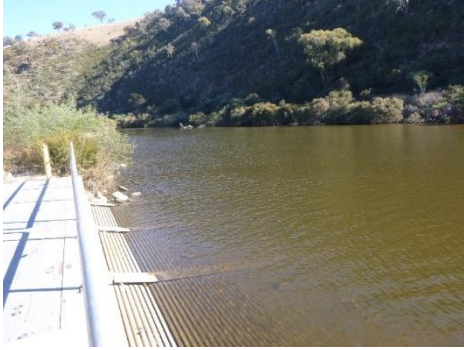
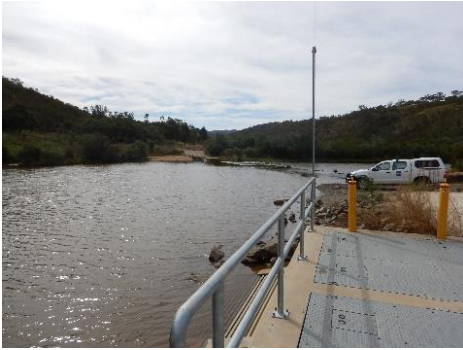
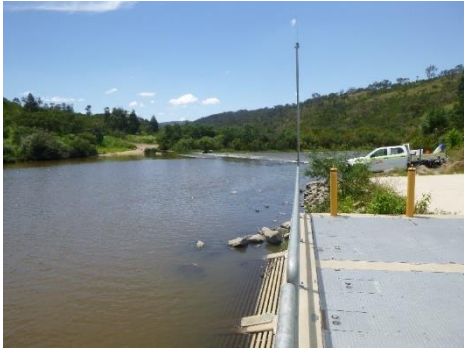
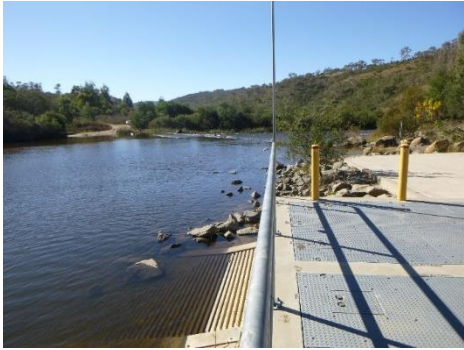
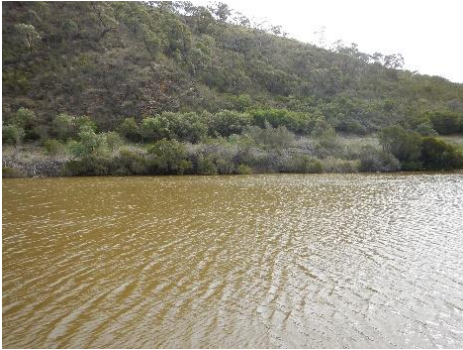
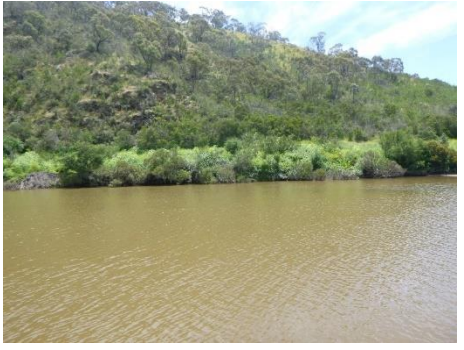
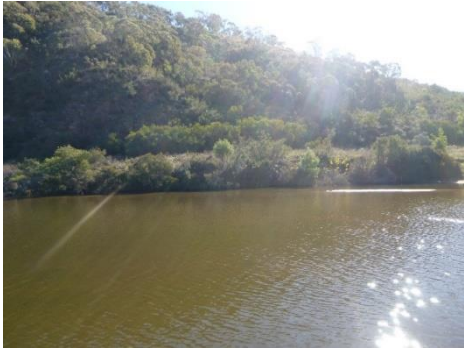
Geomorphological features at Angle Crossing (MUR19) observed in 2020 and 2021 have remained relatively unchanged since 2017. Plate 4-2 to Plate 4-4 show some degree of seasonal variation in water level, which was slightly higher during spring 2020 compared to the two autumn seasons. Changes in bed and bar exposure associated with water levels changes can be seen. Vegetation dieback and recruitment can also be observed to varying degrees. However, the riverbanks have remained stable at each of the photo points and there is no evidence of bank slumping or areas of significant erosion.

Plate 4-2 Geomorphology photo point 1 at Angle Crossing MUR19

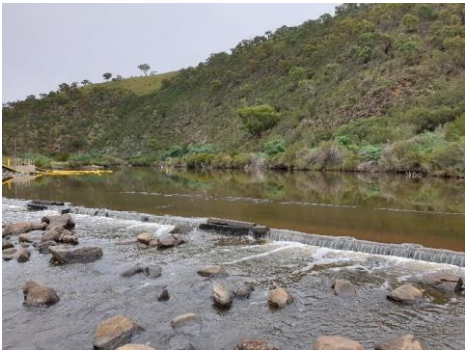
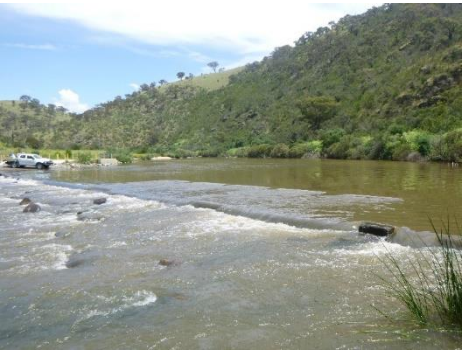
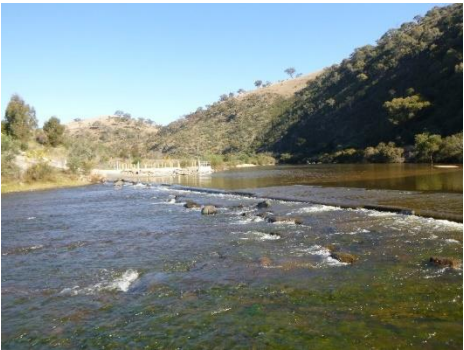
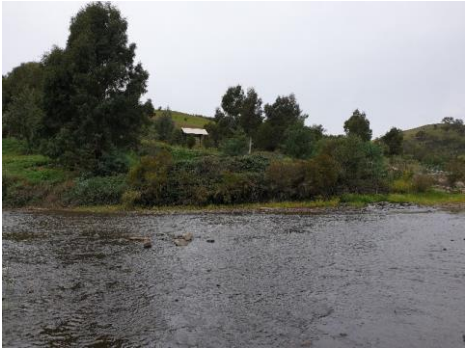
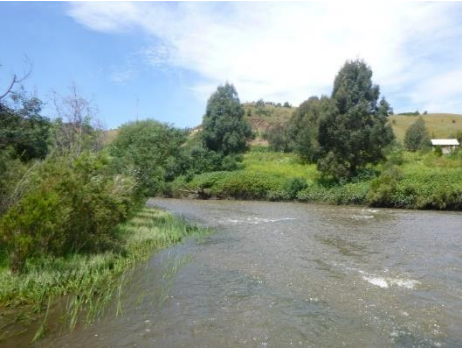
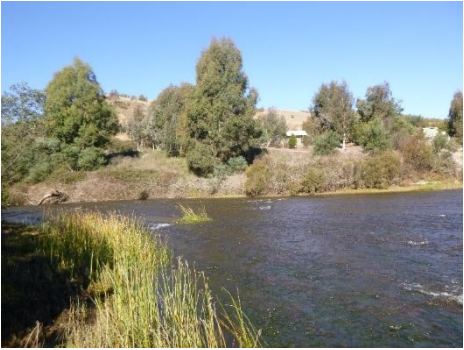
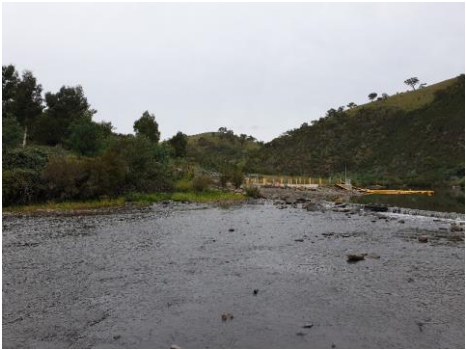
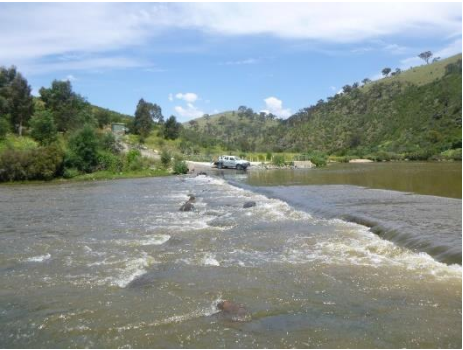
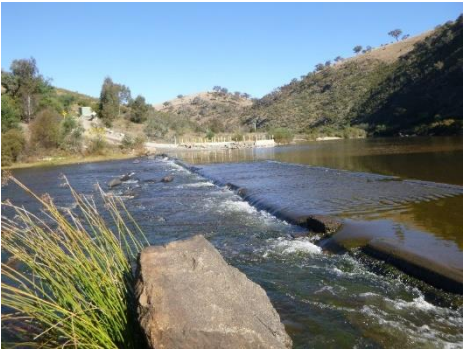
Plate 4-3 Geomorphology photo point 2 at Angle Crossing MUR19

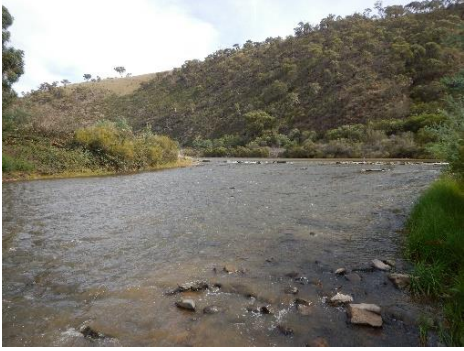
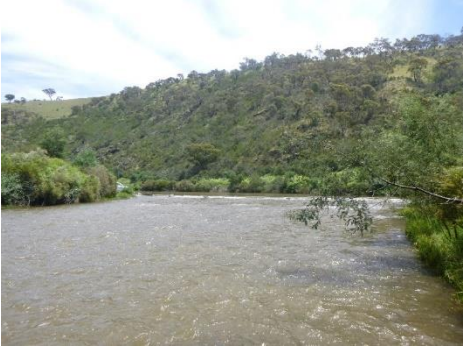
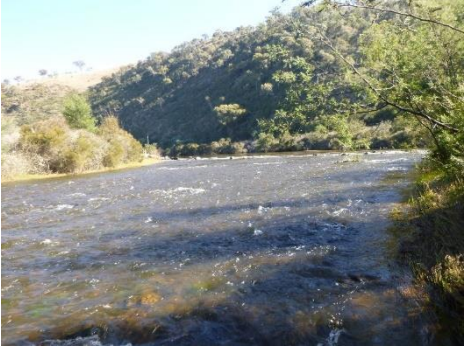
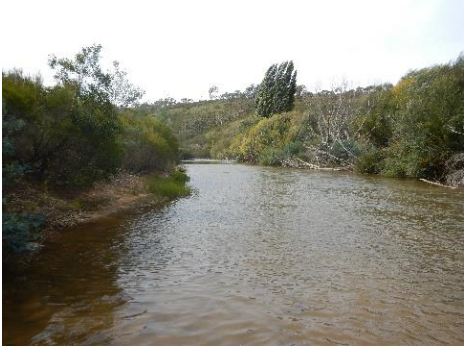
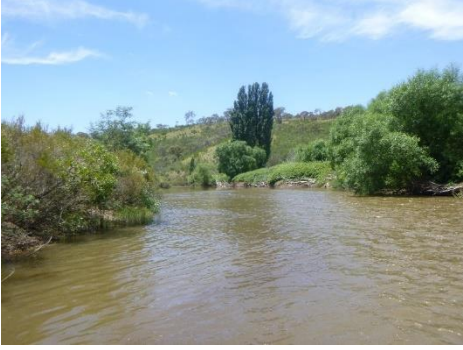
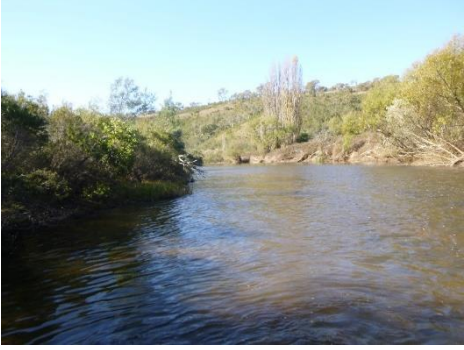
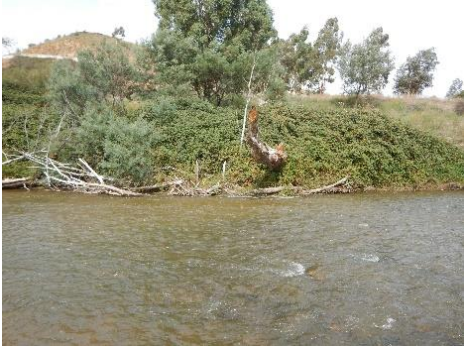
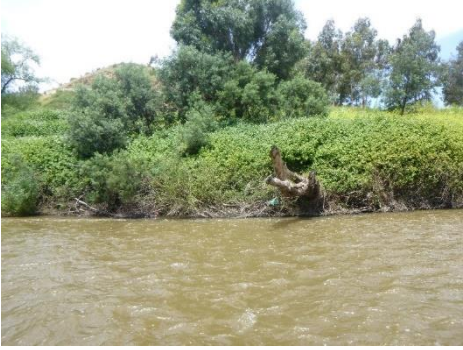
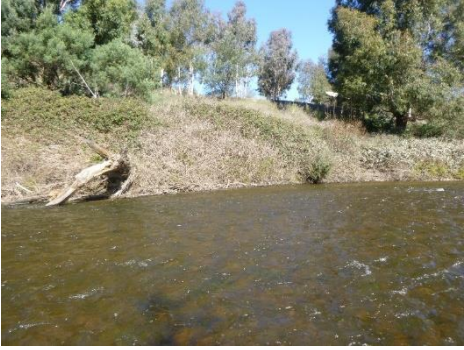
Plate 4-4 Geomorphology photo point 3 at Angle Crossing MUR19

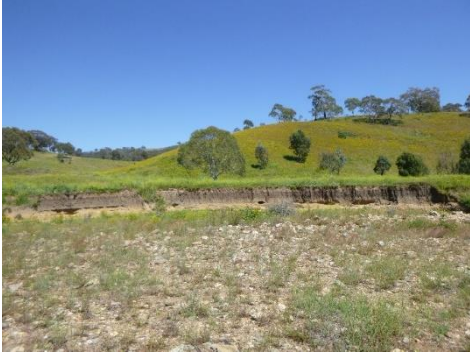
Plate 4-16 Vegetation extent and geomorphology photo point 3 downstream of Pool 29

Downstream of Pool 29 - There have been minimal changes in the vegetation downstream of Pool 29 since autumn 2020 (Plate 4-14 through to Plate 4-16). Within the channel there are three trees at the site, a native *Acacia dealbata* (Silver Wattle) on the right bank and introduced *Populus* sp. (Poplar) and *Salix* sp. (Willow) on the left bank. The vegetated bars within the channel are dominated by weeds with dense patches of *Rubus fruticosus* (Blackberry) along the water's edge, and other common weeds across the bar including *Hypericum perforatum* (St. John's Wort), *Conyza* sp. (Fleabane), *Verbascum* sp. (Mullein) and various thistles. There is also considerable coverage by grasses, including native *Poa* spp. and introduced *Phalaris* sp. (Canary Grass) and *Paspalum dilatatum* (Caterpillar Grass). Sections of both banks are bare. The vegetation was denser in spring 2020, than in either autumn 2020 or autumn 2021 which is not surprising given the die-back of introduced species.

Downstream of Pool 29 - There are large eroding sections of bank downstream of Pool 29 (Plate 4-14 through to Plate 4-16). However, there are no signs of significant bank slumps or large-scale bank erosion since spring 2017. There are some signs that sediment is being moved within the channel. For example, during autumn and spring 2020 there was an accumulation of sediment at the base of the bank that is likely due to a previous slumping event (photo point 2c in Plate 4-15). This sediment appears to have been relatively stable given it was covered in grasses and other vegetation. In autumn 2021, this sediment has been removed from the site, possibly during elevated flows. Despite this, bars within the channel appear to have neither increased nor decreased in size and the vegetated island in the riffle habitat also appears stable.

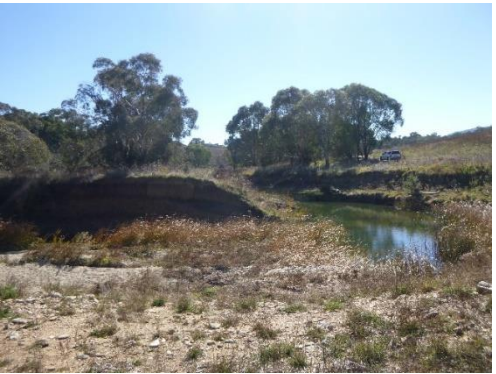
Plate 4-18 Vegetation extent and geomorphology photo point 2 at BUR2c

BUR 2c - There was evidence of slight growth in the vegetation at site BUR2c between since autumn 2020, particularly in spring 2020 (Plate 4-17 through to Plate 4-20). The site has limited vegetation close to the creek despite the wider surrounds having numerous large *Eucalyptus* spp. The banks are bare in some sections. However, part of the banks and most of the floodplain is covered by grasses, mostly *Poa* spp., and weeds such as *Verbascum* sp. (Mullein), *Hypericum perforatum* (St. John's Wort), *Rubus fruticosus* (Blackberry) and various thistle species. Several small *Populus* sp. (Poplar) and *Salix* sp. (Willow) are present within the macro-channel. Instream vegetation is dominated by *Typha orientalis* (Broad leaf Cumbungi), while *Schoenoplectus validus* (Great Bulrush) is also present in smaller patches.

BUR2c - There are large steep banks at this site and it is clear slumping and erosion have occurred overtime (Plate 4-17 through to Plate 4-20). However, there has not been significant increases in erosion since 2017. This area has previously been identified as an area for high erosion potential (GHD, 2015). This expected to occur during future high flow periods.

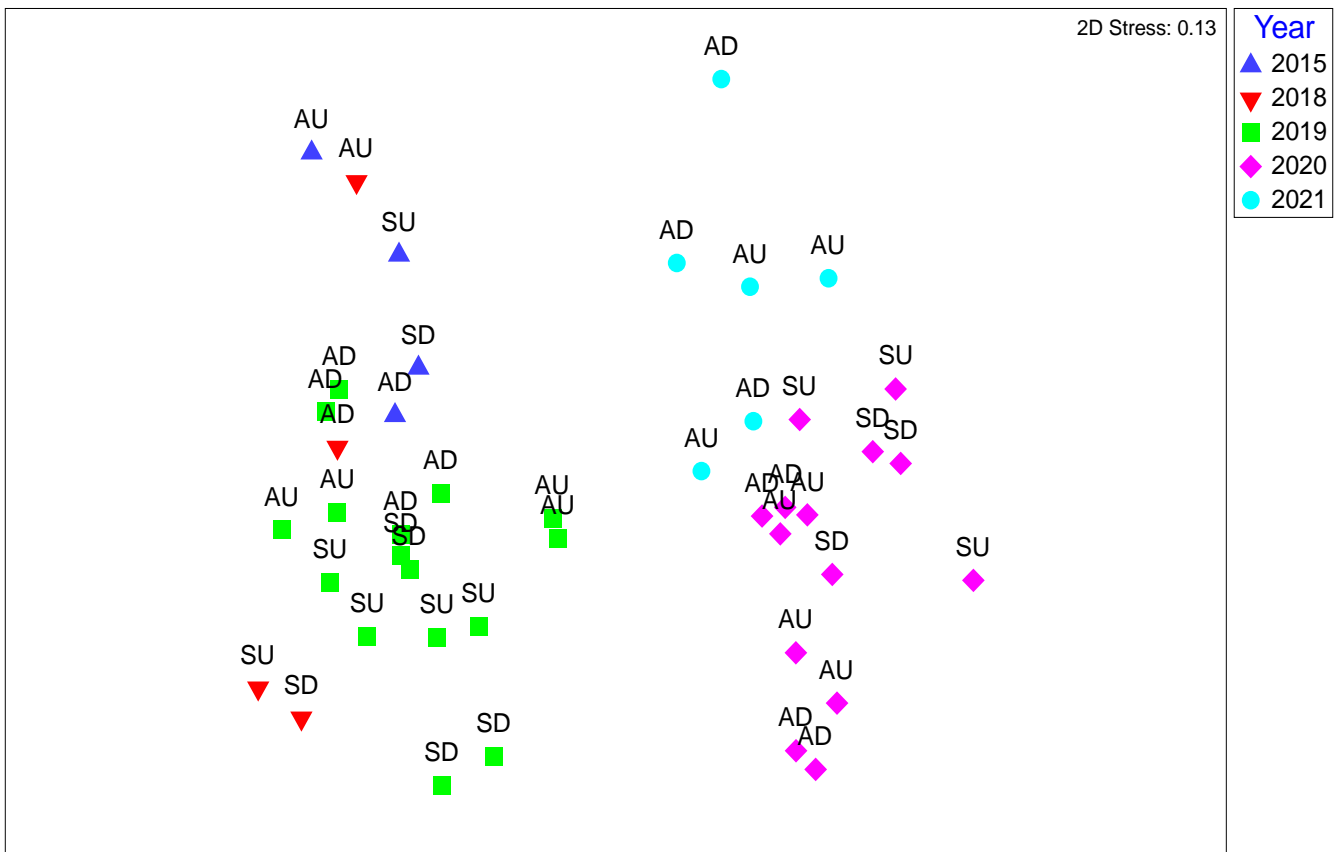
The patterns of the NMDS were confirmed by the PERMANOVA that detected no significant differences in community composition upstream and downstream of the abstraction (Pseudo-F = 2.1, P = 0.128). Given there were no obvious or statistical differences upstream and downstream of the abstraction point, no SIMPER analyses have been undertaken.

Figure 4-11 NMDS ordination of macroinvertebrate communities associated with edge habitats associated with Burra Creek. A = autumn and S = spring; U = upstream and D = downstream

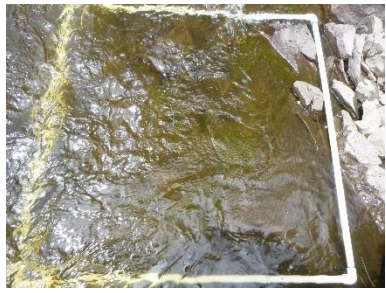
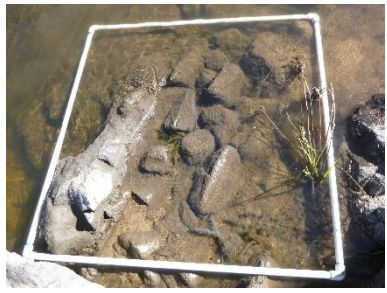
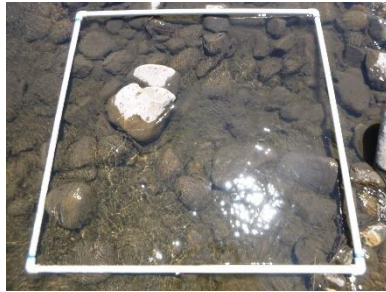
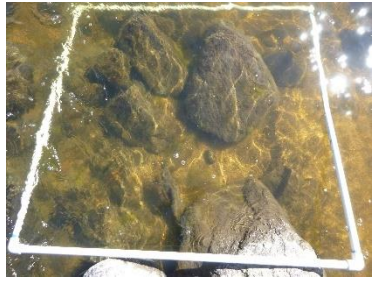
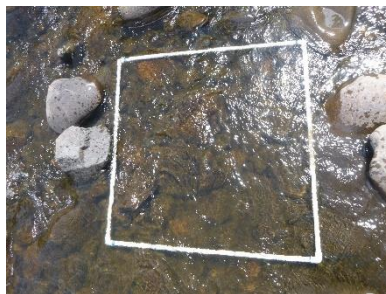
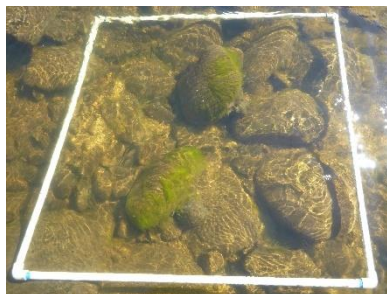
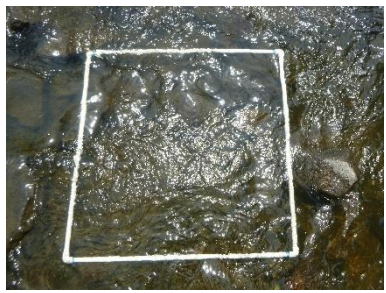
Plate 4-21 Photographs showing periphyton coverage in riffles of the Murrumbidgee River at MPS sites

Photographs of periphyton in the Murrumbidgee River are presented in Plate 4-21. Across the two seasons, there was no indication of increased periphyton coverage at sites downstream of the discharge point into Burra Creek.

MUR935 and MUR936 - Periphyton cover at MUR935 and MUR936 was similar at both sites in all seasons with a coverage of approximately 35-65%. *Persicaria* sp. was the dominant macrophyte species and there was no evidence to suggest an increase in periphyton downstream of the MPS.
