Icon Water Limited
Murrumbidgee Ecological Monitoring Program
Observation Report – Autumn 2021
Impact Monitoring Round 5

May 2021

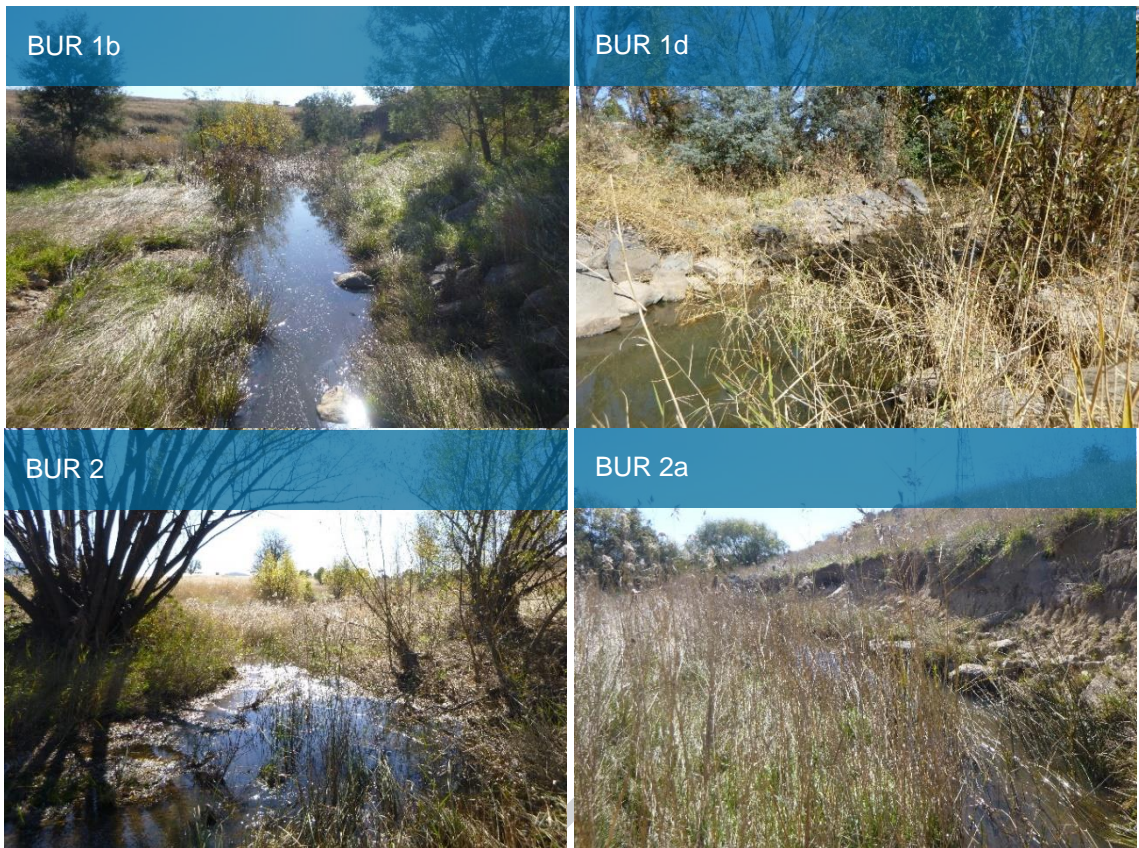
Plate 2-1 Photos of the Burra Creek monitoring sites

Despite the heavy rainfall and increased flow, the channel continued to contain dense beds of aquatic macrophytes in the form of reeds (*Typha* spp. and *Phragmites australis*), and sedges (Great Bulrush - *Schoenoplectus validus*). However, there was evidence that this vegetation was been impacted by flow and was not as healthy compared to spring 2020 (Plate 2-1). There was no noticeable increase in algae growth or periphyton cover in Burra Creek (Plate 2-2).

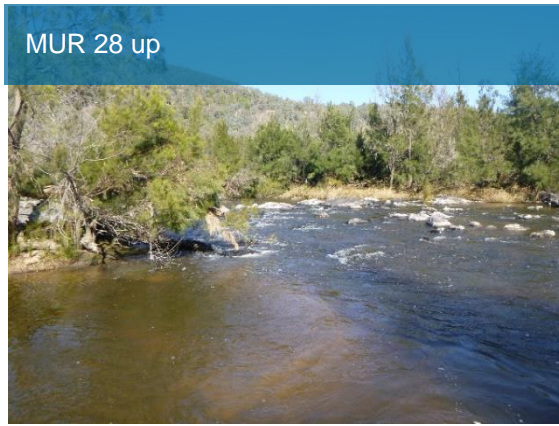
Plate 2-5 Photos of the Murrumbidgee River (MPS) sampling sites

As per the requirements of the impact monitoring, two replicate riffle samples were collected from each site. There was no noticeable increase in algae growth or periphyton cover in the Murrumbidgee River (Plate 2-5).
