Bulk Water
Alliance

Murrumbidgee to Googong Water Transfer - Terrestrial Ecology Management Plan

BWA-M2G-EN-ECP-007-2

January 2012

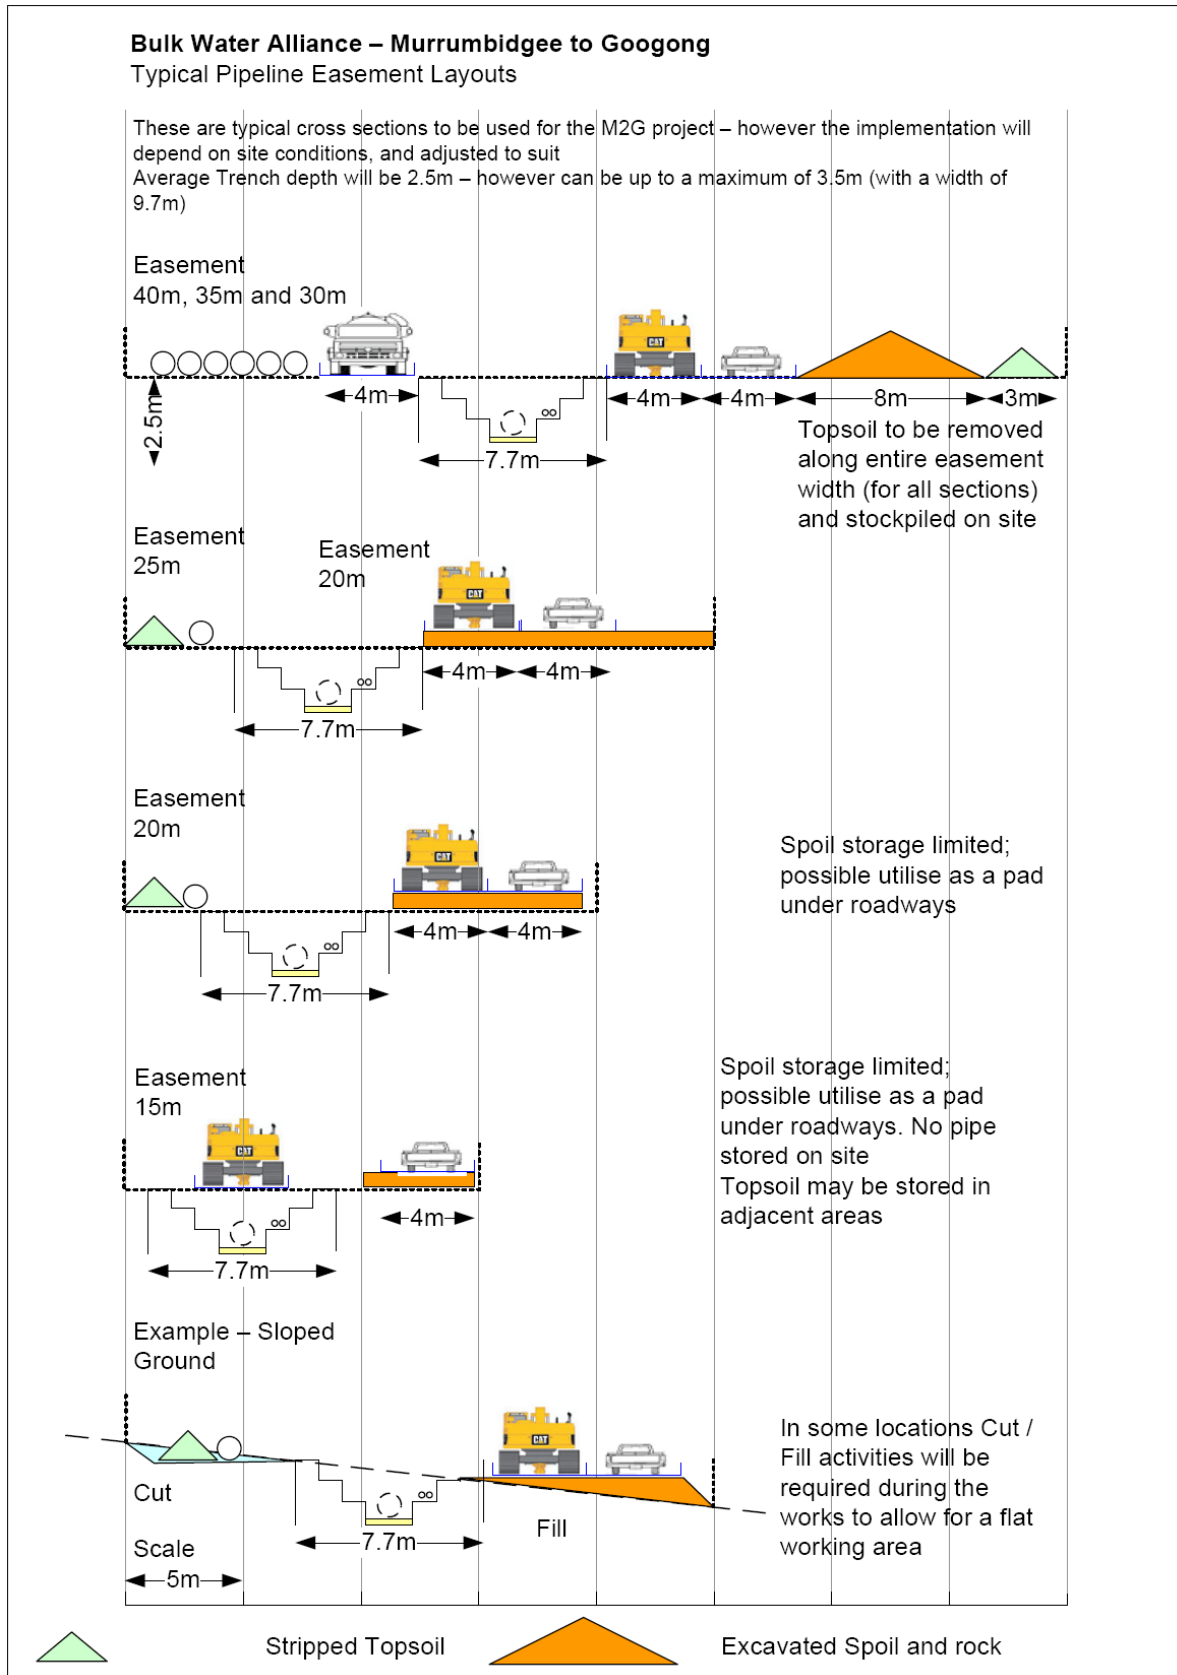
Appendix A Typical Pipeline Easement Layouts
