BIOLOGICAL RESPONSE TO FLOWS DOWNSTREAM OF CORIN, BENDORA, COTTER AND GOOGONG DAMS

Annual report July 2018

Report to Icon Water

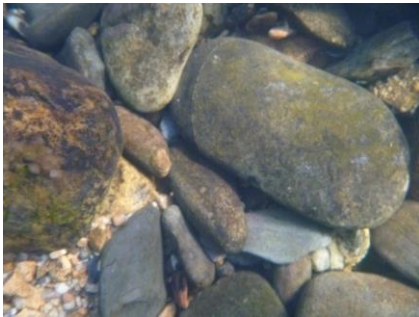
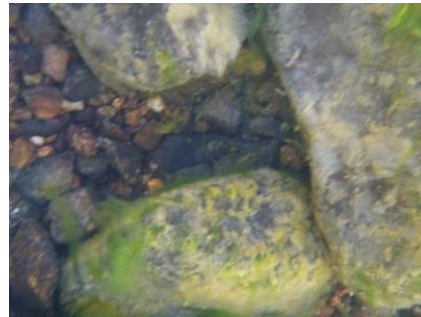
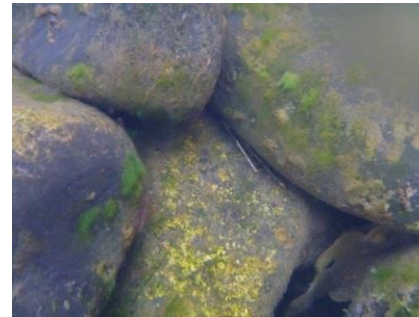
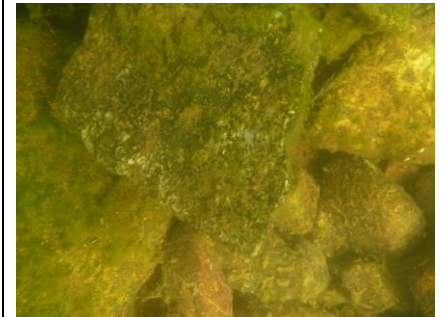
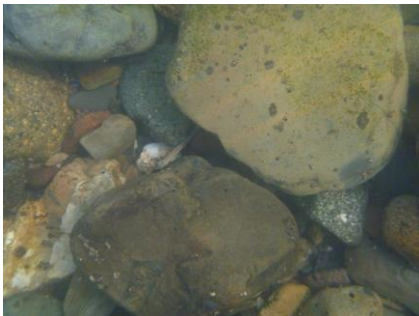
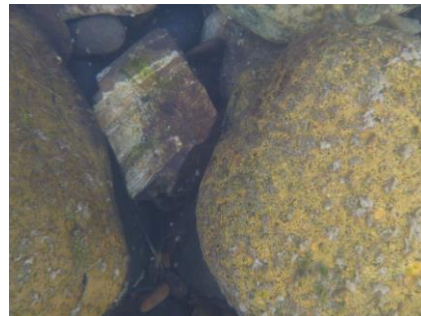
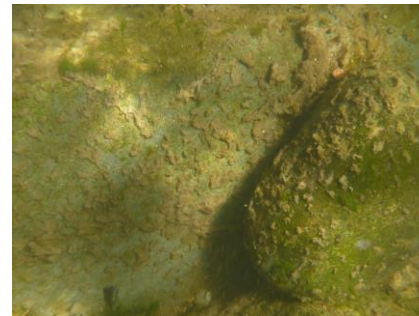
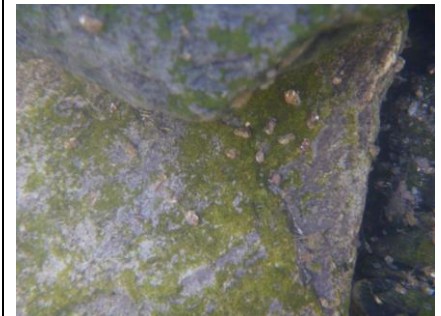
Figure 3. Filamentous algae and periphyton cover of riffle bed sediments at below dam test sites and corresponding reference sites on the Goodradigbee and Queanbeyan Rivers in **spring 2017**.

The environmental flow ecological objective of <20% cover of filamentous algae in riffle habitats was achieved at all below dams test sites except for CM3 and QM2 in spring 2017 and reference site QM1 in autumn 2018, which had >20% filamentous cover. Field observations of periphyton cover of riffle habitats were <20% in most of the sites, except for sites CM3, QM2 and GM3 in spring 2017 and site QM1 in autumn 2018 where >20% periphyton cover has been observed (Table 7; Figure 3 and Figure 4).

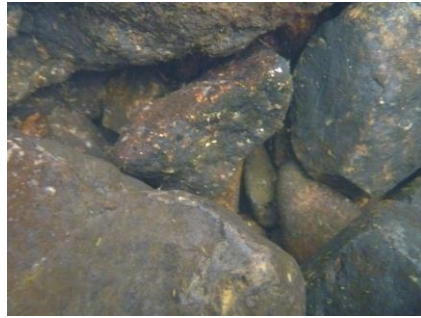
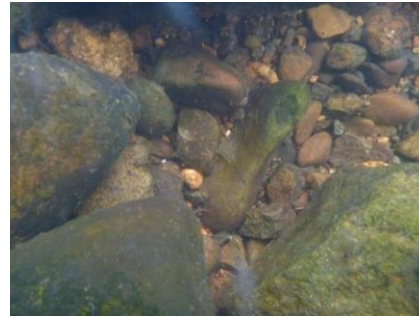
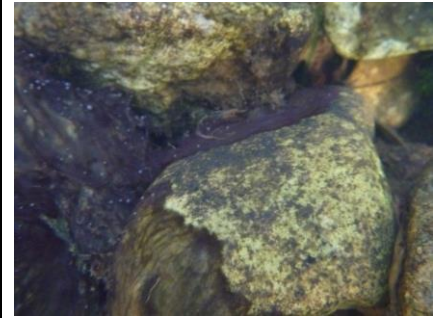
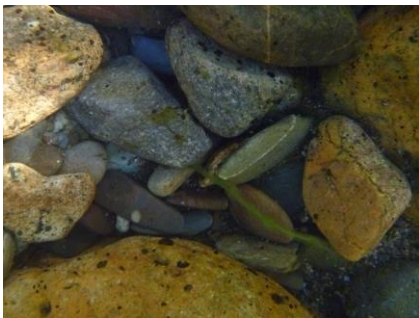
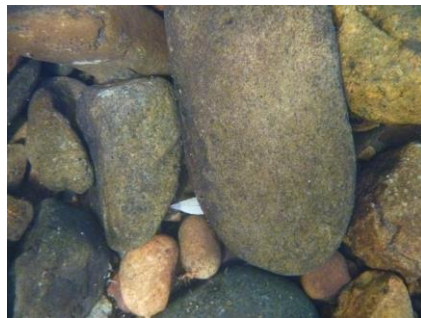
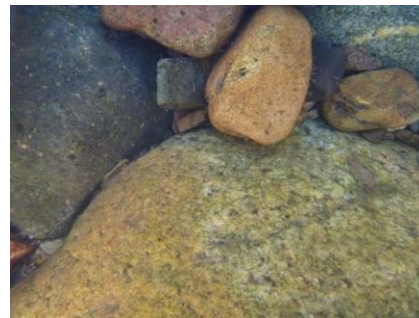
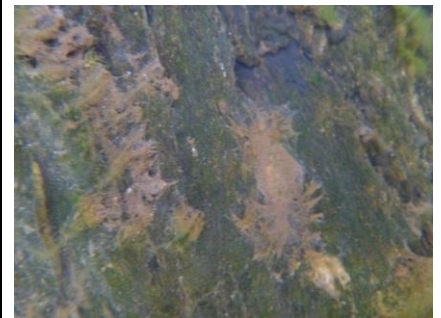
Figure 4: Filamentous algae and periphyton cover of riffle bed sediments at below dam test sites and corresponding reference sites on the Goodradigbee and Queanbeyan Rivers in **autumn 2018**.

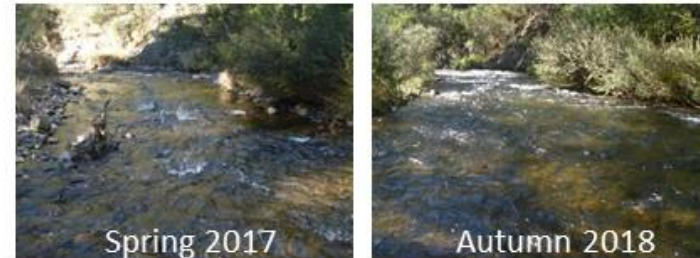
Downstream of Corin Dam

Environmental flow ecological objective	Spring 2017	Autumn 2018	Objective met?
AUSRIVAS band A	Band B	Band B	No
<20% filamentous algae cover in riffle habitat	<20%	<20%	Yes

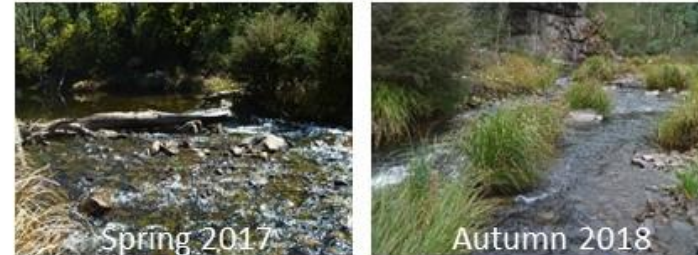
Downstream of Bendora Dam

Environmental flow ecological objective	Spring 2017	Autumn 2018	Objective met?
AUSRIVAS band A	Band B	Band B	No
<20% filamentous algae cover in riffle habitat	<20%	<10%	Yes

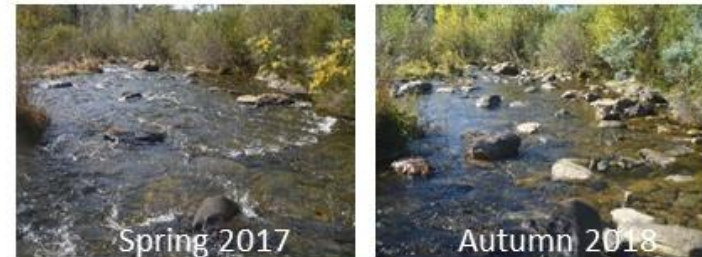
2km Downstream of Googong Dam

Environmental flow ecological objective	Spring 2017	Autumn 2018	Objective met?
AUSRIVAS band A	Band B	Band C	No
<20% filamentous algae cover in riffle habitat	<20%	<10%	Yes
