# BIOLOGICAL RESPONSE TO FLOWS DOWNSTREAM OF CORIN, BENDORA, COTTER AND GOOGONG DAMS

Spring 2020

Summary report to Icon Water

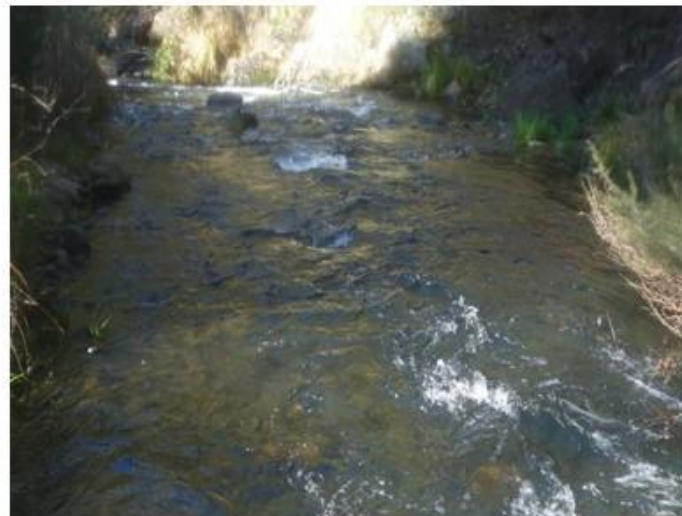
# CM1 – Spring 2020

Environmental flow ecological objective	Autumn 2020	Spring 2020	Objective met?
AUSRIVAS band A	Band B	Band B	No
<20% filamentous algae cover in riffle habitat	<10%	<10%	Yes

\* Denotes values outside guideline levels

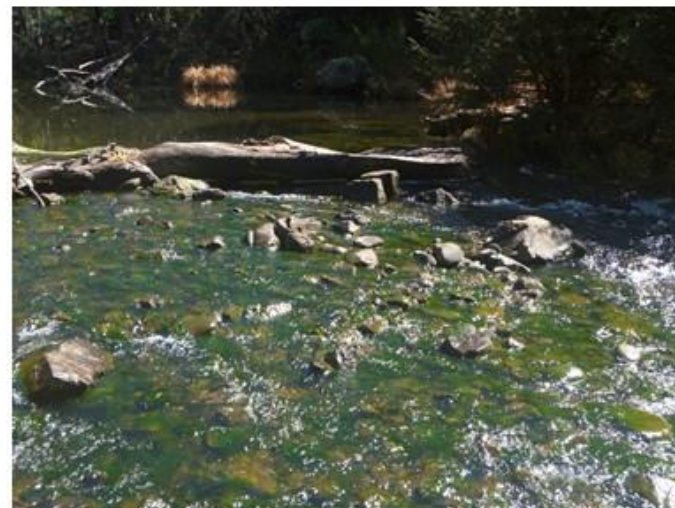
# CM2 – Spring 2020

Environmental flow ecological objective	Autumn 2020	Spring 2020	Objective met?
AUSRIVAS band A	Band B	Band B	No
<20% filamentous algae cover in riffle habitat	<10%	40%	No

\* Denotes values outside guideline levels

- Test site CM2 did not meet the environmental flow ecological objective of <20% cover of filamentous algae in riffle habitats. It is possible that low discharge resulted in lack of flow disturbance and an increase in filamentous algae growth prior to sampling.

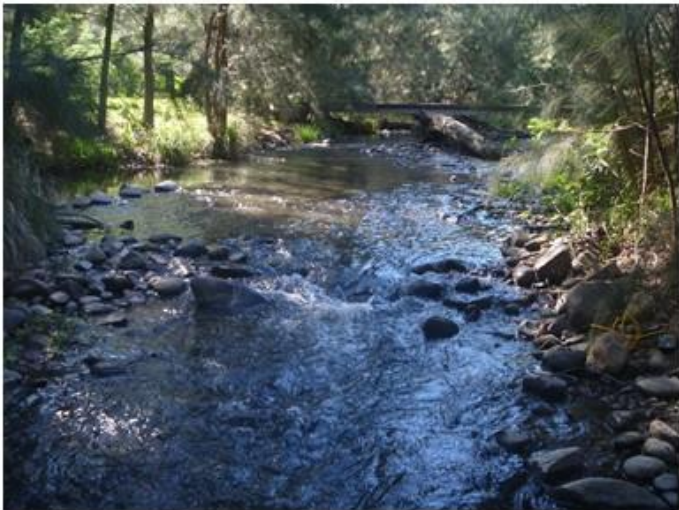
# CM3 – Spring 2020

Environmental flow ecological objective	Autumn 2020	Spring 2020	Objective met?
AUSRIVAS band A	Band A	Band B	No
<20% filamentous algae cover in riffle habitat	<10%	<10%	Yes

\* Denotes values outside guideline levels

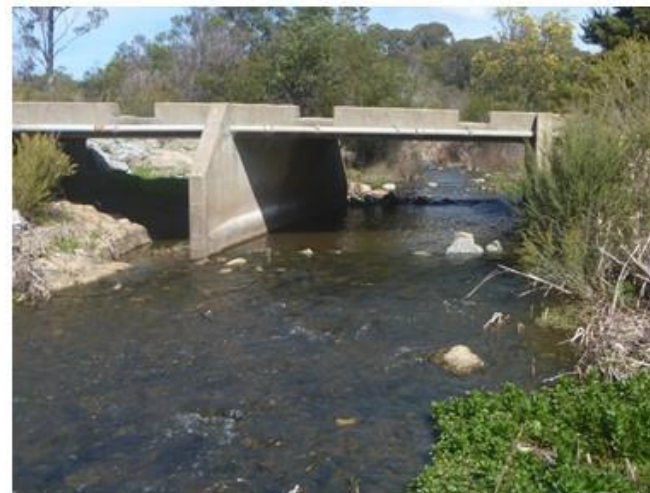
# QM2 – Spring 2020

Environmental flow ecological objective	Autumn 2020	Spring 2020	Objective met?
AUSRIVAS band A	Band C	Band A	Yes
<20% filamentous algae cover in riffle habitat	<10%	<10%	Yes

\* Denotes values outside guideline levels

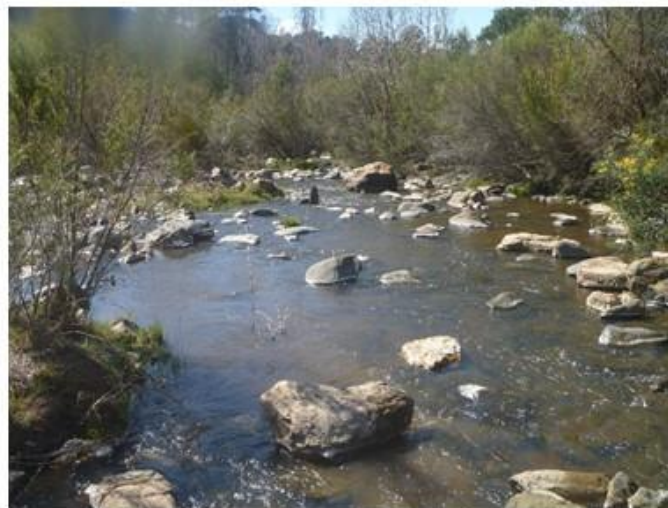
# QM3 – Spring 2020

Environmental flow ecological objective	Autumn 2020	Spring 2020	Objective met?
AUSRIVAS band A	Band B	Band B	No
<20% filamentous algae cover in riffle habitat	<20%	<10%	Yes

\* Denotes values outside guideline levels
