# 2020 Monitoring of Two-spined Blackfish (*Gadopsis bispinosus*) in relation to Environmental Flows

Conservation Research Report to Icon Water

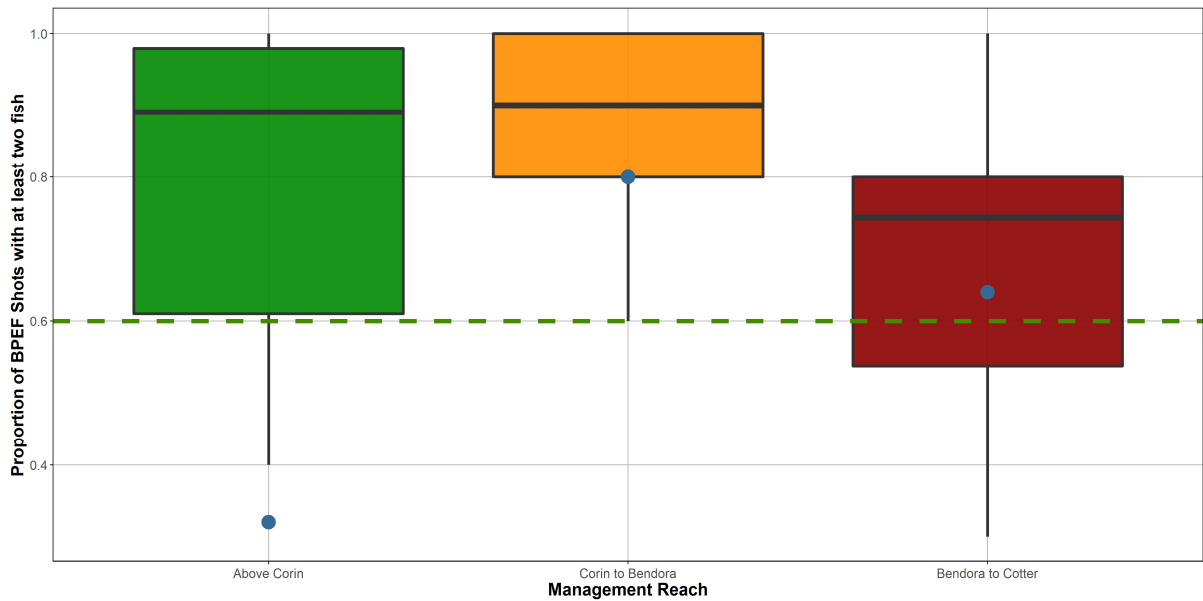
Comparing this year's results for catch (greater than 2 Blackfish per shot) against the programs long term performance showed 2020 was lower than the mean in all reaches and the lowest recorded in the Above Corin unregulated reach (Figure 2).

Figure 2. Proportion of Backpack electrofishing (BPEF) shots in a reach with 2 or more Blackfish 2009-2020 (Icon and ACT gov data combined). Blue dots are the 2020 value for each reach, compared to a box and whisker plot of 2009-2019. Green dashed line is the 60% of shots indicator and the grey line within the box is the long-term mean.

Table 3 and Figure 2). The recruitment indicator of more than 30 % of the catch in each environmental flow reach being juveniles less than 120 mm TL was also met for both reaches.

Corin to Bendora regulated reach (only one site), received its required environmental flow through this period. However, for long periods of 2019 and early 2020 the characteristic large transfer flow of water for abstraction at Bendora (usually between 100–250 ML/day) was not discharged. The reach was also impacted by the 2020 Orroral Valley Fire, though not to the extent of the Above Corin unregulated reach, with approximately 30% of its catchment burnt (ACT Government, *unpublished data*). The reach achieved the indicators for breeding and catch but was comparatively low in Blackfish catch compared to previous surveys (Figure 2). Additional sites would be required in this

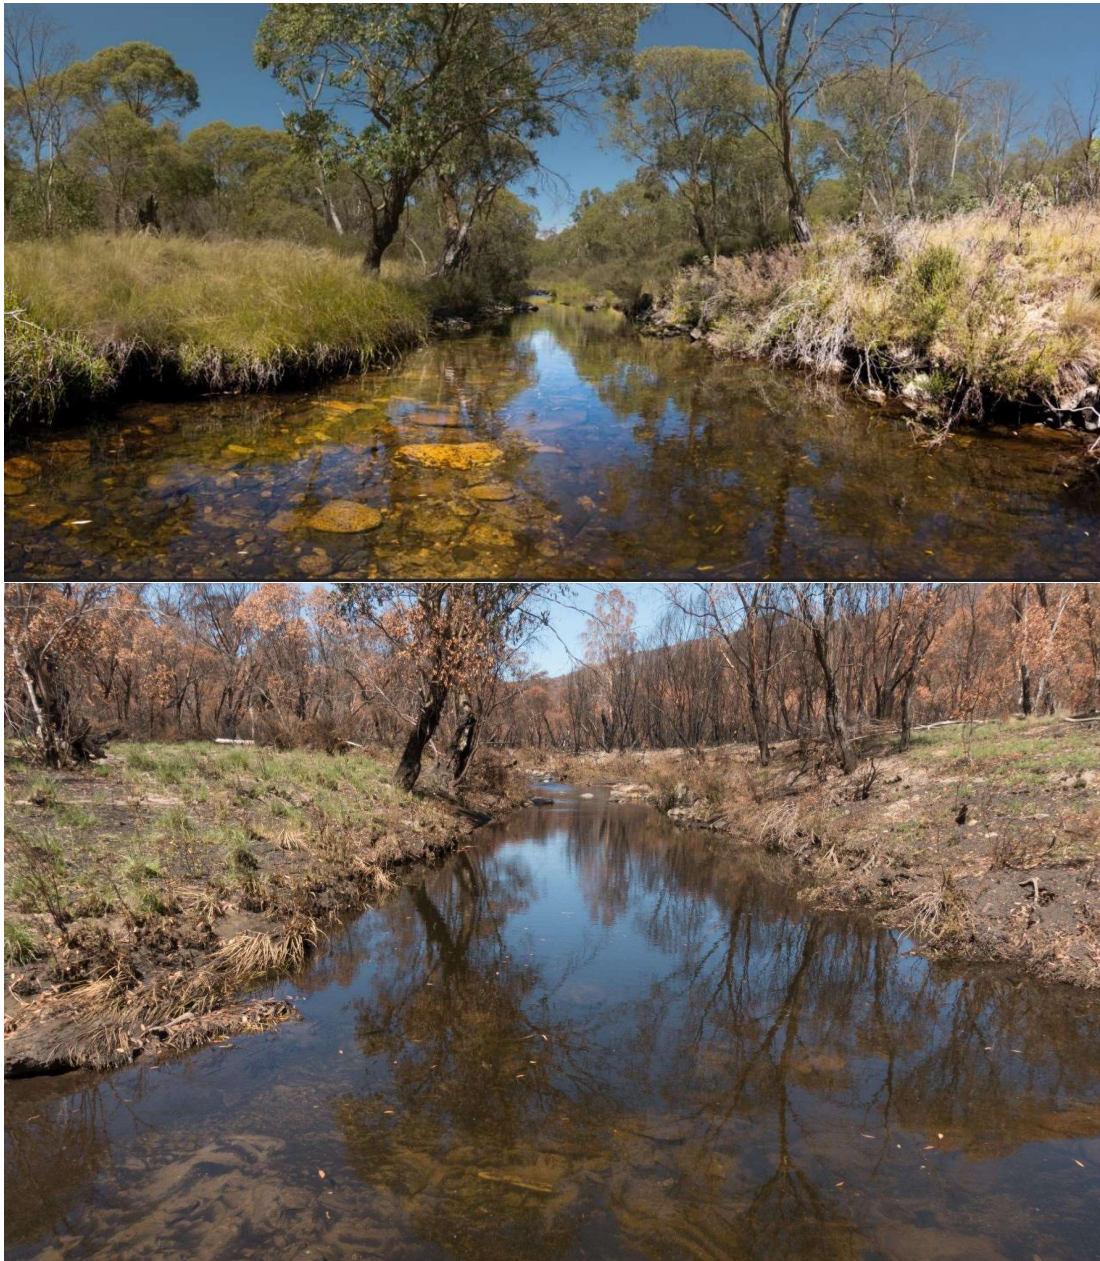
*Figure 10 Lickhole Crossing Site in the Above Corin reach, before and after the 2020 Orroral Valley Fire.*

Note the sedimentation covering the cobble substrate in the foreground post-fire. Cobble substrate is critical for Blackfish as it provides shelter, feeding and breeding habitat in the spaces under the rocks. These spaces are filled by post-fire sediment.

Erosion from the bushfire ground upper catchment is delivering a large volume of sediment and other debris into the river and reservoirs both in the above Corin and Corin to Bendora Reaches. This is a major threat to Blackfish as it smothers the rock habitat they rely on and results in more rapid heating in summer due to the shallow water.

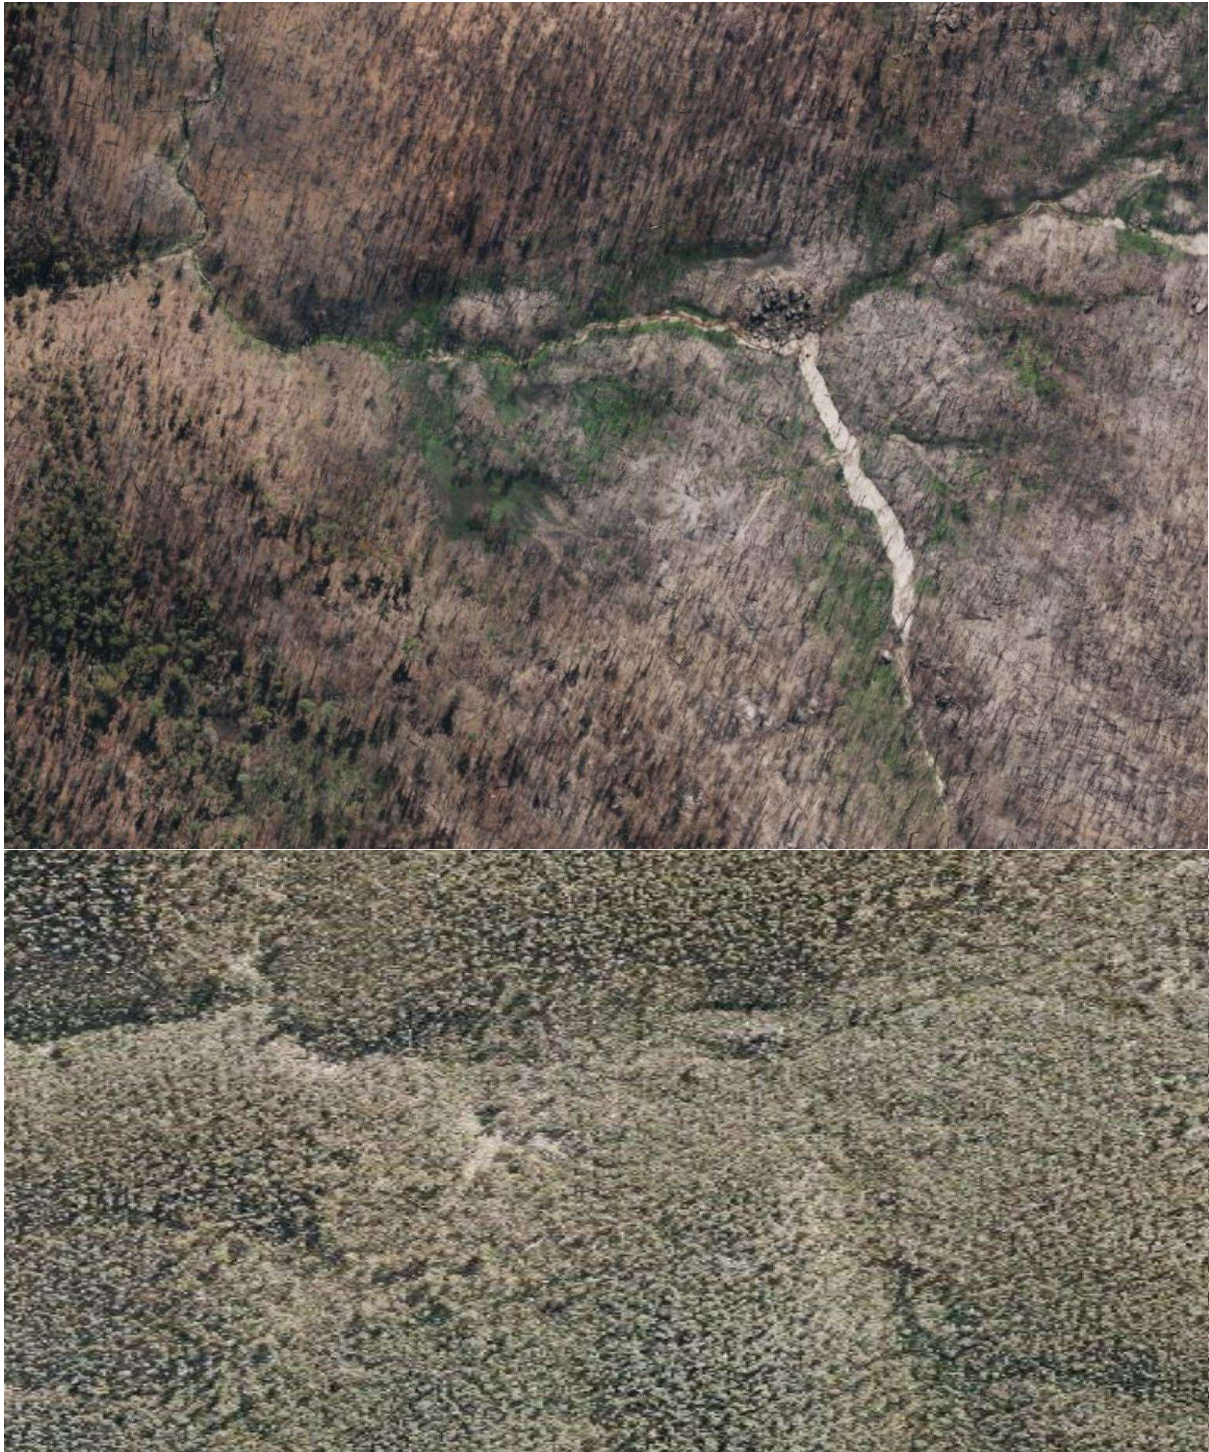
*Figure 11. Pond Creek in the upper Cotter Catchment in 2017 and March 2020 with a large sand slug.*
